A summary and analysis of bridge failures

A SUMMARY AND ANALYSIS OF BRIDGE FAILURES

A Thesis Submitted to the
Graduate Faculty in Partial Fulfillment of
The Requirements for the Degree of
MASTER OF SCIENCE

Major Subject: Structural Engineering

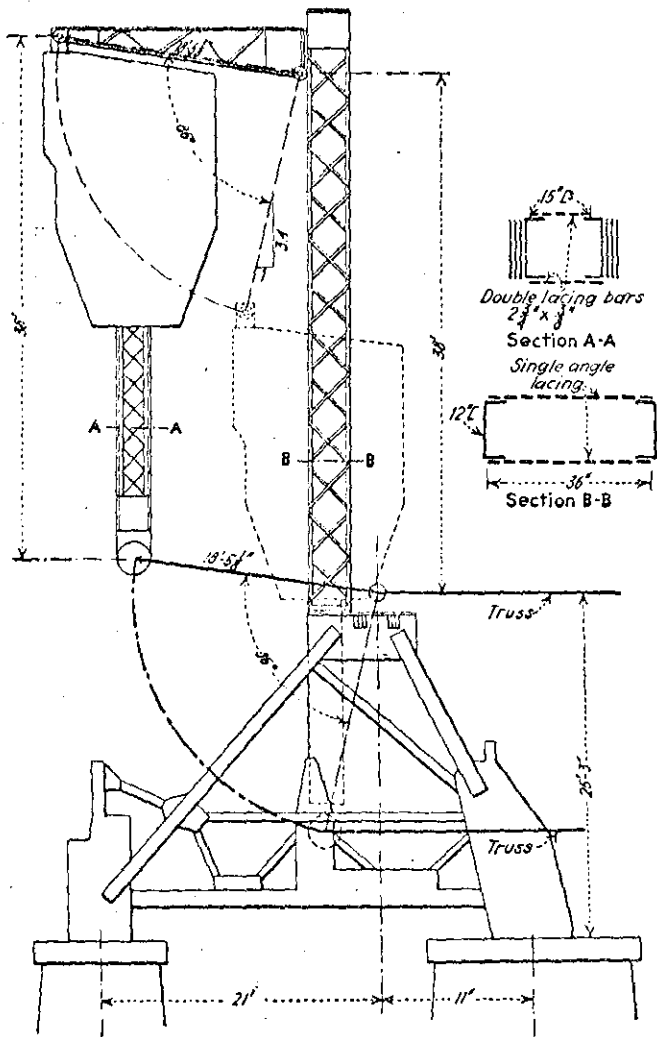
Figure 1. Diagram of counterweight system of Hackensack River Bridge (52)

The bridge consisted of a counterweight system as shown in Figure 1. The counterweight consisted of a block of concrete 20'-0" high, 11'-6" wide and 48'-10" long and weighed 750 tons. The vertical distance of the bottom of the counterweight above the roadway varied from 7 to 29 feet. The failure took place when the counterweight was approximately at the half-way point, at which time the span together with the counterweight fell into the river. The failure took place in the north leg of the counterweight tower. There was a complete fracture at the base of the leg. The leg being made up of channels with lacing showed a partly rusted tension break in the rear channel and a bending and tensile break in the other resulting in a forward thrust of the counterweight into

The Strauss Engineering Corporation of Chicago, the bridge designers, made their own analysis as to the cause of the failure. They reported that the failure was due to abnormally high friction developed at the counterweight trunnion bearing (tail bearing) of the north truss

After an investigation by Strauss Engineering Corporation it was concluded that the prime cause of the failure was the abnormally high friction developed at the counterweight trunnion bearing of the north truss which was a result of poor lubrication and poor quality bronze bushings.

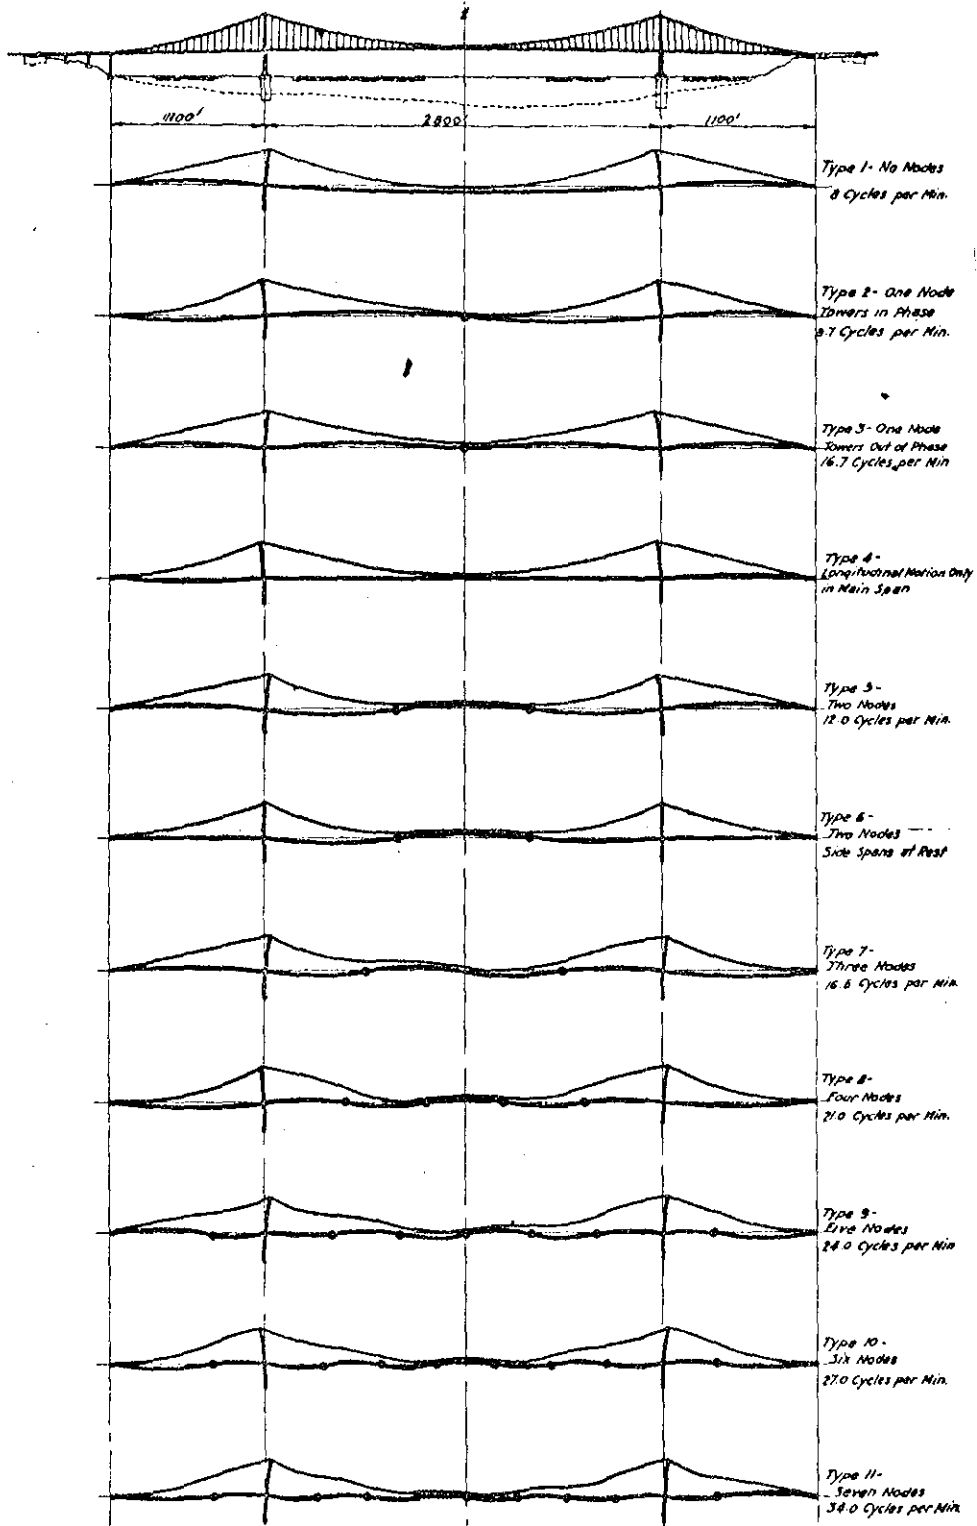
Figure 4. Modes of oscillations of Tacoma Narrows Bridge (56)

About an hour before collapse the vibration was in two segments with a node at the center of the main span, the two sides of the roadway began to vibrate out of phase with each other resulting in one side

going up while the other side was going down. Many photographs have shown this particular action. The deck would tilt to about 30° with the horizontal and the amplitudes increased to about 14 feet. The difference in elevation of the two sides of the roadway would be about 28 ft. at maximum amplitude.

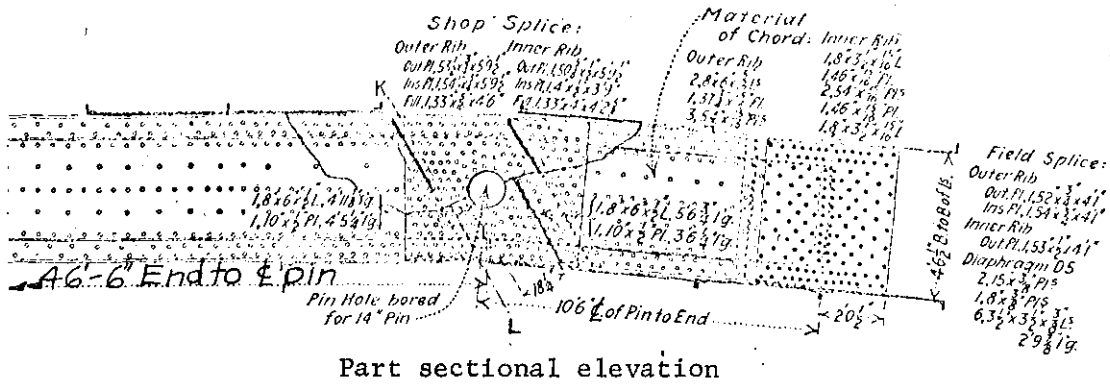
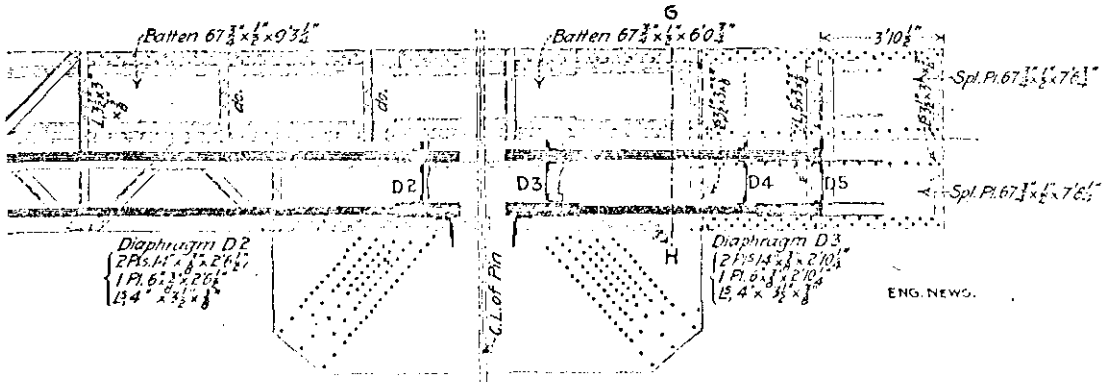
Figure 7. Member A9L of First Quebec Bridge (57)

The deflection of the member was discovered about three days prior to the collapse. A careful watch was made of it for the next two days and no more deflection was noticed but the latticing began to show signs of severe stress. A telegram was sent by the inspector in charge of erection, Mr. McClure, to Mr. Cooper. Mr. Cooper immediately wired the

The compression member A9L was constructed of four massive plate webs each made up of four rolled plates, stitch-riveted together to form

one built up plate nearly 4 in. thick. These four webs were bound together by latticing so as to act as one member. The outside dimensions of the member were 5'-7 1/2" x 4'-6 5/8". The member was reported to have had a kink in one of the inner webs before it left the fabricating shop. The member was also involved in a railway accident during shipment to the site. It was reported that the member had been repaired with excellent workmanship. It is very improbable that the workers would have placed the member in its position in the bridge had it not been straight. The length of the member was 57 ft. and if the deflection of 2 in. existed before erection it would have been noticed and rejected. The resident engineer said the deflection had always been in the member and the deflection was not caused by overstress. This was not the feeling of the other responsible men on the job. Every member was inspected by several people and it is not probable that it would go unnoticed in such an important and massive structure.

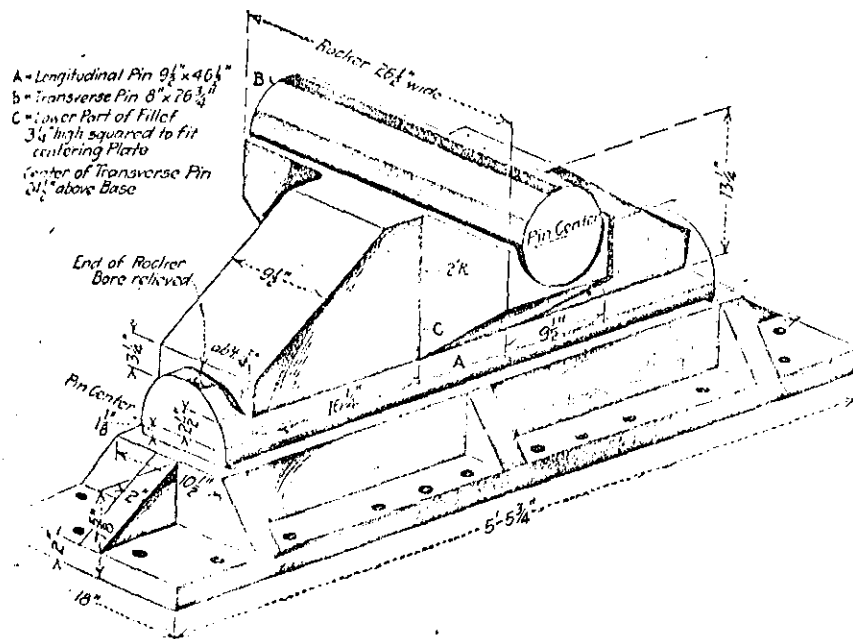
Figure 10. Diagram of rocker used for hoisting suspended span of the Second Quebec Bridge (12)

girder (see Figure 10). The lifting girder was then connected to the lifting hangars as shown in Figure 11. There seemed to be a possible unstable condition here because the point at the connection to the hangar chains was at about the same elevation as the universal joint. With the truss supported about 4 ft. above this point a small amount of eccentricity would tend to tip the girder. It was first thought that fracture of the rocker casting was the cause. However the dropping of the corner of the truss could have caused a sudden thrust and a possible rotation of the girder, allowing the one corner of the span to slip off and into the river. Every precaution had been taken to keep the span level during the jacking. The lifting chains and girders were all in good condition

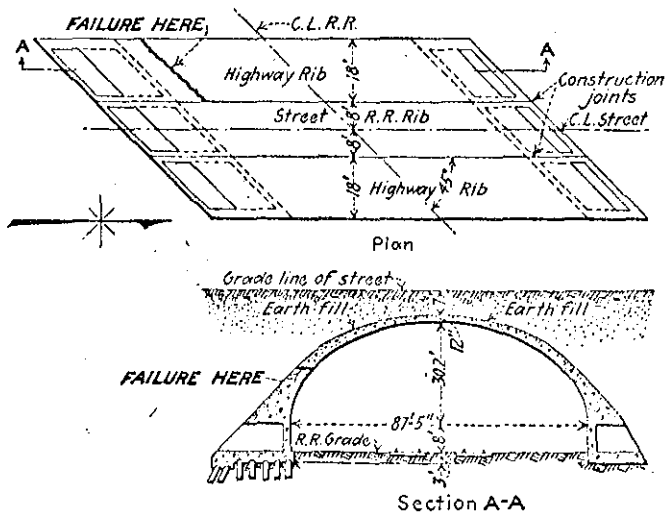
Figure 15. Sketch showing crack in Tacoma, Washington Bridge (39)

The bridge was an unusual type as shown in Figure 15. The shape of the arch was elliptical and carried a considerable amount of earth load as well as a railroad and two highway lanes. The width of the arch was 52 ft. which was made up of three separate arches of 18 ft., 16 ft., and 18 feet. These arches acted completely independent of each other.

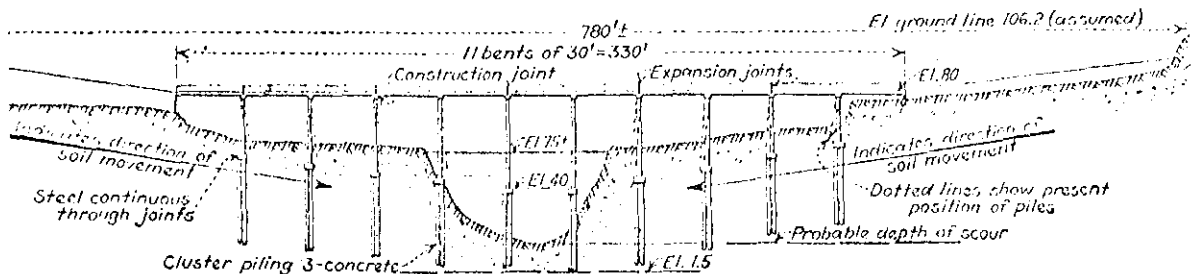
Figure 18. Reinforced concrete trestle over New River in Imperial Valley, showing movement of bents (40)

In early 1920 there appeared to be a lateral movement of the center of the bridge indicated by cracks forming with apparent tilting of the

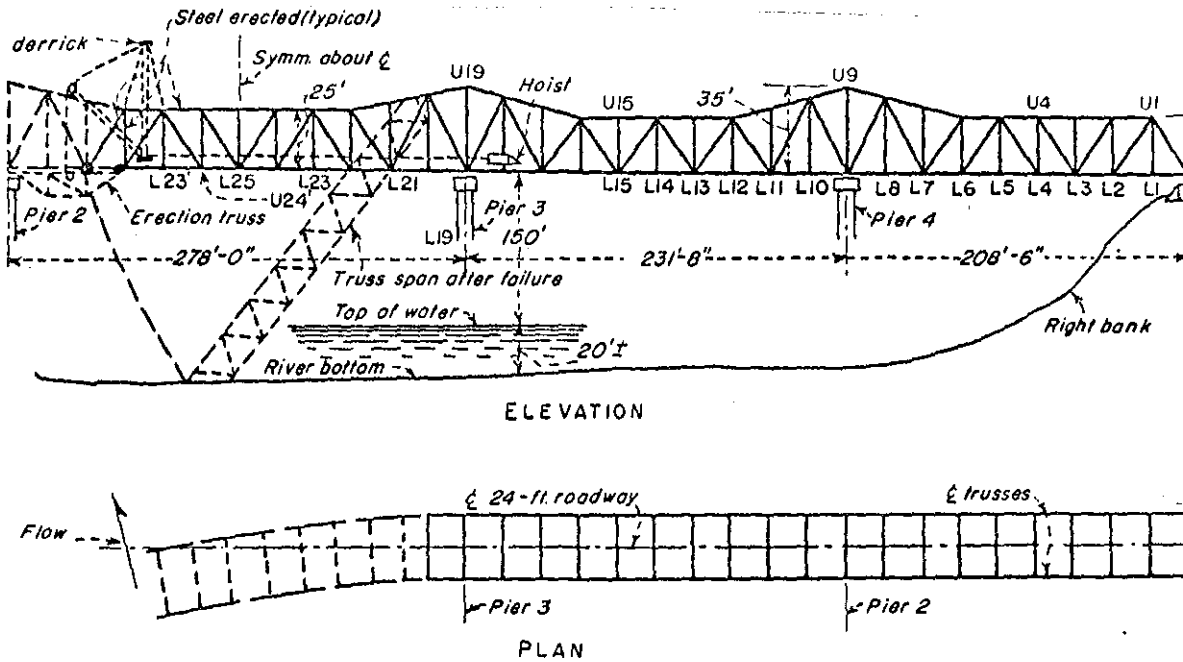
Figure 21. Details of Bluestone River Bridge showing collapsed center span (84)

At the time of the collapse there were attempts being made to beef up some of the main truss members to resist some of the erection stresses. The top chord which broke had been increased from a design section of two 13 in. channels of 31.8 lbs. per ft., and one 22 in. by 1/2 in. cover plate to two 13 in. ship channels at 50 lbs. per ft. and one 22 in. by 1/2 in. cover plate. The erection truss which was being placed in position at the time of the accident was to be under the downstream truss. The other erection truss was not in position at the time. The weight of the erection truss was about 5 tons and was being boomed out by the derrick to be suspended beneath the main truss. It
