Bridge deck condition assessment using destructive and nondestructive methods

Brandon Tyler Goodwin

A THESIS

MASTER OF SCIENCE IN CIVIL ENGINEERING

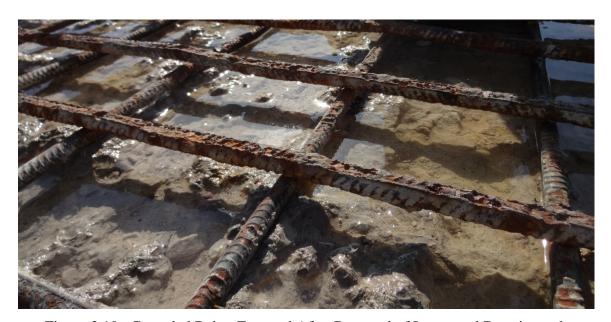
Figure 3.10. Corroded Rebar Exposed After Removal of Loose and Deteriorated Concrete by Hydrodemolition

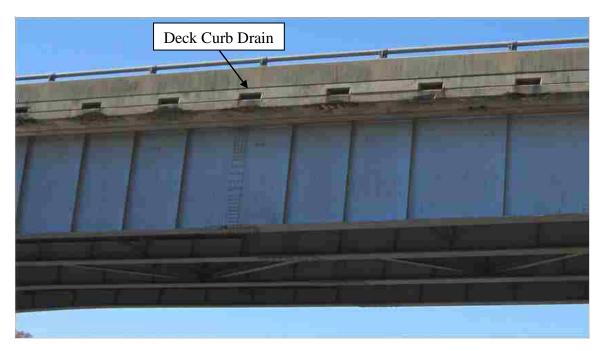
During the investigation, it was noted by researchers that the bridge experienced a large amount of deflection or vibration during heavy traffic loading. The bridge also contained deck drains within the curb. These drains were spaced along both curbs of the bridge. Heavy deterioration was noted around these drains, especially on the side and bottom of the deck as shown in Figure 3.17 below. More detailed findings were noticed with the visual inspection, GPR, cores, and the survey of the post-hydrodemolition deck. See Appendix A for bridge drawings, which include visual inspection findings and GPR results, along with the lidar survey of material removal during the rehabilitation. A complete digital version of the A1479 Bridge Investigation Drawing is included in the Digital Appendix which is further discussed in Appendix F.

Figure 3.17. Bridge A1479 Deterioration of the Deck Soffit Around Curb Drains

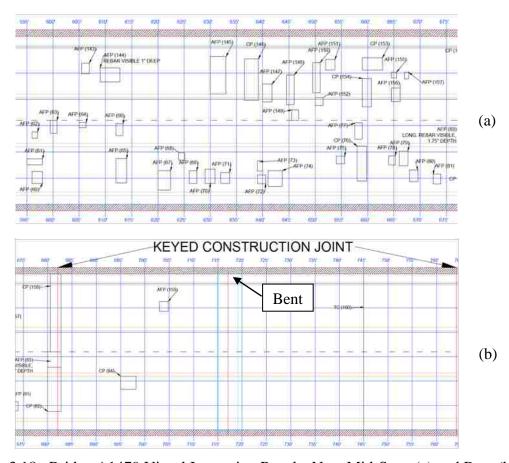
reinforcing bars visible. The majority of the documented defects were located mid-span of the girders (i.e., between the bents). Few defects were noted near the bents as illustrated in Figure 3.18 below.

Figure 3.18. Bridge A1479 Visual Inspection Results Near Mid-Span (a) and Bent (b)

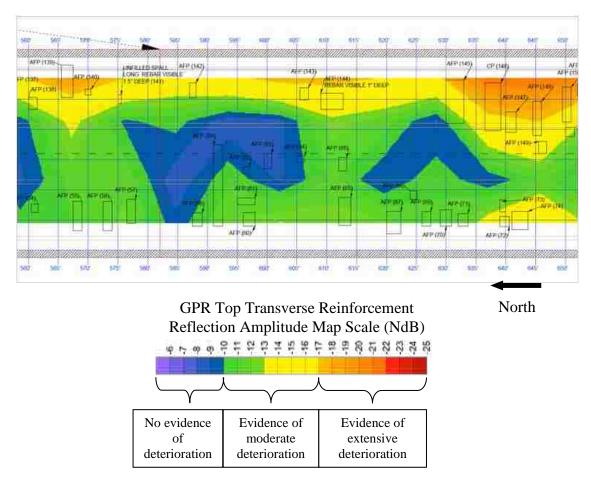
reinforcement. Figure 3.19 below illustrates the GPR results included in the bridge drawing. Increased evidence of deterioration based on the GPR results is more prevalent on the East side of the bridge deck than the West side.

Figure 3.19. Section of Bridge A1479 GPR Results

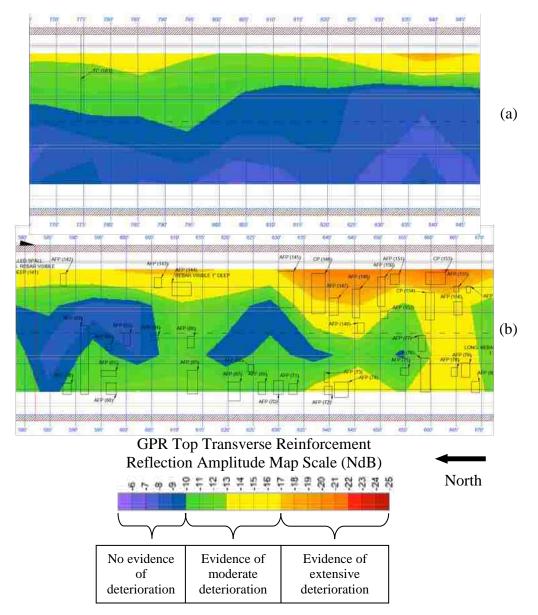
Figure 3.20. Bridge A1479 GPR and Visual Inspection Results with Low Levels of Deterioration (a), and with High Levels of Deterioration (b)

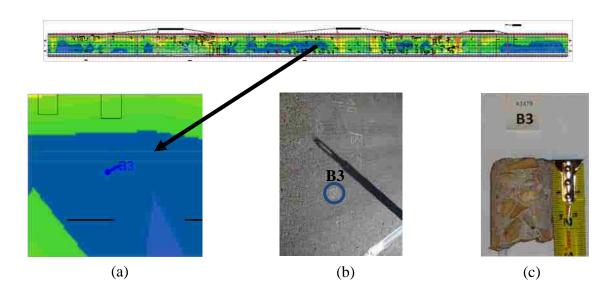
Based on the GPR results, four cores were extracted from areas of the bridge deck that had no evidence of deterioration, and five cores from areas with evidence of moderate deterioration. Figure 3.24 below illustrates the locations of Core B3 on the bridge deck drawing containing the visual investigation and GPR. Core B3 is located in an area with no evidence of deterioration based on GPR and no documented visible deterioration. Core B3 was rated good in the visual examination. Figure 3.25 illustrates Core B4, which is located in an area that has evidence of moderate deterioration based on GPR results. The core has a visual evaluation rating of fair due to a delamination. Concrete was not extracted below the delamination because the extraction process would have caused the concrete below the delamination to crumble.

Figure 3.24. Bridge A1479 Core B3, (a) On Bridge Drawing, (b) Deck Image at Core Location, (c) Extracted Core

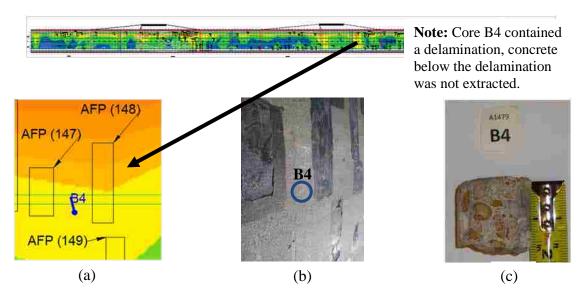
Figure 3.25. Bridge A1479 Core B4, (a) On Bridge Drawing, (b) Deck Image at Core Location, (c) Extracted Core

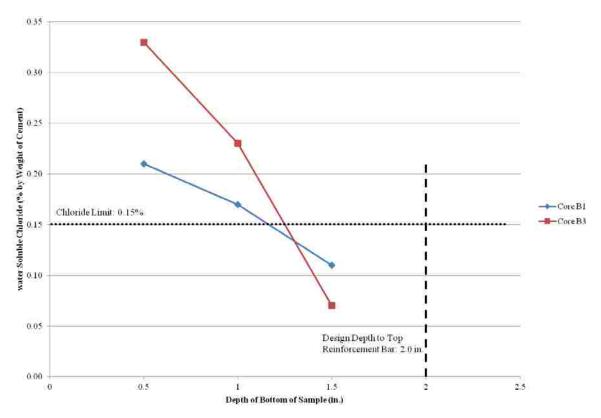
Chloride ion concentration test results were obtained for two cores from Bridge A1479, Cores B1 and B3. Both cores were rated good in the visual examination, however B1 showed evidence of moderate deterioration based on the GPR results, and B3 showed no evidence of deterioration. The chloride ion concentration results are illustrated in Figure 3.27 below. Core B3 had a higher initial chloride ion concentration than Core B1, but at a depth of 1.5 in., B1 has a slightly higher percent chloride. The bridge design specifies that the reinforcing bars have a clear cover of 2 in. As discussed in Section 2.3.2, a threshold value of 0.15% water-soluble chloride by weight of cement is used in this thesis as the threshold for the initiation of corrosion. Chloride ion concentrations at or above this level indicate the potential for corrosion of the steel reinforcing bars.

Figure 3.27. Bridge A1479 Chloride Ion Content Results

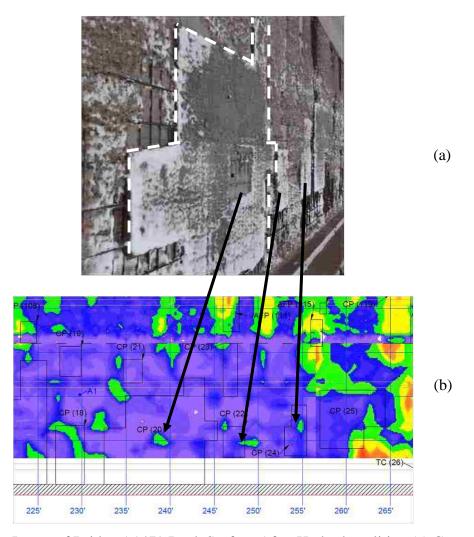
Several concrete patches remained in place on the bridge deck after the hydrodemolition process. Figure 3.29 below illustrates the correlation between the lidar results and visual investigation documentation in an area where concrete patches remained after the hydrodemolition. From the figure, it can be noted that the lidar and visual investigation results are congruent.

Figure 3.29. Image of Bridge A1479 Deck Surface After Hydrodemolition (a) Compared to Lidar Rehabilitation Survey and Visual Investigation Results (b)

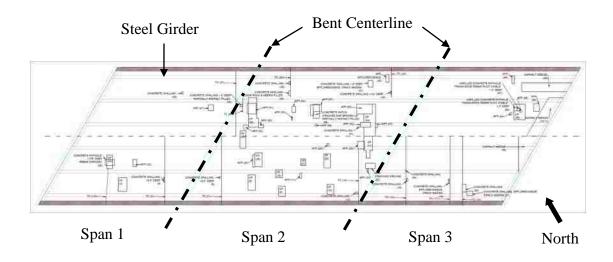
3.3.2.1 Visual inspection. From the visual inspection of the top deck surface of Bridge A1297, 69 defects were documented. Those defects included transverse cracks, concrete patches, asphalt filled potholes, efflorescence, and concrete spalls, including some spalls with reinforcing bars visible. The majority of the documented defects were located in the middle span (span 2) of the girders. Fewer defects were noted in the two end spans (span 1 and 3) of the girders as illustrated in Figure 3.36 below.

Figure 3.36. Bridge A1297 Visual Inspection Results

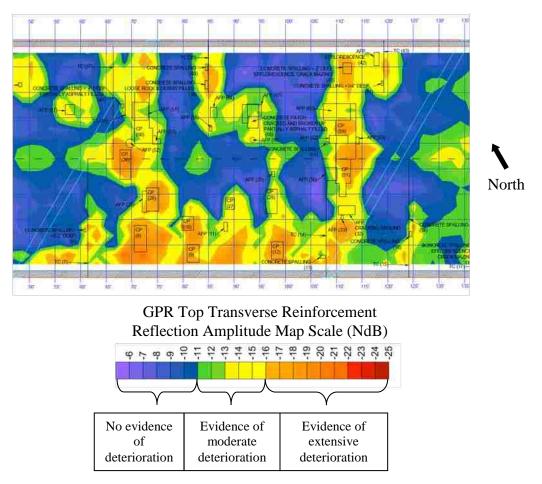
3.3.2.2 Ground penetrating radar. Both lanes of the bridge deck were scanned with GPR. Due to size constraints of the GPR push cart, 1.3 ft. of the South shoulder and 1.2 ft. of the North shoulder were not scanned. Therefore, the total width of the GPR scan was 41.5 ft., compared to the inside curb-to-curb width of 44 ft. The scan covered the entire length of the bridge deck. Figure 3.37 below illustrates the GPR results included in the bridge drawing. Increased evidence of deterioration based on the GPR results is more prevalent on the South side of the bridge deck than the North side. One theory for this phenomenon is the South edge of the bridge deck is shaded more often due to the shadow of the barrier wall created by the sun being located in the southern sky, especially in the winter when snow and deicing chemicals are piled on the shoulder.

Figure 3.37. Section of Bridge A1297 GPR Results

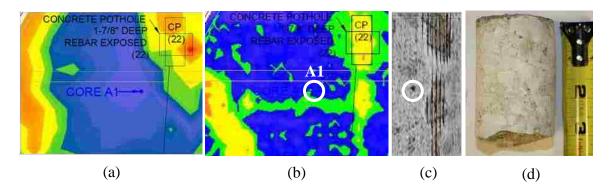
showed evidence of moderate deterioration. Approximately 2.3 in. of concrete was removed from the hydrodemolition process in the area where Core A2 was extracted.

Figure 3.45. Bridge A1297 Core A1 on GPR Map (a), Lidar Map (b), Image of Deck Around Core Location after Hydrodemolition(c), and Core Photograph (d)

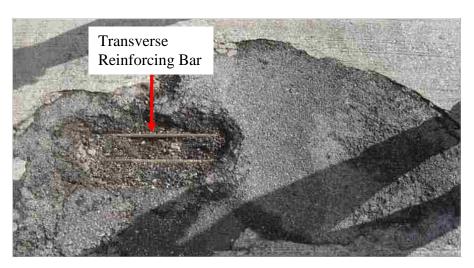
Figure 4.1. Reinforcing Bars Visible in Asphalt Filled Pothole
