Detection and characterization of impact damage in carbon fiber aircraft fuselage structure

**DETECTION AND CHARACTERIZATION OF IMPACT
DAMAGE IN CARBON FIBER AIRCRAFT FUSELAGE
STRUCTURE**

THESIS

**Master of Science
Civil Engineering**

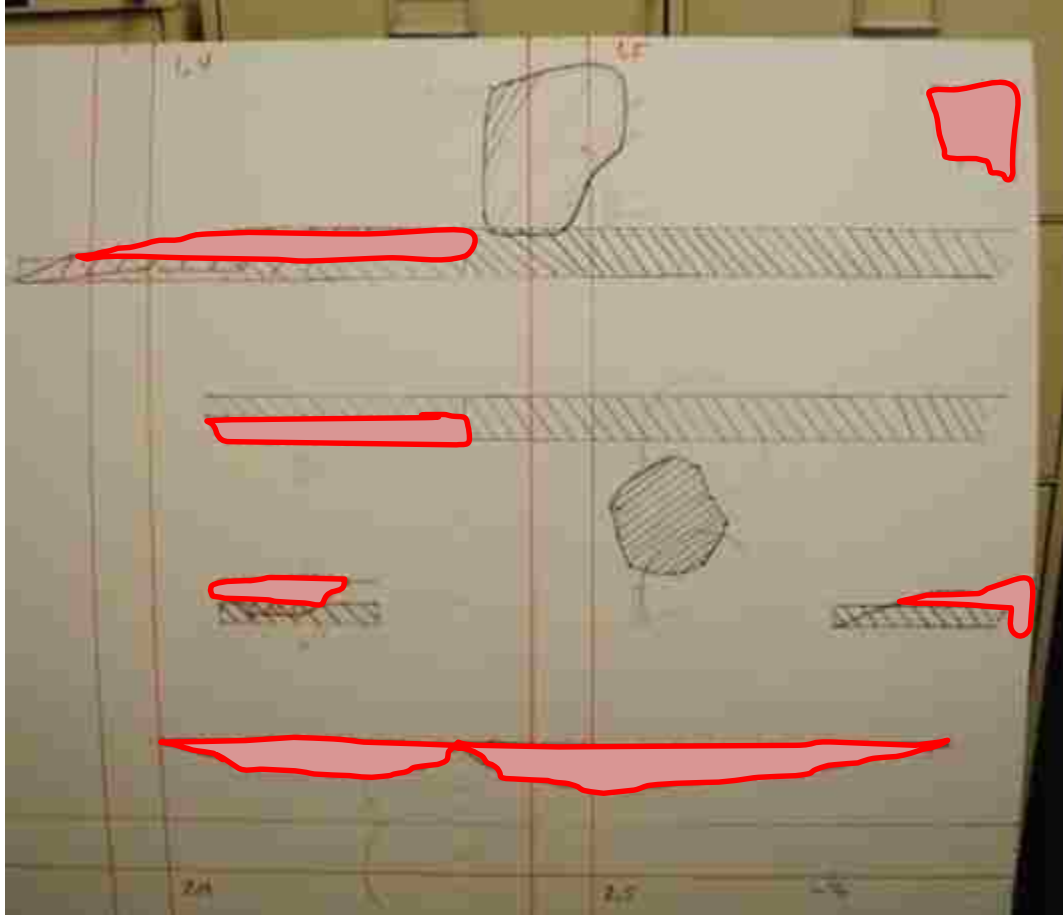
The C-scan inspections revealed significantly more information than the hand held pulse-echo inspections performed during impact testing. Flaws that were difficult to size using hand deployed UT were easily sized and mapped using a combination of amplitude and time of flight C-scan images. The difference in damaged mapping is illustrated on the top left side of panel B in Figure 4-3. The black mapped regions of damage were sized using hand held UT and the red mapped regions were mapped using a combination of UT amplitude, TOF and resonance.

Figure 4-3: Top Right Side of Panel B - Black Mapped Damage Was Detected After Impact With Hand-Held UT and Red Mapped Damage was Additional Damage Detected and Sized Using the MAUS V Scanning System

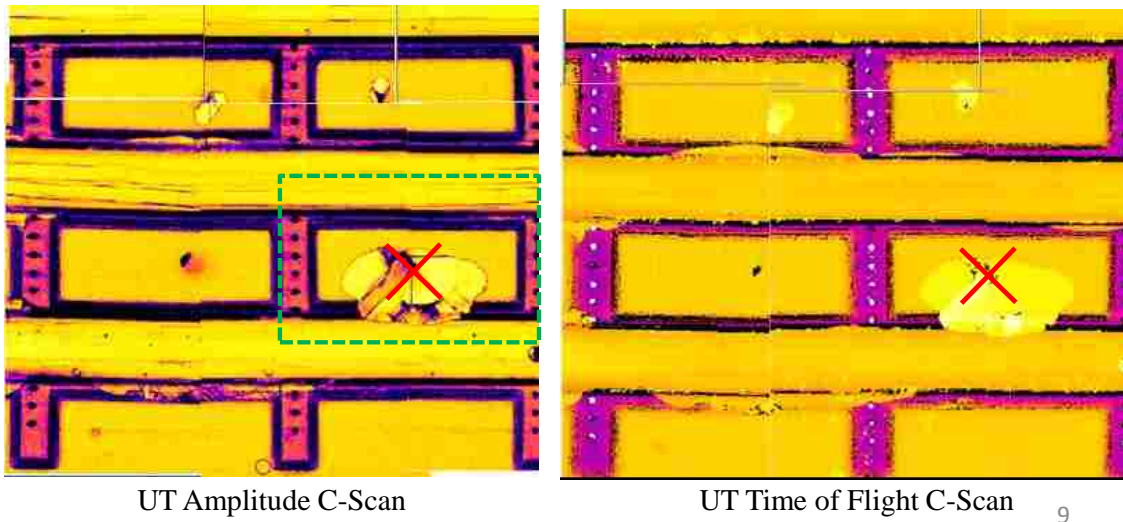
Type of Damage: Mostly interply delamination, small stringer disbond to the upper right of the impact area not detected in amplitude scan

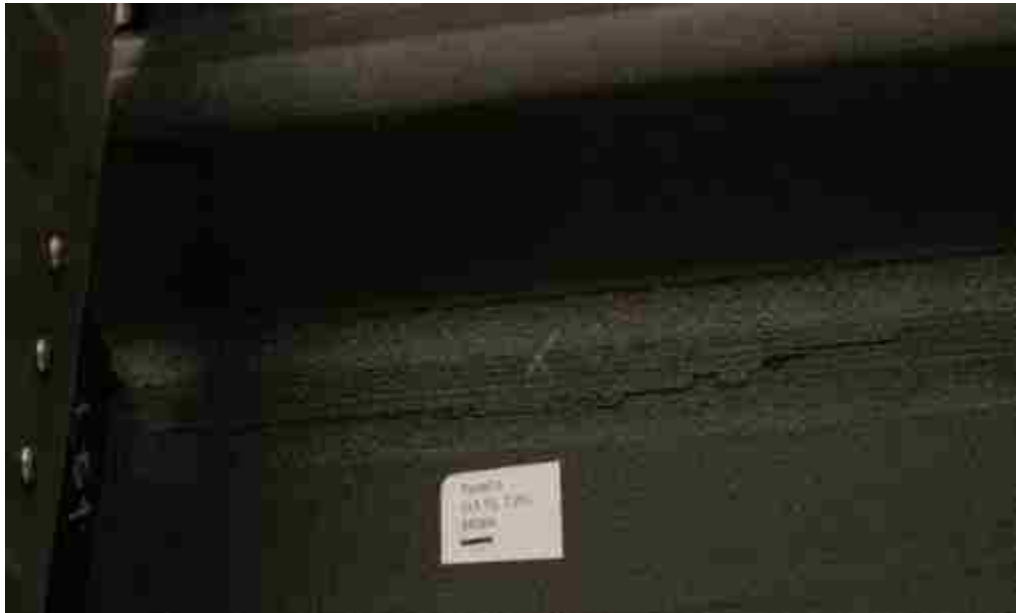
There were three main types of damage associated with the hail impact damage imparted on the panels. Depending on the location of the impact, the corresponding damage could be interply delamination in the 16 ply skin, disbonding at the skin-to-stringer flange interface (substructure delamination), delamination between the plies of the built-up shear tie pad and shear tie cracking. Interply skin and substructure delamination were detectable with the surface based NDI techniques used, but shear tie cracking was only detectable visually from the backside of the panels. An example of a visually detectable disbonded stringer flange is shown in Figure 4-15, and an example of a cracked shear tie is shown in Figure 4-16. The fractures in the shear ties were observed to occur in the vertical flange at the radius. Thus, UT inspections from the skin side could not detect this damage.

Figure 4-15: Stringer Flange Delamination Detectable from Backside of Panel A

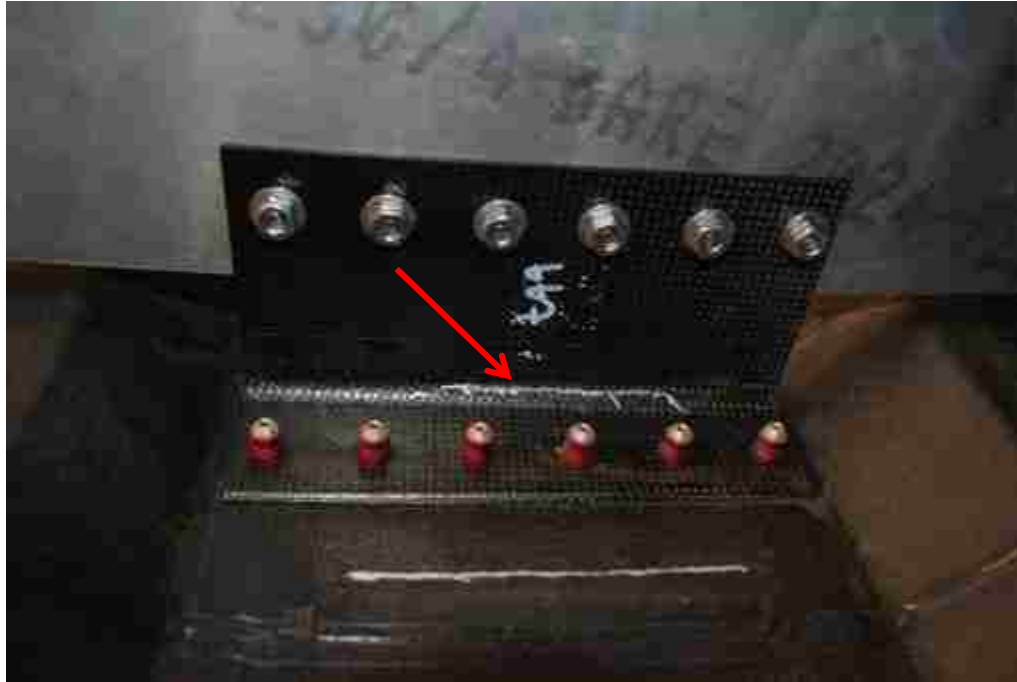
Figure 4-16: Crack on Shear Tie Bend Radius Not Detectable Using NDI from Front Side of Panel

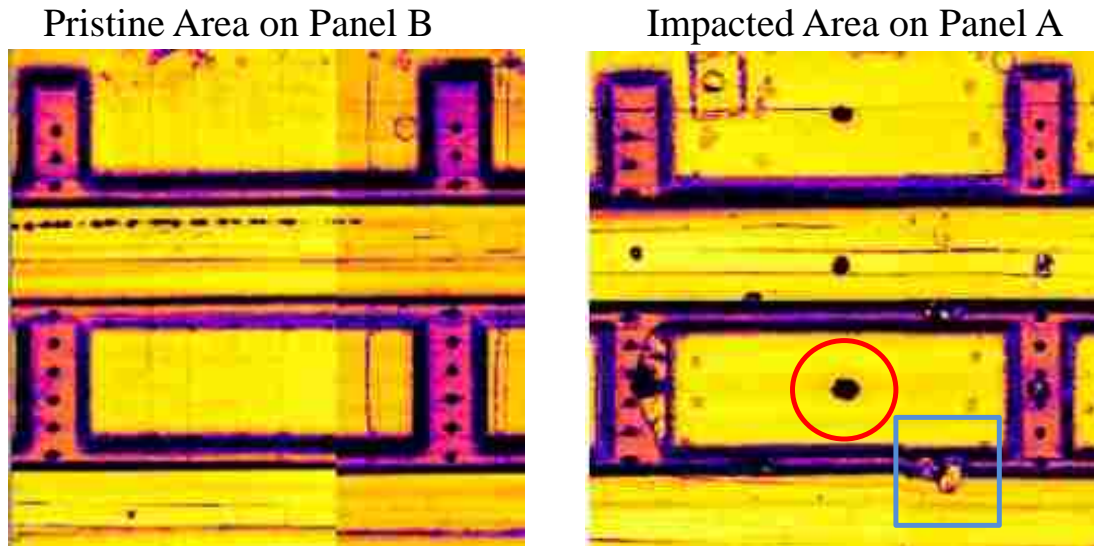
Figure 4-32: Example of Spherical Tip Impact Damage On Panel A

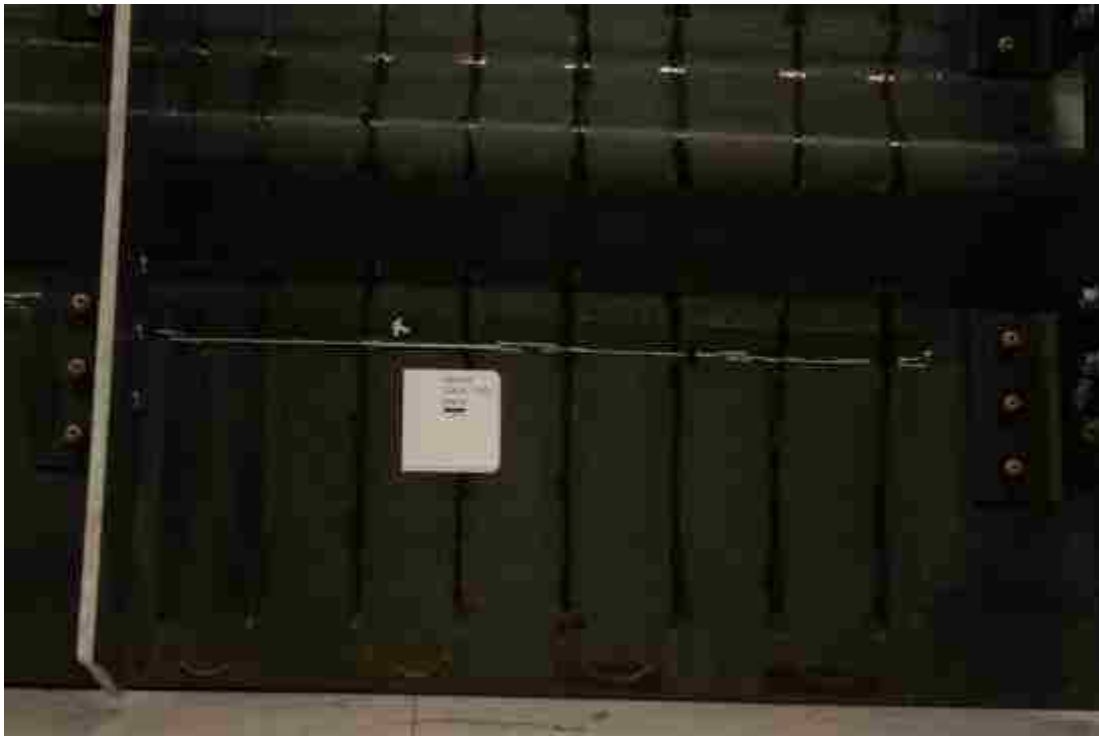
Figure 4-35: Broken Fiber Optic Due to Stringer Flange Delamination
