**Dewatering and the
Deterioration mechanisms
in sandstone structural
elements and suggestive
treatments to Elkarnak
Temples**

Abd-Elkareem. E.A. (•)

Journal of Faculty of Archaeology at Qena

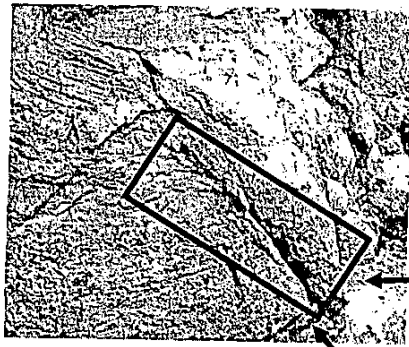
foundation⁽⁶⁾. Thus most constructive elements of these temples, particularly foundations don't need any support. They bear loads carried to them from the foundation safely, except some foundation⁽⁷⁾ Fig. (1&2).

Fig. (1)
The second baylon in *Elkarnak Temples* indicates a leaning crack below the wall and the depth of the crack in this area can be seen, as we go upwards the depth and width of the crack become less this crack is due to the failure of the ability of soil to bear wall on it.

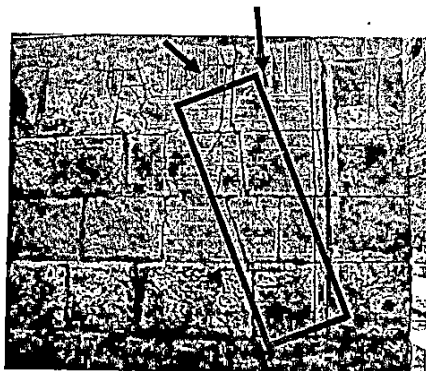
Fig. (2)
The north baylon, the second edifice shows a deep vertical crack this crack is deeper and wider at the bottom part and becomes less when it goes upwards.

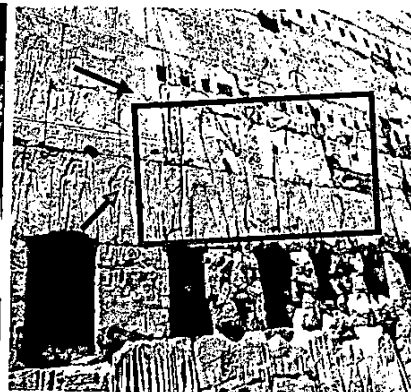
Fig. (4)
The deformations and different damages which include the areas which work as shoulders for the threshold forming holes are beginning to collapse they are unable to do its task although holes are small, it is observed that the reason for this lies in the soil to a great extent and the loads located on shoulders are a factor that causes a partial collapse as a result of sliding

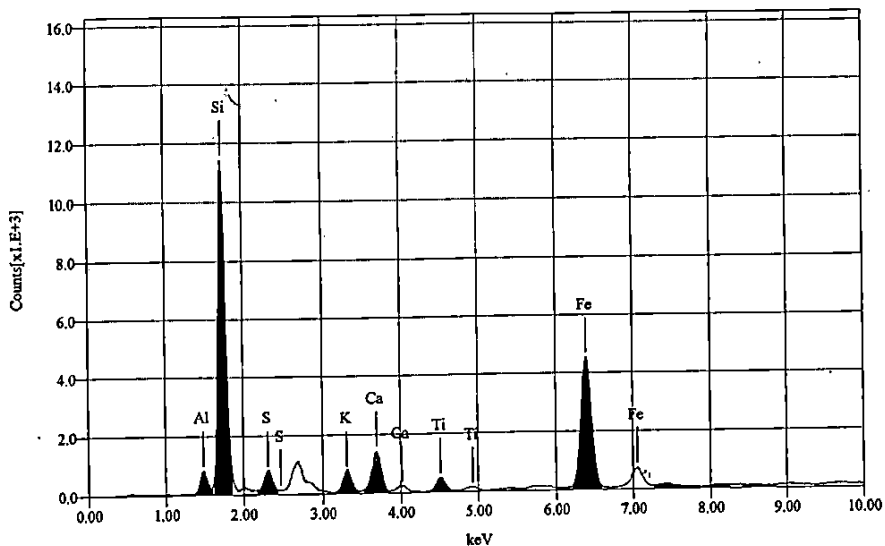
Fig. (14) a sample of sandstone taken from Elkarnak Temples, from beginning of the entrance below the interior wall of the entrance, by

EDX, it was observed that quartz dioxide is the main component and this sample contains the oxides of aluminum, iron, magnesium and quartz and calcium.

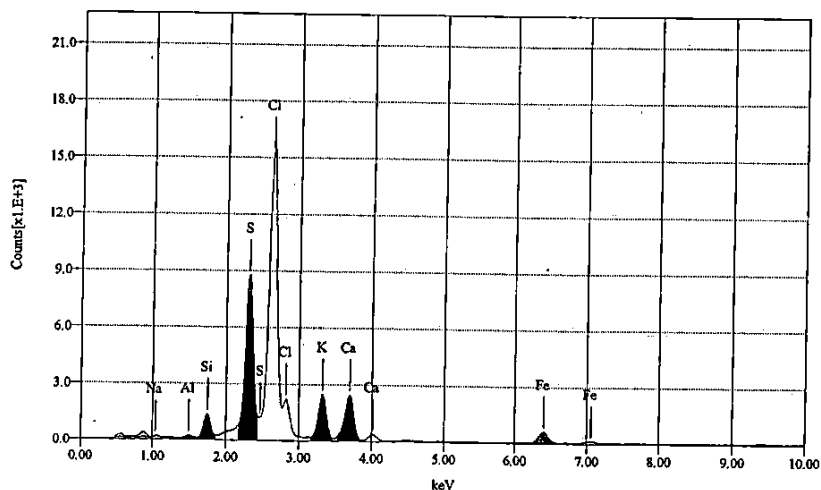
Fig. (15) a sample of salts on the sandstone, Elkarnak Temples, by EDX, this sample contains the oxides chloride and sulphate of aluminum, silicon and potassium calcium and iron.
