Effects of Glycerin Antifreeze on CPVC

Paul J. Gramann
The Madison Group

Failure of a CPVC Fire Suppression System

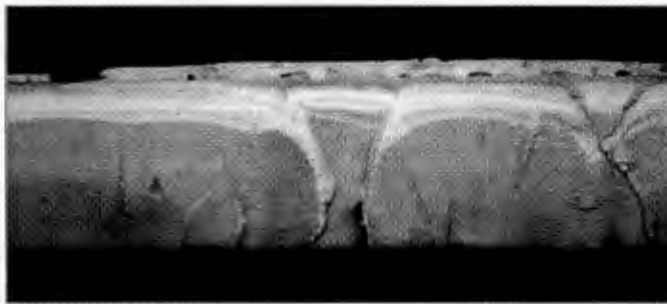
When using CPVC pipe for fire suppression systems that are susceptible to freezing, a solution of water and antifreeze must be used to ensure freezing does not take place [1]. A solution containing propylene glycol is a common option for metal piping systems. However, environmental stress cracking (ESC) [2] issues with this antifreeze have been found when used with CPVC. Figure 1 shows an example of cracking that initiated at the inside surface of a CPVC pipe that was used for a fire suppression system that contained propylene glycol. The individual cracks propagated outward from the initiation sites in a thumbnail pattern, in the process coalescing with other cracks. The CPVC fails in a brittle manner as the crack travels through the thickness, driven by the synergistic effect of the propylene glycol and stress. In this case, it is clear that the CPVC material showed high affinity to the propylene glycol allowing the solution to be locally absorbed and affect the plastic resulting in slow-crack growth and failure. For this reason, alternative antifreeze agents need to be considered for CPVC piping systems.

Figure 1 – Cracking through the thickness of a CPVC pipe that contained propylene glycol.

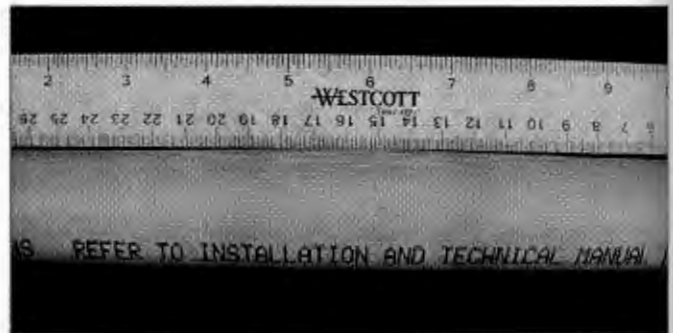
The homeowners described the leaking pipes as having striated areas of softness with regions of bulging and sagging between supports. Figure 4 shows a bulged section of pipe. Figure 5 shows striations in one of the failed pipes. The striations were evident as a lighter orange color that ran axially along the pipe. The striations were much softer than the non-striated regions of the pipe to the degree that one could press a fingernail into CPVC in these regions. During inspection of the piping system in an attic area, significant sagging of a pipe between supports was observed, see Figure 6. The pipe, which should have had maximum sag of less than 1 inch, was found to be sagging over four inches. The sagging is an indication of softening and creep of the pipe under the force of gravity.

Figure 4 – Bulging of a failed CPVC pipe exposed to a mixture of water and bio-glycerin.

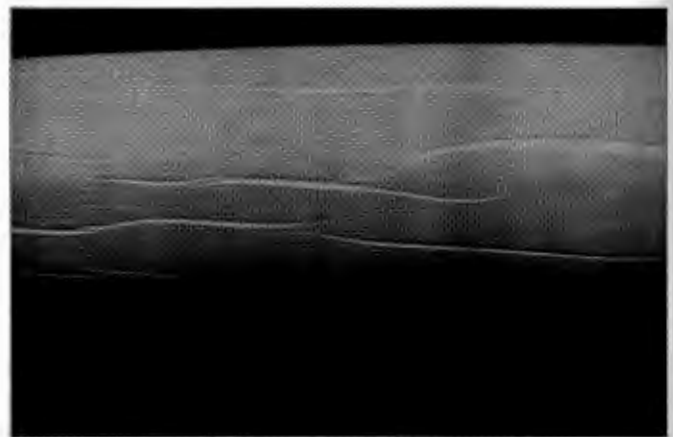
Figure 5 – Axial striations on the outside a failed CPVC pipe exposed to a mixture of water and bio-glycerin.

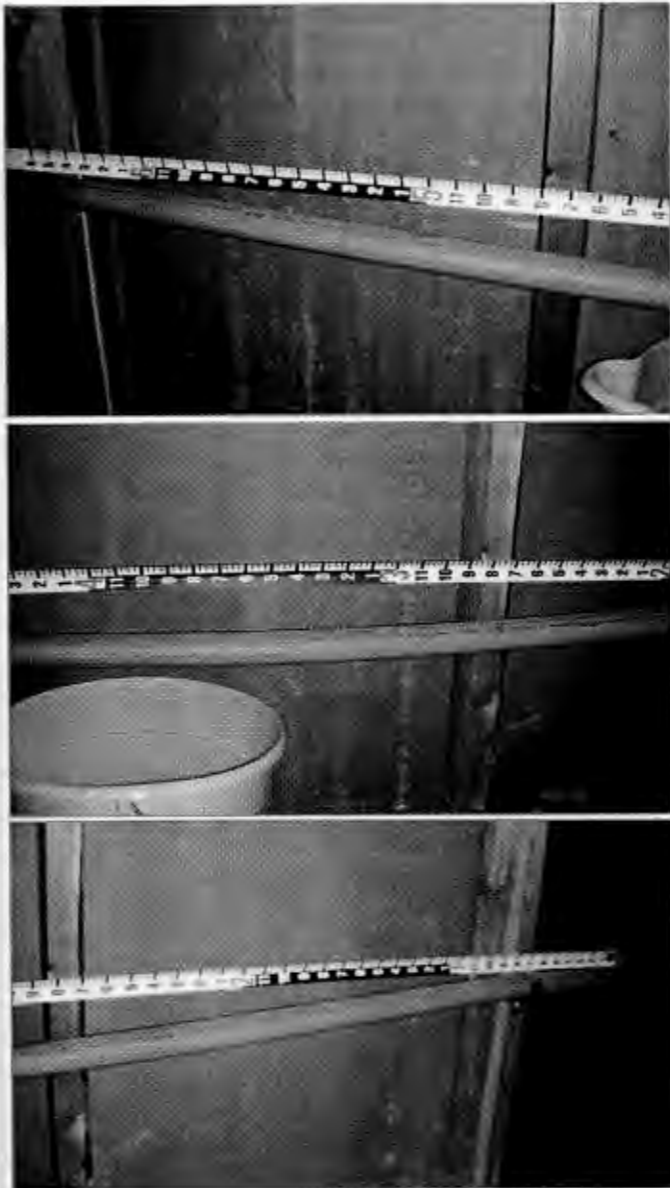
Figure 6 – Sagging of an installed CPVC pipe exposed to a mixture of water and bio-glycerin.

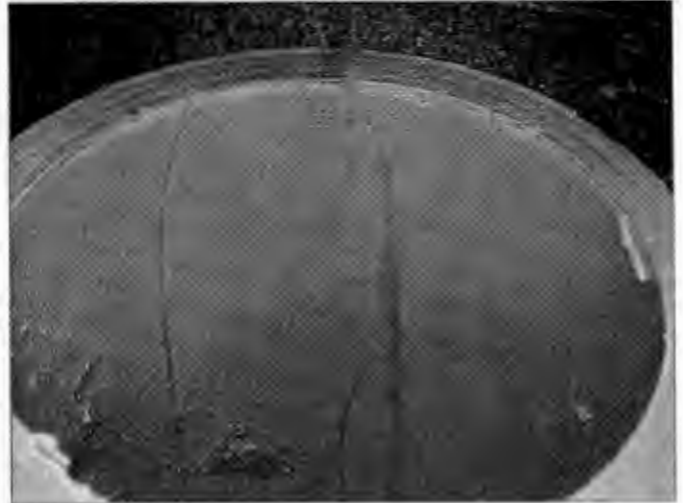
One of the failed pipes was cross-sectioned through a region that contained striations. Figure 7 shows the striations at the inside of the pipe and Figure 8 shows the striations through the cross-section. It was clear from Figure 8 that the striations had originated at the inner surface of the pipe and propagated outward. That is to say, there are limited evidence of striations on the outer wall while there are numerous striations on the inner wall.

Figure 7 – Striations evident at the inside of a failed CPVC pipe exposed to a mixture of water and bio-glycerin.

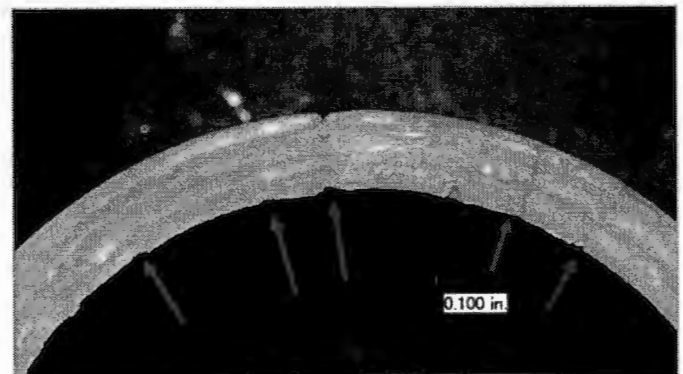
Figure 8 – Striations initiating at the inner diameter of the CPVC pipe exposed to a mixture of water and bio-glycerin.

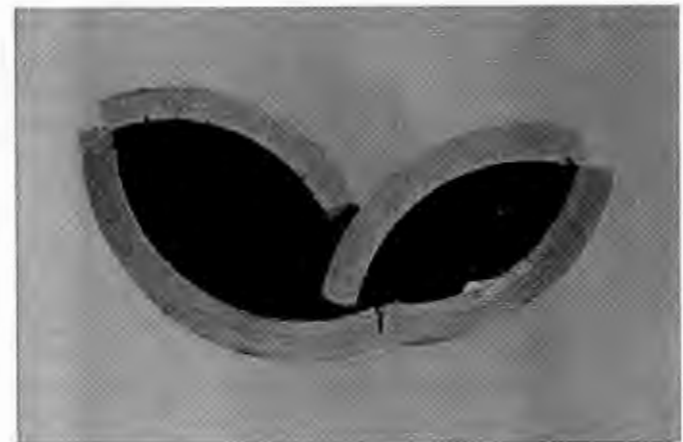
Two-inch sections were removed from failed pipes to perform flattening tests following ASTM D 442 [10], Section 8.6 to determine if the pipe had been structurally compromised. In this test, the pipe is flattened to 40% of its original diameter over a specified time period. During and after the test, the section was examined for any cracks at the outside and inside surfaces. As defined by the standard, the section passes the test if no cracking is observed. In this case, all sections that were tested cracked catastrophically at four locations approximately 90 degrees apart, see Figure 9. One of the cracks was opened and examined using a Keyence digital microscope, see Figure 10. The fracture surface showed a smooth surface immediately adjacent to the inner diameter of the pipe. The majority of the fracture surface appeared to be softened with long ductile flaps. The CPVC at the fracture was soft and material was easily displaced. It was clear that the material had been solvated, which reduced the mechanical properties of the pipe.

Figure 9 – Result of flattening test [8] of a CPVC section that was exposed to a mixture of water and bio-glycerin.

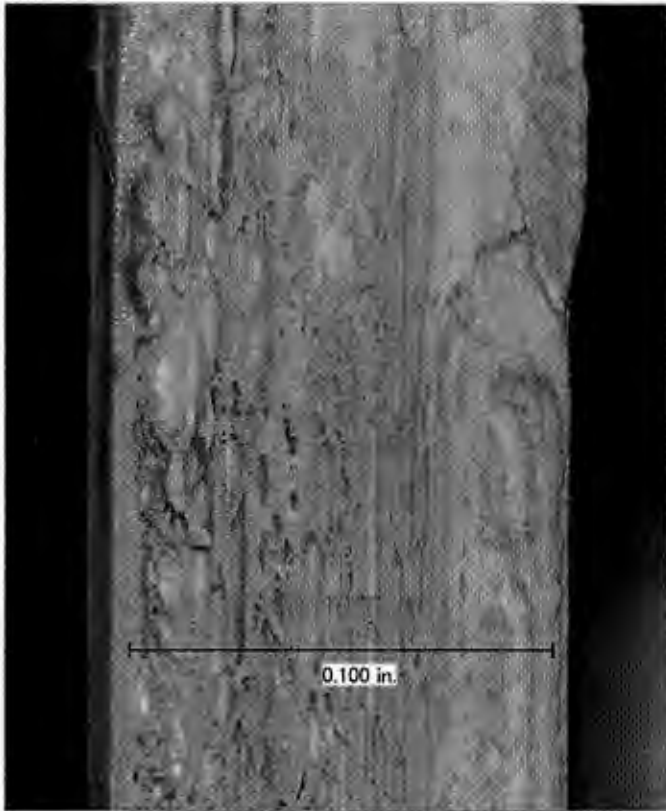
Figure 10 – A fracture surface of the pipe section shown in Figure 9.

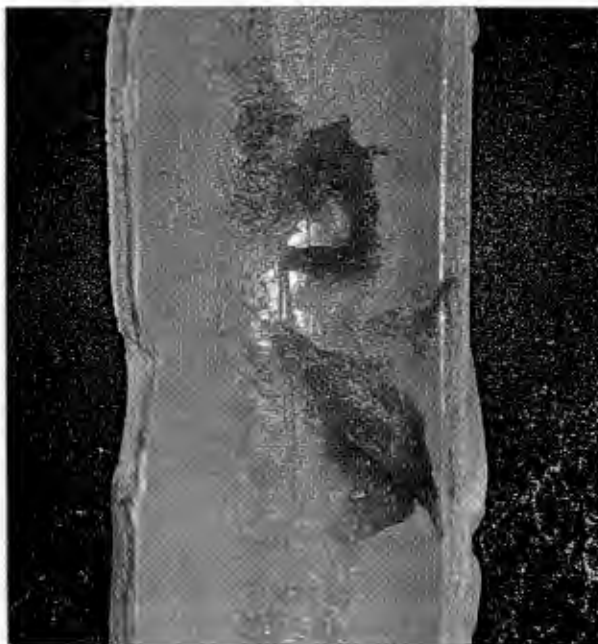
It was seen that a significant foreign mass was present at the inner surfaces of some of the pipes examined, see Figure 11. This material was greenish and had the consistency of petroleum jelly. This material was foreign to the system and could pose a problem by clogging the sprinkler head in the event of a fire. The chemical structure of this material was examined using FTIR in attenuated total reflectance (ATR) mode. A small amount of the substance was placed on the ATR unit giving the spectra shown in Figure 12. The closest library match for this material was glycerol, or glycerin (also presented

Figure 11 – Material observed at inner surface of failed CPVC pipe exposed to a mixture of water and bio-glycerin.

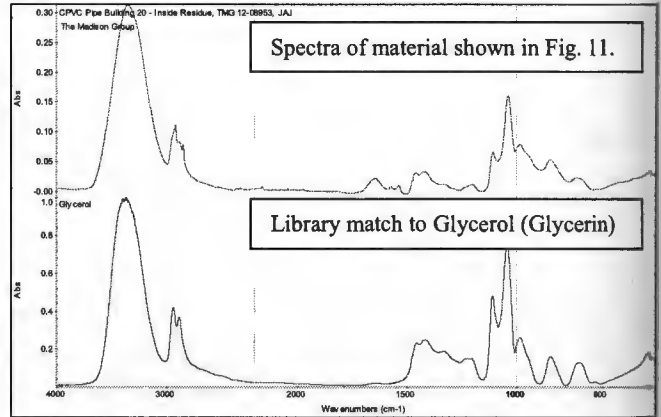
in Figure 12). Furthermore, ester functionality was observed in the spectra at approximately 1700 cm^{-1} . It should be noted that the library match shown is for pure glycerin.

Figure 12 – FTIR spectra of material shown in Figure 11.
