Evaluating the Impacts of Hurricane Maria on the Residential Construction Industry in Puerto Rico and the Effectiveness of Reconstruction Efforts

M. Bradley Wells
Brigham Young University

Master of Science

School of Technology
Brigham Young University

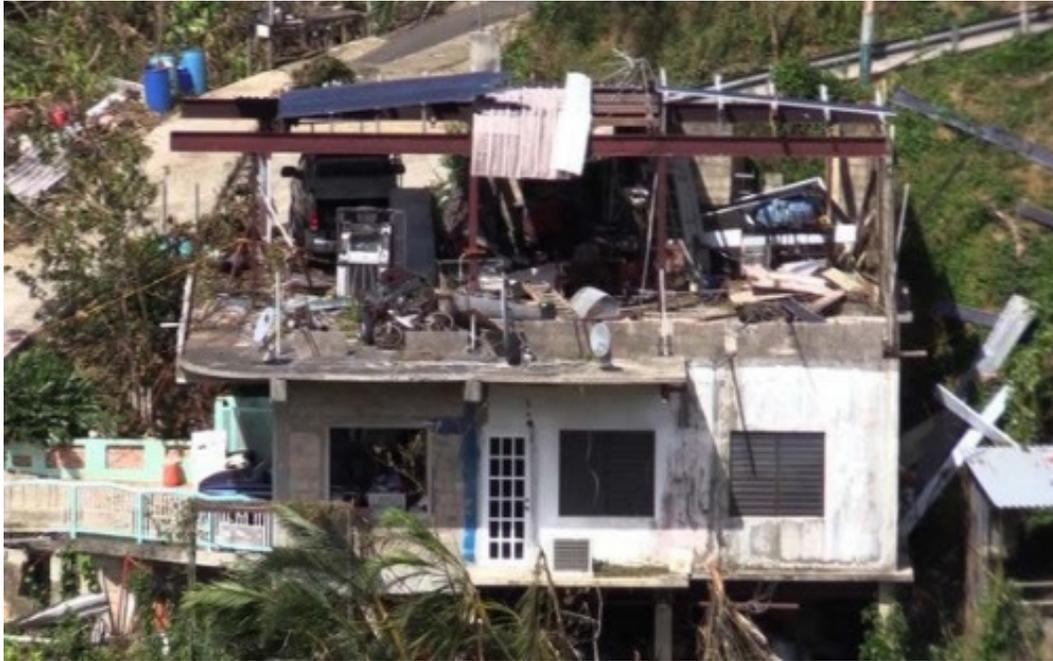
Figure 2-2: Typical structural damage from Hurricane Maria (from Pasch et al., 2019).

Puerto Rico was devastated by winds and floods. Figure 2-2 and Figure 2-3 show the typical aftermath to residential structures caused by wind damage and flooding, respectively. The government estimate of damage in Puerto Rico and the U.S. Virgin Islands due to Maria is 90 billion dollars, which makes Maria the third costliest hurricane in U.S. history, behind Katrina in 2005 and Harvey in 2017 (NCEI, 2020). The combined effect of the surge and tide produced maximum inundation levels of 6 to 9 ft above ground level to the north of Maria's landfall along the coasts of Humacao, Naguabo, and Ceiba municipalities in Puerto Rico. The destructive power of storm surge and wave action from Maria produced extensive damage to buildings, homes, and roads along the east and southeast coast of Puerto Rico. Along these areas, marinas

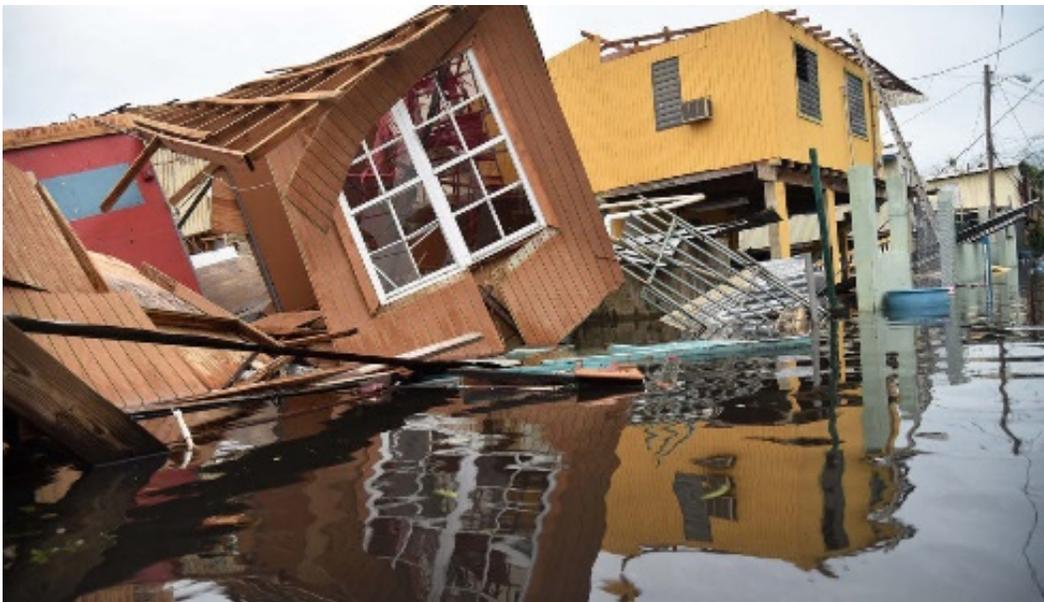
Figure 2-3: Flooding & structural damage from Hurricane Maria (from Pasch et al., 2019).

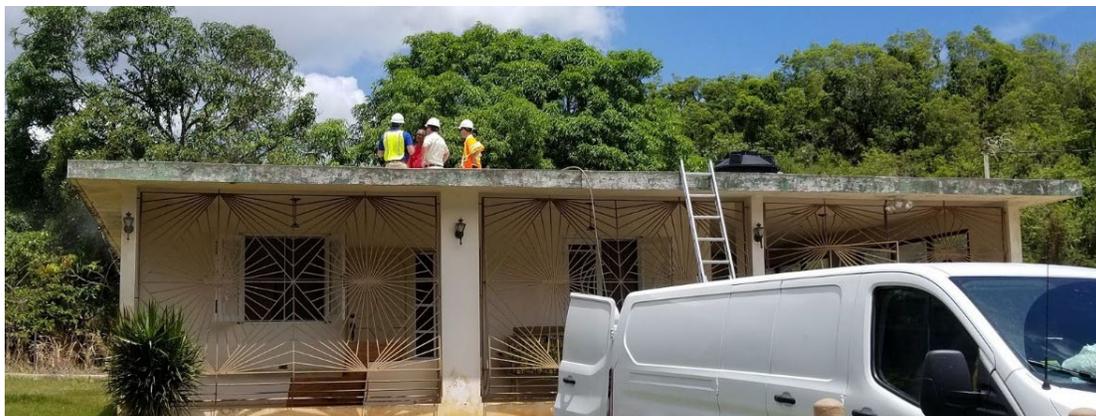
The research team met at a reconstruction site with a trade contractor who was repairing a roof damaged by the effects of Hurricane Maria. This trade contractor worked for the Tu Hogar Renace program, a HUD sponsored government program for helping non-catastrophic hurricane repair needs. Tu Hogar Renace translates to Your Home Reborn. In this program, homeowners would apply for repairs and government approved adjusters were sent out to verify legitimate damages. Approvals were based on adjuster recommendations and once approved; the trade contractors were allowed to make the necessary repairs. Contractors were paid directly through the program and not by the homeowners. Figure 4-3 is a picture of the home that the research team visited. At this site, the roofing contractor showed typical roofing repairs for damages from Hurricane Maria for flat concrete roofed homes. Structurally, the home that was being repaired was fine, but the concrete roof had begun leaking after all the rainfall from the hurricane.

Figure 4-3: Site visit to concrete flat roofed home damaged by Hurricane Maria.

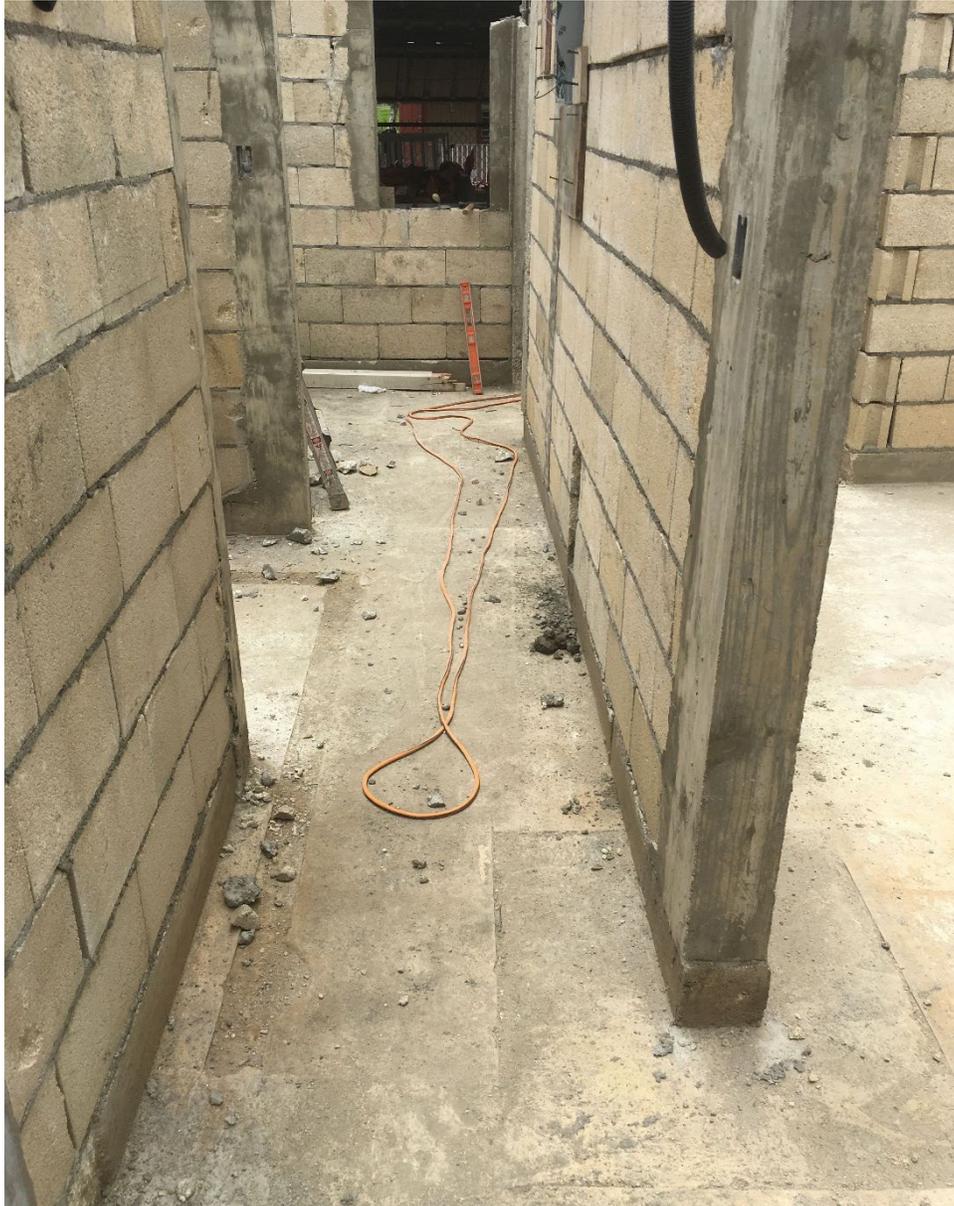
After the research team visited with the owner of Casas Borincanas, they had the opportunity to visit a home reconstruction site using a purchased home kit from Casas Borincanas. The homeowner explained the destroyed home had been a wood structure. The roof blew off during the hurricane, allowing rain to come in and flood the home, ruining everything inside. Figure 4-4 shows the construction of new block walls on an existing foundation after they finished tearing everything else down due to the mold and water damage. The homeowner said family and friends helped them clean up the debris of the ruined home. They did not have any government agency help in cleaning up their property. Figure 4-5 shows new bathroom plumbing roughed in the existing foundation. Figure 4-6 shows a code compliant residential

Figure 4-4: New wall construction on an existing foundation.

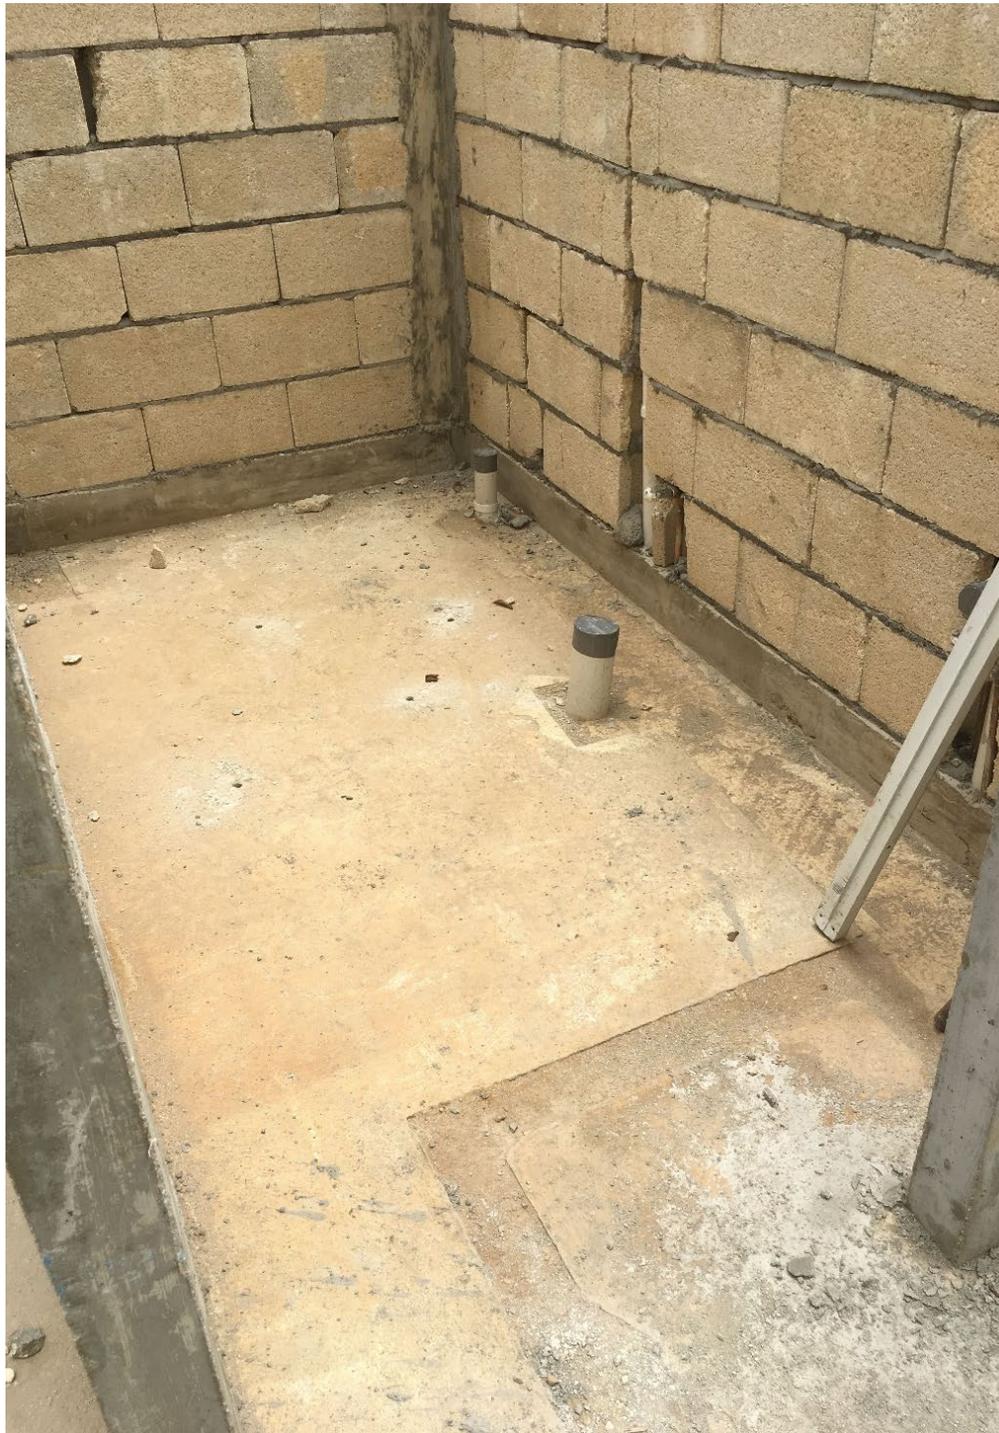
Figure 4-5: New plumbing cut into existing foundation.

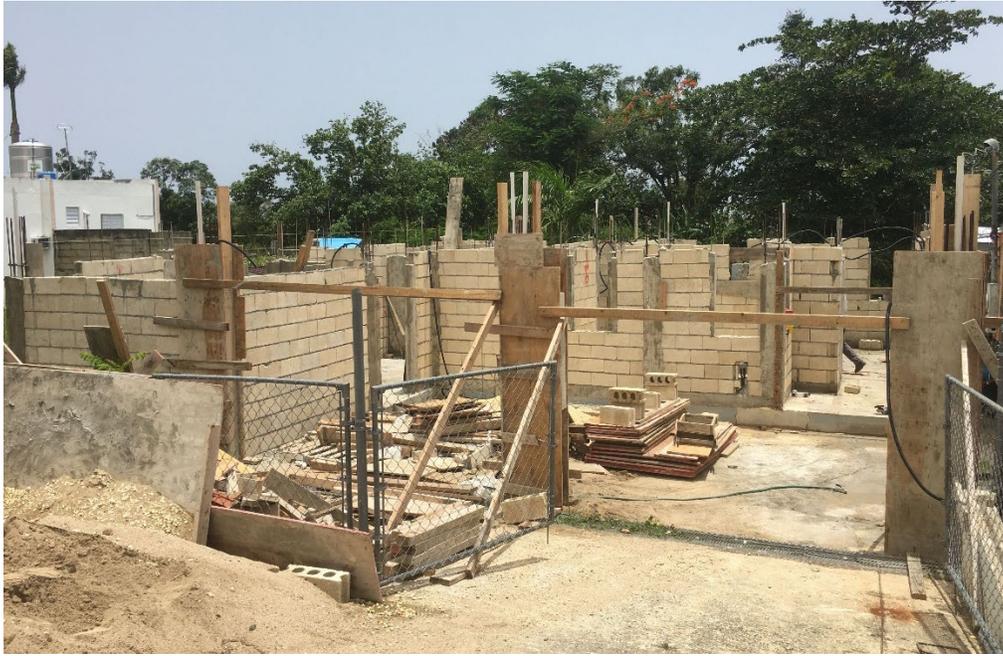
Figure 4-6: Typical code compliant reconstruction for destroyed home.

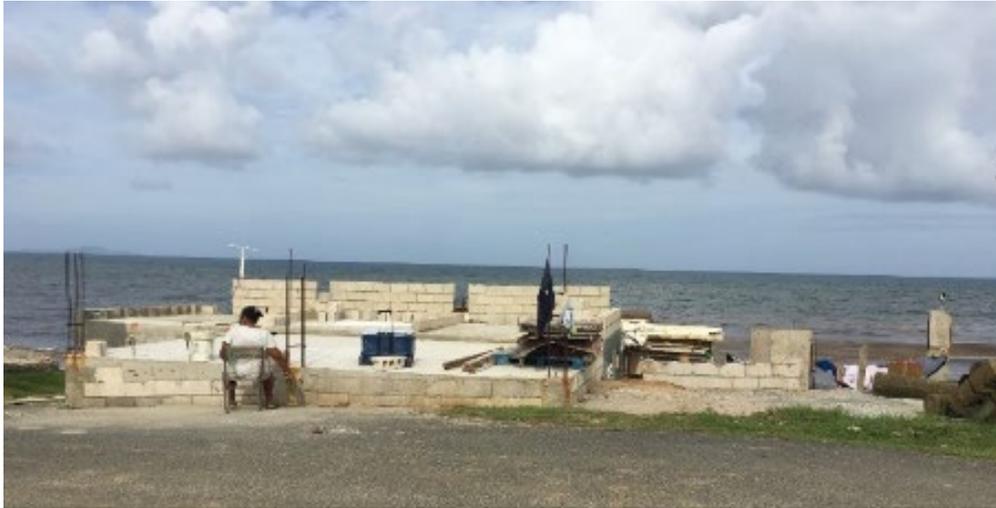
Figure 4-7: Remains of a beachfront home in Yabucoa.

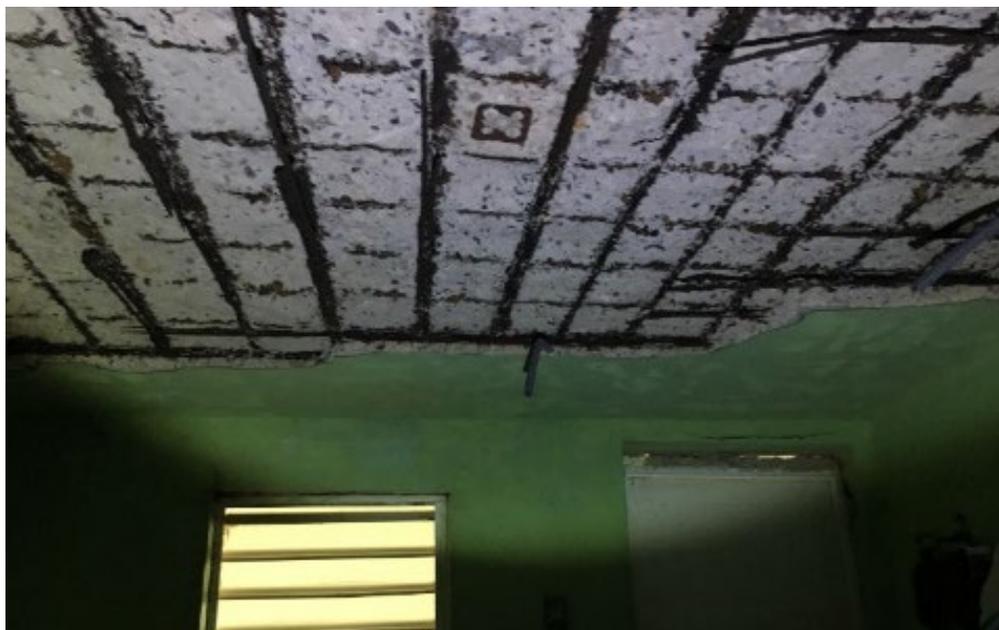
Figure 4-8: Concrete spalling and deteriorating reinforcing steel in damaged ceiling.

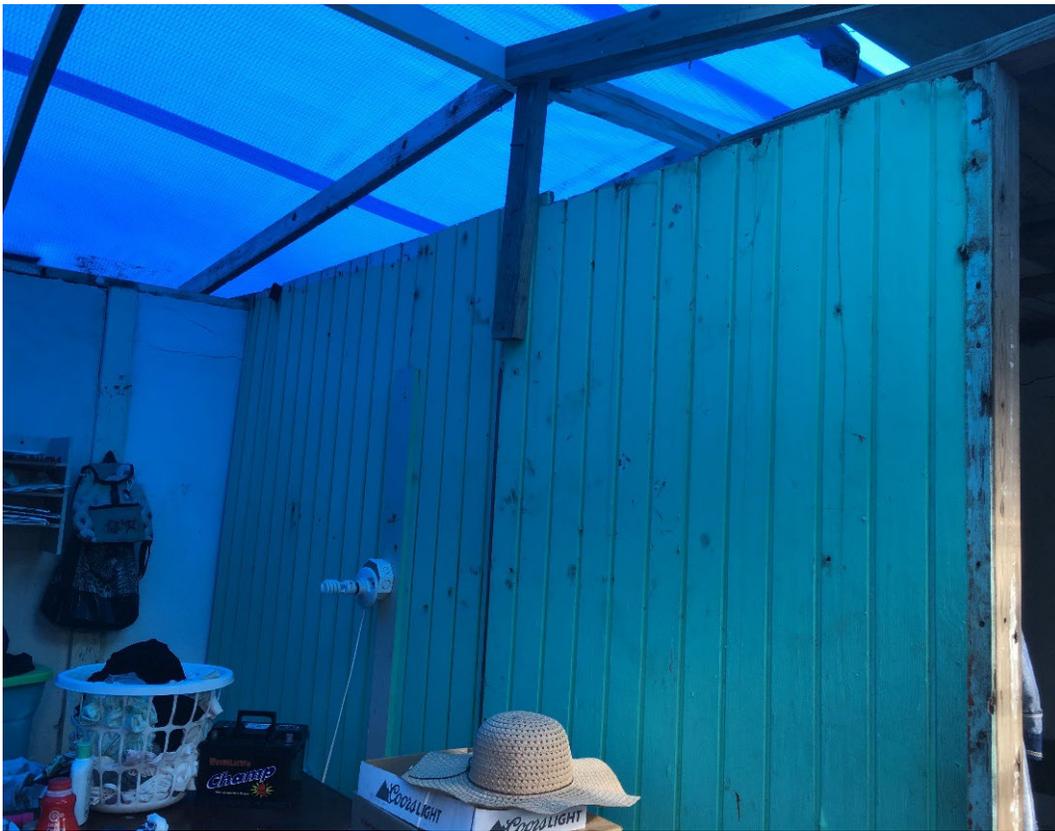
Figure 4-9: FEMA blue tarp roof on existing home in Yabucoa.

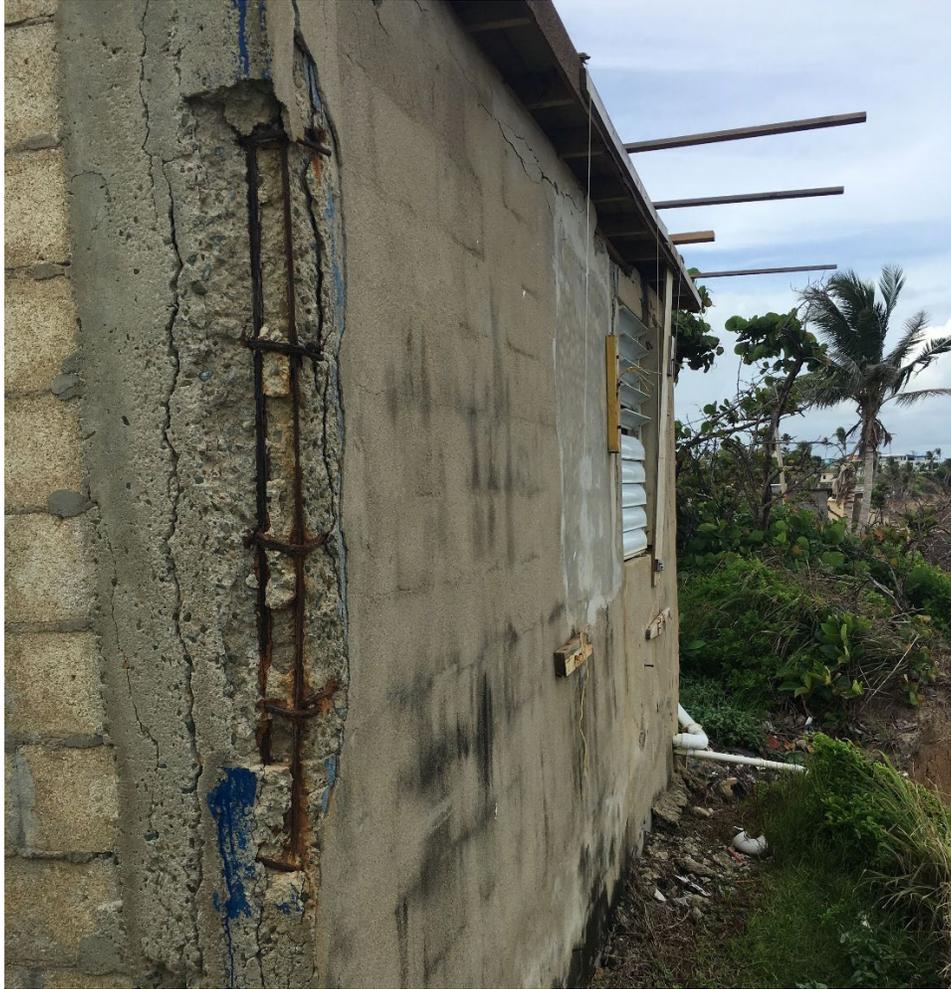
Figure 4-10: Damaged exterior concrete walls of home.

She was one of the few (percentage wise) that had all required documentation necessary to be approved for financial help by FEMA. In taking a closer look at the exterior concrete walls still standing on her home (Figure 4-10), the concrete had flaked away in many spots, exposing the reinforcing steel (rebar). Figure 4-11 shows that the reinforcing steel was delaminating and flaking apart. It was obvious that the strength of the reinforcing steel embedded in the concrete walls of her home was compromised; however, to what extent is unknown without further investigation and strength testing. This homeowner informed the research team that she had been paid approximately \$8,000 dollars by FEMA for help with repairs to her home. When

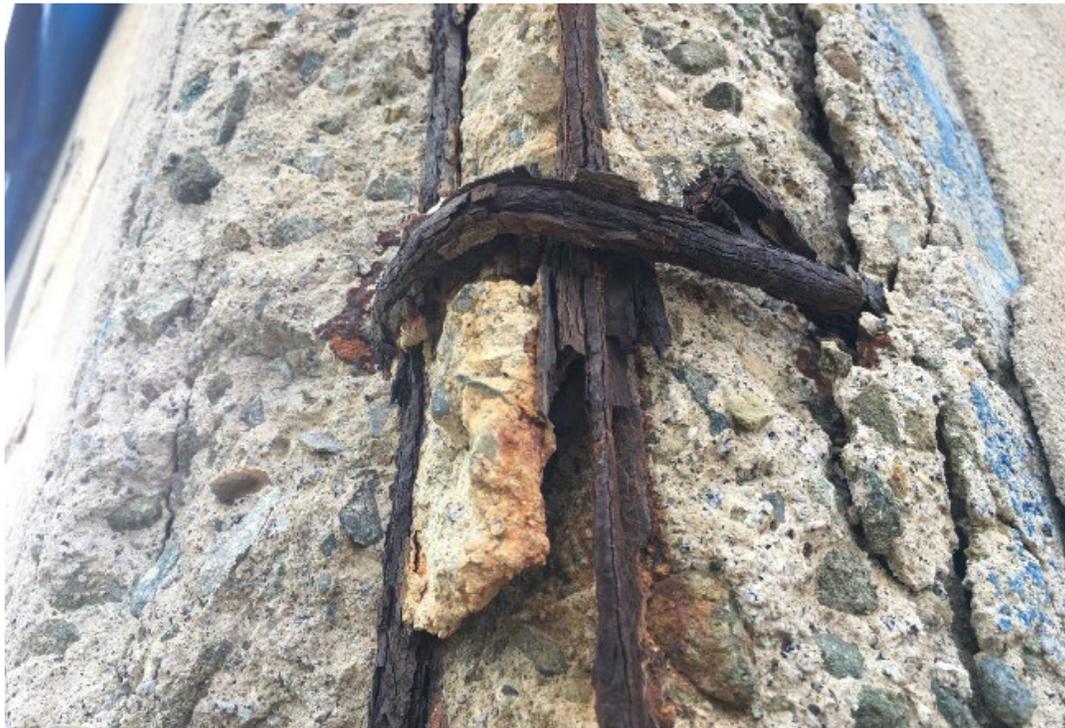
After the research team saw the damages to a home on the coast of Puerto Rico due to deteriorating/delaminating rebar, the research team asked if epoxy-coated rebar was required for construction in Puerto Rico. The architect stated epoxy coated rebar is not required, and it is typical for older rebar to become de-laminated in coastal areas due to humidity and exposure to the elements. Many poor homeowners build homes/additions a little at a time causing exposure to elements. Most homeowners build as time and money / materials allow. It is common to see rebar sticking vertically out of the corners of unfinished concrete block structures for months, if not years before the wall is completed. The humidity and salty coastal air create a natural consequence of deteriorating the reinforcing steel that is left exposed to the elements. Further testing would need to be done to determine the loss of strength of the reinforcing steel that is left exposed to the elements for an extended period.

Figure 4-11: Delaminating reinforcing steel in reinforced concrete wall.

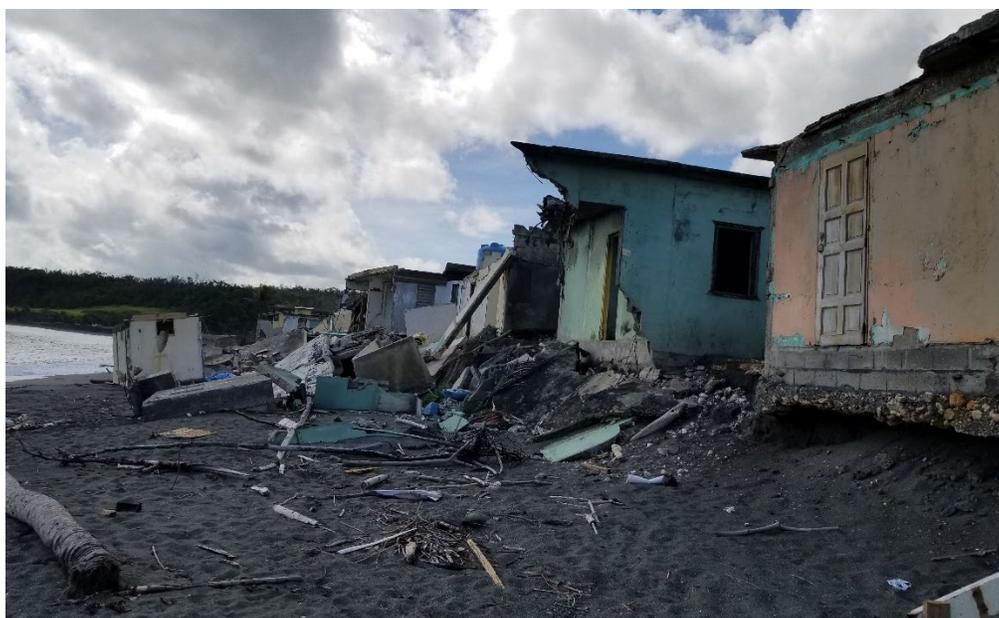
Figure 4-12: Homes destroyed at water's edge by storm surge.

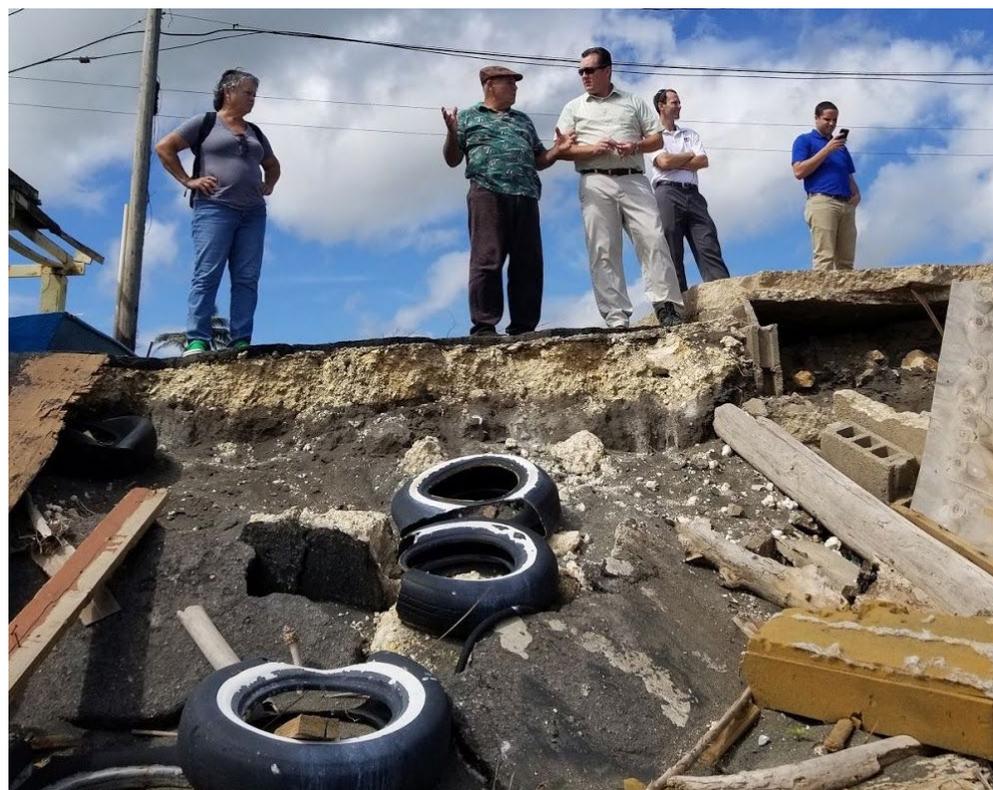
Figure 4-13: Owner explaining how the storm had undermined the foundation.

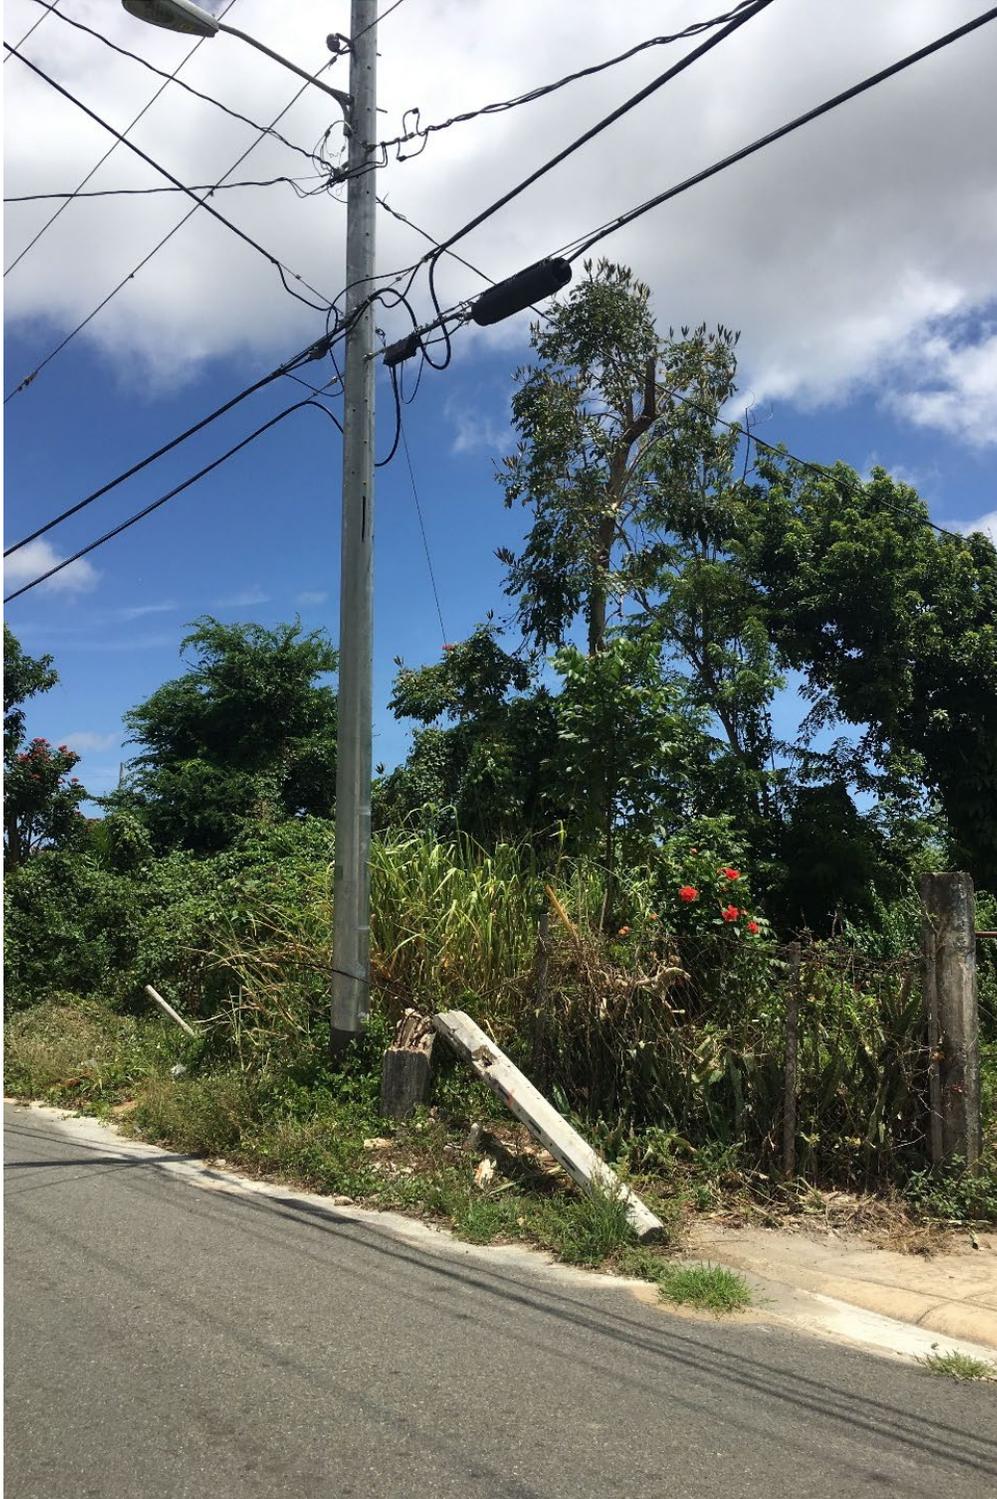
Figure 4-14: Hurricane Damage left in place.

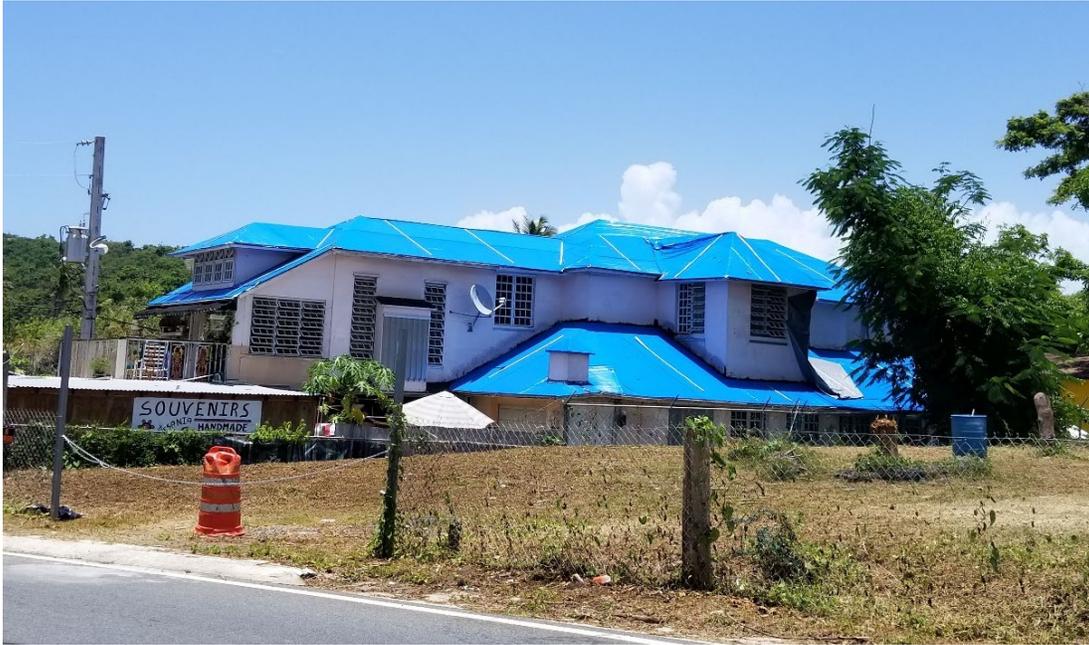
Figure 4-15: Blue tarped roof.

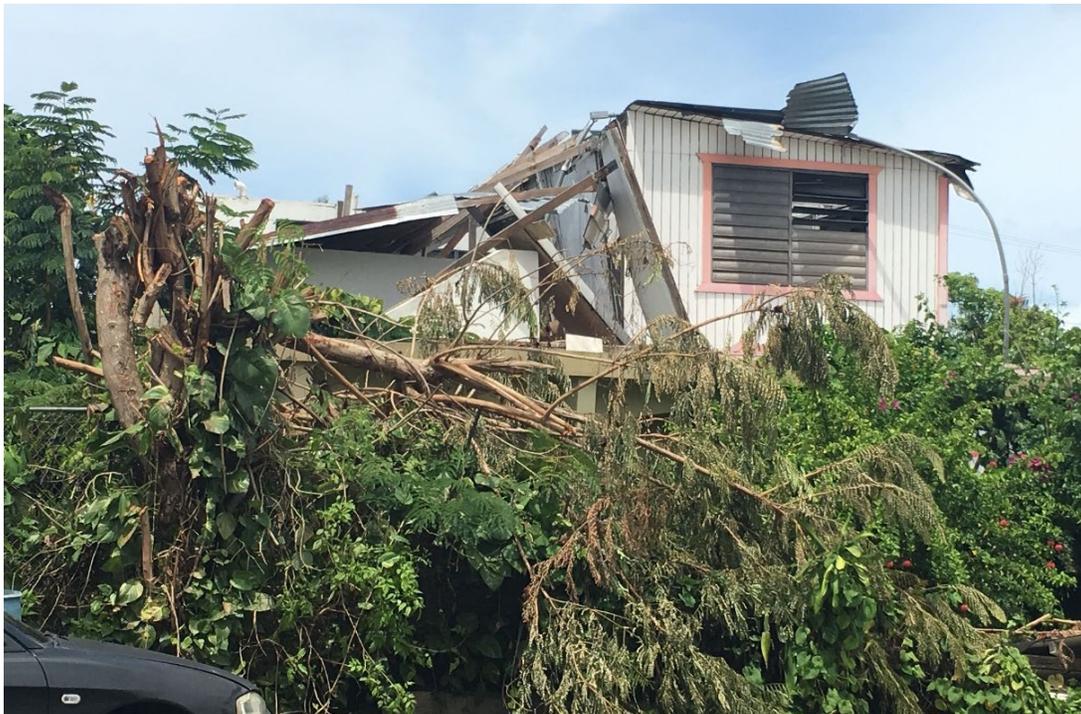
block. The director also estimated at least 60% of construction on the island was illegal, or informal construction. He explained that in most urban areas, the second-floor construction of many homes was made of wood, not built to any type of code minimums, and without permits. This type of second story structure received a lot of damage from the Hurricane Maria.

Figure 4-16: Home with uninhabitable second story wood framed construction.

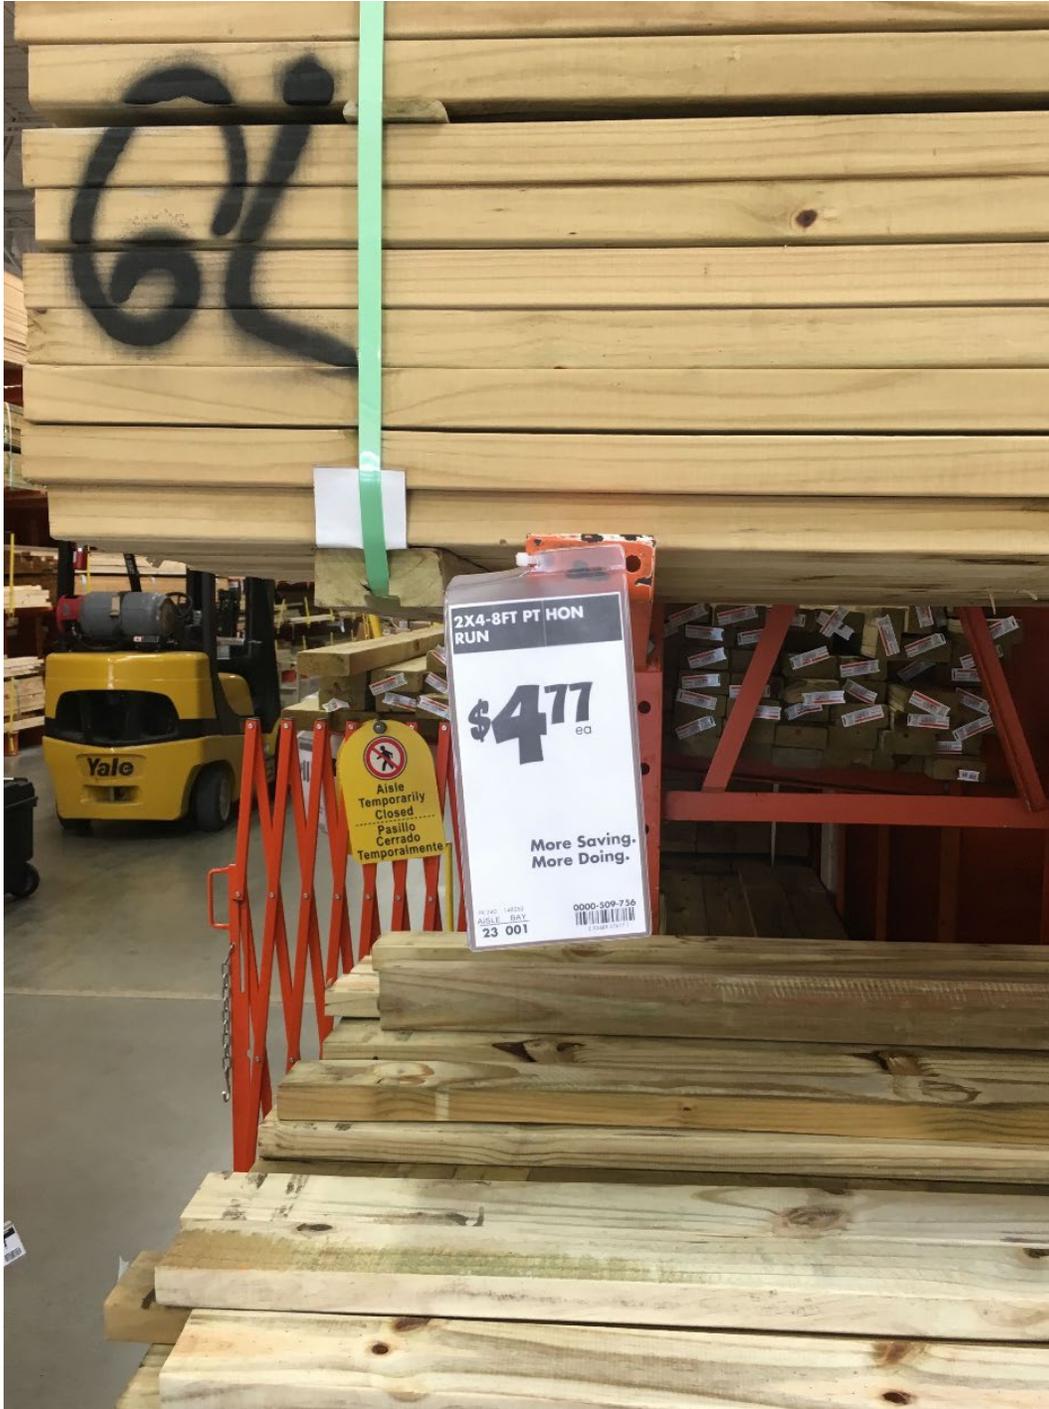
The research team noted that many materials sold / used in Puerto Rico were used/installed in ways that would not be able to survive a hurricane storm. Wood frame structures typically do not withstand a category 5 storm, but anyone can go to the local home improvement store in Puerto Rico and find dimensional lumber is plentiful and available for purchase (see Figure 4-17). Reinforced CMU walls built properly are sufficient to withstand category 5 winds due to the addition of reinforcing steel. However, when built periodically over a number of years and the reinforcing steel is left exposed to the elements for years before a wall is built, the exposure to the humid, salty sea air elements can cause failure in the reinforcing steel and weaken it (see Figure 4-18). Structural steel is also a viable option. Both options (reinforced CMU walls and structural steel) are more expensive than dimensional lumber construction. Wood structures can be made to withstand hurricane force winds, but only through careful design, proper execution, and additional material/fastener devises.

Figure 4-17: Inexpensive dimension lumber at home improvement store.

It is reasonably apparent that the poorer social class defaults to wood construction due to its low cost and easy access on the island. To lessen the damages of the next hurricane, the Puerto Rican government needs an agency (inspection services) that actively monitors new construction. Most private and government buildings and structures on the island are built to hurricane standards. The problem lies with individual, private residences. A permit process would help alleviate the burden of illegal construction. When legally permitted to build, the inspections would then become necessary. Inspections would ensure greater quality structures.

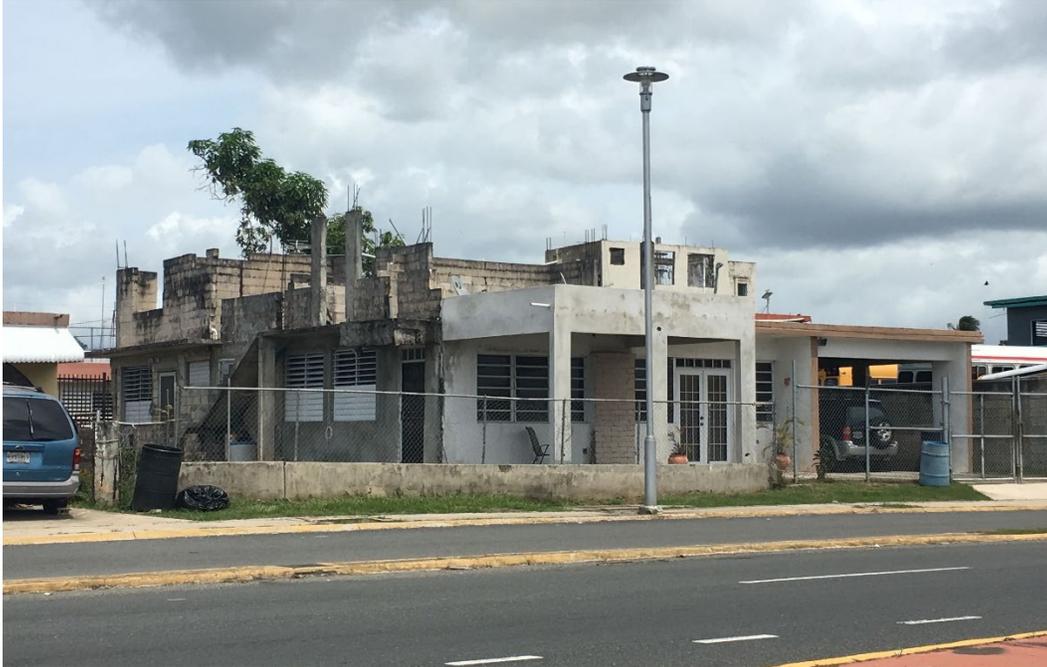
Figure 4-18: Second story masonry addition in progress.
