THESIS

EVALUATING THE LONG-TERM DURABILITY OF FIBER REINFORCED
POLYMERS VIA FIELD ASSESSMENTS OF REINFORCED CONCRETE
STRUCTURES

Colorado State University

Fall 2011

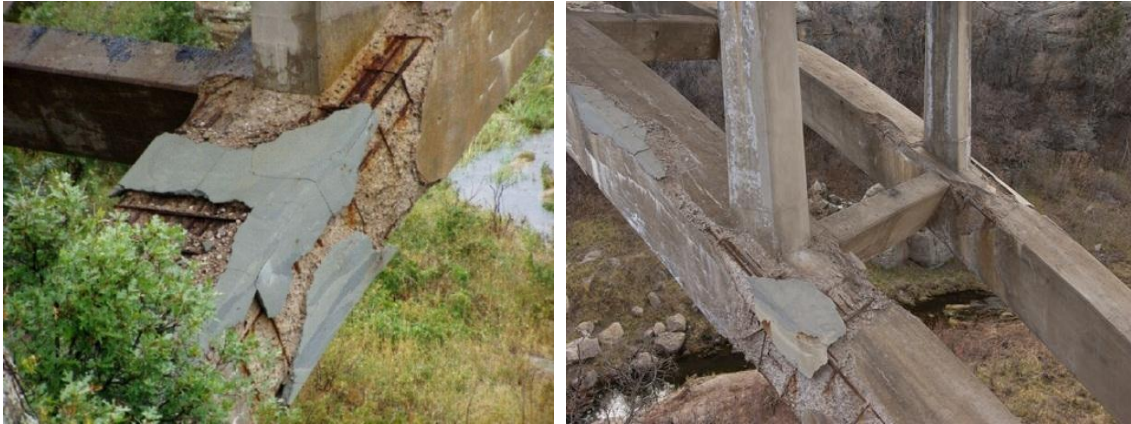
Prior to repair the concrete arches had severe spalling due to the corrosion of the internal steel reinforcement as seen in the photographs in Figures 3.8 and 3.9.

Figures 3.8 and 3.9. Concrete spalling on arch section prior to repair (Mohseni, CDOT)

Loose concrete, typically no more than the few inches of concrete cover, was removed with 6.8 kg (15 lb.) jack hammers and the exposed steel reinforcement was sandblasted free of rust. Seen below, the cross-section was restored with shotcrete which included a corrosion inhibitor, Sika FerroGard 903, to prevent further corrosion of the steel reinforcement.

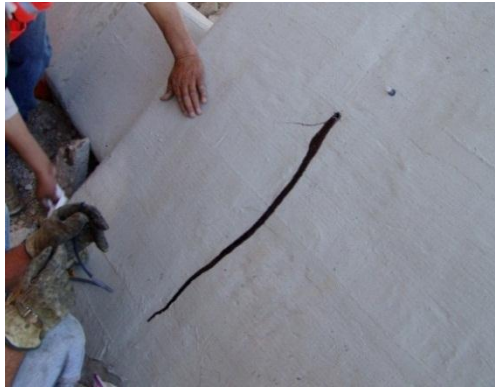
repaired by removing and re-applying the required number of layers of CFRP. A void that had been injected with resin directly following the CFRP application can be seen below in Figure 3.15. There was no documentation of this procedure or any information regarding the areas repaired or filled with resin, but it is assumed that this process was satisfactory.

Figure 3.15. Void injected with resin during 2003 renovation (Mohseni, CDOT)

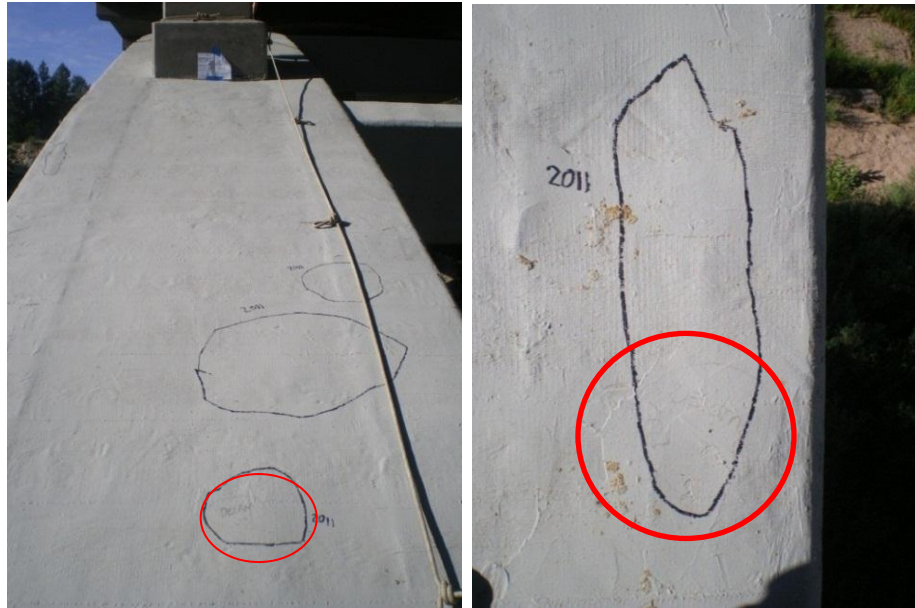
Markings made with a “permanent” marker on the bridge from the 2007 bridge inspection were barely visible at the time of the 2011 field assessment. Depending on the exposure from moisture and sun, markings on the bridge can exist for only a relatively short time with respect to the life span of the bridge. Below are three photographs of the areas identified from June 2007, two of which were barely visible at the time of the July 2011 visit. There were no markings found on the east arch from the inspections in 2005 and 2009. In addition to the three voids, three cracks in the CFRP were also identified in 2007, one of which can be seen below.

Figures 3.17 and 3.18. Outlined in permanent marker are identified areas of debonding between the FRP and the substrate developed in the structure between inspections in 2007 and 2011. Faintly denoted in the bottom of the photographs (enclosed in red circles) are previously found voids identified with “DELAM 07” and lines distinguishing the boundaries of the voids.

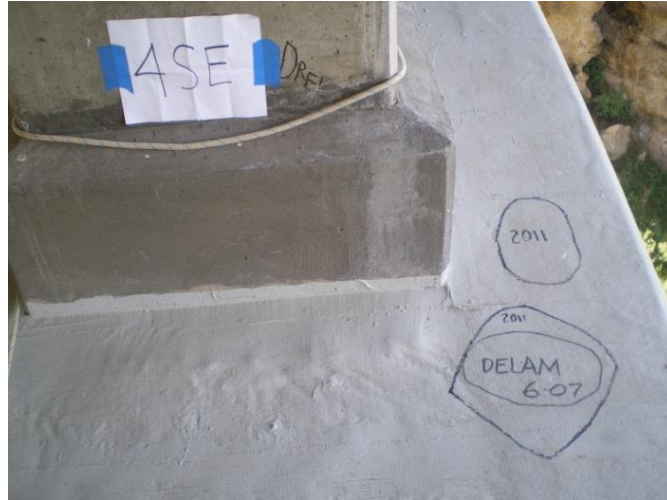
Figure 3.19. Enclosed in permanent marker are identified areas of debonded areas between the FRP and the substrate from 2011 and June, 2007. Notice in this more protected bay of the structure the markings from 2007 are more clearly visible.

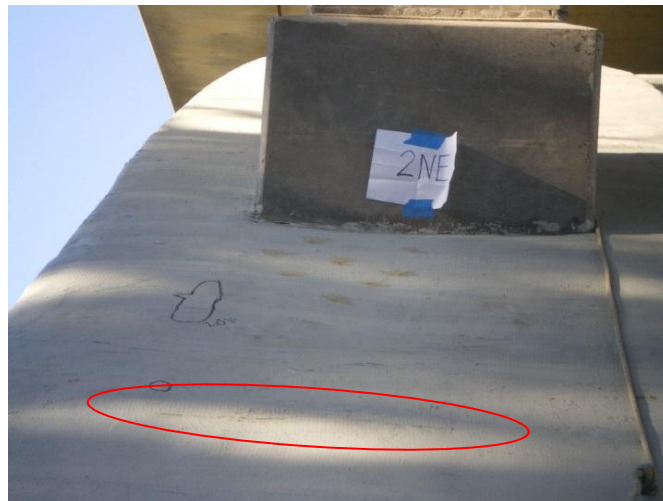
Figure 3.20. Crack identified in 2007

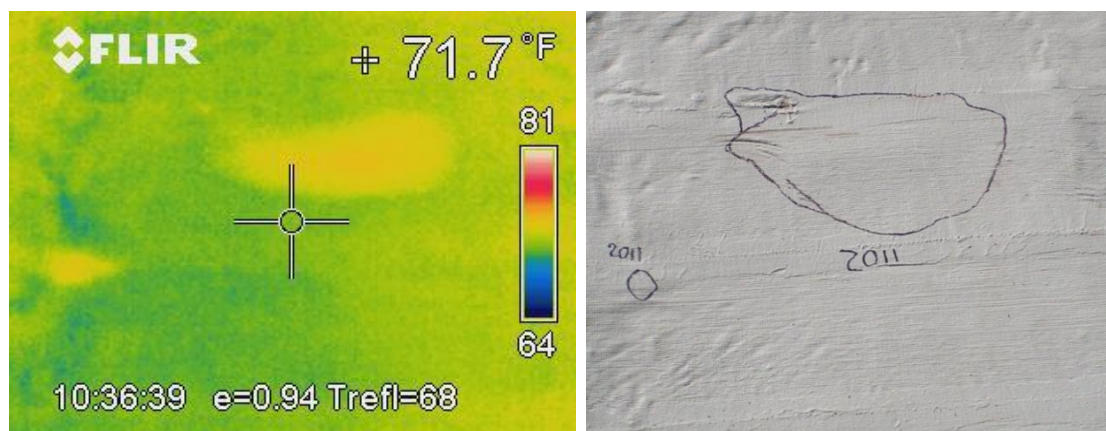
Figures 3.21 and 3.22. Photograph and thermal image from an infrared camera of two voids, (appearing yellow), found in 2011 on the 1st bay on the north side of the east arch

The images above are of two voids found in the 1st bay on the north end of the east arch. The area of the larger void was one of two areas eventually removed from the arch and is referred to as the “smaller” patch removed from the arch. Note the horizontal or transverse cracks enclosed in the red oval near the top of the void in Figure 3.23.

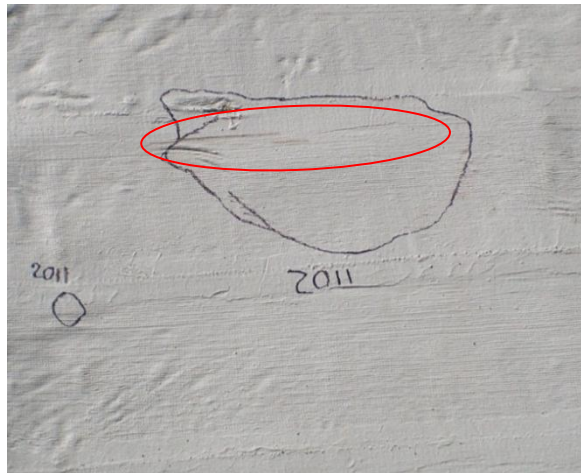
Figure 3.23. Two identified voids during the 2011 inspection, visible cracks in CFRP

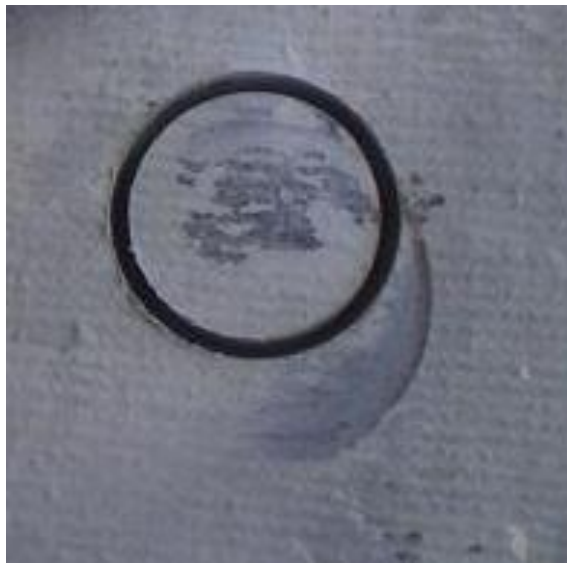
Figure 3.25. Damage caused by core bit without the use of the jig

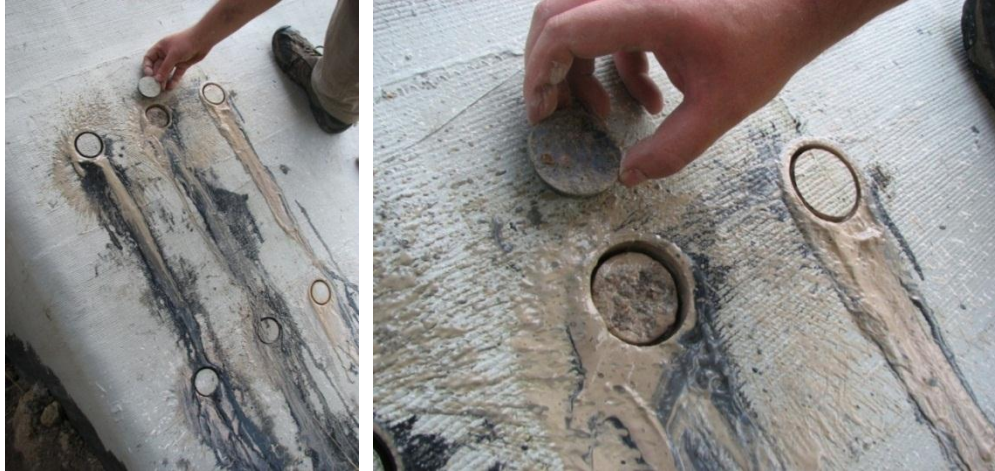
Adding torsional stresses to the circular area of CFRP and substrate inside the cored circle was inevitable due to the drilling process. These stresses were minimized by using a less aggressive drill bit with diamonds instead of a coring bit which has more aggressive carbide teeth for instance. Wet drilling by use of the ice also reduced stresses by adding water which created a slurry that removed displaced debris while using the finer particles to aid the diamonds in the cutting process. In one instance out of the 27 cored locations, the stresses induced by the drilling were enough to fail the cored section at the interface between the CFRP and the substrate. Figures 3.27 and 3.28 illustrate this occurrence.

Figures 3.27 and 3.28. The core drilling location that failed due to torsional stresses during the core drilling process, bay 1NW

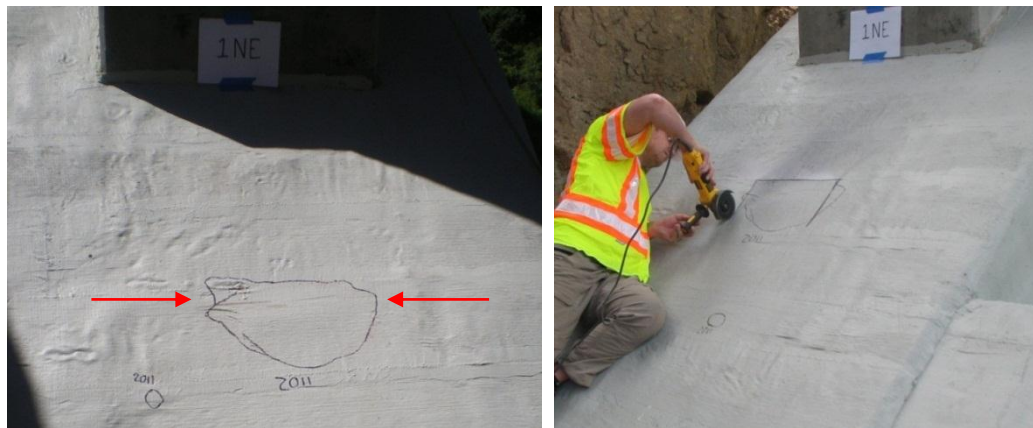
Upon cutting the lower edge of the CFRP rectangle, water exited the cut at the bottom of the void revealing standing water at the interface between the CFRP and substrate. Photographs of the void and the removal of the CFRP layer are shown in Figures 3.48 – 3.52 below.

Figures 3.48 and 3.49. Void in CFRP with transverse crack identified with red arrows and Cutting the perimeter of the void in the CFRP

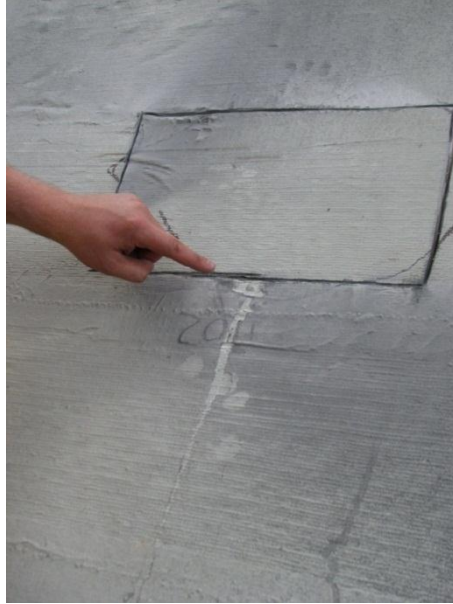
Figure 3.50. Water exiting the void area directly after the lower cut through the CFRP was completed

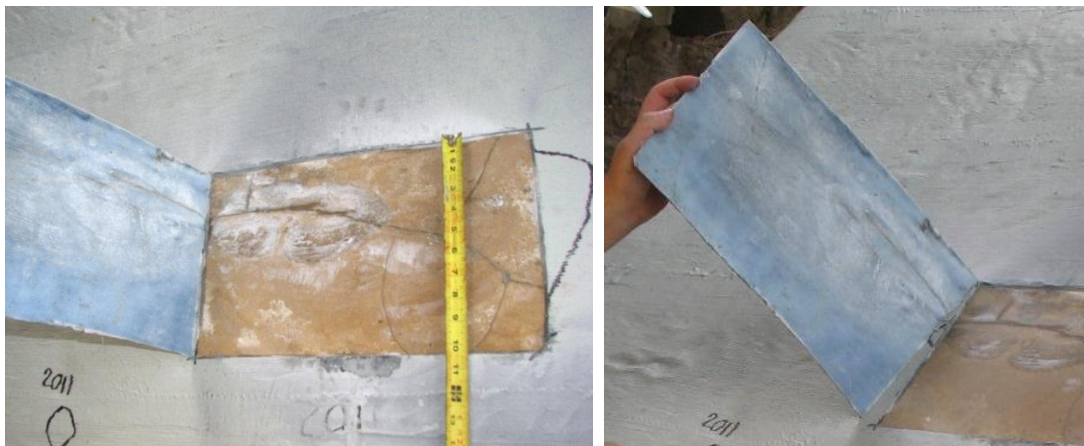
Figures 3.51 and 3.52. Cracks in the substrate were transmitted through the CFRP and notice the smooth texture and blue and white color of the underside of the CFRP

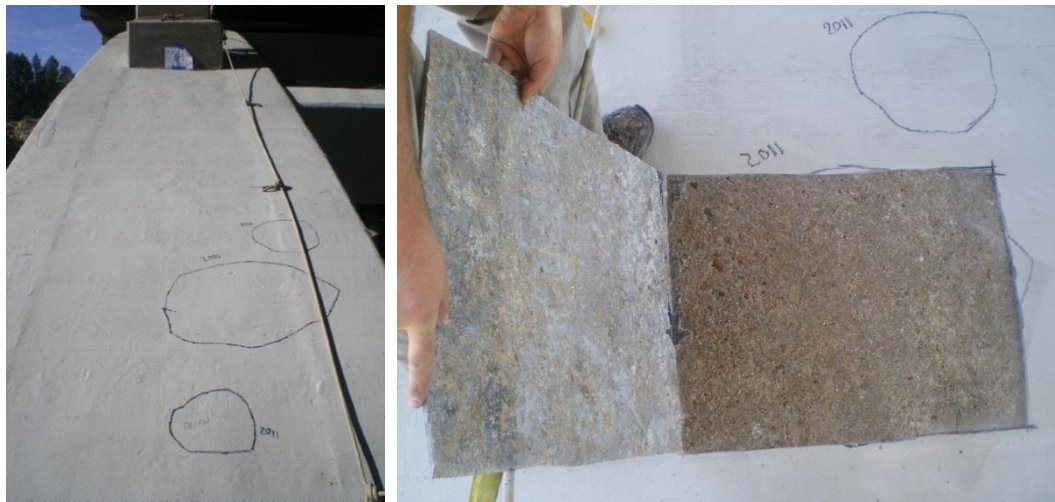
The second void was removed from the 3rd bay on the north end of the east arch. A rectangular section of the CFRP was removed with the same procedure previously described. Photographs of the area of the void and the removal of the CFRP rectangle are in Figures 3.53 and 3.54 below. There was no standing water or evident moisture in this larger void area, but there was significant pieces of the substrate adhered to the underside of the CFRP patch removed.

Figures 3.53 and 3.54. Voids found in the 3rd bay on the north end of the east arch and removal of the CFRP of the largest void

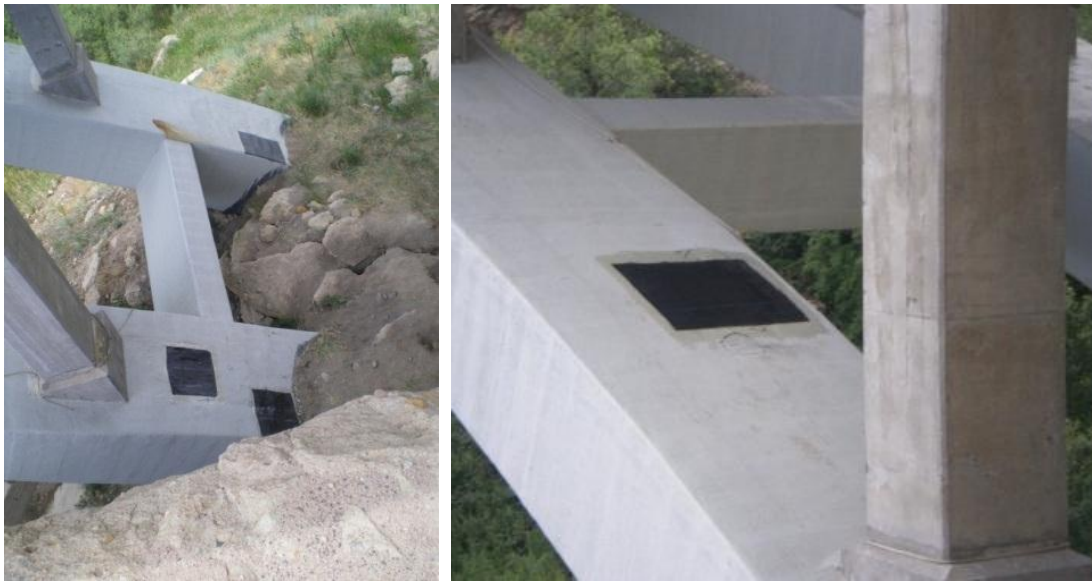
Figures 3.59 and 3.60. The repaired sections on the north end of the arches

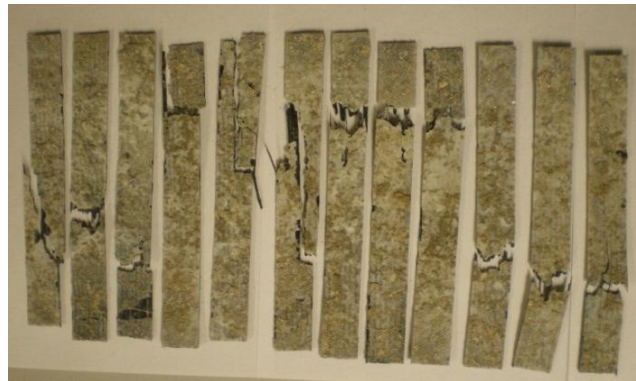
Figure 3.62. Failed tensile test specimens from the large void removed from bay 3NE, note the oatmeal appearance

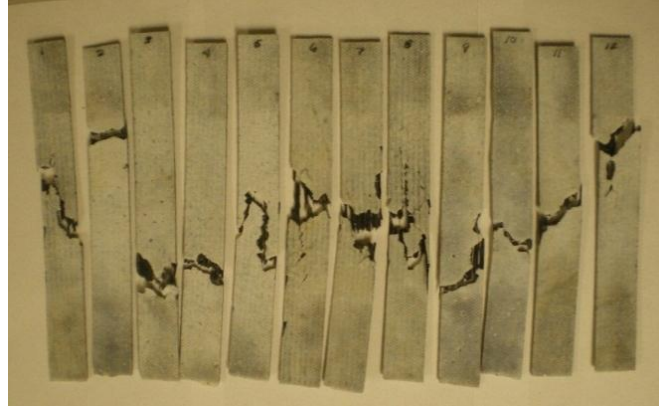
Figure 3.63. Failed tensile test specimens from the small void removed from bay 1NE, note the milky appearance

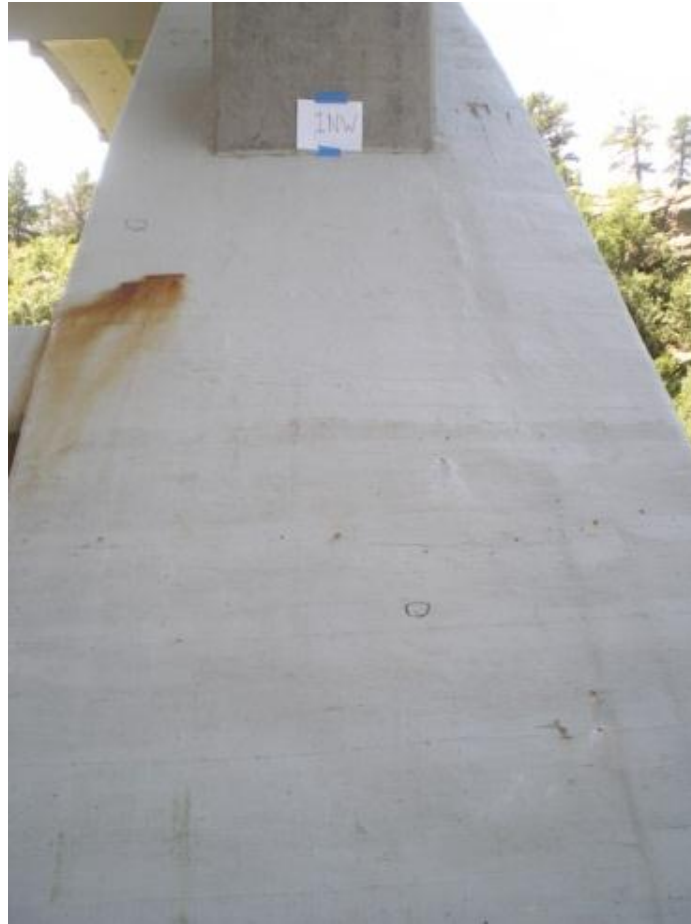
Bay 1NW: 3 Voids, 1 Rust Spot

Figure A1. Bay 1NW, 2 of the 3 small voids and rust spot

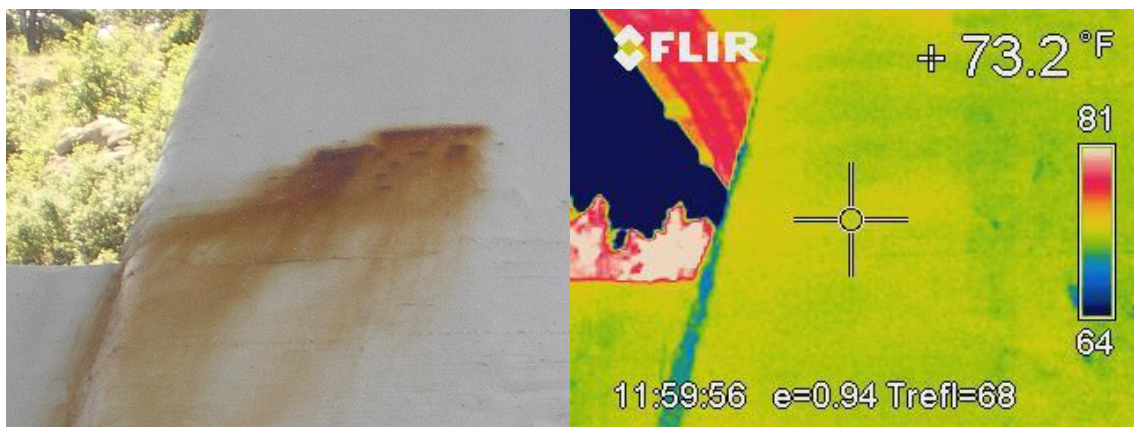
Figure A2. Photograph and thermal image of rust spot

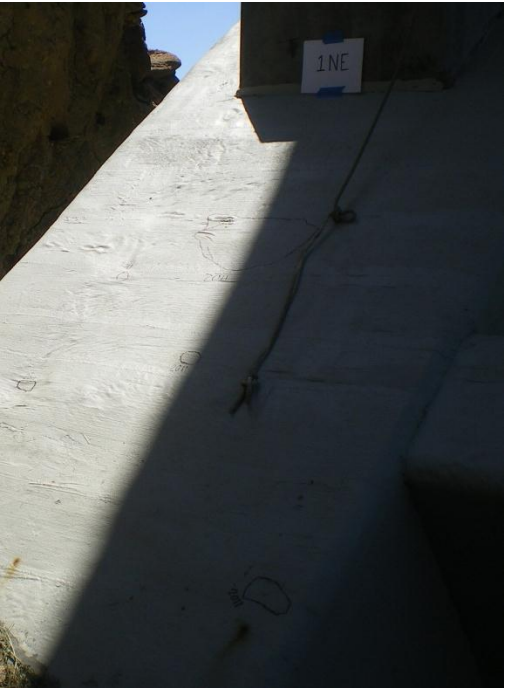
Figure A3. Bay 1NE, 5 voids

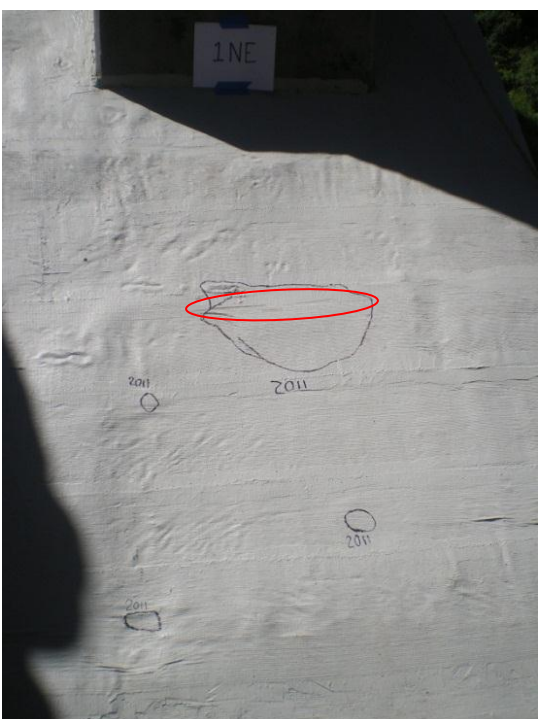
Figure A4. Bay 1NE, 4 of the 5 voids; Crack exists, enclosed in red oval, in the top of the largest void

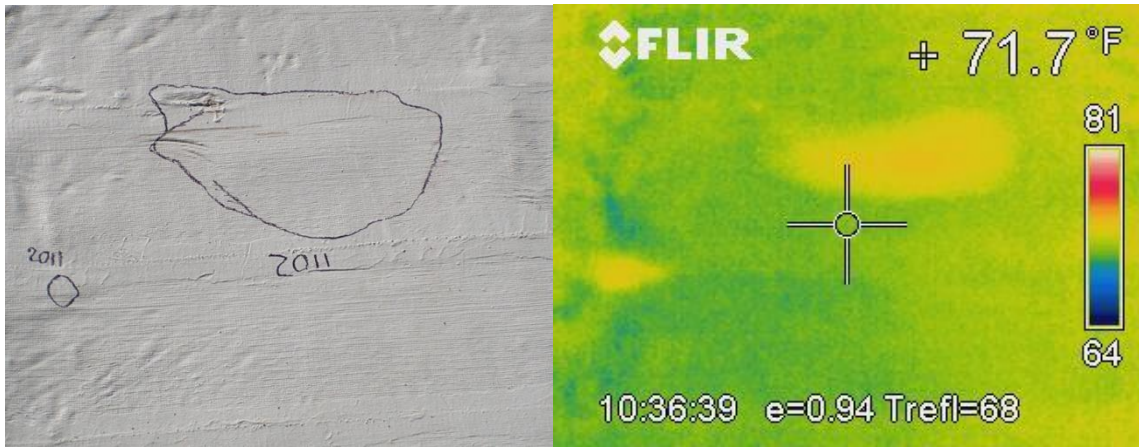
Figure A5. Photograph and thermal image of two voids in Bay 1NE

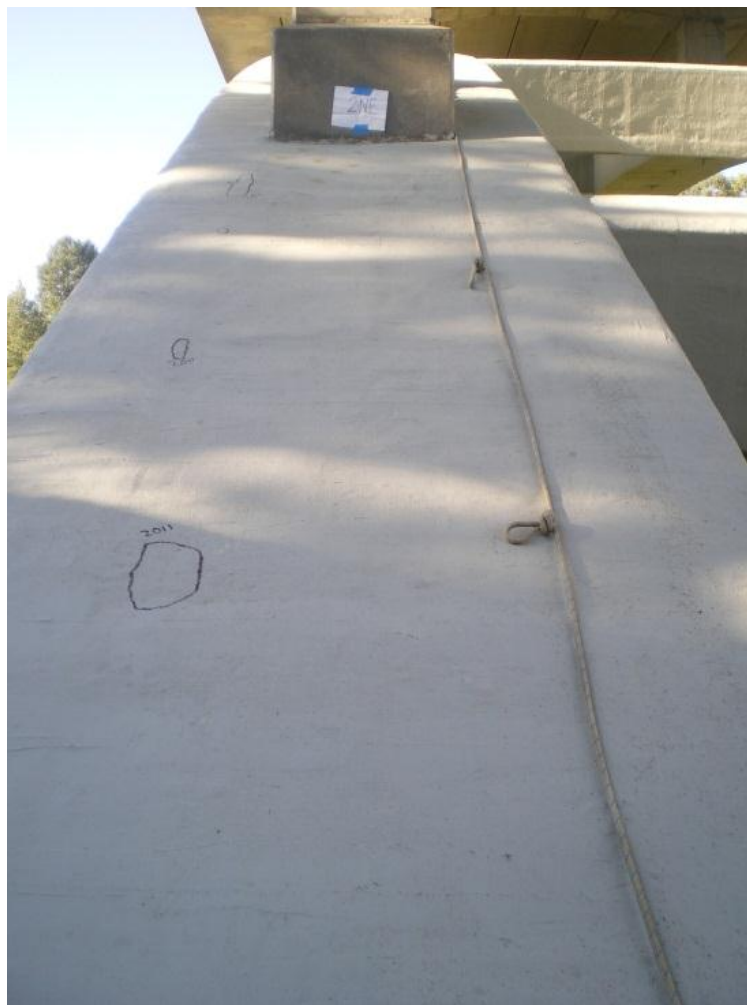
Figure A6. Bay 2NE, 3 Voids

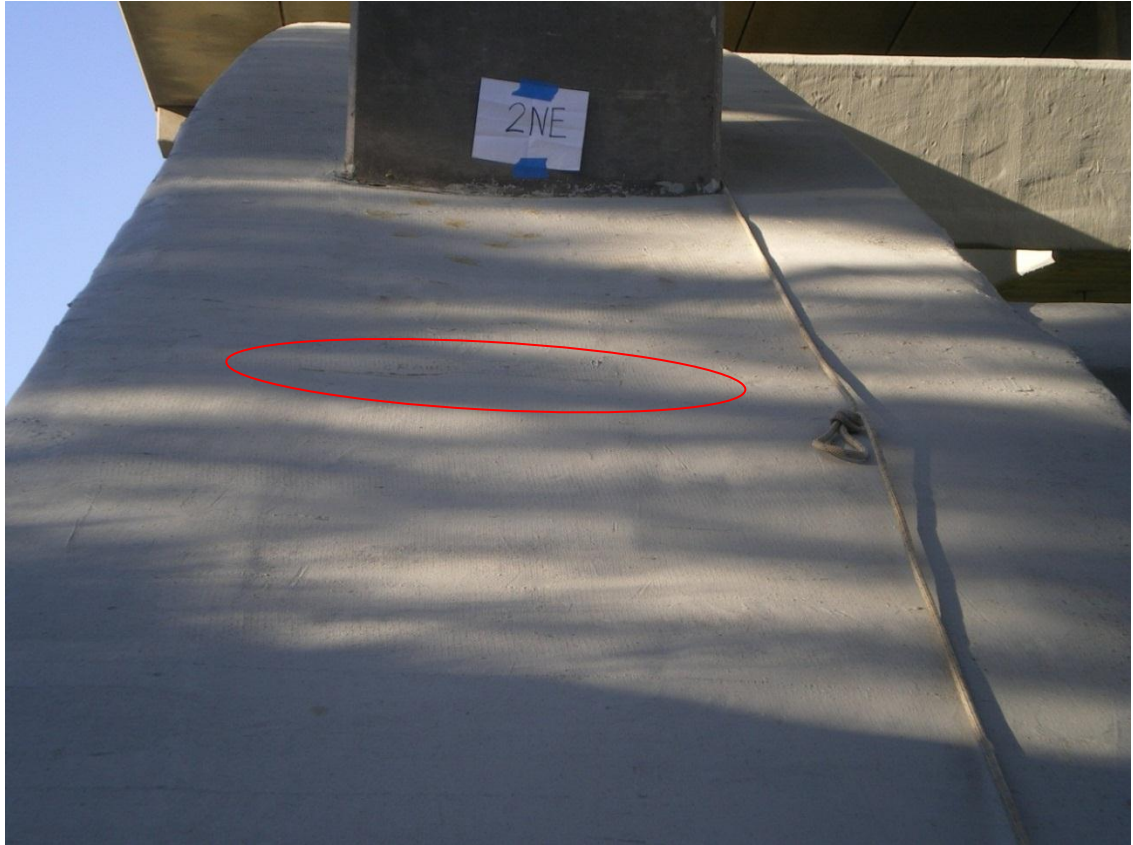
Figure A7. Bay 2NE, Crack enclosed in red oval was identified in 2007

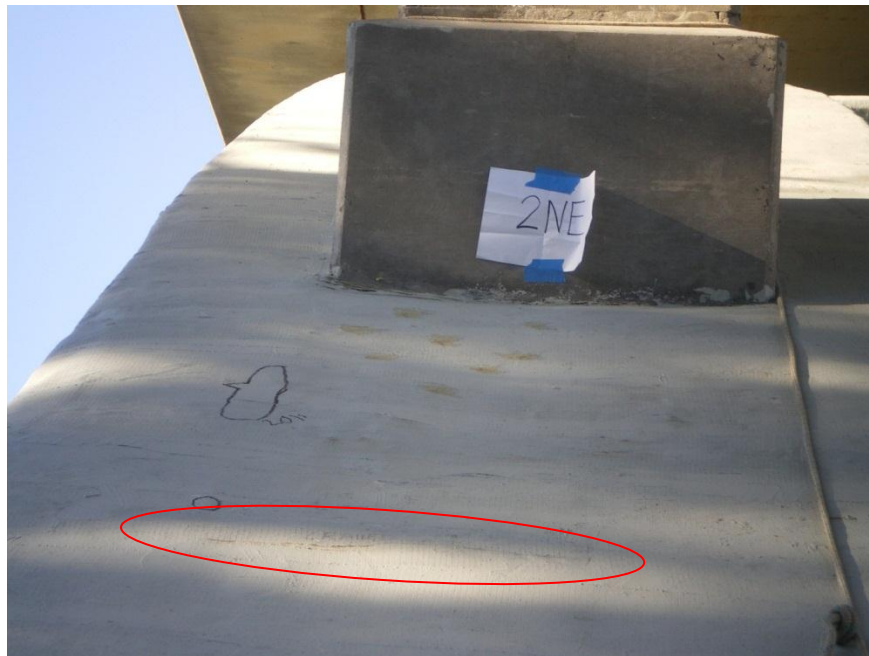
Figure A8. Previously identified in 2007, a crack enclosed in the red oval, no debonding at the location of the crack

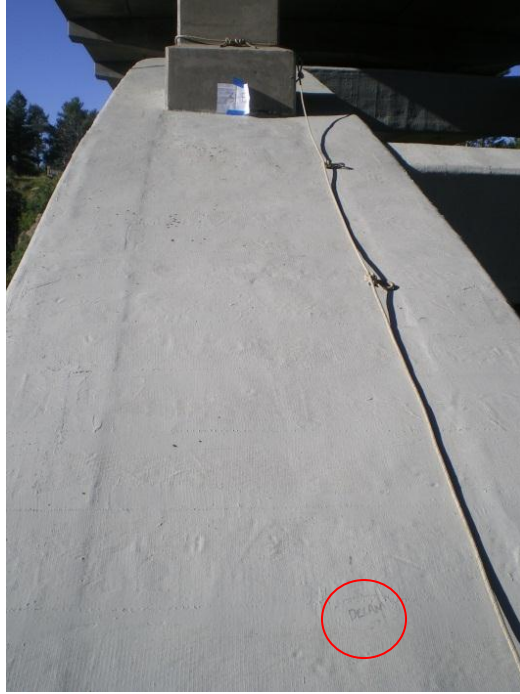
Figure A9. Bay 3NE with 1 of the 2 defects found in 2007 shown

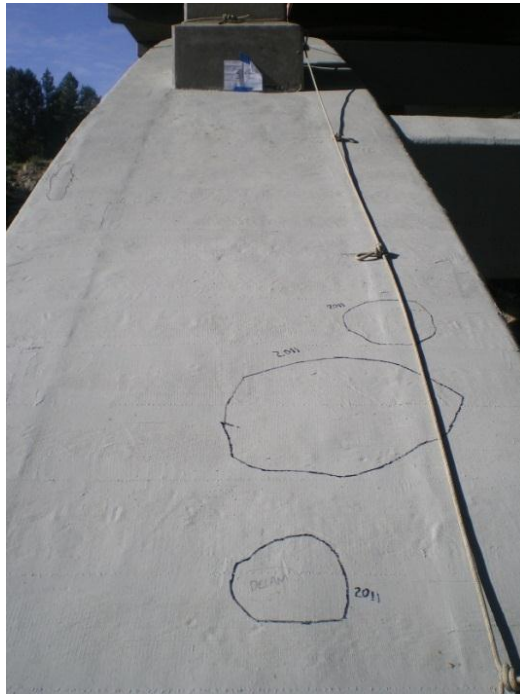
Figure A10. 4 of the 5 voids found in 2011

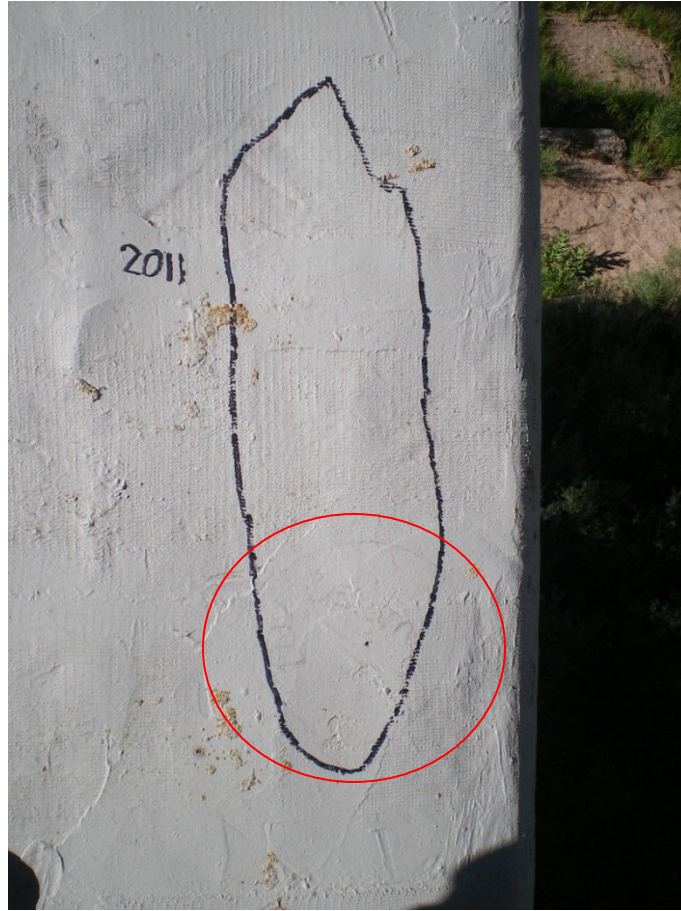
Figure A11. Enclosed in the red circle is 1 of the 2 voids found in 2007

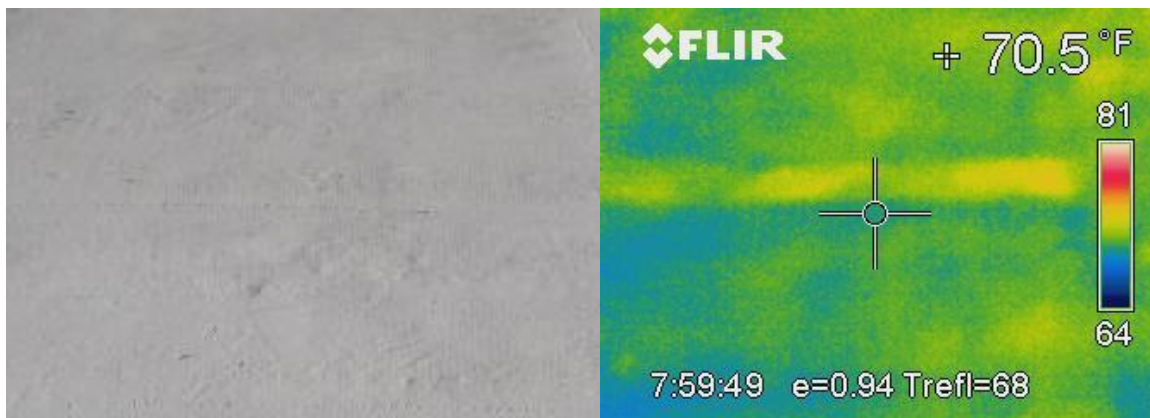
Figure A12. Photograph and thermal image of a seam in the CFRP sheets, no void present

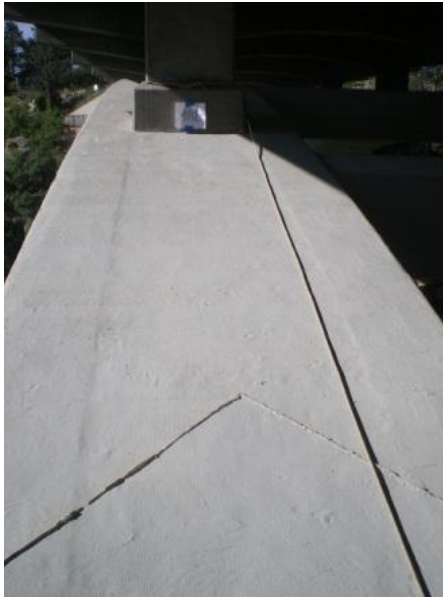
Bay 4NE: 1 Void

Figure A13. Bay 4NE, V-shaped silicone bead water diverter

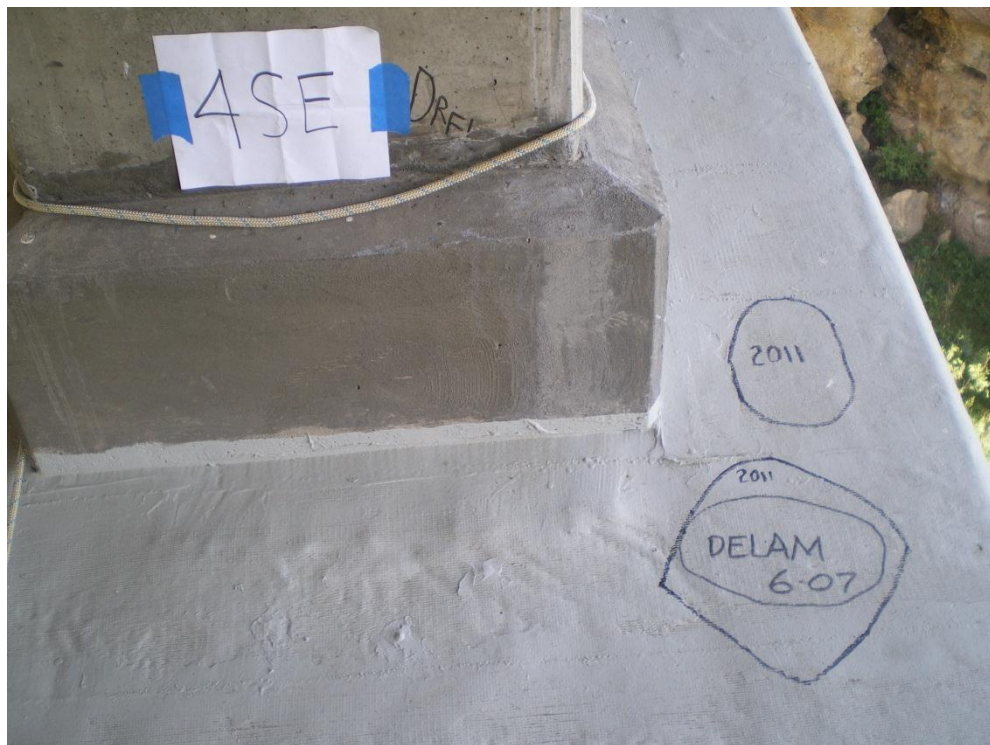
Figure A17. Void from 2007 has grown and a new void developed

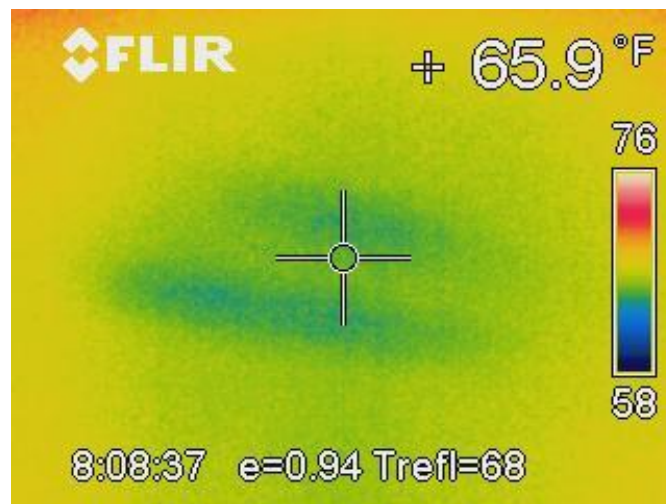
Figure A19. Thermal image of cracks previously identified in 2007

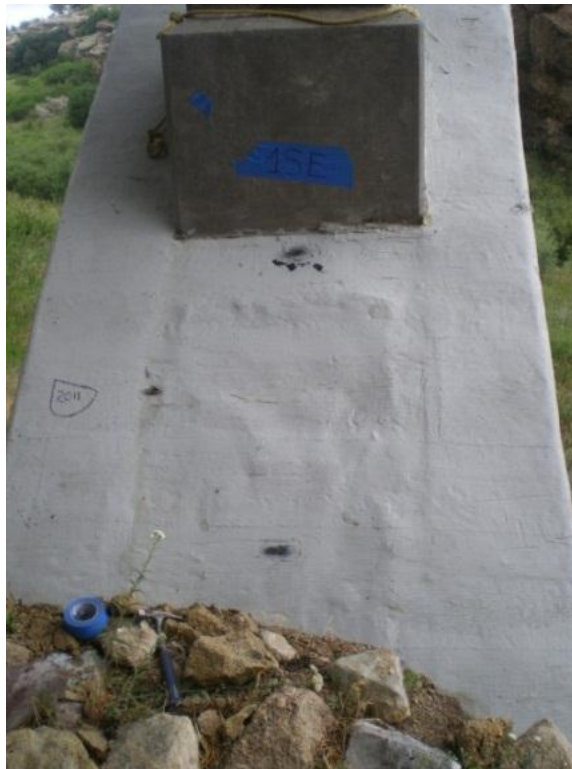
Figure A23. Bay 1SE, 1 void

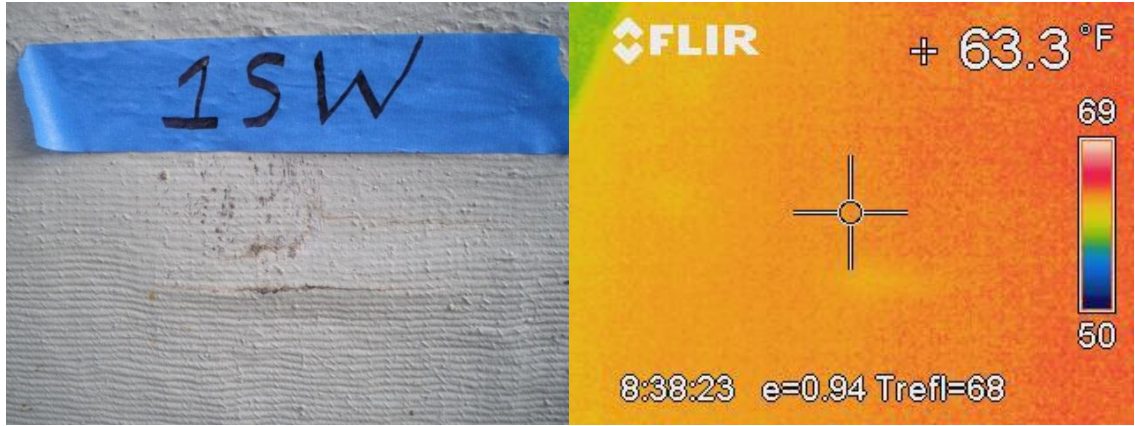
Figure A24. Photograph and thermal image of a defect found in Bay 1SW

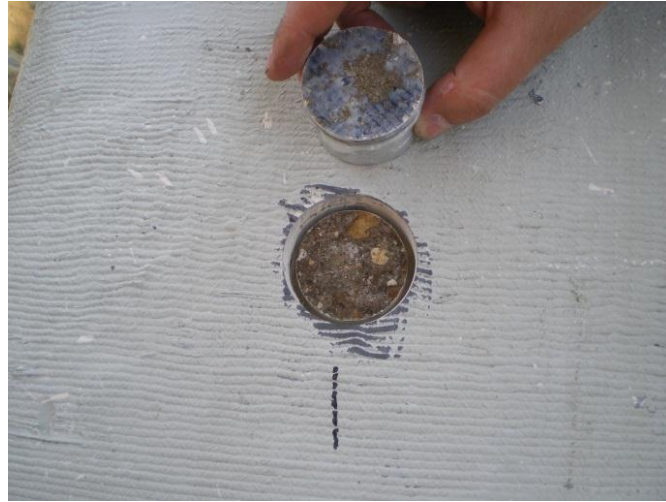
Figure B9. Test No.10, weak bond strength, and Test No.11 not available, cored area failed during drilling

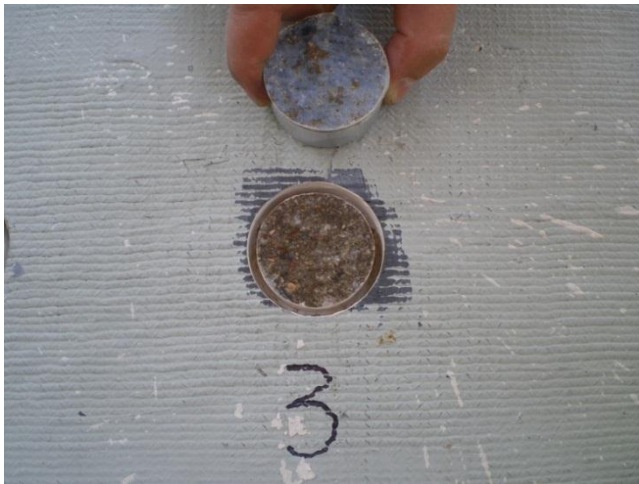
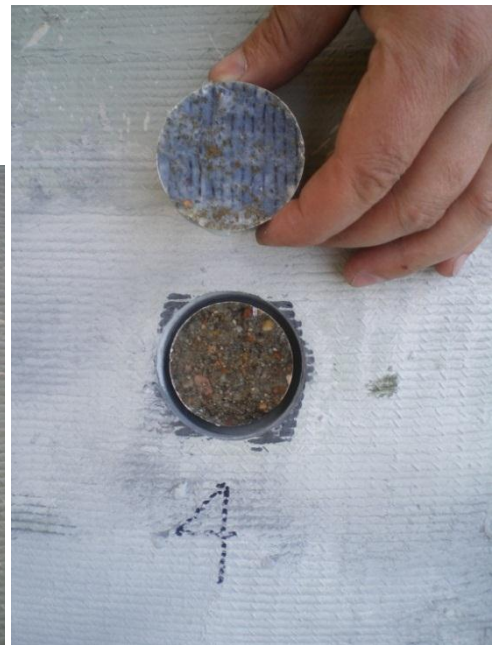
Figures B10 and B11. Test No.12, weak bond strength, and Test No.13, weak bond strength
