# **EXPERIMENTAL SEISMIC STUDY OF PRESSURIZED FIRE SPRINKLER PIPING SUBSYSTEMS**

Yuan Tian

November 9<sup>th</sup>, 2012

A dissertation submitted to the  
Faculty of the Graduate School of  
the University at Buffalo, State University of New York  
in partial fulfillment of the requirements for the  
degree of

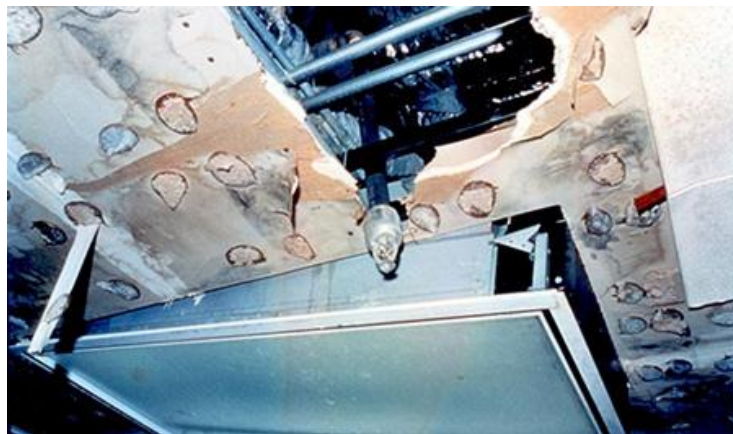
separation, was activated due to pounding with other building components. The same failure occurred from Floors 4 through 8 as a result of insufficient flexibility provided by the installed 90-degree offsets on each side of the seismic separation. For Holy Cross Medical Center, short drops (6-10 inches long) to sprinkler heads encountered failures at screwed tee when pipe or heads struck the hard (rated) ceiling, and replacements of 1,200 sprinkler heads and 401 two-piece escutcheons were reported by sprinkler repair contractors. Besides, sprinklers damaged by impact against ceiling systems, vertical supports pulled out, and failures of branch lines of small size were also reported from other hospitals.

*Figure 1-6 Rupture of sprinkler pipe at the elbow joint (from FEMA E-74, 1994)*

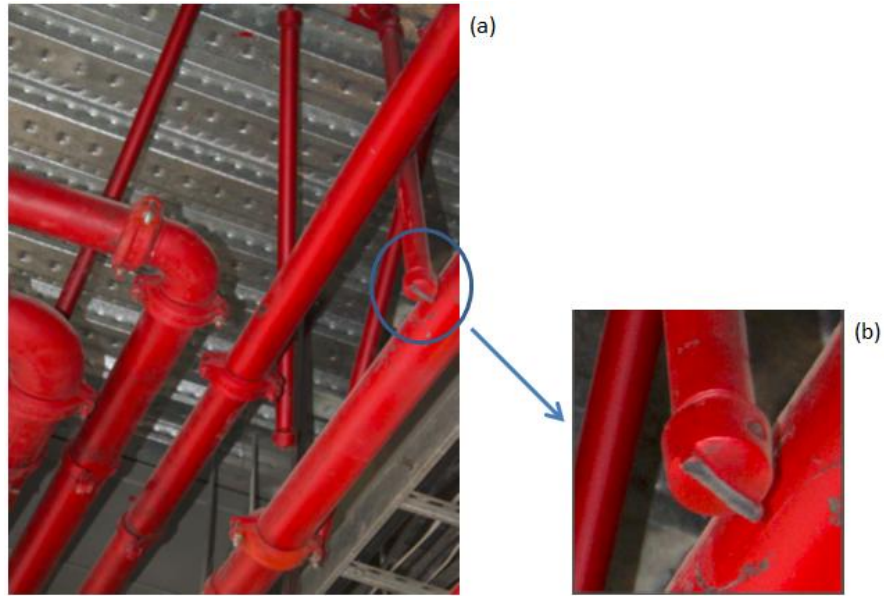
Fire sprinkler piping system damage was one of the major reasons that led to the shut-down of airport terminal at Santiago. Several braces were sheared off as shown in *Figure 1-9*. Fractures of tee joint threaded connections were also reported at the Santiago Airport (*Figure 1-10*).

Figure 1-9 Brace sheared off at the Santiago Airport (from E. Miranda, 2011)

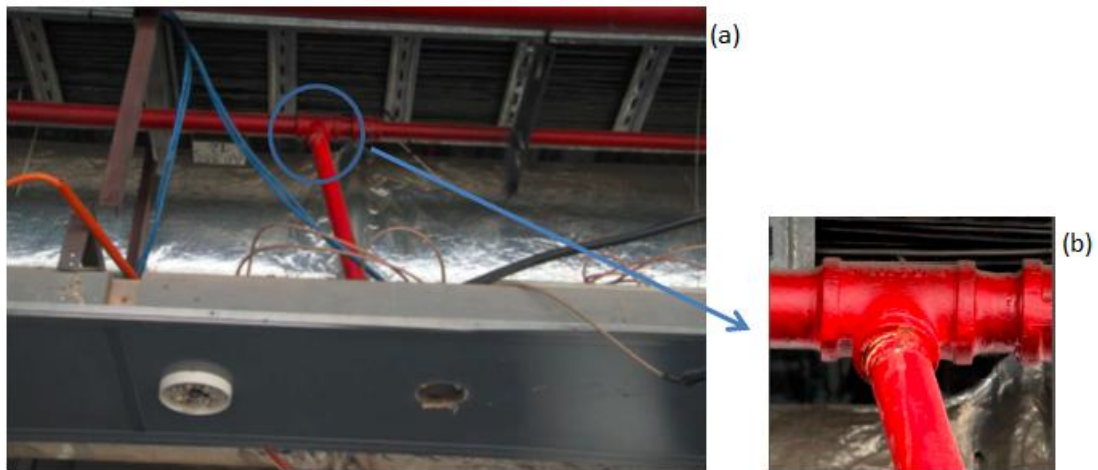
Figure 1-10 Fracture of tee joint threaded connection at the Santiago Airport (from E. Miranda, 2011)

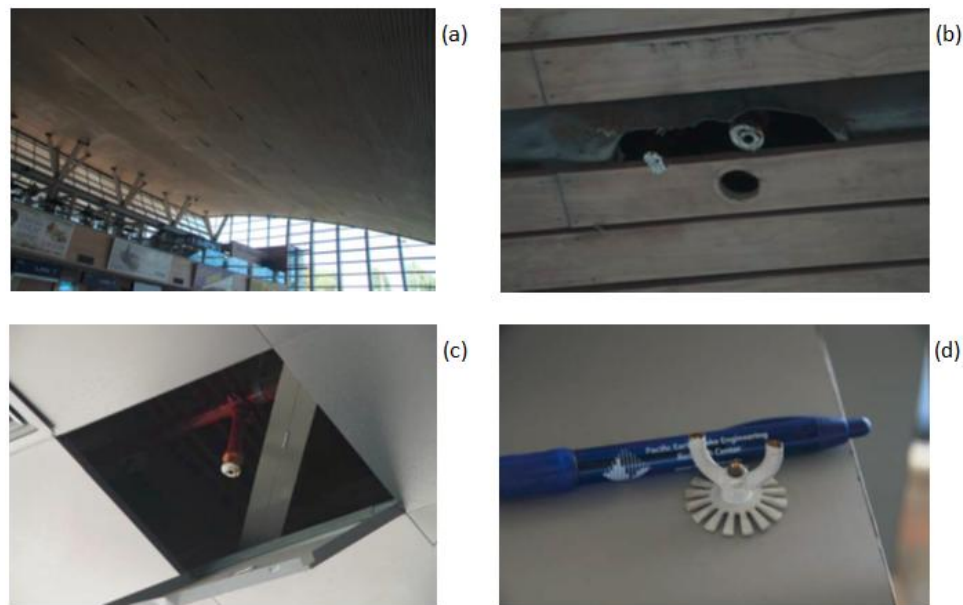
system. For other cases, sprinkler heads were moved upwards and pushed through the wood ceiling because of the significant vertical accelerations effect.

*Figure 1-11 Water damage from broken sprinkler heads at Concepcion Airport (from E. Miranda, 2011)*

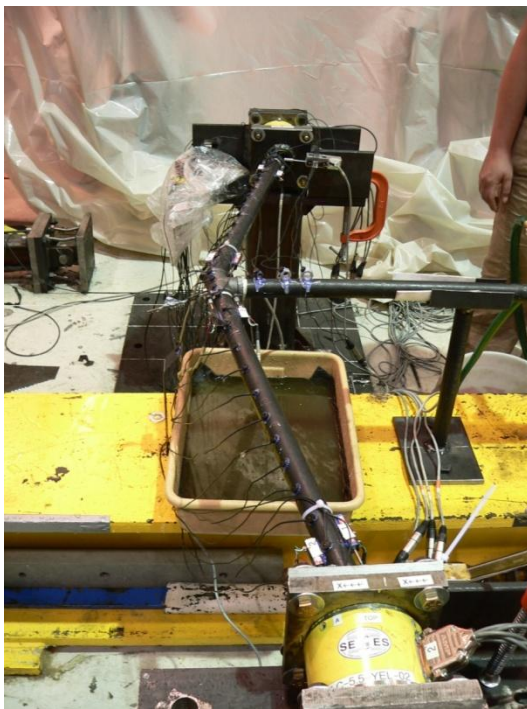
compared to the crests of the threads in the pipes and threads in the tee joint. This was observed for all specimens with nominal diameters of  $\frac{3}{4}$  in. and 1 in., which experienced both DS<sub>1</sub> (first leakage) and DS<sub>2</sub> (fracture of the pipe). The opening or fracture of the threads was initiated from the roots of the male threads in the pipes.

(a) Large inelastic rotation occurred at the ends of the pipes on both sides of the tee joint

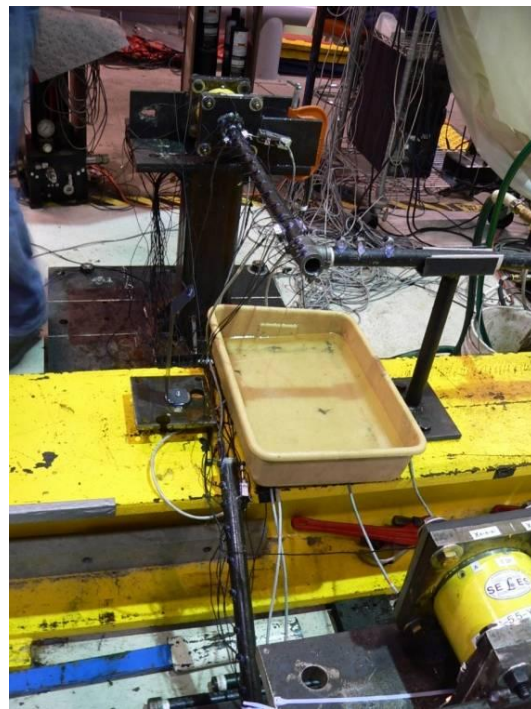
(b) Fracture of pipe occurred at the juncture of fitting and tee joint

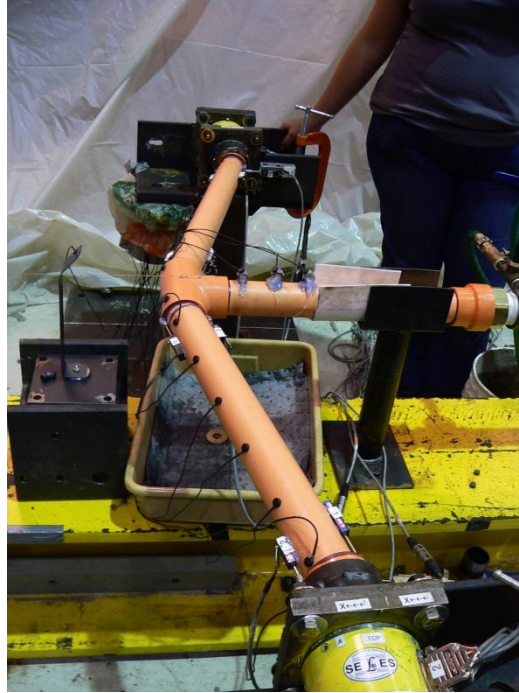
Again for all specimens, significant inelastic rotations, as shown in *Figure 3-16*, were concentrated at the ends of the pipes on both sides of the tee-joint. Note that both damage states DS<sub>1</sub> (first leakage) and DS<sub>2</sub> (fracture of the pipe) occurred simultaneously for the CPVC pipes with cement joints.

*Figure 3-16 large inelastic rotation at the end of pipes*

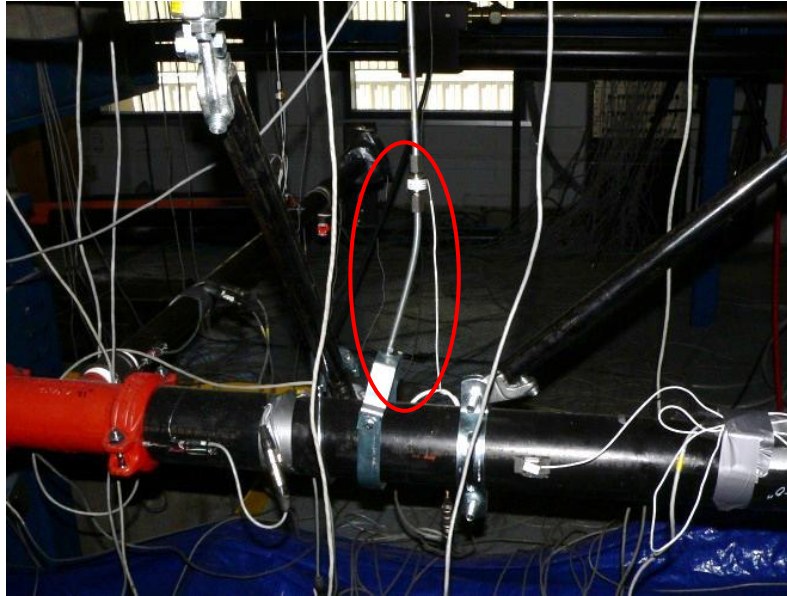
*Figure 4-34 Buckling of vertical hanger (Configuration 1-6, 100% MCE level)*

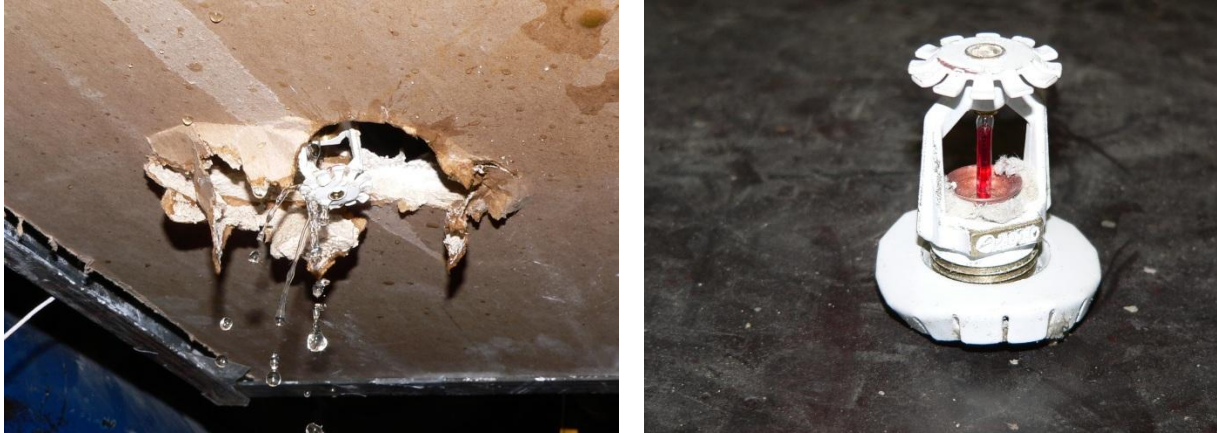
flowing out, was broken and activated water release as the sprinkler head collided with the sharp debris around the opening of the ceiling tile.

*Figure 4-36 Failure of quick response pendant sprinkler head (Configuration I-6, 100% MCE level)*

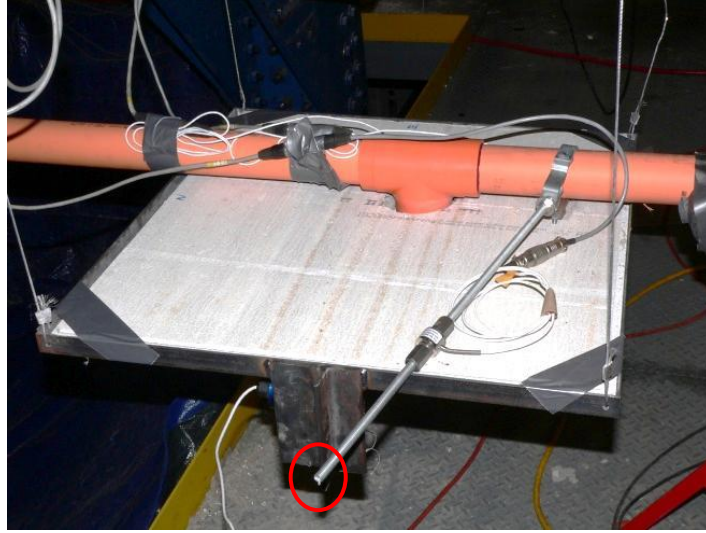
Two major failures were observed during testing of the second specimen. The first one occurred to the third configuration when the two-story specimen was subjected to 100% of MCE level of testing protocol and supported only by vertical hangers and braced with wire restraints. As shown in *Figure 4-38*, the vertical hanger attached to the LCR-18 load cell (*Figure 4-29*) supporting the branch line #5 at the first level ruptured due to local necking at the connection to the SAMMY screw.

*Figure 4-38 Rupture of vertical hanger (Configuration 2-3, 100% MCE level)*

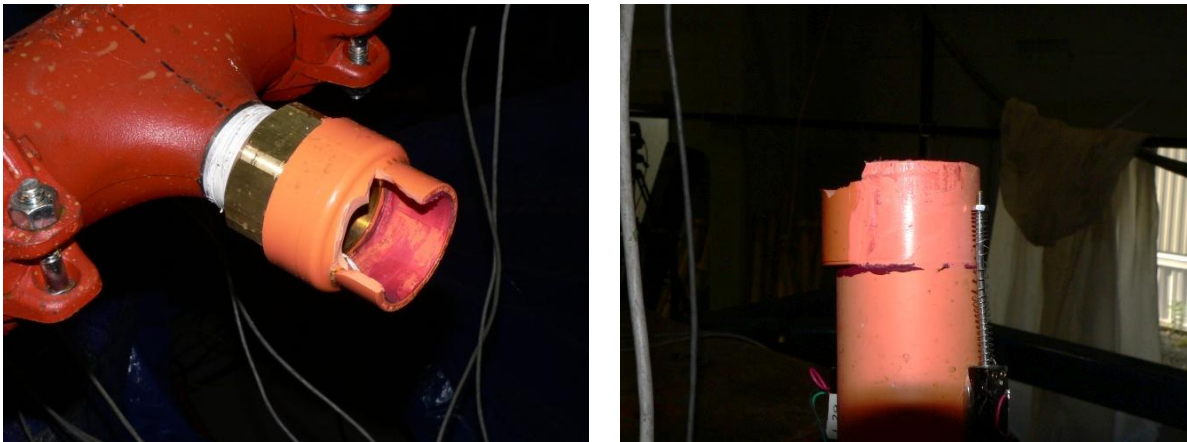
At the 100% MCE level of testing protocol, the fully unbraced specimen had a complete fracture at the tee joint of the branch line #1 at the first level, as shown in *Figure 4-39*. Unlike the failure mechanisms that were observed from the quasi-static tests on the piping tee joints described in Chapter 3, the complete fracture occurred at the root of the CPVC tee joint instead of at the end of pipes along the edge of the tee joints.

*Figure 4-39 Fracture of the CPVC branch line (Configuration 2-4, 100% MCE level)*

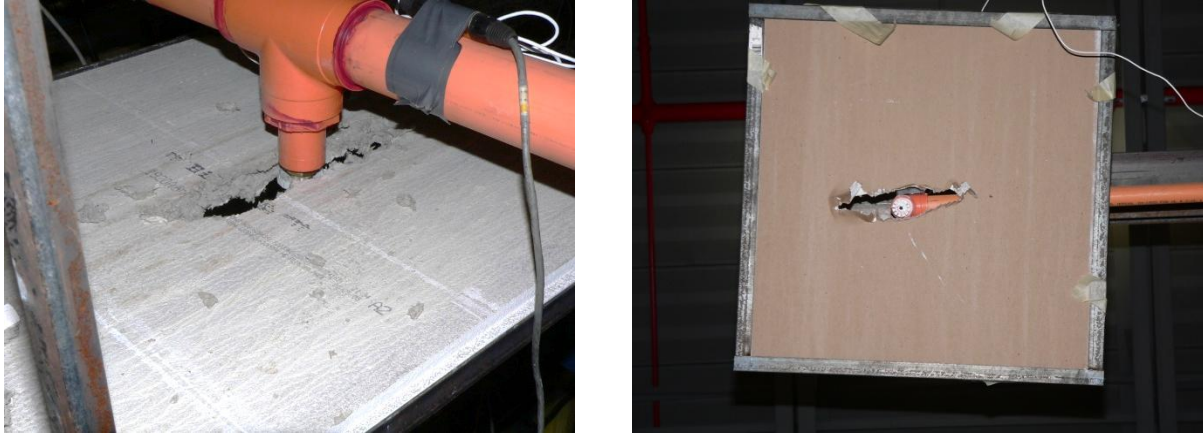
As shown in *Figure 4-40*, severe damage of ceiling tiles as a result of pounding with pendant sprinkler heads was again observed during the testing on the second specimen.

*Figure 4-40* Damage of ceiling tiles (Configuration 2-4, 100% MCE level)
