Fleet management of rural timber bridges

Major: Civil Engineering (Structural Engineering)

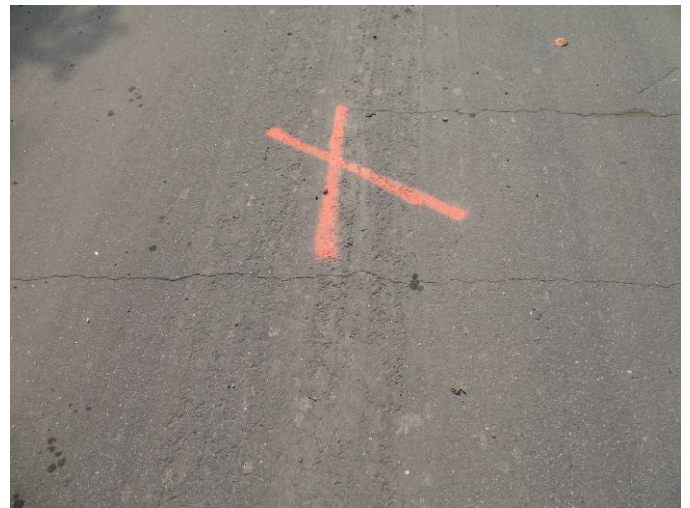
Figure 42. Pavement Chipping at West End

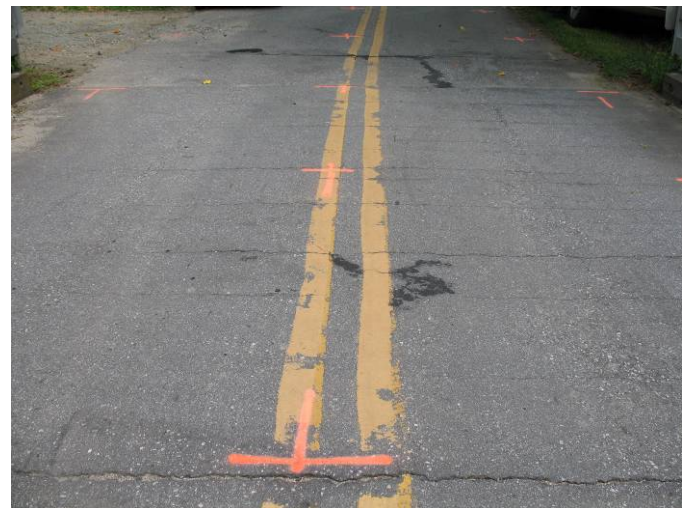
A number of transverse cracks were present throughout the bridge wearing surface and these cracks are consistent with the direction of the floorboards. Figure 107 shows the transverse cracking.

Figure 107. Presence of Transverse Cracks

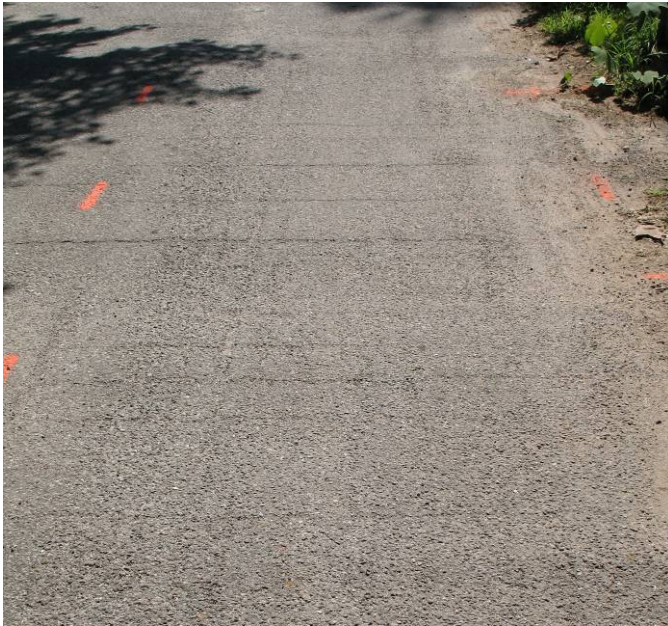
Transverse cracks were observed in the asphalt pavement at the floor board seams and are shown in Figure 13. Though determined to be relatively minor, these cracks should be noted. Overall, the asphalt pavement generally looked to be in satisfactory condition. At the transitions between the approach and the bridge wearing surface transverse cracking begins, though the transition between the roadway and asphalt does not appear to be problematic for the bridge. An uneven transition could subject the bridge to unnecessary effects from dynamic loads even though slow vehicle speeds on this roadway make this unlikely. In addition, a significant amount of debris had collected on top of the bridge near the curbs which could hinder drainage and promote seepage through the wearing surface to the decking and superstructure.

Figure 137. Transverse Cracks in the Wearing Surface Deck

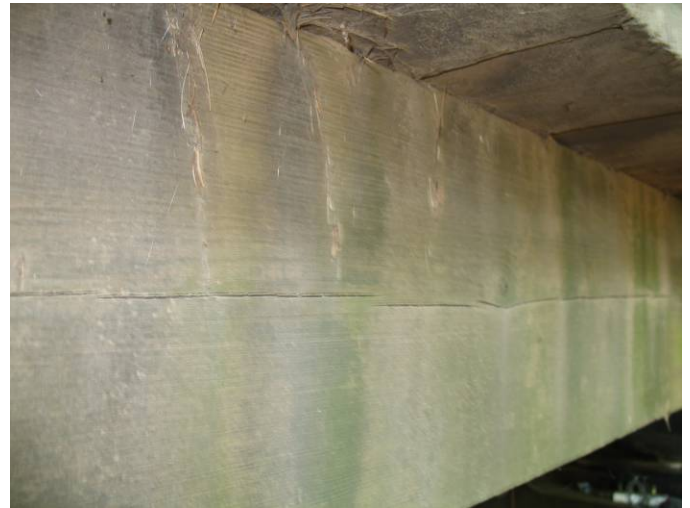
The girder bearing on the sill was sufficient and there is no misalignment. The only noticeable degradation is minor checking at the centerline of most of the girders. Figure 139 shows a typical case of checking found throughout the bridge.

Figure 139. Checking at Girder Centerline

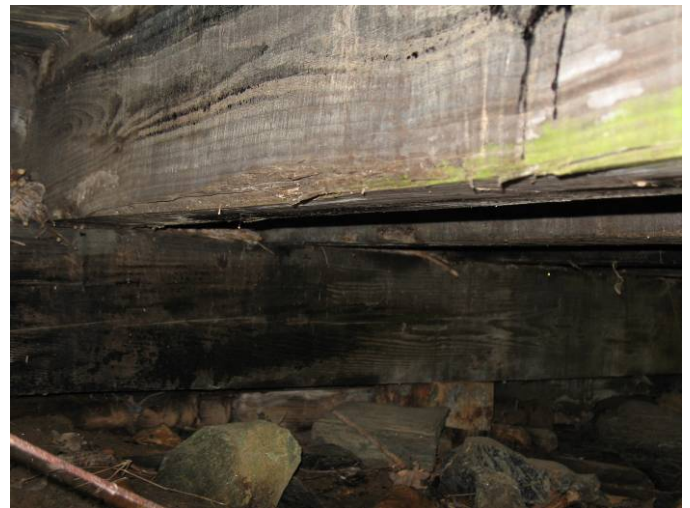
Figure 199. Mechanical Damage to Girder

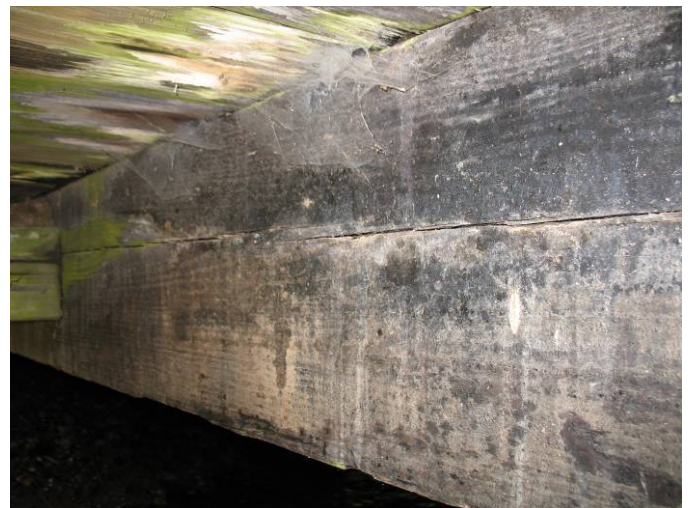
Figure 200. Checking in the Girders

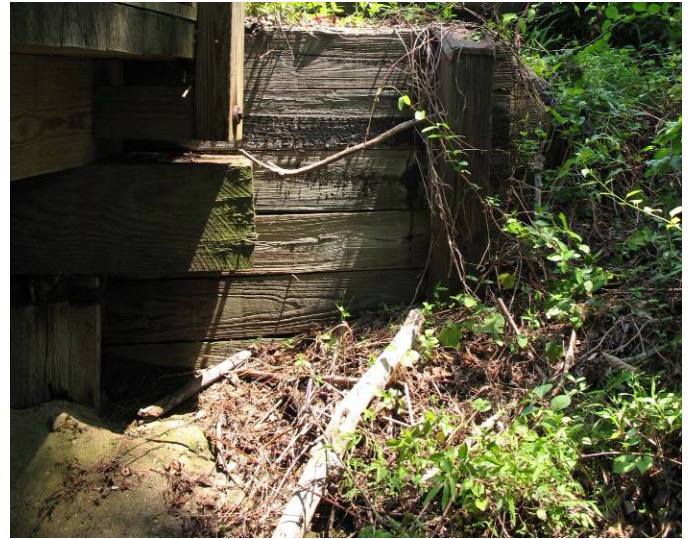
Figure 230. Wingwall Weathering and Decay

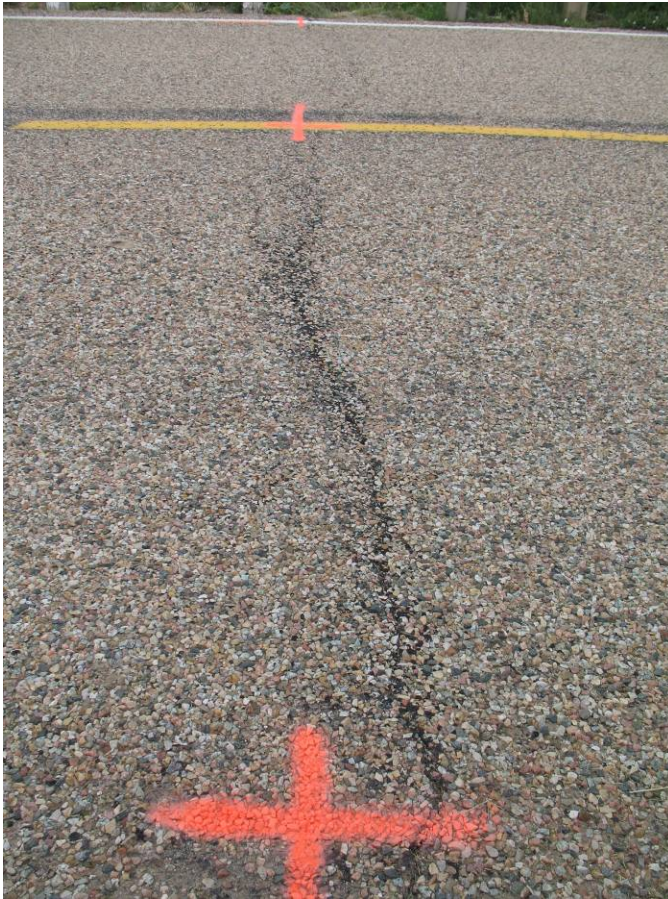
Aside from the transverse cracking, the wearing surface looked to be in good condition. One should note that the wearing surface thickness of 10-1/2 in. was greater than that typically found on timber bridges.

Figure 286. Transverse Wearing Surface Cracking

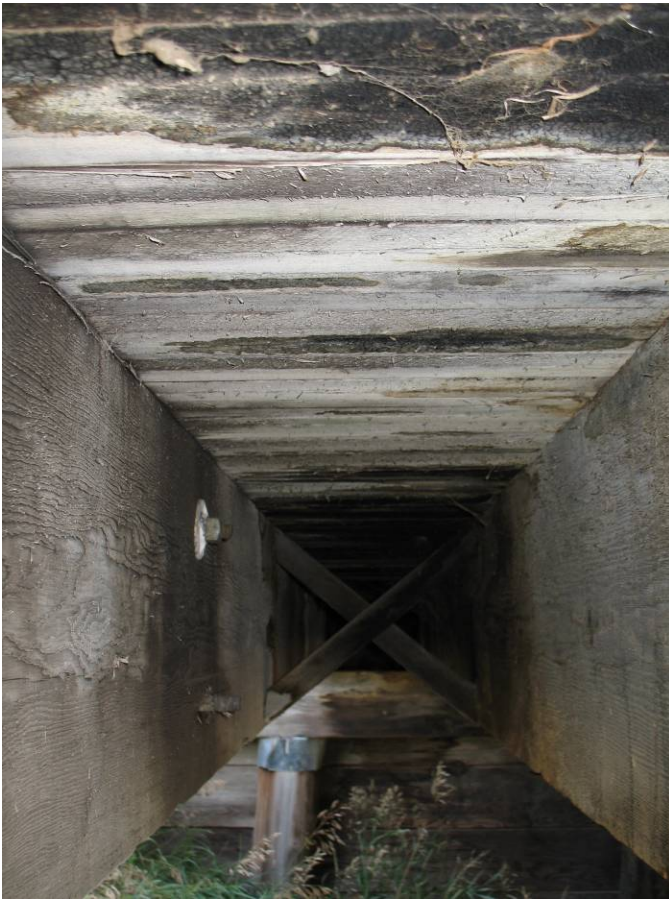
Figure 349. White Residue Formation on Deck

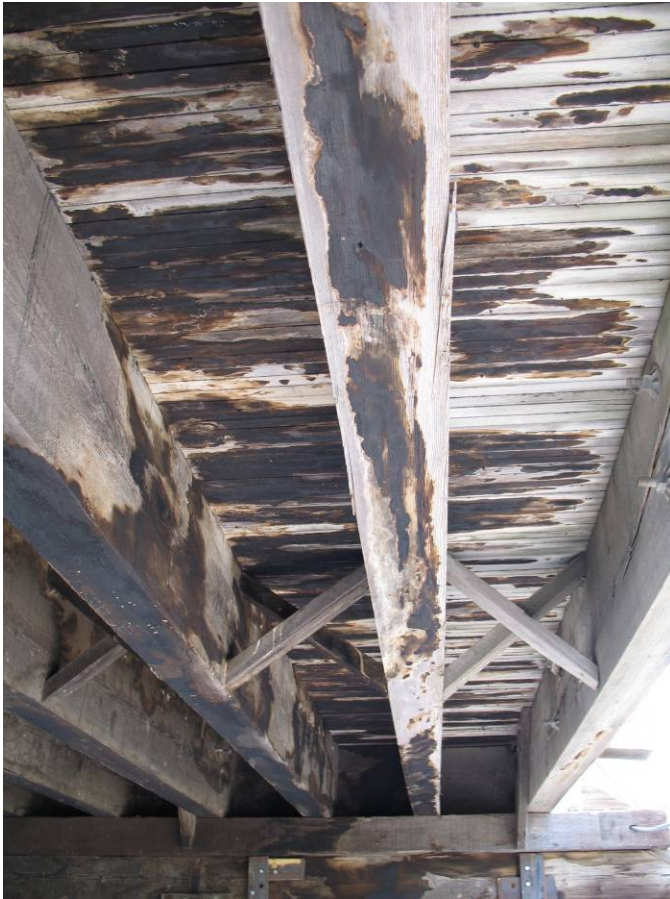
Figure 377. White Residue Formation on Deck

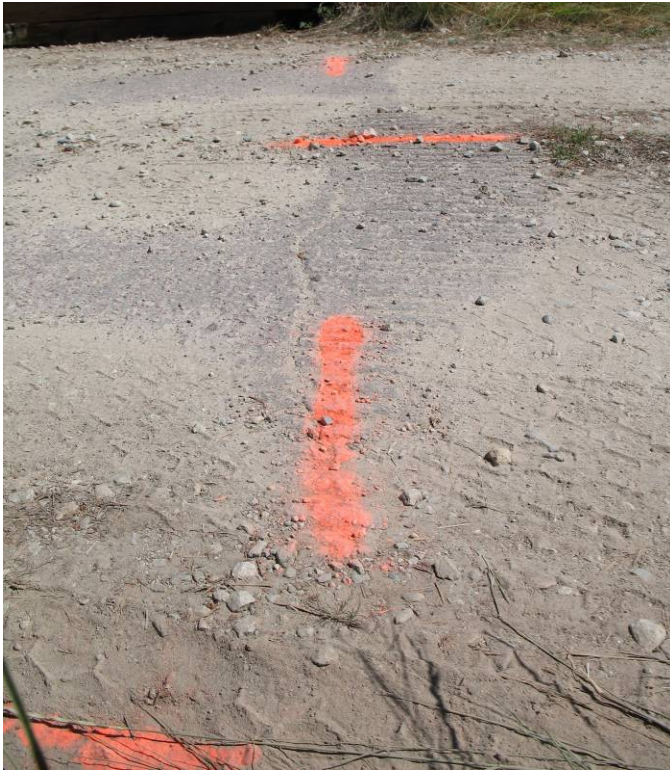
Figure 439. Wearing Surface Cracking and Debris

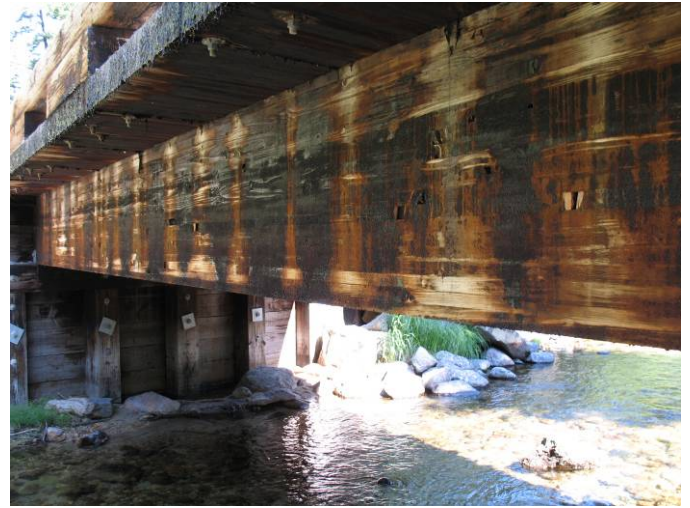
Figure 441. Girder Streaking and Holes
