Investigation of an alternative gravel roads rejuvenation method

Major: Civil Engineering (Construction Engineering and Management)

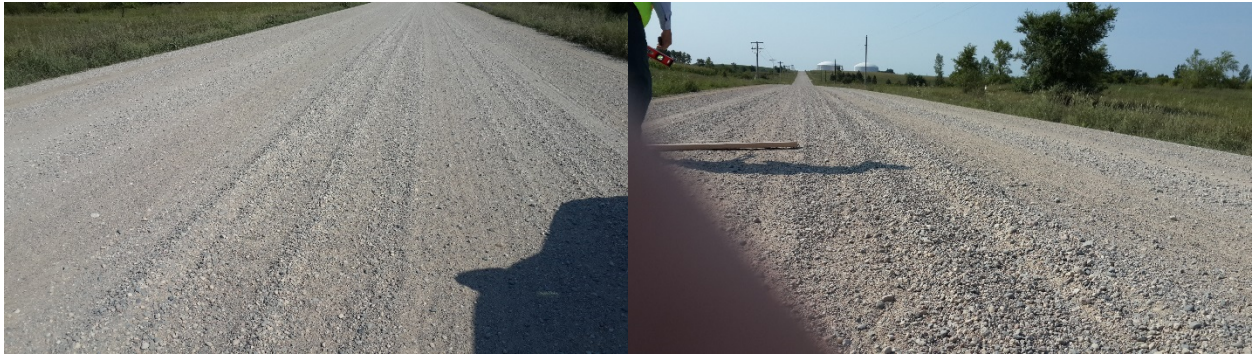
Figure 3 Loose Aggregate on CR 35, Pope County, July, 2013 (Photo by the Author)

Numerous problems stem from having excessive loose aggregate on the road surface. The loose aggregate tends to accumulate outside of the wheel path, forming ridges. The ridges pair provides “water channel” that retains water. Water retention is believed to be one of the major causes for distresses and failure of a gravel road. Crust formed in the surface will be softened, leading to rutting and potholes (Ken Skorseth and Ali Selim 2000). In addition, excessive loose aggregate

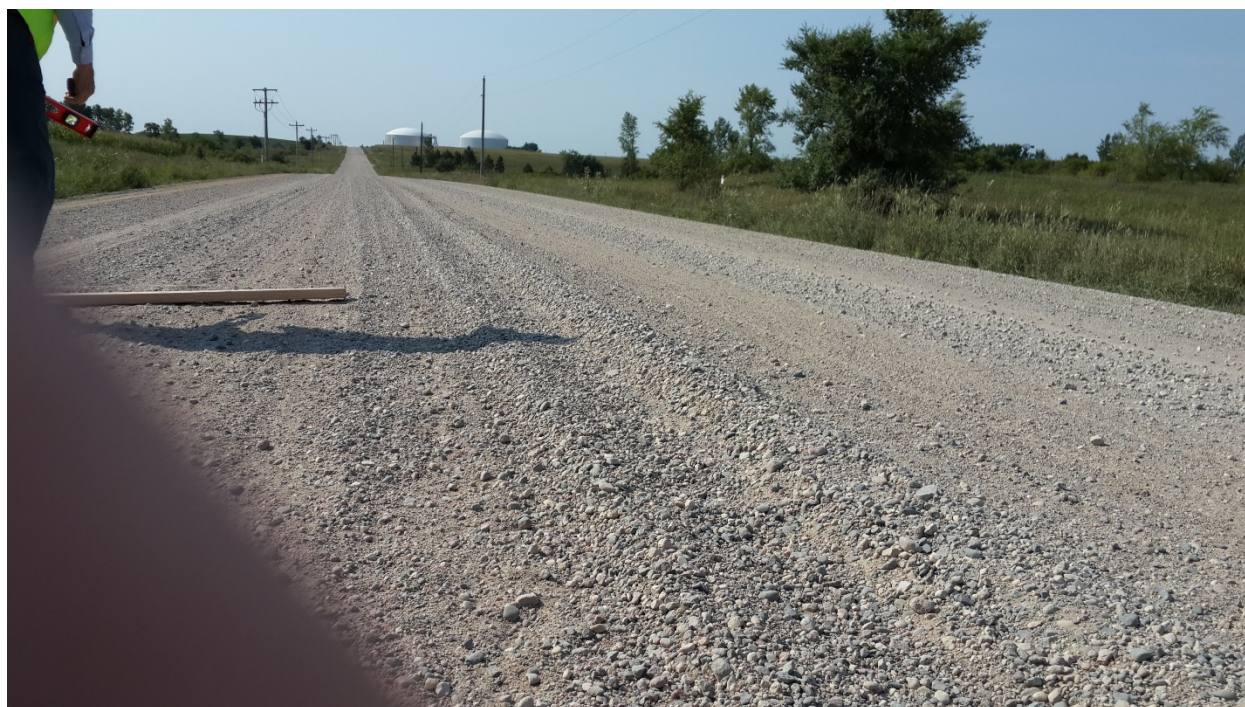
The research team visited Pope County in July, 2013. CR 35 was considered a typical road section that has a considerable amount of loose aggregate, see Figure 20. The volume of loose aggregate was estimated to be 307.24 tons/mi based on an estimate involving the scrape test.

Figure 20 Loose Aggregate on CR 35, Pope County (Photo by the Author)

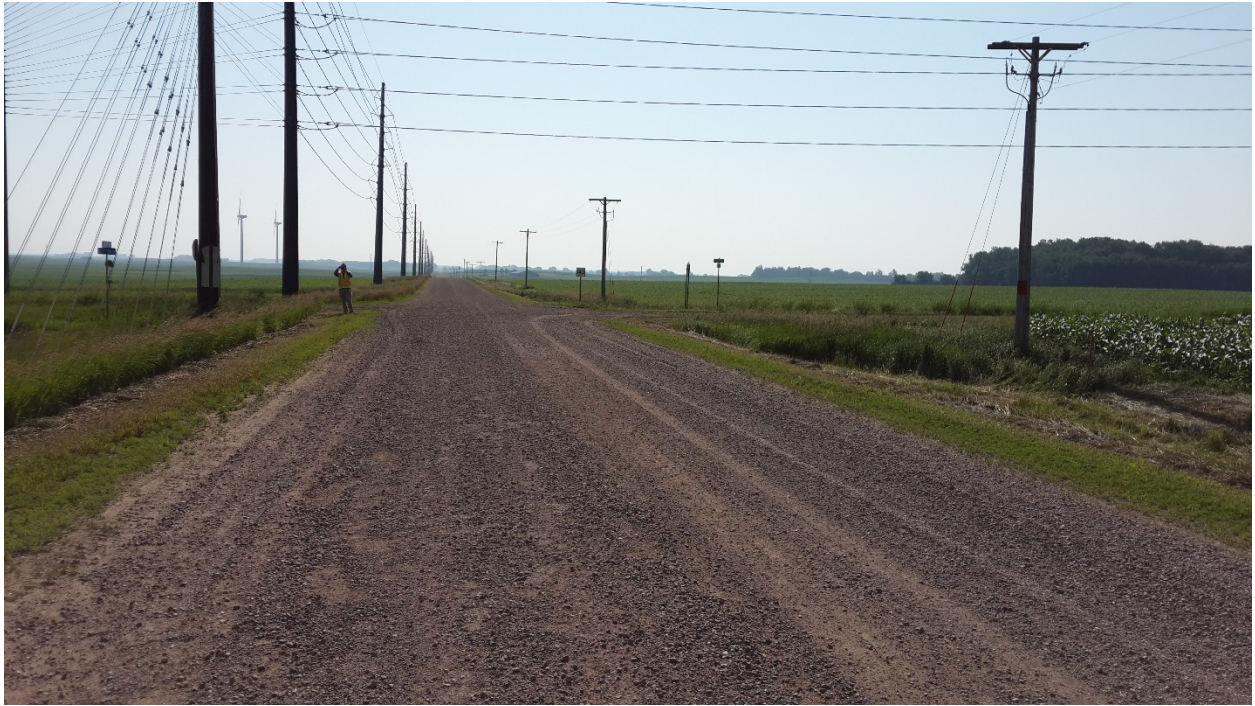
Figure 21 Jackson County Road 76 Surface Conditions in July, 2013 (Photo by the Author)

Scattered loose aggregate was seen along the road but was not considered serious. Loose aggregate accumulated away from the wheel path. Whipped-off coarse aggregate was seen along the shoulder. Loose aggregate volume was estimated to be 186 tons/mile according to the estimates based on scrape test results.

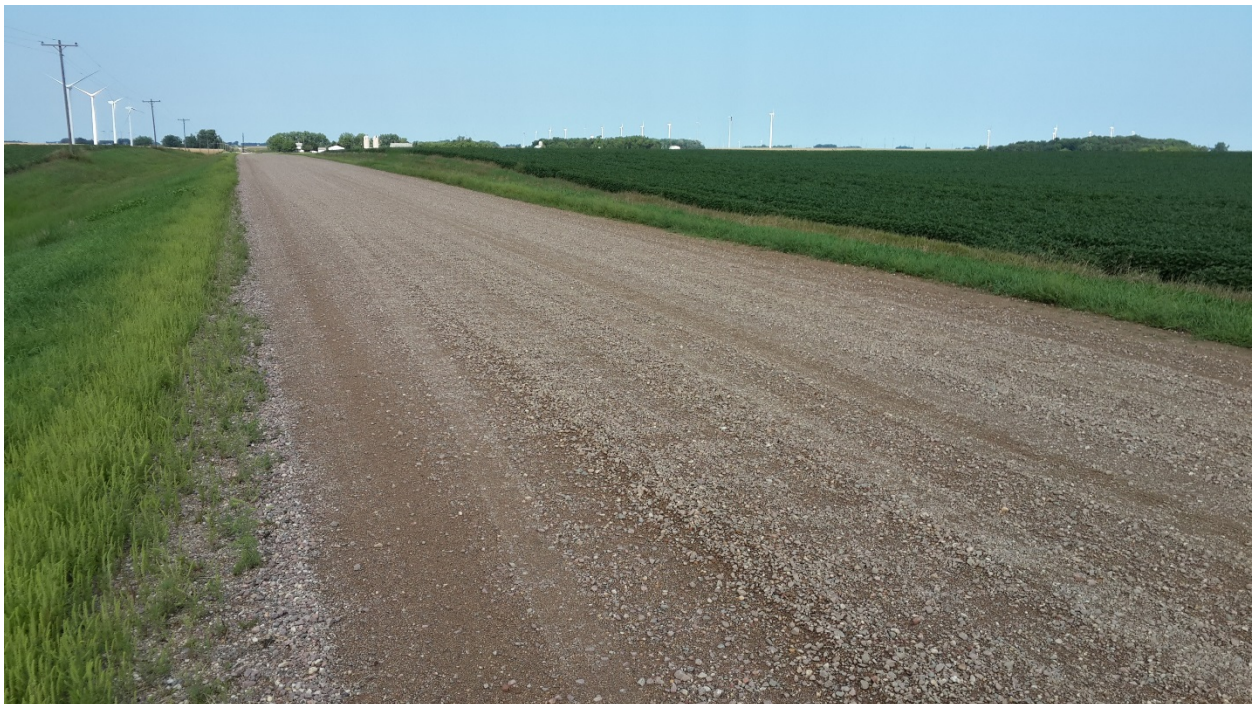
Figure 22 Jackson County Road 76 Surface Conditions in August, 2013 (Photo by the Author)

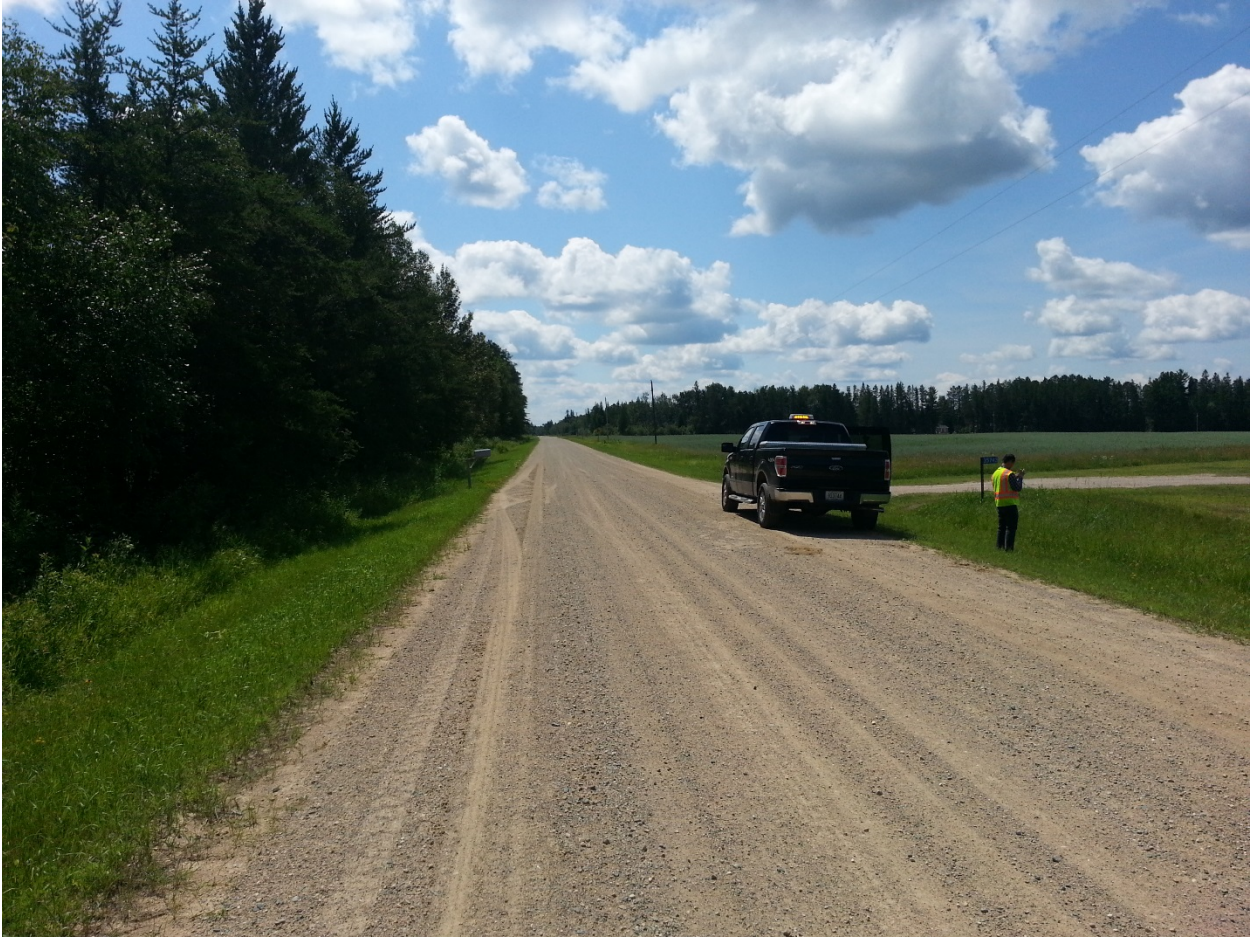
The research team visited the Beltrami County CR 23 test site once in July, 2013, before construction. The loose aggregate problem was not pronounced, as shown in Figure 23, although there was scattered loose aggregate.

Figure 23 Beltrami County Road 23 Surface Conditions in July (Photo by the Author)

Loose aggregate tonnage was estimated to be 91.3 tons/mile according to estimates based on scrape test results. The road did not comply with typical recommendation for crown slope. Measurement showed that the northbound cross slope was 1.2% and the southbound side was 1.9%.

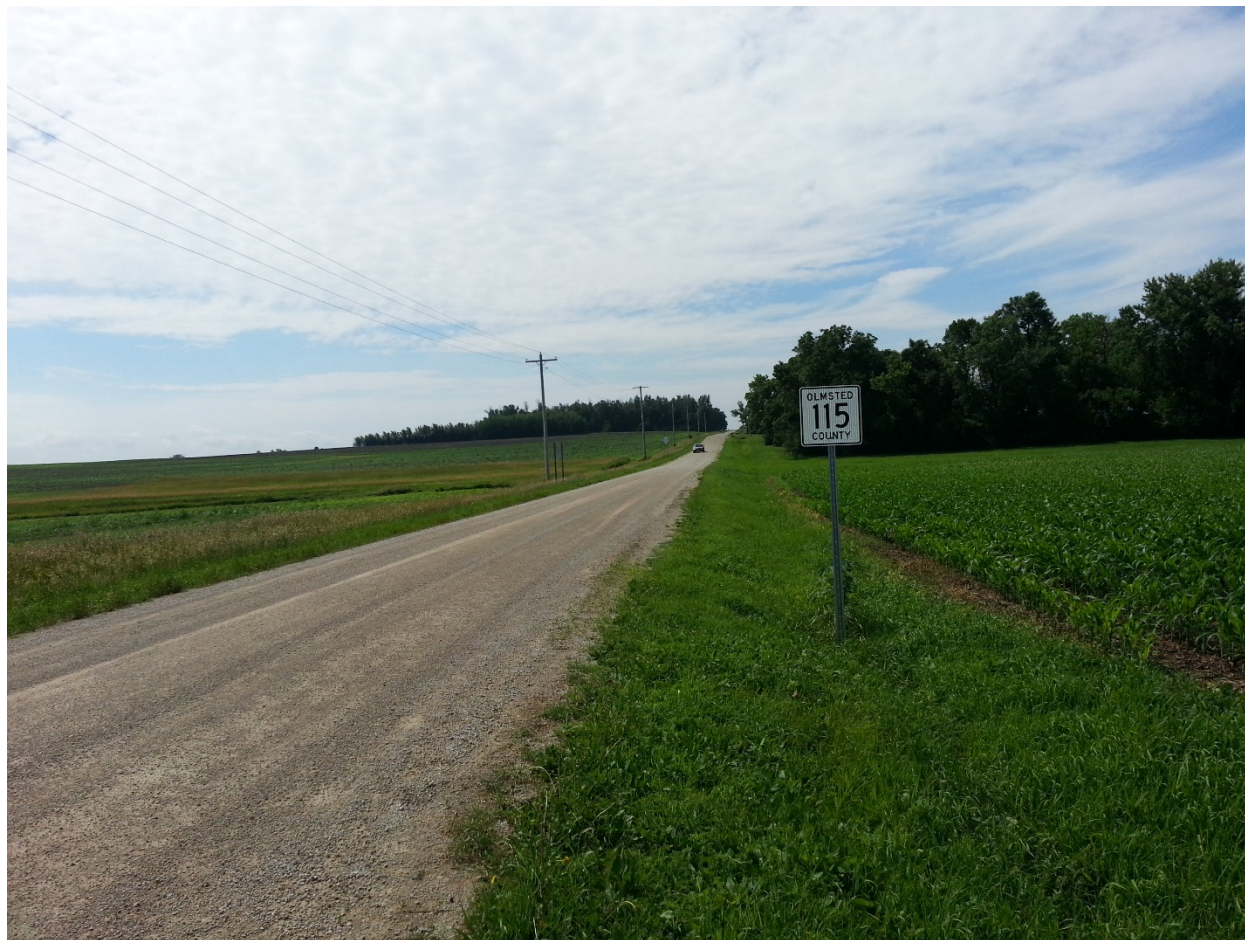
The research team visited the Olmsted County CR-115 test site once in July before construction. A small amount of loose aggregate was present on the road. Wheel paths were clearly seen in Figure 24. The wheel paths were highly compacted and had the appearance of an aged pavement.

Figure 24 Olmsted County Road 115 Surface Conditions in July (Photo by the Author)

Loose aggregate tonnage was estimated to be 71.49 tons/mile. The road has an effective crown slope. Our measurement shows that the northbound cross slope is 6.7% and the southbound side is 6%.

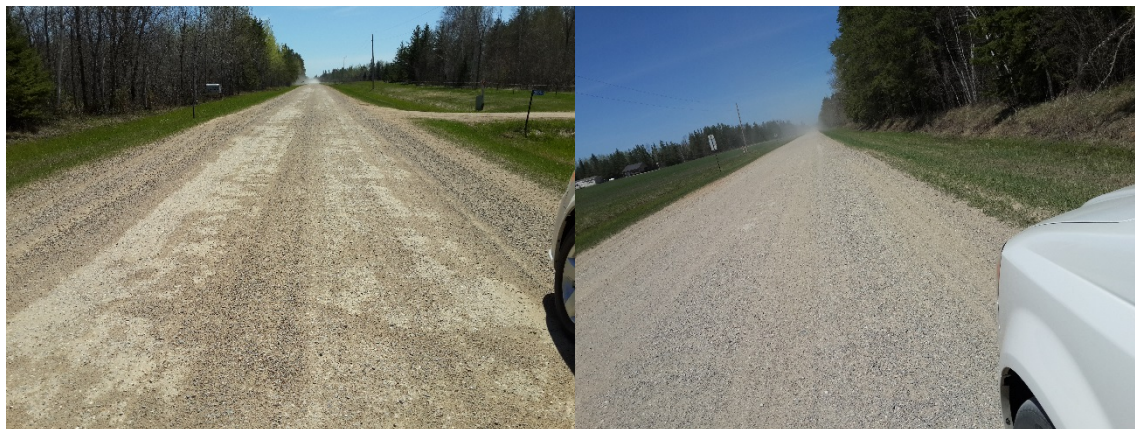
Figure 60 North Section (Left) and Middle Section (Right) (Photo by the Author)

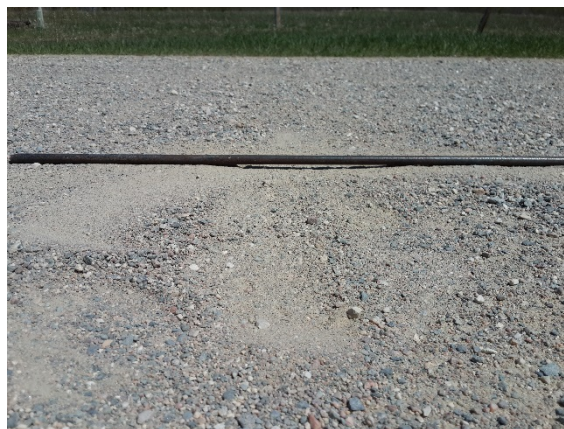
Figure 61 Typical Corrugation in the South Section/3rd Section (Photo by the Author)

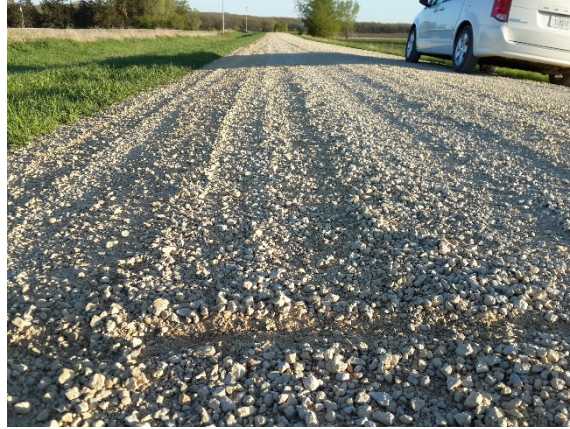
Figure 71 Loose Aggregate on the Surface of Section 1
