## Low velocity impact damage assessment in IM7/977-3 cross-ply composites using 3D computed tomography

A thesis submitted in partial fulfillment  
of the requirements for the Master of  
Science degree in Mechanical Engineering  
in the Graduate College of  
The University of Iowa

May 2015

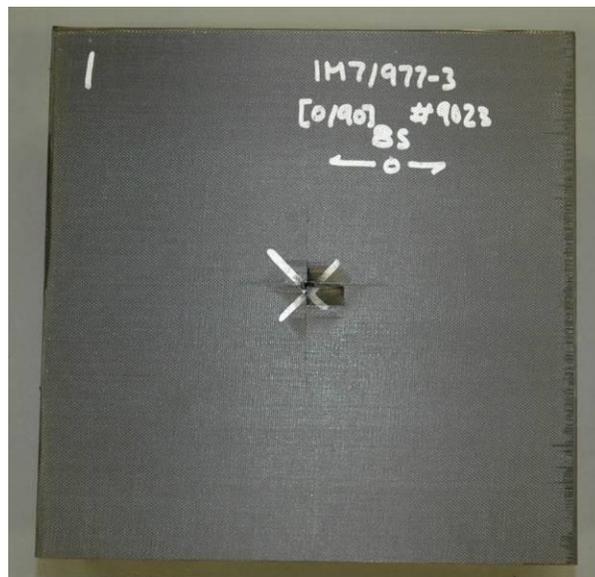
Figure 3.1: Impact Damage on the Top Surface of Specimen 1

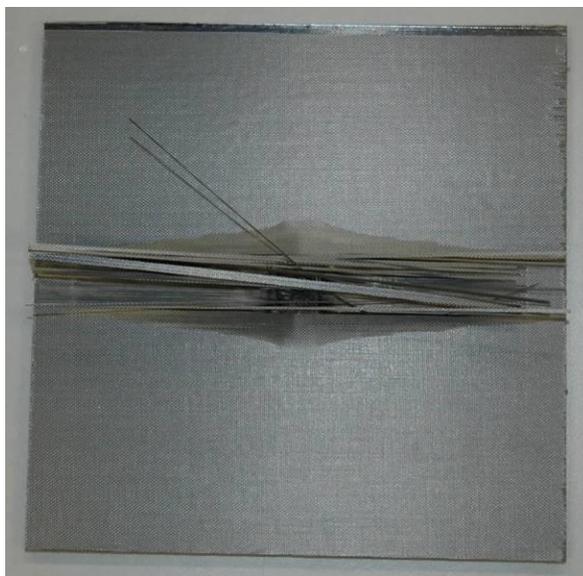
Figure 3.2: Impact Damage on the Bottom Surface of Specimen 1

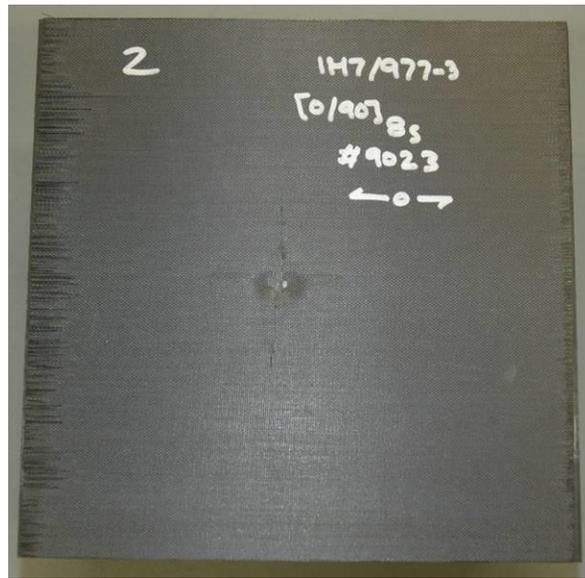
To reduce the amount of damage produced during impact, the impact energy was decreased to half of the initial value, resulting in an impact energy of 37.76 J. To achieve this, the same mass was used (12.831 kg) and the height was decreased to 0.30 m. Specimen 2 was clamped into the impact testing machine and impacted at this energy. The specimen damage, seen in Figure 3.4 through Figure 3.6, was moderate in scope with a large dent on the top surface and raised delamination on the back surface. While the damage was less than that for specimen 1, it was still more severe than desired.

Figure 3.4: Impact Damage on the Top Surface of Specimen 2

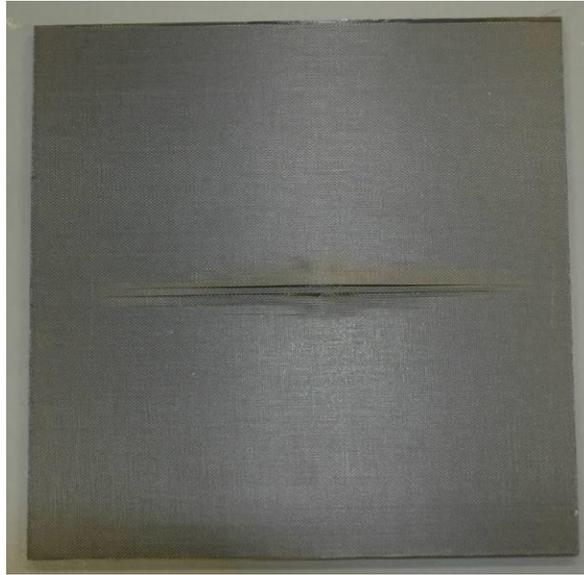
Figure 3.5: Impact Damage on the Bottom Surface of Specimen 2

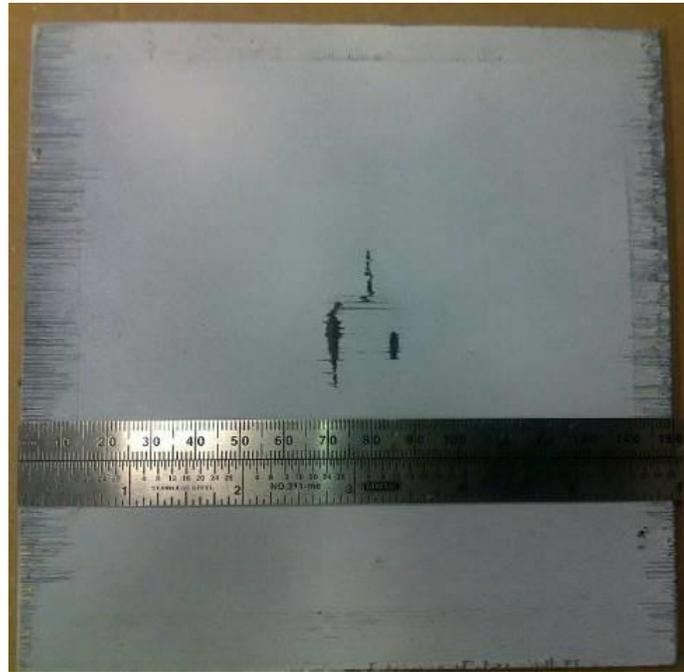
Figure 3.40: Visible Damage on the Back Side of Sample 48 (Hart 2011)

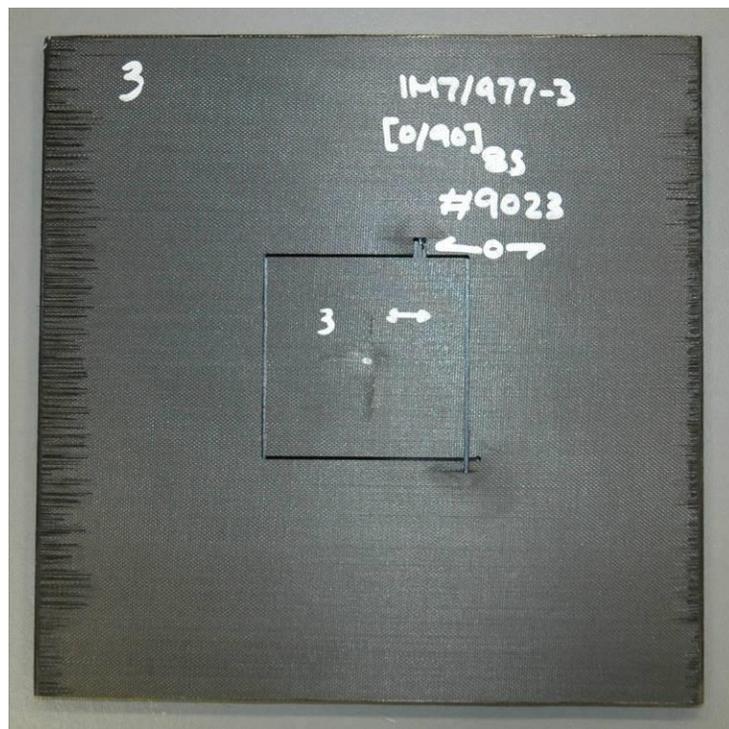
edge-surface quality of the cuts was generally excellent, there was a small amount of delamination induced near the start and stop of the cut path (located at the corner of the cut specimen, on the lower right in Figure 4.3). This delamination was a result of the crossing toolpath, and the induced damage for Specimen 3 is highlighted in the boxed region of Figure 4.4. A more detailed analysis of the cutting-induced damage is provided in a later section.

Figure 4.3: Cut Specimen 3 within Original Plate

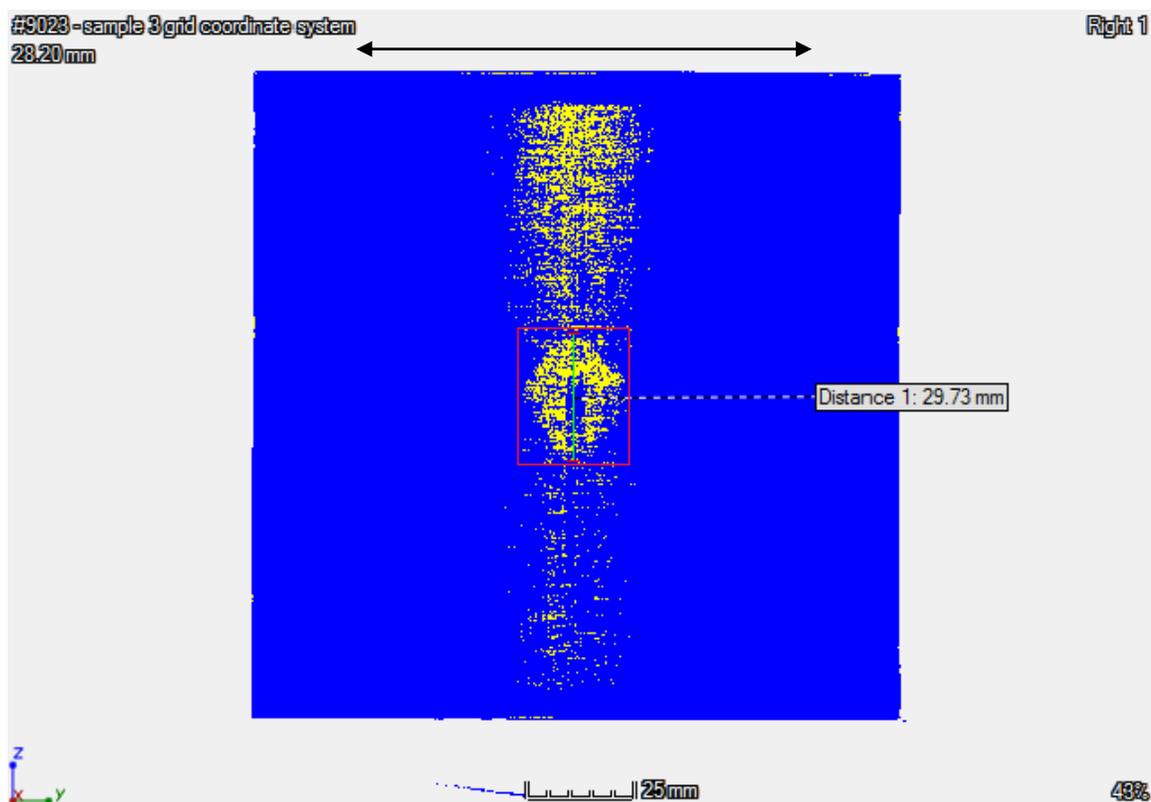
damaged volume for specimen 3 was found to be 2097.0 mm<sup>3</sup>, which was approximately 0.359 % of the total volume of the plate.

Figure 4.5: Length of Largest Internal Damage for Specimen 3 (Depth of 2.58 mm)

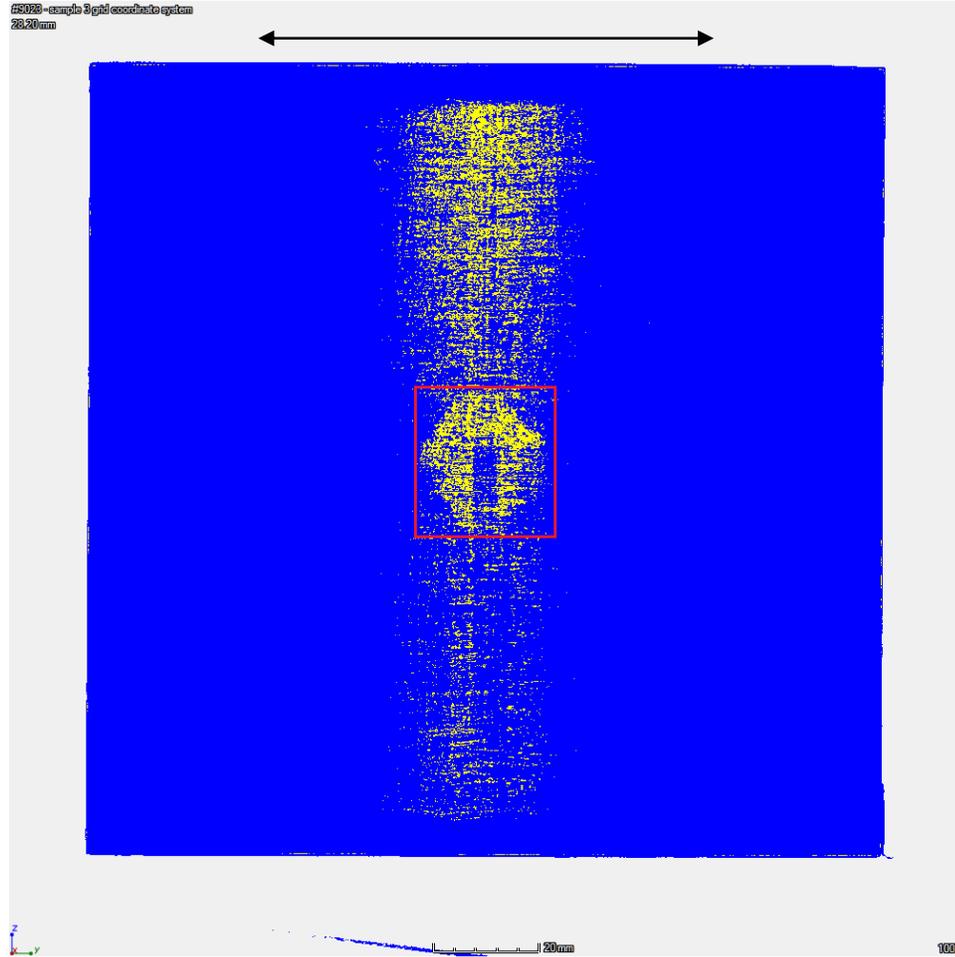
Figure 4.6: Segment with Largest Damaged Area for Specimen 3 (Depth of 2.48 mm)

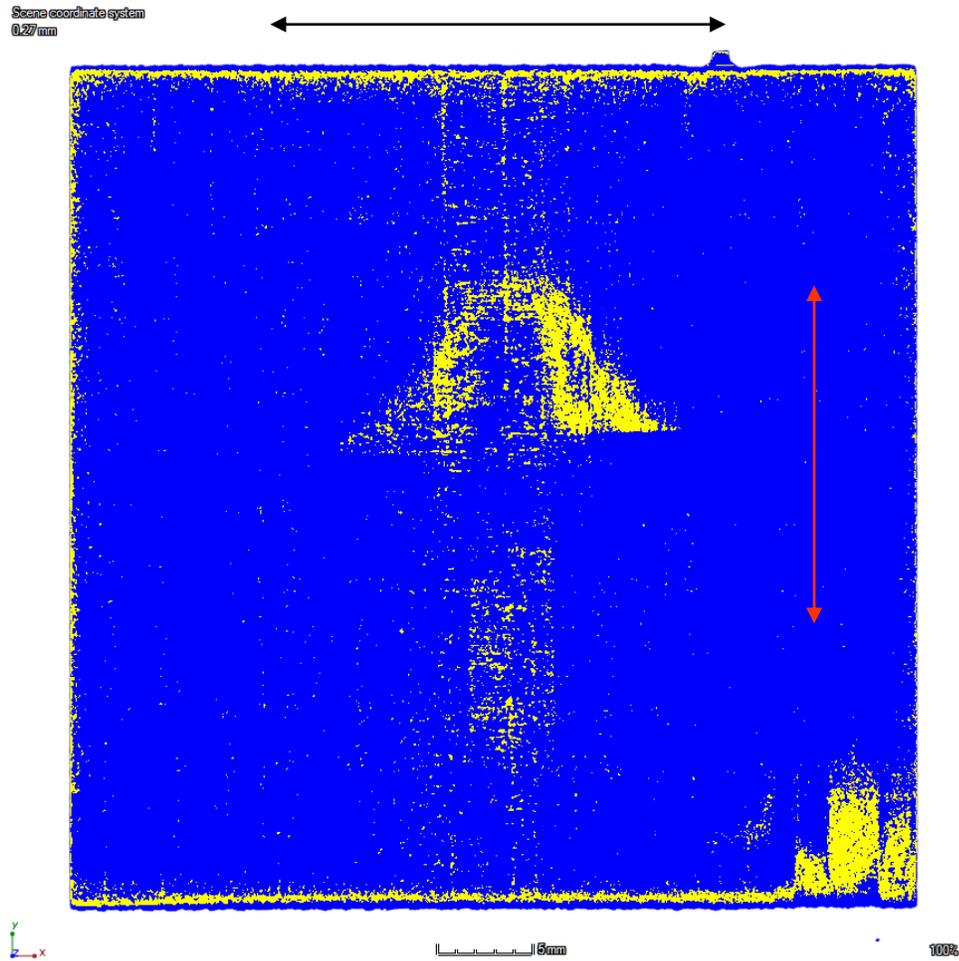
relative depth, within the 28<sup>th</sup> ply from the top) and the maximum vertical (90° orientation) damage length was found to be 29.85 mm at a depth of 3.43 mm (3.65 mm relative depth, at the interface between the 26<sup>th</sup> and 27<sup>th</sup> plies). From image processing of the cut plate, it was found that the maximum internal damaged area occurred at a depth of 1.80 mm (2.24 mm relative depth) from the impacted surface and was measured to be 132.5 mm<sup>2</sup>, shown in Figure 4.7. This CT slice occurred within the 16<sup>th</sup> ply from the top, which was the first of the two symmetric 90° fiber orientation plies. In the figure, the black arrow above the plate indicates the global 0° fiber direction, while the red arrow indicates the ply orientation. From the damaged area for this slice, the maximum damaged volume per slice was 7.79 mm<sup>3</sup>. The total damaged volume for cut specimen 3 was found to be 868.5 mm<sup>3</sup>, which was approximately 0.149 % of the total volume of the original plate. This percent volume for the damaged region was calculated using the total volume originally calculated for the uncut specimen and the damaged volume found from analysis of the cut specimen. This allows for direct numerical comparison of the percent damaged volume from the full-sized and cut specimens (presented in a later section). For this specimen, the cutting process induced additional delamination in the lower right corner as seen in Figure 4.7.

Figure 4.7: Segment with Largest Damaged Area for Cut Specimen 3 (Depth of 1.80 mm, Within Ply 16)

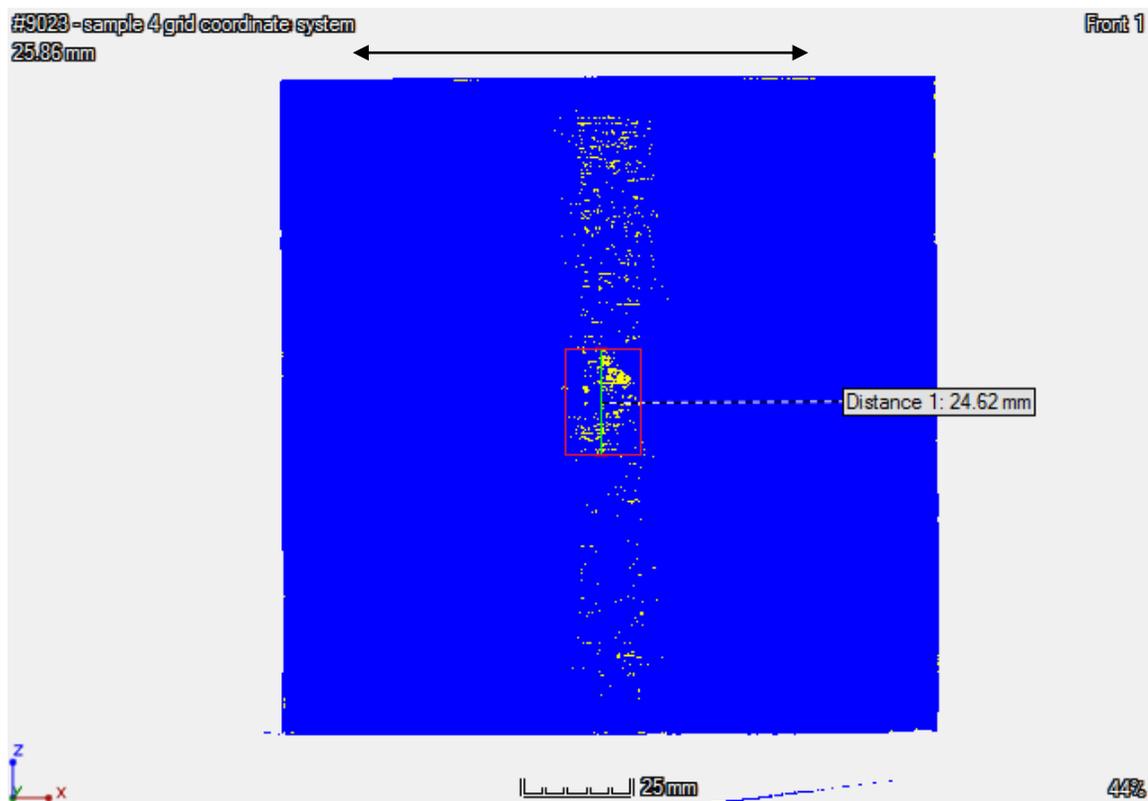
Specimen 4 had also been impacted at an energy of 20.77 J. The CT scan resolution for specimen 4 was 0.1802 mm/px and produced a stack of 38 images through the thickness of the plate. From image processing, it was found that the scan through the thickness had a total unadjusted depth of 6.31 mm. The maximum damaged length was found to be 24.62 mm at a depth of 2.67 mm (relative depth of 3.24 mm), shown in Figure 4.14. The maximum internal damaged area occurred at a depth of 2.40 mm (relative depth of 3.06 mm) from the impacted surface as was measured to be 226.1 mm<sup>2</sup>. The colorized CT scan slice with the largest damaged area can be seen in Figure 4.15. The damaged area is boxed in both figures, and the global 0° fiber orientation is indicated by the black arrow above the specimen. From the damaged area for this slice, the maximum damaged volume per slice was 40.7 mm<sup>3</sup>. The total damaged volume for specimen 4 was found to be 1331.5 mm<sup>3</sup>, which was approximately 0.214 % of the total volume.

Figure 4.14: Length of Largest Internal Damage for Specimen 4 (Depth of 2.67 mm)

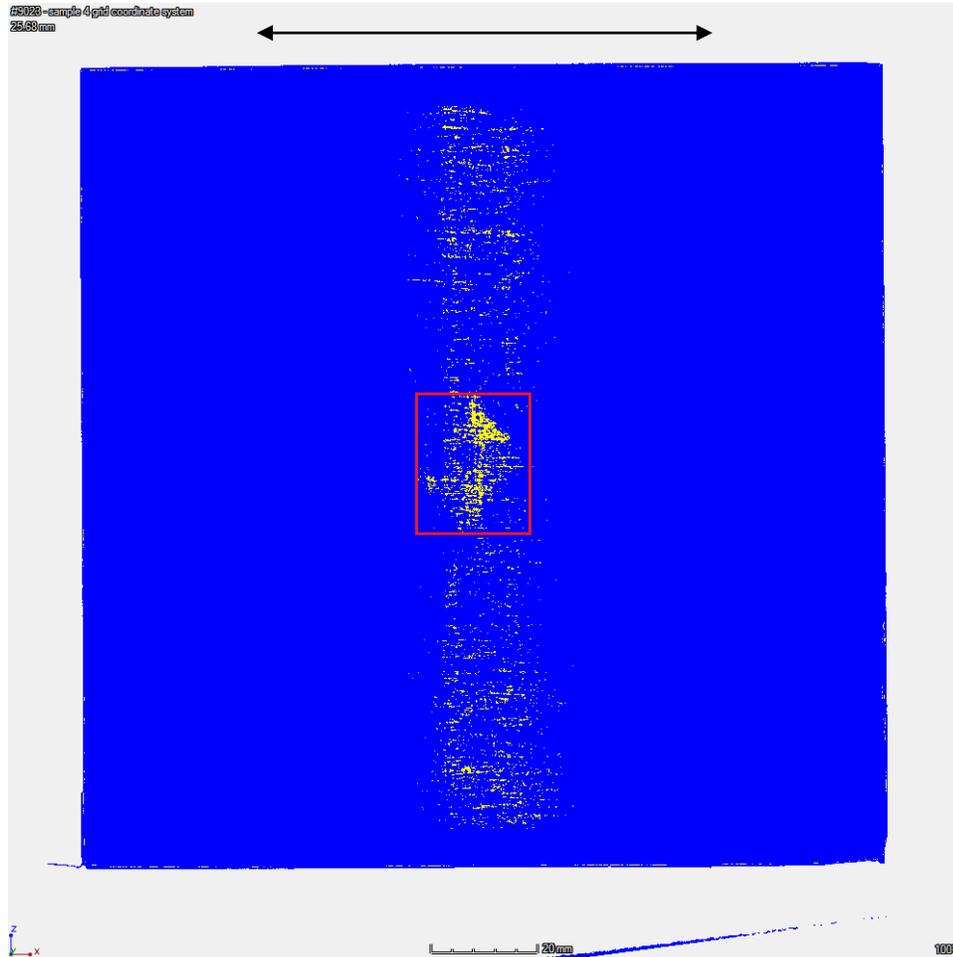
Figure 4.15: Segment with Largest Damaged Area for Specimen 4 (Depth of 2.40 mm)

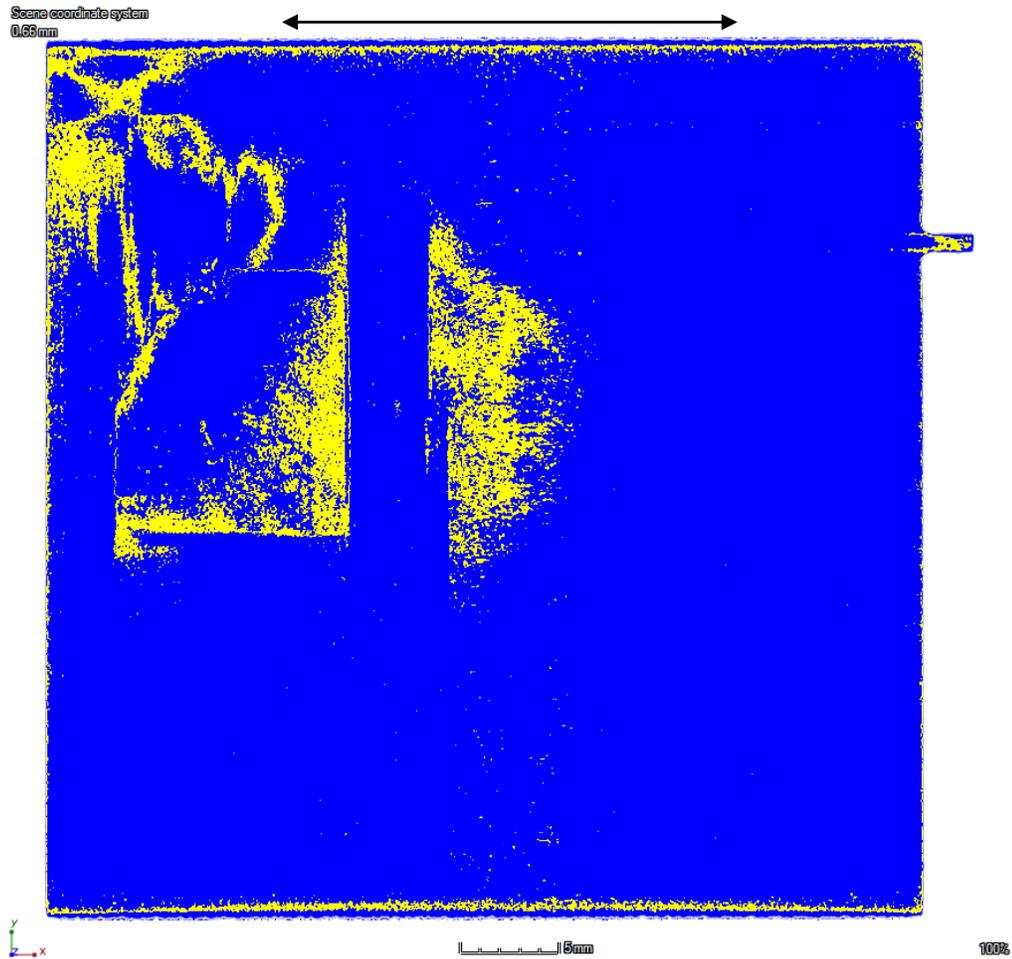
to be 28.03 mm at a depth of 0.13 mm (0.59 mm relative depth). From image processing of the small plate, it was found that the maximum internal damaged area occurred at a depth of 2.29 mm (2.77 mm relative depth) from the impacted surface and was measured to be 174.96 mm<sup>2</sup>, shown in Figure 4.16. In this figure, the black arrow above the plate indicates the global 0° fiber direction. From the damaged area for this slice, the maximum damaged volume per slice was 10.29 mm<sup>3</sup>. The total damaged volume for cut specimen 4 was found to be 539.2 mm<sup>3</sup>, which was approximately 0.087 % of the total volume of the original plate. For this specimen, the cutting process induced additional delamination in the upper left corner, as seen in Figure 4.16.

Figure 4.16: Segment with Largest Damaged Area for Cut Specimen 4 (Depth of 2.29 mm)

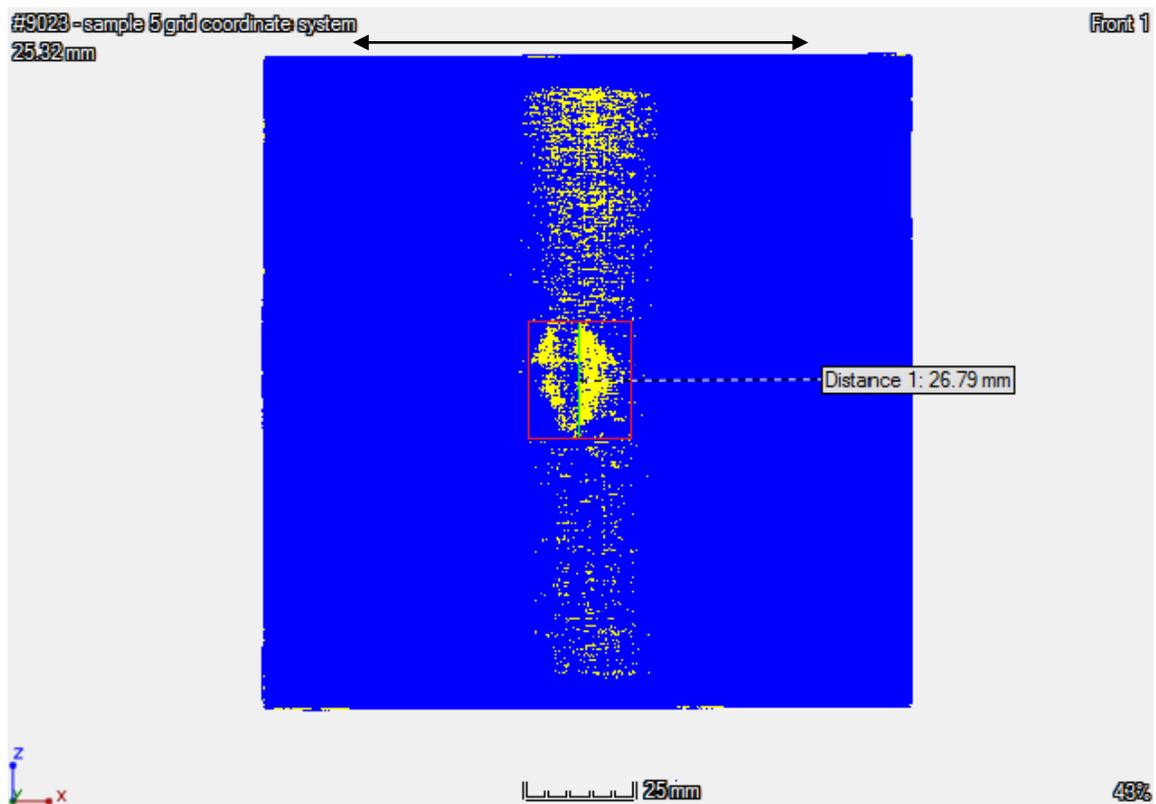
Specimen 5, as with specimens 3 and 4, had been impacted at an energy of 20.77 J. The CT scan for specimen 5 also had a resolution of 0.1802 mm/px and produced a stack of 31 images through the thickness of the plate. From these images it was determined that the scan had an unadjusted plate depth of 5.05 mm. The maximum damage length was found to be 26.79 mm, occurring at a depth of 2.49 mm (relative depth of 2.70 mm). This can be seen in Figure 4.17. From image processing it was found that the maximum internal damaged area occurred at a depth of 2.32 mm (relative depth of 2.52 mm) from the impacted surface. The maximum damaged area was measured to be 887.8 mm<sup>2</sup> and is shown in Figure 4.18. The black arrow above the figures indicates the global 0° fiber orientation, and the damaged area is boxed in both figures. From the damaged area for this slice, the maximum damaged volume per slice was 160.0 mm<sup>3</sup>, which was approximately 0.434 % of the total volume.

Figure 4.17: Length of Largest Internal Damage for Specimen 5 (Depth of 2.49 mm)

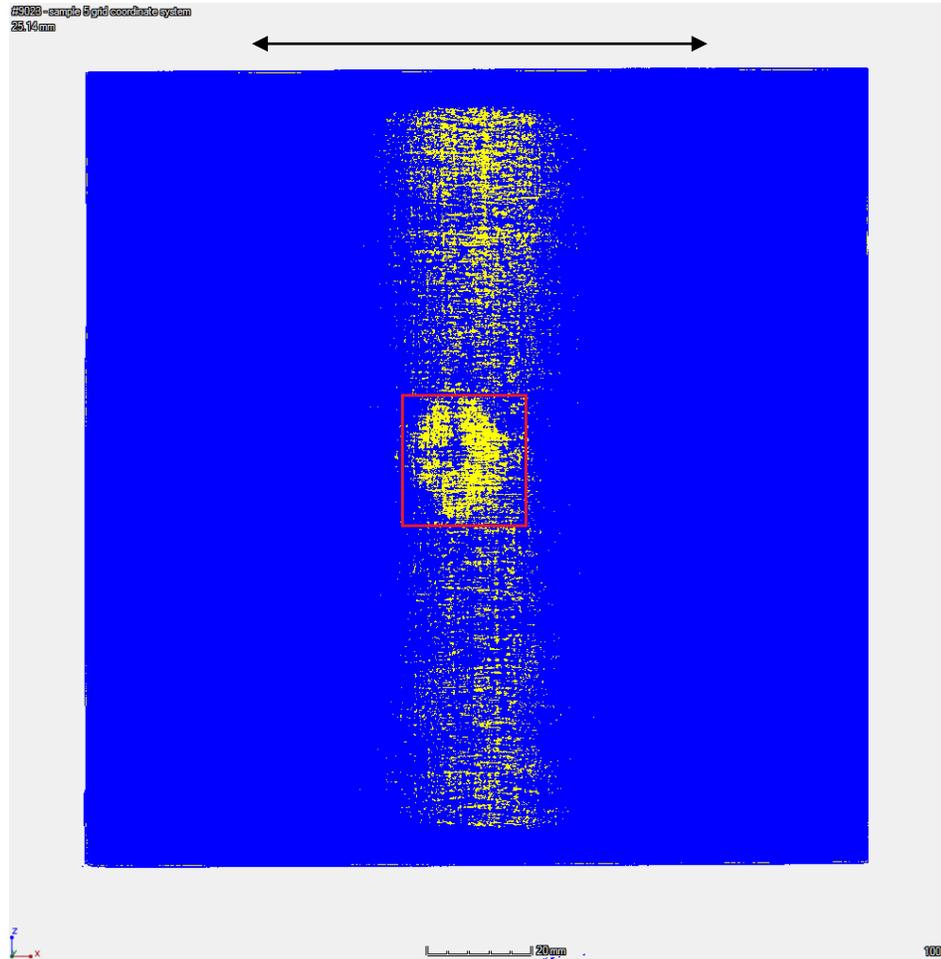
Figure 4.18: Segment with Largest Damaged Area for Specimen 5 (Depth of 2.32 mm)

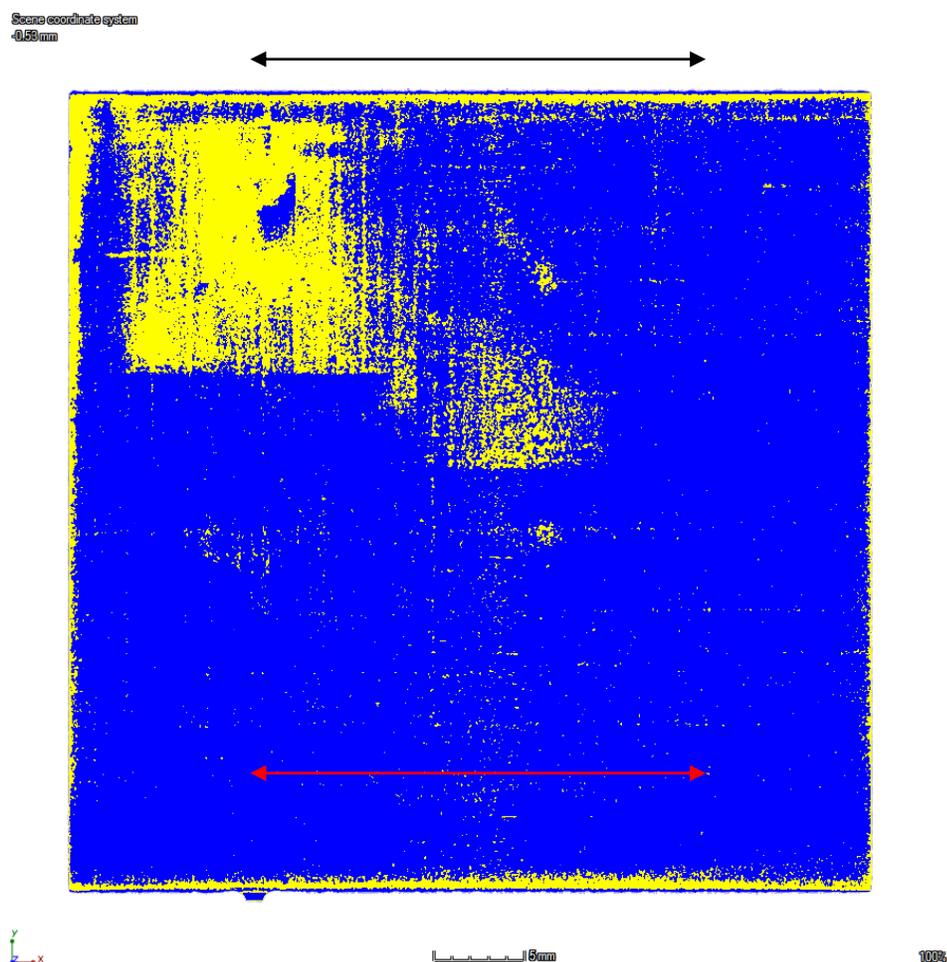
be 28.60 mm at a depth of 3.74 mm (3.94 mm relative depth, within the 28<sup>th</sup> ply). From image processing of the cut plate, it was found that the maximum internal damaged area occurred at a depth of 3.02 mm (3.24 mm relative depth, within the 29<sup>th</sup> ply) from the impacted surface and was measured to be 289.31 mm<sup>2</sup>, shown in Figure 4.19. This occurred at the interface between the 24<sup>th</sup> and 25<sup>th</sup> plies from the top surface. In this figure, the black arrow above the plate indicates the global 0° fiber direction. As this slice occurred at a ply interface, the red arrow indicates the fiber orientation of the lower ply. From the damaged area for this slice, the maximum damaged volume per slice was 17.01 mm<sup>3</sup>. The total damaged volume for cut specimen 5 was found to be 1141.1 mm<sup>3</sup>, which was approximately 0.206 % of the total volume of the original plate. For this specimen, the cutting process induced additional delamination in the upper left corner as seen in Figure 4.19.

Figure 4.19: Segment with Largest Damaged Area for Cut Specimen 5 (Depth of 3.02 mm, Between Plies 24 and 25)

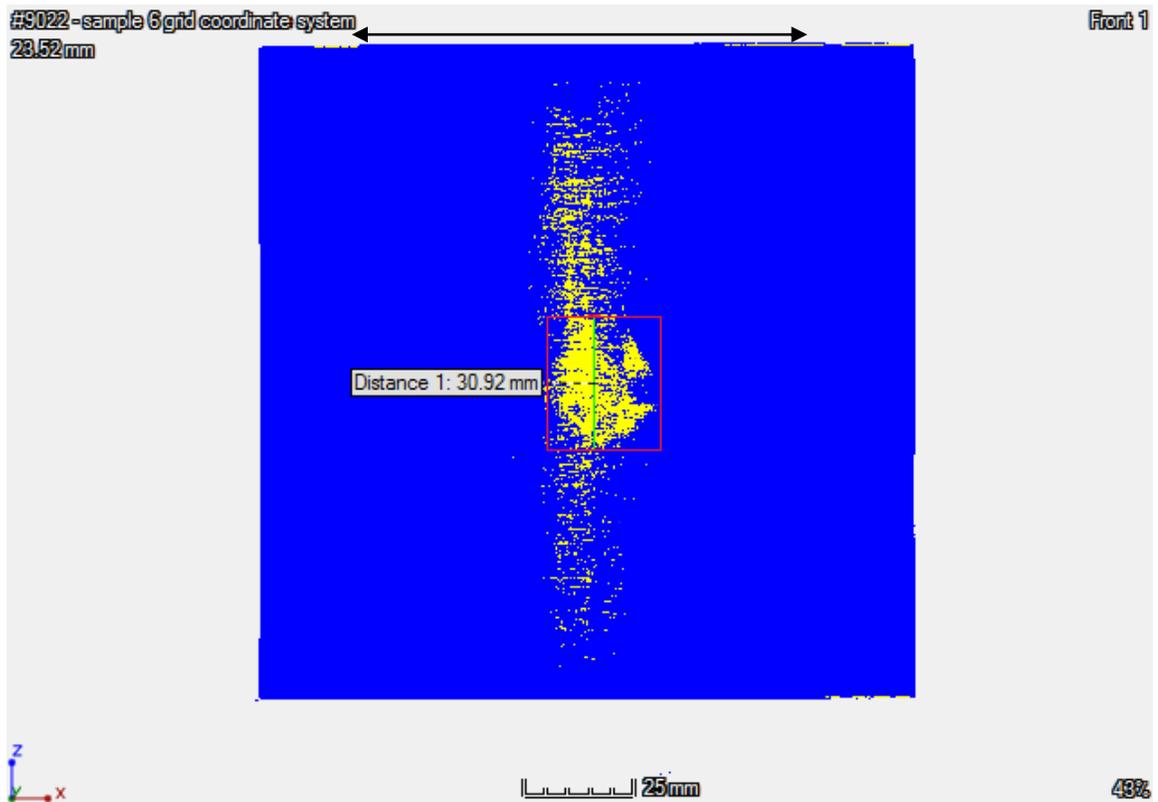
Specimen 6 had been impacted at an energy of 29.27 J. The CT scan for specimen 6 had a resolution of 0.1802 mm/px and resulted in a stack of 39 images through the thickness of the plate. From these images it was determined that the scan through the thickness had a total unadjusted depth of 6.49 mm. The maximum damage length was found to be 30.92 mm at a depth of 2.17 mm (relative depth of 3.24 mm), which can be seen in Figure 4.23. From image processing, it was found that the maximum internal damaged area also occurred at approximately 2.17 mm (3.24 mm relative depth) from the impacted surface. The maximum damaged area was measured to be 775.3 mm<sup>2</sup> and is shown in Figure 4.24. The damaged area is boxed in both figures, and the black arrow indicates the global 0° fiber orientation. From the damaged area for this slice, the maximum damaged volume per slice was calculated to be 139.7 mm<sup>3</sup>. The total damaged volume for specimen 6 was found to be 2671.3 mm<sup>3</sup>, which was approximately 0.479 % of the total volume.

Figure 4.23: Length of Largest Internal Damage for Specimen 6 (Depth of 2.17 mm)

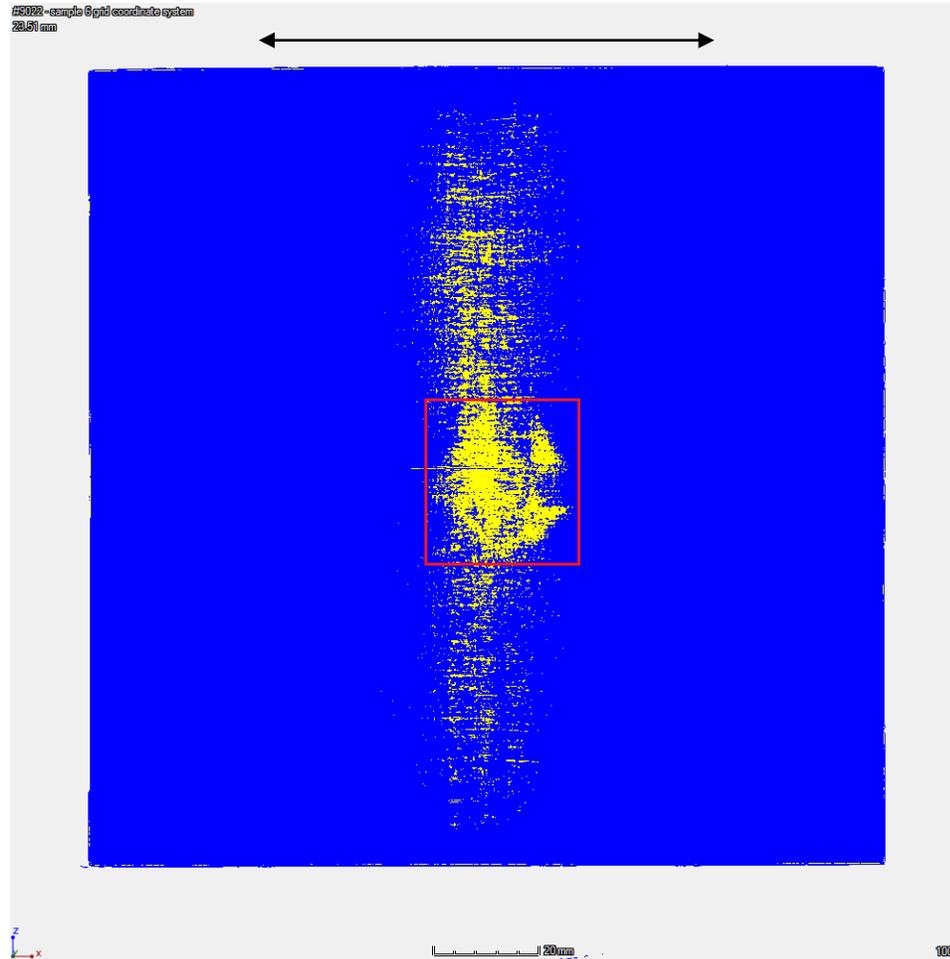
Figure 4.24: Segment with Largest Damaged Area for Specimen 6 (Depth of 2.17 mm)

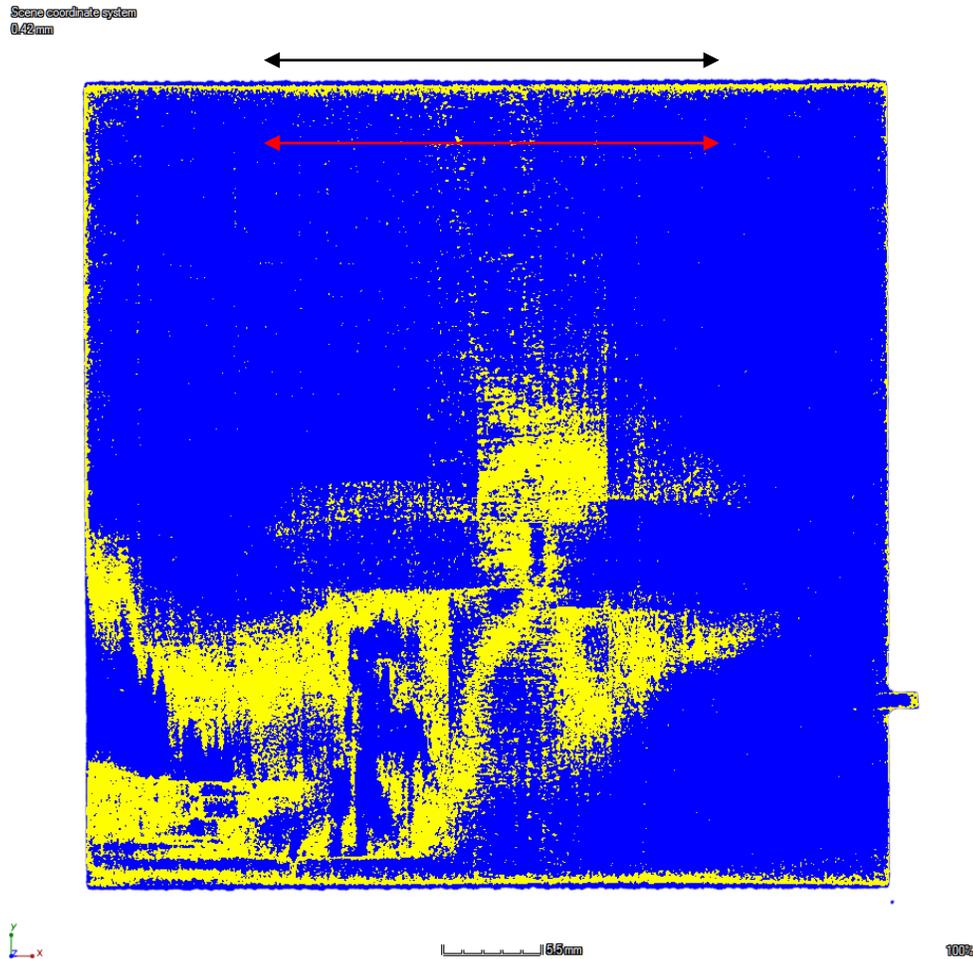
Figure 4.25: Segment with Largest Damaged Area for Cut Specimen 6 (Depth of 1.76 mm, Between Plies 14 and 15)

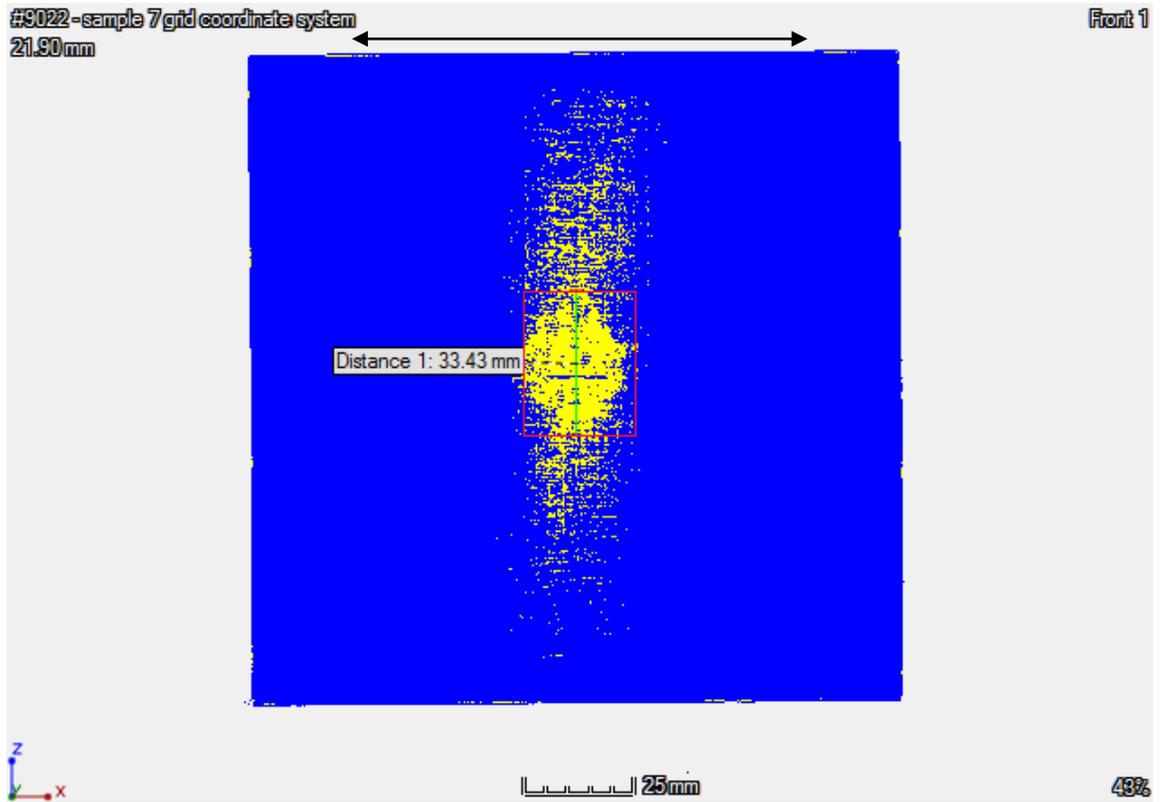
Figure 4.29: Length of Largest Internal Damage for Specimen 7 (Depth of 2.17 mm)

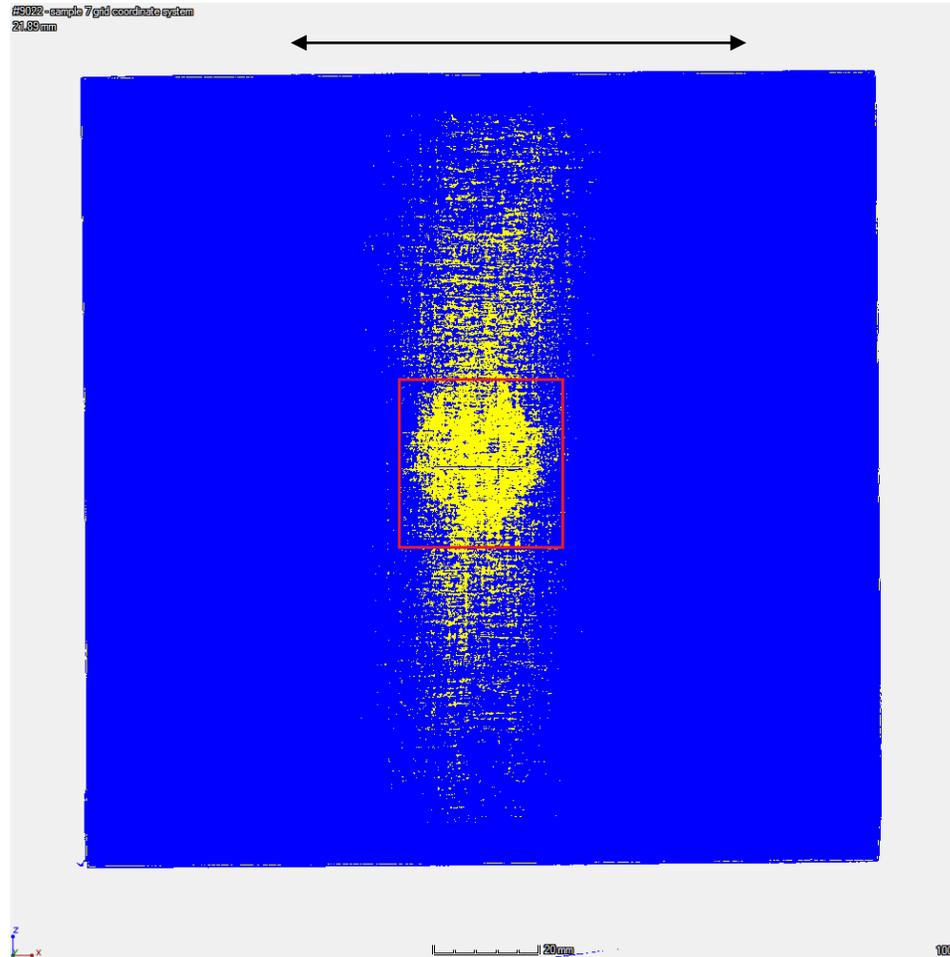
Figure 4.30: Segment with Largest Damaged Area for Specimen 7 (Depth of 2.17 mm)

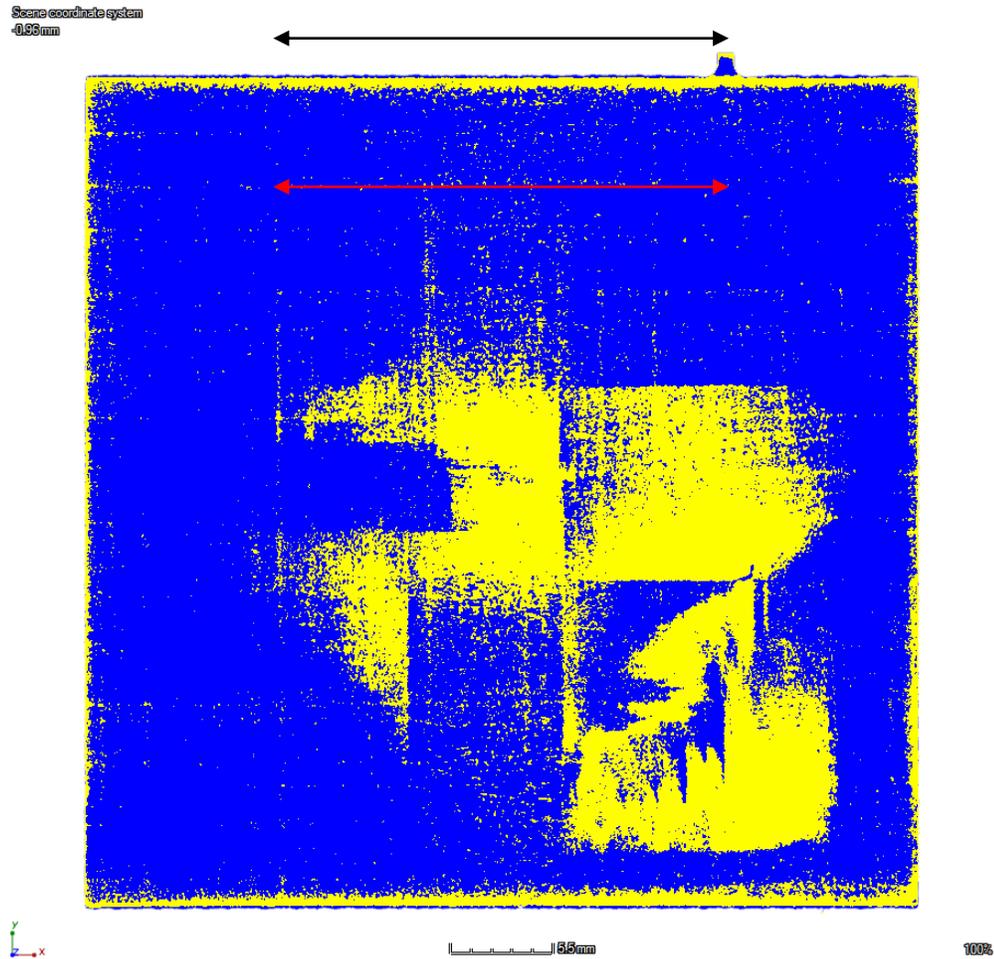
Figure 4.31: Segment with Largest Damaged Area for Cut Specimen 7 (Depth of 3.01 mm, Between Plies 23 and 24)

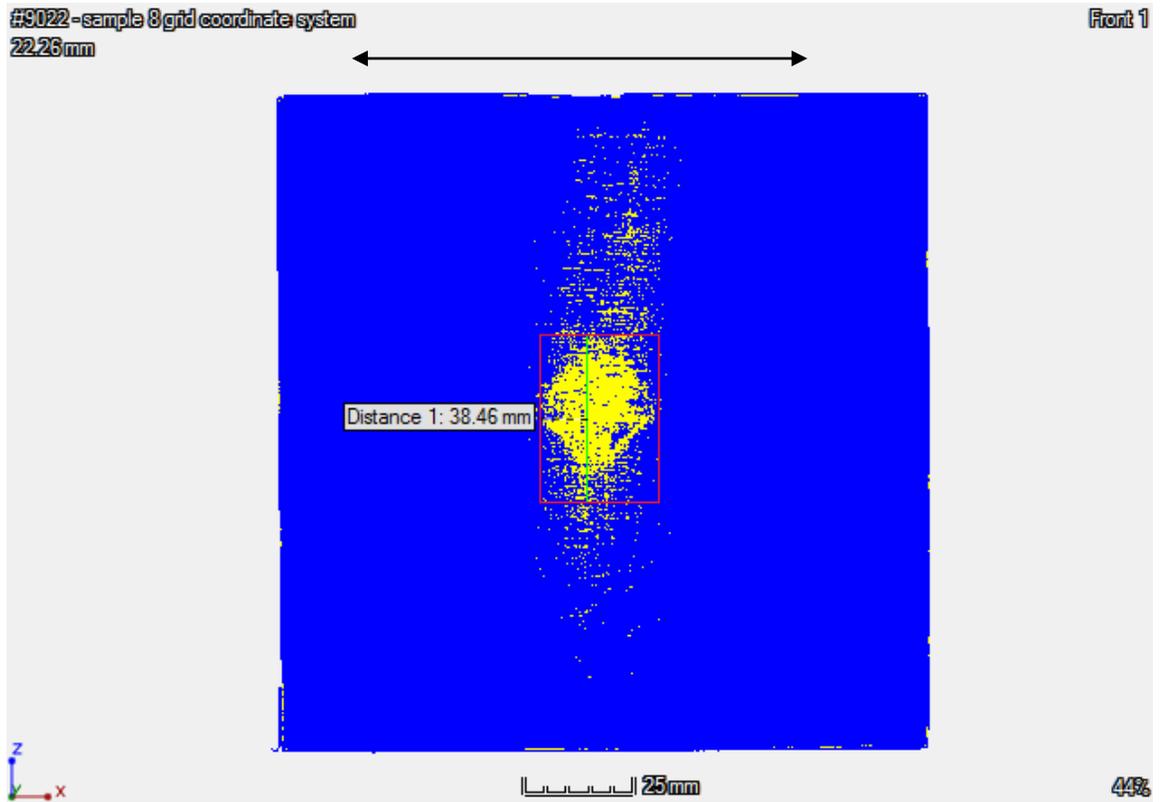
Figure 4.35: Length of Largest Internal Damage for Specimen 8 (Depth of 2.32 mm)

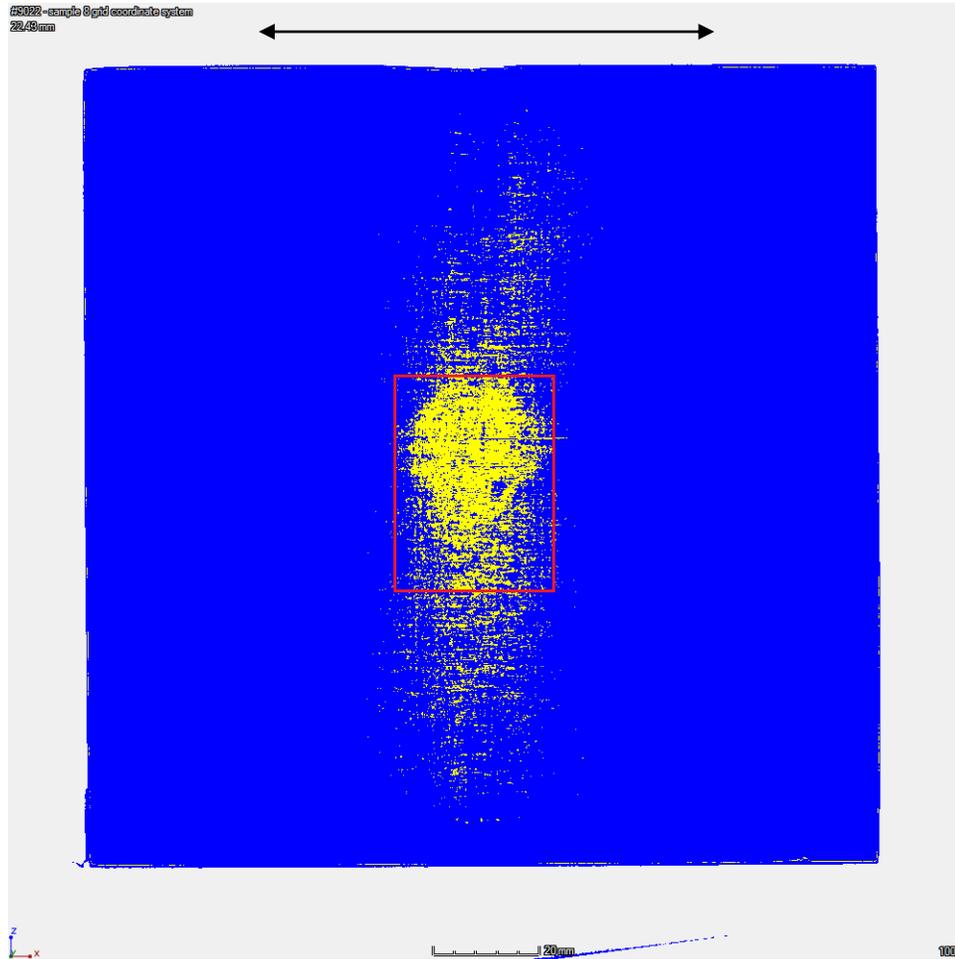
Figure 4.36: Segment with Largest Damaged Area for Specimen 8 (Depth of 2.55 mm)

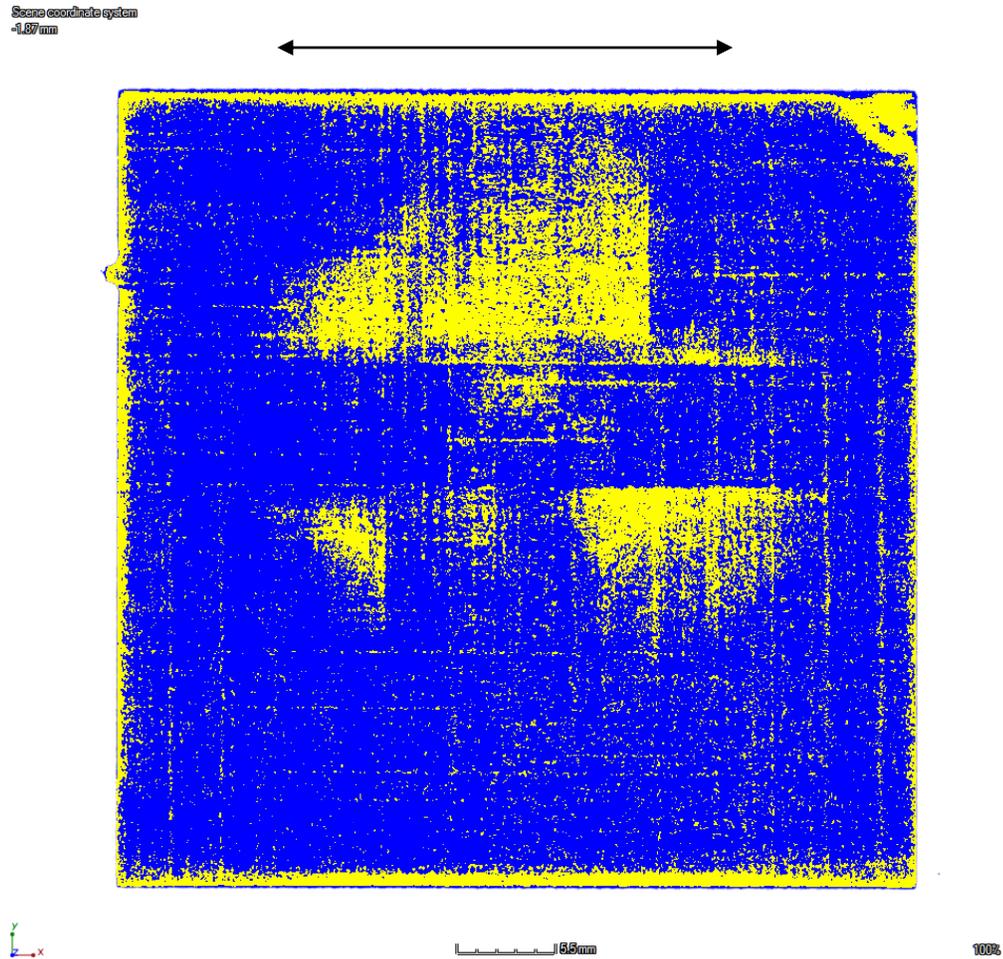
Figure 4.37: Segment with Largest Damaged Area for Cut Specimen 8 (Depth of 3.57 mm)

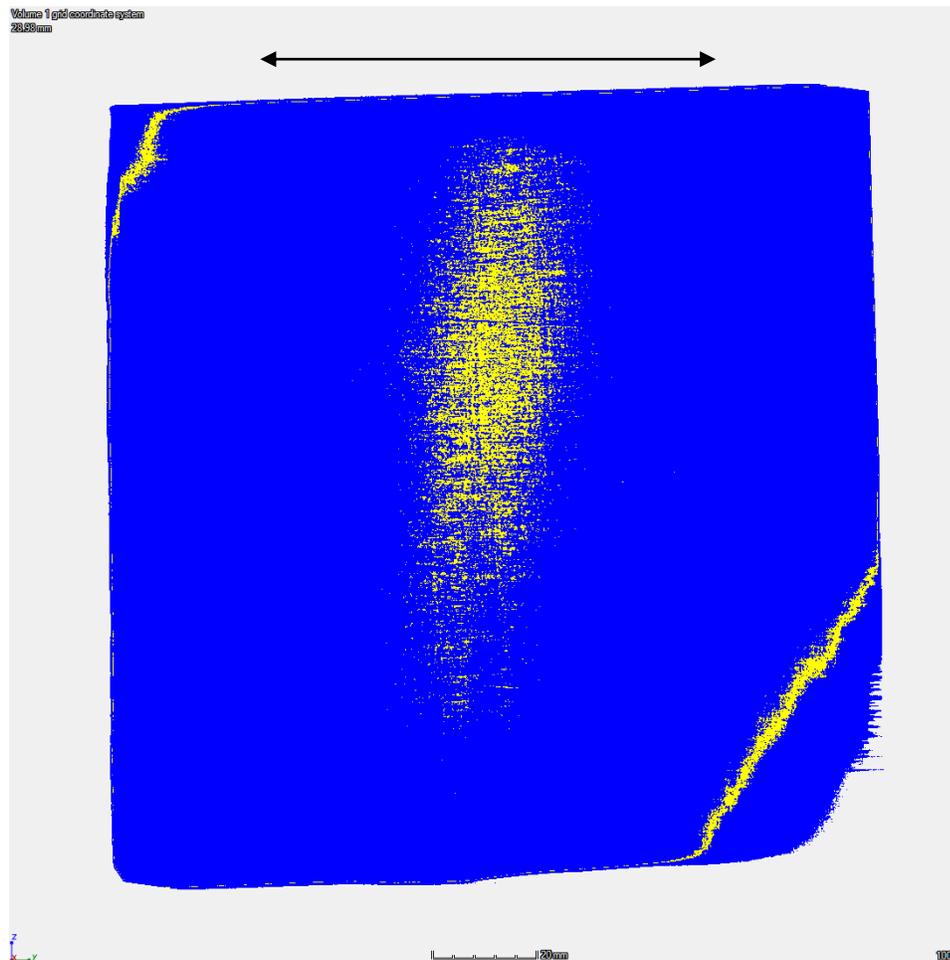
Figure 4.38: Internal Segment from Specimen 9 (Depth of 4.17 mm)
