## Low velocity impact damage assessment in IM7/977-3 cross-ply composites using 3D computed tomography

A thesis submitted in partial fulfillment  
of the requirements for the Master of  
Science degree in Mechanical Engineering  
in the Graduate College of  
The University of Iowa

May 2015

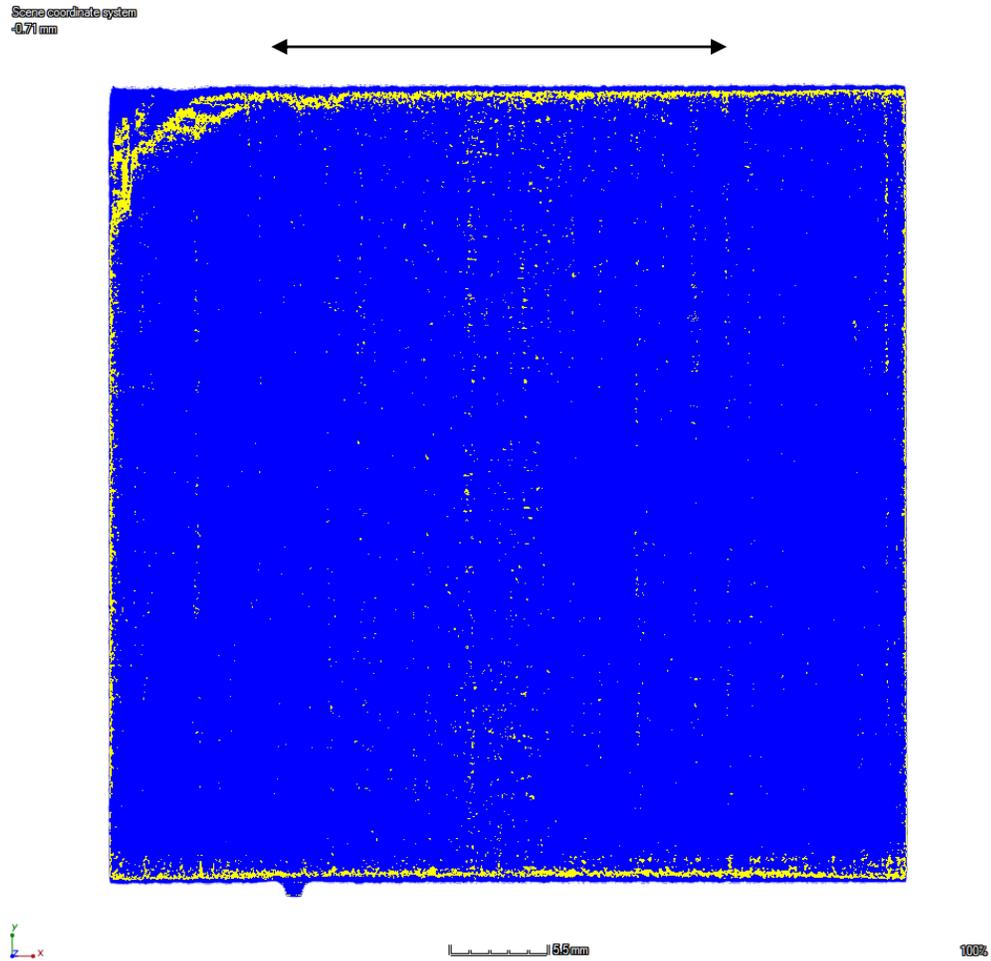
Figure 4.39: Internal Segment from Cut Specimen 9

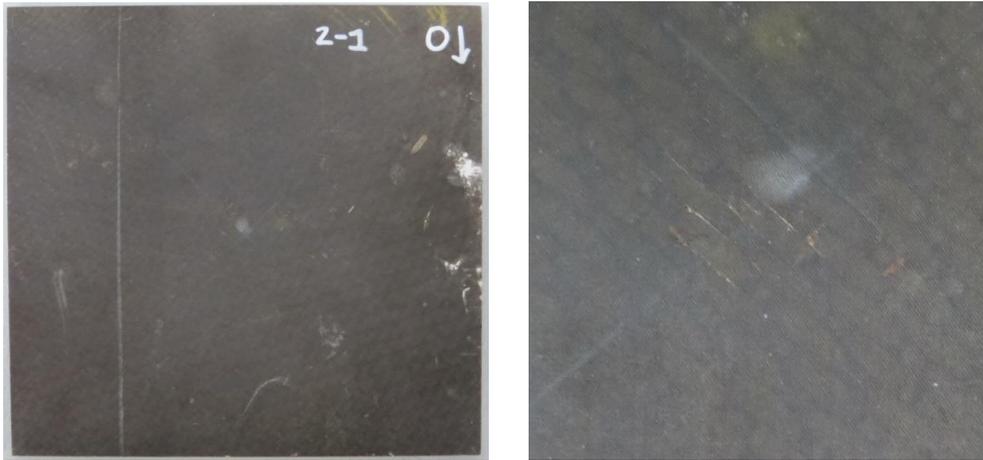
Figure 4.50: Front (Left) and Back (Right) Damage to Specimen 2-1, Impacted at 16 J (Song 2014)

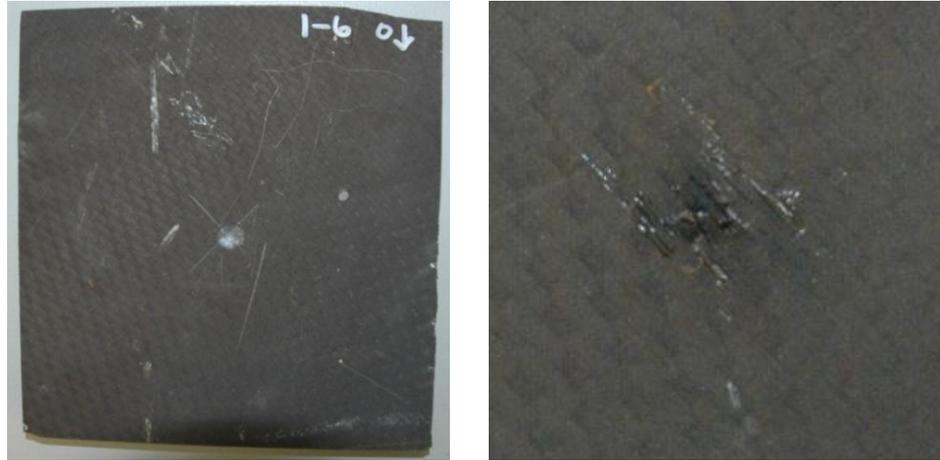
Figure 4.51: Front (Left) and Back (Right) Damage to Specimen 1-6, Impacted at 22.5 J (Song 2014)

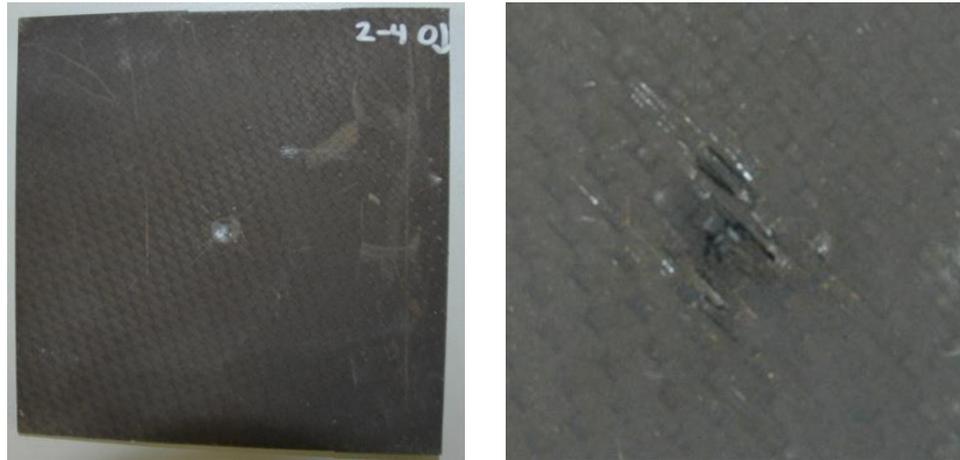
Figure 4.52: Front (Left) and Back (Right) Damage to Specimen 2-4, Impacted at 26 J (Song 2014)
