Rapid repair of severely damaged RC columns under combined loading of flexure, shear, and torsion with externally bonded CFRP

RAPID REPAIR OF SEVERELY DAMAGED RC COLUMNS UNDER
COMBINED LOADING OF FLEXURE, SHEAR, AND TORSION
WITH EXTERNALLY BONDED CFRP

A DISSERTATION

CIVIL ENGINEERING

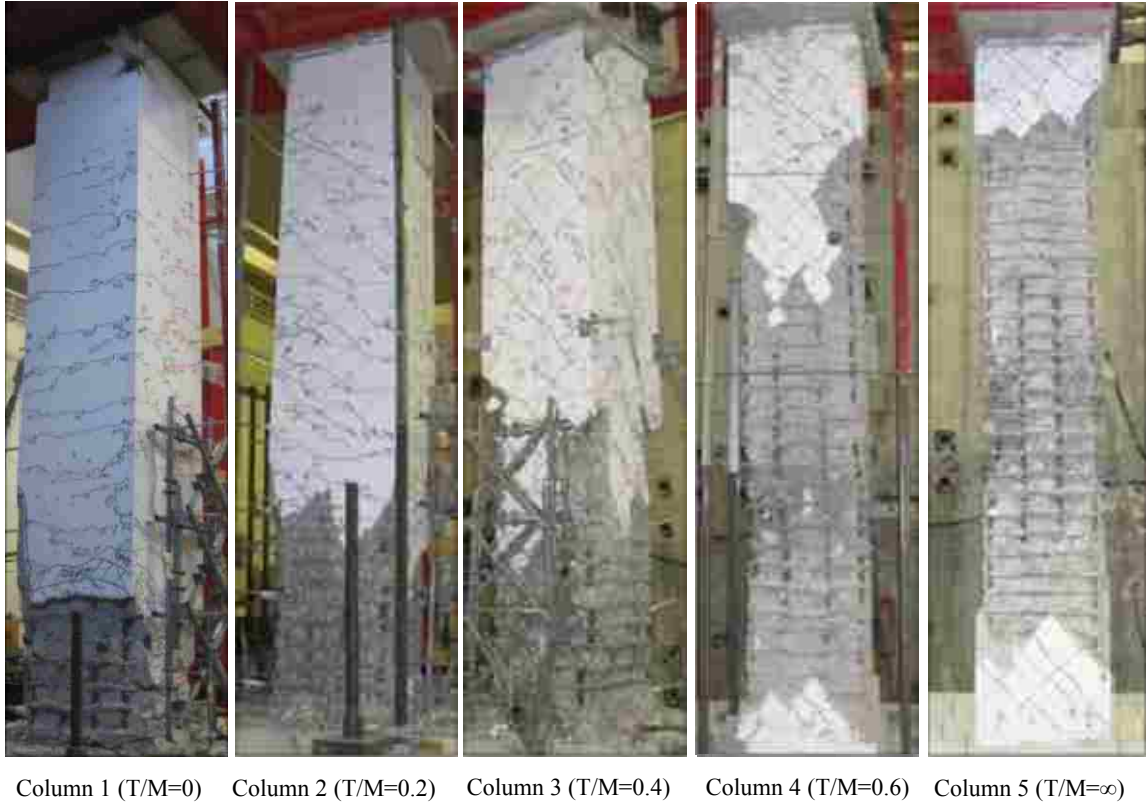
Fig. 2 Damage conditions of the original columns after previous tests.

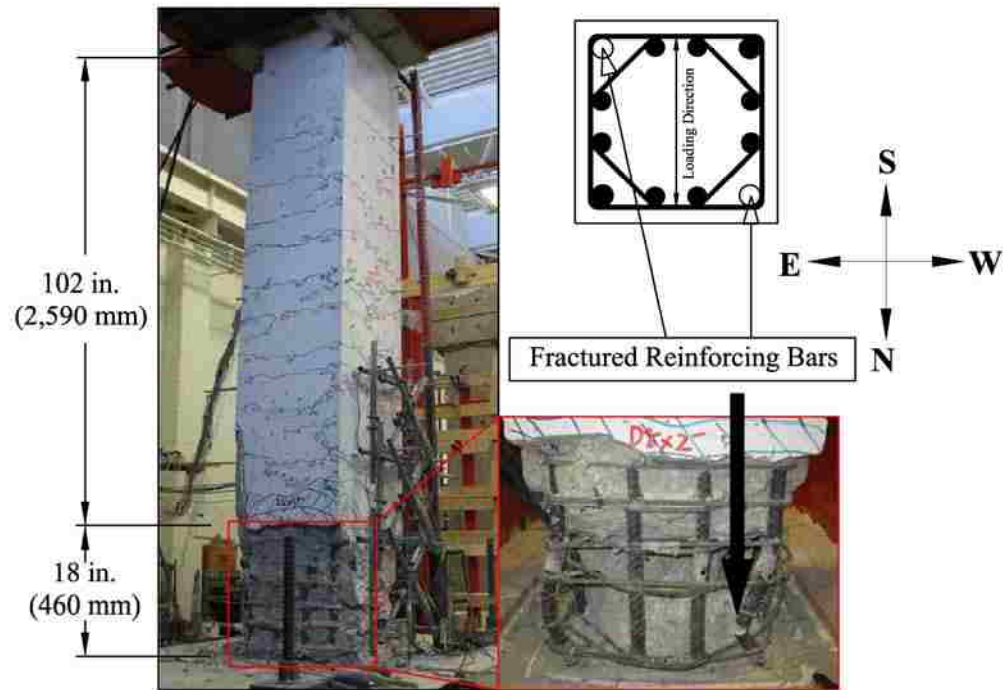
Fig. 2. Damage to Column 1 ($T/M=0$).

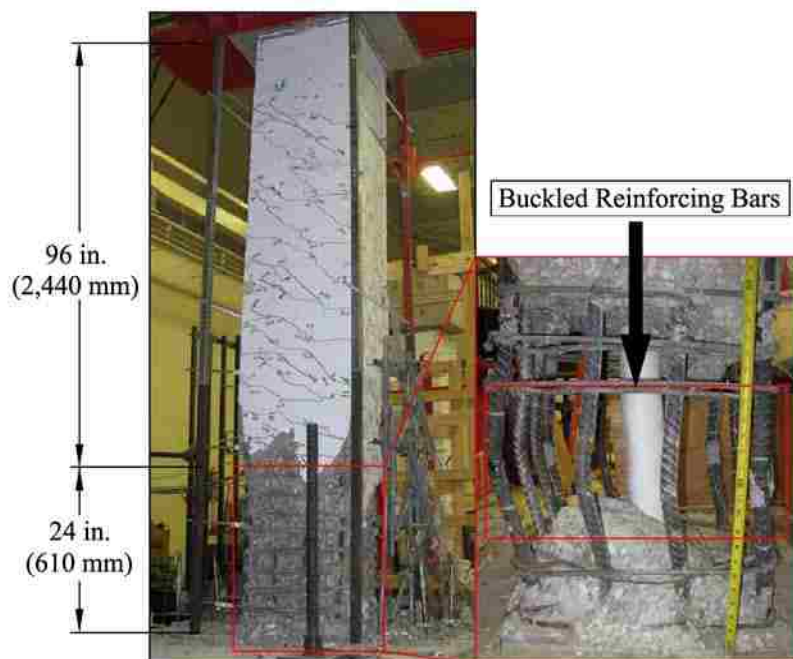
Fig. 3. Damage to Column 2 ($T/M=0.2$).

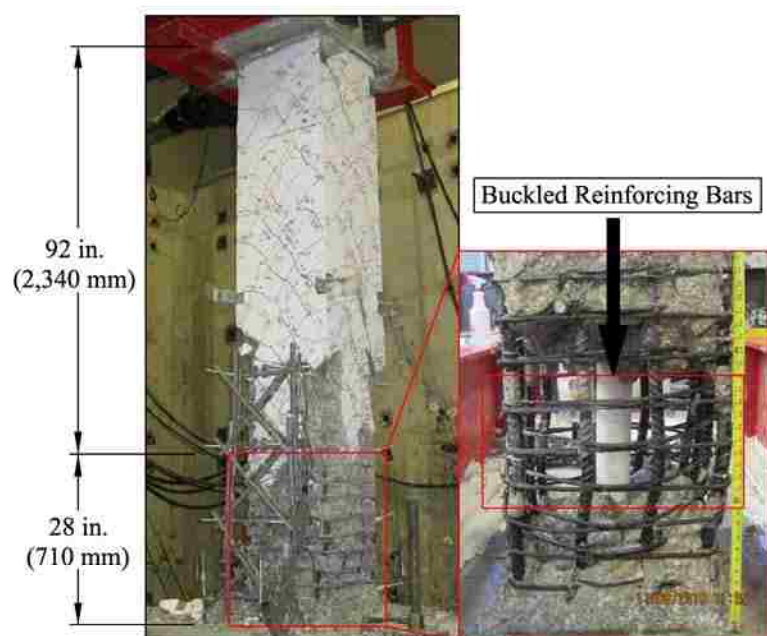
Fig. 4. Damage to Column 3 ($T/M=0.4$).

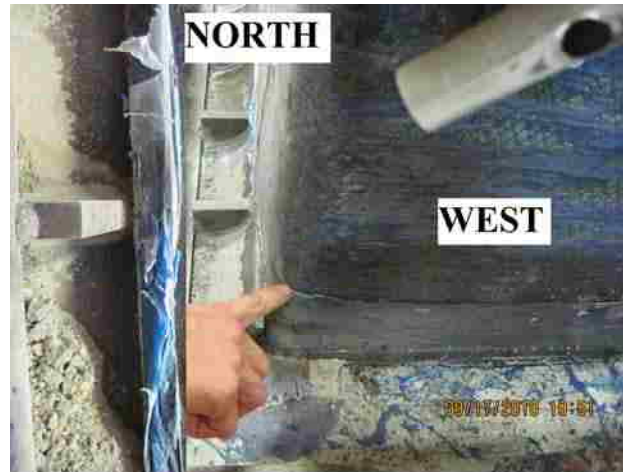
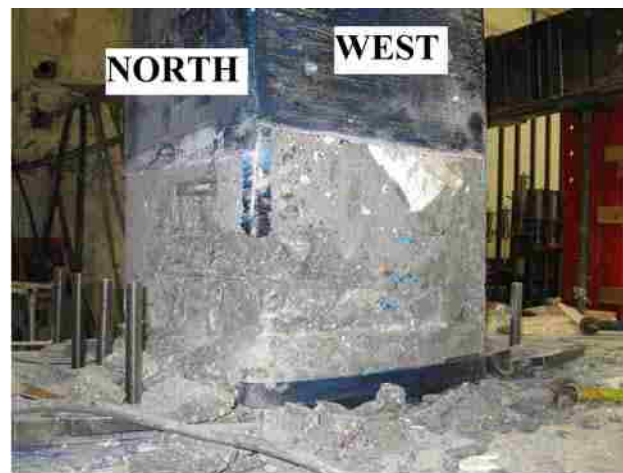
Fig. 14. Failure of repaired Column 1-R ($T/M=0$) - northwest corner.

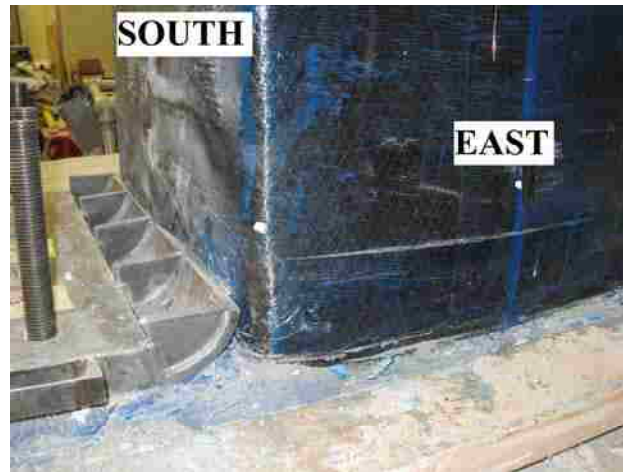
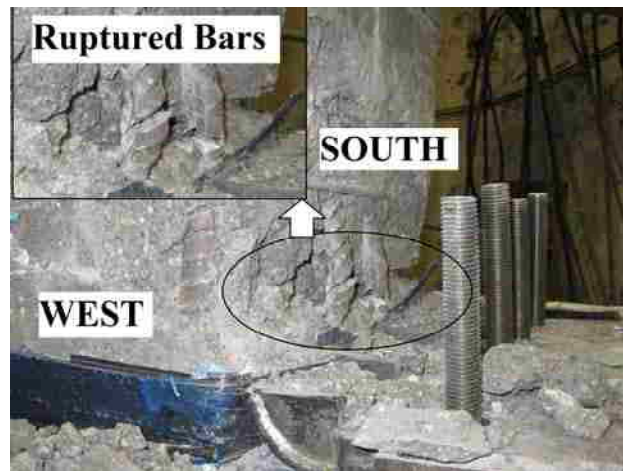
Fig. 15. Failure of repaired Column 1-R ($T/M=0$) - south side.

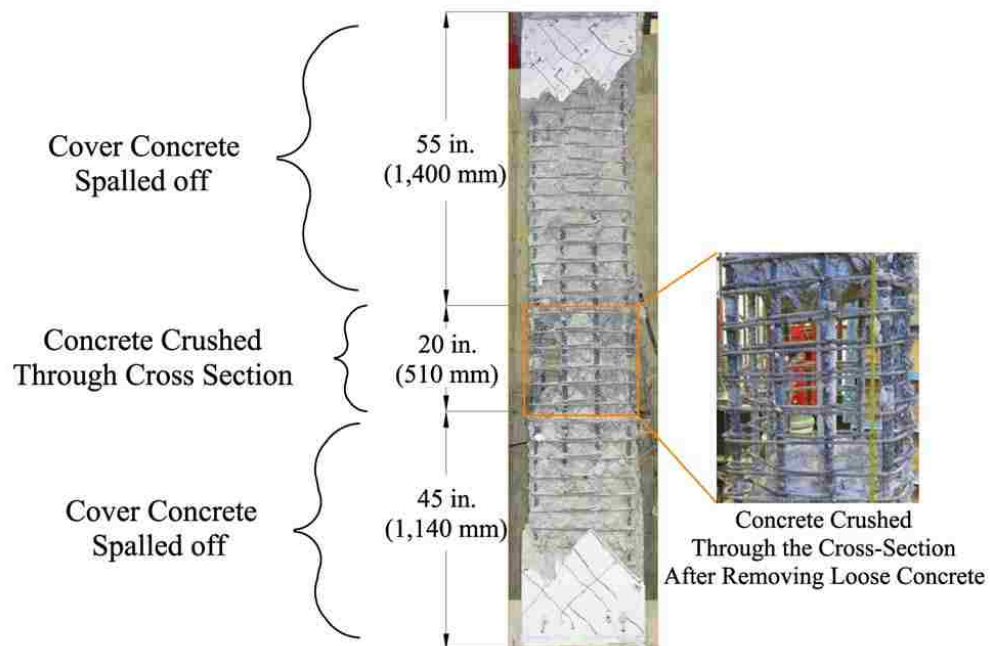
Fig. 2 - Damage condition of concrete in original column.

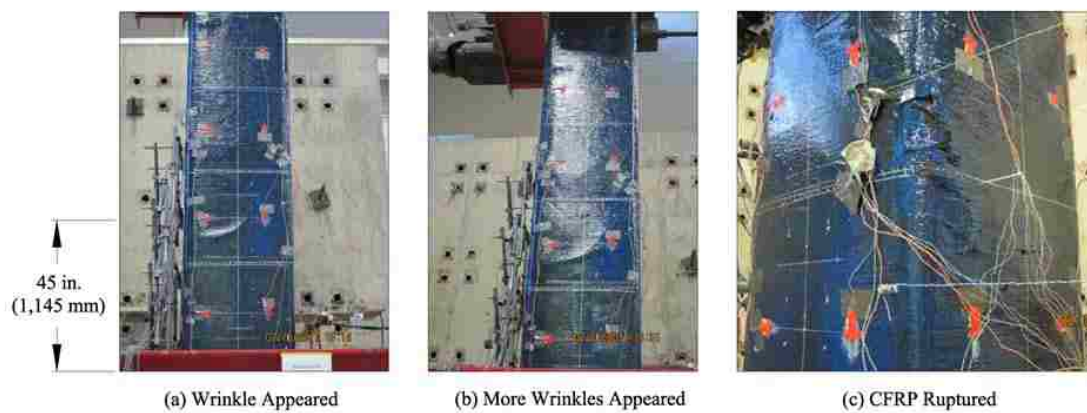
Fig. 5 - Failure of repaired column.

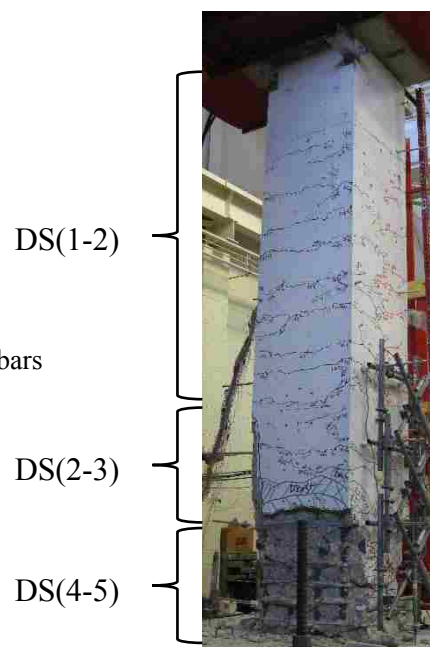
Fig. 6. Damage to original column prior to repair
