January 2013

# Evaluating CFRP-Masonry Bond Using Thermal Imaging

Joseph Christopher Ross

A thesis submitted in partial fulfillment  
of the requirements for the degree of  
Master of Science in Civil Engineering  
Department of Civil and Environmental Engineering  
College of Engineering  
University of South Florida

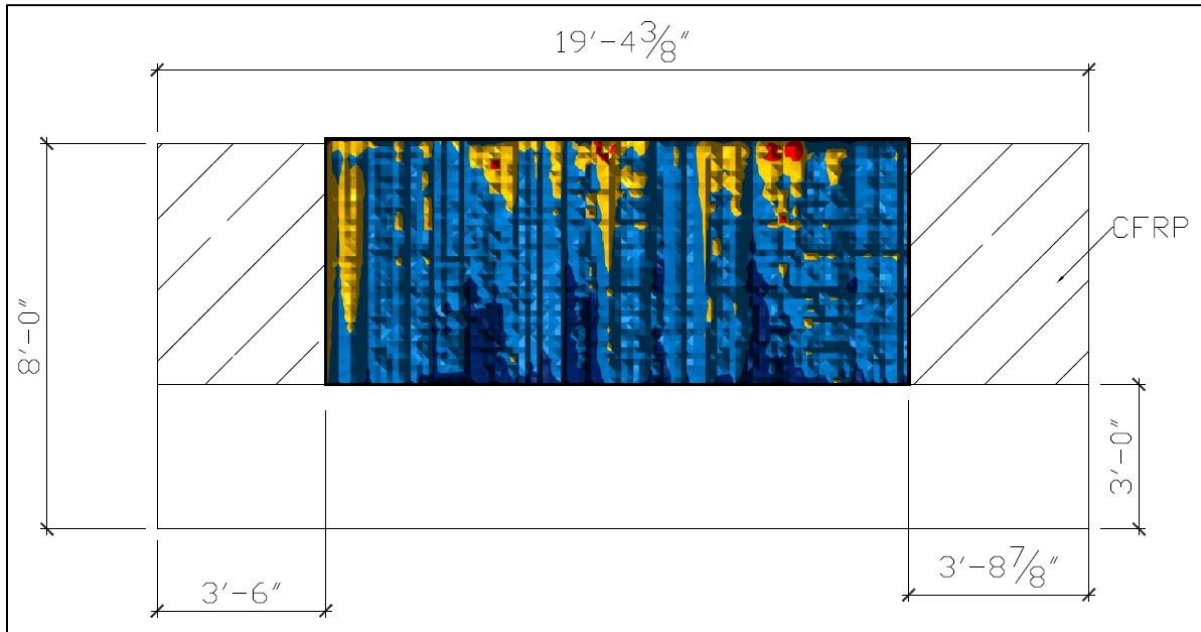
**Figure 60: Results on Wall 3**

Figure 60 shows the scanning results superimposed on a sketch of the wall. This is to scale and visually shows where the thermal variations are occurring on the wall.

Anomaly #	Coordinates (X, Y)	Comments
5	13'-0", 6'-5"	Defect
6	13'-0", 7'-10"	False Reading, scanner stopped.
-	Global warm regions	Caused by passive heat sources.

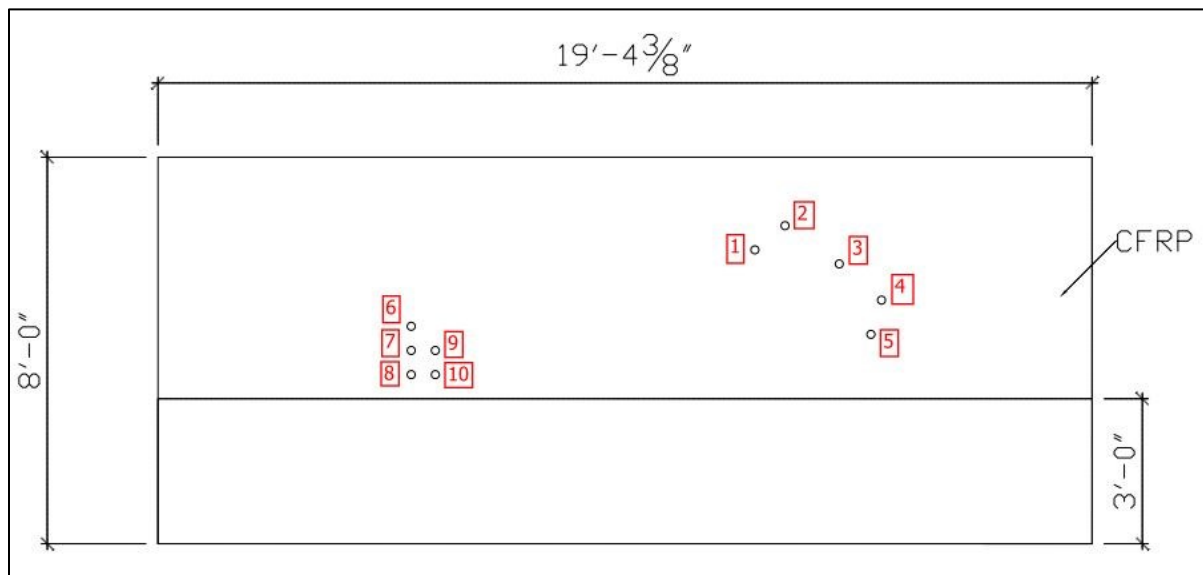
**Figure 62: Wall 2 Pull-Off Recommendations (North Side Elevation Shown)**

Pull-Off #	Coordinates (X, Y)	Expected Outcome	References
3	14'-1 1/2", 5'-9 1/2"	No Bond	Anomaly #10, Figure 54
4	15'-0", 5'-0 1/2"	No Bond	Anomaly #14, Figure 54
5	14'-9 1/2", 4'-4"	No Bond	Anomaly #16, Figure 54, Hot Spot 2 from Figure 41
6	5'-3", 4'-6"	Substrate Failure	Lower thermal fatigue, Figure 14
7	5'-3", 4'-0"	Substrate Failure	Lower thermal fatigue, Figure 14
8	5'-3", 3'-6"	Substrate Failure	Lower thermal fatigue, Figure 14
9	5'-9", 4'-0"	Substrate Failure	Lower thermal fatigue, Figure 14
10	5'-9", 3'-6"	Substrate Failure	Lower thermal fatigue, Figure 14

Specific locations are recommended for testing as shown in Figure 62: the hot spot that was confirmed by sounding, thermography, and scanning; four other anomalies identified on wall 2; and at least five tests in a good/cold region. This would involve a total of ten pull-off tests on wall 2. Table 7 provides additional details on pull-off recommendations for wall 2. Wall 3 should test all anomalies except for the one that is too close to the FRP edge, one additional test in a region of high thermal fatigue, and five in a region of low thermal fatigue. Anomaly 2 on wall 3 would put the pull-off disk partially on bare masonry and this would skew the results. Recommendations for wall 3 are shown in Figure 63 and are further explained in Table 8. One location is recommended that is not in its corresponding location (weak bond in upper west region and strong bond in lower east region). This is because an anomaly was found here, however, except for this one; the others follow the pattern of either being at the top of the wall, on the west, or both in order to validate the general prediction. These tests should preferably be completed within a year or two in order to ensure that the results of the non-destructive testing are still valid and significant further deterioration does not occur. The locations specified should be close to the coordinates listed, but a tolerance of  $\pm 1$  in. is acceptable as the disks themselves are generally 2 in. in diameter.
