## Study The Causes of Failure of Furnace Wall Tube In Thermal Power Plant (Part I)

The failure of furnace wall tubes, boiler 6 –Najibia power station on March 2005 leading to plant shutdown was investigated. The present work deals with the experimental investigation to recognize the causes of failure. These included:1- Determination of scale density and its compositional analysis, 2-Spectrometric analysis of tube alloy material, 3-Mechanical testing of tubes material and 4- Examination of microstructure of the alloy. The results indicated that the recorded internal scale density  $\sim 45 \text{ mg/cm}^2$  may interfere with the heat transfer process leading to overheating. The loss of some alloying elements due to excessive heating reduces the strength of the alloy. An increase of hardness was detected to (720-800 HV) at the failed side which reflects the effect of metal hardening. Furthermore, the microstructural examination indicated the phase transformation of the pearlite to the martensite which confirmed the hardening effect leading to tube brittleness then rupture thereafter. The probable causes of tube failure were discussed.

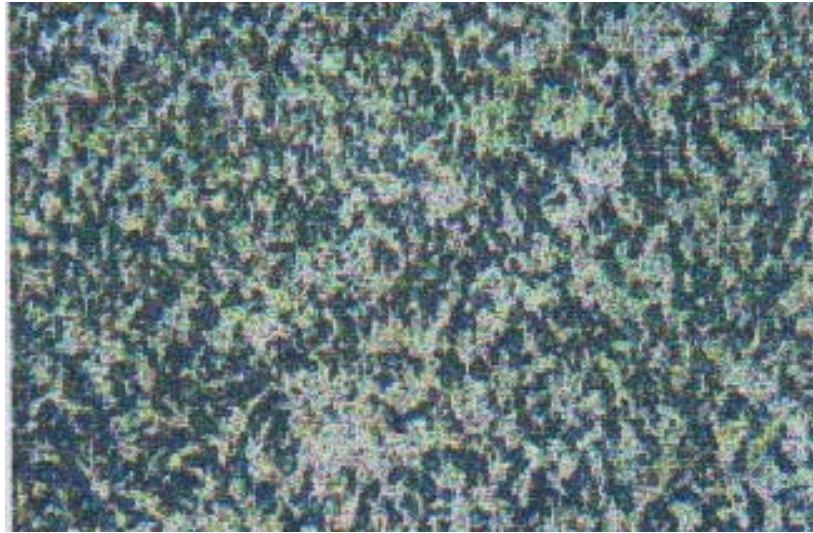
**Metallurgical Examination:** Undoubtedly, there is a remarkable correlation between the mechanical properties and the alloy composition in terms the allotropic forms (Raman and Petkovic 1981). It was found that the hardness increased in the bulged-ruptured region of the fire side (hot) of the tube wall to higher values of 720-800 HV compared to the hardness values of 136-147 HV observed in the opposite side (cold region). The hardness of the intact tube was in the range of 150-185 HV (see **Table 4**). For instance, the new tube showed normal hardness values of 150- 230 HV with the normal structure of pearlitic steel (**Plate 2**).

**Plate 2-** Normal microstructure of the intact new tube ( Steel 20), boiler 6 showing the two phases of ferrite and pearlite ( HV 175 ), etched by nital,200x .
