Study of Deterioration and Conservation of A mosaic Pavement in the Baron's Palace, Egypt

*Dr . Mohamed K. Khallaf

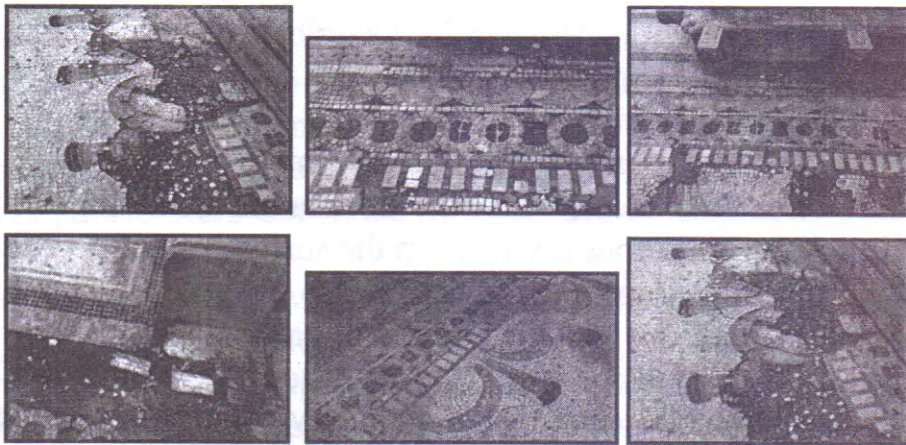
Many deterioration phenomena were found in the mosaic pavement, their include disintegration of tesserae from the floor, cracks and micro cracks, lacunae, loose of mortar between tesserae, disintegration of tesserae with ground layer, deterioration of mortar, erosion of tesserae, crystallization of salts, stains and layers of dirt, figs. (2).Condition Assessment of the mosaic pavement is divided

Detachment Between Mosaic Layers, Separation or void between two layers of the mosaic. A detachment is generally not visible and can be detected by the corresponding hollow sound produced when the surface of the mosaic is tapped.fig.(2),(3).

Fig. (2) Shows the mosaic pavement deterioration for example, lacuna, cracks, detachment between mosaic layers, detached tesserae, and deteriorated Tesserae.

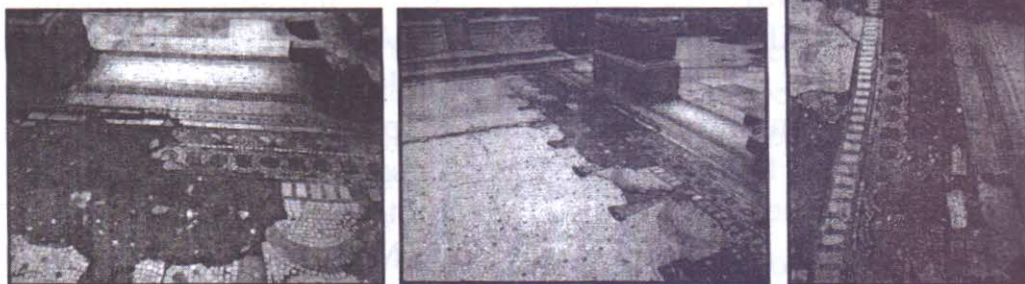
Crystallization of Salts, Mineral crust of Salts, efflorescence or white powder- like crystals. fig.(4)

Fig. (4) Shows different deterioration phenomena of the mosaic pavement.

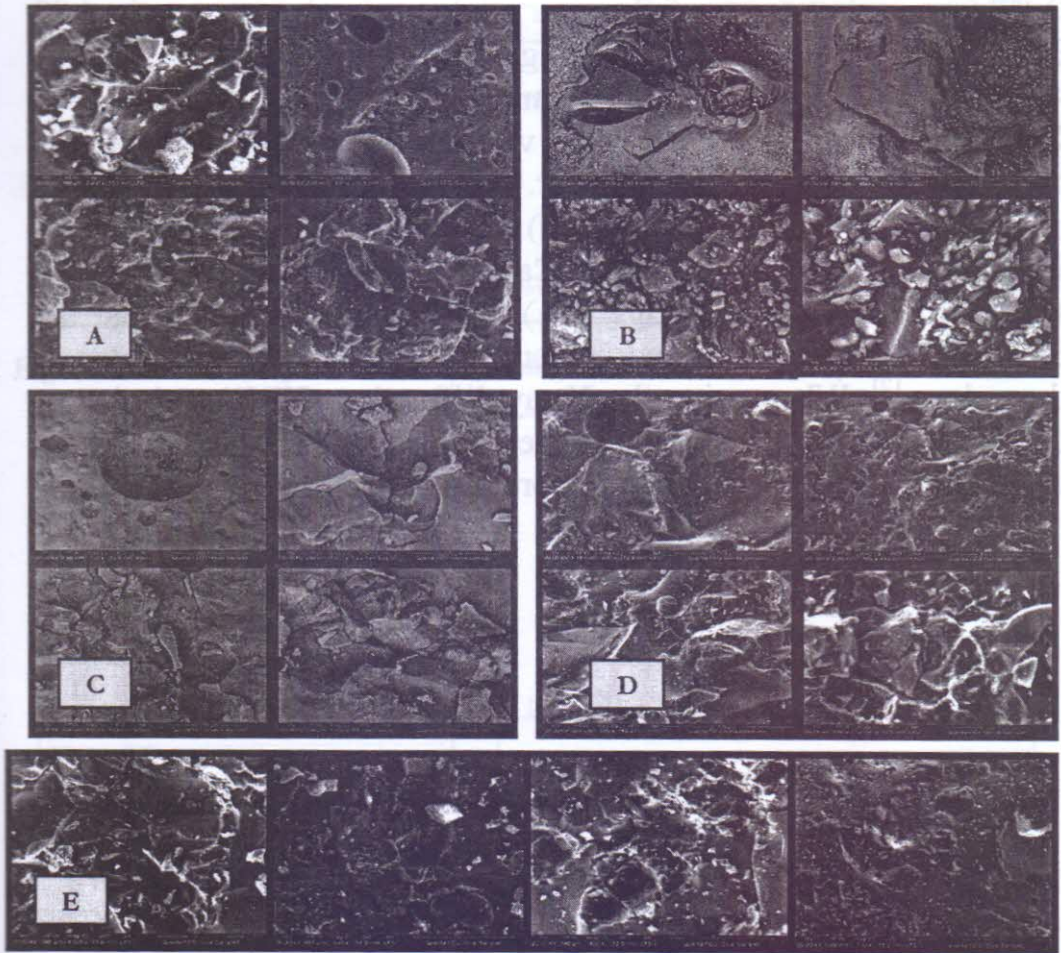
The colored mosaic tesserae were studied by SEM /EDX to determine the sources of colors and the kind of fluxes which add to the glass matrix to reduce the firing temperature in addition to determine the chemical composition of the mosaic tesserae. Investigation by SEM of the mosaic tesserae samples showed the erosion, disintegration by the salt crystallization, cracks, loose some parts, voids and air bubbles may be related to problems in the manufacturing processes,⁽¹⁰⁾ figs. (5). Analyses by EDX unit were indicated that the source of the green color in mosaic tesserae is copper which used at ratio 1.16 % and iron at ratio 1.97 % in addition to cobalt at ratio 0.51 % .⁽¹¹⁾ The result showed that the source of flux is calcium which exists at ratio 10.55 % in addition to traces of potassium at ratio 0.78 % , fig. (6). Regarding to the red color of mosaic tesserae, the results indicated that the source of the red color is iron which used at ratio 3.95 %. The result showed that the source of flux is calcium which exists at ratio 11.04 % in

Fig. (5) SEM photomicrographs of mosaic tessera samples (A) green (B) red (c) white (D) blue (E) yellow, showing cracks in glass network, loose some parts, pores, disintegration between parts, air bubbles and salts crystallization.

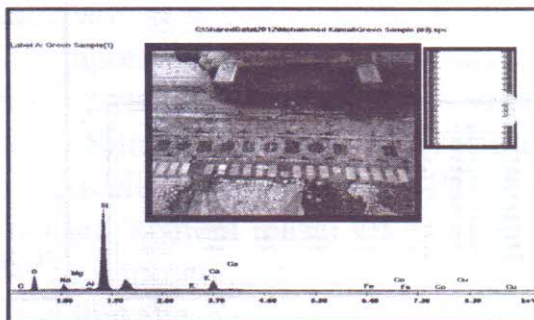
Fig. (6) Shows EDX pattern of the green mosaic tesserae.

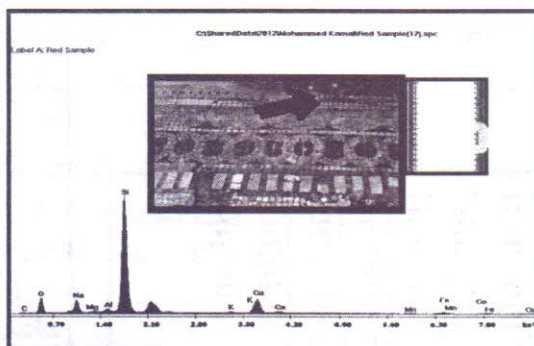
addition to potassium at ratio 1.01 % , fig. (7). On the other hand results indicated that the source of the white color in mosaic tesserae is calcium which used at ratio 12. 57 % and the source of flux is calcium in addition to traces of potassium at ratio 0.38 % , fig. (8). Related to results the source of blue color is copper at ratio 0.89 % in addition to cobalt at ratio 0.47 % and the source of flux is calcium at ratio 13.69 % , fig. (9). Finally, results indicated that the source of yellow color in mosaic tesserae is iron which used at ratio

Fig. (7) Shows EDX pattern of the red mosaic tesserae.

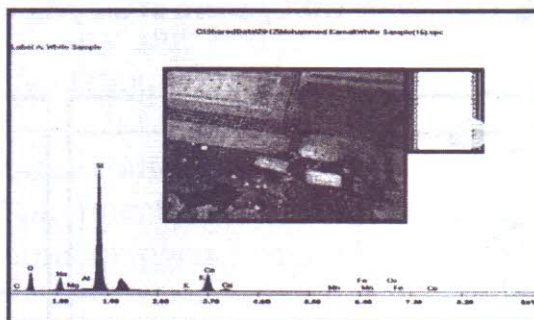
Fig. (8) Shows EDX pattern of the white mosaic tesserae.

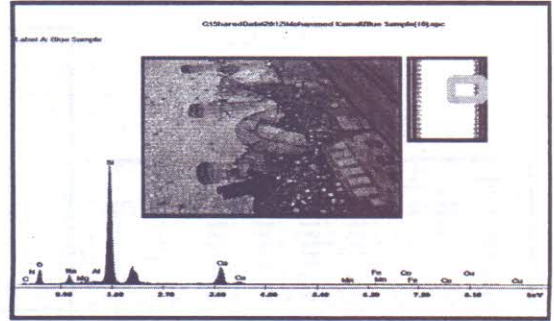
Fig. (9) Shows EDX pattern of the blue mosaic tesserae.

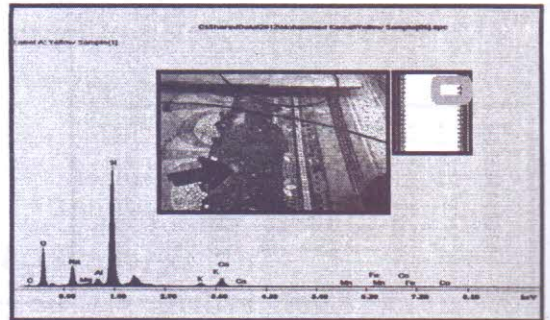
0.47 % and the source of flux is a mixture of calcium at ratio 4.88 % and potassium at ratio 1.7 % , fig. (10).⁽¹²⁾

Fig. (10) Shows EDX pattern of the yellow mosaic tesserae.

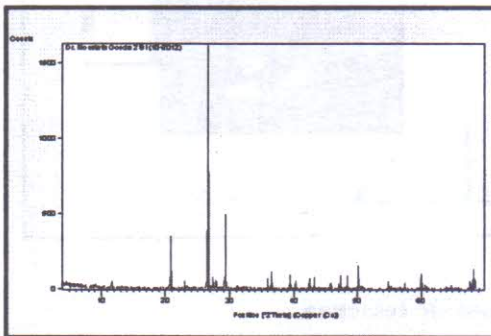
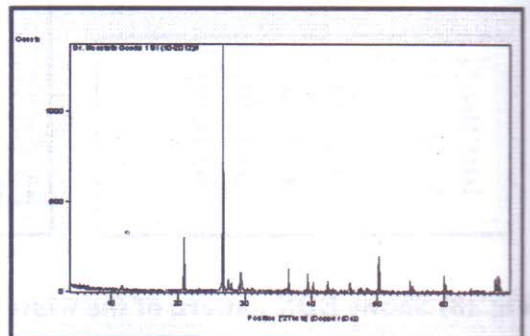
X-ray diffraction (XRD) analysis was used to identify the mineral composition of the mosaic mortar. It showed that, mortar consists mainly of quartz card No. (5-0490) and calcite, Card No. (5-0586), in addition to traces of gypsum, Card No. (6-0046) and halite as a salt. Card No. (5-0628) figs. (11). This results indicated that the mosaic mortar was Portland cement also, related to the mortar of the palace ⁽²⁾. When using the X-ray diffraction (XRD) techniques, the chemical products to be analyzed in a sample should be present in quantities of several percent in order to detect the corresponding

Fig. (11) Shows XRD patterns of mosaic pavement mortar.

peaks on the XRD pattern. This means, it is very difficult to detect the anhydrous mineralogical components of Portland cement. Moreover, the main hydration product of Portland cement (tobermorite, CSH / Calcium Silicate Hydrate) is nearly amorphous , so that it is very difficult to detect it by XRD. The other main component of a mature cement past, Ca (OH)₂, in general is transformed within a few months into Ca CO₃ due to carbonation by CO₂ of the air, so that the XRD peak of this final product can not be distinguished from the XRD calcite peak belonging to limestone aggregate. All these things together mean that it is practically impossible to distinguished a cement mortar after some months or a few years of curing.⁽¹³⁾ Gypsum could be formed by sulfur dioxide oxidation and subsequent sulfation of calcite,⁽¹⁴⁾ which is present both in the cement paste and in sand:

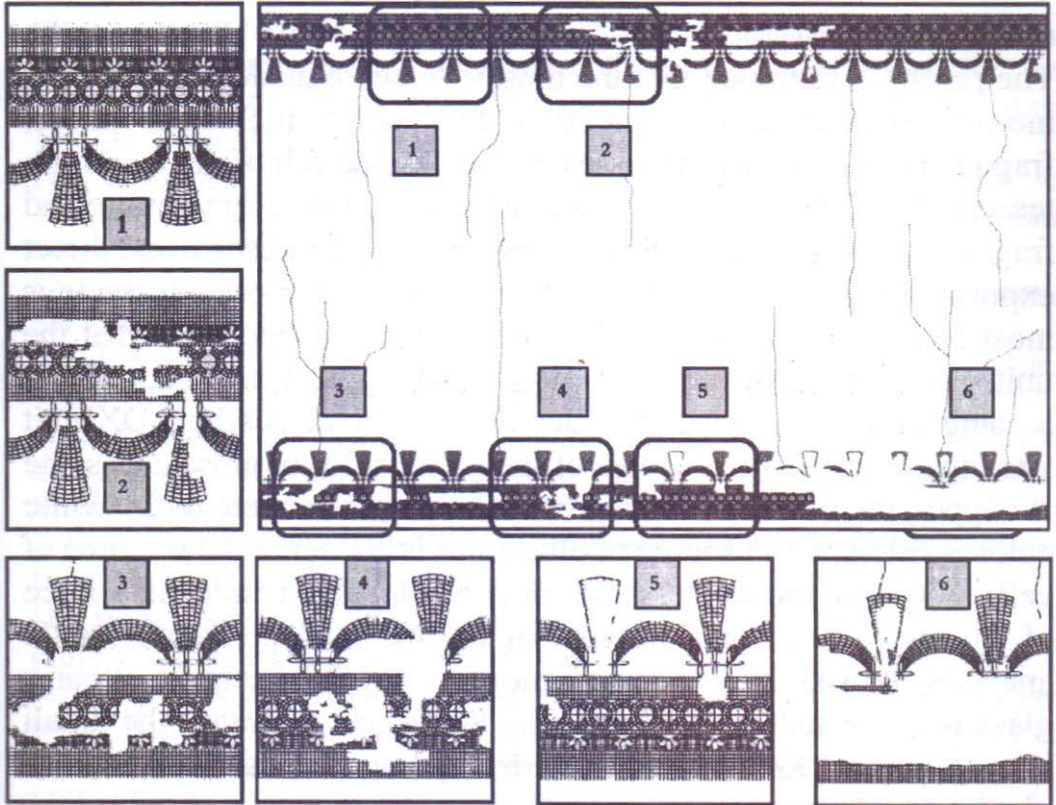
Documentation of the mosaic pavement was carried out using A CAD computer program. Dereriation phenomena was appeared in this documentation, fig., (12).

Fig. (12) Shows documentation of the mosaic pavement and its deterioration phenomena using A CAD computer program.

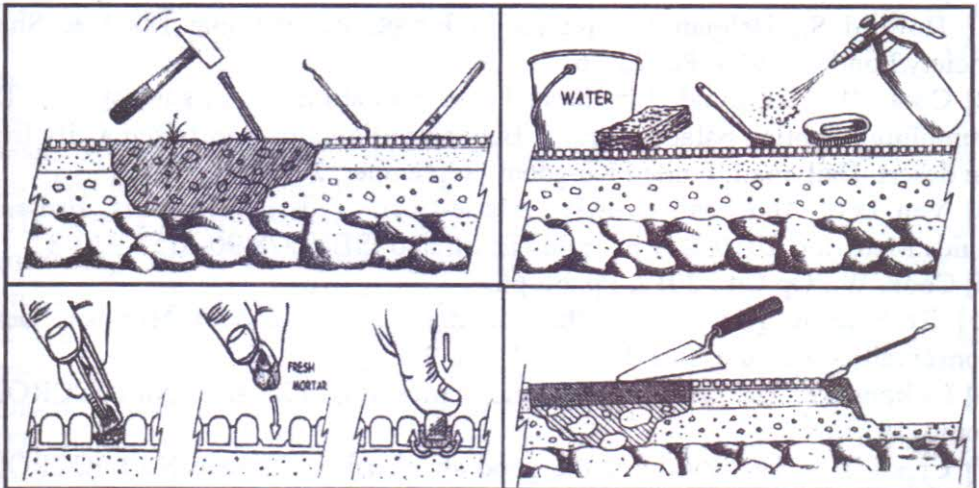
Fig. (13) Shows treatment and conservation processes of A mosaic pavement.

Cleaning should be carried out gradually, starting with the removal of less strongly adhering deposits, like soil, before proceeding to more strongly adhering deposits, such as micro-organisms (lichens, etc.). While cleaning, water should be used in minimal amounts and changed as soon as it becomes dirty. Chemicals should not be used for cleaning as they can damage mosaics. Cleaning can be carried out with or without water. The most commonly used cleaning tools are scalpels, dental tools, wooden sticks, chisels, various kinds of brushes (never metal brushes), paintbrushes, manual blower bulbs, vacuum cleaners, sponges and hand held water sprayers. Each tool has specific characteristics and must therefore be used for specific operations. The incorrect use of a tool can damage the mosaic and break the tool. ⁽¹⁶⁾ fig. (13).

Placing detached tesserae back in their original position and with their original orientation using mortar. ⁽¹⁸⁾ For example to reset detached tesserae, the use of a lime-rich mortar made of lime putty and a fine aggregate is recommended. A liquid mortar containing very fine aggregates should be used to fill a void between preparatory layers, by injection using a syringe. Hydraulic lime should be used as a binder because the mortar must be able to set without being in contact with air. fig. (13).

it is harder and more resistant. Aggregates of the appropriate color and size should be chosen carefully for, as with any surface mortar, aesthetic issues have to be considered. ⁽²⁰⁾ When looking at the mosaic, attention should not be drawn to the intervention mortars. The color and texture of the mortar should therefore blend in visually with those of the mosaic so that the mosaic surface always remains visually dominant. ⁽²¹⁾ fig. (13).
