The Evaluation of Corrosion Problems In Condensate Return Lines –South Refineries Company

N. J. Hamadi* , G. A. K. Hassan** and A. A. Al-Shaheed**

**South Refineries Company.

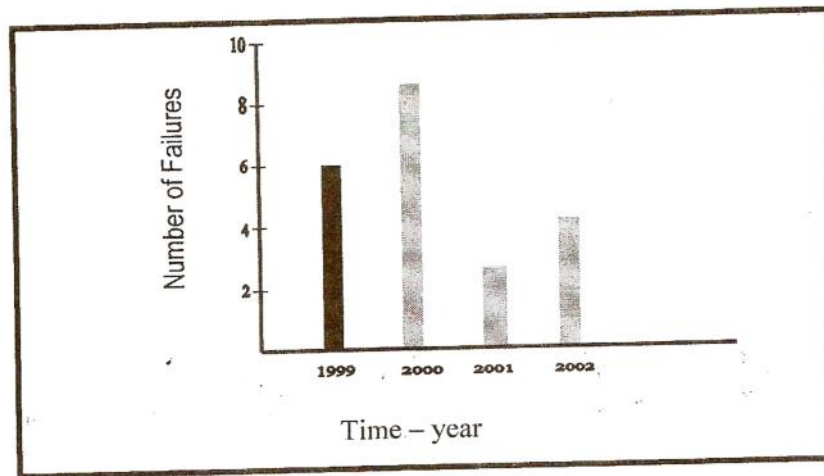
Fig. (1) -Represent the number of failures during the period 1999-2002

condensate from 10 branches of different diameters tubes. The header is located horizontally between unit No.700 and 800. A partial replacement for the failed regions were undertaken. Unfortunately, the leakage appeared after one month of maintenance. The frequency of the failures occurred during 1999-2002 were indicated in Fig. (1).

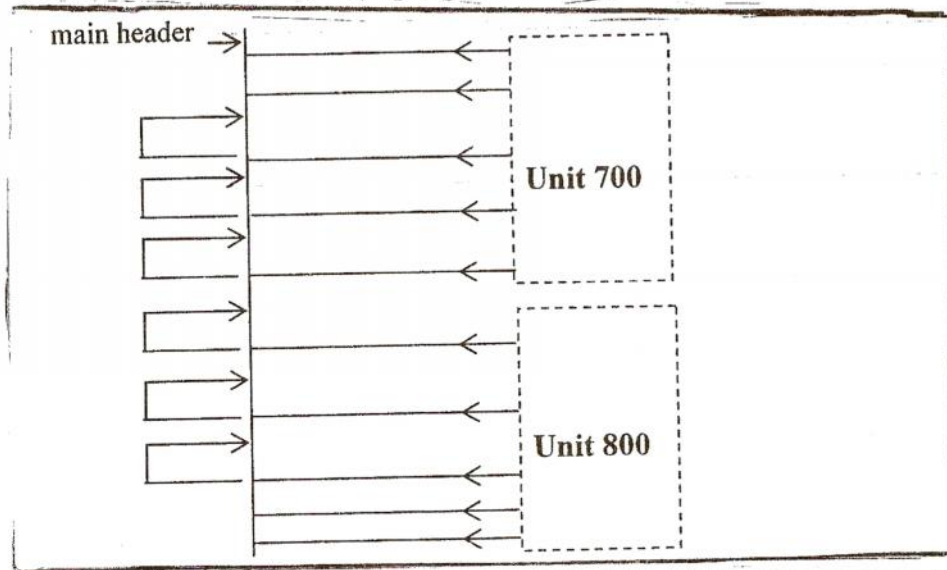
Fig. (2) – Location of the failure occurred in the main header condensate return lines-South Refinery Company.

Inspection of the condensate returns main header 75 mm diameter, 60 m length and 5 mm thickness showed heavy leakages which received the

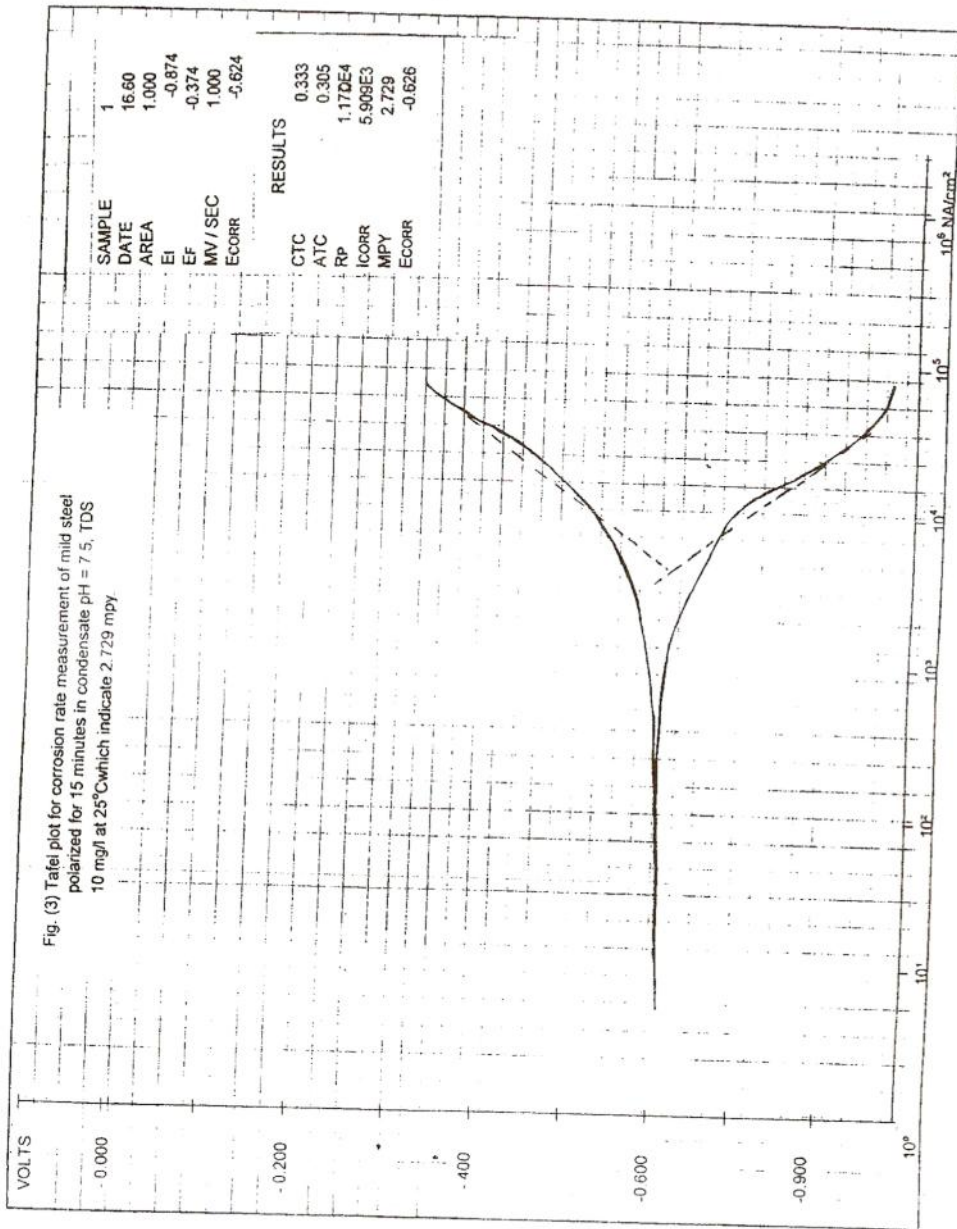
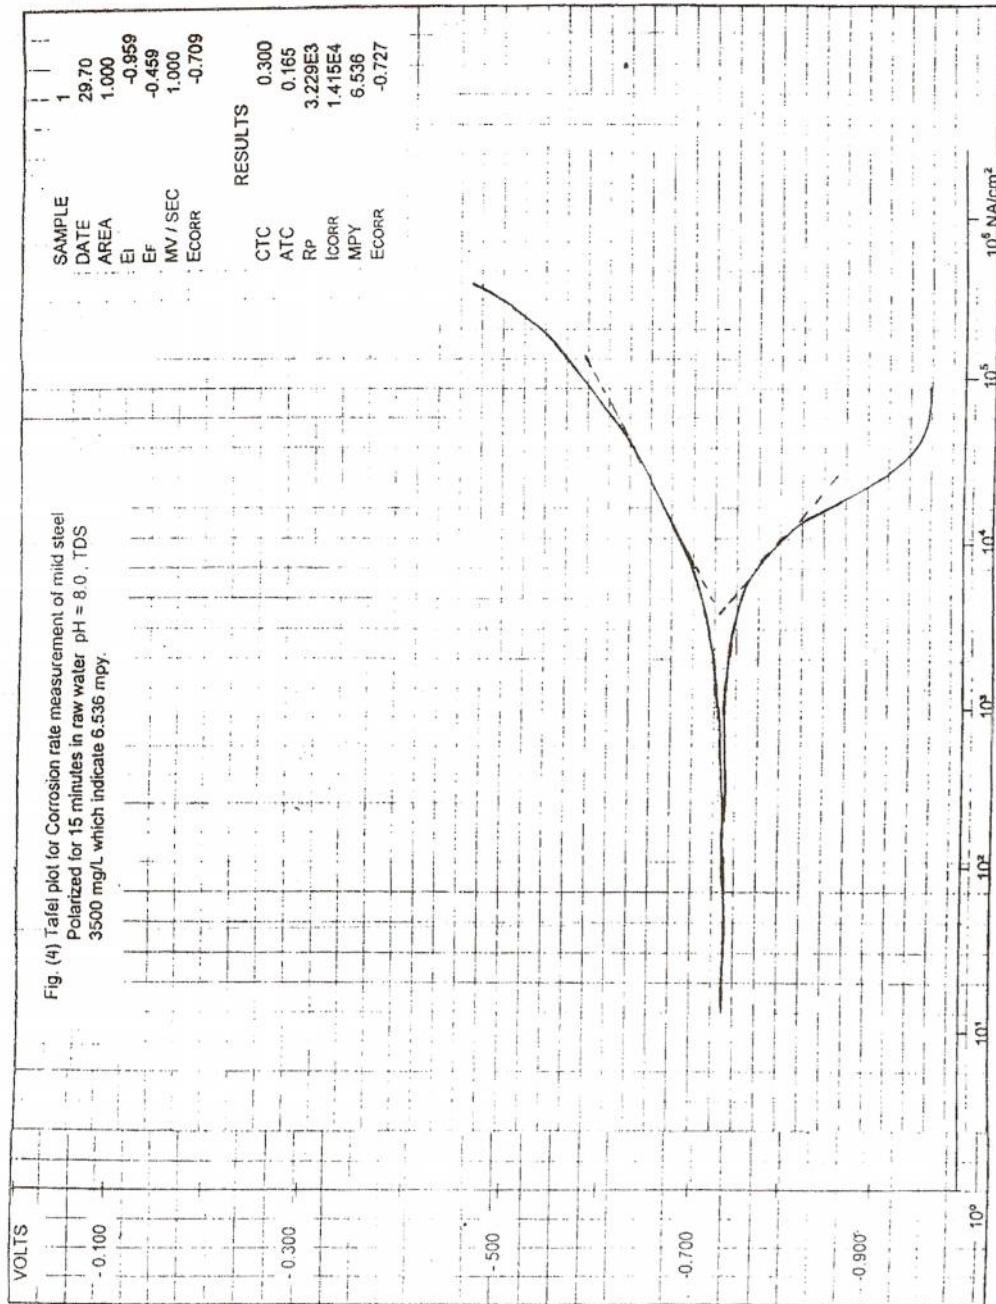
indicated that condensate showed relatively low corrosion rate (2.7 mpy) compared to that observed with raw water (6.5 mpy), refer to Fig. 3 & 4 . However , although the condensate in reality showed low corrosivity to the metallic surfaces in the short term experiment. But, practically it did not confer sufficient protection against corrosive agents such as H^+ , O_2 , CO_2 in the long term exposure (Hochheimer 2000).

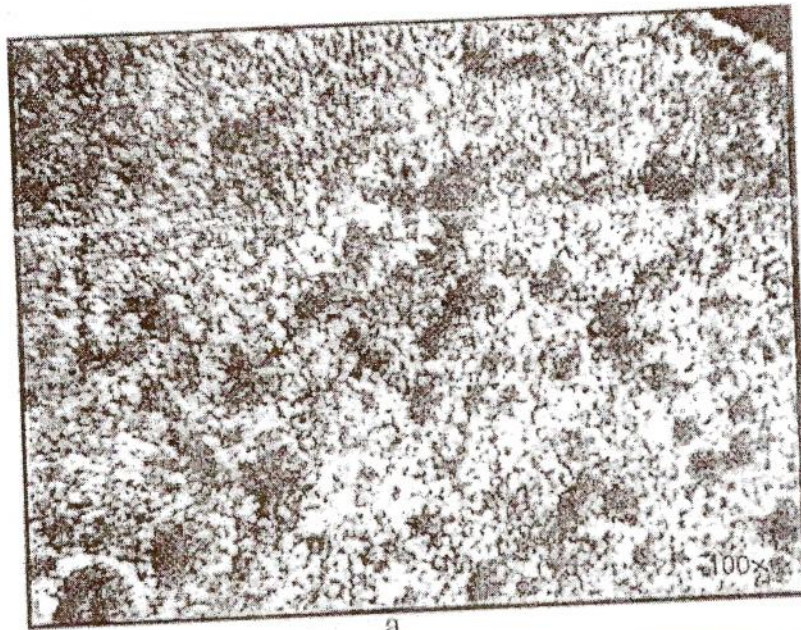
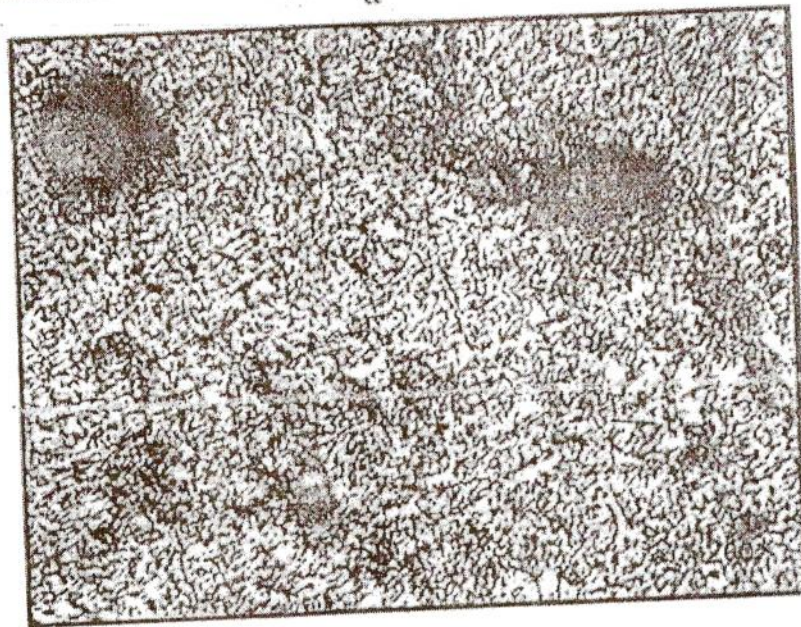
Plate 1- Localized pitting corrosion in the mild steel (106B) pipe interior , specimen 1, a-100x and b-200x .

Microscopic examination: The results of microscopic examination of the corroded area (specimen 1) showed that pits are varying from single pit holes to a wide spread attack approaching uneven localized pitting corrosion (see plate 1). The intact area adjacent to the corroded area (specimen 2) showed a distortion of the micro structure to the extent that the ferrite incorporate very low percentage of pearlite. Plate 2 indicate clearly the phase change of steel micro structure (Pollack 1981).

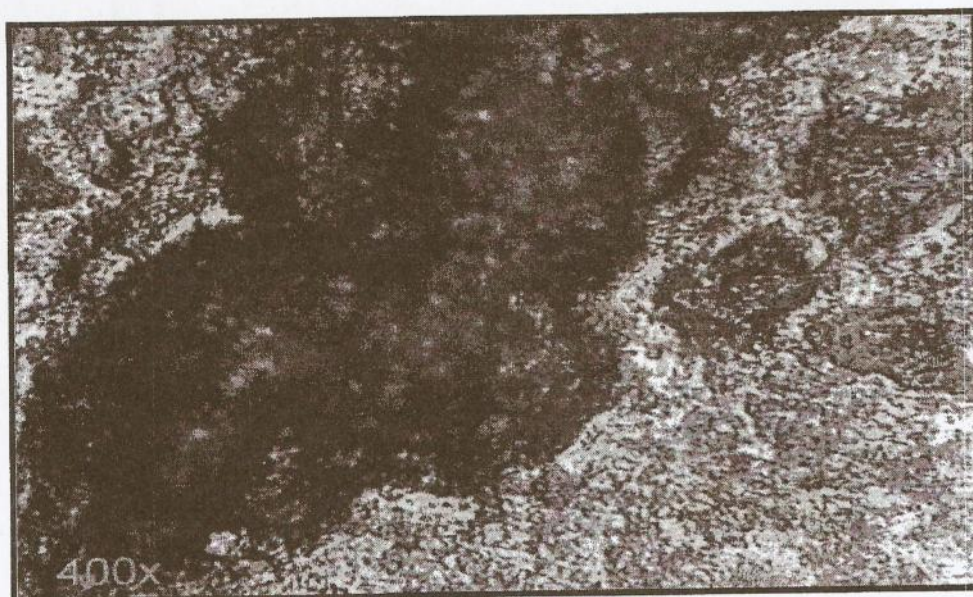
Plate 3- Surface feature of mild steel (106B) pipe interior showing the pitted areas, specimen (3) ,etched by nital,400x.

The cross sectional area (specimen 3) visually showed pit penetration to more than 70% of the wall thickness. Some of the pits emerged together to form wide mouth pit as appeared in Plate 3. The corrugation of the pit mouth is the characteristics of carbon dioxide attack. Plate 4 showed the normal microstructure of steel with no distortion.

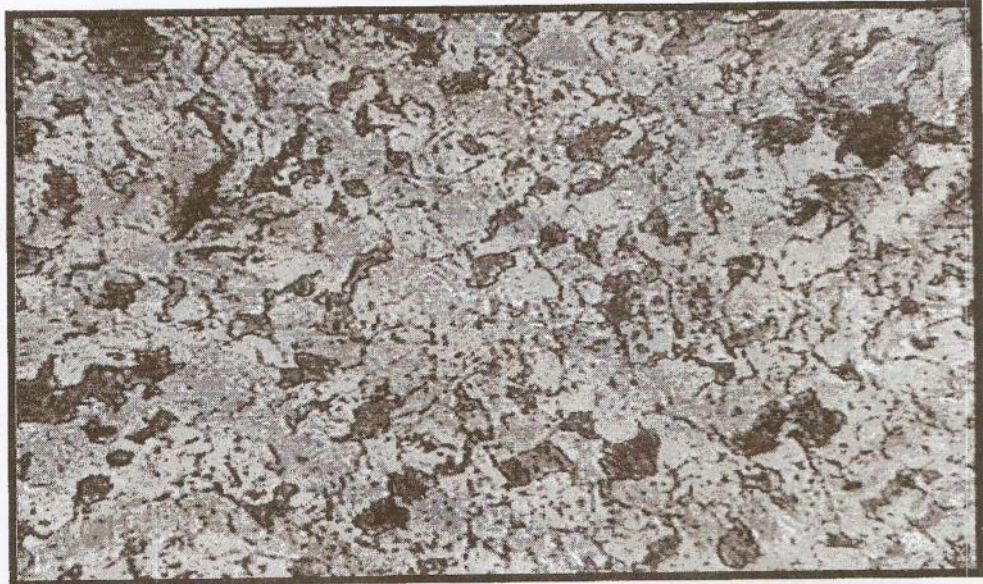
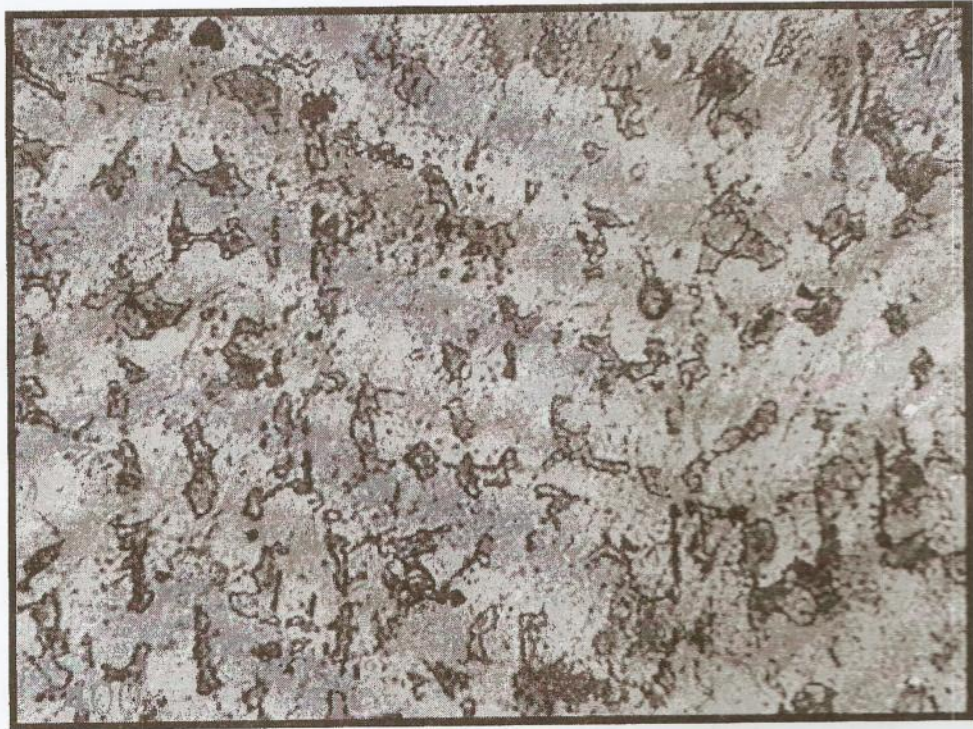
Plate 4(a&b) - Microstructure of mild steel (106B) showing the normal structure of the two phases of steel, specimen(4), etched by nital ,400x .

The intact cross sectional area (specimen 4) showed that there was no evidence of microstructural changes as evidently appeared in Plate 4(a & b). **Corrosion rate measurements:** from the results obtained from the polarization of the pipe specimens on an electrochemical cell, it was
