Ultimate load tests of modified Parker type high truss bridge

Ultimate load tests
of a
modified Parker type high truss bridge

A Thesis Submitted to the
Graduate Faculty in Partial Fulfillment of
The Requirements for the Degree of
MASTER OF SCIENCE

Department: Civil Engineering
Major: Structural Engineering

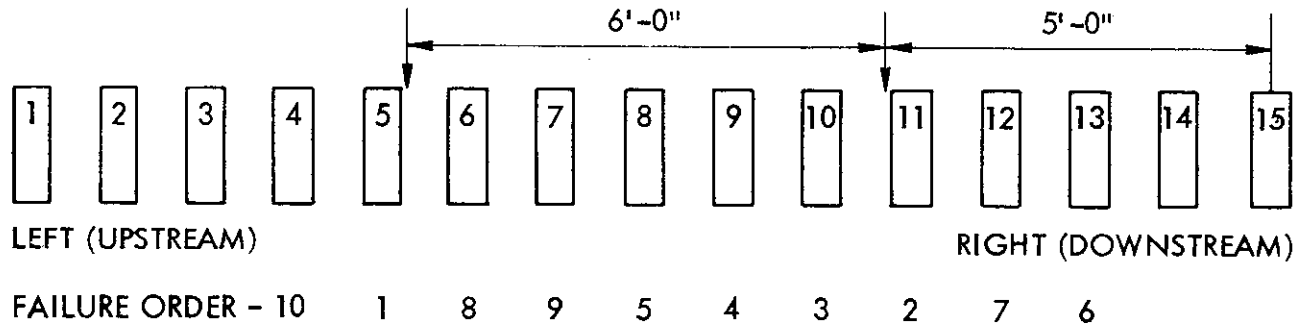
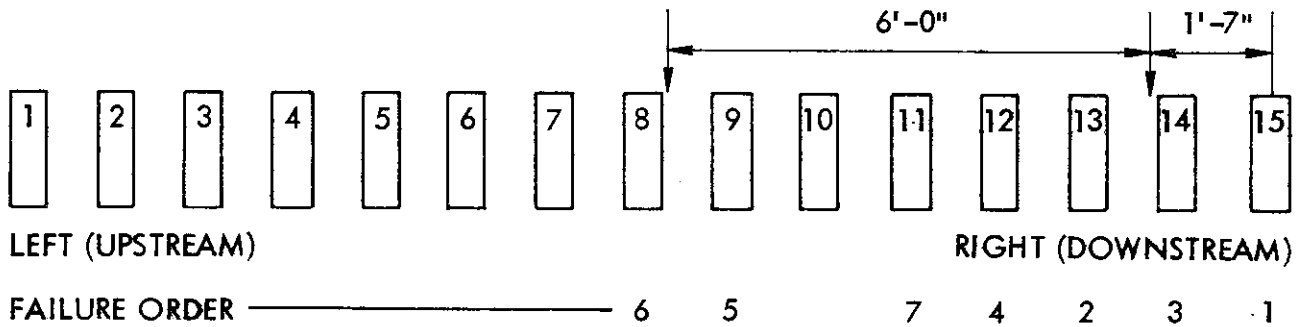
Fig. 13. Numbering system and failure order of stringers for deck tests 1 and 2.

Figure 13 shows the order in which the stringers failed for each of the two deck tests. The first two stringers to fail in deck test 1 were near the applied loads. The third through seventh stringers to fail were mainly under the influence of the loads on the right side of the panel. This behavior indicates either that more of the load was applied to the right side of the panel than to the left side of the panel or that the right side of the panel was not as strong as the left side of the panel. The last three stringers to fail were under the influence of the loads on the left side of the panel.

The first four stringers to fail in deck test 2 were located near the load that was applied toward the edge of the panel. These stringers failed first because there were fewer stringers available to take the load that was applied toward the edge of the panel. The next two stringers to fail were under the load applied near the center of the panel. The final stringer to fail was located midway between the loads. This stringer failed as a result of the unfailed stringers trying to carry the load that had been carried by the previously failed stringers.

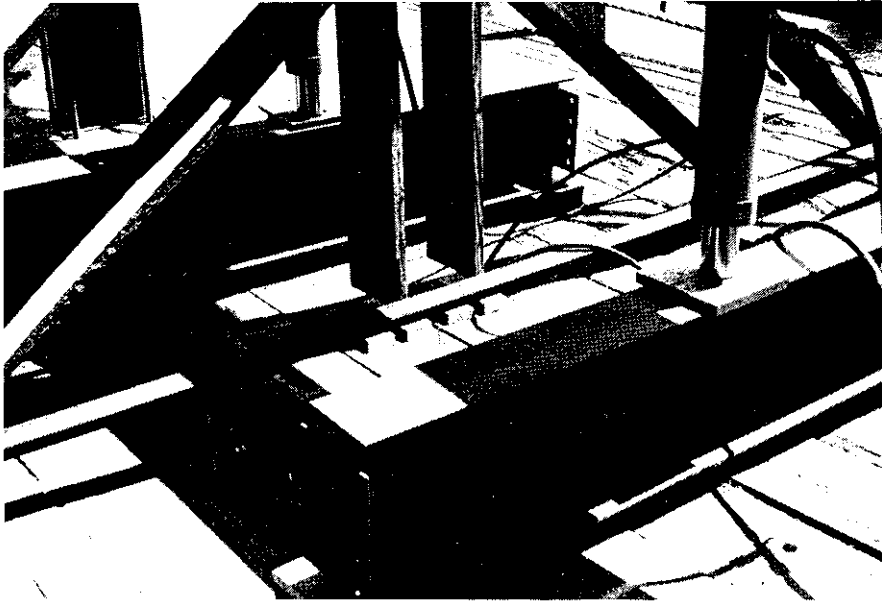
The load was first applied in increments of 10 kips, but as the loading progressed to higher levels, the load increments were reduced to 5 kips until failure was reached. Loading proceeded as planned on the first test at loads up to 65 kips, when the fifth stringer from the left broke. As the load was increased up to the maximum load of 101.5 kips, stringers split and failed. The behavior of the deck at loads above 65 kips can be seen in Fig. 17 and the failure order of the stringers in Fig. 13. At each failure there was a sudden drop in load. However, upon reloading there was usually a recovery of load and a further increase in load. After the failure of 10 stringers the test was terminated because the deck was unable to sustain any additional load. Figure 18 shows the top of the deck at a load near failure. The failed stringers are shown in Fig. 19.

Fig. 18. Photograph of deck test 1 near ultimate load.

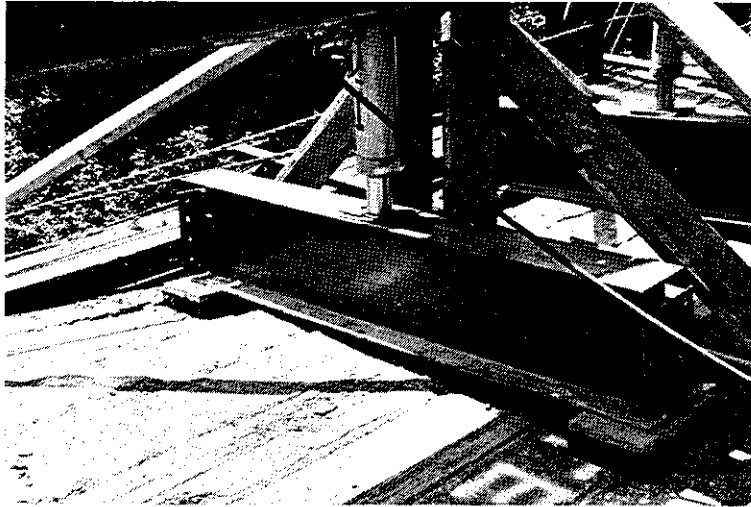
The second test went according to test procedure plans up to a loading of 50 kips. For loads greater than 50 kips the behavior of the deck can readily be seen in Fig. 20. As the load was increased up to the maximum load of 77.4 kips, stringers split and failed. The failure

Fig. 21. Photograph of deck test 2 near ultimate load.

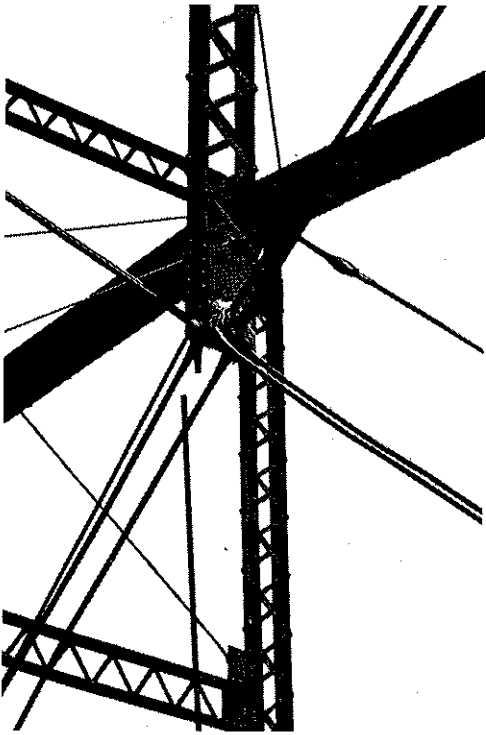
Fig. 34. Photograph showing location of failure of member L₅M₅.

with the same difficulty to a load of 130 kips. At this load the flaking of the rust on the hangers at L_5 (upstream side) was very noticeable.

At a total load of 133 kips (106 kips at L_5 and 27 kips at L_4), one of the hangers at L_5 (upstream side) failed. The location of the failure and a close-up of the fracture are shown in Figs. 34 and 35. When the failure occurred, a portion of the load transferred from L_5 to L_4 resulting in a load of 63 kips at L_5 and 38 kips at L_4 (resulting in a loading ratio of 1.66 to 1). The decision was made to apply all additional load at L_5 , rather than at both L_4 and L_5 , to try to restore the original load ratio (4:1) and increase the loading at critical L_5 . The load at L_5 was increased to 68 kips when the jack stroke limit was reached. The structural tubes were repositioned at this point to allow the application of additional load. During reloading, the diagonal member near L_5 (member L_4M_5 -- shown in Fig. 2a) started to buckle. The observation was made that the truss deflection was large enough that there was a 4-in. gap between the timber stringers and the floor-beam at L_5 . This occurred because of the continuity of the floor system and the lack of a positive tie between the timber floor and floorbeams. The hanger at L_5 (the one that did not fail on the upstream side) had buckled as shown in Fig. 36, due to the unloading for the repositioning of the jacks. The member buckled because it had been elongated under load and thus, under the reduced load, the member was too long for the distance between L_5 and M_5 . After repositioning of the structural tubes was completed, the load was reapplied. The load was increased to 125 kips (90 kips at L_5 and 35 kips at L_4), and instrumentation readings were taken. The load continued to be

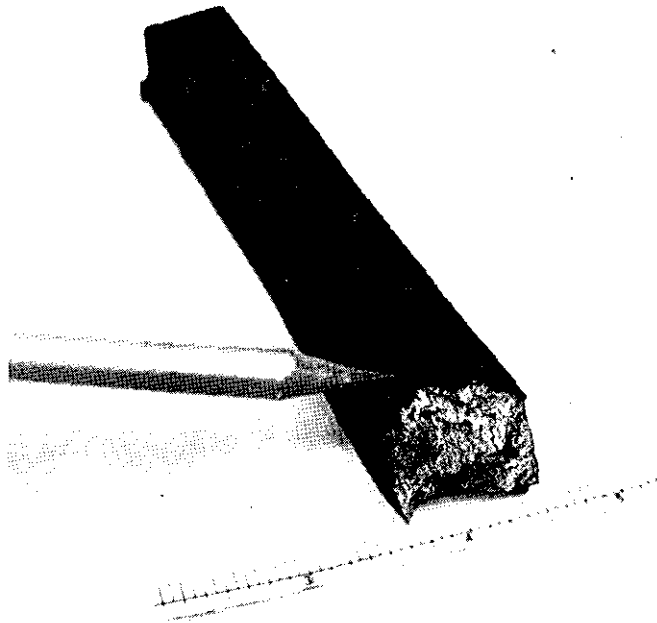
Fig. 35. Photograph of fracture.

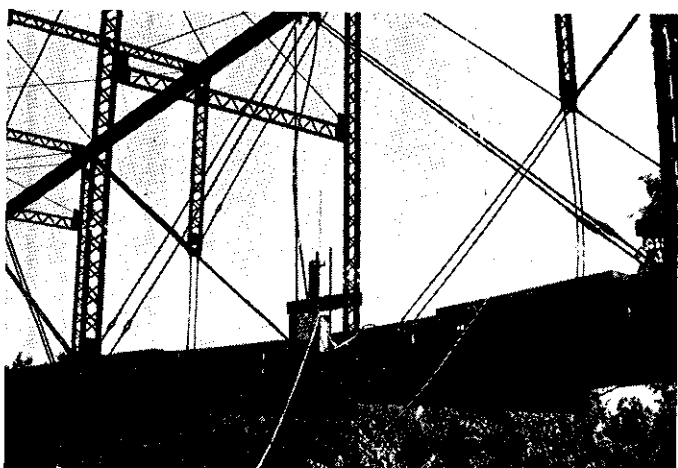
Fig. 36. Photograph of hangers buckling at L_5 .

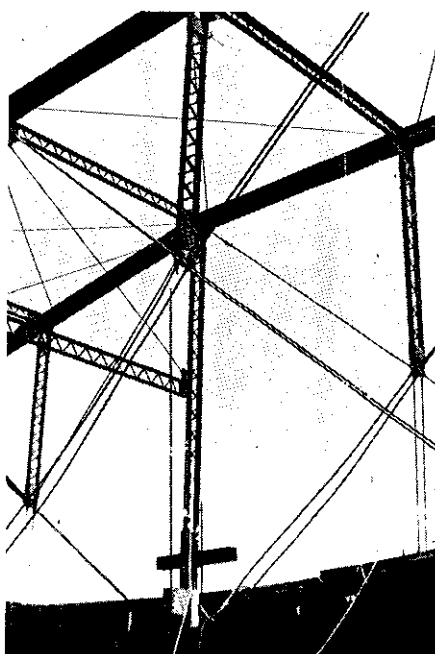
Fig. 37. Photograph of distortion of lower chord at L_5 .

increased until it was 112 kips at L_5 and 28 kips at L_4 . At this load a significant distortion of the bridge was visible, as shown in Fig. 37, but the remaining hanger at L_5 on the upstream side had not failed.

After readings were taken at this load, the load was removed from L_5 , because any further increase in load would only have caused more distortion of the lower chord at L_5 . During the attempt to remove the load from L_5 , the bridge came down on the nuts on the tube on the downstream side. Increasing the load at L_5 was necessary to relieve these nuts. After the load had been removed from L_5 , the load at L_4 had increased to 45.5 kips. Instrumentation readings were taken at this load. The load was increased at L_4 , with instrumentation readings being taken at intermediate levels. The capacity of the loading system was reached at a load of 78.5 kips. Instrumentation readings were taken and the load removed.

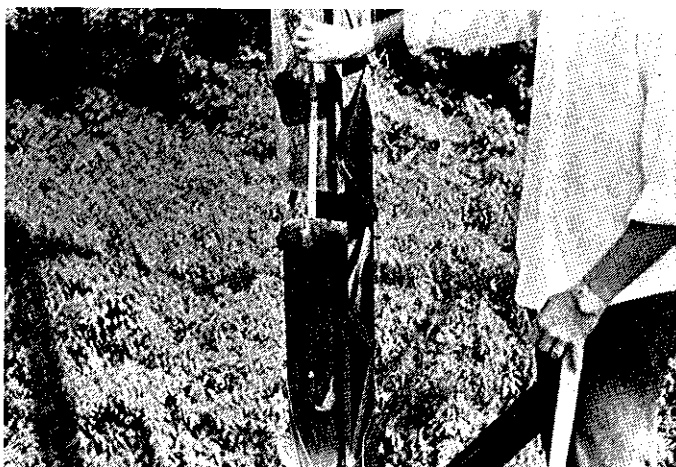
Fig. 38. Photograph of damaged member (one channel cut).

It was decided that further testing of the trusses would not provide additional meaningful information. The decision was then made to pursue the objectives of the second truss test by "damaging" one of the key members and reloading. To simulate the damage, member L_2U_2 was cut with an acetylene torch. This member was damaged because it is representative of laced channel compression members. Secondly, severely damaging an end post would result in an immediate catastrophic failure. Finally, the forces required to sufficiently damage an end post would require the use of an elaborate loading system. The cut (Fig. 38) was made 46 in. from the center line of the pin and 32 in. from the timber deck, with only one of the two channels comprising the member being cut. Initial instrumentation readings were taken and reloading at L_4 began. The

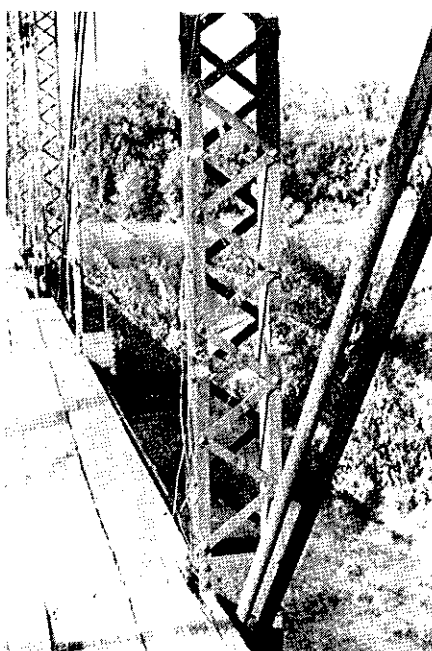
Fig. 39. Photograph of damaged member with only web of outside channel remaining.

load was increased to 70 kips with sets of instrumentation readings taken at periodic intervals. After the load of 70 kips was reached without any signs of additional distress, the decision was made to cut the other channel comprising member L_2U_2 to obtain a failure of the truss. The member was cut so as to leave only the web of one channel remaining intact (Fig. 39). The load at L_4 was again increased to 70 kips without any signs of distress. The load was again removed from the bridge, and one bar of member L_2U_1 was cut. The truss was again loaded at L_4 to a load of 72 kips with no apparent signs of distress. The load was removed, and the decision was made to cut member L_2U_2 completely through (Fig. 40). The load was again applied at L_4 , with the load reaching 39 kips before the member collapsed upon itself (forming a complete but shorter member) at the cut location (Fig. 41). This resulted in a slight drop in load. The load was then increased to 72 kips with no further distress of the truss. The load was removed and all testing terminated because of the potential danger of collapse during any additional member damage.

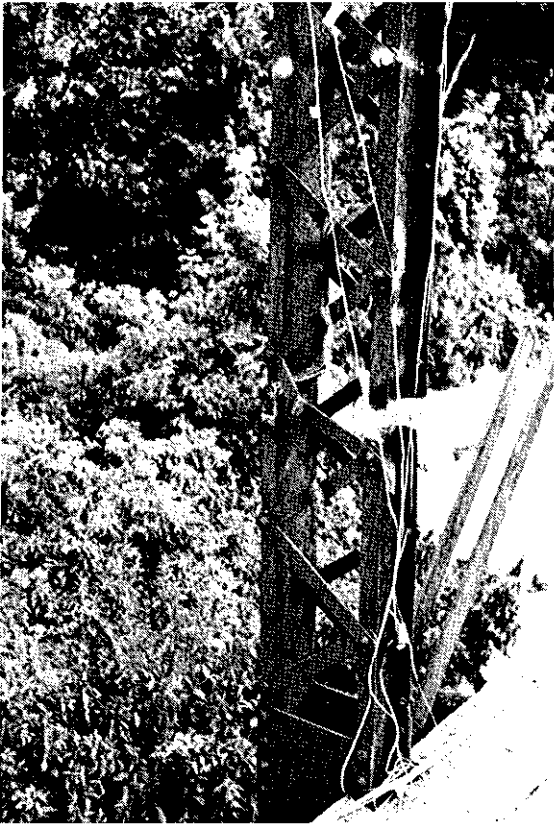
Fig. 40. Photograph of damaged member cut completely through.

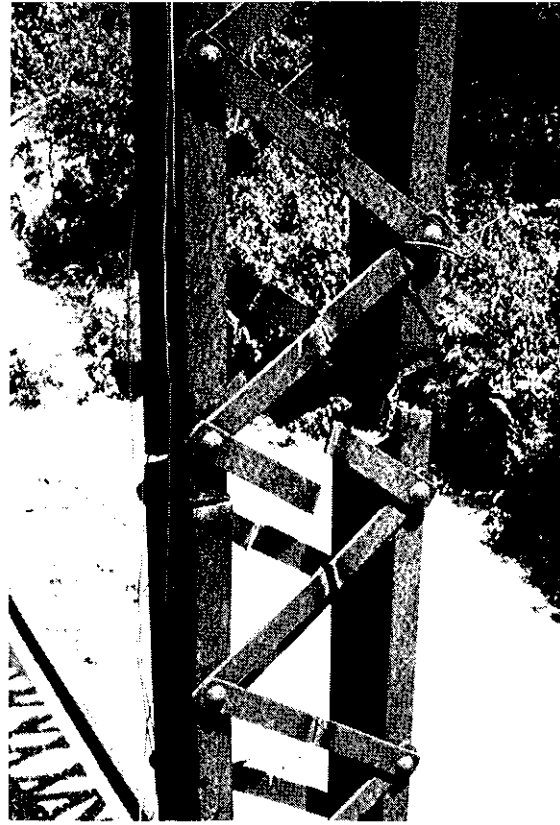
Fig. 41. Photograph of damaged member after collapsing upon itself.

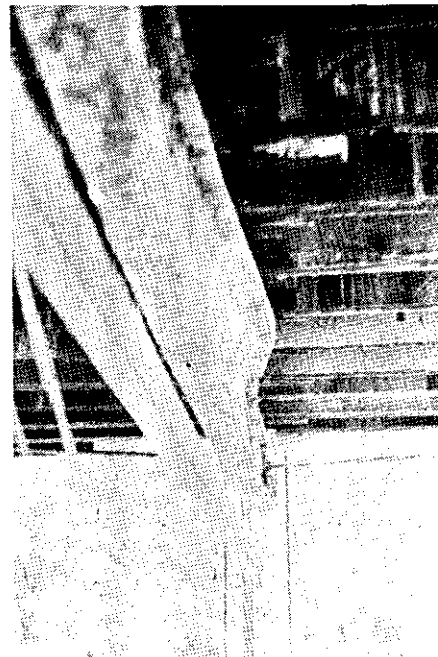
The test of floorbeam 4 proceeded without any lateral distortion or excessive end distress up to a load of 50 kips. The observation was made at this load that the plate connecting the floorbeam to the truss was bent considerably. Loading continued up to 65 kips. After

Fig. 51. Photograph of lateral buckling of floorbeam 4.

reaching this load, three bolts broke on the upstream end connection of the floorbeam to the truss, and the load dropped to 61 kips. These bolts were located on one side of the interior part of the connection of the floorbeam to the verticals (Fig. 50). At this time the floorbeam was approximately $3/8$ in. out of line at its centerline. The floorbeam had buckled laterally (Fig. 51) only between the load points, indicating that the load points provided lateral bracing. The floorbeam was reloaded to 66 kips, when four bolts broke on the upstream connection of the floorbeam to the truss, causing the load to drop to 54 kips. These bolts were located on the other side of the interior part of the connection of the floorbeam to the verticals (Fig. 52). An attempt was made to increase the load, but it could only be increased to 55 kips due to extensive lateral buckling of the beam, thus terminating the test.

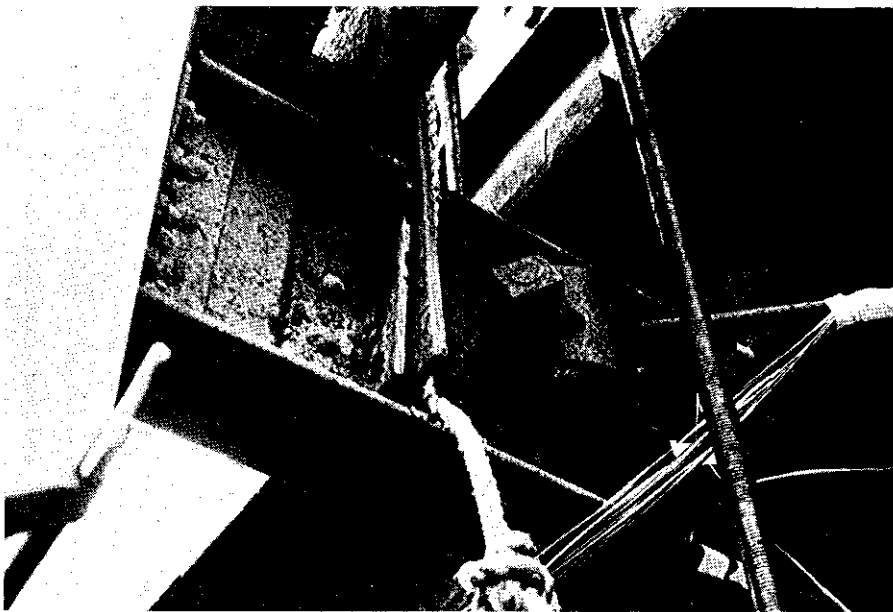
Fig. 52. Photograph showing where last four bolts broke.
