Use of carbon fiber reinforced polymers for the repair of impact damaged prestressed concrete bridges

Brian Jon Kempers

A thesis submitted to the graduate faculty
In partial fulfillment of the requirements for the degree of
MASTER OF SCIENCE

Major: Civil Engineering (Structural Engineering)

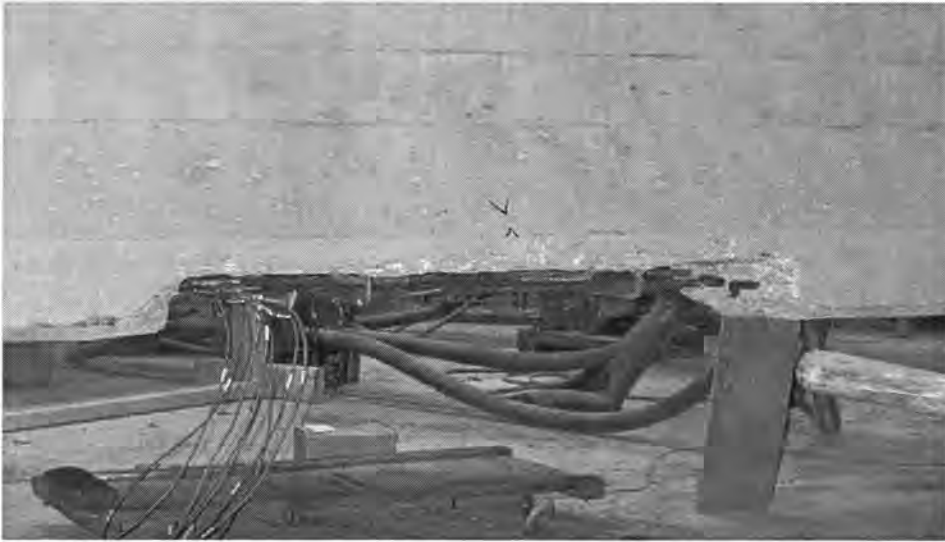
A 3-foot section of concrete was removed from the center of the bottom of the P/C beam. The section was 4 inches deep measuring from the bottom. Four inches was chosen because that left the bottom four strands showing, while the next layer of four strands was still encased in concrete. The four inches taken out also allowed just enough room to be able to patch the damaged area. A large chipping hammer was used for the removal of the concrete, but significant care had to be taken so as not to sever any of the prestressing strands. The damaged section is shown in Figure 3.11, and a photograph of the damaged area is shown in Figure 3.12.

Figure 3.12. P/C beam with concrete removed.

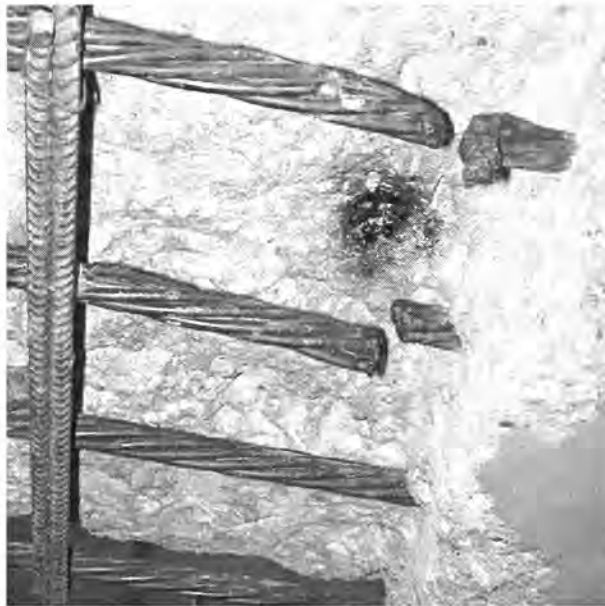
Figure 3.13. Strands after severing.

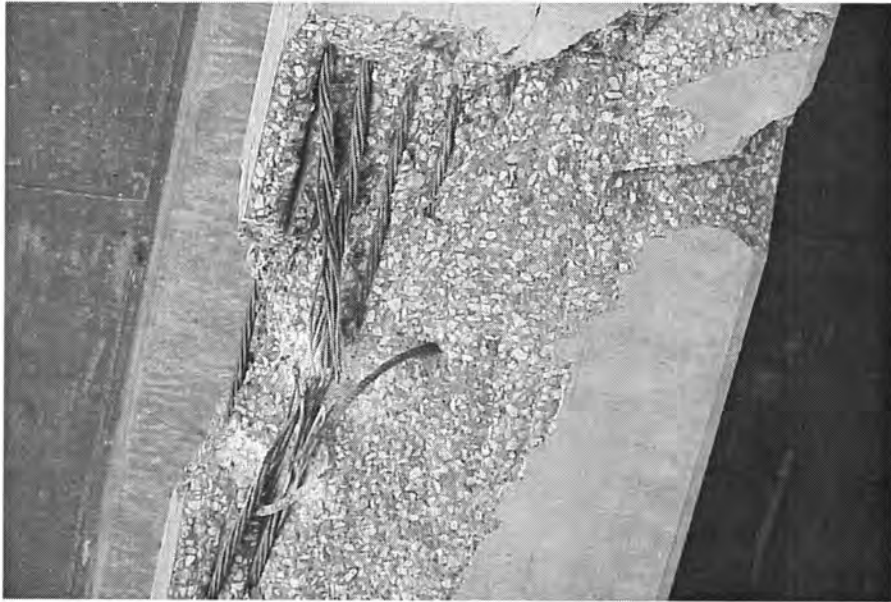
Figure 3.19. Photograph of the damage to Beam 2 in the Altoona Bridge.

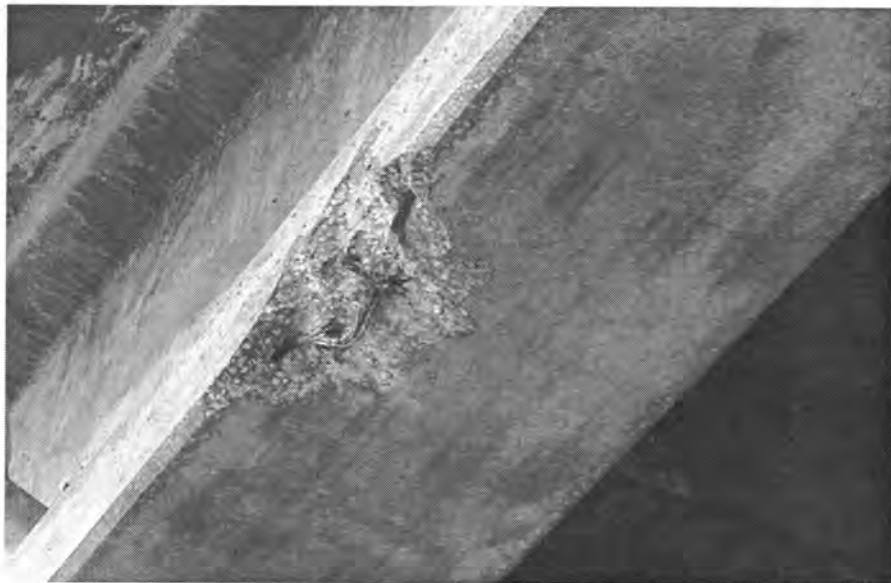
Figure 3.20. Photograph of the damage to Beam 1 in the Altoona Bridge.

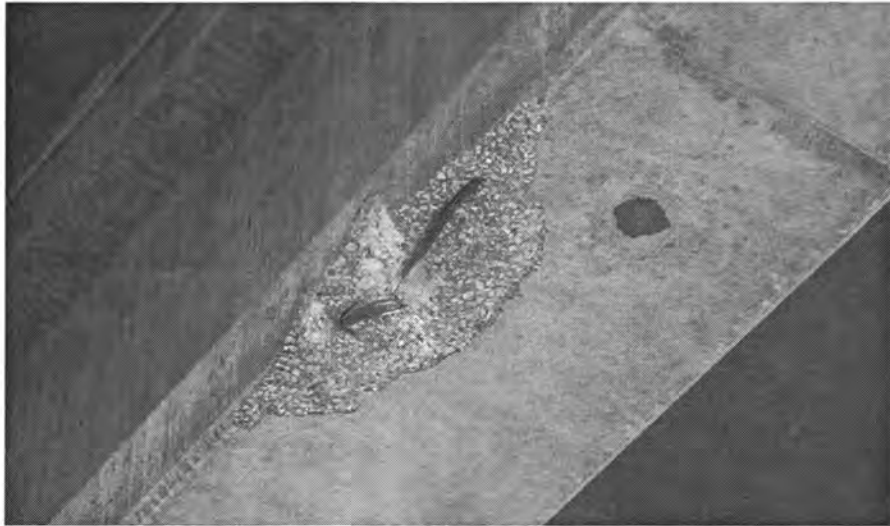
Figure 3.21. Photograph of the damage to Beam 5 in the Altoona Bridge.

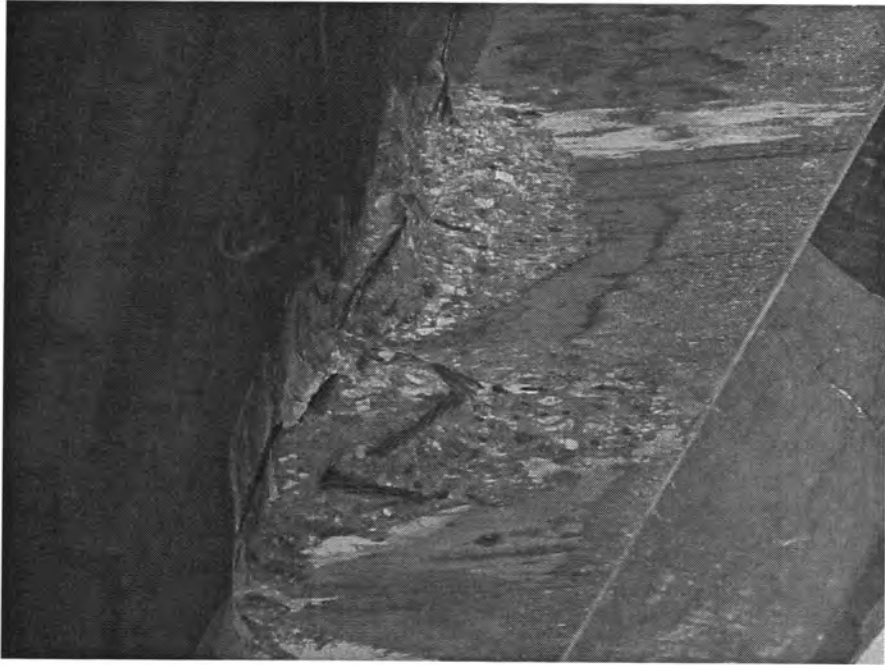
Figure 3.31. Photograph of the damage to Beam 1 in the Osceola bridge.

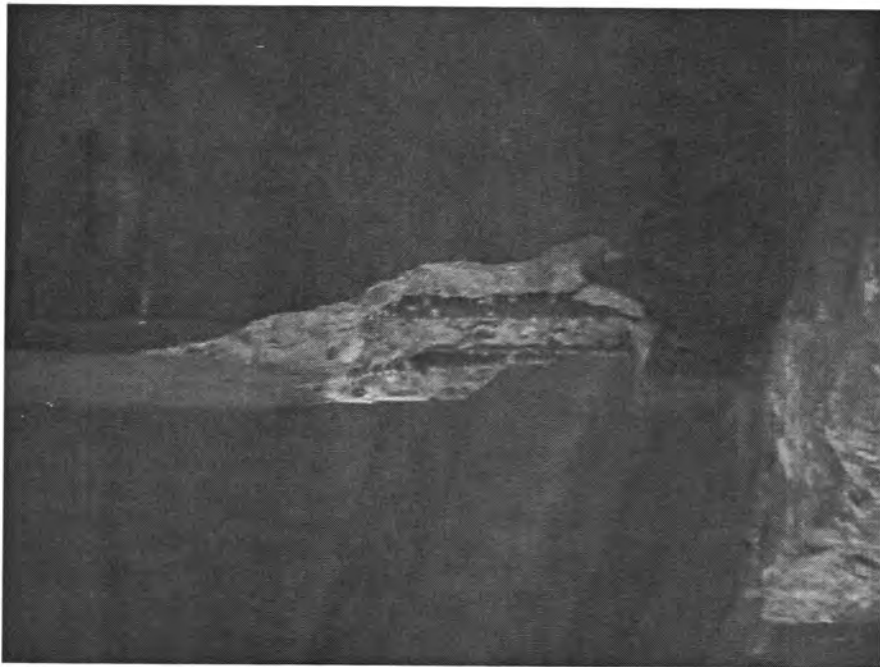
Figure 3.32. Photograph of the damage to the diaphragm in the Osceola bridge.

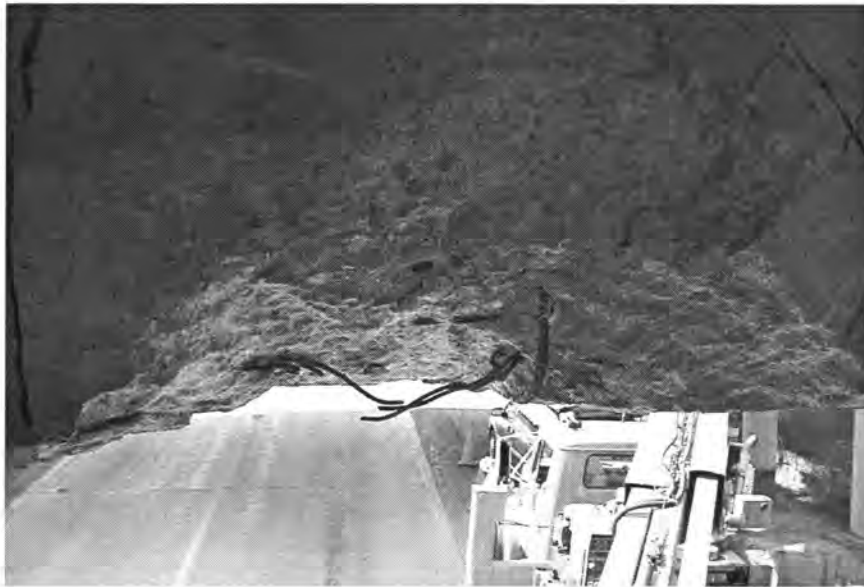
The bridge incurred some damage due to an overheight vehicle traveling south on Highway 169. The vehicle missed the seven northernmost beams and struck the final two, Beams 8 and 9. Beam 9 sustained significant concrete loss and also lost a prestressing tendon. Two of the damaged areas are shown in Figure 3.40 and 3.41. Appendix B contains a more thorough report of the damage.

Figure 3.40. Photograph of severed prestressing strand on Beam 9 in the De Soto bridge.

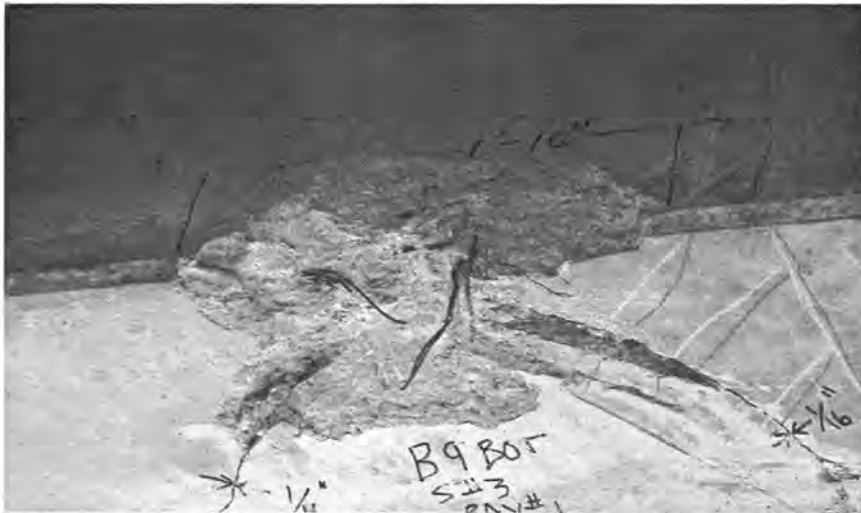
Figure 3.41. Photograph of severed prestressing strand in the De Soto bridge.

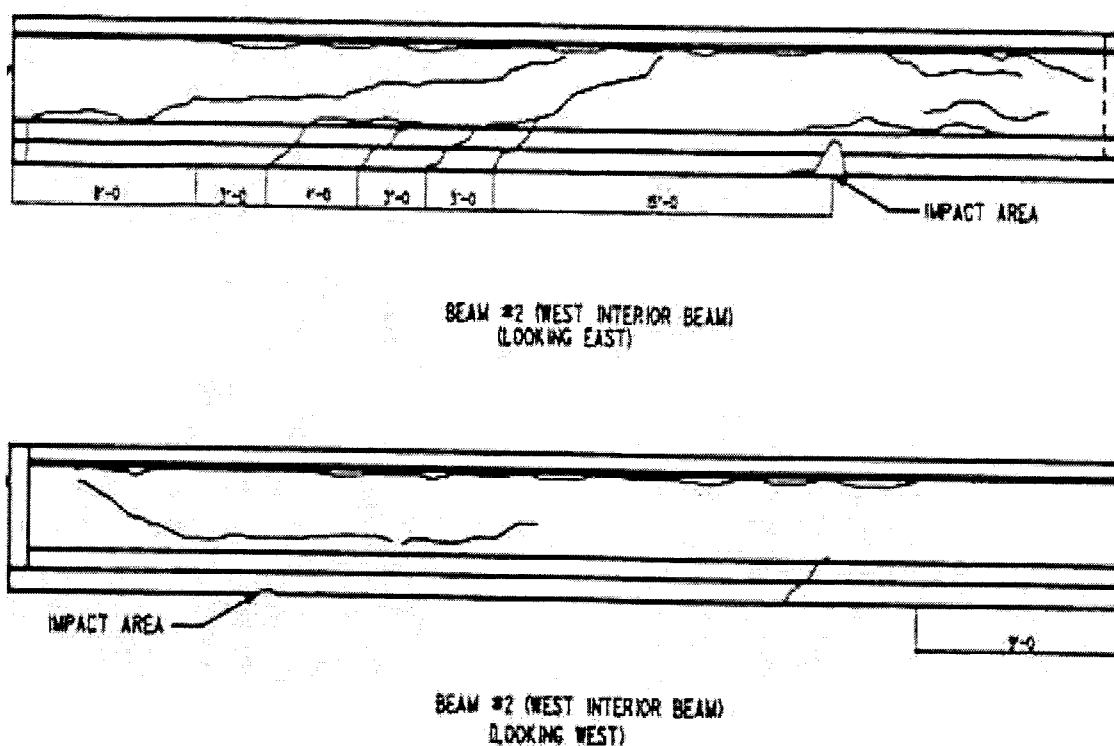
Figure A24. Altoona beam #2 damage drawings.

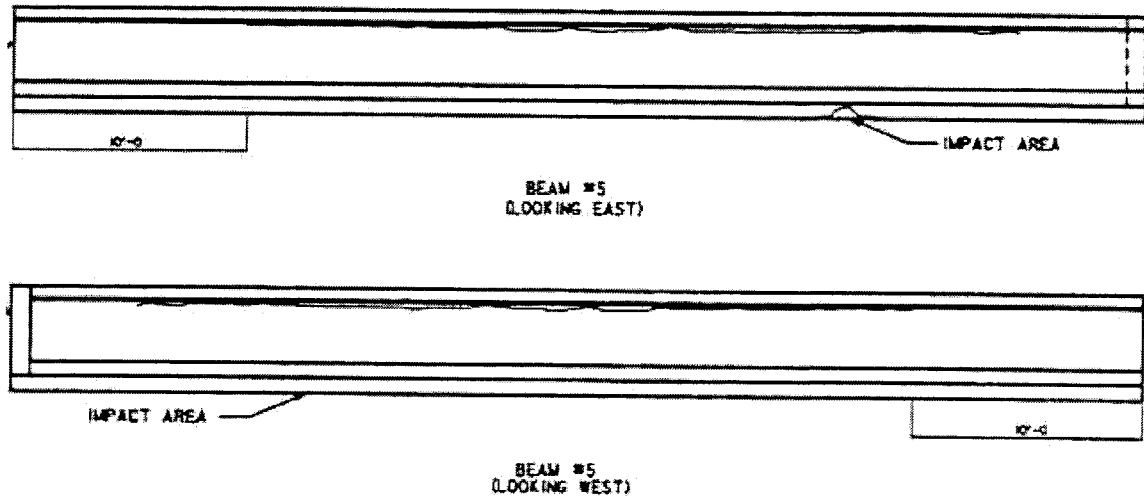
Figure A25. Altoona beam #5 damage drawing.

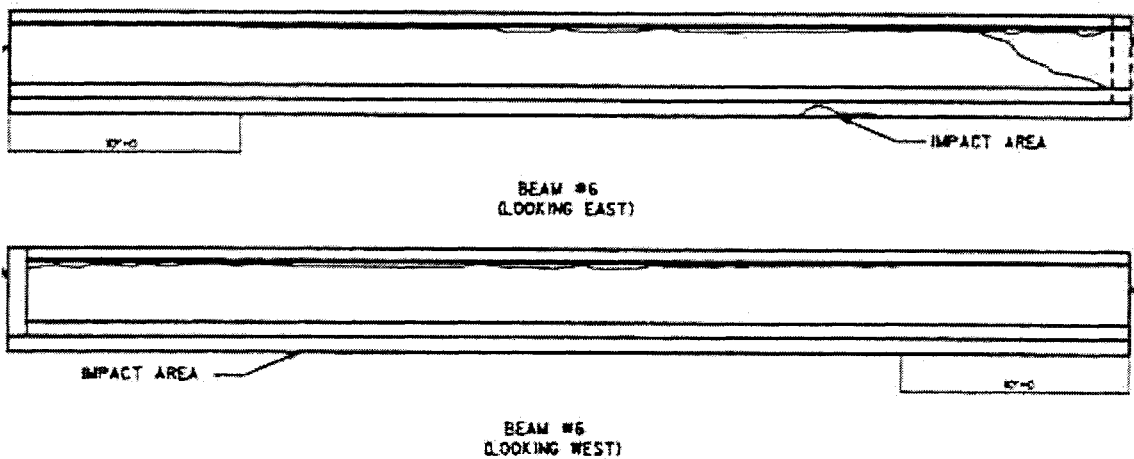
Figure A26. Altoona beam #6 damage drawing.

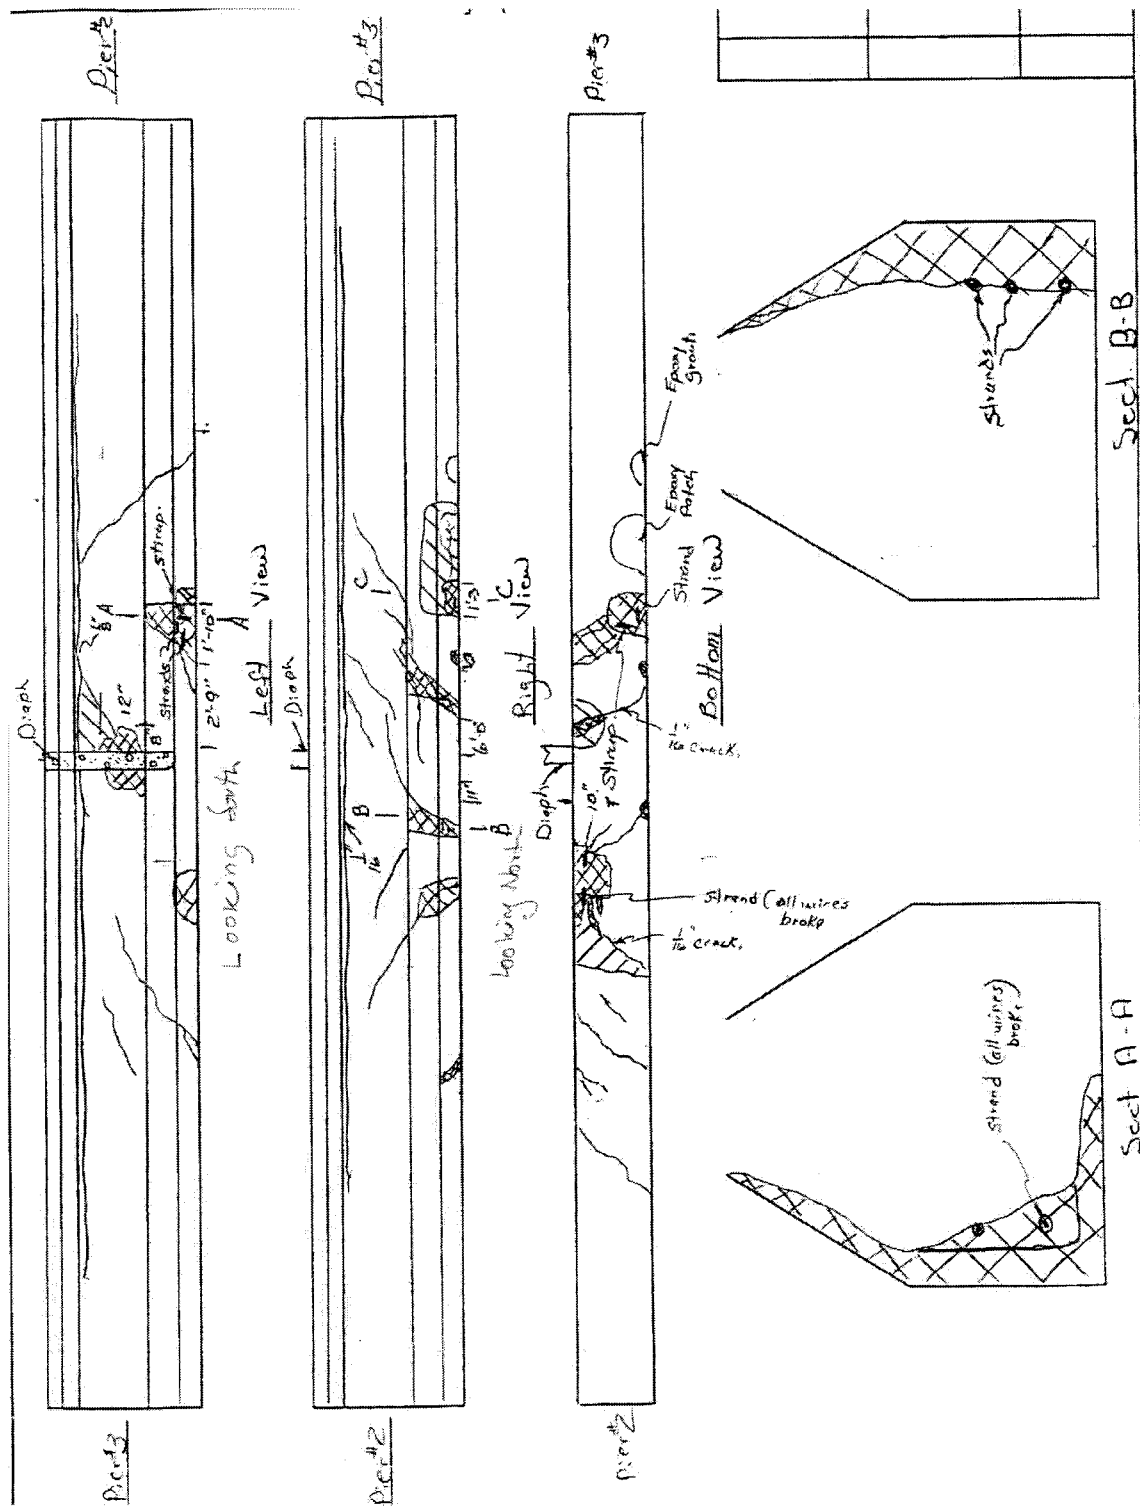
Figure A28. De Soto damaged beam drawing.
