Using Soybean Oil Soapstock for Stabilizing Granular Shoulders

Using soybean oil soapstock for stabilizing granular shoulders

Major: Civil Engineering (Construction Engineering and Management)

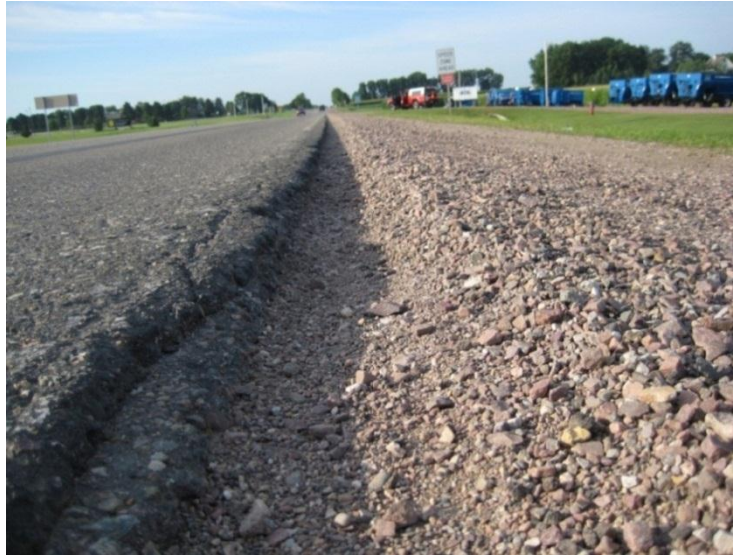
Edge rutting on granular shoulders is a traffic safety concern because it poses a safety hazard for vehicles. The possible bad results include crossing to an adjacent lane, encroaching on the far side of roadway, or skidding on shoulders or roadways, which would cause potential collision or rollover (Hallmark et al. 2006). Figure 1 shows an example of edge rutting that has developed along the interface between a pavement and a granular shoulder. Edge rutting is caused by three factors, wind and air currents, vehicle off-tracking, and drainage. Over time, wind and air currents from large vehicles blow fine material away from the shoulder and large particles are exposed on the shoulder surface that are more easily removed by vehicle off-tracking. Off-tracking refers to the situation where rear tires run a different path from front tires during vehicle's turning movement. Water from pavement drainage accumulates along the pavement edge, softens the granular material and makes shoulder materials unstable.

Figure 1. Edge rutting on granular shoulders (by Thang Phan)

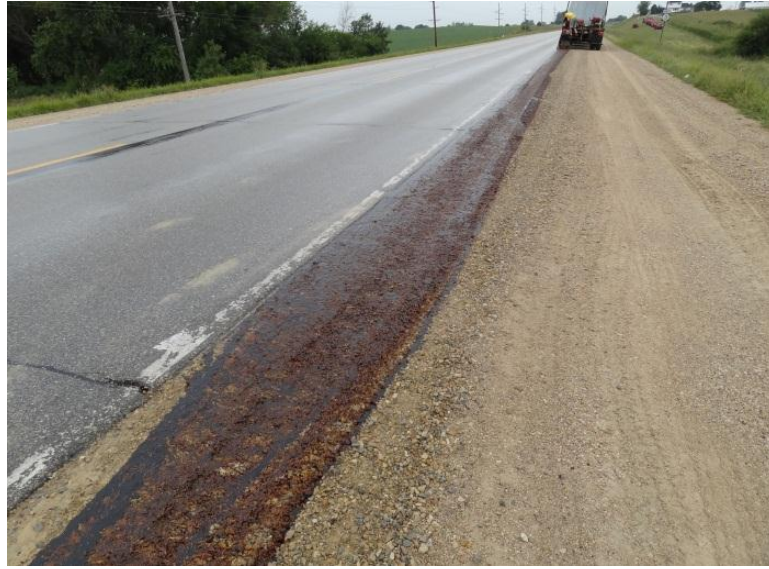
On August 18, 2011, a rain was encountered during the construction activities executed around Allison and Shell Rock. Figure 12 shows the result of the soapstock application on the westbound shoulder of IA 3 nearby and east of Alison when it was raining. The rain became heavy in the afternoon, thus work was suspended until the next day. Apparently the rain did have some negative effect on the treatment, because many of the locations where soapstock was applied during the rain performed poorly in comparison to other work locations in post observations.

Figure 12. Spraying in the rain on IA 3 near Allison

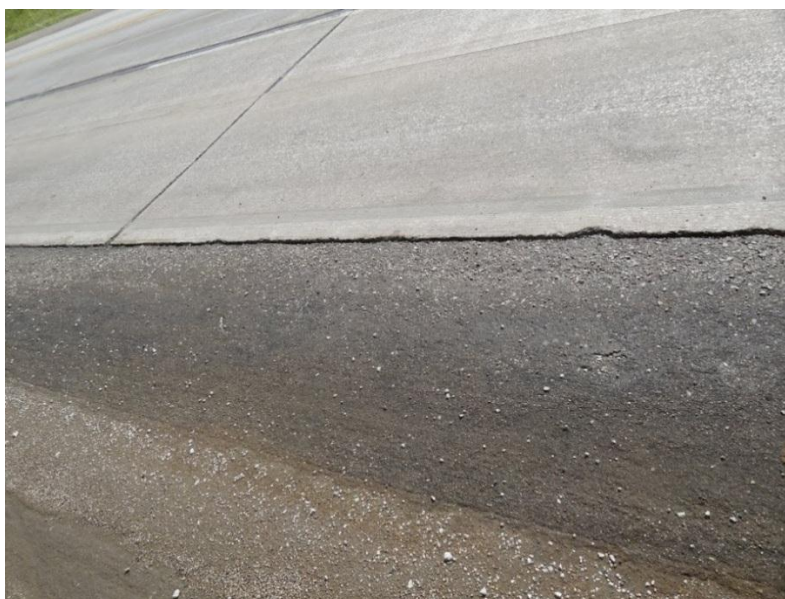
**Figure 20. Southbound shoulder of US 169 south of Algona**

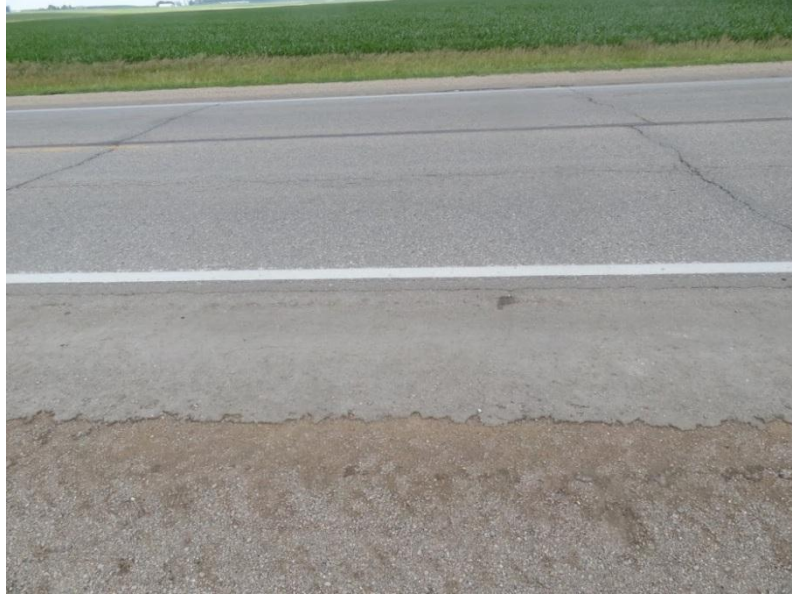
Figure 21 provides an example of good shoulder performance for this area. This shows a section of the US 169 shoulder adjacent to the southbound lane just south of Algona, where a thin layer of soapstock remained firmly on the shoulder. Another example is shown in figure 22. The shoulder section was on US 18 near Garner with a thicker layer of soapstock on surface.

Figure 21. Eastbound shoulder of US 18 near Garner

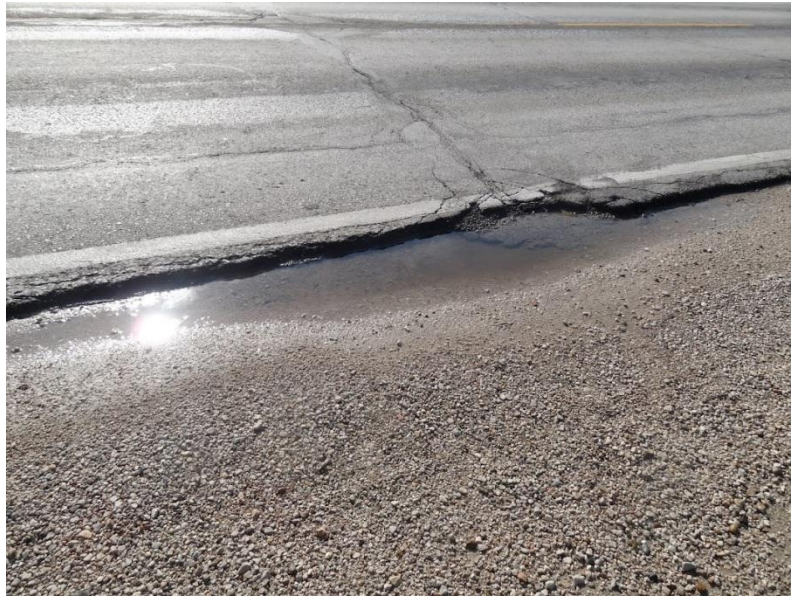
Figure 23 shows an example of newly developed edge ruts. The shoulder section was on US 169 just south of Algona. The photo was taken right after a brief rainfall in Algona, and a small water pond was observed.

The possible reason for this failure might be water erosion. There is an uphill grade adjacent to this location, which results in water runoff that erodes the edge drop off area. Also, the pavement had more than one layer of asphalt which raised its elevation, which increased the elevation difference between the pavement and shoulder along the edge.

Figure 22. Edge rut developed around south of Algona

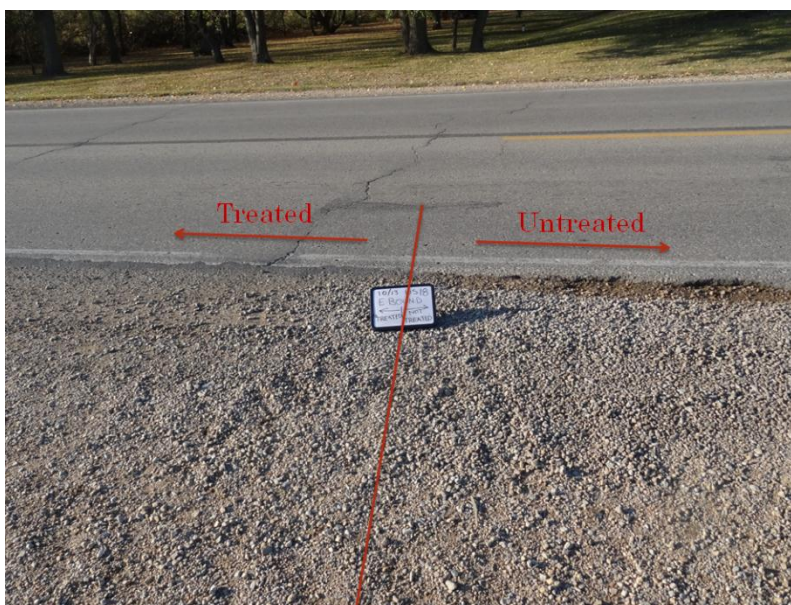
Figure 24 shows an example of a comparison of an untreated shoulder edge and the untreated one. The photo was taken on October 13, 2011 about 2 months after application at US 18 near Garner. On the right side of the red dividing line, a small amount edge rutting could be observed where soapstock was not sprayed. On the left side of the red dividing line, the original edge rut was more severe than the one on the right, but it had been filled with granular material and covered with soapstock.

Figure 23. Compared results of treated and untreated shoulder edge

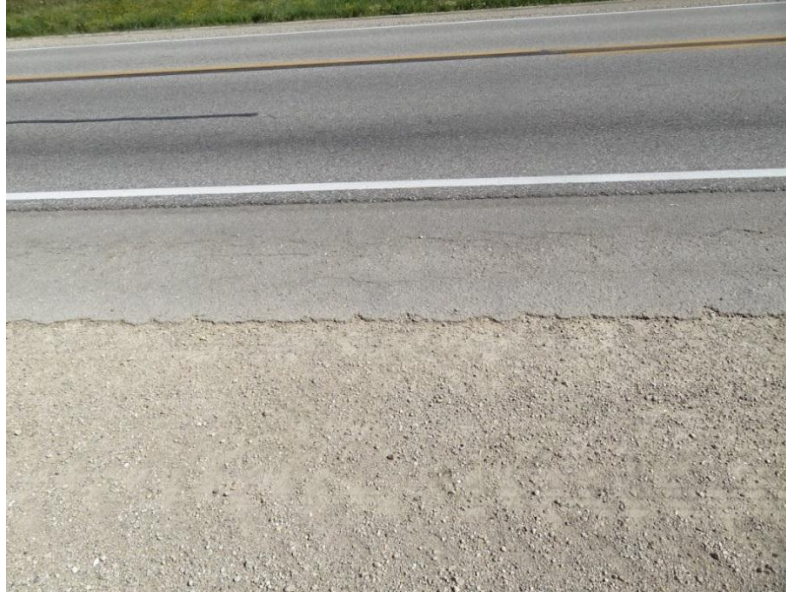
Figure 25 provides an example of good shoulder performance for this area. This shows a shoulder section of IA 3 on adjacent to the eastbound lanes just east of Waverly, where a thick layer of soapstock remained firmly on the shoulder. Another example was shown in figure 26. The shoulder section was on US 63 near Denver, where soapstock had penetrated into the shoulder and could not be easily seen.

Figure 24. Eastbound shoulder of IA 3 east of Waverly

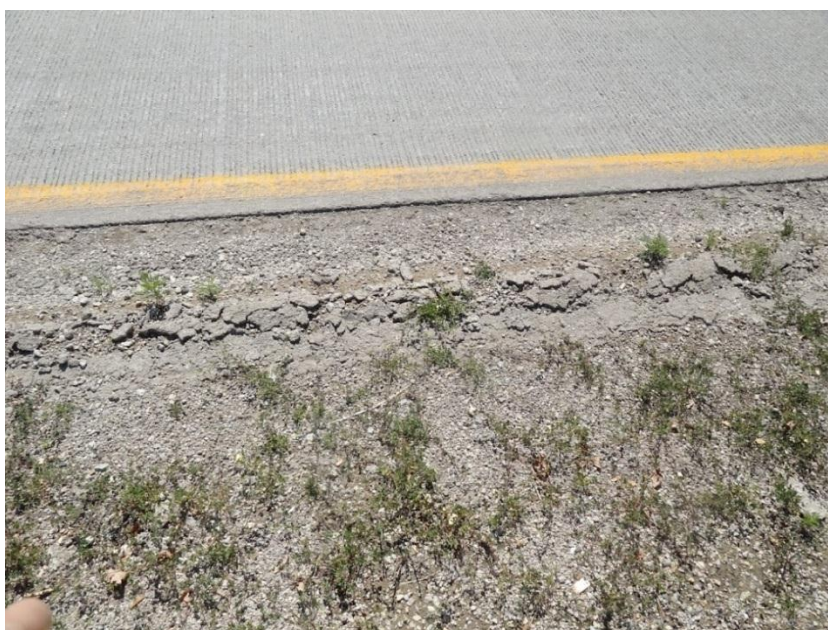
Figure 28 shows another undesired situation where the soapstock was not remaining on the inside shoulder of US 63 on northbound near Denver. Part of shoulder materials had been displaced by the traffic.

Figure 27. Northbound inside shoulder of US 63 near Denver

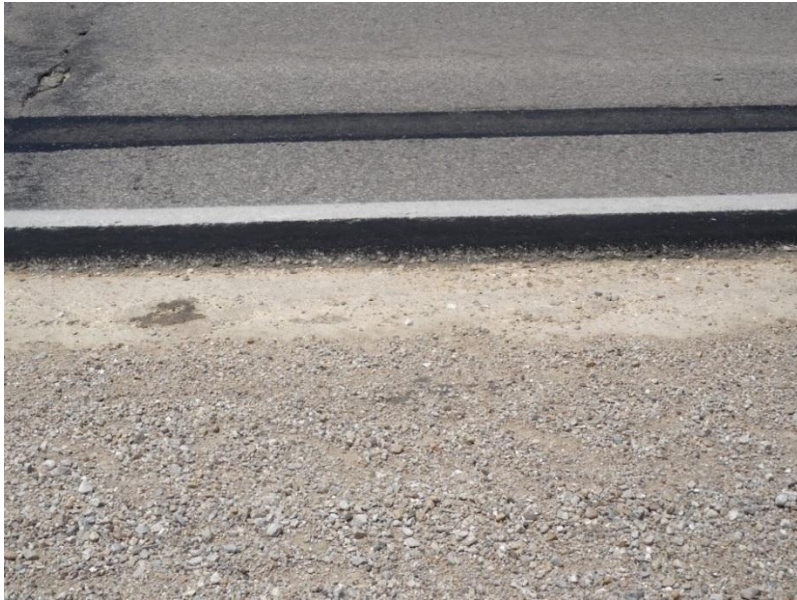
Figure 28. Shoulder of US 18 on eastbound near east of West Union
