A feasibility study of a computer-based wind turbine blades surface flaws inspection method

A thesis submitted to the graduate faculty
in partial fulfillment of the requirements for the degree of
MASTER OF SCIENCE

Major: Industrial Engineering

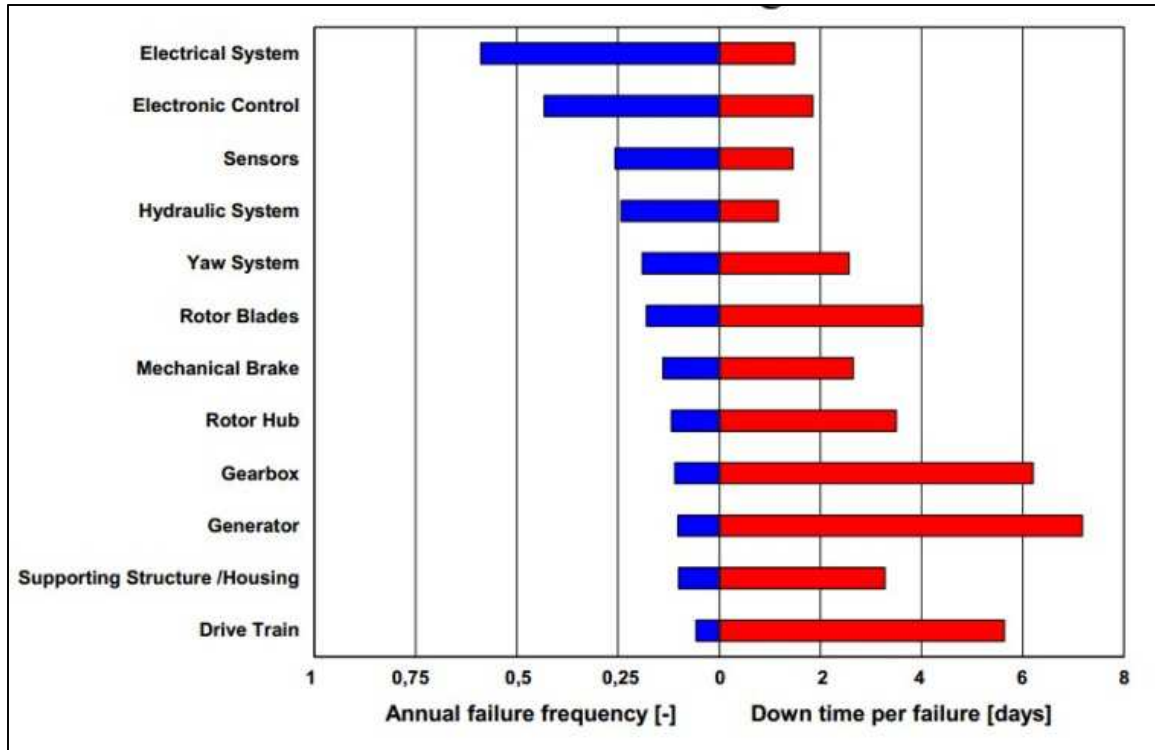
Figure 1. Failure frequency and downtime of components

Although lack of information on cost breakdown of components of O&M, blade failure ranks in the top third of failure rates among all the critical large mechanical components. In addition, it adds a significant downtime per failure, which is 4 days on average with expensive equipment such as cranes required along with skilled technicians (Hahn, 2006). Early inspection can help prevent severe structural damage and reduce O & M costs (SGS Group, 2010). A report by SGS group points out that there is 26% additional cost to blade manufacturers to fix a blade incident but could have been corrected by an increase of 0.64% of the total turbine blades cost to the third-party inspection company.

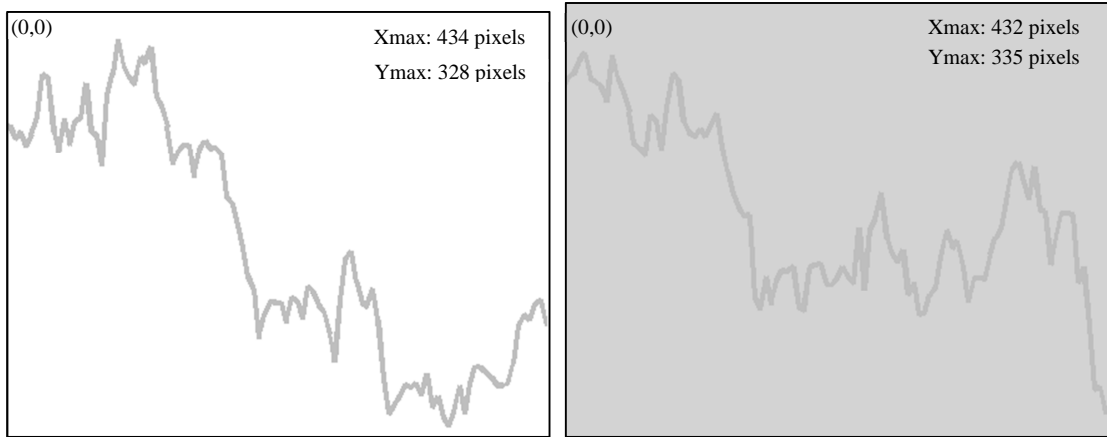
For the first group shown in Figure 3, one synthetic crack has a white background with RGB values of [255, 255, 255] and the other one has a light gray background with RGB

values of [211, 211, 211]. Both of the cracks have the same gray color [190, 190, 190] with a uniform thickness of three pixels. This group of samples addressed some of the effects of background color on image processing results.

Figure 3. Different intensity level of pixels of the background of two synthetic cracks (a)|(b)

The first group of synthetic cracks did not show that the method can detect a crack with lighter background color easier than the one with darker background color. When applying the *graythresh* function, the two images resulted in very different optimal threshold numbers. With the optimized threshold values, both of the images resulted in clearly delineated defects. Not surprisingly, the applicable threshold range was significantly different between the two images. The one with a white background had valid threshold number from 0.746 to 0.999. But the one with a gray background had a threshold number between 0.745 and 0.827. Higher threshold numbers were able to eliminate more noise with low- to middle-level intensity from the background, which

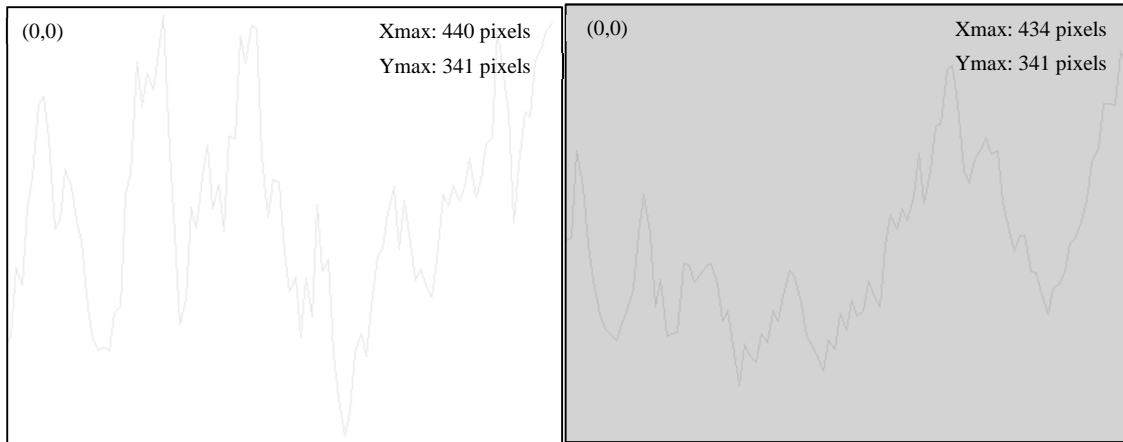
In the second group shown in Figure 4, the background colors of the two synthetic cracks are white and light gray, the same as in the first group. The image with the white background color has color index [234, 234, 234] for its cracks and the other one has color index [190, 190, 190] for its cracks. The numbers were selected to generate hairline cracks that have a very small intensity difference from their background and are hardly recognized by human eyes. The purpose of the samples in Group 2 was to understand the relationship between background color and the color of the crack itself. Both of the synthetic cracks in Group 2 have uniform thickness 1, which examines whether the detection method is sensitive to hairline thickness cracks.

Figure 4. Hairline thickness synthetic cracks with different intensity level of pixels (a)|(b)

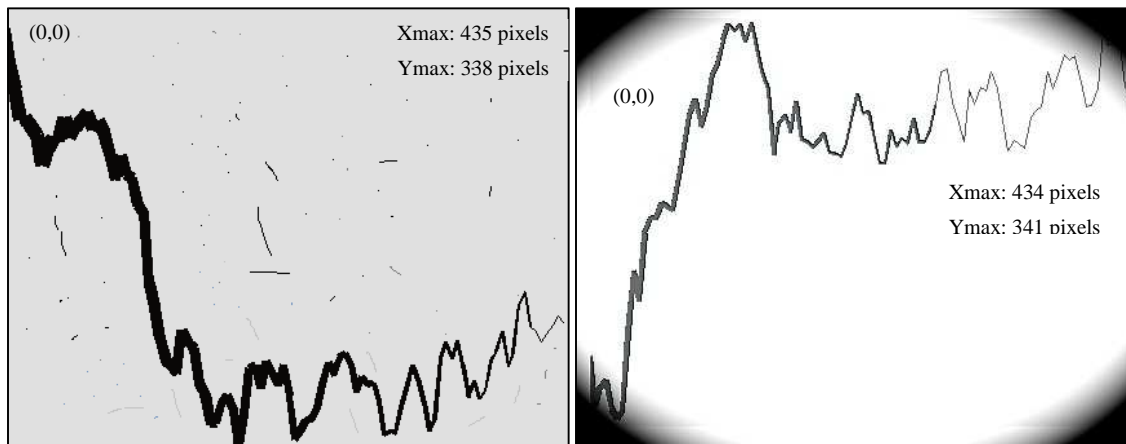
Figure 5. Non-uniform synthetic cracks with (a) noise and (b) uneven illumination

The third group shown in Figure 5 has two non-uniform thickness synthetic cracks with one that has a maximum thickness equal to 9 and the minimum thickness equal to 1. The color of the crack is selected as honeydew [240, 255, 240] to represent a severe crack that goes into the fiberglass lamination. The background color is white with a transparent color from -40% to 20% and irregular noises. After converting the image to gray-scale, the background turned white since the hue and saturation were eliminated. The reason to design a non-uniform thickness/width crack was to determine the relation between the

thickness of a crack and the degree of continuity in imaging processing. The other crack of the group had the same size but contains significant uneven illumination in the background, which cannot be eliminated by transforming the image to gray-scale. These representative synthetic cracks were analyzed using the following methods and their results were compared to the results from field images in the result section.

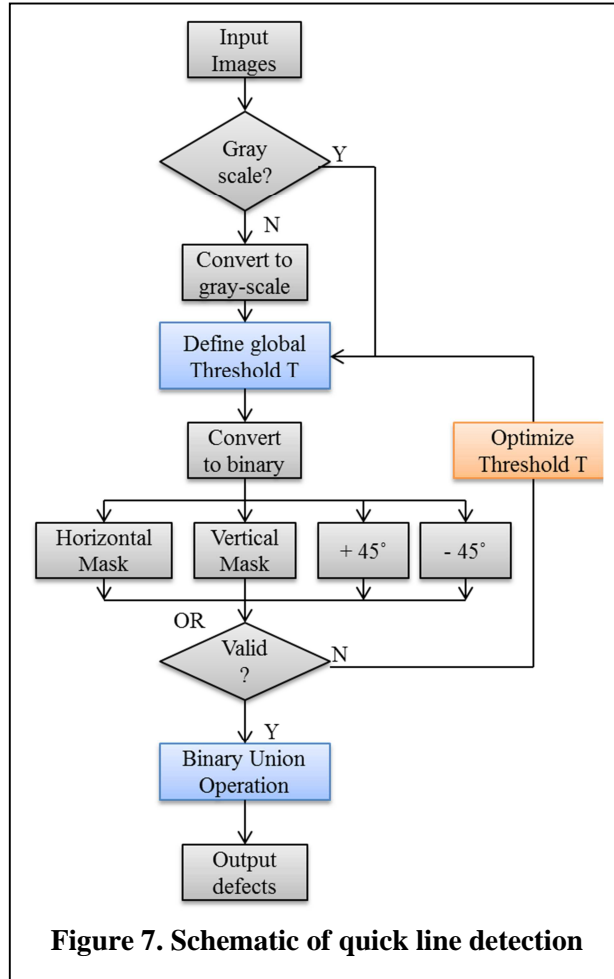
A line detection method was used to perform a quick scan that could be used on a large scale wind turbine blade. It is simple, fast, and sensitive to individual line segments. Cracks can be treated as a set of segments. A line is a basic type of intensity discontinuity in a digital image and the most common method to detect them is to process the image with a linear spatial filter mask with a binary format as shown in Figure 7. The process consists of moving the center of the mask from point to point in an image and computing the response at each point, which is the sum of the product of the mask

Figure 7. Schematic of quick line detection

Edge detection has the same steps as linear detection in Figure 7 except for using edge detection masks, rather than using standard line detection masks. The third group of synthetic cracks had non-uniform thicknesses and noises along the background. Edge detection was used for both of the synthetic cracks and the results were compared to line detection in the result section.

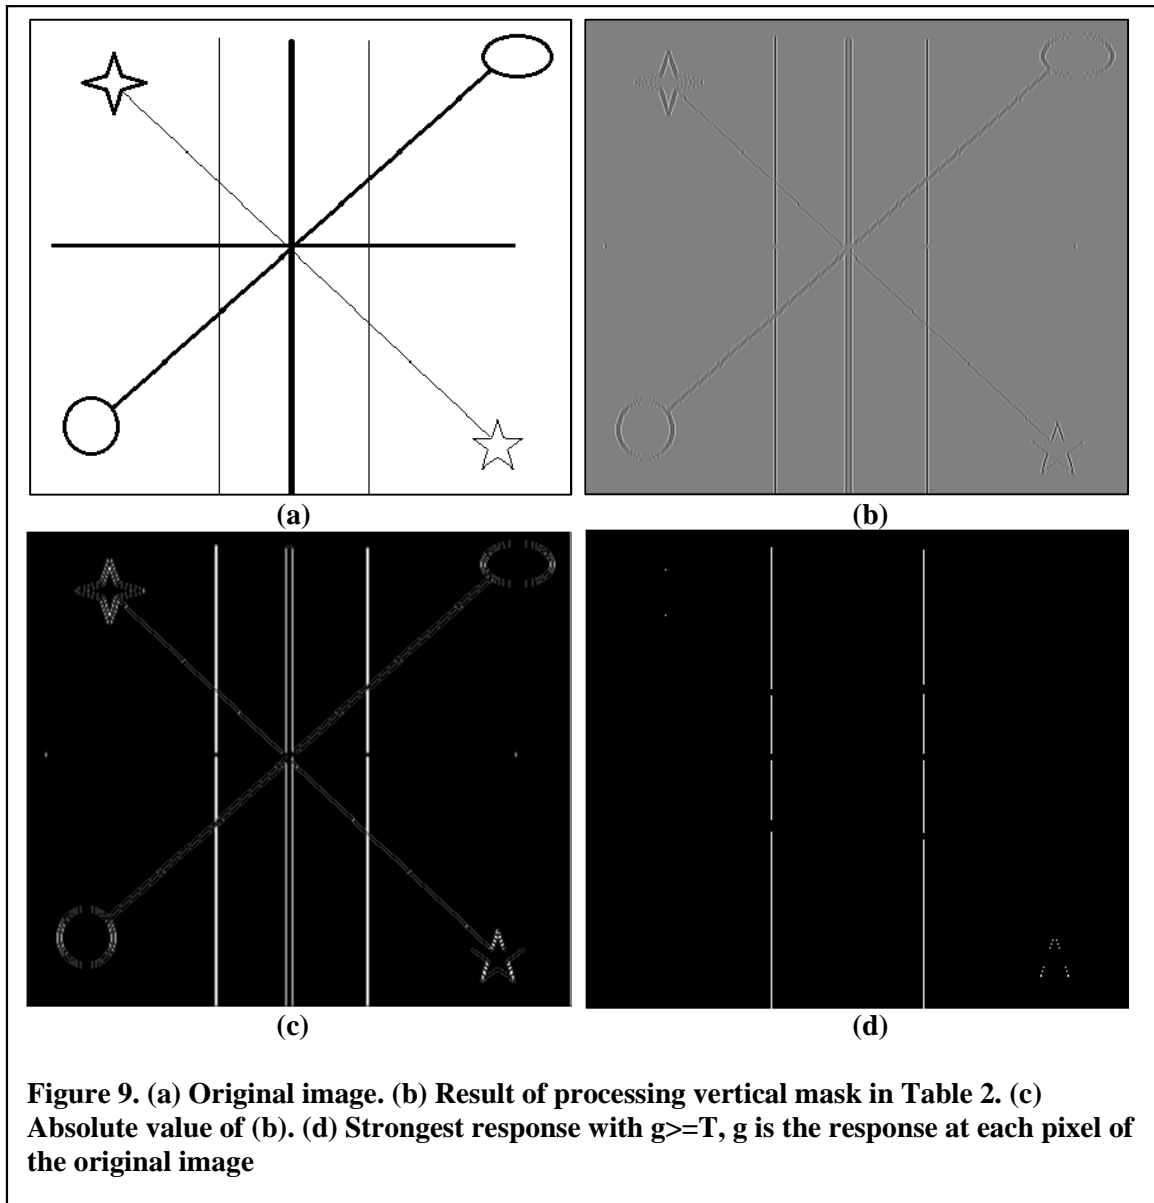
Increasing the number from 2 to 3 smoothed the output image but continually increasing the number will create fuzzy results. Although the vertical line detector masks responded strongly to one pixel thickness lines, it can recognize all vertical lines with different thicknesses as shown in Fig 9 (b).

Figure 9. (a) Original image. (b) Result of processing vertical mask in Table 2. (c) Absolute value of (b). (d) Strongest response with $g \geq T$, g is the response at each pixel of the original image

Theoretically, only an odd number length of masks is considered since R is the response from the center of the filter mask at a specific point (x, y) . The smallest mask is a 3×3 matrix and there are four standard line detection masks corresponding to the orientation of the lines, namely, horizontal, 45° , vertical, and -45° . The larger number -2 in the mask matrix represents the direction of the mask and it has a strong response to one pixel thickness segments. For instance, the vertical line with thickness one is the strongest after filtered with mask in Figure 9 (d).

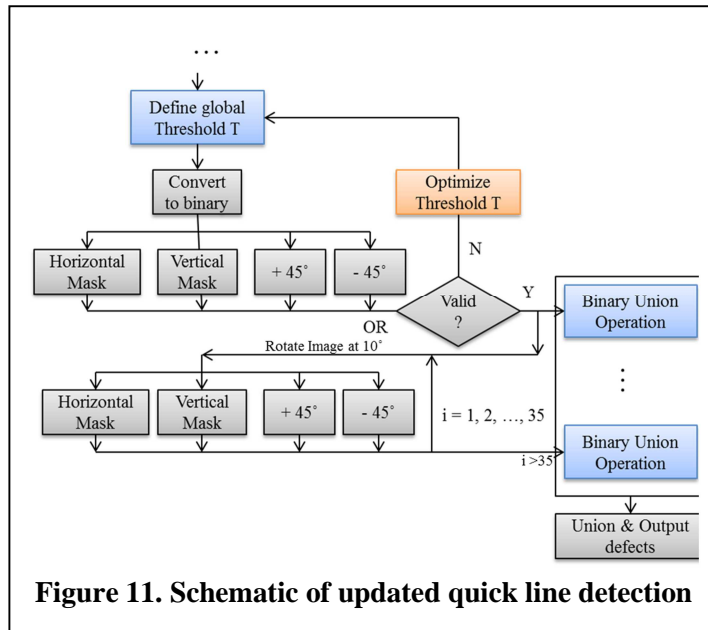
oriented the same as the four masks above? Then it is complex to have line detector masks for every possible direction of lines. However, one method is to rotate the image counterclockwise with a user defined step size while keeping the masks stationary,

Figure 11. Schematic of updated quick line detection

say 1° . After line detection, we can rotate the image back to its original orientation and take the union operation, which maps the detected flaws from each rotation step to one united matrix. Therefore, the line detection method will be able to detect more defects that were limited by the direction of line detector mask. The change to Figure 7 can be seen in Figure 11. However, rotating an image in a very small angle will significantly knock down the detection speed. Based on experience, 10° is a reasonable step size that can capture cracks from every direction with a user acceptable fast response.

With the rotating image and binary union operation added to the line detection method as shown in Figure 11, line detection was able to capture cracks in every direction (not only horizontal, vertical, $+45^\circ$, and -45°) and the staircase caused by the small size of 3×3 detector masks was minimized. Line detector masks are very sensitive to noise and thus, it minimized the Type 1 error but had difficulty with Type 2. The line detection

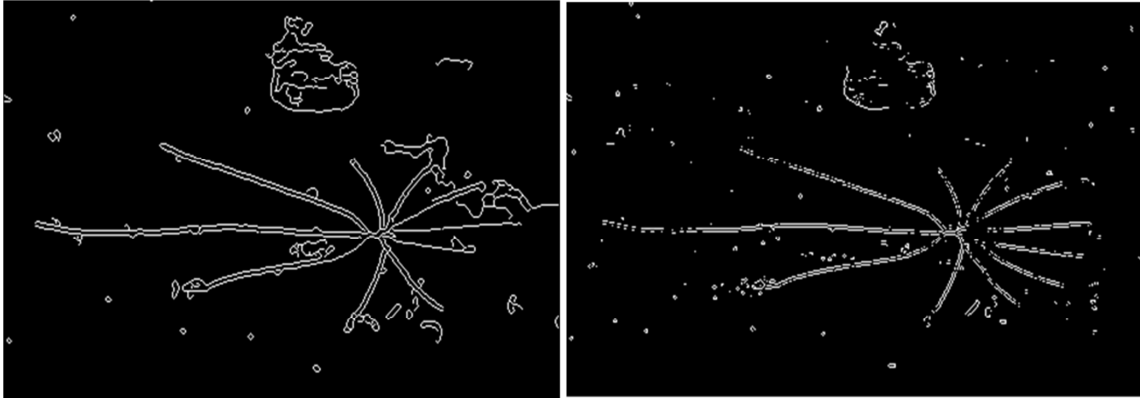
The crazing crack from Figure 6. (c) contains a lot of noise, which is common to rotor blades, especially in a places like deserts with strong wind. Both *Canny* and *Sobel* were able to reduce the background noise impact, which means the computer-based visual inspection method is feasible for onsite application.

(a) *Canny* optimal

(b) *Sobel* Optimal

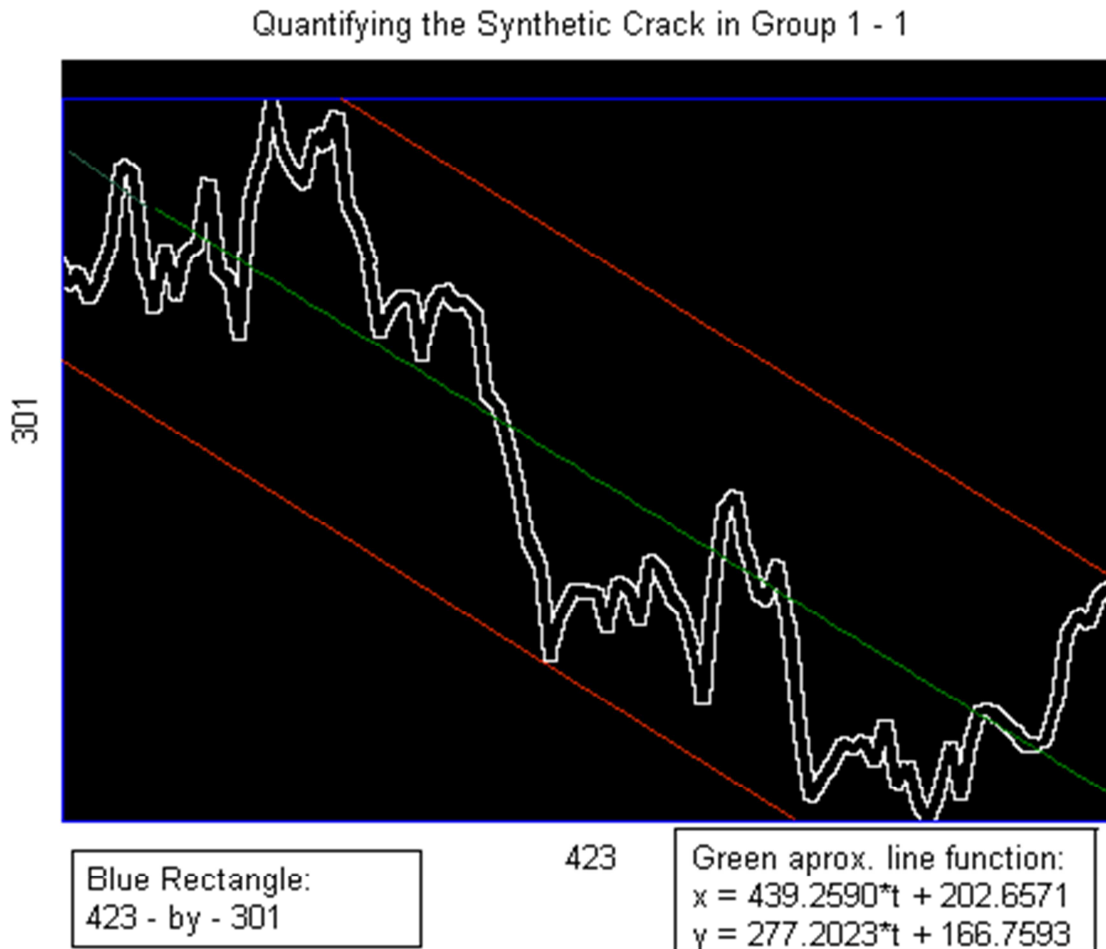
The two parallel lines in red enclosed the cracks with minimum distance to the green line as shown in Figure 17.

Figure 17. Quantification of the Synthetic Crack in Figure 3 (a)

The severity of a crack was defined by its intensity along the crack and its size. The size of the crack is shown in Figure 17. However, the intensity of the crack is not straightforward since the line and edge detection methods only detected the edges of the crack. Also, the location of the cracks on the WTB can be critical. For instance, if a crack occurred along the leading edge or the root section may create more potential damages or accelerate the potential structural damage than other areas since the leading

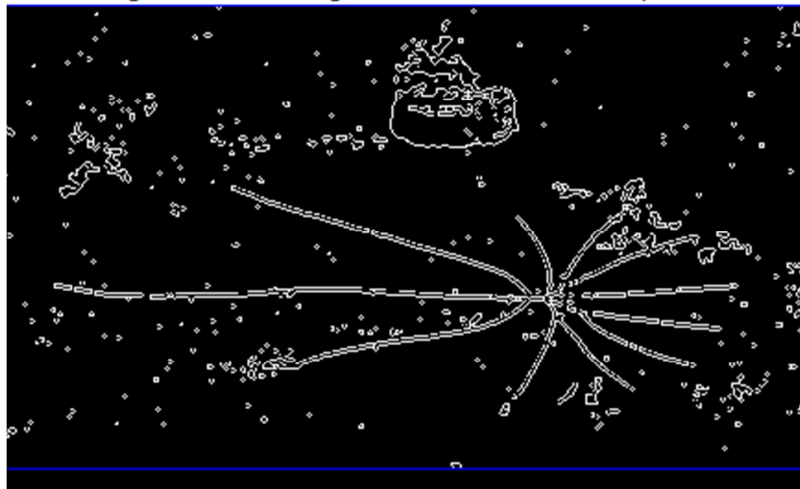
Crazing cracks with background noises and boundary box
