A quantitative analysis of shoreline erosion processes, Lake Sakakawea, North Dakota

A QUANTITATIVE ANALYSIS OF SHORELINE EROSION
PROCESSES, LAKE SAKAKAWEA, NORTH DAKOTA

A Thesis
Submitted to the Graduate Faculty
of the
University of North Dakota
in partial fulfillment of the requirements
for the degree of
Master of Science

Bulletin No. 85-05-MMRRI-01

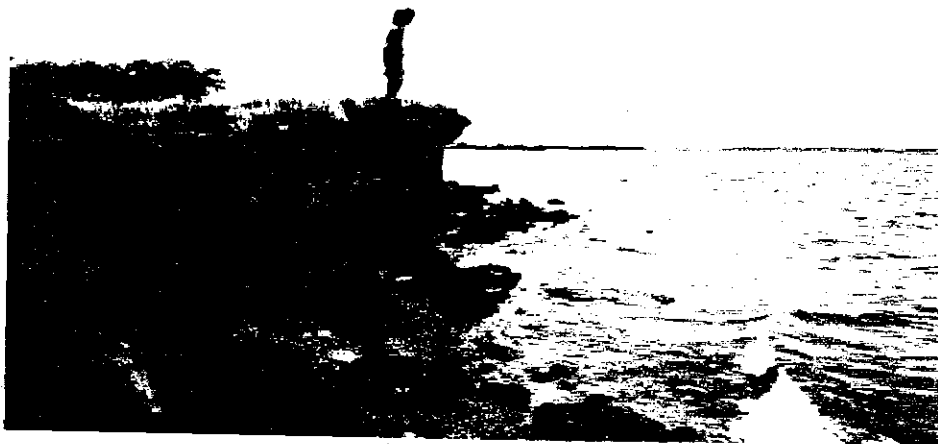
Figure 11. During high pool levels, colluvium is removed by waves and subsequent undercutting of the primary sediment and/or bedrock occurs. Station 1, August 22, 1983.

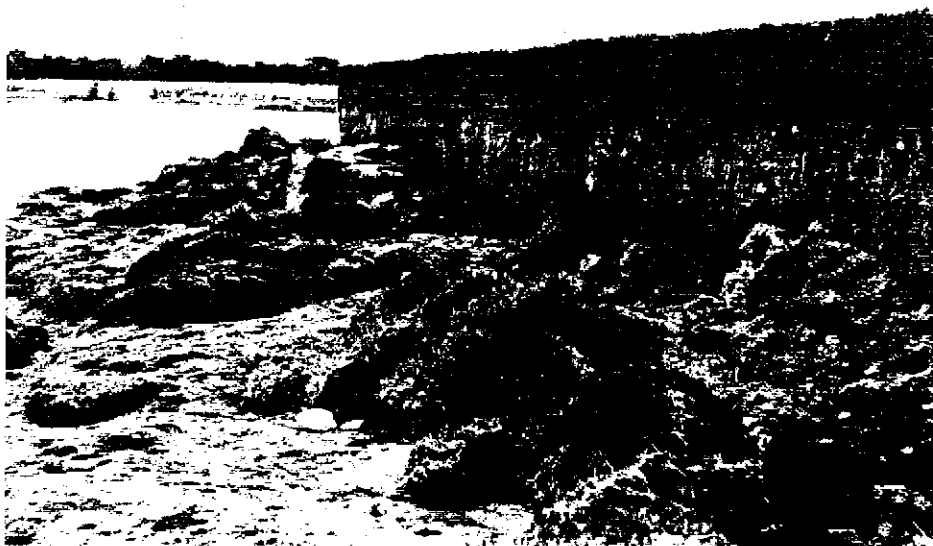
Figure 13. After the pool level recedes, the undercut, wave-worn banks will once again reach a relatively stable profile. Station 3, October 20, 1984.

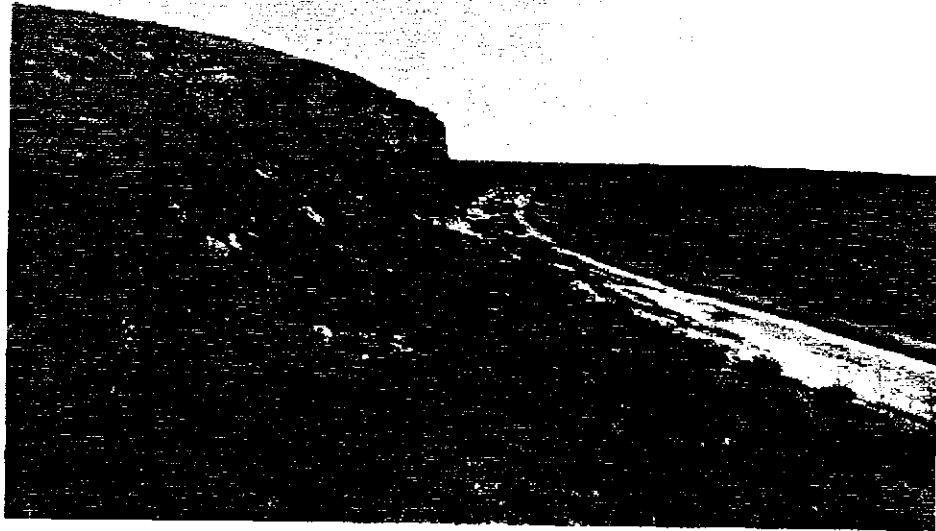
Figure 23. A stable slope (foreground), characterized by vegetation, and a slope in the process of becoming stable (background) as colluvium accumulates along the lower slope. Station 59, December 3, 1983.

The amount and type of vegetation on a bank also affects wave erosion (Mickelson and others, 1977). Once a semi-stable slope is allowed to form and vegetation is able to take root (Figure 23), the vegetation can contribute to subsequent bank stability. Vegetation not only can protect the surface but also roots help hold the sediment together (Figure 24).

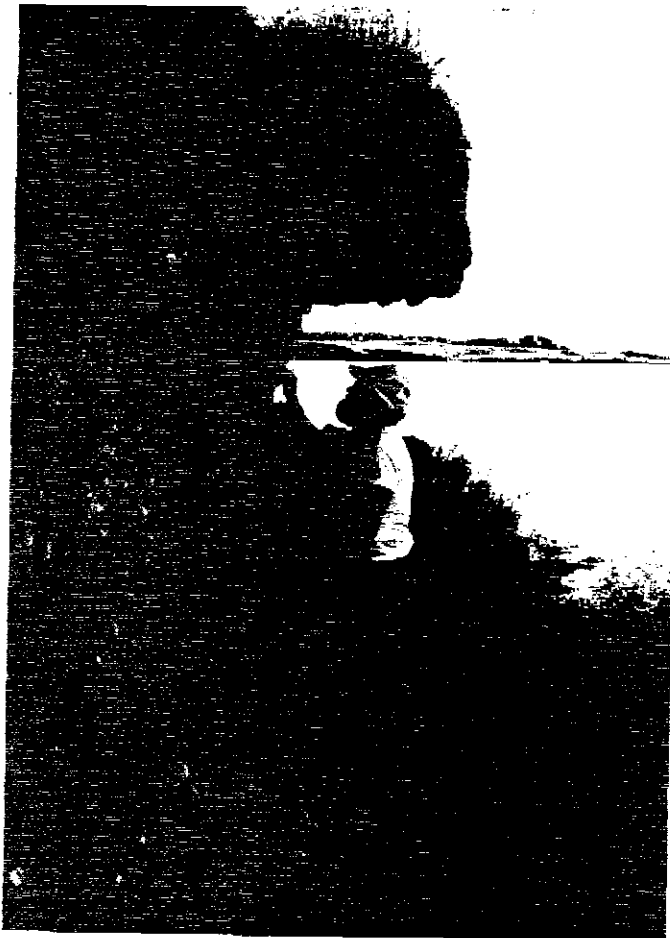
Figure 24. Overhanging root-bound loess above more-erodible Snow School till. Station 1, July 14, 1983.

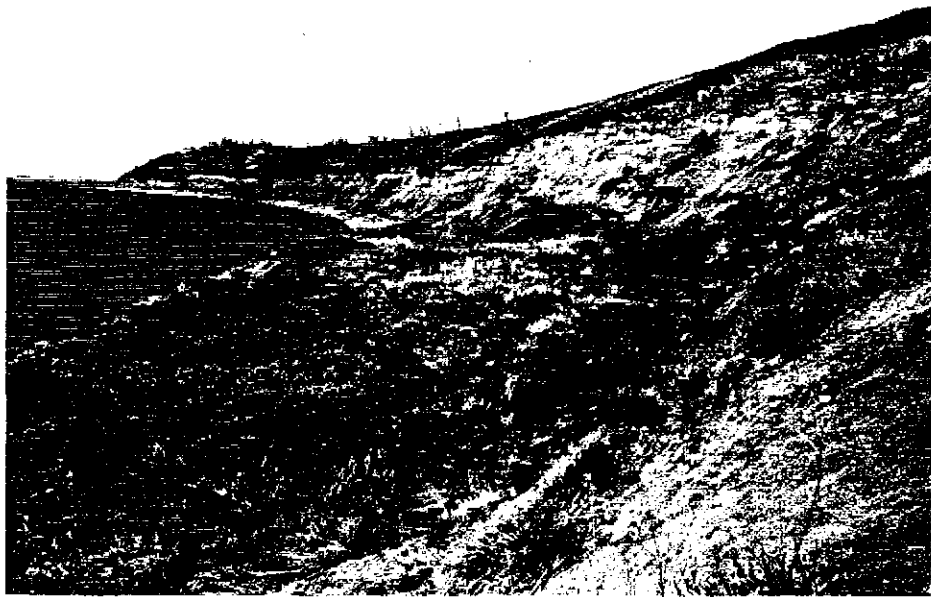
Figure 32. Slump/earthflow failure below Riverdale. The irregular mass extending from bottom left to the center is the toe of the slump which subsequently failed by flowing. May 16, 1983.

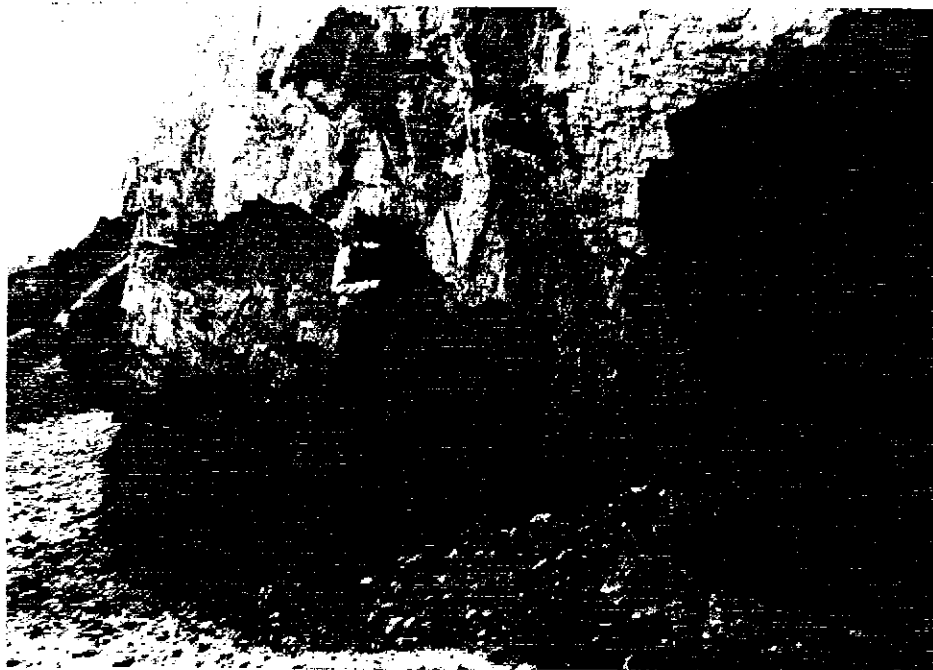
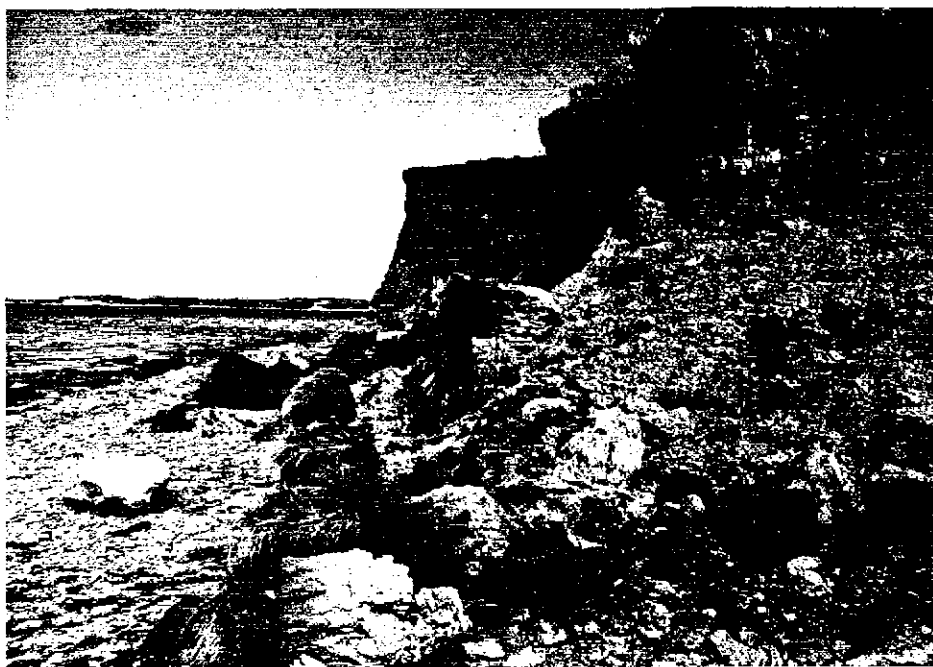
Figure 35. Blocks of till and loess resulting from thaw failure. Station 56, May 17, 1983.

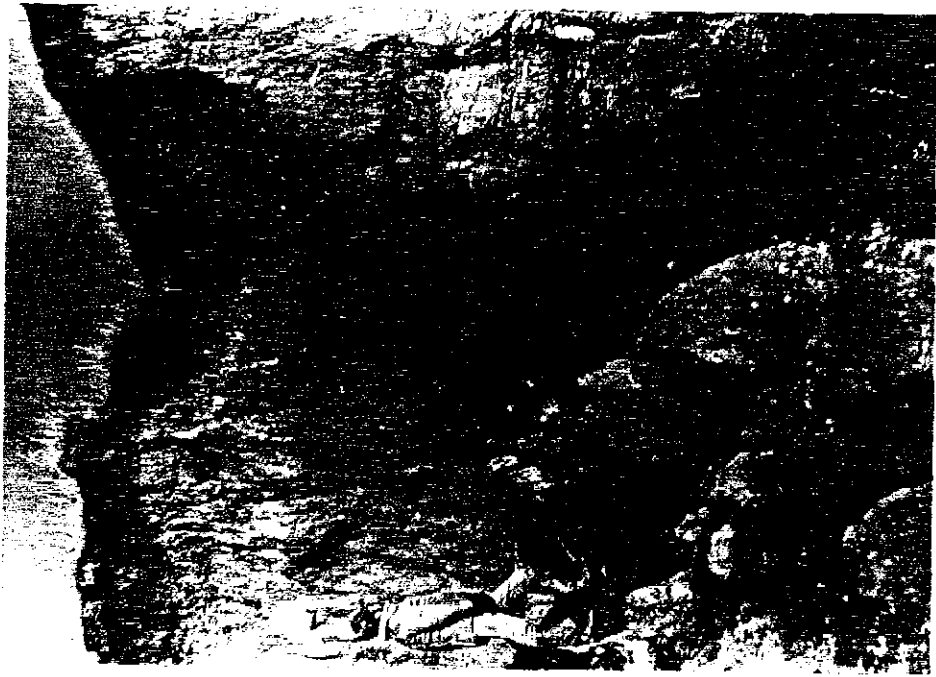
Figure 37. Debris flow resulting from saturation of clay-rich sediment re-entrant. Station 56, February 25, 1984. (These failures also can be the result of rainwater runoff.)

Once thaw begins, however, rapid bank failure follows. Falls, planar slides, and topples along previously bound joints (Figures 35 and 36), and various types of flow failure (Figures 36 and 37) succeed one another through the end of the thaw period, typically near the end of April. For another brief interval, the banks of Lake Sakakawea become relatively stable. Only as the pool level of Lake Sakakawea begins to approach its maximum level does the water again impinge upon the toes of the banks. Wave action accompanying these high pool levels removes some or all of the sediment (colluvium) that has accumulated because of thaw-failure.

Although snowmelt is primarily important because of its effect on pool level, it can also contribute to thaw failure (Reid, 1984, 1985). Most of the surfaces above the banks at Lake Sakakawea are fairly level or slope toward the lake. It appears this is true of Lake Audubon also. Where a lakeward slope exists, meltwater can infiltrate and flow along the contact of the upper thawed zone and the underlying frozen zone. This contributes additional water to the banks and may cause various types of debris flows, earthflows and mudflows (Figure 37).

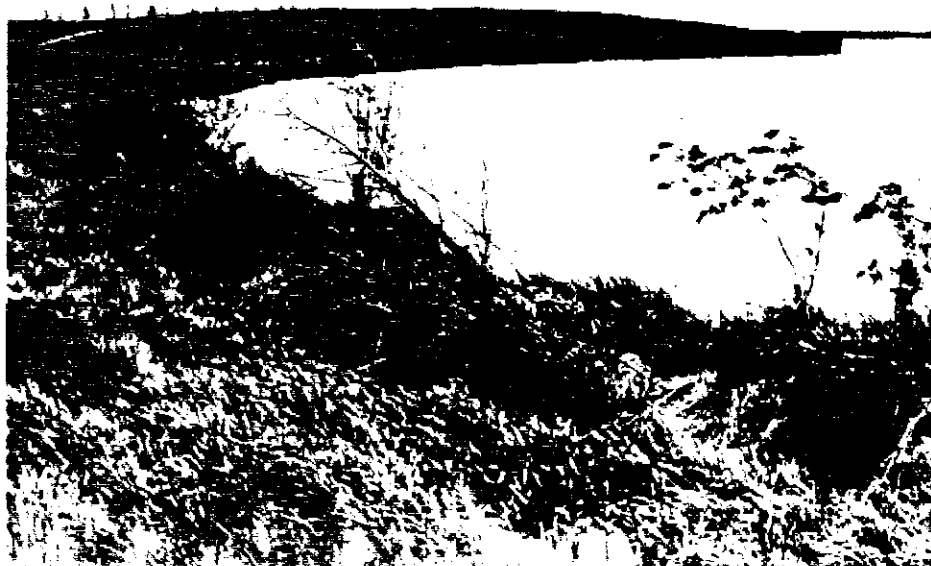
Figure 46. Ice-push ridge of grass, tree saplings and till at east end of Lake Audubon. Between stations A1 and A2, May 31, 1984.

At Lake Sakakawea, however, these mechanisms merely redistribute off-shore sediment because the pool level is low during that time. However, at Lake Audubon, winter ice-shove was the dominant cause of bank recession in 1984. The pool level that winter was maintained higher than usual and the expanding lake ice impinged directly on the banks. Ice-shove ridges resulted, especially along the east end where the erosion stations were located. Figure 46 shows one such ridge along a low area between stations A1 and A2. The ice effectively weakened the bank such that even slight wave action was sufficient to cause bank failure. If future pool levels are kept high during the winter at Lake Audubon additional rapid bank recession can be expected.

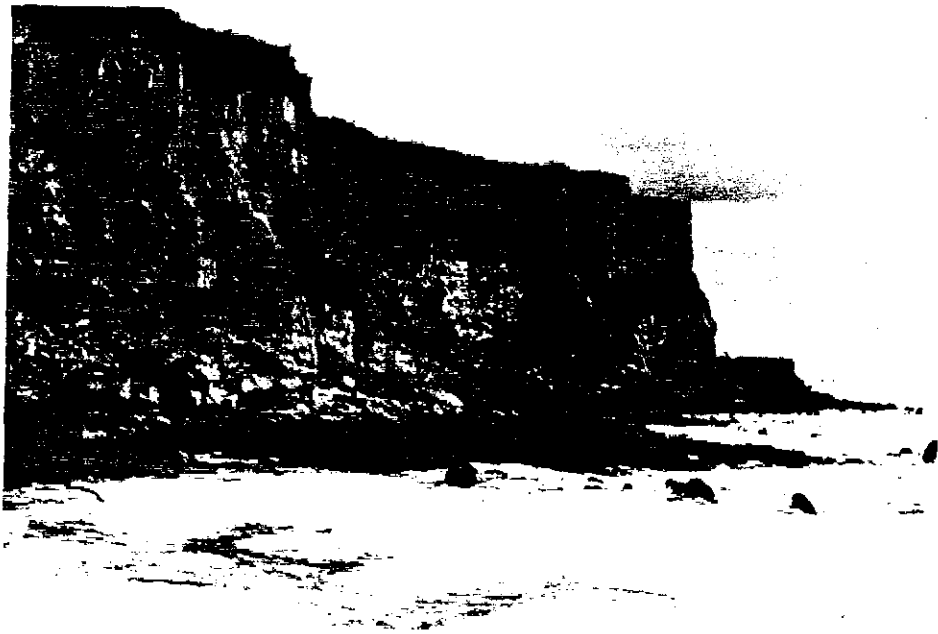
Figure 47. Colluvium apron on ice resulting from frost-thaw.
The mode of failure was probably toppling.
Station 56, March 31, 1984.

1) delayed bank failure, due to wave erosion, but activated by another process after the last measurement prior to freeze-up; and, 2) significant thaw failure before the first spring measurement date. The latter is probably the case at station 56, because in March 1984, a large amount of colluvium was observed on the lake ice at that station (Figure 47). Thus, there was no strong positive correlation between bank recession (Y) and the dependent variables used, and no significant models were generated.

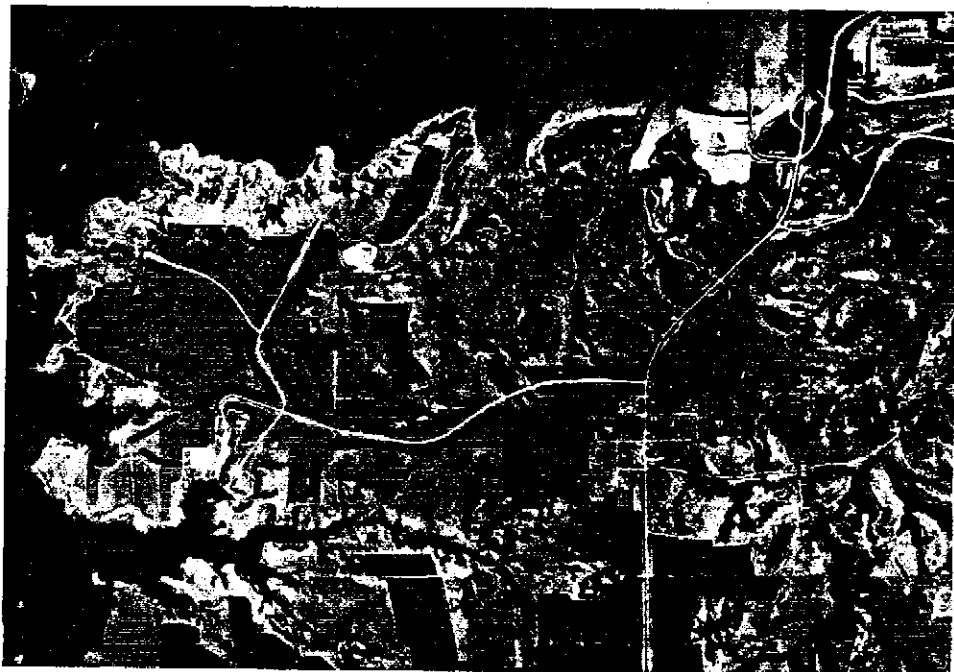
Figure 48. Aerial photograph of Lake Sakakawea State Park, July 1, 1958.

In summary, figures 48, 49 and 50 illustrate the dynamic changes which occurred at Lake Sakakawea State Park between 1958 and 1976.

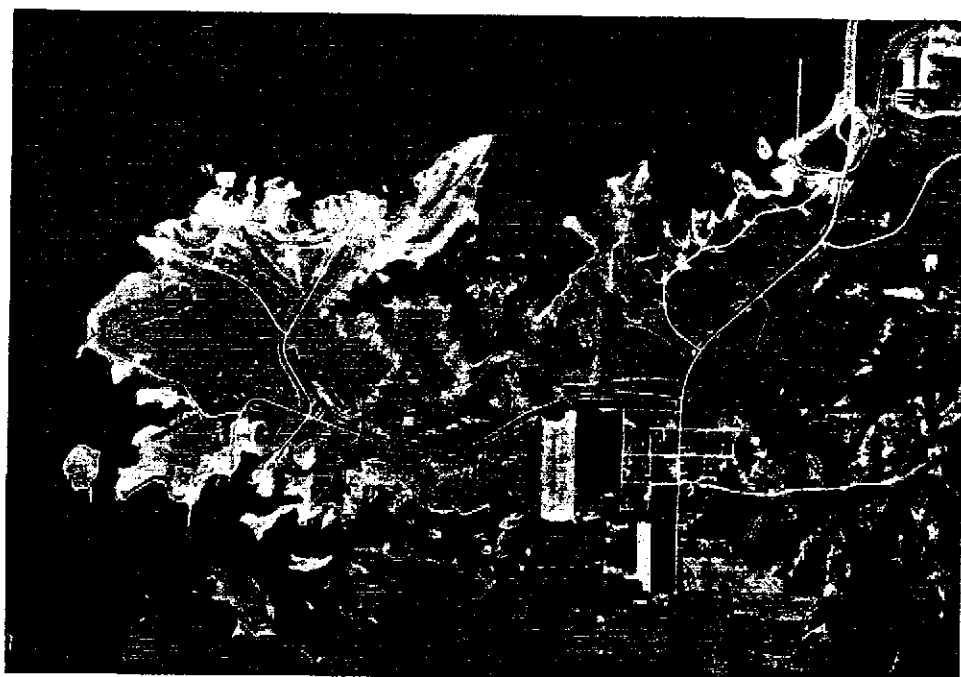
Figure 49. Aerial photograph of Lake Sakakawea State Park, September 14, 1966. Note the amount of change since 1958 due to inundation.

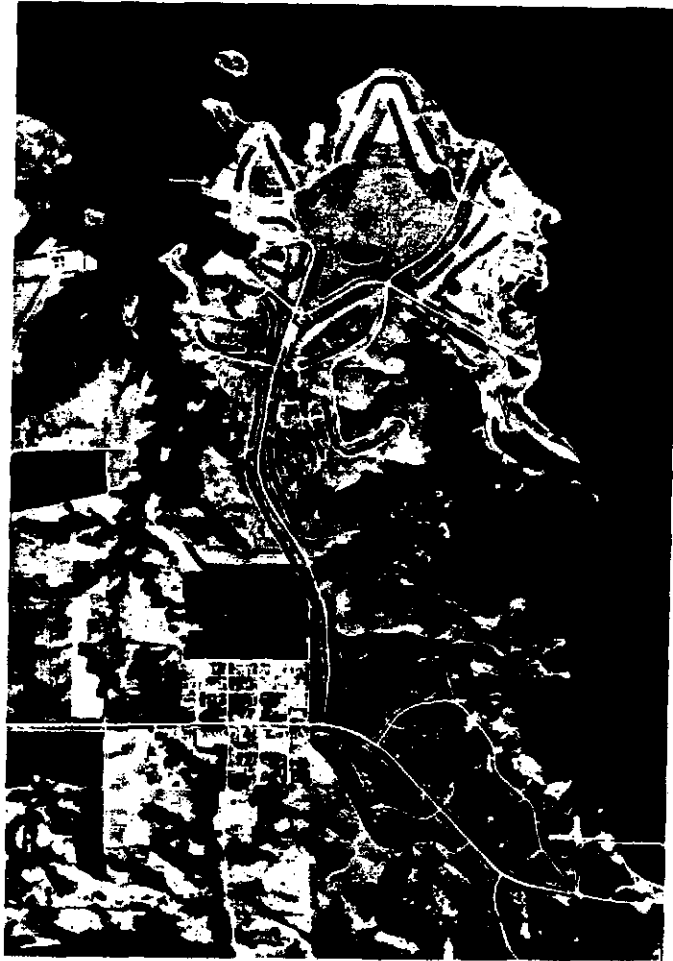
Figure 50. Aerial photograph of Lake Sakakawea State Park, July 14, 1976. Note the amount of change since 1966. This was probably primarily due to shoreline erosion by waves.
