A study of effects of a new agricultural-based deicer on the properties of pavement concrete

A thesis submitted to the graduate faculty
in partial fulfillment of the requirement for the degree of
MASTER OF SCIENCE

Major: Civil Engineering (Civil Engineering Materials)

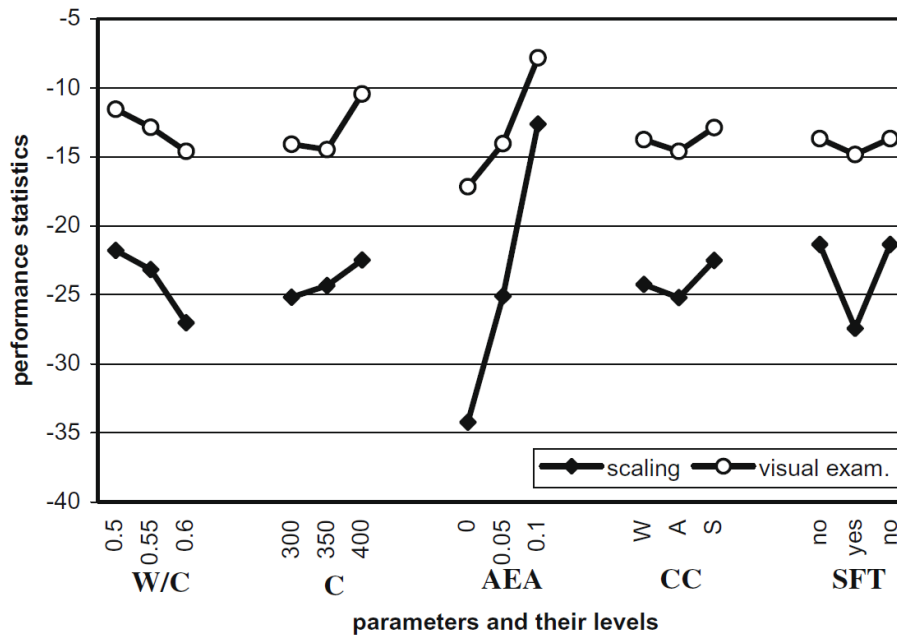
Figure 6. Effect of w/c, cement content (C), air-entrainment (AEA), curing conditions (CC) and surface finishing treatment (SFT) on scaling resistance [41]

entrainment and a surface finishing treatment improve the scaling resistance as discussed earlier. The curing condition can be complicated and, in this study, air cured concrete is more vulnerable to scaling which makes sense because of poor cement hydration.

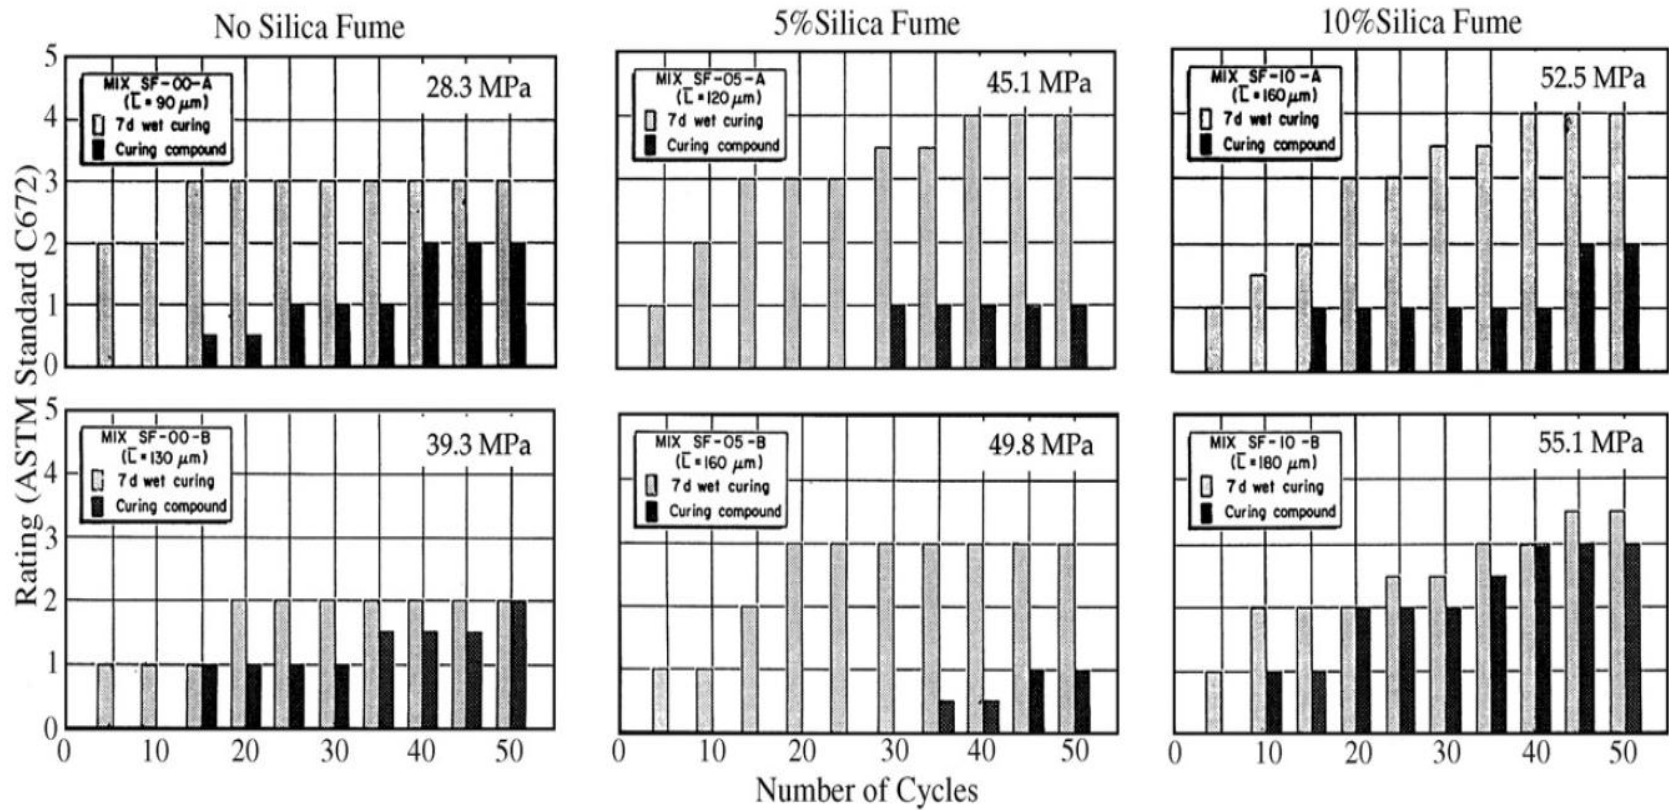
Figure 7. Scaling rates of silica fume addition concrete [49]

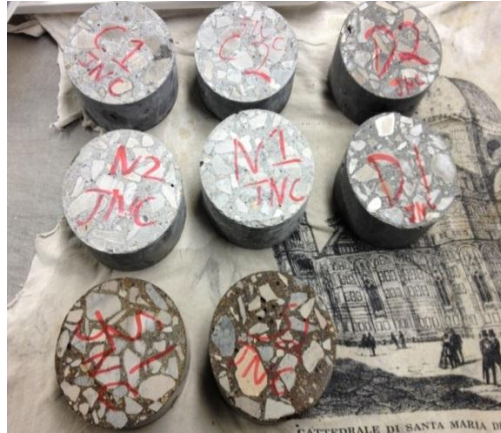
Figure 9. 2-in circular disks for water absorption test

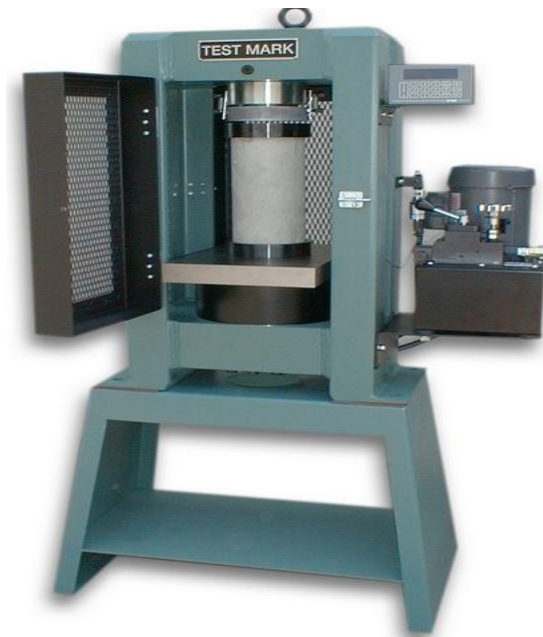
Figure 11. Compression tester

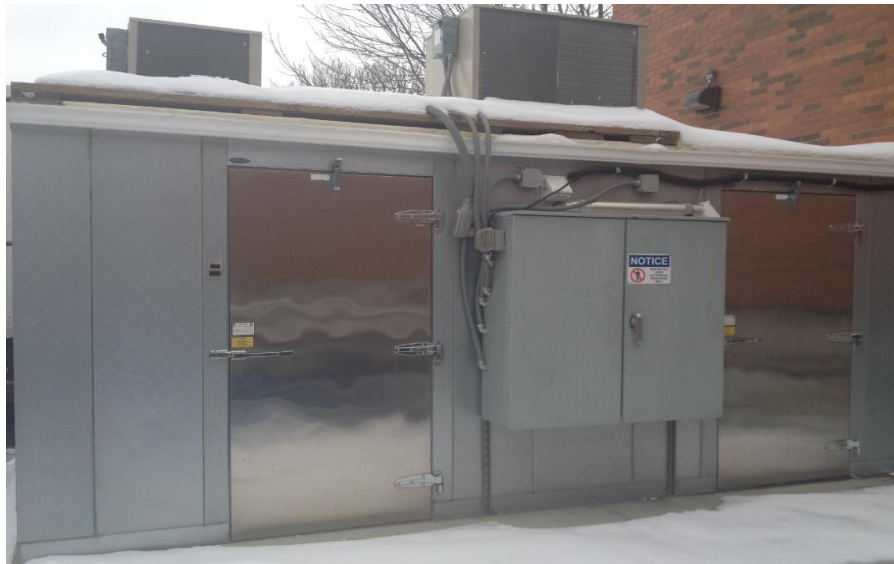
Figure 12. Freezing chamber

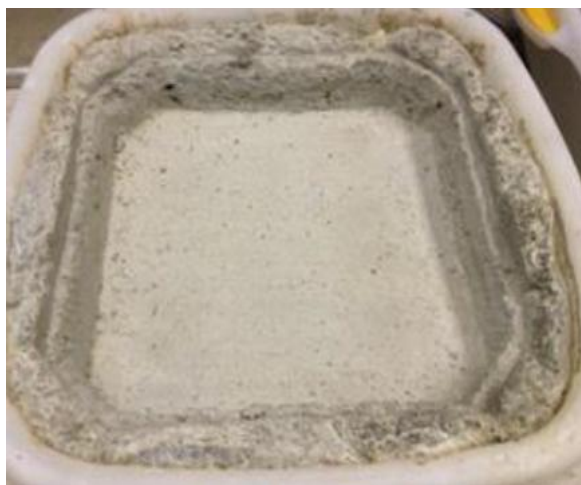
Figure 14. Concrete slab for salt scaling evaluation

Slab with 9-in by 9-in ponding area was created by forming concrete dikes at the periphery as shown in Figure 14.

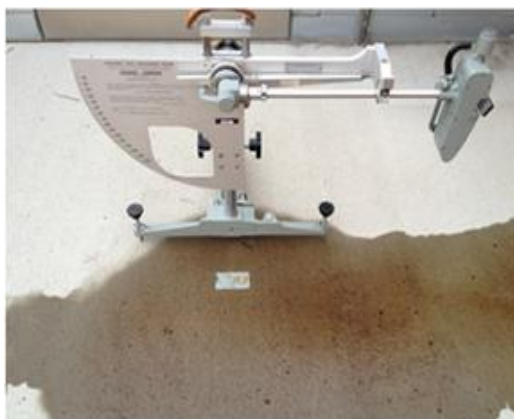
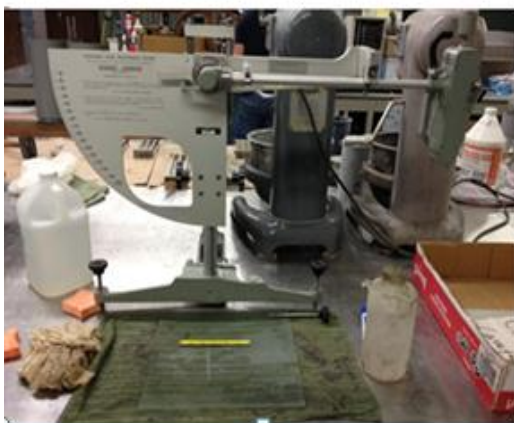
(a) Concrete slab

(b) Sand-blasted glass

important adjustment is the slide length. Since the rubber slide is going to propel over the rough surface to reach its final position, the contacting length or area between the slider and the surface is critical. It is required to have a length of contact path between 4-7/8 and 5-inch (124 and 127 mm).

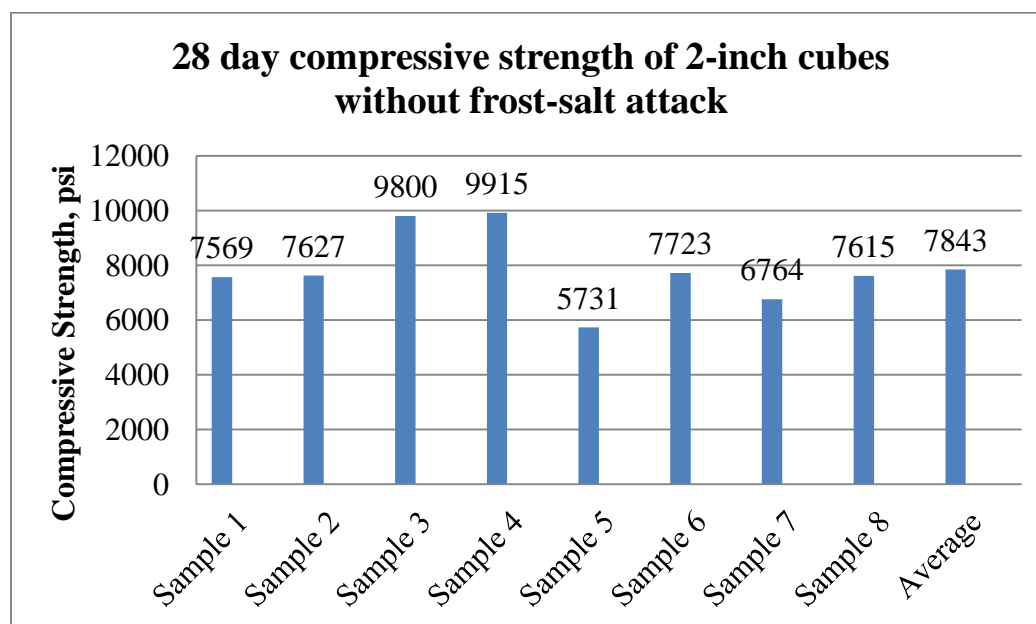
Figure 22. 28-day compressive strength of mortar cubes without frost-salt attack

The largest strength difference occurred between cubes before and after frost-salt attack by 3% NaCl solution. The average strength of 3% NaCl group cubes was around half of average strength of cubes before frost-salt attack indicating that cubes in NaCl solution has a 50% strength reduction. The cubes of 4% CaCl₂ group also showed a relative large amount of damage. The average compressive strength was around 70% of average strength value of cubes before frost-salt attack meaning a 30% strength deduction. Deionized water also did damage cubes. The strength decline was roughly 10% comparing with the strength of those undamaged. The standard deviation of the strength results is large which might be caused by micro-cracking development after frost-salt attack. No microstructure observations have been made to verify this point.

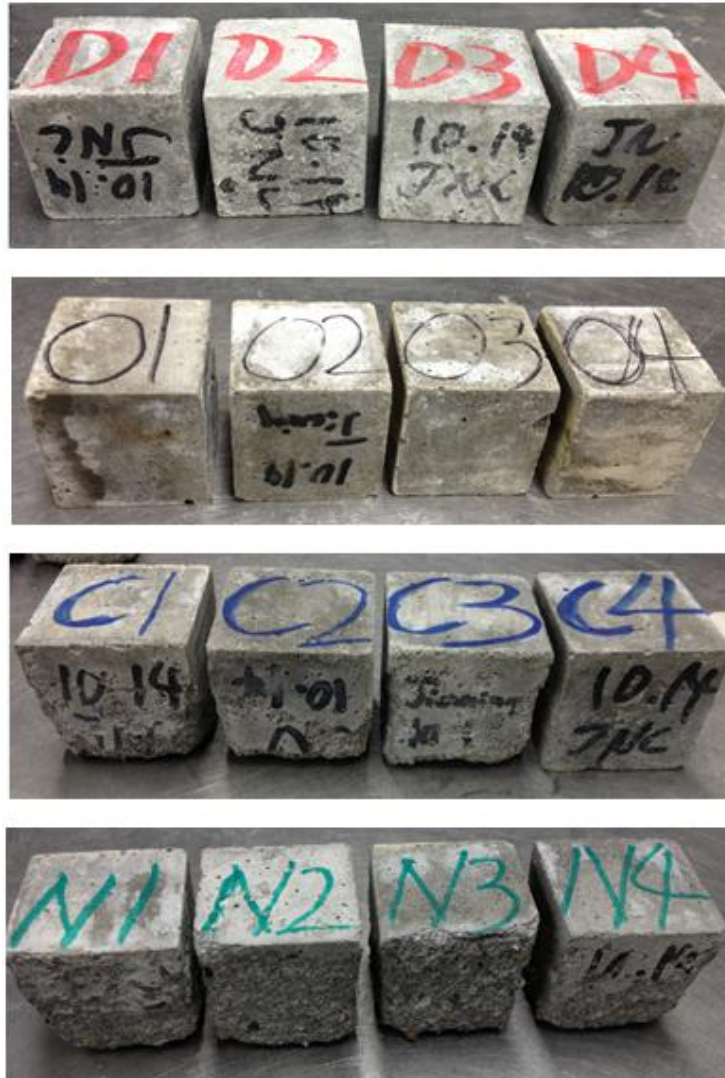
Figure 24. Cubes with surface materials removed after 10 cycles

It should not influence mechanical properties (compressive strength) of concrete. A possible explanation to this is the most removed surface materials were at the corners of cubes and the cube in compression test was in relatively unstable geometrics as shown in Figure 26.

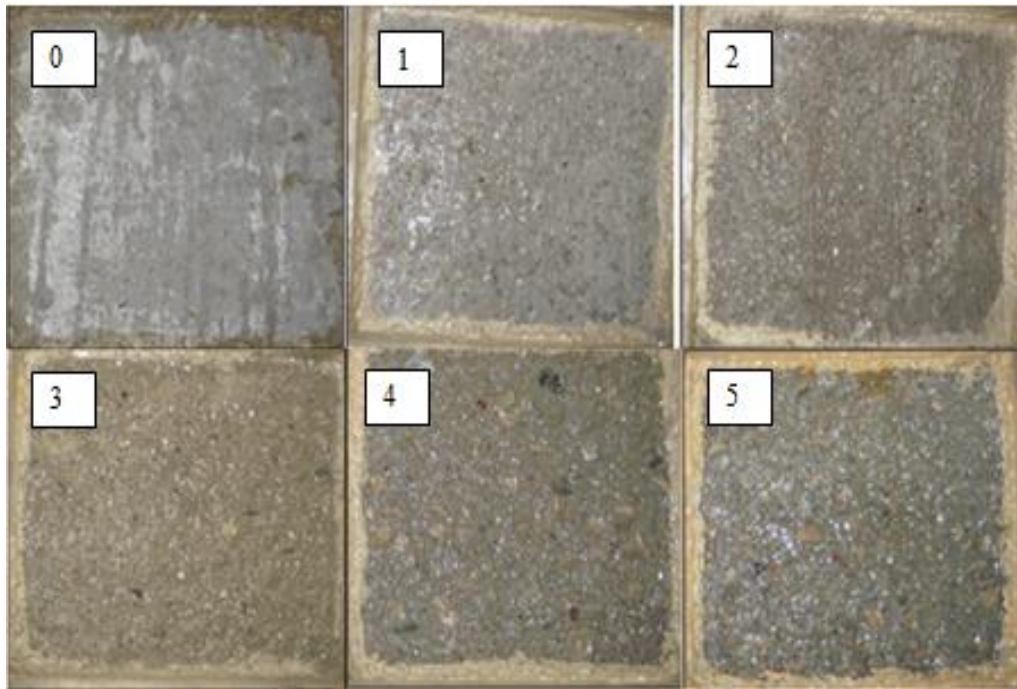
Figure 26. Scaling rating from 0 to 5

The rating system was explained with “5” being the most severe scaling and “0” meaning no scaling. Figure 27 shows the visual difference from 0 to 5. From Table 10, it can be found that slabs in deionized water had almost no surface scaling. It is consistent with literature study that no scaling damage occurs without presence of deicing salts. The scaling damage of Season I was also negligible. Residues on surface were washed off from the slabs of Season I group and no scaling can be visually observed. It should be noted that, since the ponding area of slab surface is protected by molded concrete dikes around the periphery, loose materials from the frost damaged dikes can be washed into the sieve and measured as part of the mass loss.

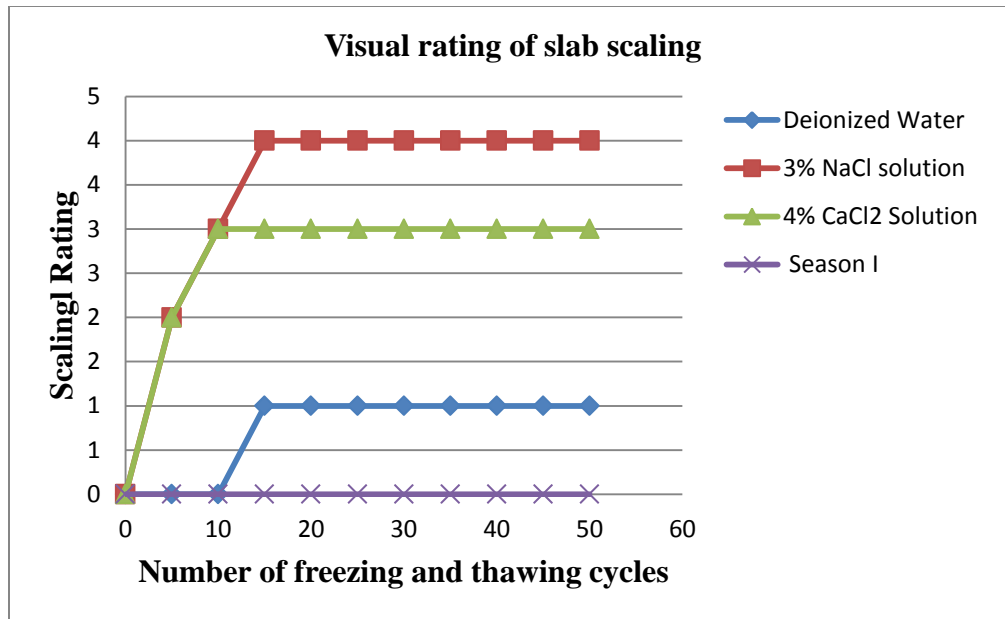
Figure 27. Visual rating of slab scaling

Although the amount of removed materials from the dikes is much smaller comparing with the removed superficial materials, it could contribute to an unreliable scaling rating. Remind of findings of the structural degradation test that cubes in 3% NaCl and 4% CaCl₂ solutions were damaged most severely. The scaling damage also followed this trend. Being slightly different from the degradation damage, scaling damage of the two groups (3% NaCl and 4% CaCl₂ solutions) was almost at the same level. Both 3% NaCl and 4% CaCl₂ solutions caused surface deterioration and the scaling rating after 50 freezing and thawing cycles was either 3 or 4 referring severe scaling. Figure 28 and Figure 29 summarized the visual rating and unit area mass loss rating, respectively, of the slabs at every 5 cycles until 50 cycles was reached.

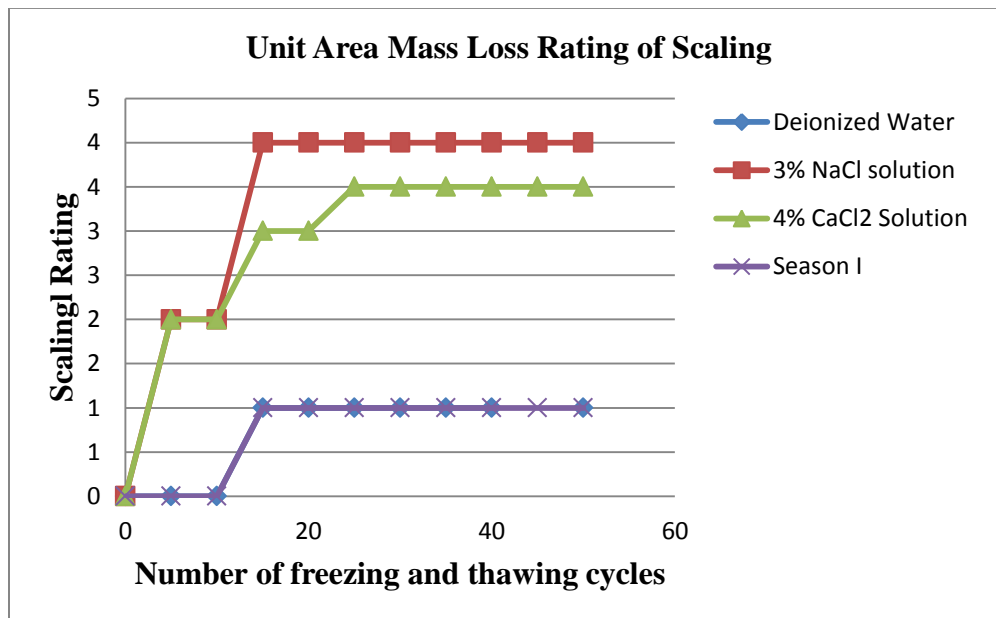
Figure 28. Unit area mass loss rating of scaling

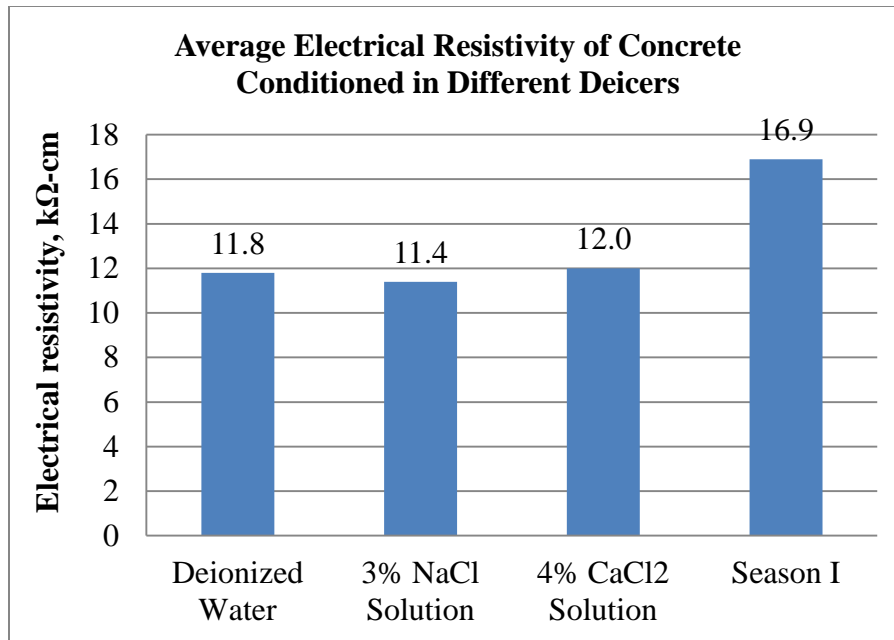
Figure 31. Average electrical resistivity of concrete conditioned in deicers

For electrical resistivity readings, a higher value indicates lower permeability of chloride ions beneath the tested concrete surface [58]. A conclusion can be made that Season I greatly changed the surface electric resistivity of the concrete comparing with the other two deicers according to Figure 32. The average electrical resistivity is much higher than those of others implying the lowest permeability. This result matches with proposed sealing effect of Season I on concrete and it is suspicious that a specific constituent of Season I deicer clogged pores near the concrete surface when cylinders were immersed in Season I for 14 days. However, since the composition of Season I was not provided and no microscopic observation of micro-structure were conducted, it is difficult to reach a solid conclusion on this finding.

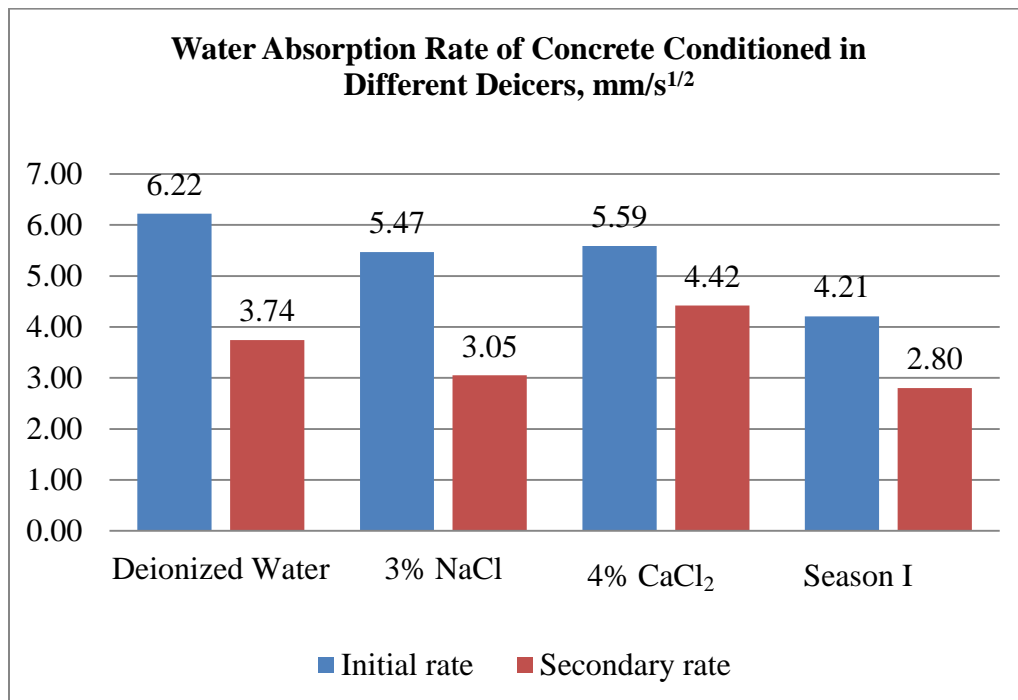
Figure 33. Water absorption rate of concrete

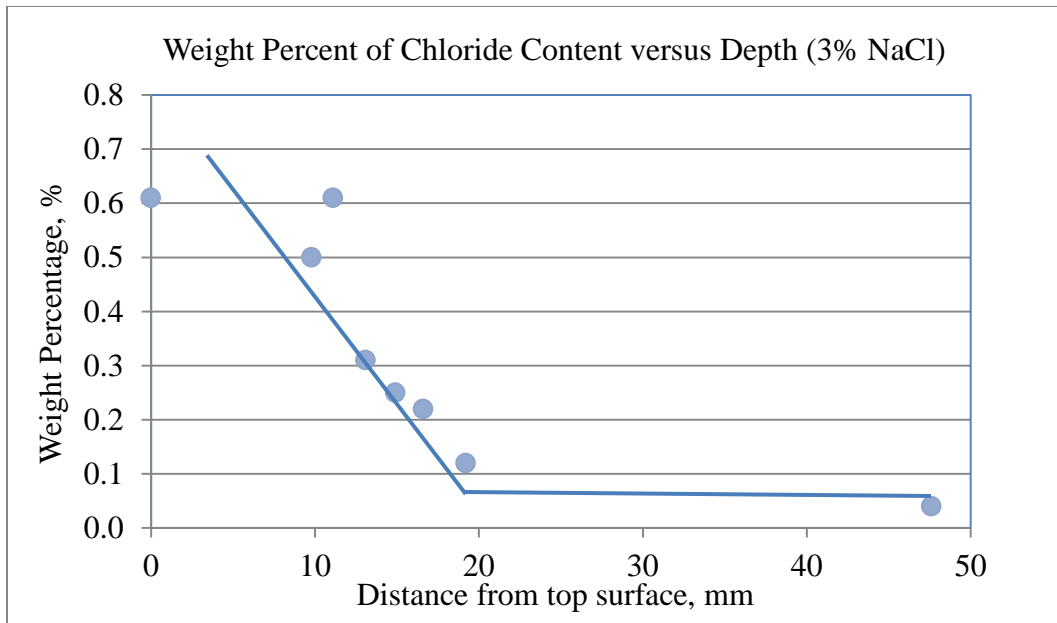
Figure 34. Chloride content versus depth for 3% NaCl specimen

Results of the analysis are shown in Figure 35 and Figure 36 for NaCl solution penetrated sample and Season I penetrated sample. The NaCl solution penetrated about 19 mm where the weight percent of chloride drops drastically and Season I penetrated around 13 mm from the top surface of the cores. Table 14 and Table 15 are summarized results of chemical compositions versus the specimen depth. The exact relationship between scaling damage and deicer penetration depth is hard to interpret at this stage due to limited amount of samples in EDS analysis. However, the results suggest 3% NaCl solution penetrated 6 mm deeper than Season I deicer which might be resulted from more deicer ingress of slabs in scaling. Another contributing factor might be that, comparing with the NaCl solution, Season I is much more viscous due to the organic compounds it contained and it made Season I less flowable in pores. The particle size of these organic compounds might be too large to penetrate through capillary voids of concrete.

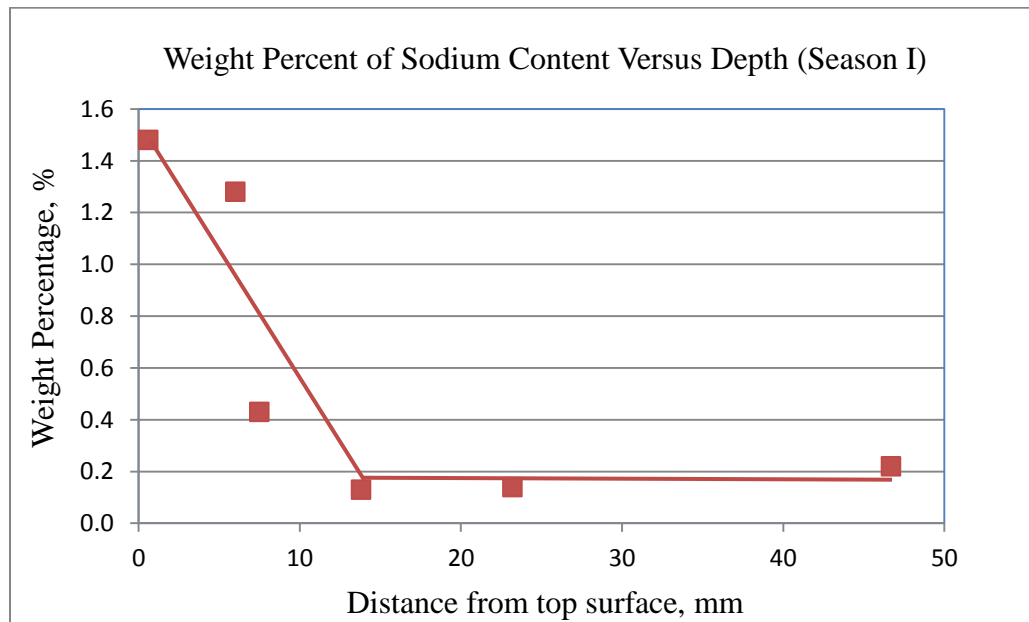
Figure 35. Sodium content versus depth for Season I specimen

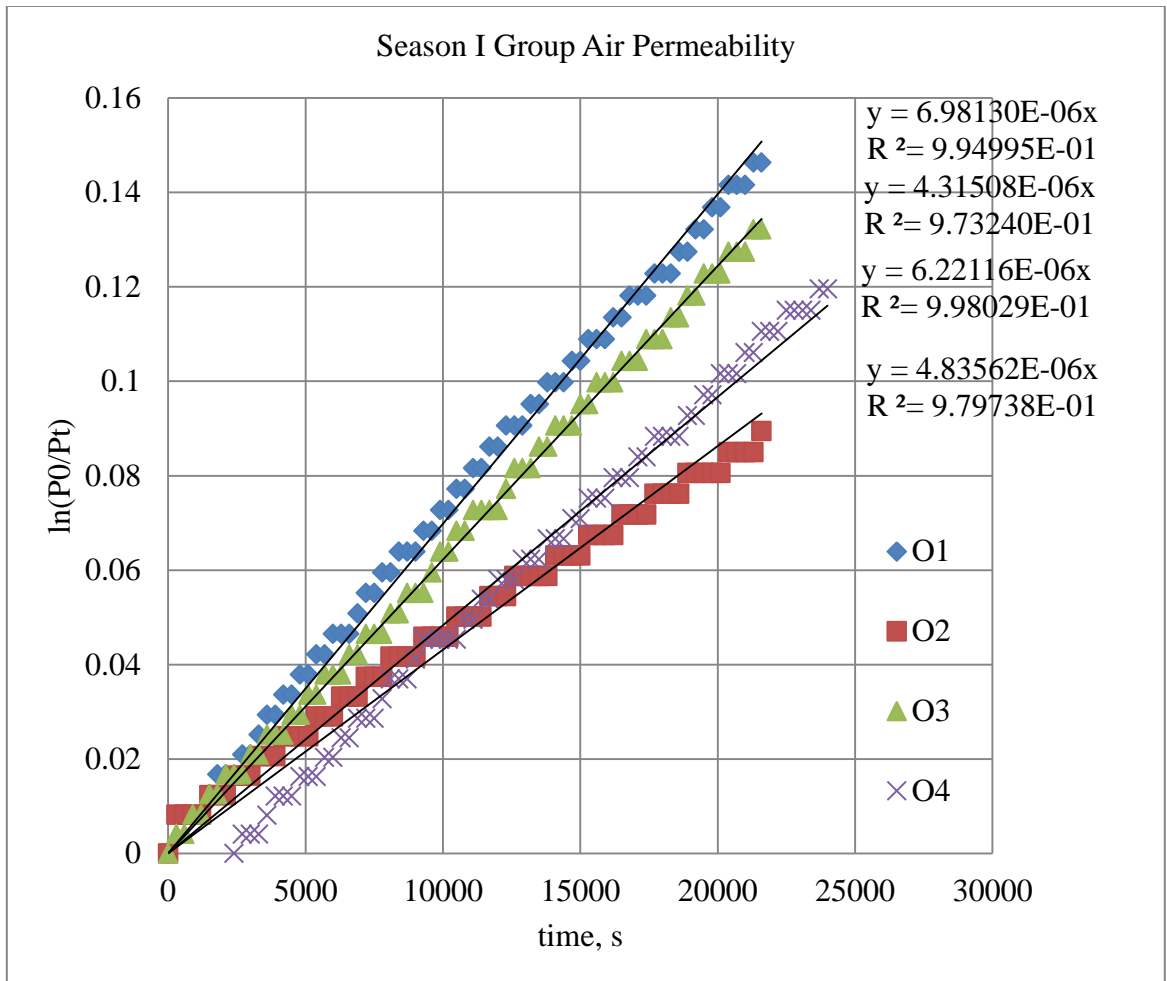
Figure 45. Permeability of concrete disk immersed in Season I
