# APPLYING MODERN TECHNOLOGY IN THE PRESERVATION OF HISTORIC CONCRETE PICNIC TABLES

Michele M. Anderson  
*University of New Mexico*

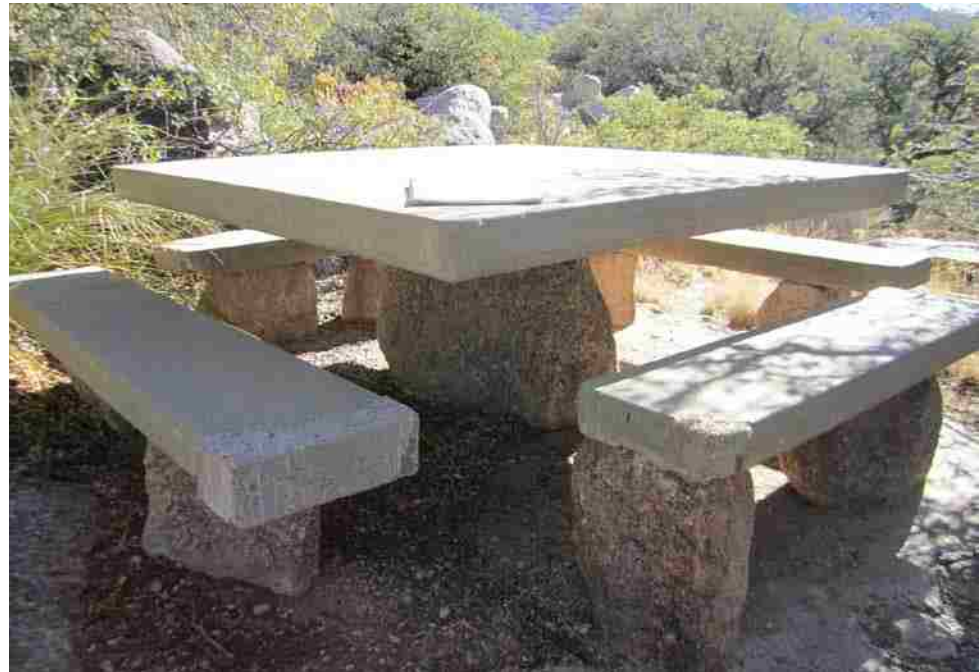
Figure 2. CCC picnic table constructed on natural rock (Source: Joelle Hertel)

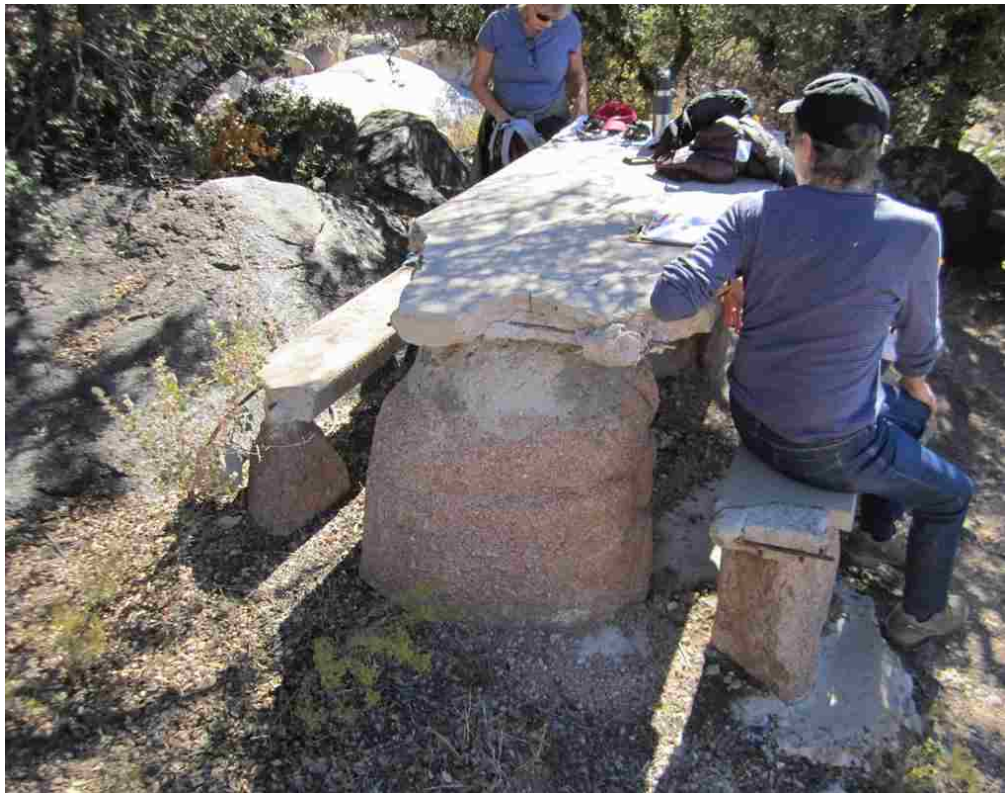
Figure 3. Picnic table and bench vandalized (Source: Joelle Hertel).

Today, the simple concrete picnic tables stand without any obvious environmental or chemical defects. The only noticeable wear to the concrete structures is vandalism to the tables and benches (Figure 3). So too do many other historic concrete structures, such as the first concrete road built in 1891, the first reinforced concrete skyscraper known as the Ingalls Building built in 1903, Thomas Edison’s house circa 1908, and the Hoover (Boulder) Dam built in 1936. Over time, however, concrete mix designs have changed such that they may not be compatible with historic mix designs. This can be an issue in the case of the simple concrete picnic tables, which need to be repaired due to vandalism.

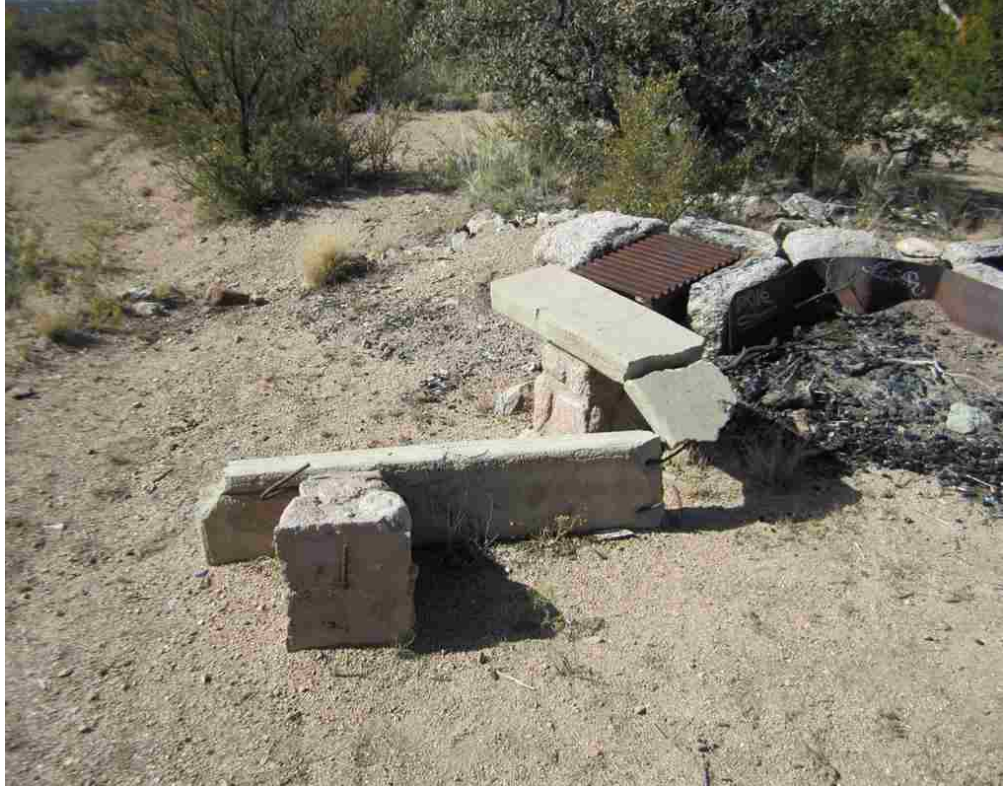
Figure 4. Historic concrete broken bench used for testing samples.

The methodology to understand the materials and elements used in the historic concrete consisted of digital microscopes, scanning electron microscopes (SEM), petrographic analysis, and color analysis. In addition, a non-destructive test using the rebound (Schmidt) hammer was performed. The technology was used to discover, analyze, confirm, or eliminate causes of materials used in the historic mix and determine the current condition of the historic concrete. Professional laboratories performed SEM and petrographic analysis as well as color analysis. All historic concrete tested by the various forms of technical apparatus came from the same broken bench (Figure 4).

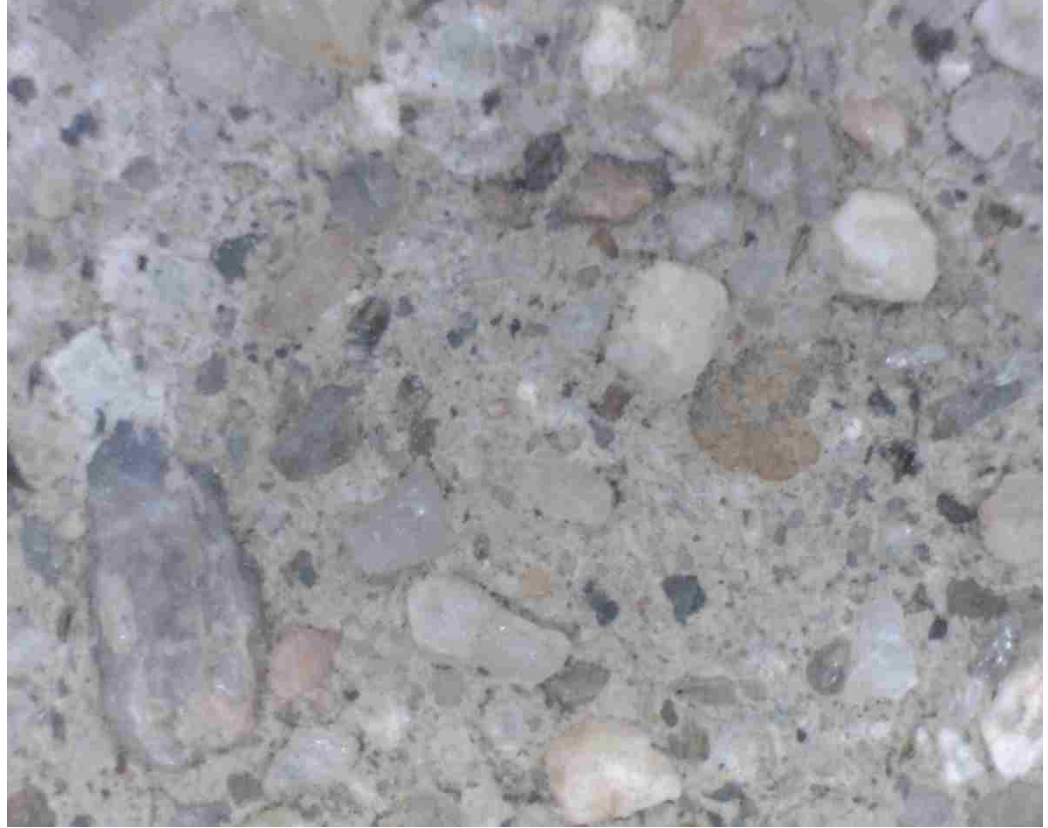
Figure 5. Digital microscope image of historic concrete surface.

The first apparatus used to examine the historic concrete was a digital microscope. The digital microscope amplified the surface areas of the historic concrete as illustrated in Figure 5. Information gathered showed aggregate size and distribution of the historic mix. Maximum aggregate size and distribution of smaller aggregates were used in the new concrete mix design. After each new mix was cured and tested for compression strength, a sample of the surface was checked using the digital microscope and compared against the historic concrete for quality of aggregate distribution and finish characteristics.

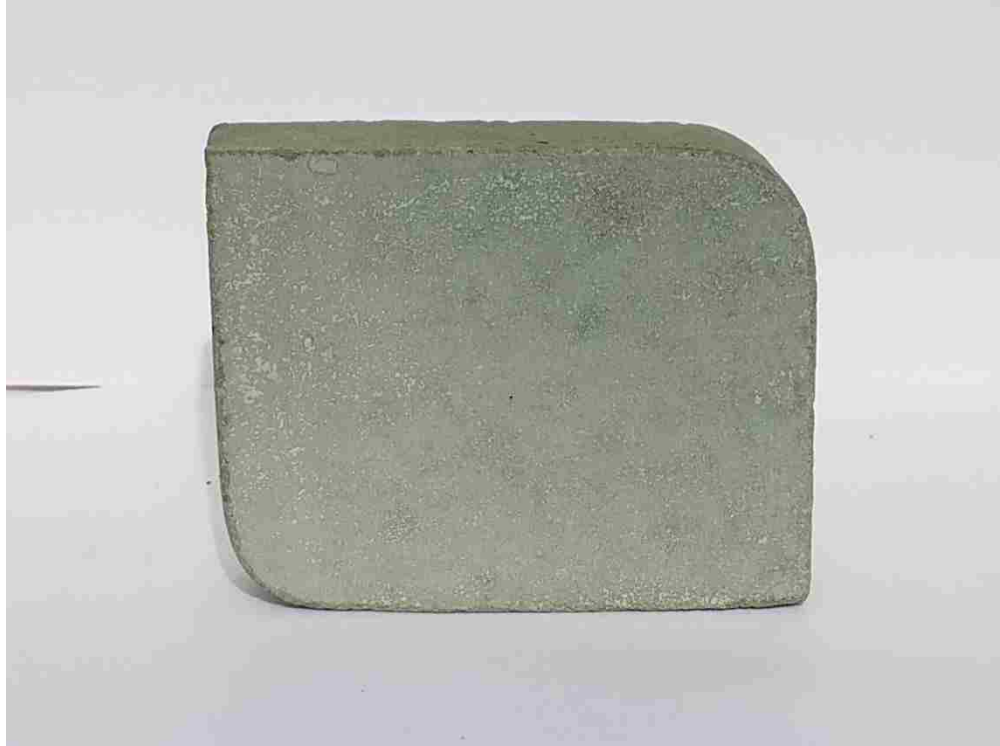
Figure 8. Concrete dye sample.

Color analysis was performed at L.M. Scofield Company. The findings of the color scan were matched with commercial dyes to produce a color sample. It was determined the color needed to produce the dye for new concrete mix designs was pure chromium oxide. A sample of the dye color was produced by L.M. Scofield for consideration (Figure 8).

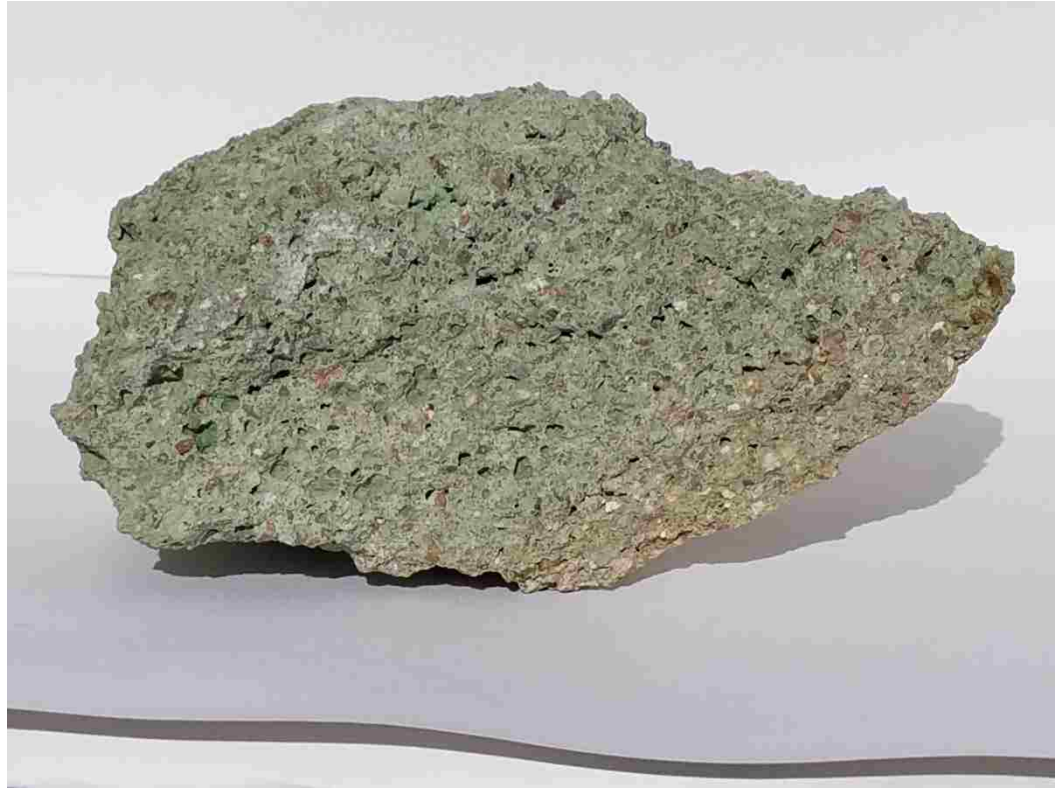
Figure 9. Sample of historic concrete from broken bench.

The final step in the concrete lab was to match the green color of the historic concrete (Figure 9) using the Batch #3 mix design. With each concrete mix, a measured amount of a green dye was added and cured in two-inch cube molds. The amount of dye added to subsequent mixes and cured depended upon the results of the previous batch after curing and unmolding then compared to the color of the historic concrete. Three batches of color-dyed cubes were produced in all (Figure 10). Mix #1 used 18 oz./ft<sup>3</sup> (18

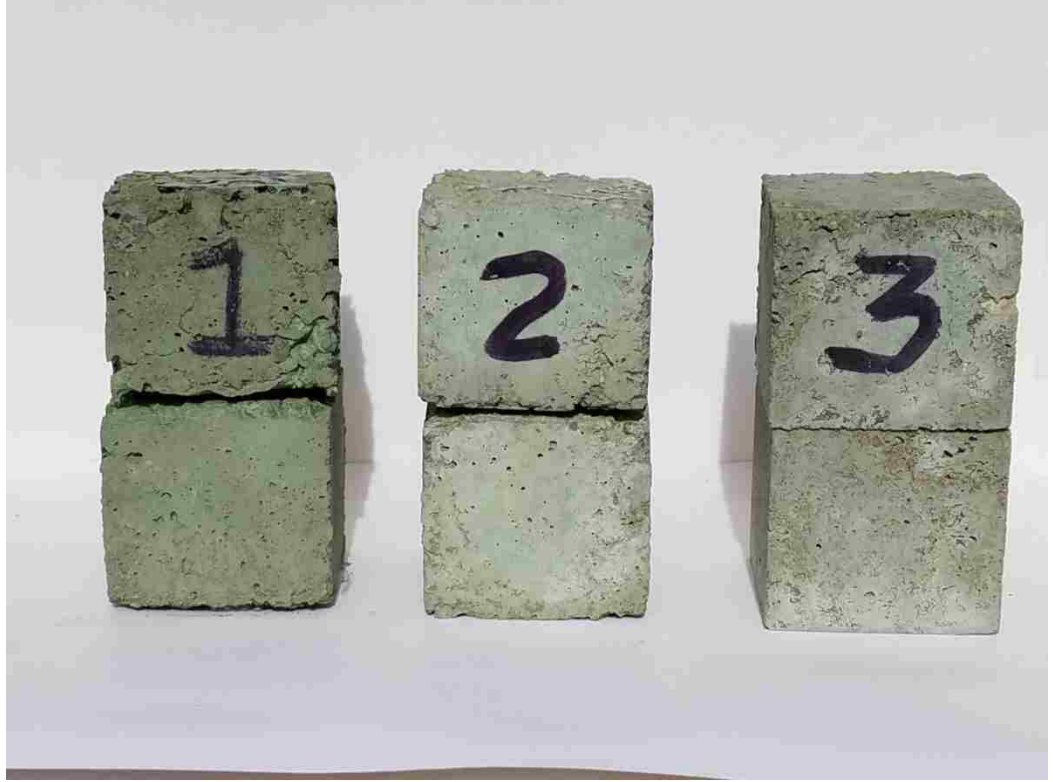
Figure 10. Color dyed cubes.

kg/m<sup>3</sup>), mix #2 used 7.2 oz./ft<sup>3</sup> (7.2 kg/m<sup>3</sup>), and Mix #3 used 3.6 oz./ft<sup>3</sup> (3.6 kg/m<sup>3</sup>) to develop the samples for the new concrete that would match the historic concrete.

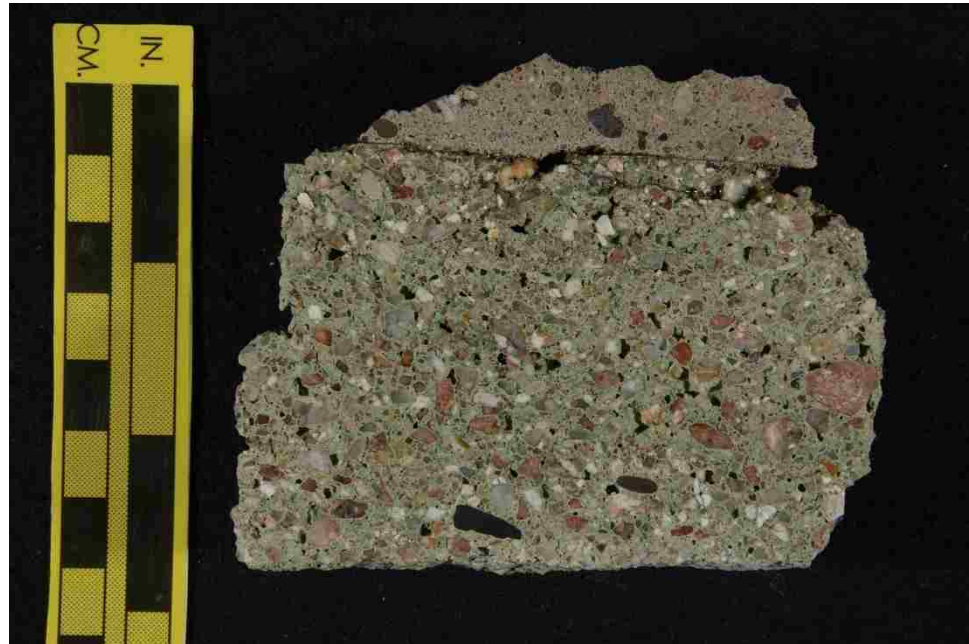
Figure 13 Sample polished and thin sliced for testing (Source: DRP).

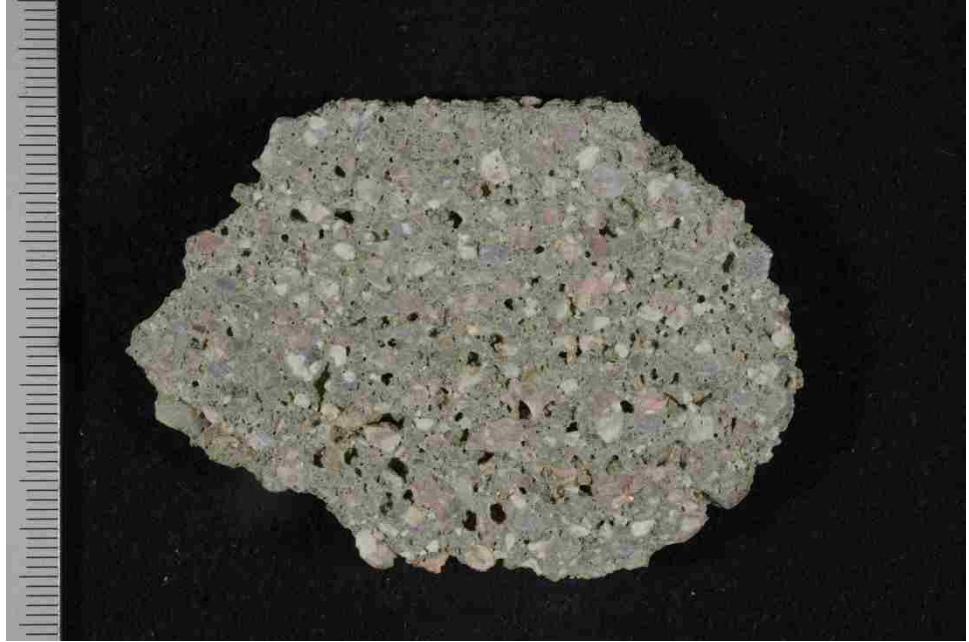
Figure 16. Phenolphthalein test, no staining (Source: DRP).

- The phenolphthalein (phenol) test indicated highly carbonated (Figure 16)
- Very little calcite observed which implies the sample is old and extremely weathered

Carbonation throughout the depth of the historic concrete was determined by the phenolphthalein test. As discussed in section 3.2, concrete over time draws in CO<sub>2</sub> from the atmosphere and a chemical reaction occurs when it encounters the alkaline hydrates of the concrete and dissolves in the concrete pore water. Corrosion of the embedded reinforcing steel was present within the broken bench used for testing samples.

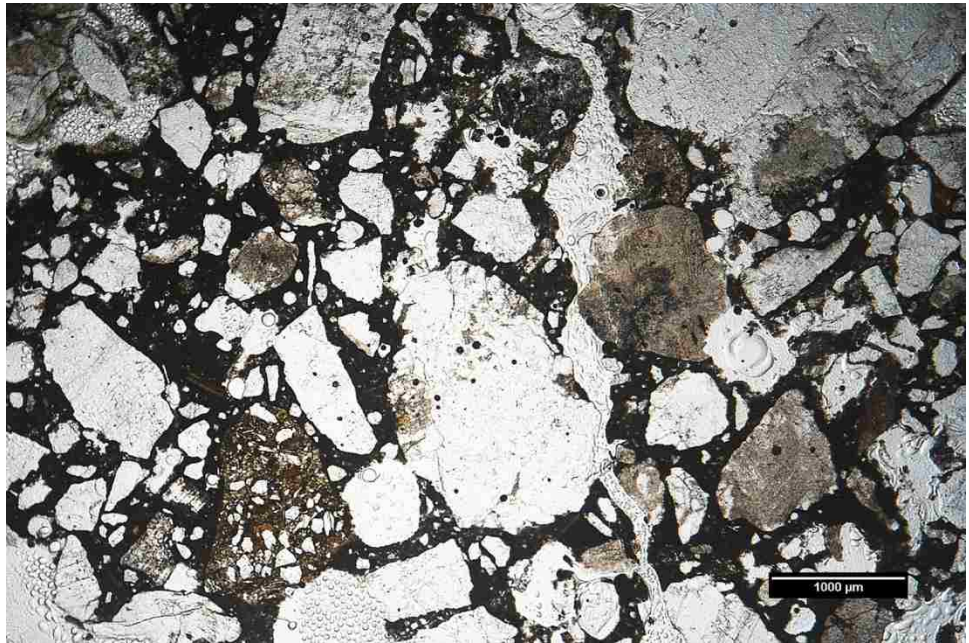
Figure 17. Aggregate with no signs of ASR (Source: DRP).

- Very minor deposits of ettringite were observed
- Aggregate is in good condition and did not show any signs of chemical attack or chemical reaction with the other concrete ingredients, ASR, in xpl (Figure 17)

The petrographic analysis further noted that although ASR is well-known durability issue in northern New Mexico, no evidence of reactions was observed on any of the samples. The report continues the findings may reflect initially low alkali content of the concrete and/or the pervasive carbonation of the concrete, which reduces pH to levels below that which ASR occurs.

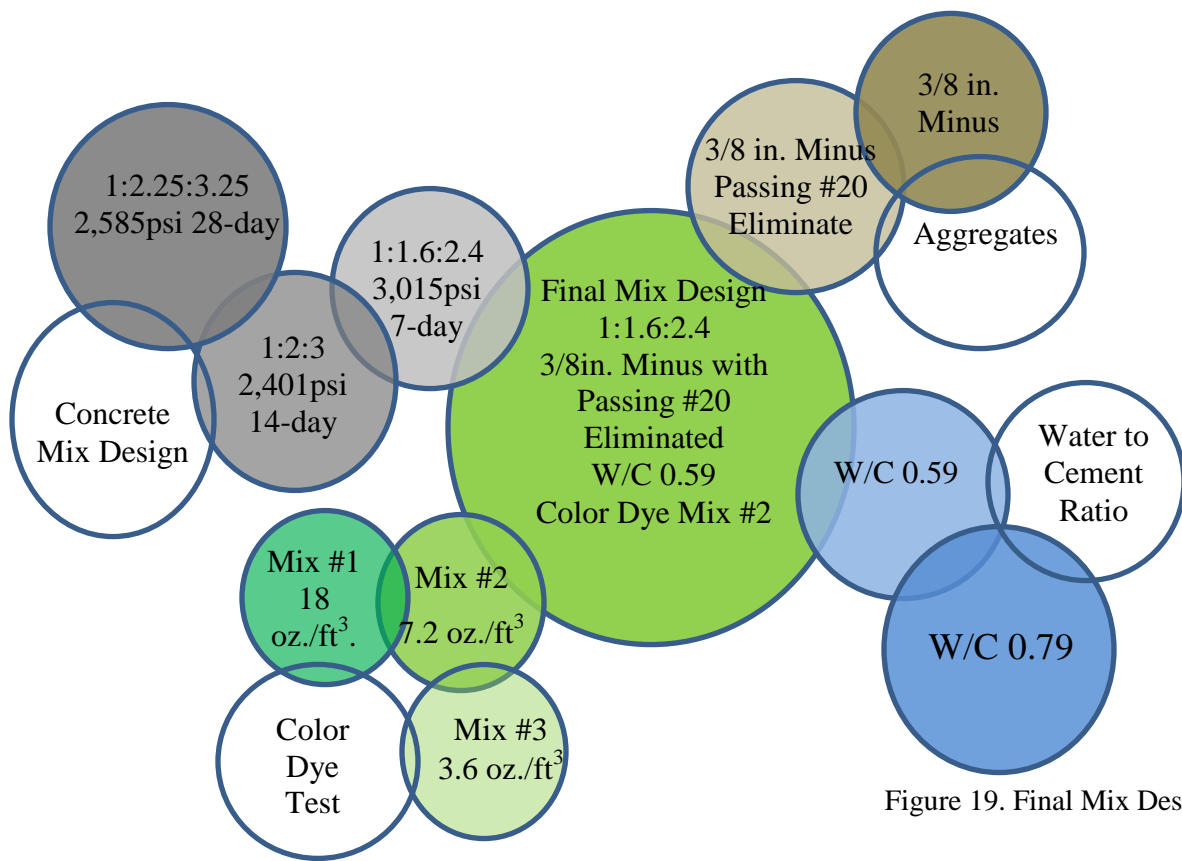
Figure 19. Final Mix Design

aggregates were eliminated by discarding coarse aggregates that passes the #20 sieve. The proportions for batch #2, 1:2:3, adjusted the amounts of both coarse and fine aggregates to improve the visual characteristics of the finished mix. A w/c of 0.59 was used in batch #2 to test for increased compressive strength. Added benefits of a reduced w/c include increased durability and resistance to weathering. This would be a benefit in the high desert and mountainous climate the historic picnic tables are located. Compression tests on batch #2, with the w/c of 0.59, initially showed a higher early strength at 7-day but quickly diminished by the 14-day break with results less than that of batch #1 at the same time period.

The non-destructive rebound hammer testing of the historic concrete, although documented as problematic for aged and carbonated concrete, produced an estimated current strength between 4,600 psi (32MPa) to 3,067 psi (21MPa) for 50% higher than that of un-carbonated concrete surfaces. Batch #3 was developed to be a higher strength material, than batch #1 and #2, in order to repair the picnic tables with a comparable concrete mix. Using the aggregate proportions from batch #2, and increasing the amount of cement by 25% and the water content to maintain a w/c of 0.59, batch #3 tested at the 7-day break to 3,015 psi (20.8 MPa) or  $0.98f'_c$  of the estimated current strength. Although the full 28-day testing was not accomplished due to constraints with use of the concrete lab, batch #3 is a vital mix design for restoration of the historic picnic tables in comparable strength and visual characteristics.
