## Accelerated repair and replacement of expansion joints

**Accelerated repair and replacement of expansion joints**

Major: Civil Engineering (Structural Engineering)

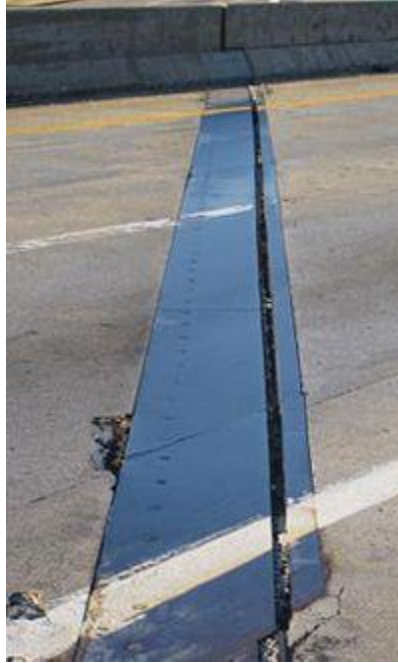
Sliding plate joints consist of one steel plate freely sliding over another steel plate embedded in the bridge deck. When the bridge expands and contracts, these plates are able to slide over one another to accommodate the movement. A typical sliding plate joint can be seen in Figure 2.1. Sliding plate joints are no longer used by the Iowa DOT in replacements or new construction, but there are still some older bridges that have these joints in place. Sliding plate joints are not water tight. Over time, these joints can experience severe failure to the steel plates. Rust formation can cause the two plates to fuse together, preventing any movement to occur and reducing the structural strength. This can lead to the plates separating from their attachments. This, in conjunction with extensive cyclic loading from traffic, leads to failure in sections of the joint.

**Figure 2.1** Typical sliding plate joint (MO DOT)

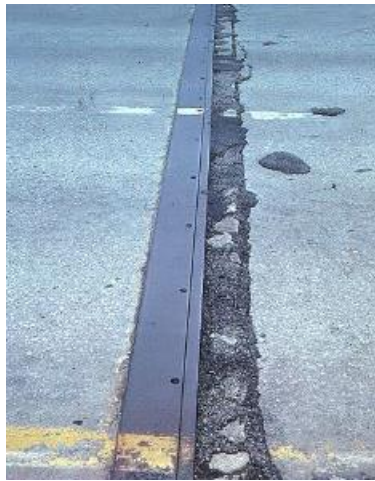
**Figure 2.2** Sliding plate fused and separated from abutment (Jahren & Miller)

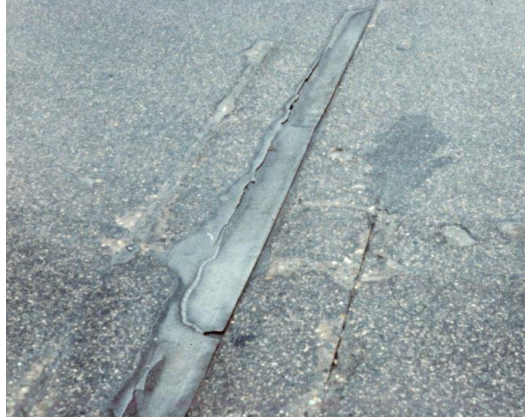
**Figure 2.3** Cracked sliding plate joint (Ohio DOT)

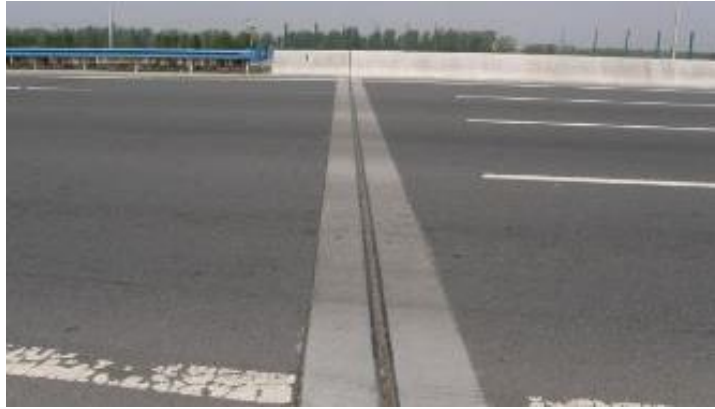
Strip seal joints consist of two steel extrusions embedded in the approach slab and bridge deck. A neoprene gland is then placed in the gap, attached to the steel extrusions. This gland provides a water barrier to protect the structural components below the joint and the flexible nature of the material allows it to move with the expansion and contraction of the bridge. A typical strip seal joint can be seen in Figure 2.4. Strip seals are becoming the most common joint used in expansion joint replacements for the Iowa DOT. The neoprene gland is usually the first part of the joint to fail after about 15 years. These glands can be removed and replaced with relative ease, and does not compromise the structural integrity of the joint. A strip seal joint typically only needs full replacement if damage has occurred to the steel extrusion due to rust or snow plow damage, or if there is severe spalling of the concrete header surrounding the joint.

**Figure 2.4** Typical strip seal joint (ArchiExpo)

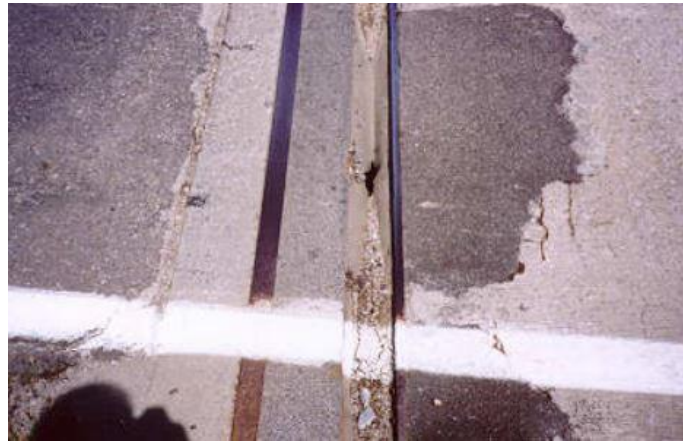
**Figure 2.5** Strip seal joint with punctured gland (Baker)

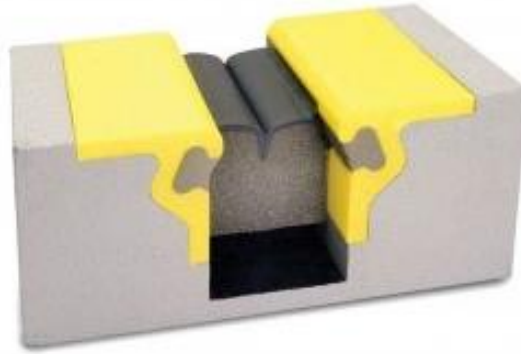
In recent years, a strip seal retrofit designed by EMSEAL has become increasingly popular as an option with Midwest DOTs. The EMSEAL bridge expansion joint system (BEJS) utilizes a compression seal that can be installed against the flat surface of the joint. This system is ideal for when a steel extrusion fails, but there is no major damage to the surrounding concrete. It can be installed with minimal, if any, demolition, and bypasses the need for a steel extrusion. A typical profile of the EMSEAL BEJS can be seen in Figure 2.6.

**Figure 2.6** EMSEAL BEJS retrofit schematic (EMSEAL)

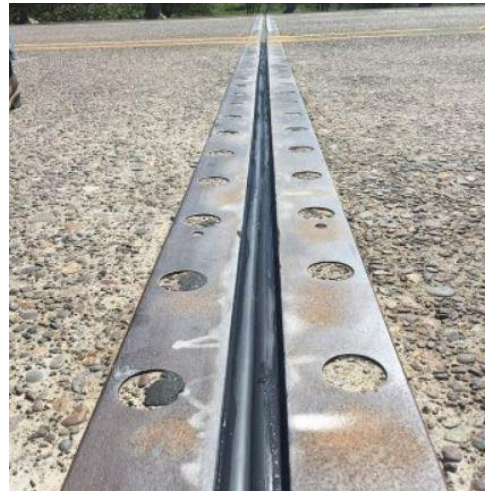
**Figure 2.7** EMSEAL BEJS retrofit (EMSEAL)

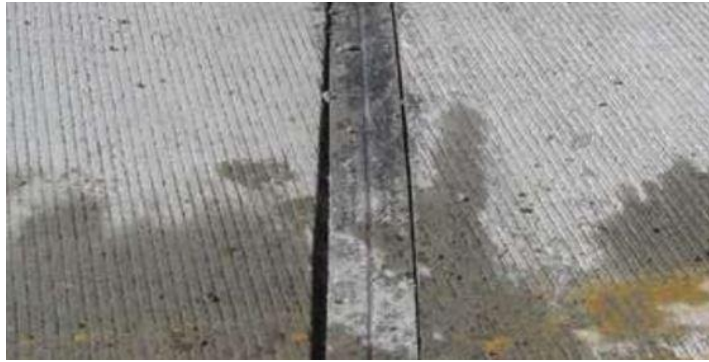
Compression joints consist of a compressive seal in the gap between the bridge deck and abutment concrete. A typical compression joint can be seen in Figure 2.8. Although compression joints are being phased out of use by the Iowa DOT, there are still many bridges in Iowa that use them. Compression joints have similar failure patterns to strip seal joints. The compression seal is typically the first thing to fail after around 10 years. With compression joints, it is optional whether or not to include a steel armor with the joint. If the steel armor is included, it typically fails due to rust or the cyclic loading of traffic.

**Figure 2.8** Typical compression joint (MO DOT)

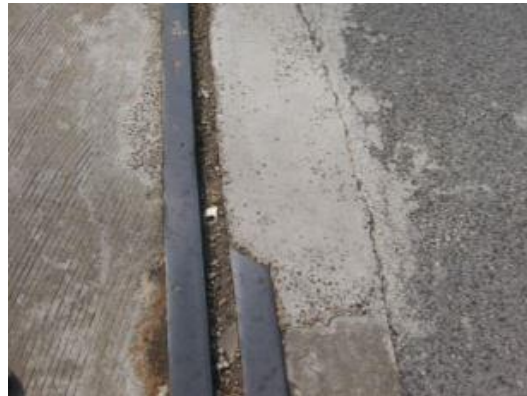
**Figure 2.9** Compression joint with broken anchor (Miller)

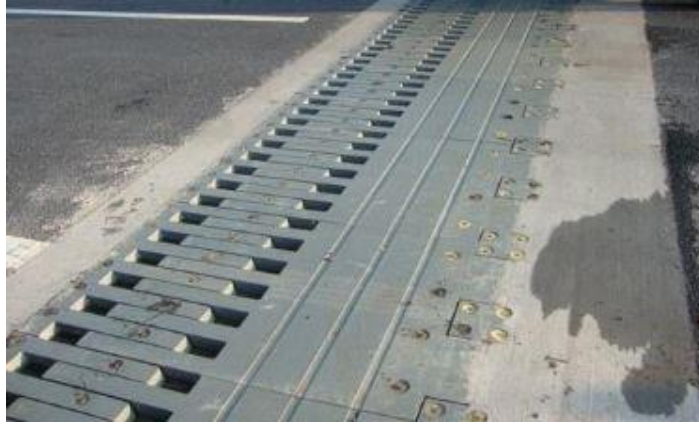
Finger joints and modular joints are typically used for larger bridges that require movement of more than 5 inches. Finger joints are comprised of interlocking “fingers,” while modular joints are a series of connected strip seals. Typical views of these two joints can be seen in Figure 2.10 and Figure 2.11. Both of these joints are very effective for larger bridges. When a component of either joint is damaged, it can simply be replaced without affecting the rest of the joint system. Finger joints are not water tight, however, which can lead to erosion of the soil below and/or damage to substructure elements. Modular joints fail similarly to strip seals, and can be repaired in a similar manner.

**Figure 2.10** Typical finger joint (Haider)

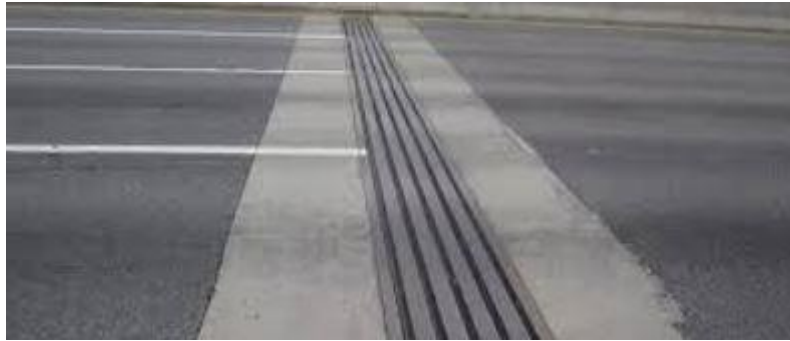
**Figure 2.11** Typical modular joint (Mayer)

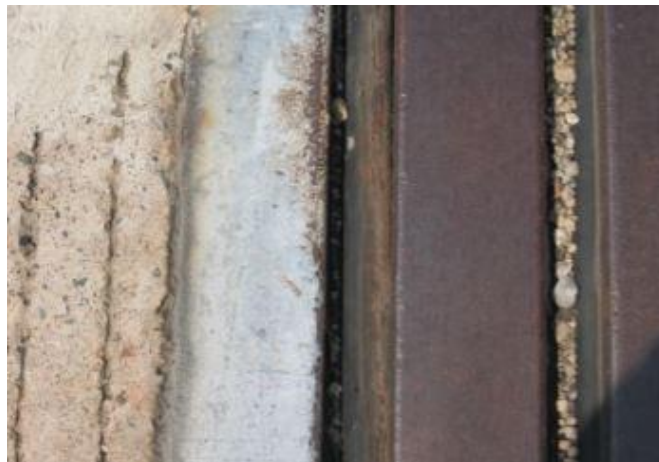
**Figure 2.12** Modular joint with debris, preventing closure (Miller)

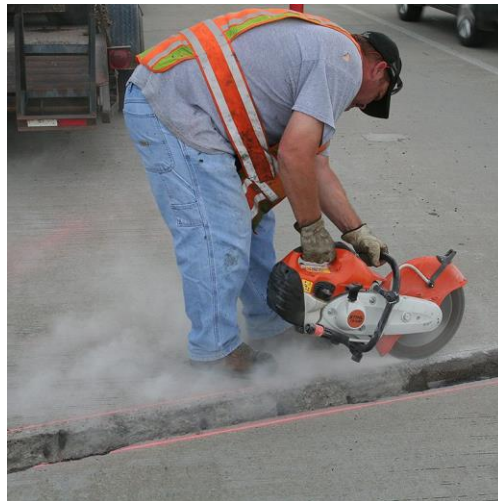
There are some concerns, however, with saw cutting in an accelerated context. Saw cutting leaves a smooth surface on the remaining concrete. This has the risk of creating a poor bond with the new concrete, and would likely need to be roughened before the placement of new concrete. This also means a potential loss of the existing reinforcing steel, requiring dowels to be installed. Saw cutting also requires a larger workforce and creates potential overcuts that would need to be filled (Phares and Cronin).

**Figure 2.13** Saw cutting (EMSEAL)

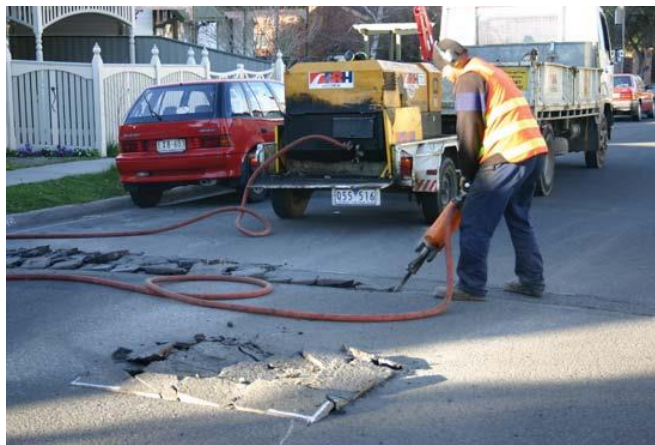
The largest drawback to pneumatic breakers for accelerated removal is the large workforce and time needed to complete the demolition. These are significantly longer than the other two demolition methods evaluated in this study. There is also some risk associated with the chiseling action of the pneumatic breaker. This mode of demolition can potentially cause micro-fracturing in the remaining concrete and damage the existing reinforcing steel.

**Figure 2.14** Pneumatic breaker (EMSEAL)

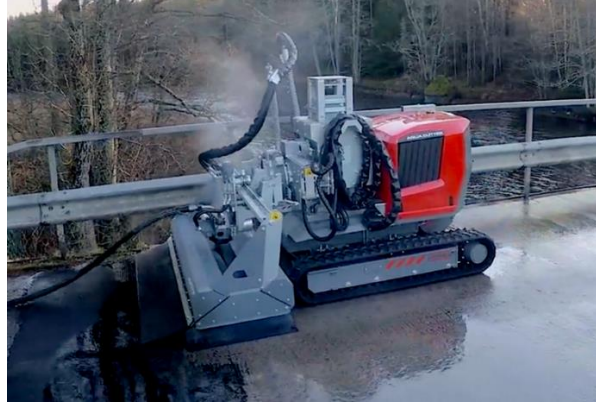
Hydrodemolition is the process of directing pressurized water to demolish concrete. Generally, the hydrodemolition unit is programmed and controlled by a walk-behind operator (Figure 2.15). The operator controls the rate of the water pressure, speed of the nozzle as it performs its passes, and the width of the demolition area. With the semi-automated equipment, a very small workforce is needed for hydrodemolition. Similar to pneumatic breakers, hydrodemolition leaves a rough surface that is likely good for concrete bonding. Unlike pneumatic breakers, though, hydrodemolition does no damage to the existing reinforcing steel (except perhaps to the epoxy coating) and results in minimal residual cracking in the remaining concrete. Hydrodemolition is also the fastest of the three demolition methods evaluated.

**Figure 2.15** Hydrodemolition equipment (Equipment world)

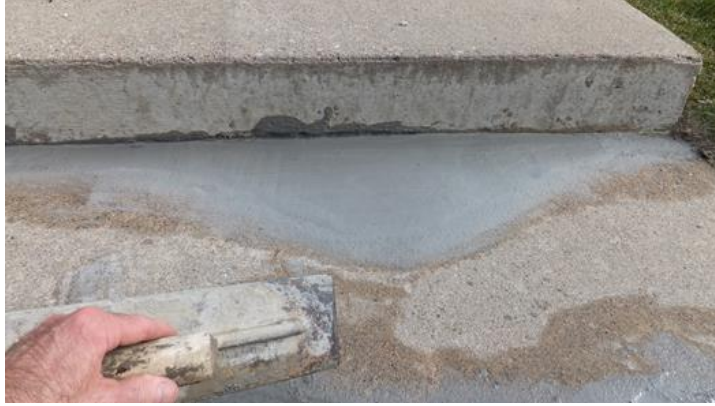
Historically, MPC has only been used for smaller patch jobs (Figure 2.16). With such a short working time, it may be difficult to use on larger expansion joint projects. MPC is documented to have been used by Alaska, Maryland, and Virginia DOTs (Burris 2015).

**Figure 2.16** Magnesium phosphate cement (Burris)

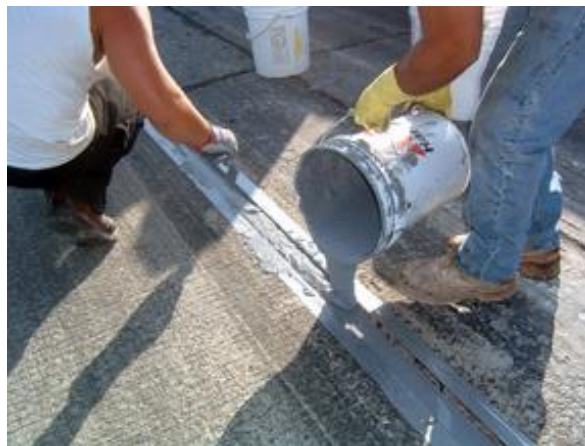
Elastomeric concrete is a mixture of a polymeric binder and aggregate that has been growing in popularity as an expansion joint repair material. It bonds well to concrete and steel and, unlike Portland cement concrete, has a very low spalling risk. Elastomeric concrete can be placed within 4-5 hours and opened to traffic roughly 3 hours after it sets (Gergely 2009). The service life of elastomeric concrete is approximately 25 years before it needs to be replaced.

**Figure 2.17** Elastomeric concrete (D.S. Brown)

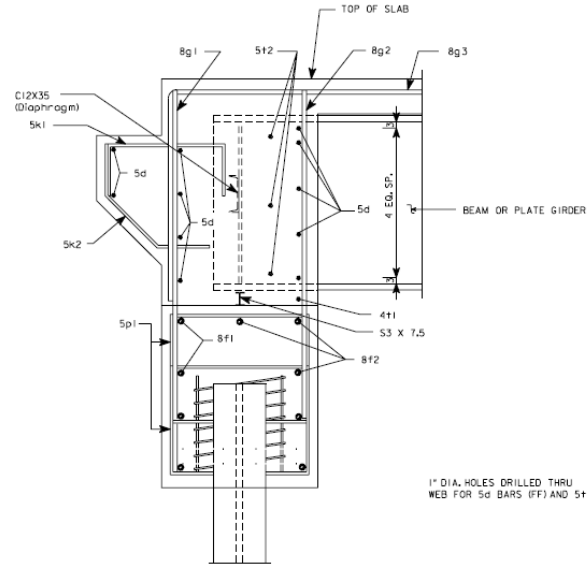
Integral and semi-integral abutments are similar to one another, and are options for joint elimination at the bridge deck-abutment interface. Both integral and semi-integral abutments can be constructed in an accelerated context when the main slabs are precast and sealed with a cast-in-place UHPC connector. In an integral abutment, the bridge girder ends are encased in the backwall, and the abutment moves along with the thermal movement of the bridge deck. A typical profile of an integral abutment can be seen in Figure 2.19.

**Figure 2.19** Typical integral abutment (Morandeira)

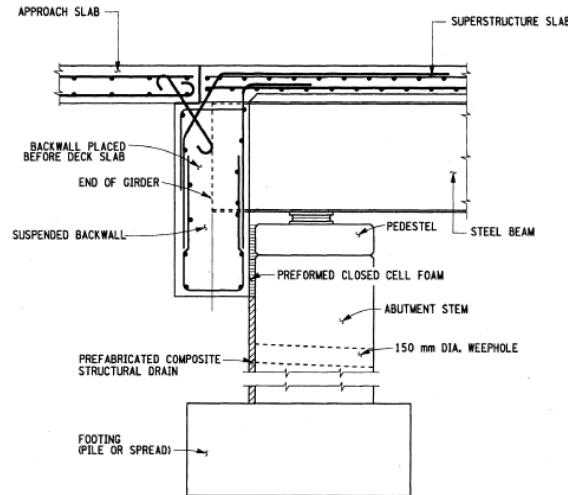
Semi-integral abutments differ from integral abutments in that semi-integral abutments still have the girders sit on a bearing pad. The girder ends are still encased in the backwall, but the bearing pads allow the foundation to be fixed instead of moving with thermal effects. Semi-integral abutments are typically used when it is not possible to use an integral abutment (due to length, skew, or other factors). They are also more common when being considered for a joint retrofit. A typical profile of a semi-integral abutment can be seen in Figure 2.20.

**Figure 2.20** Typical semi-integral abutment (Moranderia)

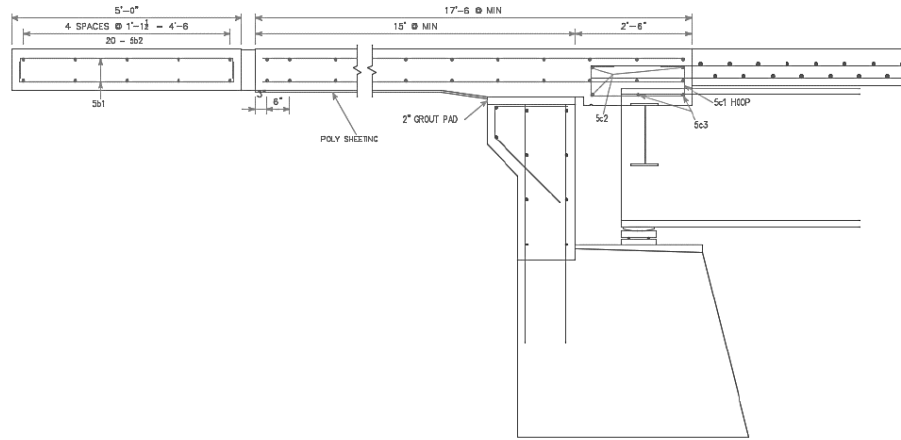
The deck over backwall concept was developed in phase three of Jahren's research into the accelerated repair of bridge expansion joints. This concept explores the idea of moving the expansion joint that is typically at the abutment into the bridge approach slab. This allows any water that seeps through the joint to flow into the soil beneath, instead of damaging the substructure. Similar to integral and semi-integral abutments, the use of precast panels and cast-in-place UHPC connectors could be used to accelerate the construction of this system. A preliminary Iowa DOT detail of the deck over backwall concept can be seen in Figure 2.21.

**Figure 2.21** Preliminary deck over backwall design (Morandeira)

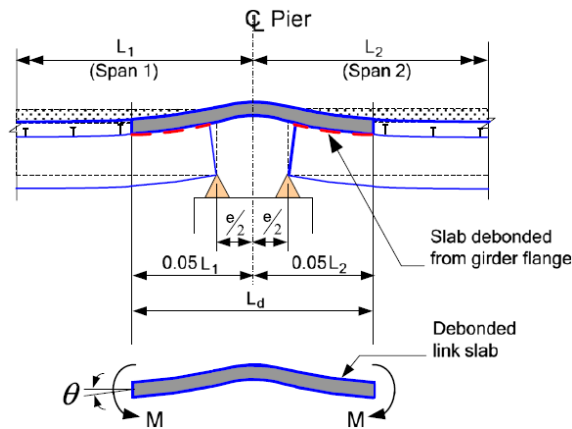
Link slabs are a common way to replace expansion joints over bridge piers. The slab is debonded from the girder to allow for rotation due to thermal movement of the bridge deck. UHPC has been used for link slabs previously, and can be adapted for accelerated construction using one of many fast-setting concrete mixes. Ductal's JS1212 mix of UHPC is one such option that would cure quickly. A typical link slab can be seen in Figure 2.22.

**Figure 2.22** Typical link slab (Morandeira)

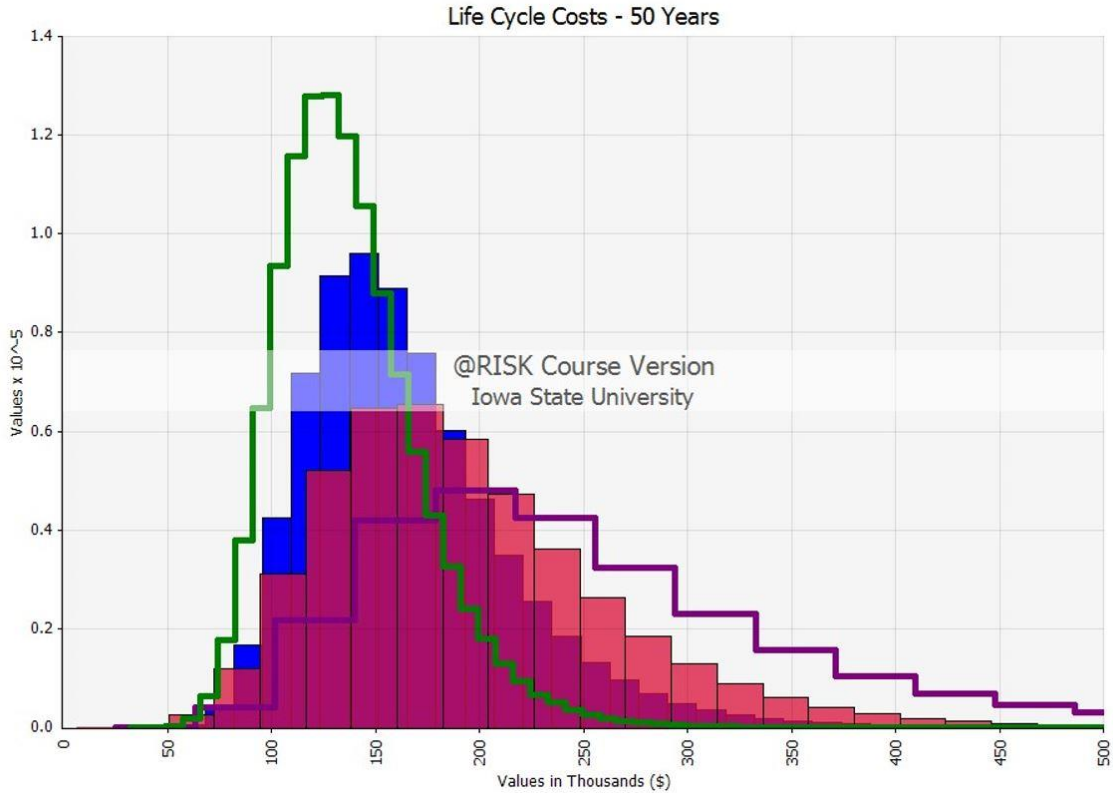
**Figure 4.1** Cost distribution for 30' bridge, 50-year bridge life

For a 30' bridge with a 50 year life, the most cost effective option is scenario 3, utilizing hydrodemolition, UHPC, and an A36 railing. This is due to the use of the EMSEAL BEJS after the A36 railing. This delays the need for a full replacement of the expansion joint beyond the scope of a 50 year life cycle. When comparing the proposed replacement (scenario 2) to current practices (scenario 1), the proposed replacement estimates a lower cost in all three cost categories.

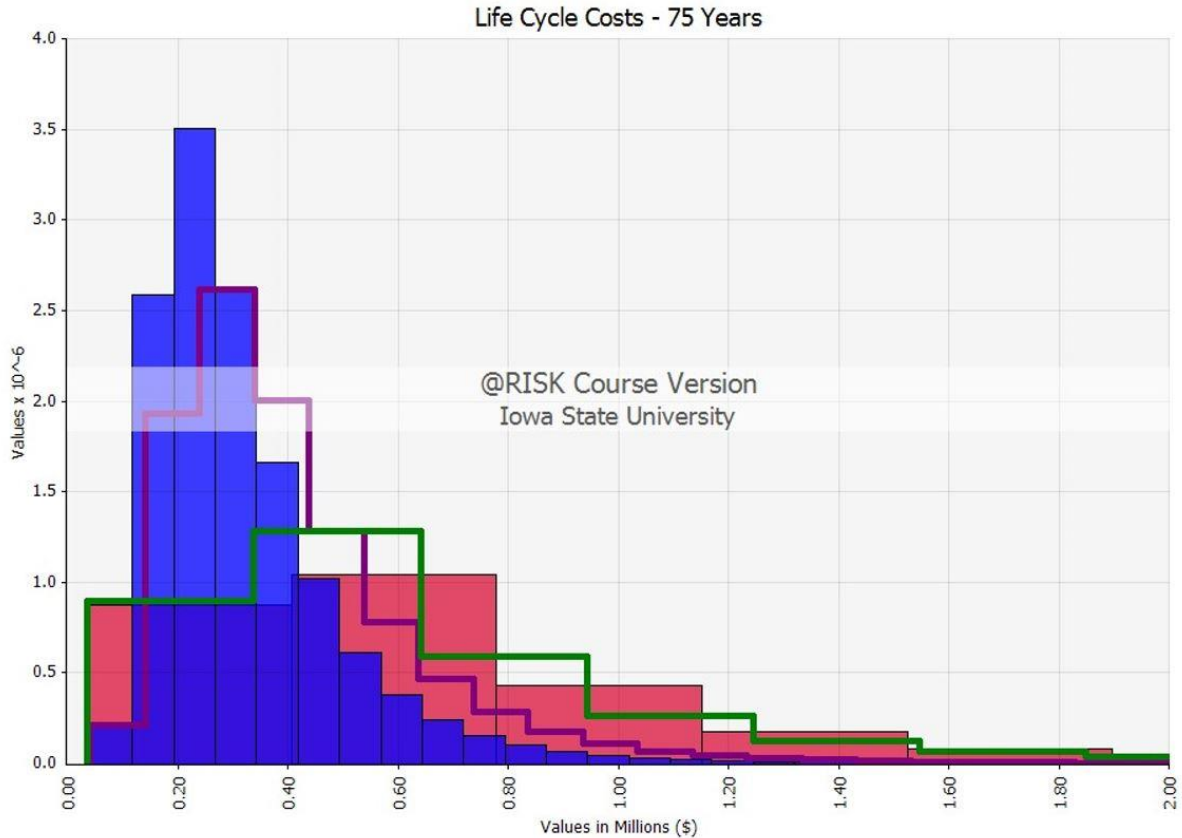
**Figure 4.2** Cost distribution for 30' bridge, 75-year bridge life

For a 30' bridge with a 75 year life, the proposed replacement (scenario 2) surpasses scenario 3 for the lowest estimated life cycle costs. The most likely cost of the proposed replacement is about \$125,000 less than current practices, with the current practices (scenario 1) becoming the highest estimated costs of all the scenarios.

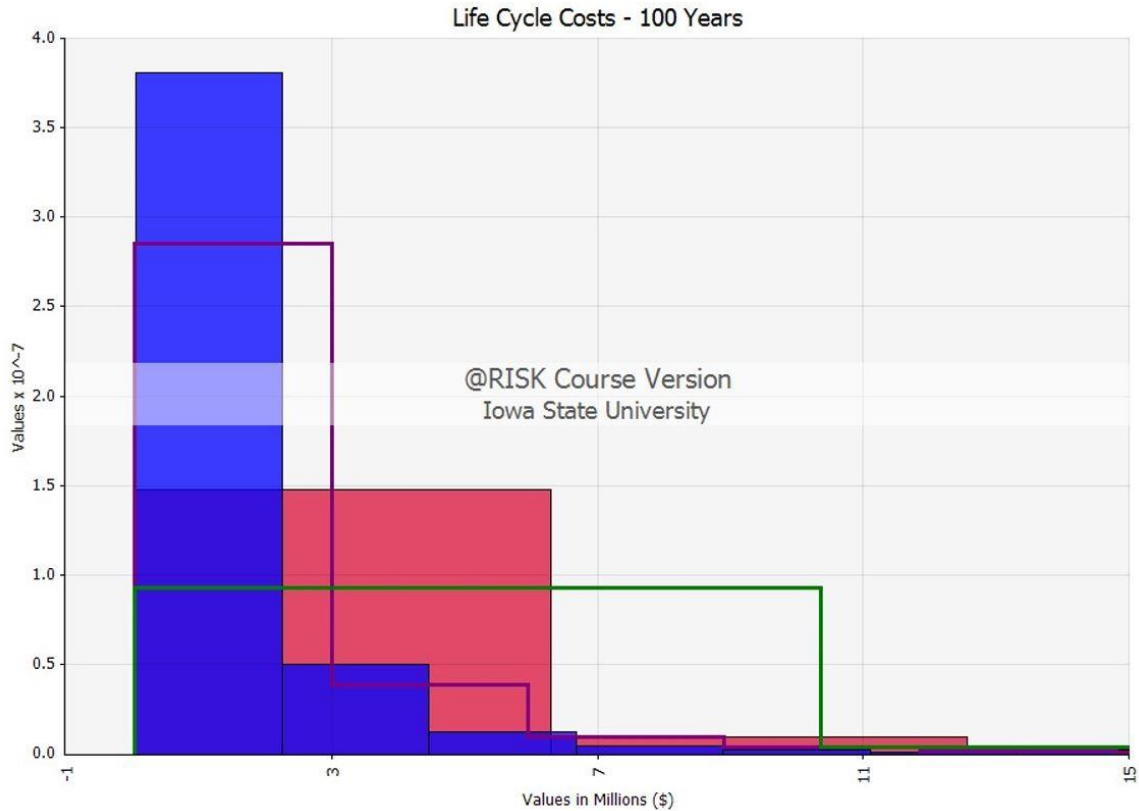
**Figure 4.3** Cost distribution for 30' bridge, 100-year bridge life

For a 30' bridge with a 100 year life, the proposed replacement (scenario 2), utilizing hydrodemolition, UHPC, and a stainless steel rail, has the lowest estimated life cycle costs. The current practices (scenario 1) and scenario 3 have similar estimations for the highest life cycle costs. Scenario 4, utilizing a pneumatic breaker, PCC, and a stainless railing, has a considerably lower cost than scenarios 1 and 3. This is mostly due to the extended joint life the stainless steel railing provides.

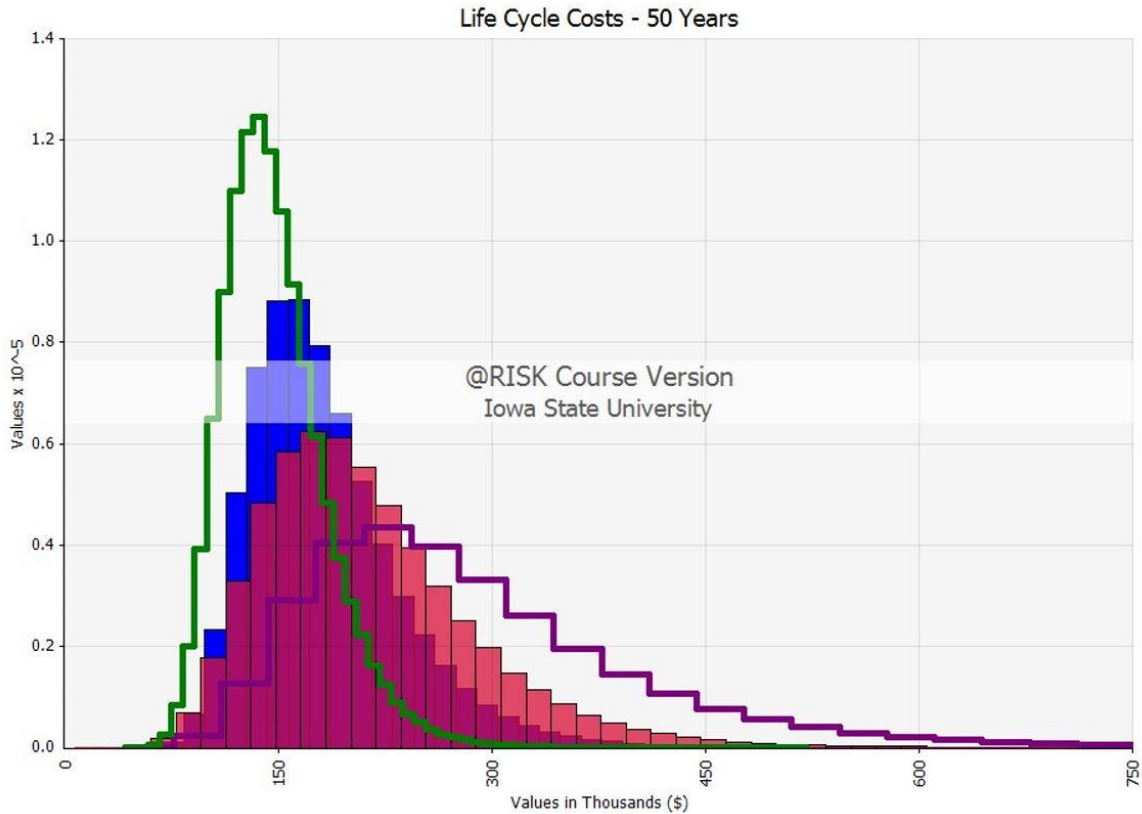
**Figure 4.4** Cost distribution for 44' bridge, 50-year bridge life

The trends identified in the 30' bridge analysis are also present for the 44' bridge. For a 50 year life, the lowest estimated cost is, again, for scenario 3 with the use of the EMSEAL BEJS retrofit. The proposed replacement (scenario 2) also still has a lower life cycle cost than the current practices (scenario 1).

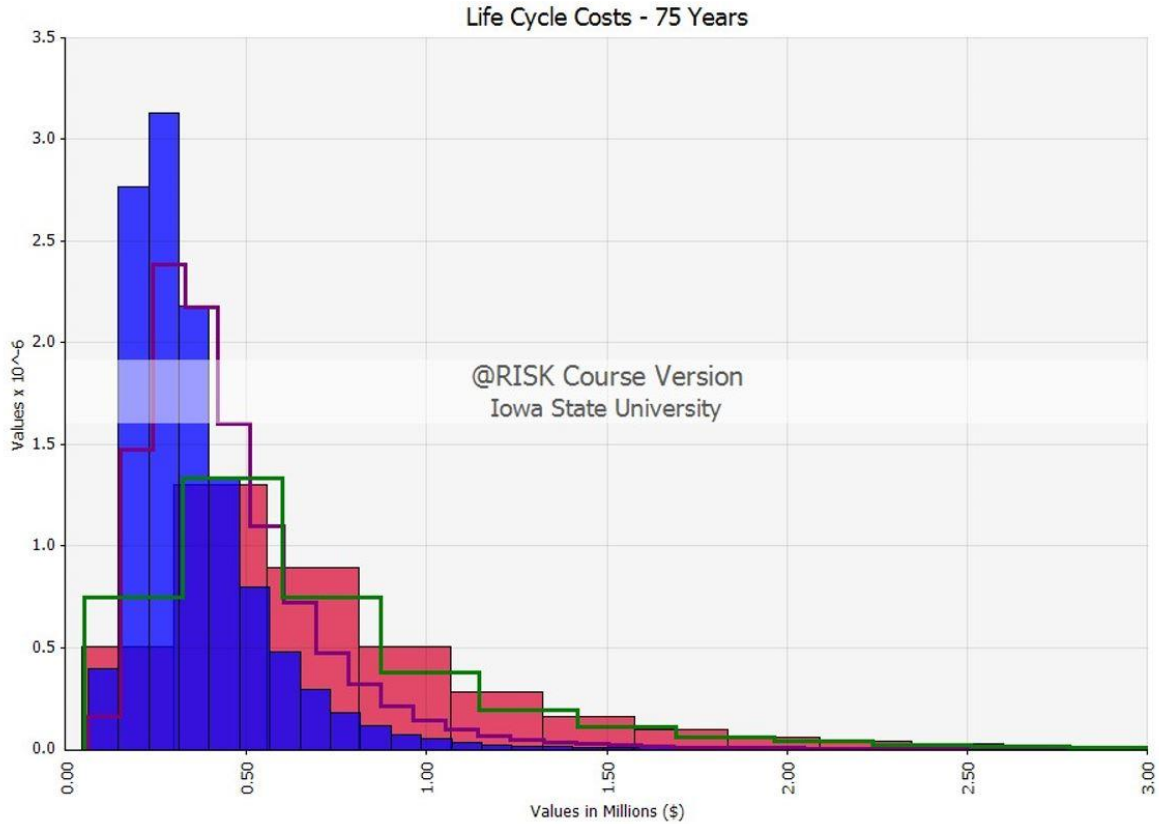
**Figure 4.5** Cost distribution for 44' bridge, 75-year bridge life

For a 44' bridge with a 75 year life, the proposed replacement (scenario 2) surpasses scenario 3 for the lowest estimated life cycle costs like the 30' bridge. The most likely cost of the proposed replacement is about \$170,000 less than current practices, with the current practices (scenario 1) becoming the highest estimated costs of all the scenarios.

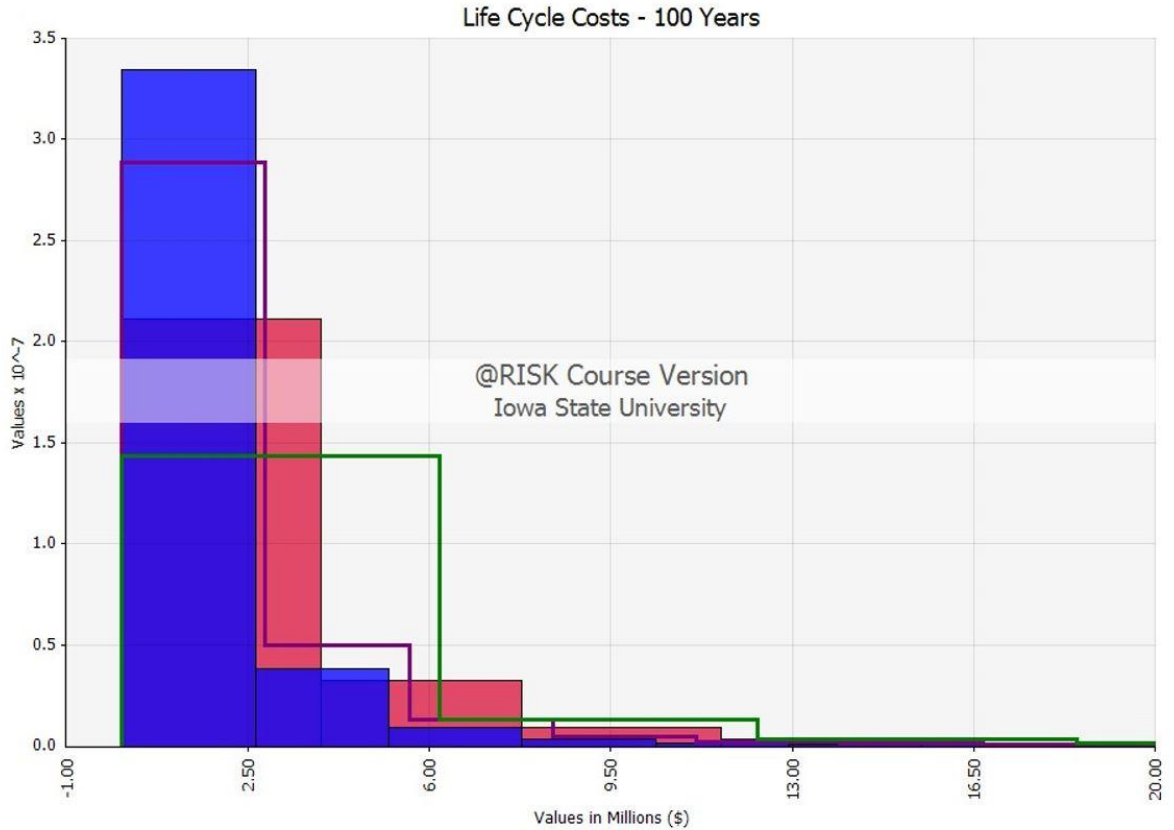
**Figure 4.6** Cost distribution for 44' bridge, 100-year bridge life

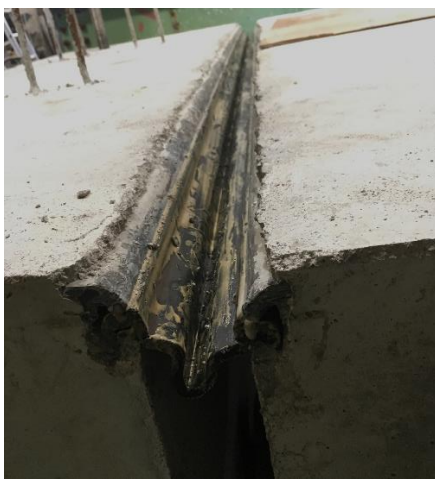
**Figure 5.1** D.S. Brown A2R-400 strip seal (Ruble)

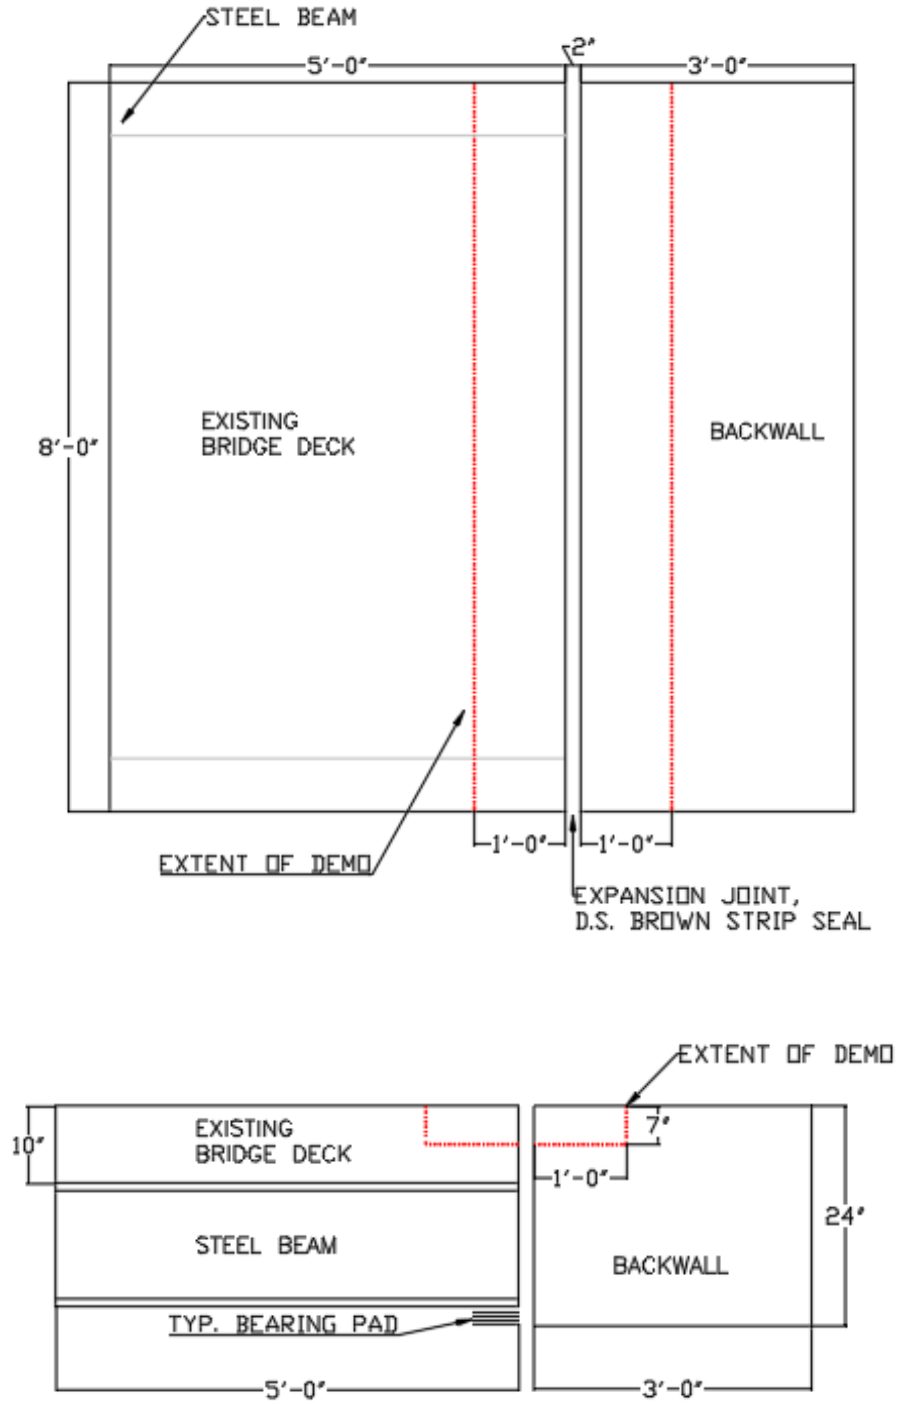
When replacing the expansion joint, a 1' strip of concrete was removed with hydrodemolition on both sides of the joint to a depth of 7". This demolition area allowed the existing steel extrusion to be removed and replaced with a new steel extrusion. This concrete was replaced with UHPC.

Figure 5.2 Geometry of lab specimen (Ruble)

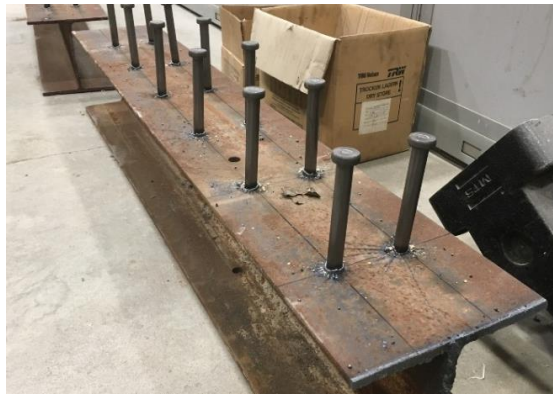
The existing bridge deck section was supported by two 11” deep steel beams. The two steel beams are on the outer ends of the width of the section, which mimics the spacing of typical girders on a DOT bridge. The beams have shear studs in the top flanges, embedded into the concrete of the bridge deck (Figure 5.3). The beams were 5’ long.

**Figure 5.3** Shear studs on steel beams (Ruble)

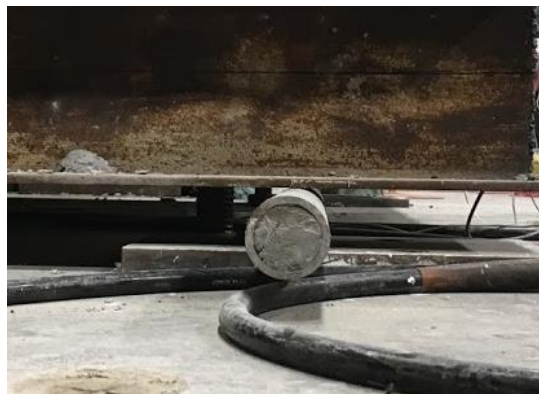
The end of the existing bridge deck near the joint sits on 3” bearing pads. The other end of the existing bridge deck is supported by a steel pipe filled with concrete. This filled pipe acts as a roller, allowing the specimen to move freely horizontally. The roller is supported by a steel section in order to maintain a level surface on the specimen (Figure 5.4).

**Figure 5.4** Bridge deck roller support (Ruble)

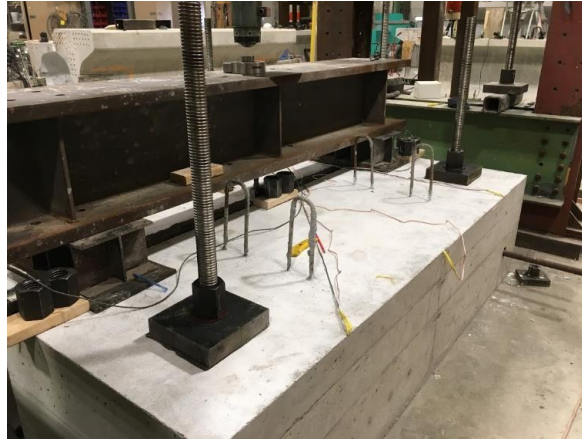
The backwall section of the specimen sat directly on the floor. The end of this section is tied down to the strong floor of the laboratory, allowing it to act as a fixed support (Figure 5.5).

**Figure 5.5** Backwall fixed support (Ruble)

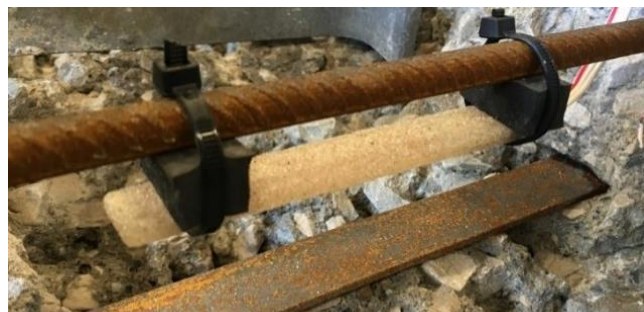
**Figure 5.6** Embedded concrete strain gauge (Ruble)

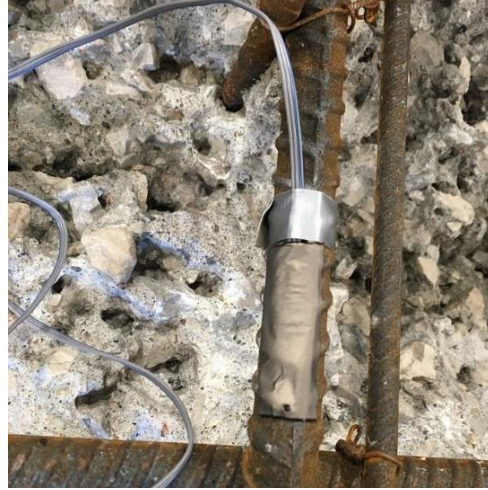
**Figure 5.7** Reinforcing strain gauge (Ruble)

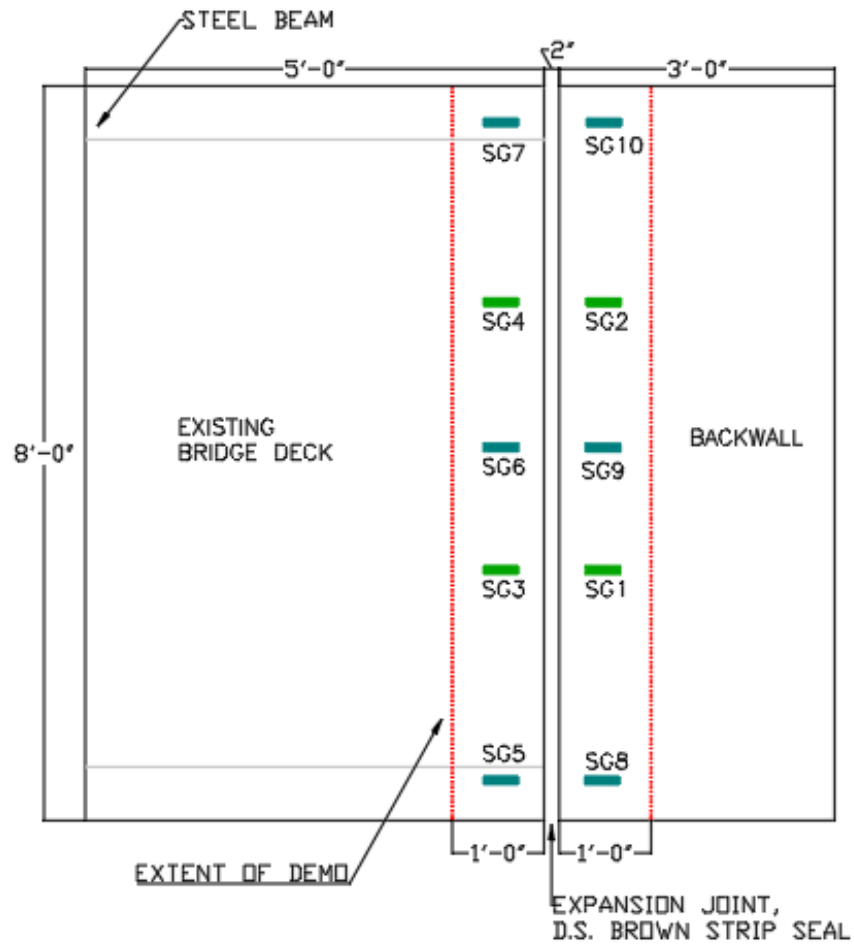
Strain gauges were used to measure the strain throughout the expansion joint. Four reinforcing steel strain gauges were used (SG1-4), two on each side of the joint within the demolition area. They were placed one-third and two-third the length of the joint. Six embedded concrete strain gauges were used (SG5-10). They were placed on the end and middle of the joint on both sides. These locations and labels can be seen in Figure 5.6.

**Figure 5.6** Strain gauge layout (Ruble)

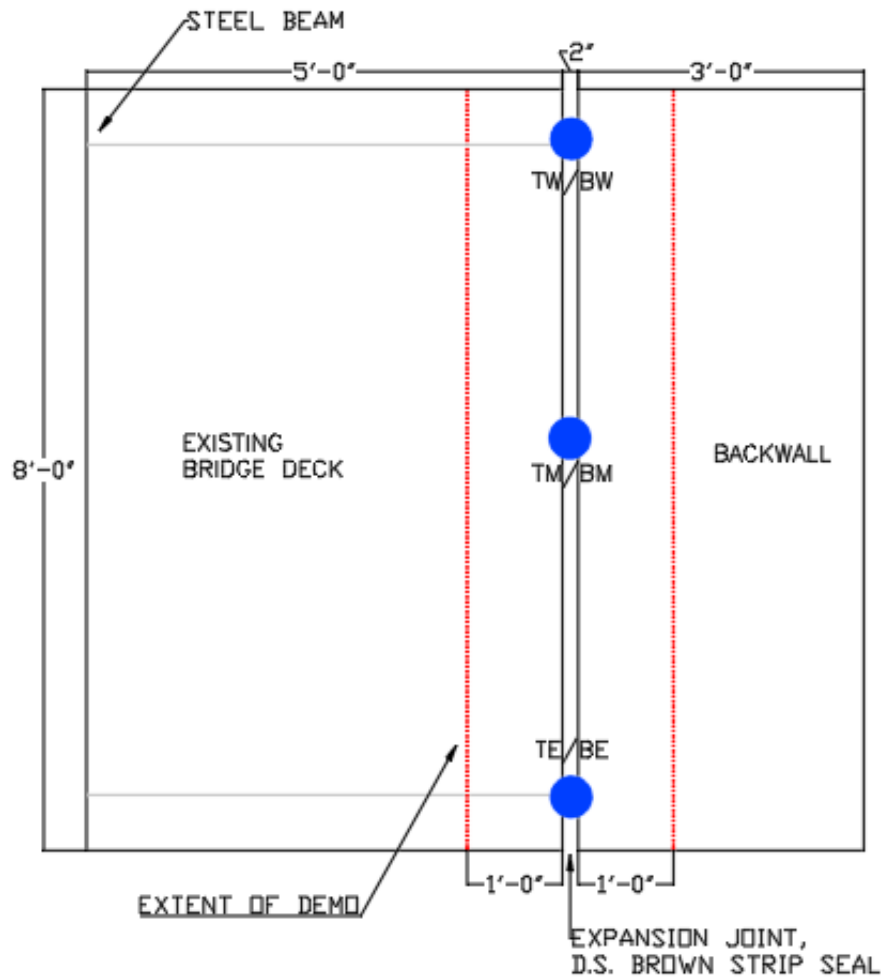
String potentiometers were used to measure any displacement that occurred during testing. Three string potentiometers were placed over the joint to measure horizontal displacement and three string potentiometers were placed below the joint to measure vertical displacement. The locations of the string potentiometers can be seen in Figure 5.. The string potentiometers on top of the specimen have labels beginning with “T”, while the string potentiometers below the specimen have labels beginning with “B.”

**Figure 5.9** String potentiometer layout (Ruble)

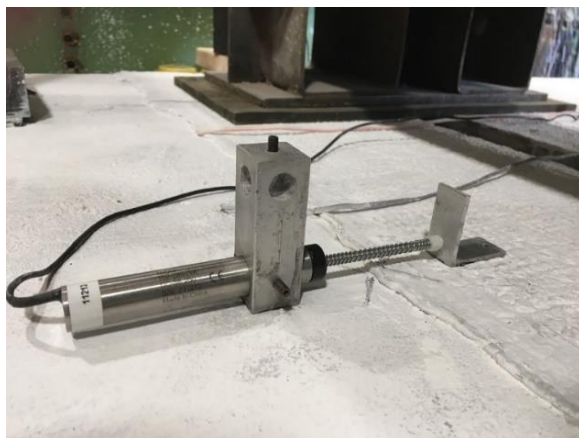
**Figure 5.7** Direct current linear variable differential transformer (Ruble)

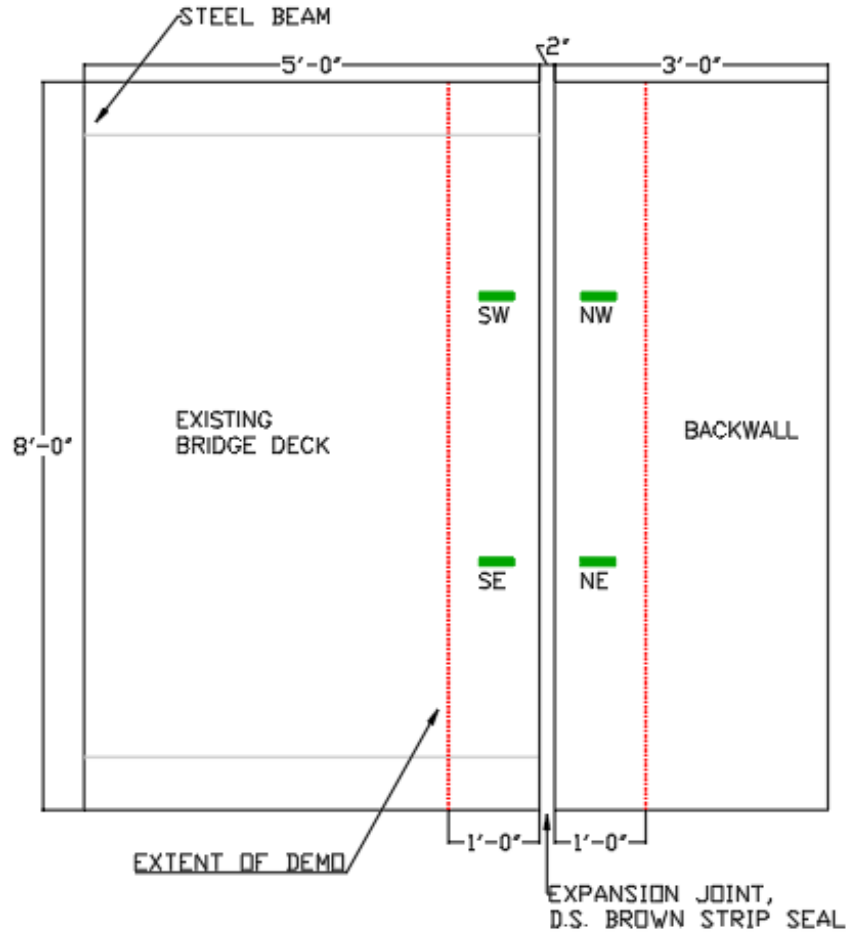
DCDTs were used to measure any displacement that occurred at the interface between the new UHPC and the existing concrete. Four DCDTs were used, two on either side of the joint. They were placed at one-third and two-third the length of the joint. The locations and labels of the DCDTs can be seen in Figure 5.8.

**Figure 5.8** DCDT layout (Ruble)

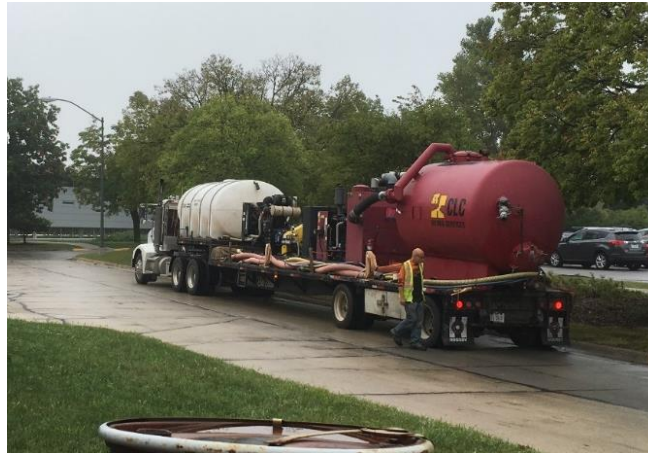
**Figure 5.10** Water tank truck (Ruble)

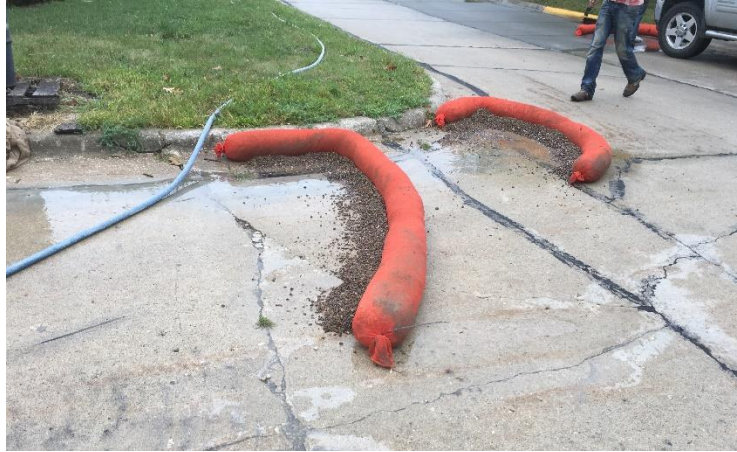
The mobilization for the hydrodemolition took approximately 3 hours. This included filling up the water tank from the fire hydrant, positioning the Aqua Cutter onto the test specimen, hooking up the Aqua Cutter to the water tank, and setting up the wastewater filtering systems. For this project, a series of filter socks and pea gravel were used to filter the concrete particulates out of the water before it entered the storm drain (Figure 5.11).

**Figure 5.11** Filter socks (Ruble)

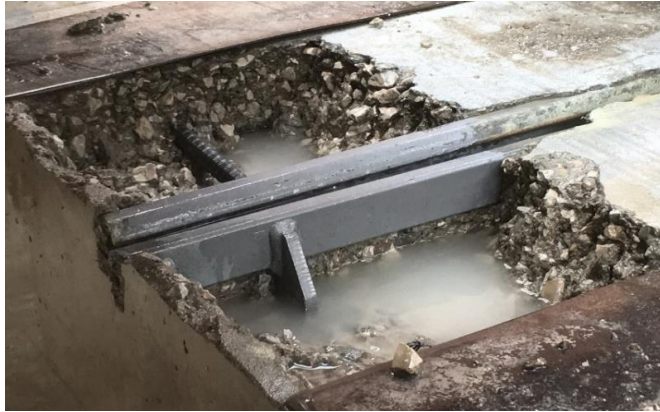
section. It took the Aqua Cutter approximately 10 minutes to complete one foot of demolition. Periodically, CLC Hydro Services would pause the Aqua Cutter to check on the progress of the demolition and make sure no unwanted damage was occurring. The demolition took approximately two hours from the start of the trial-and-error process to the completion of demolition. When the Aqua Cutter completed the demolition of the expansion joint, CLC Hydro Services cleaned the demolition area and removed the excess water from the joint.

**Figure 5.12** Hydrodemolition progress (Ruble)

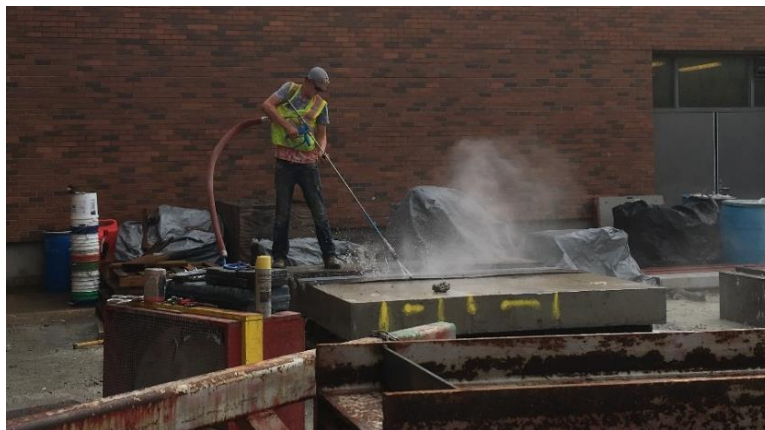
**Figure 5.13** Cleaning the joint after hydrodemolition (Ruble)

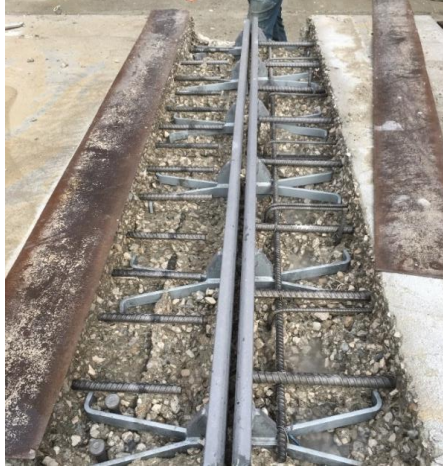
**Figure 5.14** Completed hydrodemolition (Ruble)

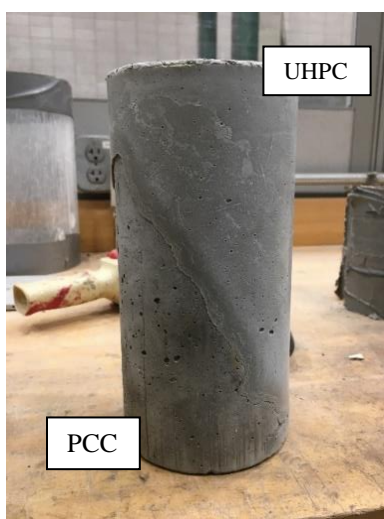
The slant shear test utilizes three cylinders made with half UHPC and half traditional concrete. The two materials are joined at a 30 degree angle at the halfway point in the cylinders. When a compressive force is applied to these cylinders, they will eventually fail along the 30 degree joint line (Figure 5.15).

**Figure 5.15** Slant shear cylinder test (Ruble)
