## Accelerated repair and replacement of expansion joints

**Accelerated repair and replacement of expansion joints**

Major: Civil Engineering (Structural Engineering)

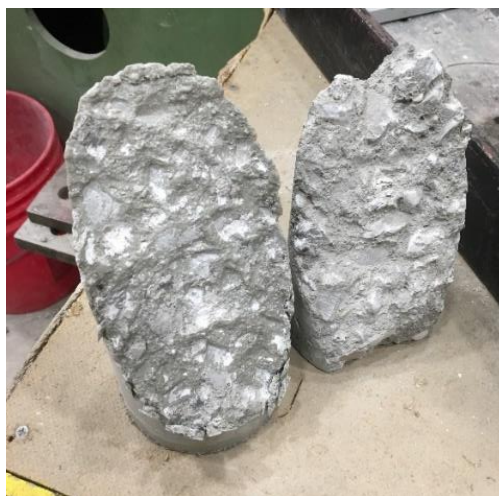
**Figure 5.16** Cylinder 1 slant shear failure (Ruble)

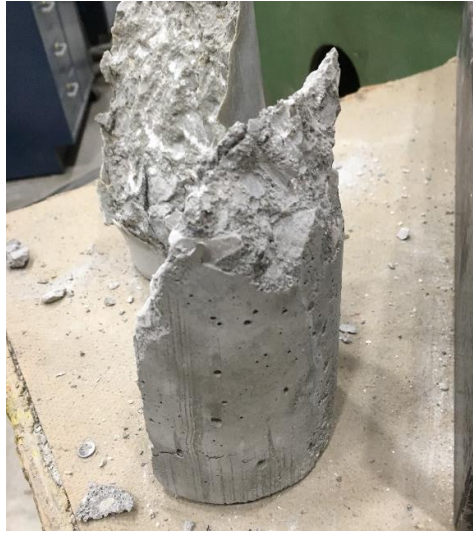
**Figure 5.17** Cylinder 2 slant shear failure (Ruble)

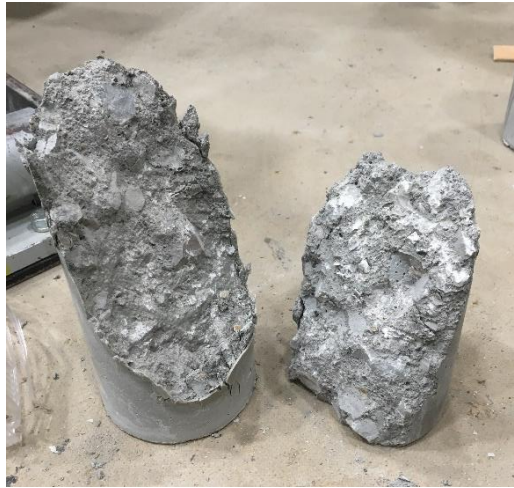
**Figure 5.18** Cylinder 3 slant shear failure (Ruble)

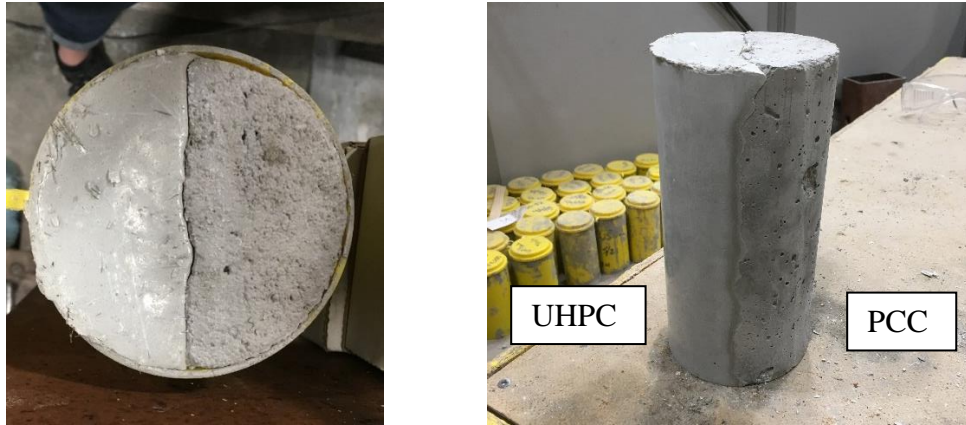
**Figure 5.19** Split cylinder interface (Ruble)

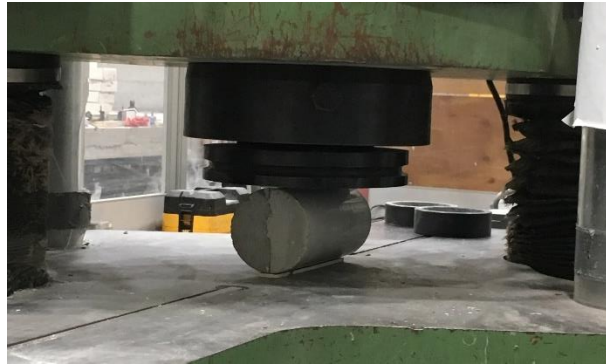
**Figure 5.20** Split cylinder test (Ruble)

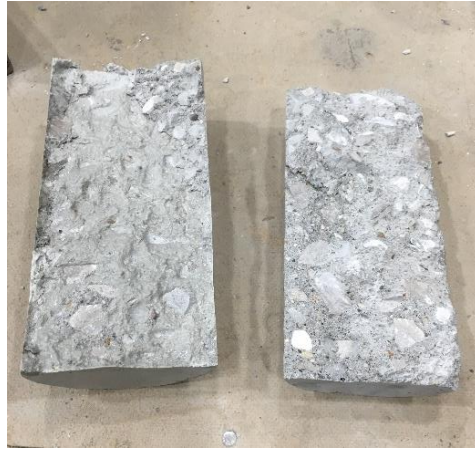
**Figure 5.21** Cylinder 1 split cylinder failure (Ruble)

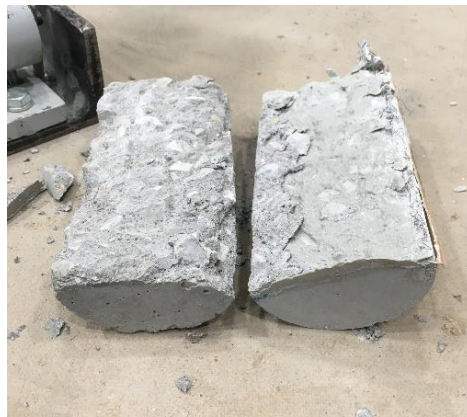
**Figure 5.22** Cylinder 2 split cylinder failure (Ruble)

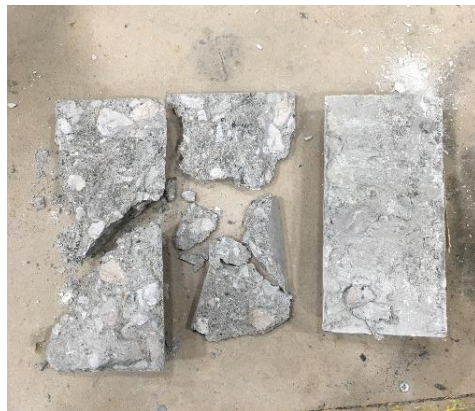
**Figure 5.23** Cylinder 3 split cylinder failure (Ruble)

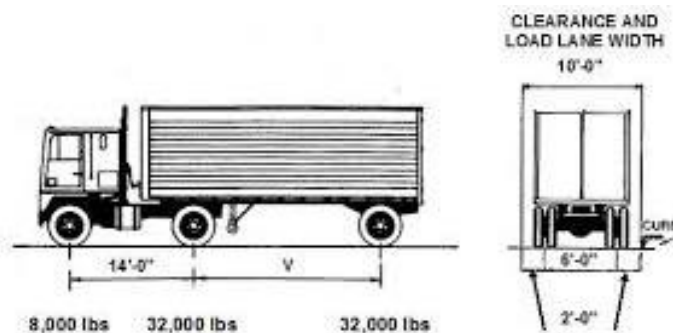
**Figure 5.24** HS-20-44 truck (Morandeira)

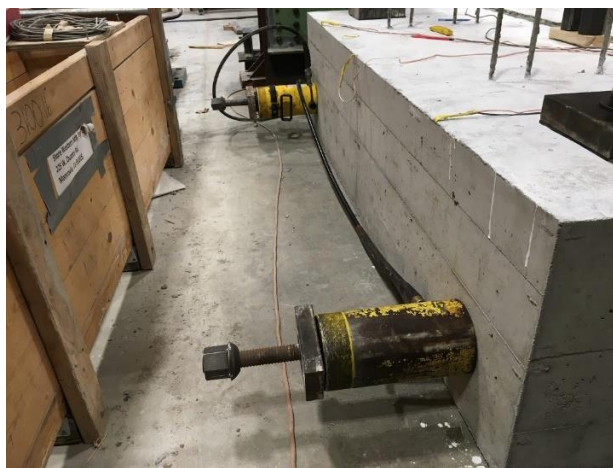
**Figure 5.25** Actuators used to mimic thermal loading (Ruble)

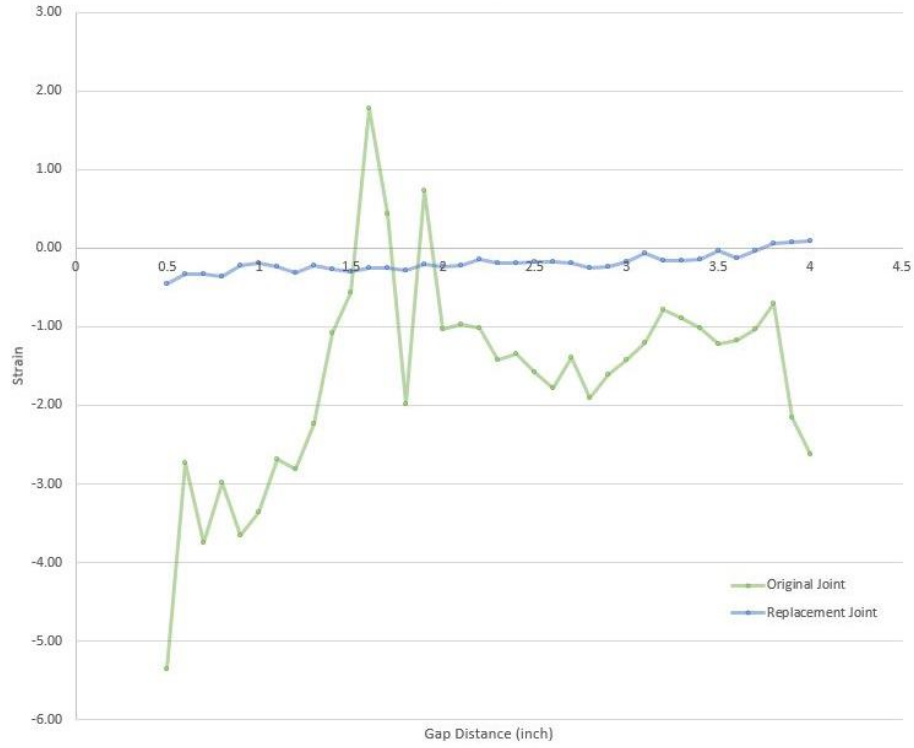
**Figure 5.26** Average concrete strain, thermal performance test (Ruble)

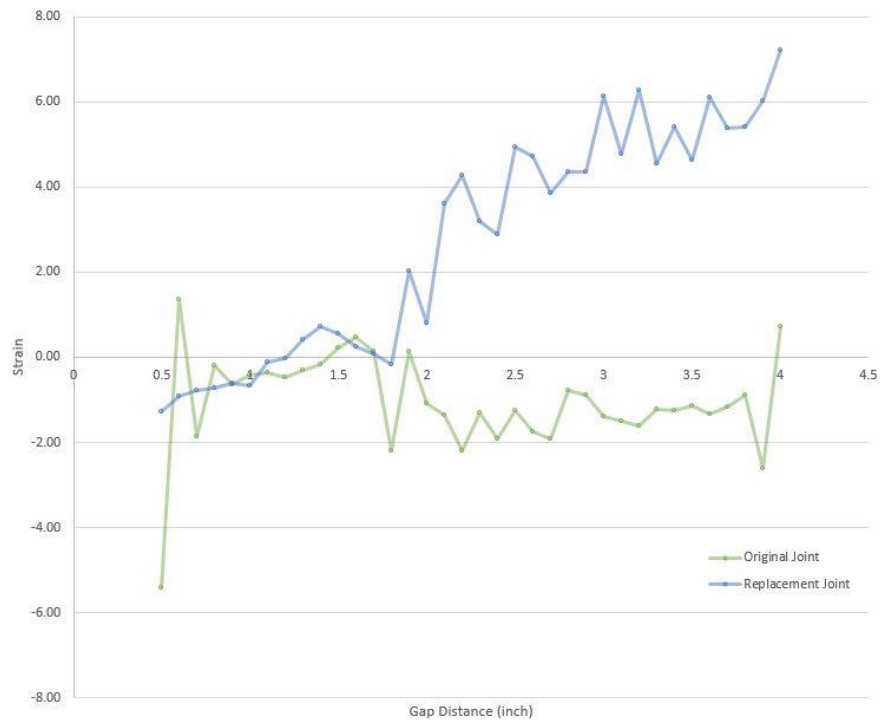
**Figure 5.27** Average reinforcing strain, thermal performance test (Ruble)

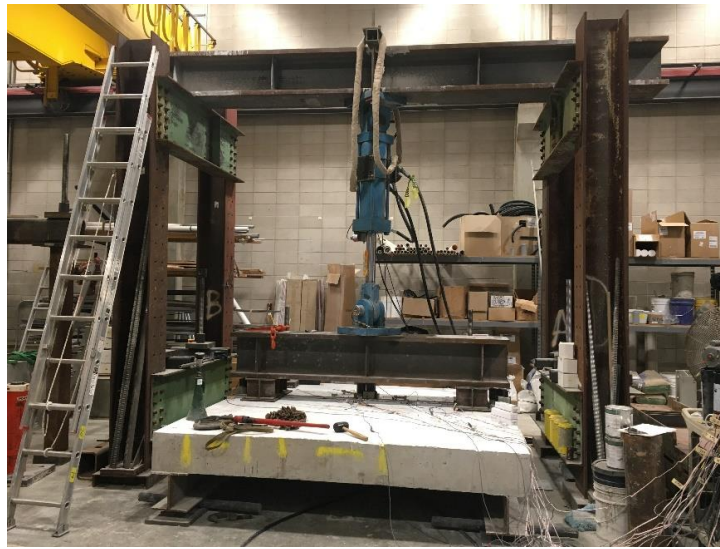
**Figure 5.28** Fatigue loading set up (Ruble)

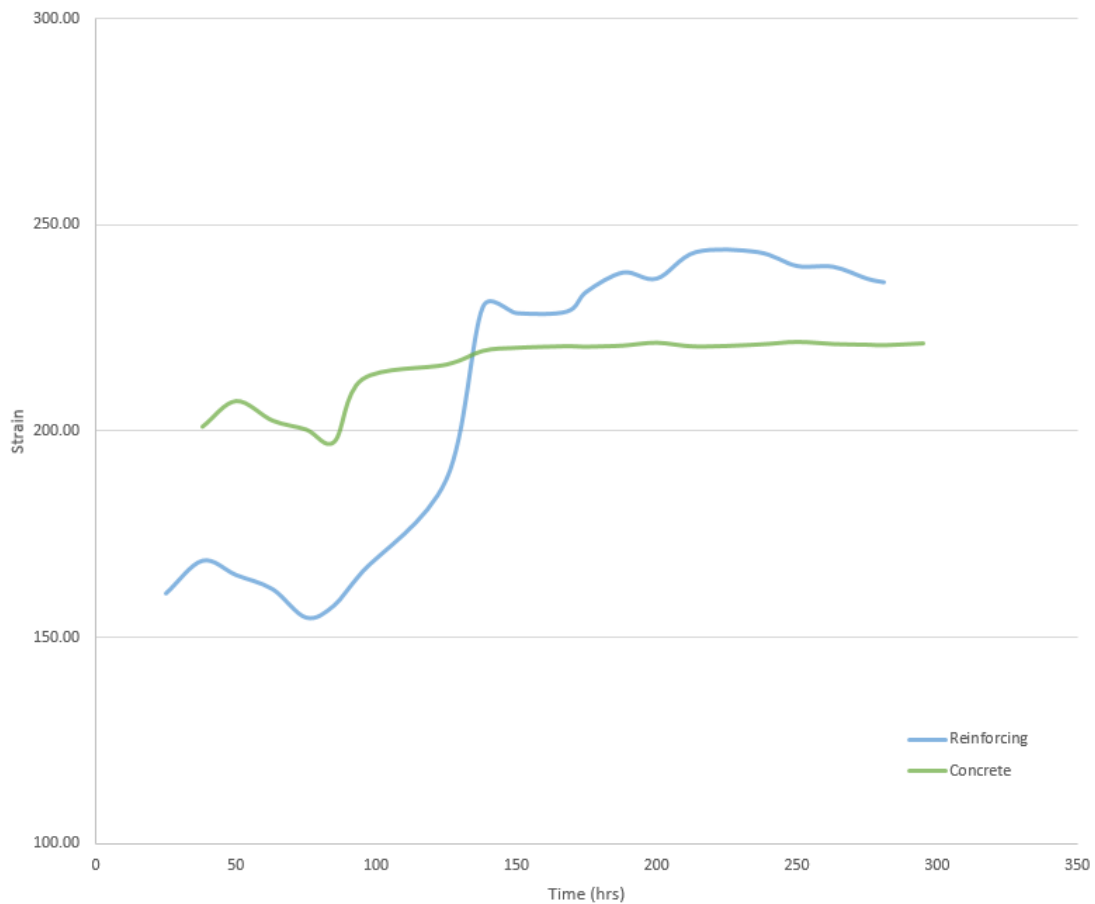
**Figure 5.29** Average strain over time (Ruble)

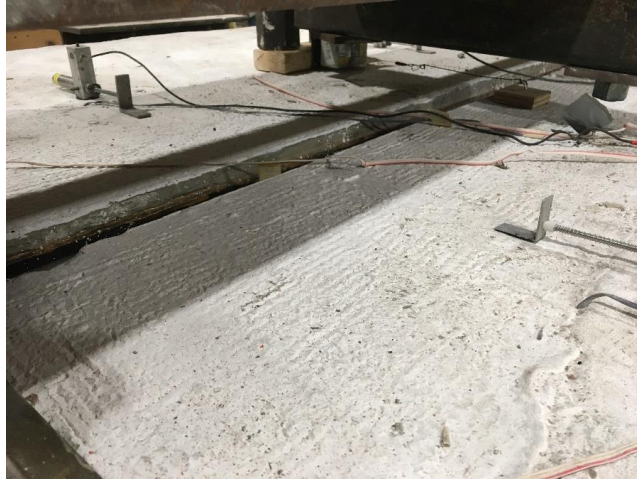
**Figure 5.30** Visual inspection of specimen (Ruble)

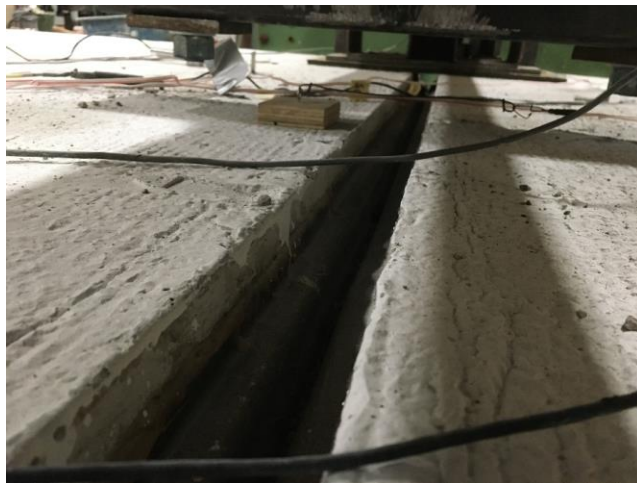
**Figure 5.31** Visual inspection of joint (Ruble)
