## An Investigation of Surface Characteristics of Enamel Treated with Infiltrative Resin: A Scanning Electron Microscopy Study

A thesis submitted in partial fulfillment of the requirements for the degree of Master of Science  
in Dentistry at Virginia Commonwealth University.

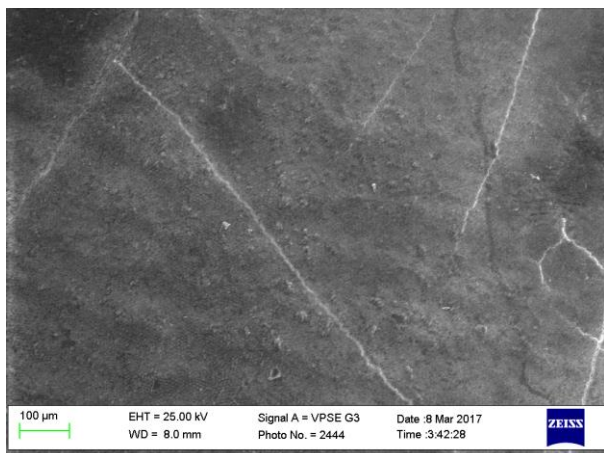
This increased porous enamel was successfully infiltrated in the experimental teeth, which was determined by the absence of hollow prism cores and a restoration of an intact surface. A common presentation of the samples included areas of concentrated enamel rods visible at the level of the tooth surface, with resin either displaying a slight thickness which was visible on the tooth surface in irregular patterns, or interspersed within the typical honey-comb pattern of the enamel rods, filling in areas of porosity between adjacent prisms. While significant heterogeneity existed between teeth, visualization of enamel rods within the resin, as well as microcracks, and fissures, in varying degrees, were common findings. While the porosities in the demineralized tooth structure appeared successfully infiltrated, returning its surface appearance closer to that of sound enamel, the resin coated surfaces did maintain a high degree of visible roughness and surface irregularity. SEM images from T2 appeared generally similar to those in T1, and qualitative differences before and after toothbrushing were mainly noted by direct comparison of paired images. Characteristic images are shown from teeth prior to toothbrushing below (Figures 5-7).

Figure 5: Tooth 2. Location B. T1. 250X Magnification.

Figure 6: Tooth 4. Location B. T1. 250X Magnification.

Figure 7: Tooth 10. Location B. T1. 250X Magnification.
