An experimental validation of a statistical based damage detection approach

A thesis submitted to the graduate faculty
in partial fulfillment of the requirements for the degree of
MASTER OF SCIENCE

Major: Civil Engineering (Structural Engineering)

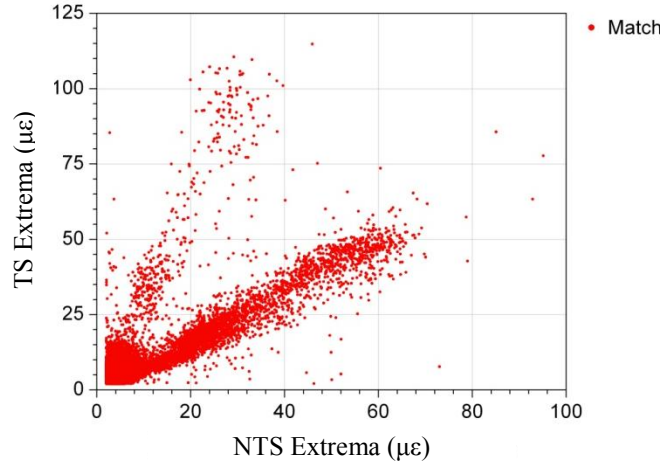
The event extrema from two sensors (one TS and one NTS) are matched to form x-y pairs that can be shown on a scatter plot (Figure 1.3). Initial data are collected during a “training” process which defines the “normal” behavior. This process is completed for all applicable and desired sensor pairs. In some cases up to four quadrants of pairs (maximum-maximum, maximum-minimum, minimum-maximum, and minimum-minimum) are present depending on the sensitivity of the sensors to the longitudinal location of the vehicle. Once all scatter plots are created, limits for the data are manually set by an engineer. A typical scatter plot with defined limits is shown in Figure 1.4.

Figure 1.3 Matched Data Points from Two Sensors (Wipf, Phares and Doornink 2007)

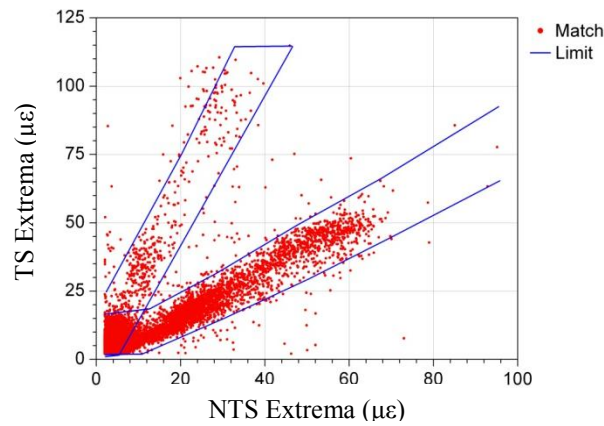
Figure 1.4 Matched Data Points with Applied Limits (Wipf, Phares and Doornink 2007)

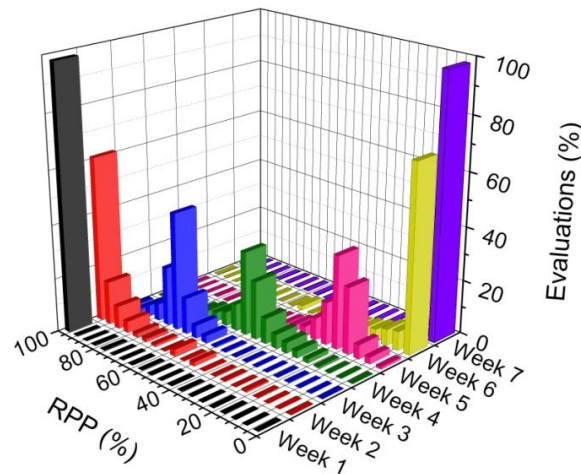
Figure 1.6 Gradually Occurring Damage Daily Assessment Histogram (Wipf, Phares and Doornink 2007)

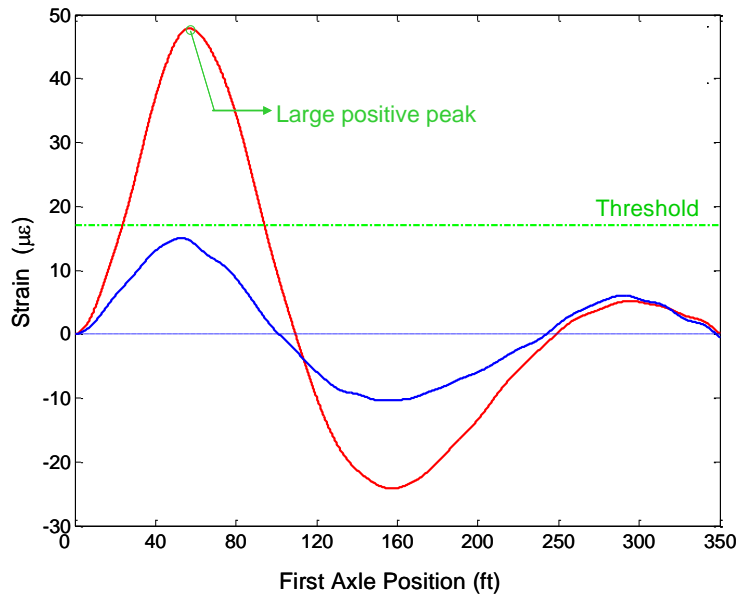
For each truck event, a girder bottom sensor produced one large positive peak if a threshold was properly defined, as shown in Figure 1.11. It was found that the sensor on the girder closest to the vehicle travel lane consistently produced a higher peak strain (above the threshold), thereby determining the truck travel lane. The deck bottom sensors nearest the left wheel line of the right lane truck and the right wheel line of the left lane truck consistently showed the best truck axle detection ability. Data acquisition frequency testing was also completed and it was found that 62.5 Hz was considered to be the minimum frequency required for axle detection (Lu 2008).

Figure 1.11 Truck Event Girder Bottom Strains (Lu 2008)

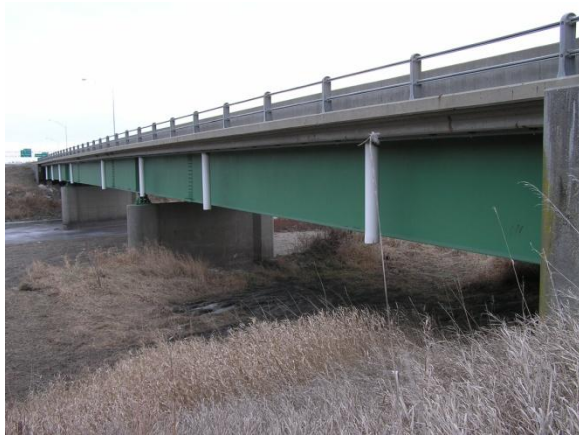
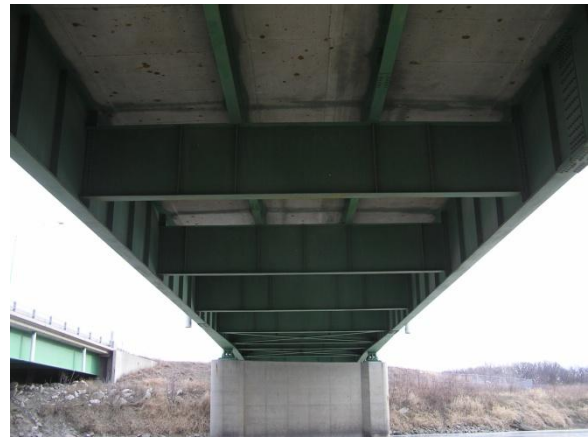
Figure 4.1 Photographs of the US30 South Skunk Bridge (Lu, 2008)

a. Side View

b. Bottom View

As with related work preceding that described herein, the bridge used in this project was the Eastbound US Highway 30 (US30) Bridge crossing the South Skunk River near Ames, IA (Figure 4.1). The US30 Bridge has three spans with two equal outer spans (97.5 ft) and a longer middle span (125 ft), a width of 30 ft, and a skew of 20 degrees. The superstructure consists of two continuous welded steel plate girders, 19 floor beams, and two stringers that support a 7.25 in. thick cast-in-place concrete deck. The bridge supports are pinned at the west pier and are roller-type supports at the east pier and at each of the abutments. The abutments are stub reinforced concrete and the piers are monolithic concrete (Lu 2008). The general bridge framing plan along with general member dimensions can be seen in Figure 4.2.

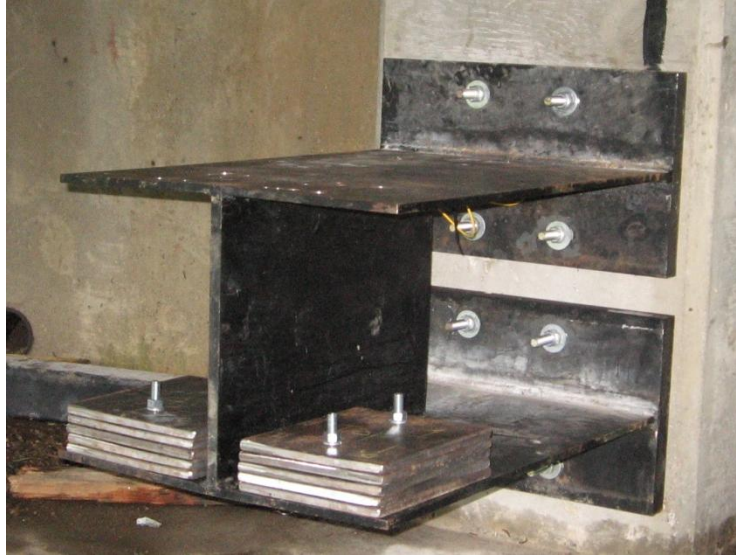
Figure 4.8 Photo of Sacrificial Specimen

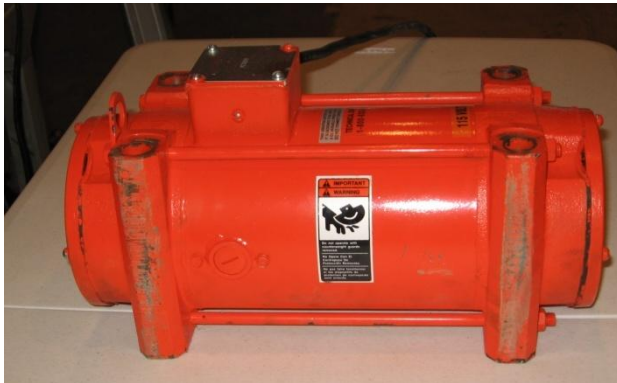
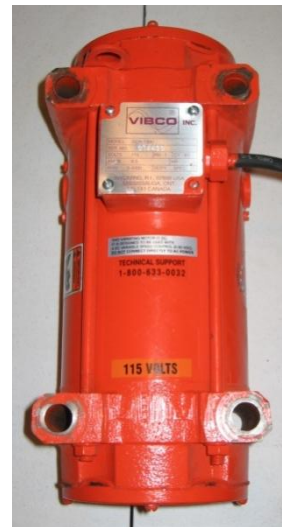
Figure 4.17 Photograph of Rotary Shaker

a. Side View

b. Top View

Figure 4.17. The rotary shaker is a motor with eccentric weights which rotate at a user specified frequency up to 100 Hz. The rotary shaker may be “dialed in” to the resonant frequency of the attached object to create very large strain values and number of cycles. To accumulate damage quickly, the shaker was bolted to the free end of the sacrificial specimen and then operated near the natural frequency of the sacrificial specimen. This induced high levels of strain at the high rate needed to create fatigue cracks in a relatively short time. Mass was added to the sacrificial specimen as shown in Figure 4.14 to reduce the resonant frequency to within the operable range of the shaker. In general, the rotary shaker was operated in the range of 60 Hz to 70 Hz.

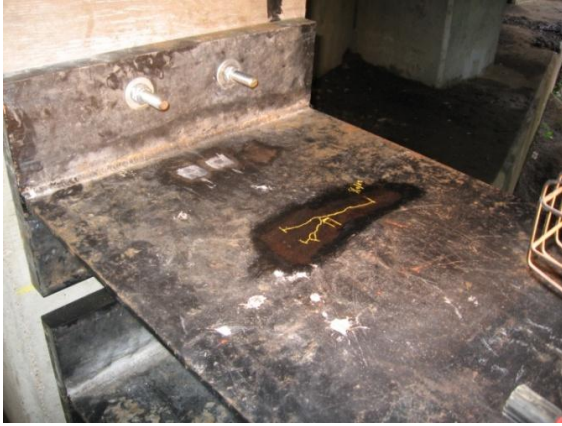
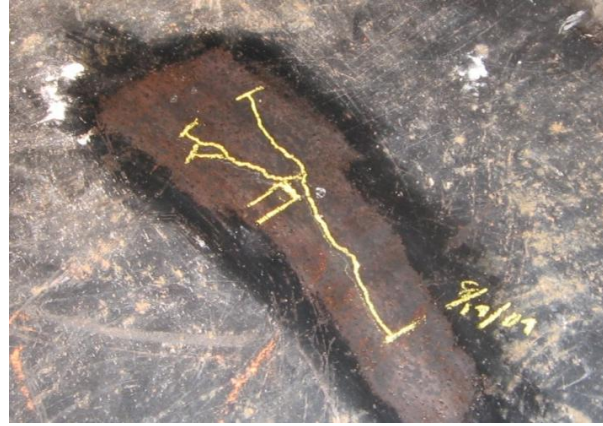
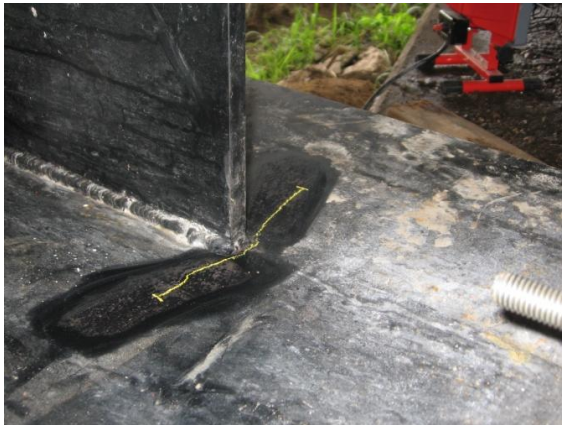
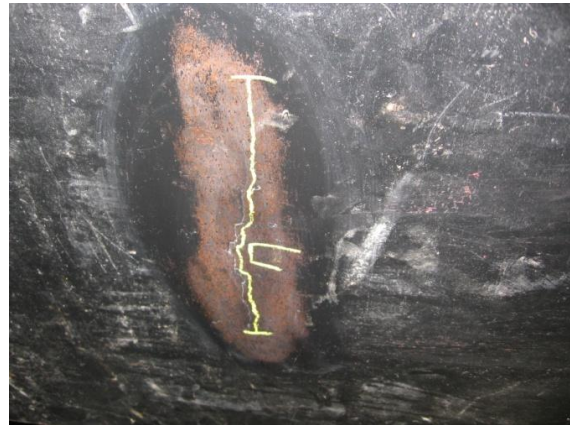
a. Top web plate cracking

b. Close-up of top web plate cracking

c. Bottom web plate cracking

d. Underside of bottom web plate cracking

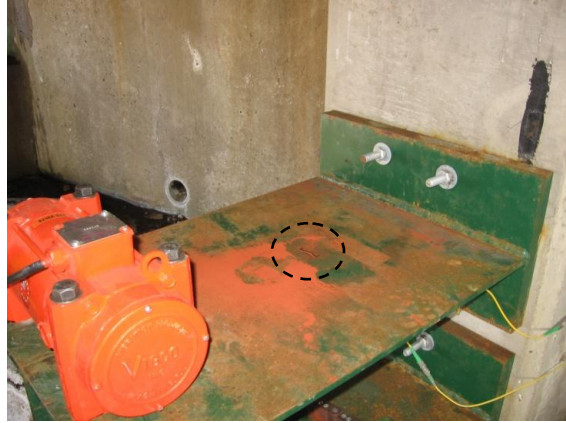
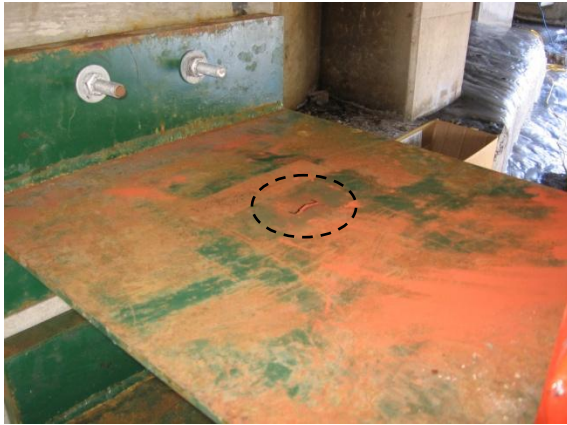
a. Overview of Top Web-Plate Cracking

b. Top Web-Plate Cracking

c. Close-Up of Crack

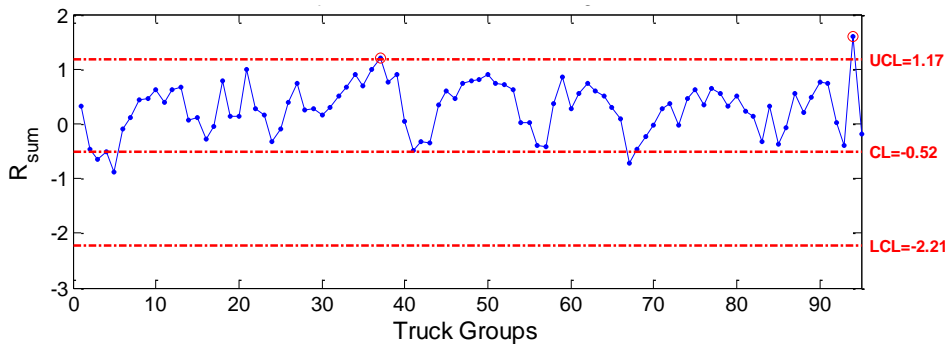
The control charts corresponding to the 1.75 in. crack are shown in Figure 5.8. All of the data points for sensors 3 and 4 are below their respective LCLs again indicating damage detection. The data point trends for sensors 1 and 2 (Figure 5.8a and Figure 5.8b) both shifted down opposite of the results from the 1.50 in. crack but similar to those for the 1.25 in. crack. This shift could be due to slightly differing loading conditions from placing the load transferring vertical strut in a different location than it was previously but does not have any adverse effects on the damage identifying capabilities of the control charts.

Figure 5.8 Post-Damage Sacrificial Specimen 2 Control Charts (1.75 in. crack)

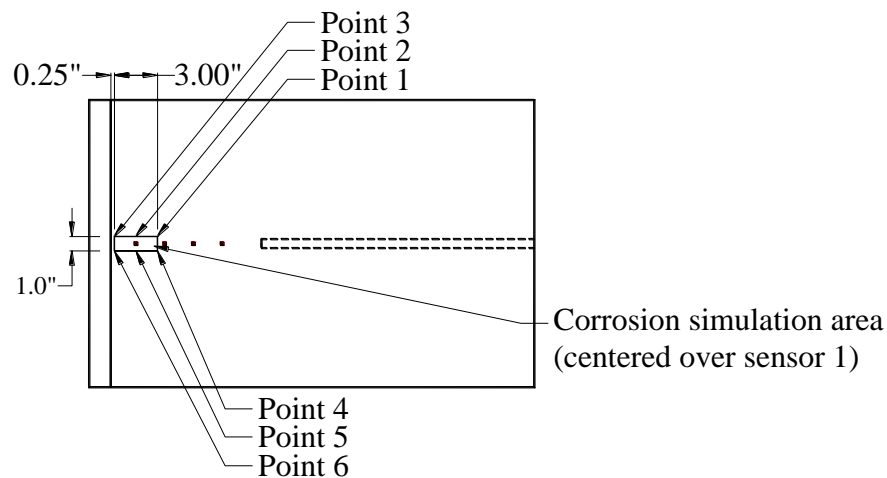
Following the collection of the training data, roughly five percent of the total plate thickness in a 1 in. by 3 in. section centered over Sensor 1 was removed. The location was centered over Sensor 1 to determine the effects of the corrosion when directly over a sensor and when in close proximity to other sensors. The locations of the simulated corrosion area and measurement points are shown in Figure 5.11. To measure the decrease in plate thickness, an additional steel plate was placed over each point and the distance from the top to the top plate was recorded. After grinding, this process was repeated and the percent decrease was calculated for each measurement point, the measurements are tabulated in Table 5.1

Figure 5.11 Corrosion Simulation Area Details
