Asbestos Cement Pipe Condition Assessment and Remaining Service Life Prediction

A thesis submitted in partial fulfillment
of the requirements for the degree of
Master of Science in Civil Engineering

August 2016
University of Arkansas

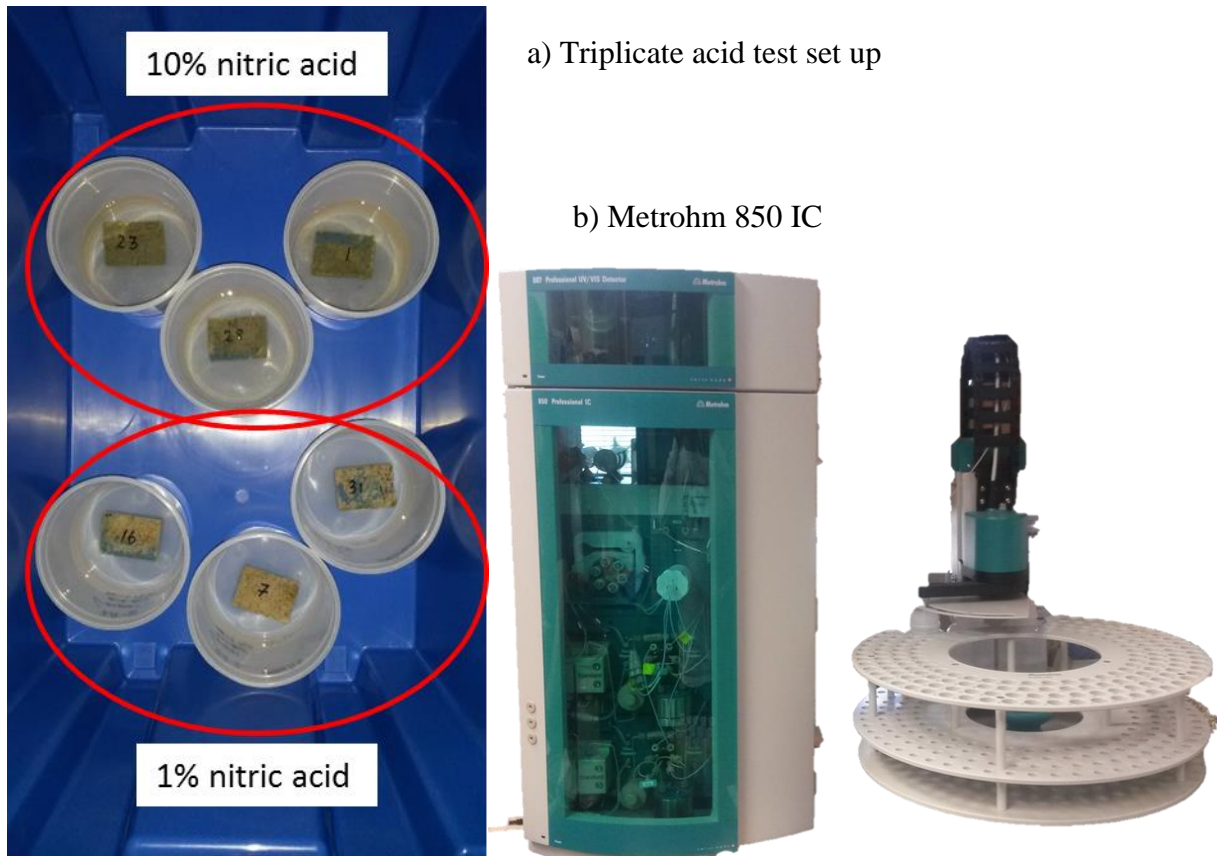
(Figure 4-3) prepared for each acid strength. Fifteen mL samples of solution were taken at different exposure times similar to Phase I: 1, 7, 14, 28, 60, 100, and 180 days. The concentration of calcium in each solution is then measured and plotted for each acid strength as a function of exposure time. The calcium was separated from other ions in the solution by using a Metrohm 850 professional Ion Chromatograph (IC) as shown in Figure 4-3. For use in the IC, the 15 mL solutions were first diluted to a pH of 3, which is within the operating range of the IC. The diluted solution was then placed in the IC which characterizes all the ions in the solution. Through preliminary tests, Magnesium was also found to be a good indicator of the degradation trend for these samples. Therefore, Calcium and Magnesium were identified as ions of interest and future measurements focused on these two ions. By comparing the trends of all acid strengths, the issue of using accelerated acid degradation to study AC degradation behavior can be addressed. The pH was monitored in these samples as an option to monitor how lime leaching raises the pH. However, preliminary results showed that pH is not a viable means of measuring degradation trends since changes in the low pH levels ($\text{pH} < 1$) cannot be confidently measured.

Figure 4-3. a) Sample set up for Phase II b) Ion Chromatograph
