Assessing Corrosion Damage in Post -Tensioned Concrete Structures Using Acoustic Emission & A Preliminary Investigation Of Biopolymer Doped Cement Mortar for Use in Structural Restoration

ASSESSING CORROSION DAMAGE IN POST-TENSIONED CONCRETE STRUCTURES
USING ACOUSTIC EMISSION & A PRELIMINARY INVESTIGATION OF BIOPOLYMER
DOPED CEMENT MORTAR FOR USE IN STRUCTURAL RESTORATION

Civil Engineering

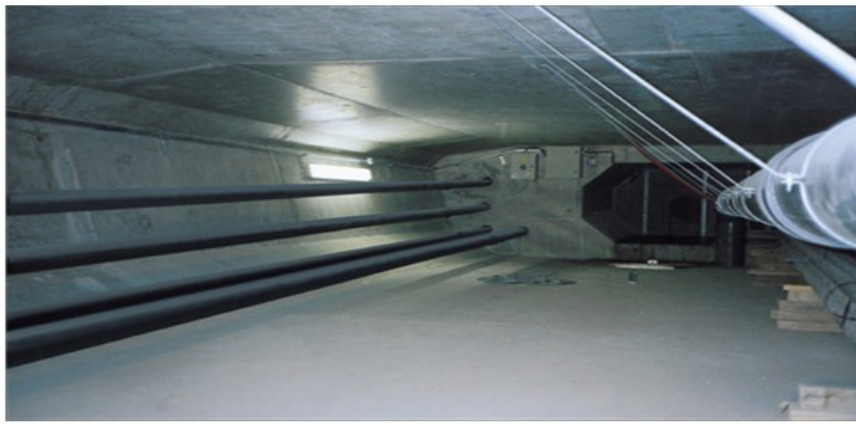
Figure 1.1: External Post-Tensioning in a bridge (www.cclint.com)

Both of these methods of PT were developed at the same time, and are extensively used. In some cases like bridges, mixed post-tensioning is also preferred wherein both internal and external post-tensioning is adopted. In both external and internal PT, the tendons pass through either metal, High Density Poly Ethylene [HDPE], or poly propylene ducts to transfer stresses from the strands to the concrete. Figure 1.1 and 1.2 shows external and internal post-tensioning.

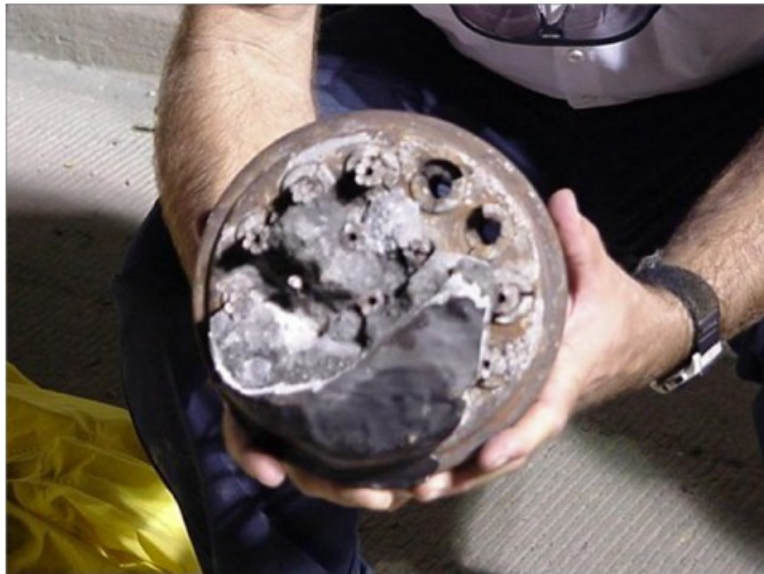
Figure 1.3: Corroded anchorage in Mid Bay Bridge (www.dot.state.oh.us)

Of 600,000 bridges in the U.S., roughly 18% are prestressed. Some of these are exhibiting corrosion in the prestressing strands. Major factors for corrosion include carbonation, high chlorides in the grout mix, ingress of chlorides due to the environment (deicing salts or location of the bridge in coastal regions), air pockets in ducts, bleed water, and faulty construction practices. High corrosion levels have been found in Florida due to the coastal climate. Some of the major bridges in that area include the Sunshine Skyway Bridge, the Niles Channel Bridge, and the Mid Bay Bridge. The Mid Bay Bridge was opened in 1993, and by 2000 the corrosion levels in some tendons were so high that 11 tendons in the bridge had to be replaced. The same was observed in the Skyway Bridge and the Niles channel bridge. Figure 1.3 shows severe corrosion in the anchorages of Mid Bay Bridge.

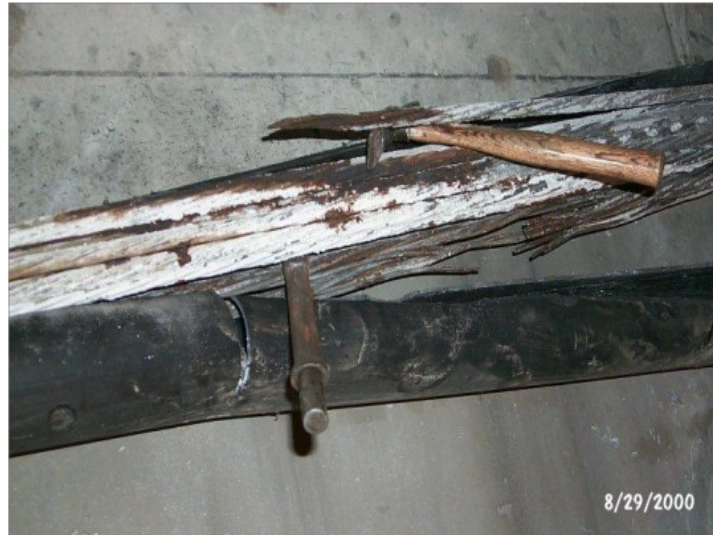
Figure 1.4: Cracked duct showing severely corroded strand (www.dot.state.oh.us)

It was also observed that cracking of the ducts due to faulty construction practices or slipping of the ducts at deviator blocks or anchorages in the Mid Bay Bridge left the strand exposed to the environment, thereby accelerating the corrosion process. In Figure 1.4 and 1.5 show cracking and slipping of ducts in the Mid Bay Bridge.

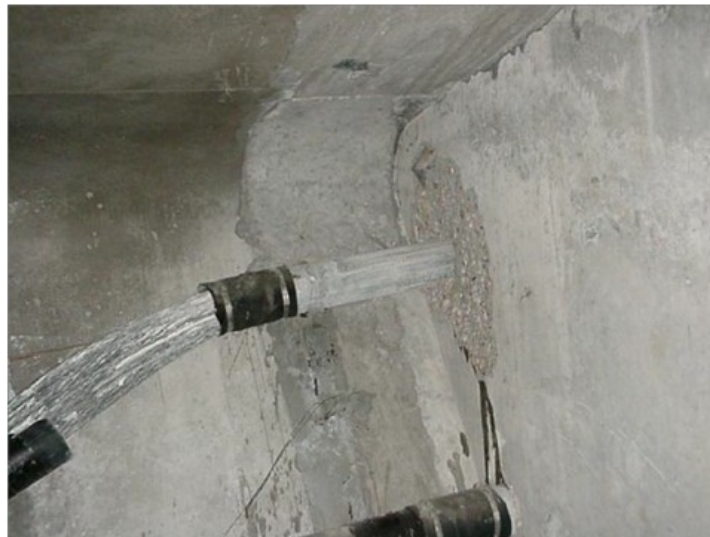
Figure 1.5: Slipping of duct at deviator block (www.dot.state.oh.us)

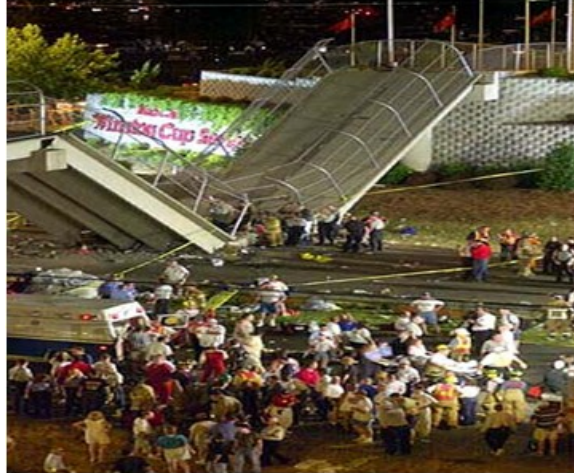
Figure 1. 7: Lowe's Motor Speedway Bridge Collapse, May 2000, US
(www.onlineathens.com)

In May 2000, a 24.5 m (80-ft) section of the Lowes Motor Speedway Bridge in North Carolina collapsed killing and injuring several people. Investigations have revealed that the cause of the collapse was corrosion of the strands. This was in turn due to the use of a grout with excess calcium chloride during the general repair and maintenance procedures of the bridge. Figure 1.7 shows the collapsed section of the Lowes Motor Speedway Bridge. In 2011, the FHWA released a list of 35 post-tensioned bridges across the U.S. that are experiencing corrosion in their strands due to excess chlorides in the grout mix, and the list is expected to increase.

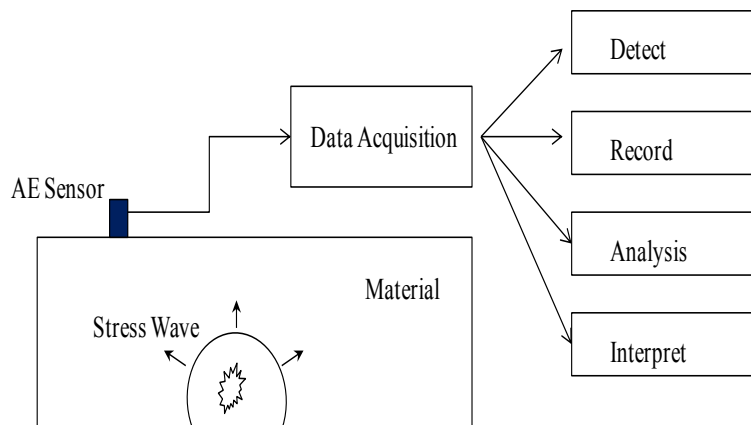
Figure 1.8: AE Source Mechanism

However one of the interesting aspects of AE monitoring is that existing defects cannot be detected unless they are actively releasing energy. Therefore, if a crack or other defect is not growing (for example a crack that is self-arresting), AE activity will not be detected from that crack unless other sources are present, such as friction (also referred to as fretting). A schematic of AE mechanism is shown in Figure 1.8.

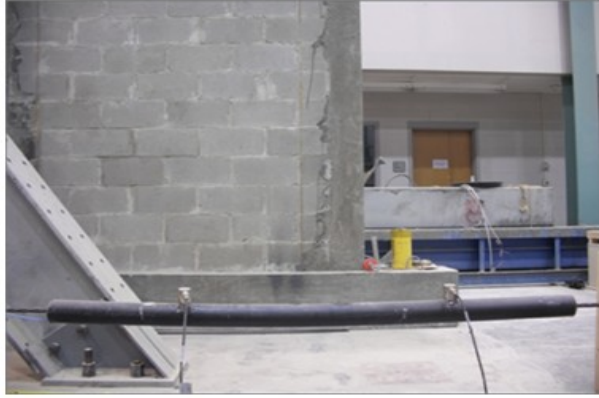
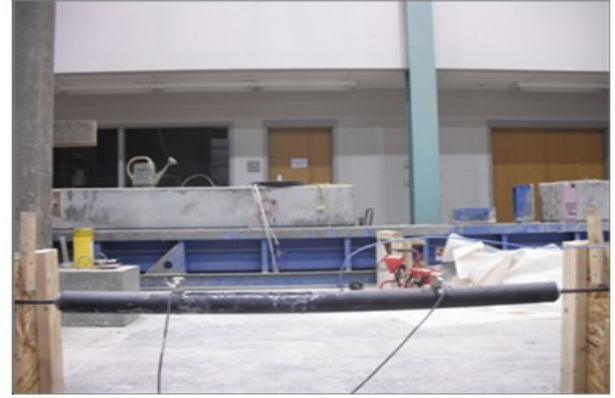
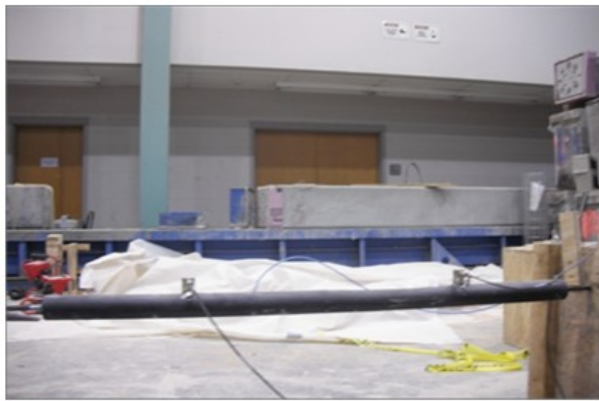
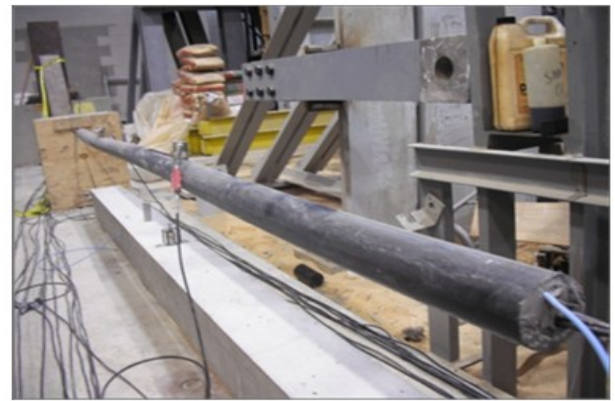
Figure 2. 2: External Post-Tensioned Specimens: (a) Control, E1; (b) Wet-dry 4 ft, E2; (c) Exposed Strand, E3; and (d) Wet-dry 10ft, E4

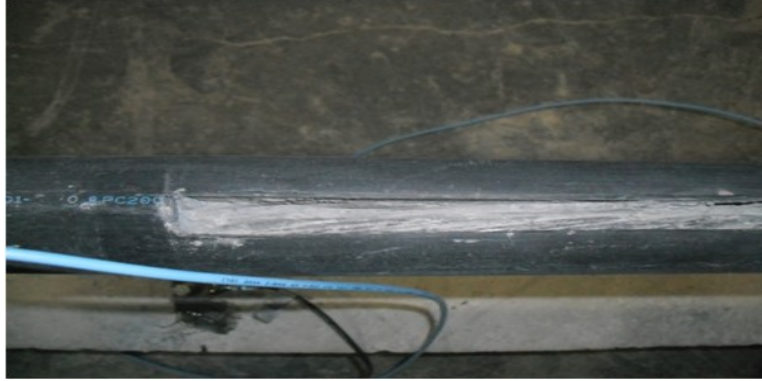
Figure 2. 3: Top view of specimen E3

Specimen E3 measured 1.22 m (4 ft.) in length and had the strand exposed to the environment mimicking an air void and corrosion under environmental conditions. To achieve this, a small section of size 300 mm x 25 mm (12 in. x 1 in.) was cut from the HDPE duct and a small piece of wood was placed, so that when the duct is grouted the grout will fill the duct leaving the strand exposed. Figure 2.3 shows the exposed strand specimen, E3. This specimen was left exposed to the atmosphere for the first 45 days, after which a small quantity of 2% NaCl solution was sprayed only once on the strand to induce corrosion. The two remaining specimens, E2 with a length of 1.22 m (4 ft.) and E4 with a length of 3.05 m (10 ft.) , had 300 mm (1 ft.) long, 25 mm (1 in.) wide and 12.5 mm (1/2 in.) deep grooves to facilitate wet-dry cycling. Figure 2.4 shows the groove for specimen E4. These wet-dry specimens were subjected to 3 days wet (Monday to Wednesday) and 4 days dry (Thursday to Sunday) cycles. Initial wet-dry cycles were started after five days of start of AE with a 2% NaCl solution. This NaCl solution was

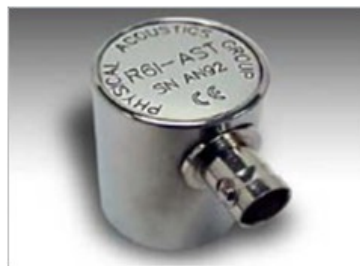
Figure 2. 6: R6i AE sensor (Mistras Group, Inc.)

Each of the specimens was monitored with two acoustic emission (AE) resonant sensors, 55 kHz with an integral 40 dB pre-amplifier (R6i) as shown in Figure 2.6, (Mistras Group, Inc.). The sensors were strategically located on the specimens to pick up corrosion activity. The sensors were connected to a 16-channel data acquisition system (Sensor Highway II, Mistras Group, Inc.). For the internal PT specimens, one AE sensor was positioned at the center of the top surface of the specimen while the other sensor was positioned on one face of the cross-section between the strand and the grout, as shown in Figure 2.7.

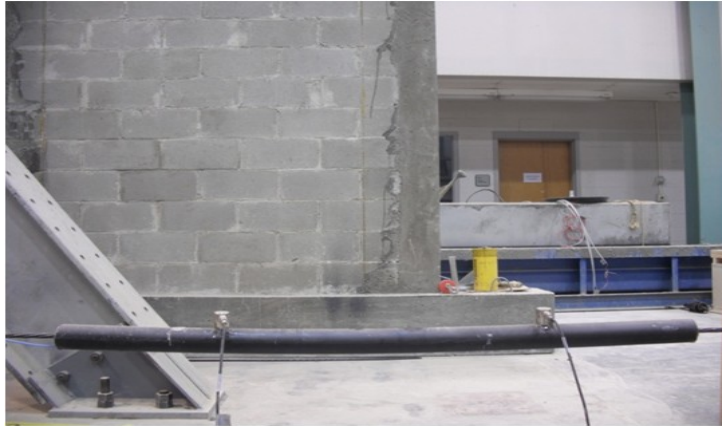
Figure 2. 8: Positioning of sensors on external PT specimens

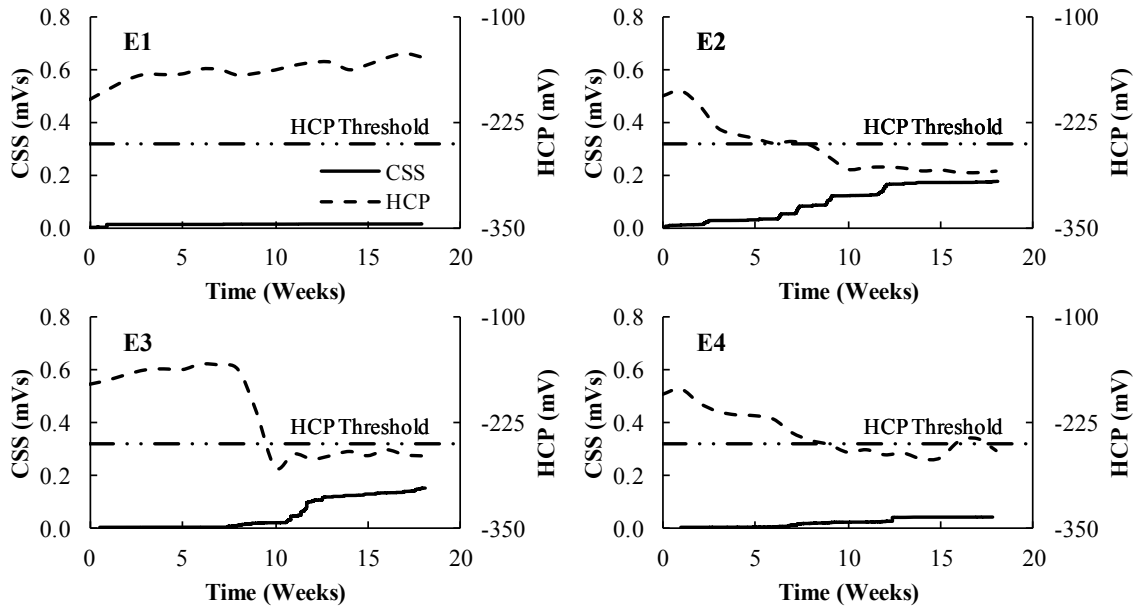
Figure 2. 9: CSS vs. time and HCP vs. time for external PT specimens

The ASTM criterion for corrosion of steel in concrete for a silver chloride (AgCl) reference electrode is given in Table 2.2. The half-cell potential [HCP] with respect to time and cumulative signal strength [CSS] with respect to time for each external PT specimen are plotted in Figure 2.9. The HCP measurements were taken with an impedance voltmeter on a weekly basis. In specimen E1, the control specimen, the HCP

measurements indicate that corrosion did not initiate. This agrees with the AE data as minimal AE activity was collected over the span of the test.

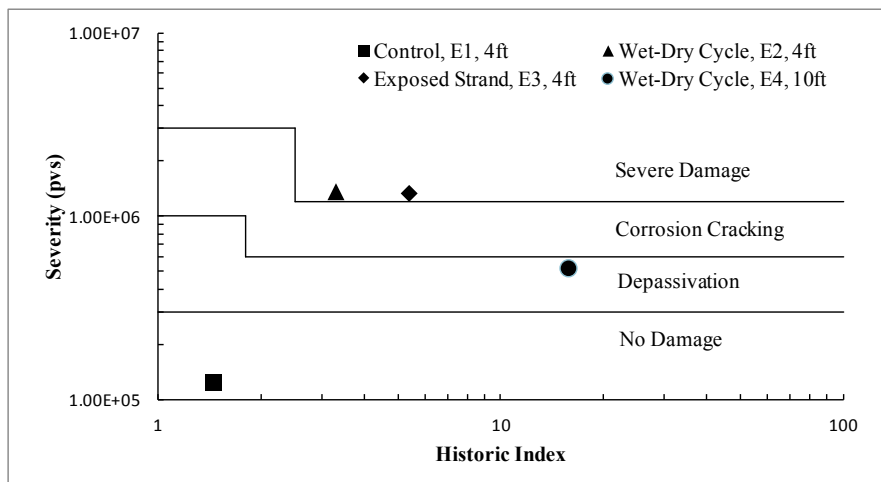
Figure 2. 17: Intensity analysis chart for external PT specimens

$K=0.85N$ if $201 \leq N \leq 500$; d) $K = N-75$ if $N \geq 501$; e) $J= 0$ for $N < 50$; and f) $J=50$ for $N \geq 50$. To portray the level of damage, an Intensity Analysis chart is subdivided into regions where each region corresponds to a particular level of damage.

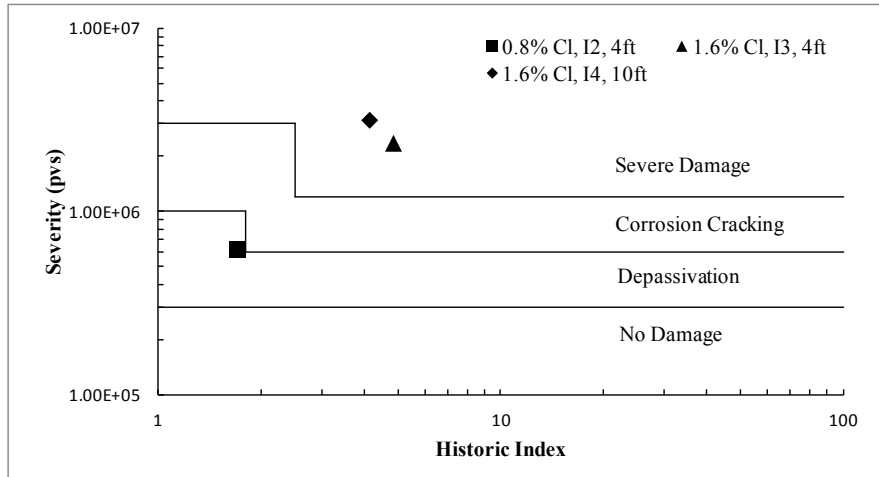
Figure 2. 18: Intensity analysis chart for internal PT specimens
