## Assessing the Effects of Reconstruction on the Commercial and Civil Construction Industry Following Hurricane Maria in Puerto Rico

A thesis submitted to the faculty of  
Brigham Young University  
in partial fulfillment of the requirements for the degree of  
Master of Science

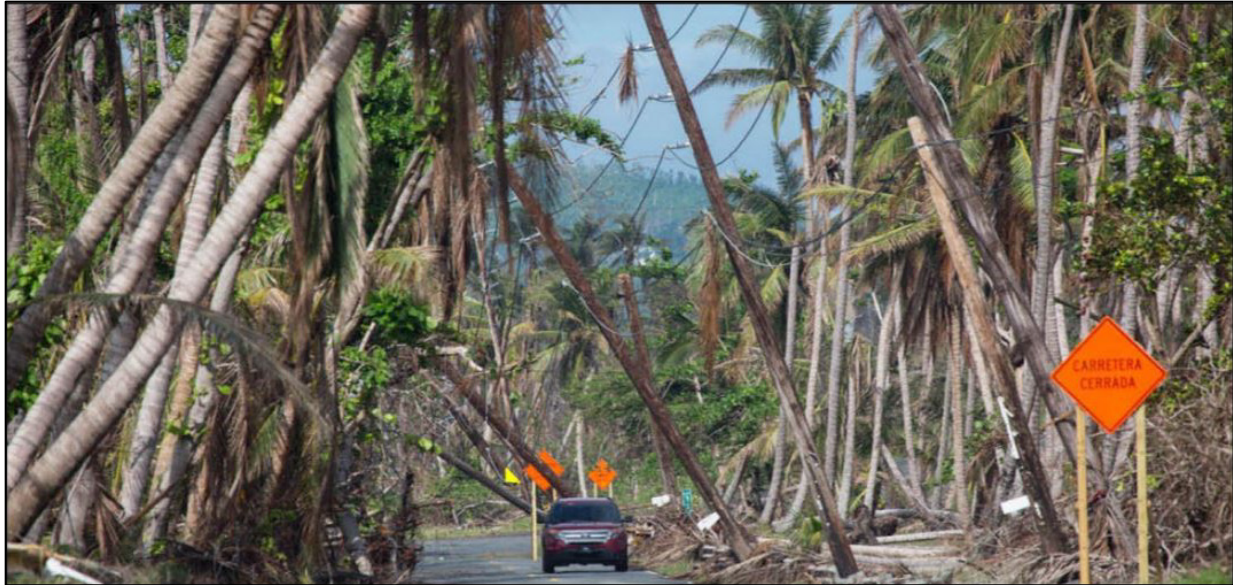
**Figure 2-1: Example of Downed Power Lines in Puerto Rico (Image Courtesy GAO, 2019)**

The strong winds created by Irma also caused damages to the electrical grid in Puerto Rico. Electric Power Authority (PREPA) had 1.1 million customers, out of 1.5 million total customers in the island, that lost electric power at the time of its landfall. Figure 2-1 illustrates the damage suffered to the electrical grid. Two days later 865,000 remained without power, and five days following the storm 371,000 customers were still without power (Alvarado, 2017 and Johnson et al., 2017). Hospitals were also affected, as the Puerto Rico Health Department reported about forty-two percent of local hospitals were using generators due to a lack of electricity during this time (Alvarado, 2017). Because of the lack of power at filtration plants, around 362,000 Puerto Rico Aqueduct & Sewer Authority clients were left without water immediately following the storm. Five days after the passage of Irma, that number decreased to 62,000 customers without water, most of them located in the San Juan area (Alvarado, 2017). The lack of electric power also caused 781 of the 1,600 telecommunications towers around the island to cease operating (Alvarado, 2017).

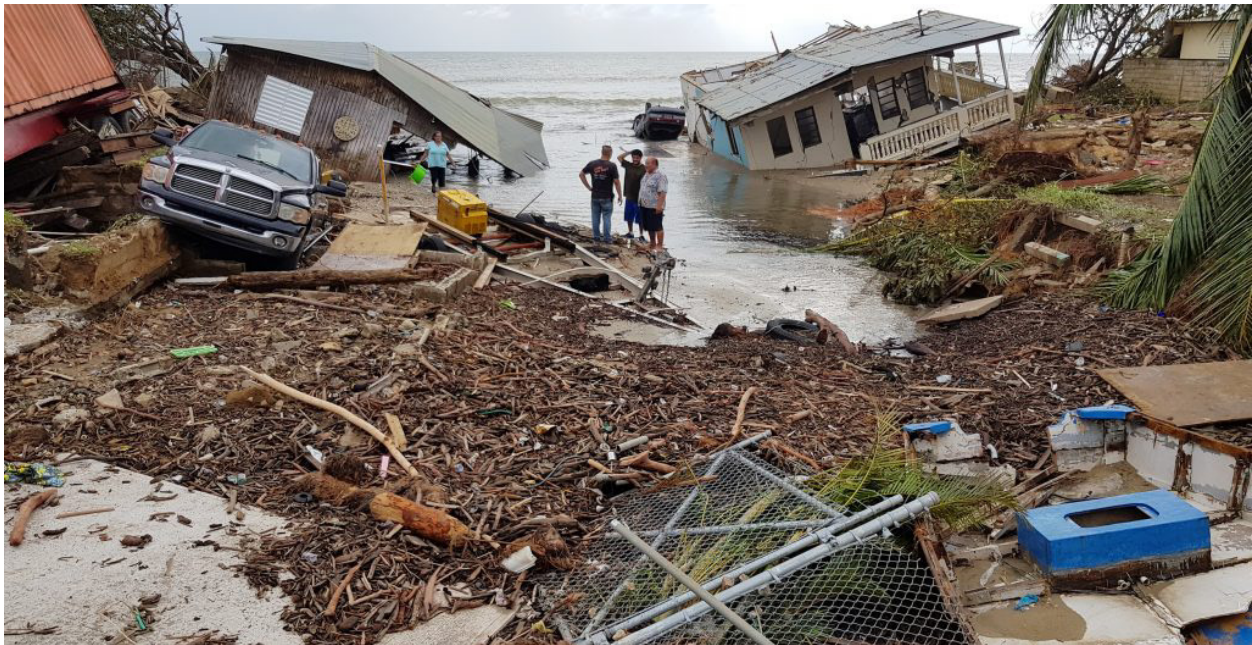
**Figure 2-2: Damage Caused by Maria (Image Courtesy Pagan-Trinidad, 2019)**

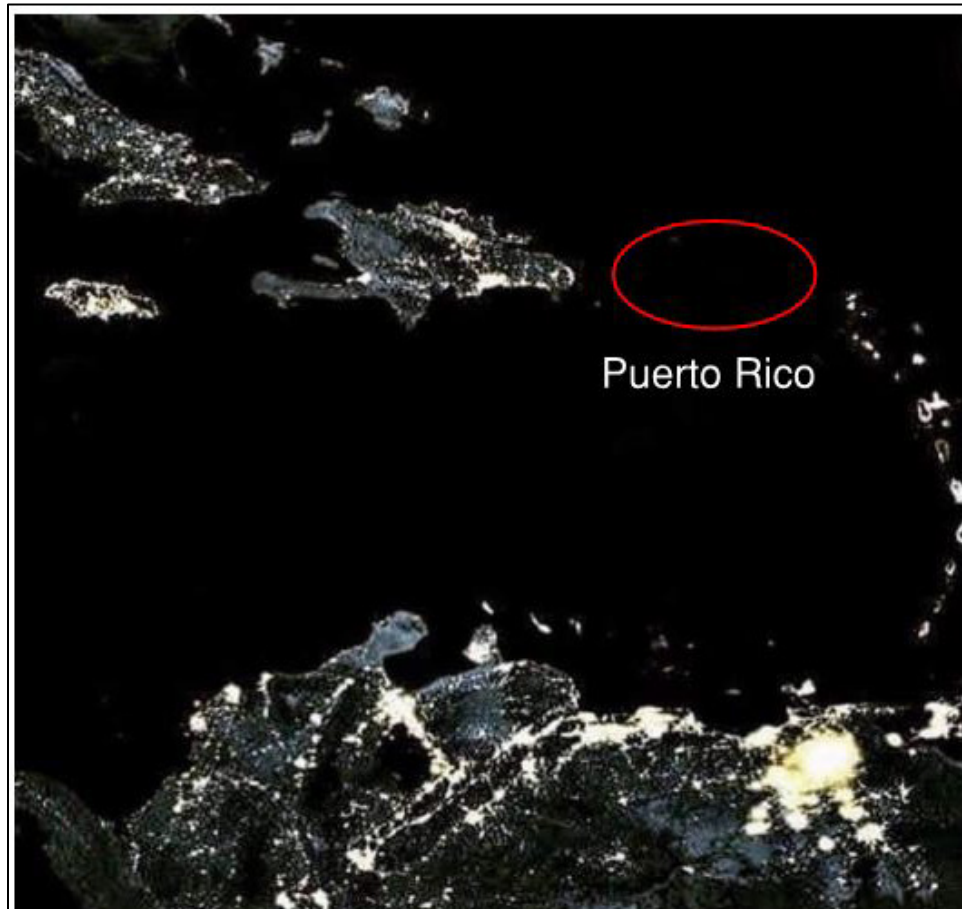
The hurricane completely destroyed the island's power grid and infrastructure. It left power lines lying on the ground and rivers flowing over bridges. Following the storm, none of the island's 3.4 million residents had electricity as the island's power infrastructure had essentially been destroyed, leaving the island in darkness as shown in Figure 2-3. Originally the governor had estimated that the repairs to the grid would take a month to get electricity back for the whole island (Rodriguez, 2017). This, however, was not the case as it actually took nearly a year, 328 days, for the entire island to get its electricity restored (CDP, 2018). After spending \$3.2 billion erecting 52,000 new electrical poles and stringing 6,000 miles of wire to restore power to the island (Robles, 2018), chief executives of Puerto Rico Power Authority (PREPA) argued that the Puerto Rico's electricity system is not in much better condition post Maria than how it was before the storm initially destroyed the power infrastructure on the island. They

**Figure 2-3: Puerto Rico at Night Following Maria (Image Courtesy Ramos, 2017)**

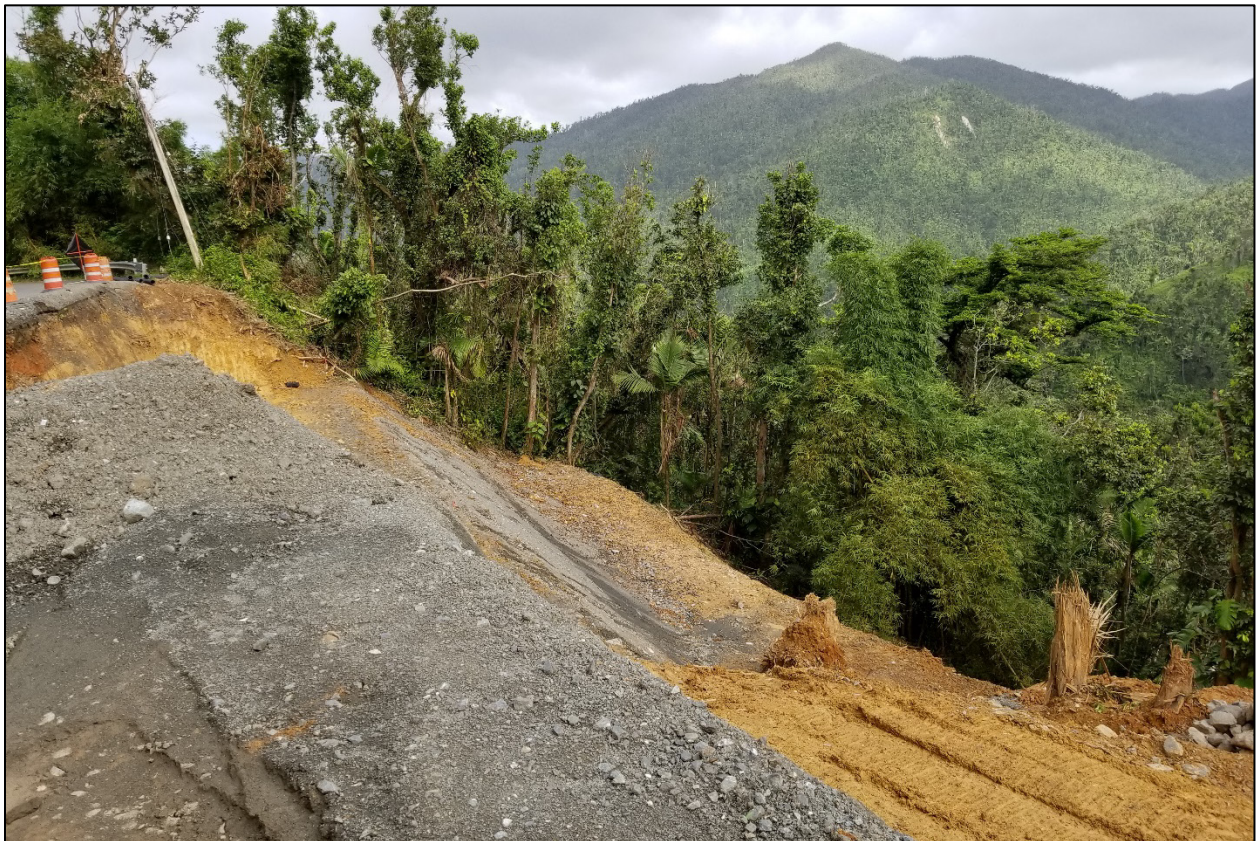
**Figure 4-3: Las Piedras Landslide Repair in El Yunque**

Reconstruction. When Las Piedras Construction needed to increase their workforce to handle to new emergency related projects, they overcame the lack of skilled labor challenge by hiring relatives of their current employees. They found that when doing that, the training was better received, and the length of training shortened. Equipment shortage was not an issue for this company because they own their own heavy equipment. However, the materials for their projects were affected because of the congestion at the ports. After Maria, Las Piedras Construction found a new opportunity to work in the reconstruction of the National Rain Forest El Yunque with over fifteen reconstruction projects being done there. One of these projects is illustrated in Figure 4-3, as well as another landslide in the background.

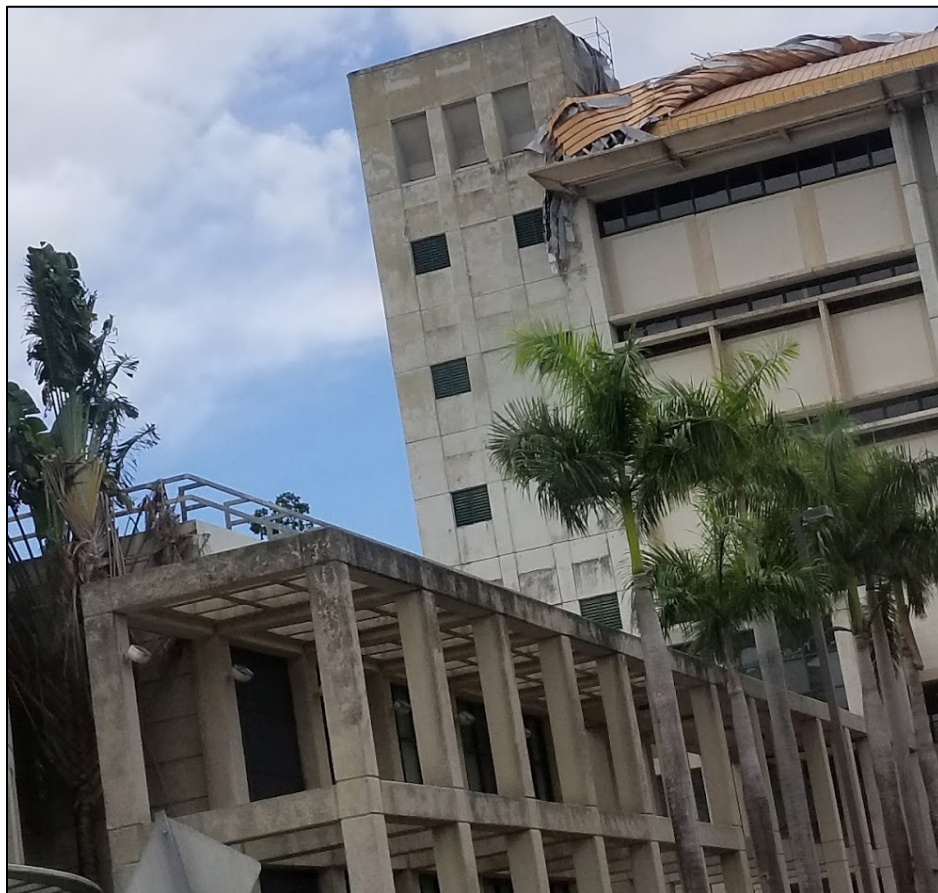
**Figure 4-4: Damage to Commercial Structure Visible One Year After Hurricane Maria**

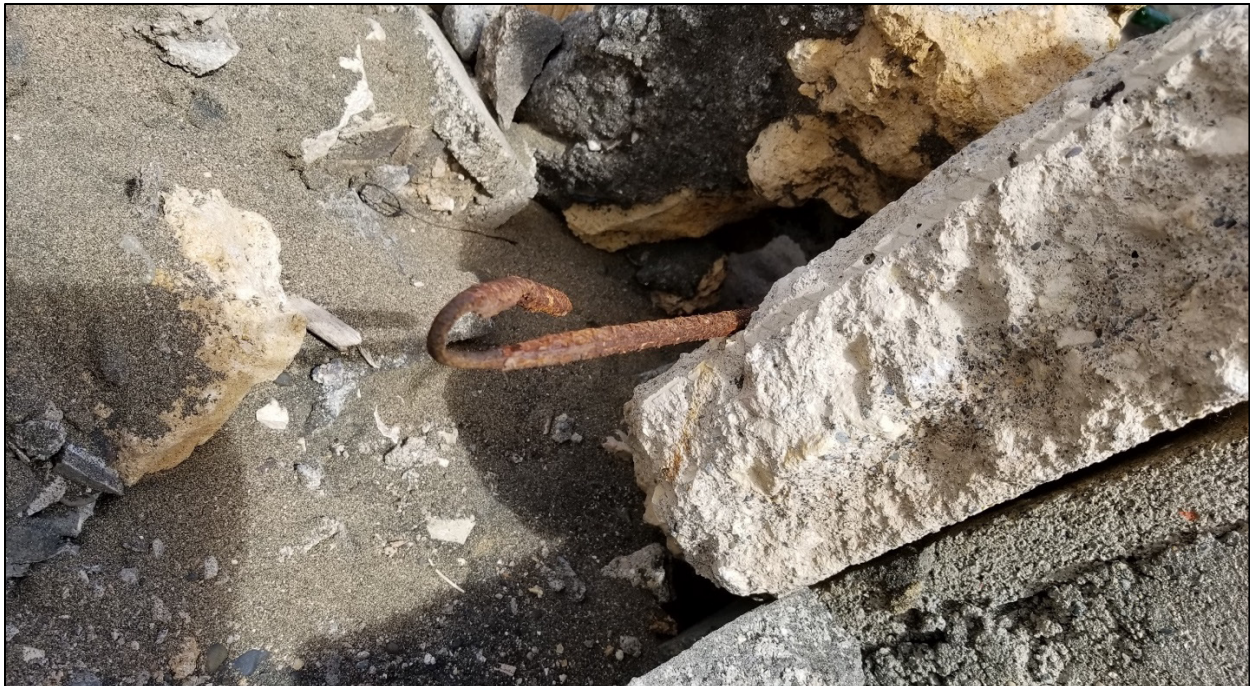
**Figure 4-5: Results of Delaminated Rebar Exposed to Elements**

money upfront and cutting corners with permitting. As described by an architect, “people do not want to spend money or time regarding permits in order to build right. So, they hire Chiveros for their cheap labor. Chiveros are usually from the surrounding islands and build without plans,” (A chivero is an individual that offers cheap unskilled labor.) This may lead to cost savings up front, but not in the life of the product. Another common problem that the architects discussed was with the rebar utilized in structural projects. The architects indicated that it is typical for rebar in Puerto Rico to delaminate because epoxy coating rebar is not a standard. The delamination is caused by the sea water and saltpeter leaking through cracks in the concrete and making contact with the rebar. At this point, the rebar begins deteriorating at a faster rate due to the exposure to the weather elements and the lack of epoxy protection. An example of this delamination is shown in Figure 4-5.

Rather than epoxy coating the rebar, instead a common practice for protecting the life and integrity of structures is the use of Sika FerroGard on the exterior of the concrete. The exterior layer of existing paint is removed, then the Sika FerroGard is applied directly on the concrete to strengthen the rebar inside. Sika FerroGard is a “corrosion inhibiting impregnation coating for hardened concrete surfaces. It is designed to penetrate the surface and then to diffuse in vapor or liquid form to the steel reinforcing bars embedded in the concrete. Sika FerroGard protects the embedded steel by depositing a physical barrier in the form of a protective layer on the surface of the steel reinforcement. This barrier inhibits corrosion of the steel.” (Sika, 2020). This product seems to work. However, it is a reactive solution to treat the delamination problem after the delaminating begins. It is not a preventive solution so there are still many structures that experience delaminating issues. Sika FerroGard is mainly used in in the preservation and restoration of historic and existing buildings.

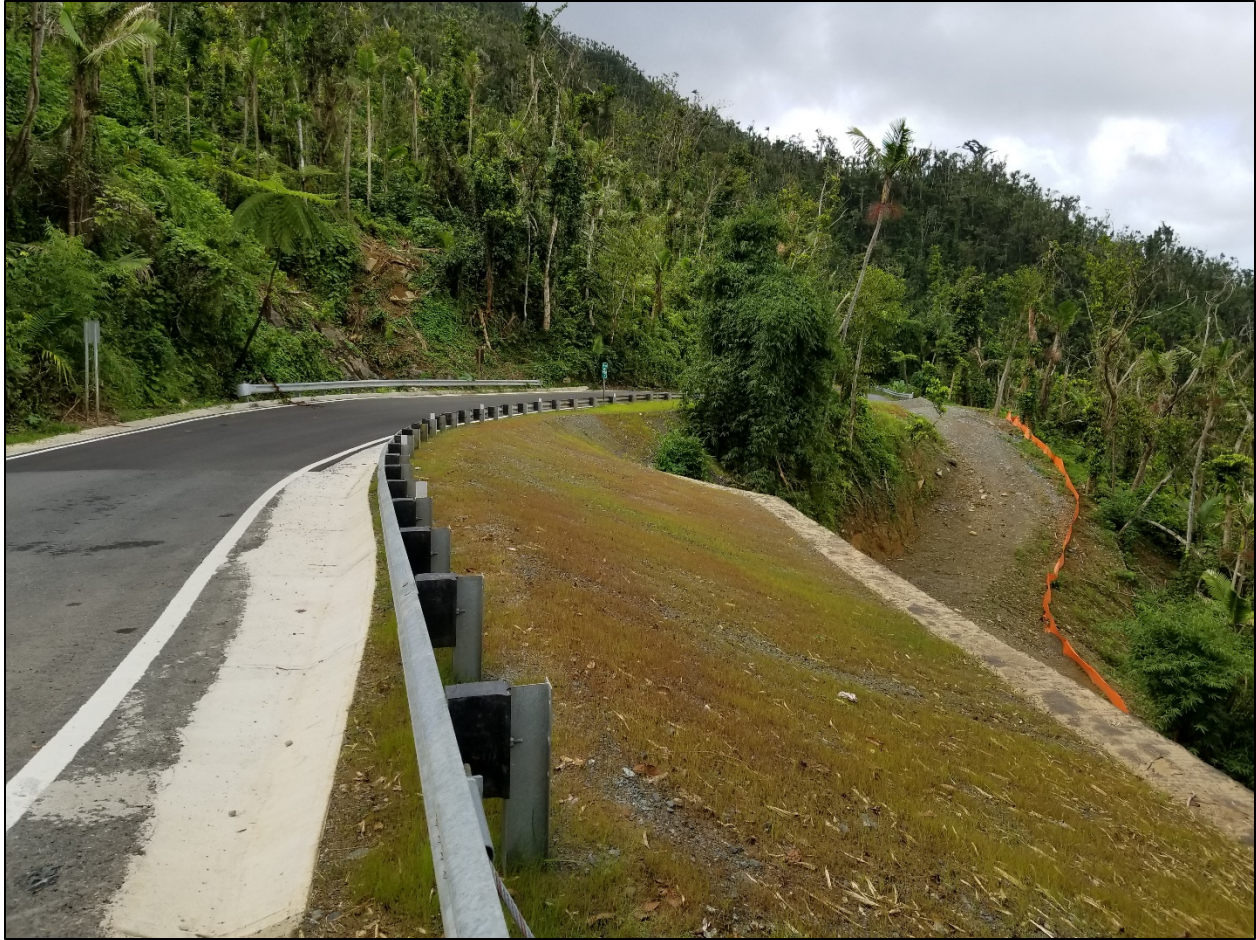
**Figure 4-6: Landslide Reconstruction in El Yunque National Rainforest**

This research also explored reconstruction effects on El Yunque, the only tropical rainforest in the U.S. National Forest Service. El Yunque includes some a number of roadways and trails in some of the highest mountainous region on the island. It was discovered that landslides affected the reconstruction efforts in its rainforest, and closed roads and trails along its path. There were around 240 landslides that impacted the roads and trails in El Yunque. Due to the FAA aviation tower being located in El Yunque, several volunteers and first responders aided in the road clearing; however, some clearing had to be contracted out for the larger landslides, as shown on Figure 4-6. The contractors also aided in the preservation of the forest by engineering “step pattern” retaining structures to increase their stability and avoid future relapses.

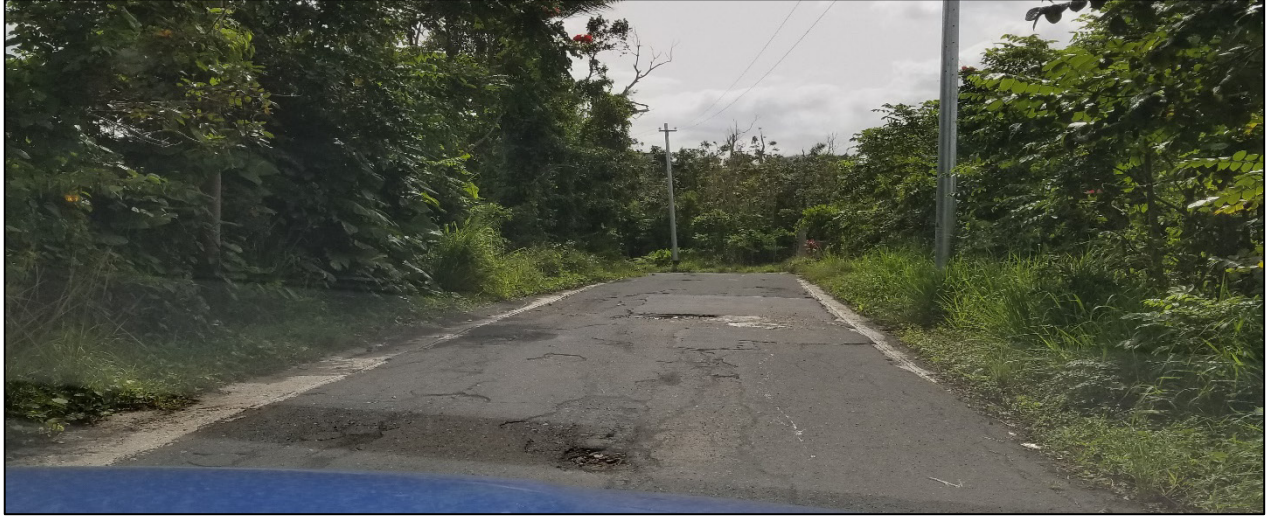
**Figure 4-9: Rural Road Damage**

Both storms caused significant amounts of damage to Puerto Rico’s roadway infrastructure, rendering them unfit for normal, use as shown in Figure 4-9. Bridges were also affected and destroyed by Hurricane Maria, as the floods caused the collapse of sixteen bridges throughout the island. One of these bridges, shown on Figure 4-10, had repairs underway a year after the storm. In some areas, bridges are the only way to connect towns so any damage to them would cause the local residents to be cut off from civilization (Russell and Blair, 2018). Funds for the roads and bridges repairs followed the format of the road clearing, with both federal and state funds being used. According to the civil contractors, the process for evaluating which roads received what funding was determined by their respective jurisdiction. The jurisdiction was determined by the number of numerical digits the road named had. Repairs on roads with one, two, or three numerical digits, the major roads, would fall under the National Highway System jurisdiction while four-digit roads would fall under FEMA jurisdiction as these were smaller roads belonging to the municipalities. This was key for contractors to know which projects to resort their manpower and efforts to, because of the guaranteed federal grants available for payment once the job was completed.

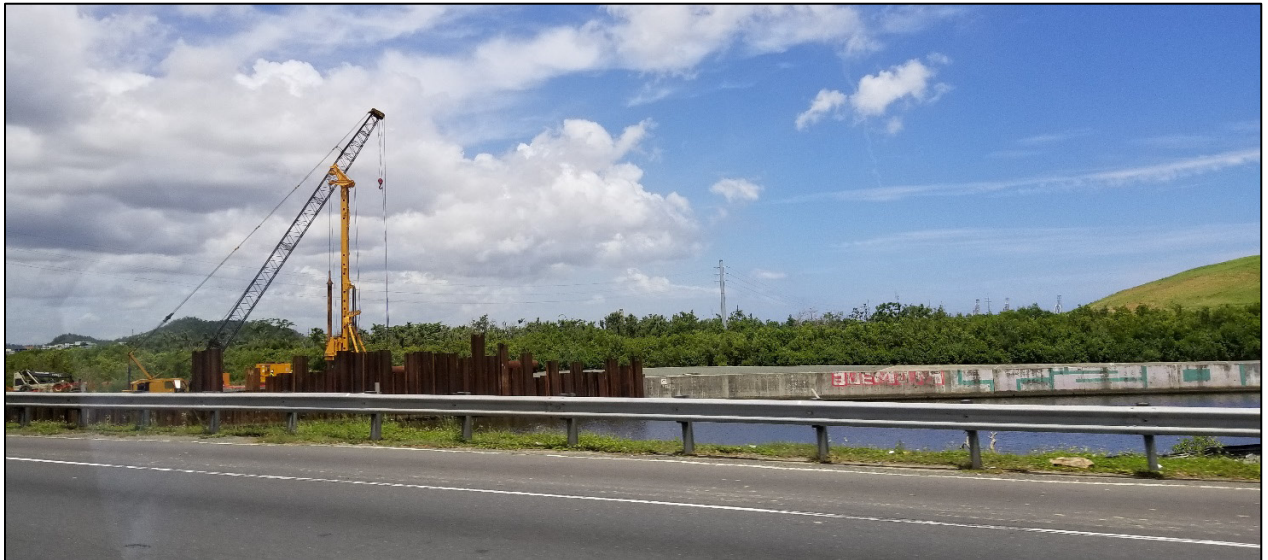
**Figure 4-10: Piles Driven into the Ground for Bridge Reconstruction**

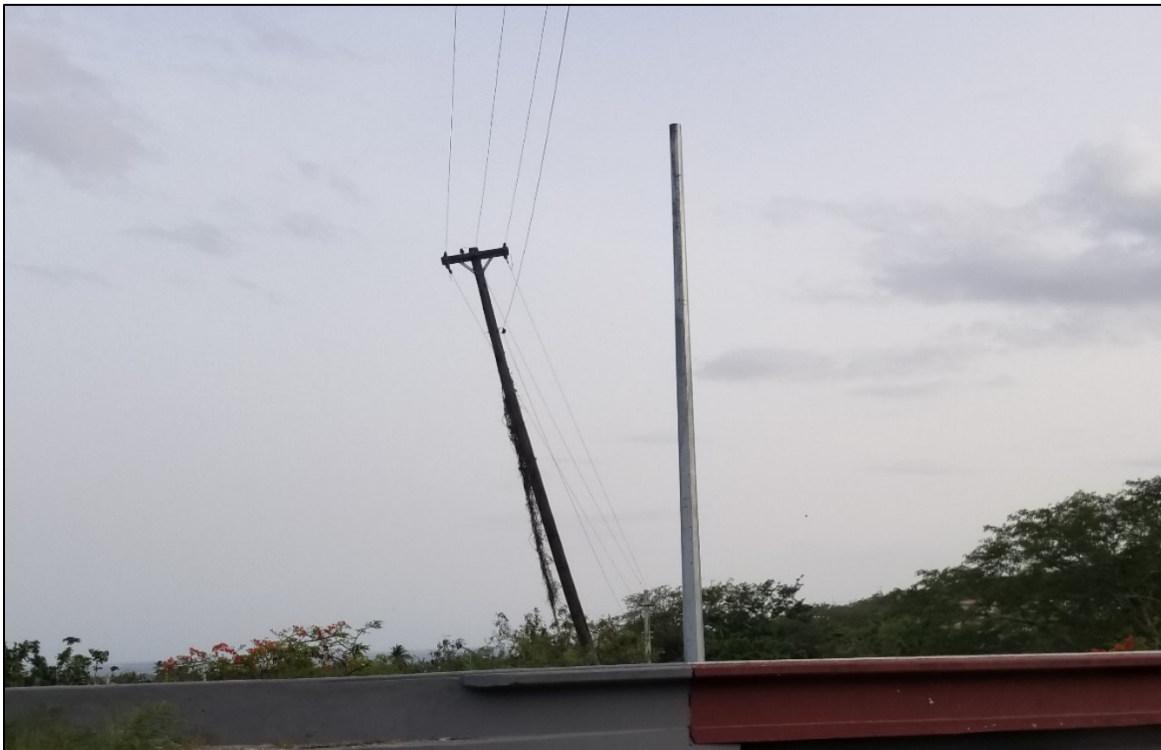
**Figure 4-13: Damage to Electrical Grid**

One of the biggest immediate challenges throughout reconstruction was fixing and dealing with the damage to the electrical power grid. Bigger power plants that generate electricity did not suffer much damage, but the power grid that distributes the electricity did, as shown on Figure-13. Puerto Rico's outdated and unmaintained electrical power grid suffered heavy damage by the strong winds and debris during Hurricane Maria's landfall. This coupled with the fact that their concrete poles failed made it difficult to begin the reconstruction process. The poles failed because they were only engineered to support the electrical cables and not the additional communication cables that were renting space on the poles. The repairs to these poles were still underway a year after the storm as shown on Figure-14.

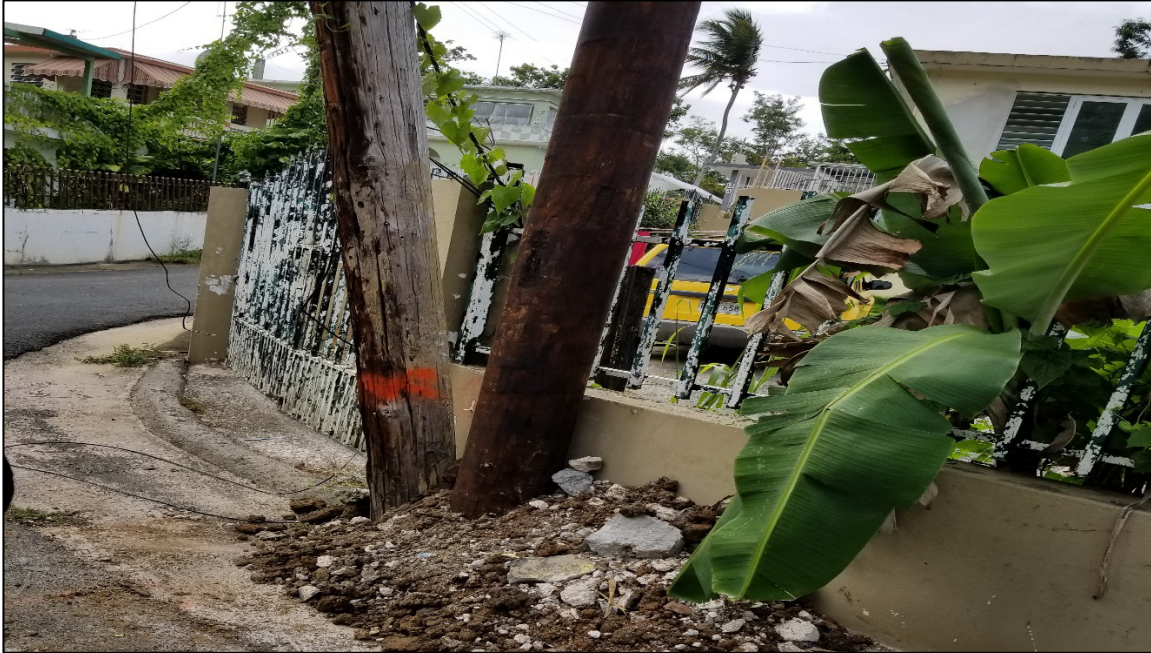
**Figure 4-14: Electrical Grid Repairs**

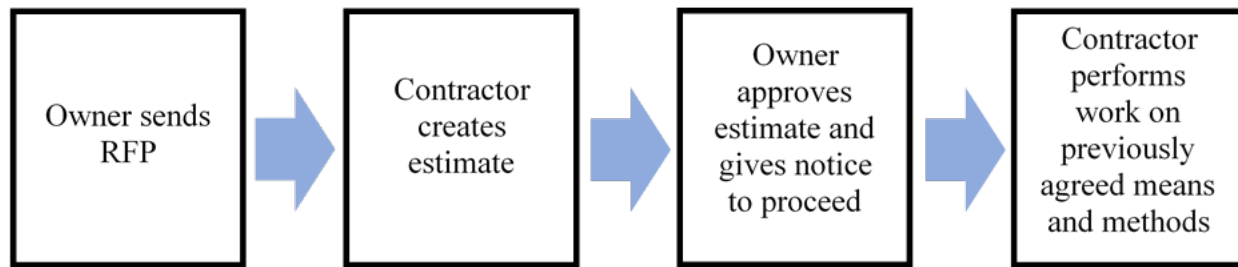
**Figure 4-15: Design Build Process**

This research discovered that there were a number of changes that occurred to the typical business practices as a result of Hurricane Maria. Contracting methods, such as project delivery, changed significantly during this time. For example, prior to Hurricane Maria, Design-Bid-Build was the traditionally approved project delivery method; however, during the reconstruction process Guaranteed Maximum Price (GMP) and Design Build were being accepted as a new norm. For instance, one contractor described their process on a Design Build project; “we received a request for Proposal (RFP) from the owner, then our estimating department provided an estimate. In a matter of hours, the owner would issue a notice to proceed with the instruction of using previously accepted means and methods to perform the work.” This Design Build process is shown in Figure 4-15 below. Specifically, this type of change was necessary for the rebuilding to move forward quickly and ultimately sped up this project by six times. However, this method was only successful with contractors who had previously performed work with an owner, and the owners were comfortable using the previous means and methods as an acceptable benchmark for the work.

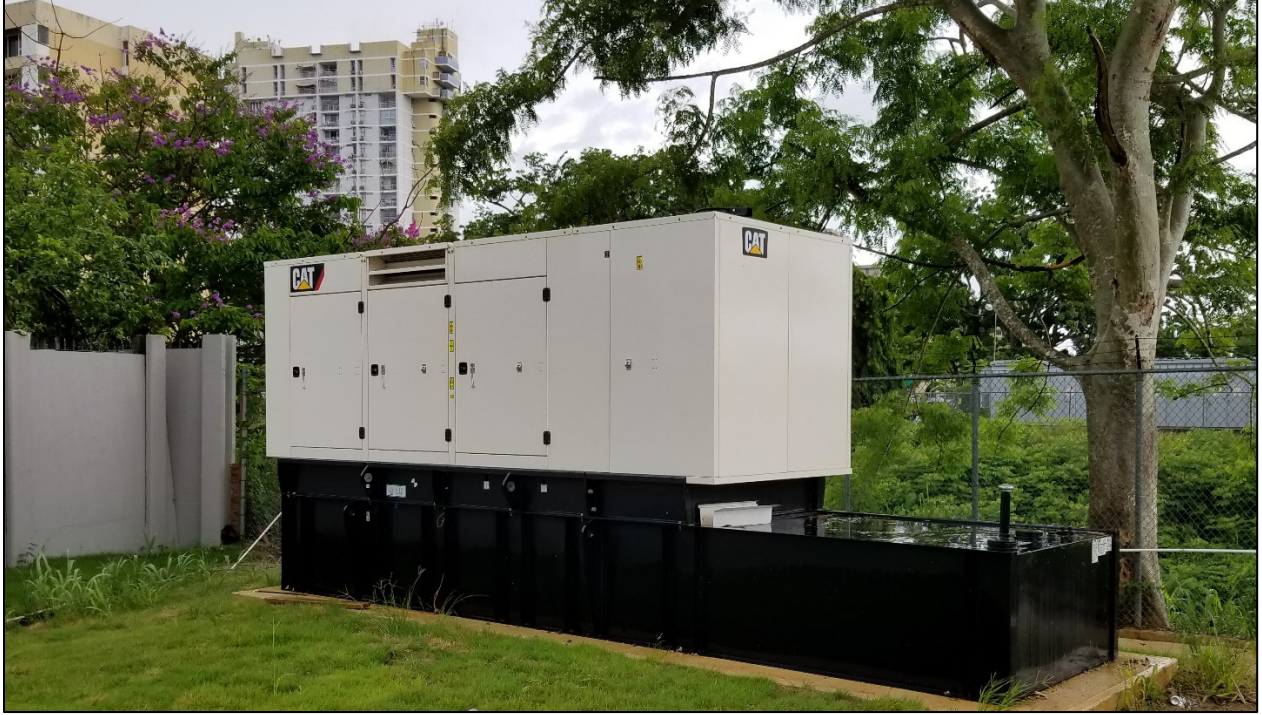
**Figure 4-16: Generator Being Installed in a Mixed Use Development**

Another equipment related change caused by Hurricane Maria was the increase of large commercial generators being used by businesses. With the unreliability of electricity caused by the damages to the power grid, as discussed in Section 4.5: Challenges Created by Reconstruction, many owners incorporated backup generators into the design of their ongoing and future projects. This was done to diminish the number of blackouts experienced after the electrical grid was restored. An example of this is shown in Figure 4-16 below. Some owners took additional measures beyond installing generators by incorporating a combination of solar panels and batteries into the electrical design of their buildings with the hopes of mitigating the risks associated with another potential fuel rationing event that would limit the amount of fuel needed to power their generators.
