# Assessing the ability of interactive pipe liners to withstand host-pipe failure\*

This paper presents an investigation into the behaviour of a number of pipe liner materials, with the specific aim of determining their ability to remain intact during failure of the cast iron host main. Three different liner systems have been evaluated along with an unlined control. One of the liners (epoxy resin lining) is a non-structural technique, whereas the other two (Subcoil and a new development) are semi-structural (or interactive) liners.

**Key words** | cast iron, pipe liner, renovation, semi-structural, water main

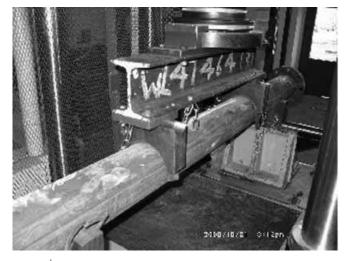
Figure 2 | Pipe section under test showing load application through a spreader beam.

gauges. Figure 2 shows the general arrangement of a pipe

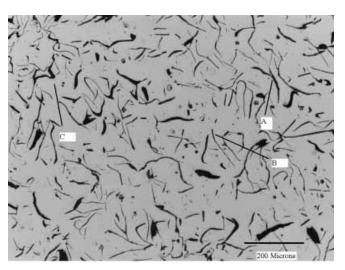
Figure 3 | Microstructure of the un-etched cast iron.

Microstructural analysis carried out on the pipes revealed typical features for a horizontally cast grey cast iron. Figure 3 shows a typical area of the un-etched microstucture. Figure 4 shows the same area as Figure 3, but the microstructure has been etched using 2% Nital.

From Figure 3 it can be seen that graphite flakes are present in three different morphologies, namely acicular (A), scythe shaped (B) and rosette (C). These different microstructures are thought to result from differing

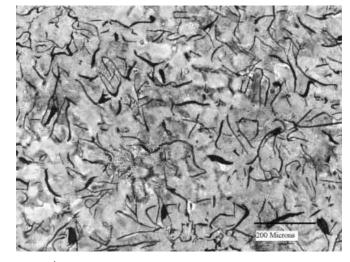
Figure 4 | Low magnification photomicrograph of an etched section of pipe.

cooling rates being experienced across the pipe section. From Figure 4 it is apparent that the microstructure is predominantly pearlitic. This is confirmed in Figure 5, which shows a pearlitic region at higher magnification.

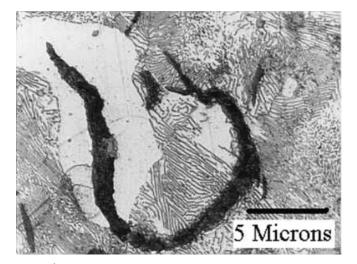
Figure 5 | Photomicrograph depicting regions of pearlite within the etched microstructure.

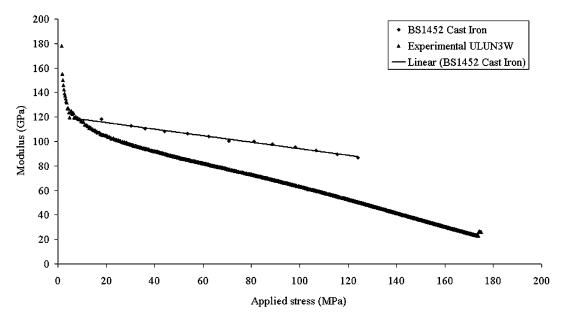
Figure 8 | Variation of modulus with applied stress, showing both experimental and literature data (Angus 1976).

(Figure 8) and hence non-linear methods have to be used to analyse the data more fully, as developed below. The aim of the analysis is twofold, to determine the momentcurvature relationship and to estimate the stress in the cast iron when the pipes fracture.

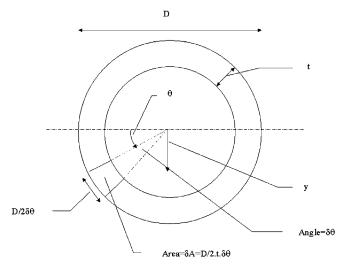
Figure 9 | Schematic representation of an element under stress.

We now consider the geometry of the pipe section (Figure 9). The force on an element of area (D/2). t.  $\delta\theta$  is given by:

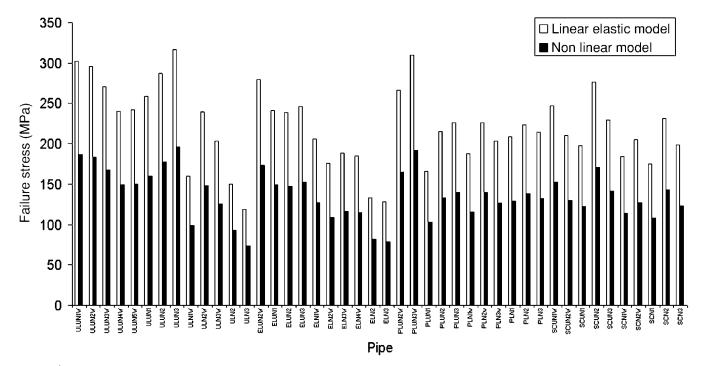
Figure 10 | Bar chart of the failure strengths for all pipes, showing values obtained using both the linear elastic approach and the non-linear analysis.

reported previously. Figure 10 shows all of the data for the full range of pipes tested.

Examination of the data indicates that at any given condition there is some spread. This is believed to be due to material variability, for un-notched samples, and material variability combined with variations in notch geometry, for notched samples. The notched samples show a lower strength, as expected. There is no obvious variation in the results for the dry tests and the corresponding wet tests. Hence in Table 3 (where the results from different liners can be compared), dry and wet data are averaged together. It is clear from Table 3 that there is no clear effect of liner type on the pipe failure strength. Figure 11 shows this graphically. The apparent variations in pipe strengths in the plot are thought to be due to material variability, batch to batch variation differences in processing and so on.

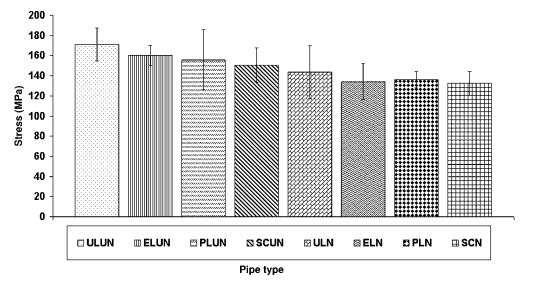
Figure 11 | Plot showing the variation of mean gross failure stress and standard deviation for all samples.

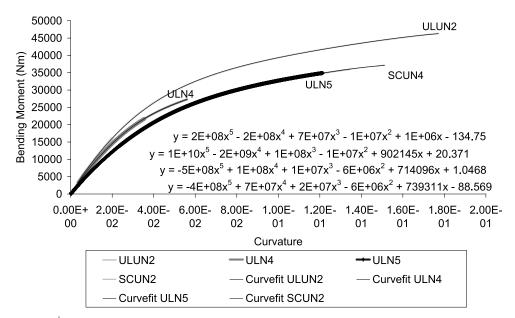
Figure 12 | Plot of bending moment versus curvature for the pipes in bending; the curve fits are also given, with the equations for the line.

It is also useful if a value for the modulus of the material can be obtained from bending results to enable a comparison with the moduli obtained from the tensile tests and hence provide greater confidence in the results obtained. The bending moment-curvature plot, Figure 12, has a slope EI. Thus by taking the slope of the curve using curve fitting procedures and then dividing the value obtained by the second moment of area, I, for the pipe concerned, an approximate value for the modulus of the pipe at zero curvature may be obtained.

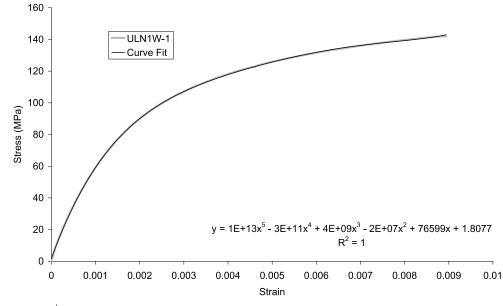
Figure 13 shows the experimental stress-strain data for specimen ULN1W and the associated regression curve. The  $R^2$  value determined indicates that the numerical fit is excellent within the range of values represented by the experimental data. The equation of the regression line, at the bottom of the plot, enables values for the required A-type coefficients to be found.

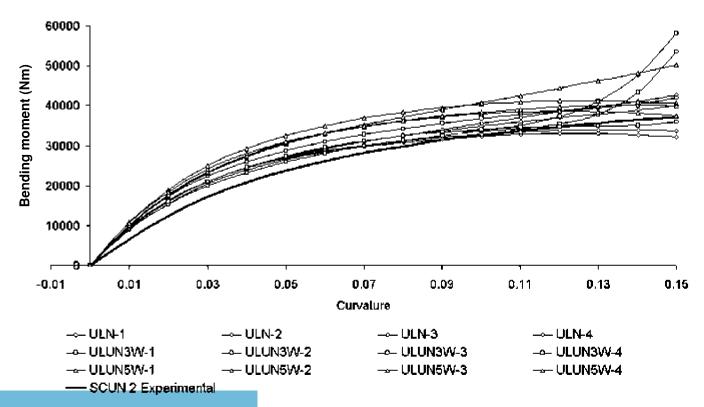
Figure 14 | Plot of predicted and experimental bending moment versus curvature for specimen SCUN2.

Figure 14 shows the predicted and measured bending moment-curvature response for an un-notched pipe. It can be seen that the predicted data are reasonably accurate at low values of curvature. However at high curvatures the predicted values can deviate markedly from

the measured data. There are two causes for this deviation. The first is that, at lower curvatures, there is less magnification of any errors in the model. The second is that the polynomial curve fit, used to obtain the values of the coefficients used in the model, are only accurate within the range of data represented by that particular

The other way in which tensile and bending results may be compared is using the bending moment-curvature plot (Figures 14 and 15). This may be directly derived from the tests on whole pipes or obtained from tensile test data, as described above. The agreement between the two sets of data, given the degree of non-linearity of the material is fair, particularly at low curvatures. However, at higher values of curvature, the agreement becomes less accurate owing to the factors mentioned in the previous section.

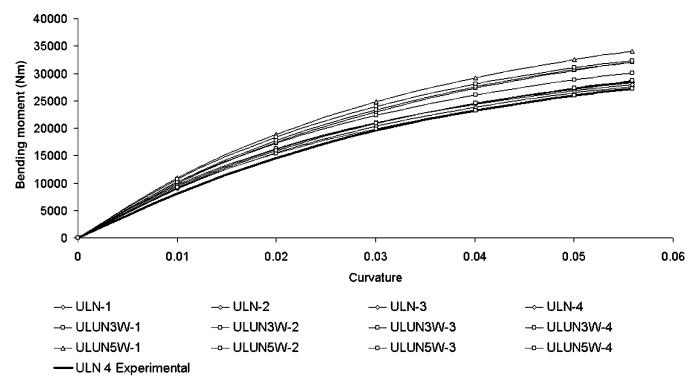
Figure 15 | Plot of predicted and experimental bending moment versus curvature for ULN4.

These large deviations are not seen in the case of the notched samples, since the presence of the notch prevents the specimens from reaching the elevated curvatures possible in the un-notched pipes. Figure 15 shows the predicted and measured bending moment-curvature response for a notched sample. Less deviation from the measured values is seen in comparison with the un-notched specimens.
