## Bank erosion processes in streams in the U.S. Midwest

**BANK EROSION PROCESSES IN STREAMS IN THE U.S.  
MIDWEST**

A thesis submitted in partial fulfillment  
of the requirements for the Doctor of  
Philosophy degree in Civil and Environmental Engineering  
in the Graduate College of  
The University of Iowa

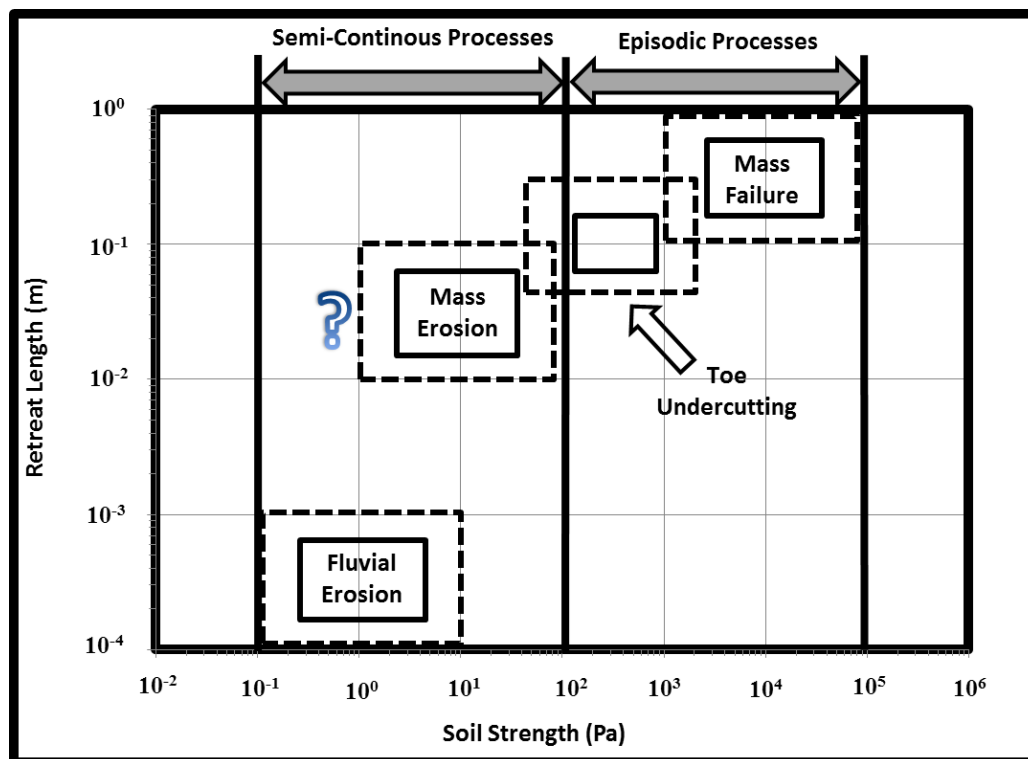
Figure 2.2 A conceptual figure showing different modes of bank erosion.

The second mode of bank erosion is mass erosion, which is also a quasi-continuous process (Vermeyen, 1995), however, it requires higher-magnitude hydrodynamic shear stresses to occur than fluvial erosion (Huang et al., 2006). Due to the higher shear forces, mass erosion proceeds at a higher rate of erosion and results in larger retreats of the bank soil comparatively to fluvial erosion but smaller retreats with respect to mass failure. It is classified as an “intermediate amplitude” erosional process (e.g., Gaskin et al., 2003). The retreat length scale for fluvial erosion is usually in millimeters, whereas, for mass erosion is in centimeters and for mass failure in meters (Fig. 2.2).

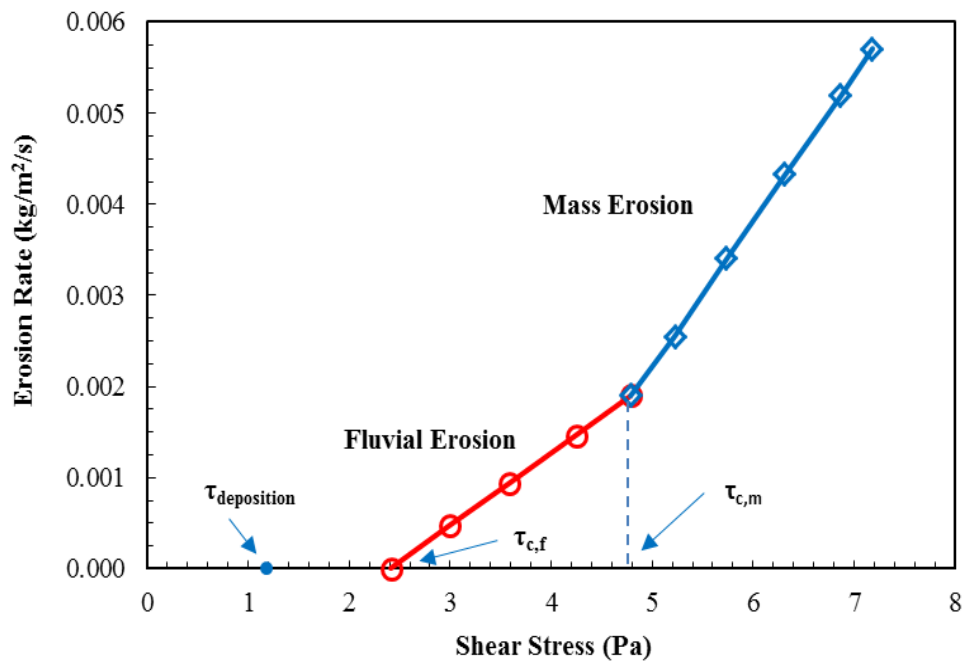
Figure 2.3 An idealistic illustration of fluvial and mass erosion (redrawn from Vermeyen, 1995). Fluvial erosion (red circle-marked line) occurs at the lower range of shear stress while mass erosion (blue square-marked line) ensues at the upper range of shear stress.

A conceptual schematic, found in Figure 2.3, illustrates the sequence of occurrence of fluvial (red circle-marked line) and mass erosion (blue square-marked line) processes for a homogeneous soil as function of the shear stress magnitude. Clearly, there is a regime change in the mode of bank erosion from fluvial to mass erosion once the shear stress increases and surpasses a threshold value for the onset of mass erosion, which is called *mass erosional strength*,  $\tau_{c,m}$ . This change is depicted by the slope variation of the erosion line in Figure 2.3. The slope of the segment corresponding to mass erosion is higher than the one for fluvial erosion, indicating higher erosion rates or retreat rates. During mass erosion due to the higher rate of erosion, the retreat manifests as the detachment of soil chunks or clods (Fig. 2.4) from the bank profile or with the removal of soil layers in the form of “thin sheets” (e.g., Mazurek et al., 1999; Gaskin et al., 2003; Winterwerp and van Kesteren, 2004; Huang et al., 2006; Kothiyari and Jain, 2008; Winterwerp et al., 2012).

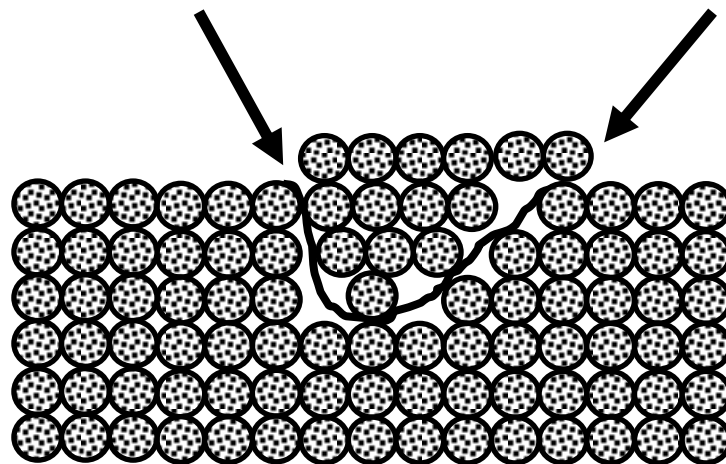
Figure 2.4 Mass erosion (redrawn from Winterwerp and Van Kesteren, 2004).

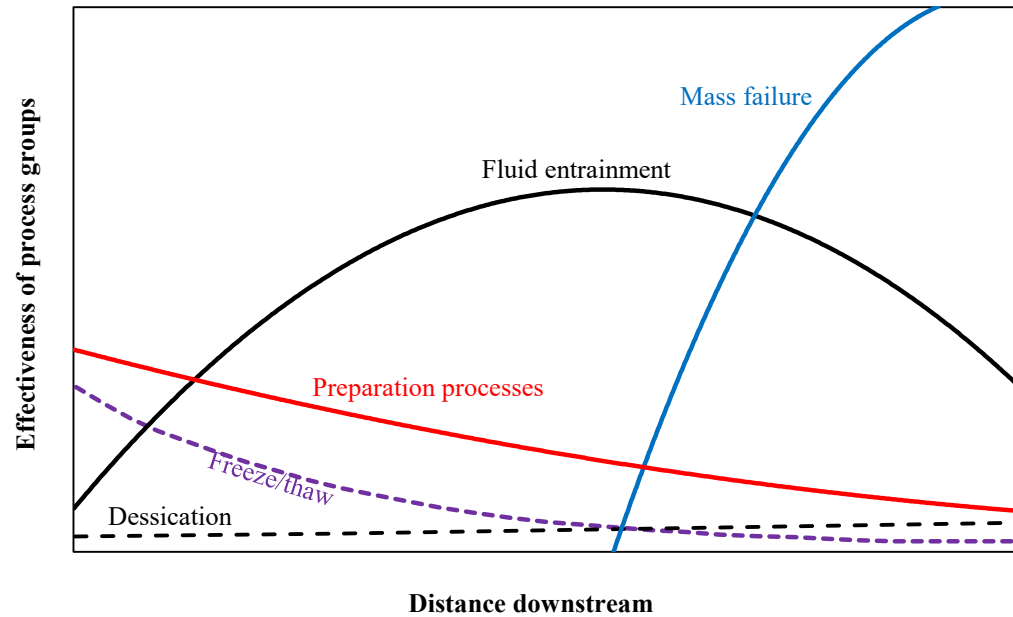
Figure 2.5 Conceptual model of erosional process dominance at the watershed scale (Rinaldi and Darby, 2008; After Lawler, 1992).

the hydraulic forces of the flow, and mass failures driven by gravity (Fig. 2.5). Generally, mass failure will most likely dominate bank retreat in the lower reaches of a watershed where the critical bank height is more often exceeded (ASCE Task Committee, 1998). On the other hand, fluvial and mass erosion will dominate in the middle reaches of a watershed where the stream power, and therefore, the shearing action of flow is highest (Fig. 2.5, Lawler, 1992). This conceptual figure provides some general insight into the dominant bank erosion process and the potential interaction among those different modes at different location in a watershed. Although this conception is not always valid as many other factors such as bank soil composition, seepage, groundwater dynamics, and the presence of roots may dictate the dominant mode of erosion at certain locations within a watershed, the figure provides a good representation of the relationship between different processes along a river continuum.

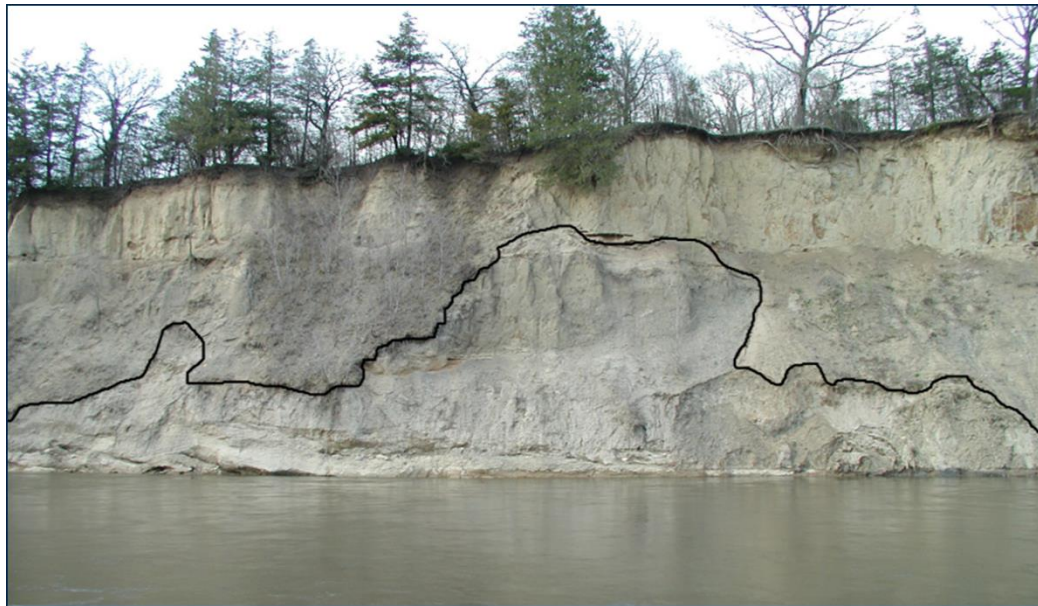
Figure 3.1 Mass failure in the upper Minnesota River (source: Dave Thomas).

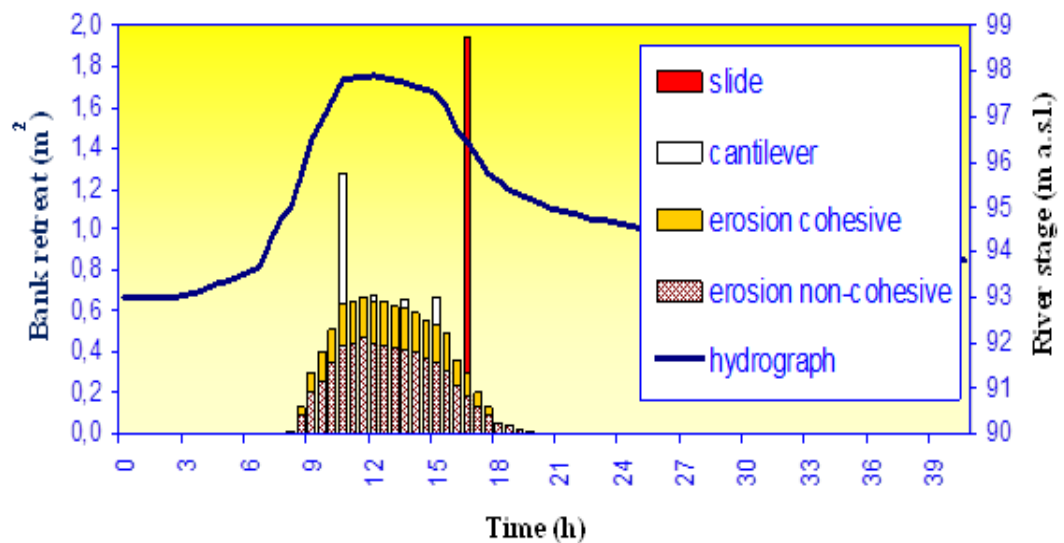
Figure 3.2 Illustration of the modes of bank erosion: from fluvial to mass failure (source: Thanos Papanicolaou and Massimo Rinaldi).

Most attention has been given to mass failure, the upper limit of bank erosion, while only few studies have considered fluvial and mass erosion (Papanicolaou et al., 2006; Rinaldi and Darby, 2008). It is relatively easier to identify and quantify catastrophic mass failure, which typically occurs as falling slumps or sliding layers of bank soil (Fig. 3.1) during infrequent time periods. Yet, it is difficult to monitor fluvial and mass erosion, which occur at the grain or clod scale and on a rather continuous basis (Fig. 3.2).

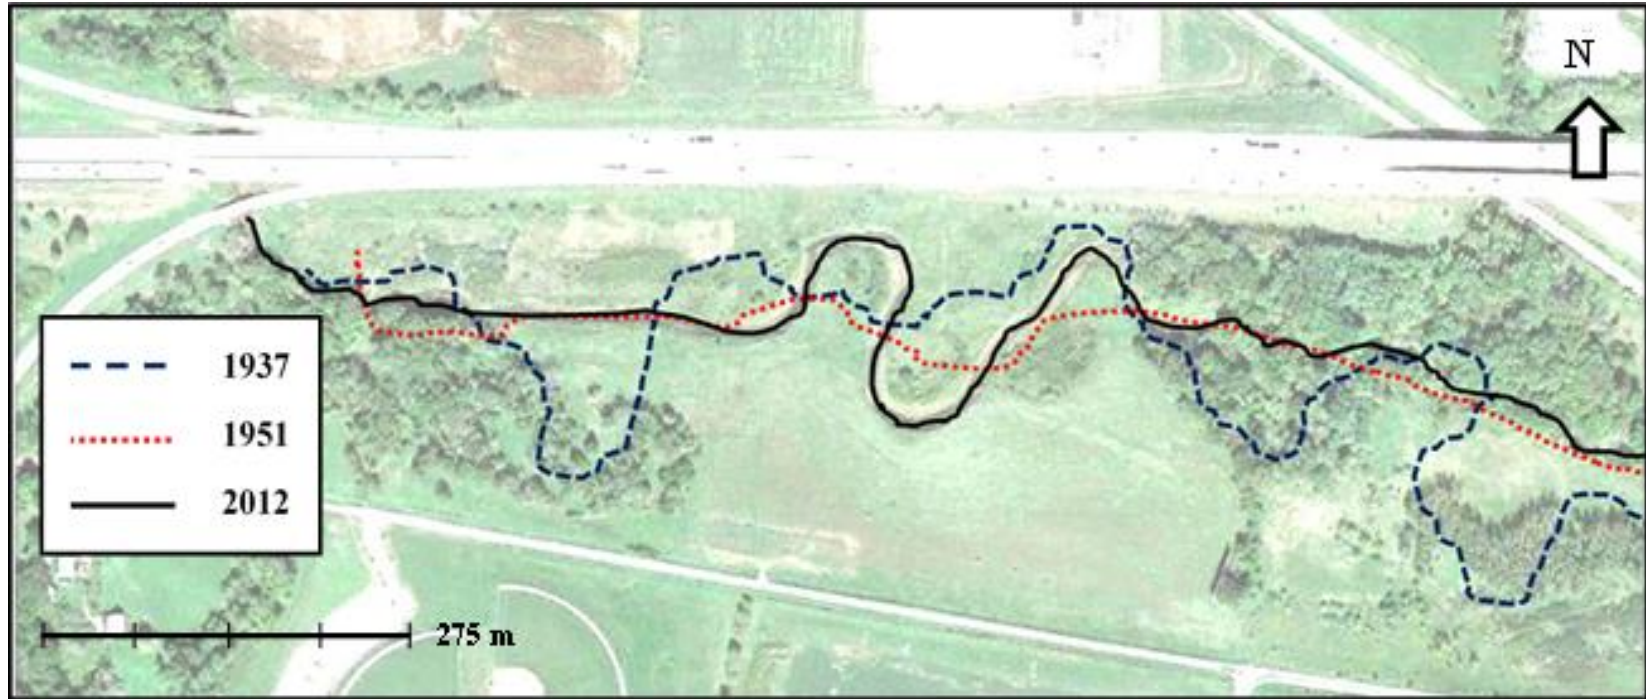
Figure 5.2 Historical planform changes in Clear Creek from 1937 to present, modified from Langel (1996).

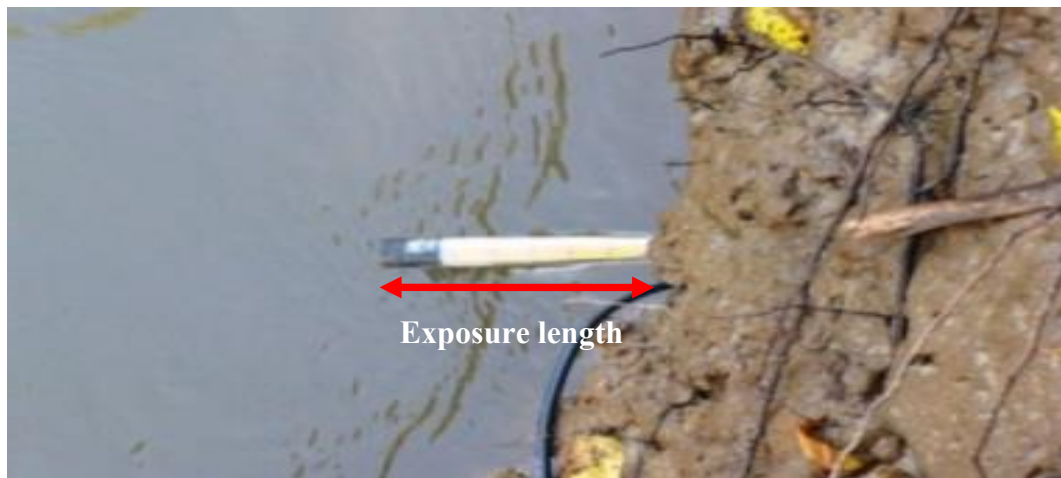
Figure 6.2 PEEP exposure length after a flood event.

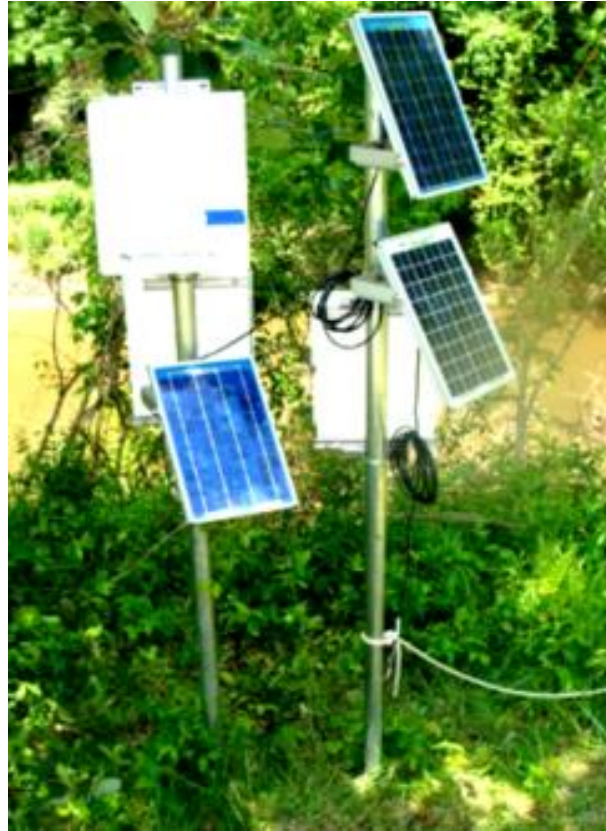
Figure 6.3 Data loggers and solar panels attached to a pole on the nearby floodplain.

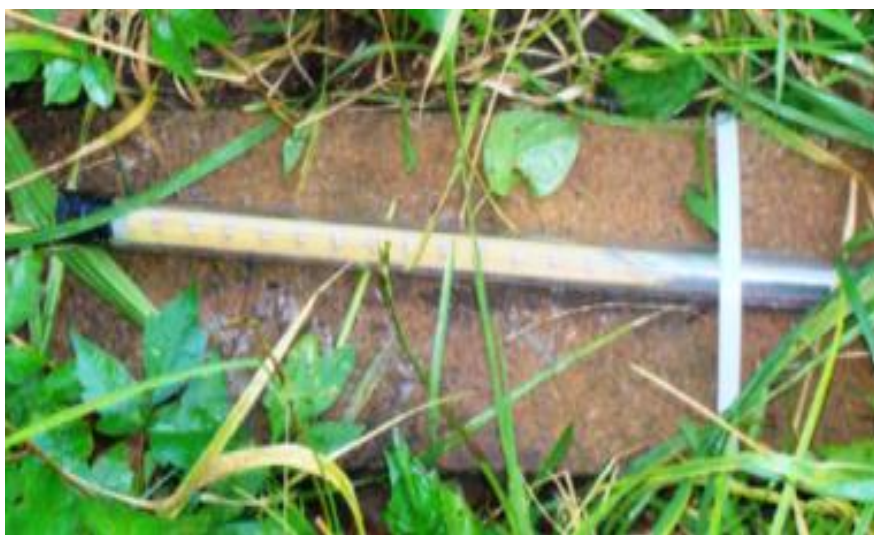
Figure 6.4 A reference PEEP was secured on the nearby floodplain.

An integral component of the photo-resistant PEEP system is the reference PEEP sensor (Bertrand, 2010). The reference PEEP was mounted on a cement block surface and secured on the nearby floodplain for sites 1 and 2 (Fig. 6.4) in order to provide unobstructed reference PEEP voltage outputs,  $V_{rP}$ , that represented the maximum (fully exposed) outputs for any ambient light condition (McDermott and Sherman, 2009). This type of data,  $V_{rP}$ , was needed for two reasons. First, for detecting when the PEEP is fully exposed ( $V_{CS} \approx V_{rP}$ ) and need to be reset (Hydro Scientific Ltd., 2004). The PEEP

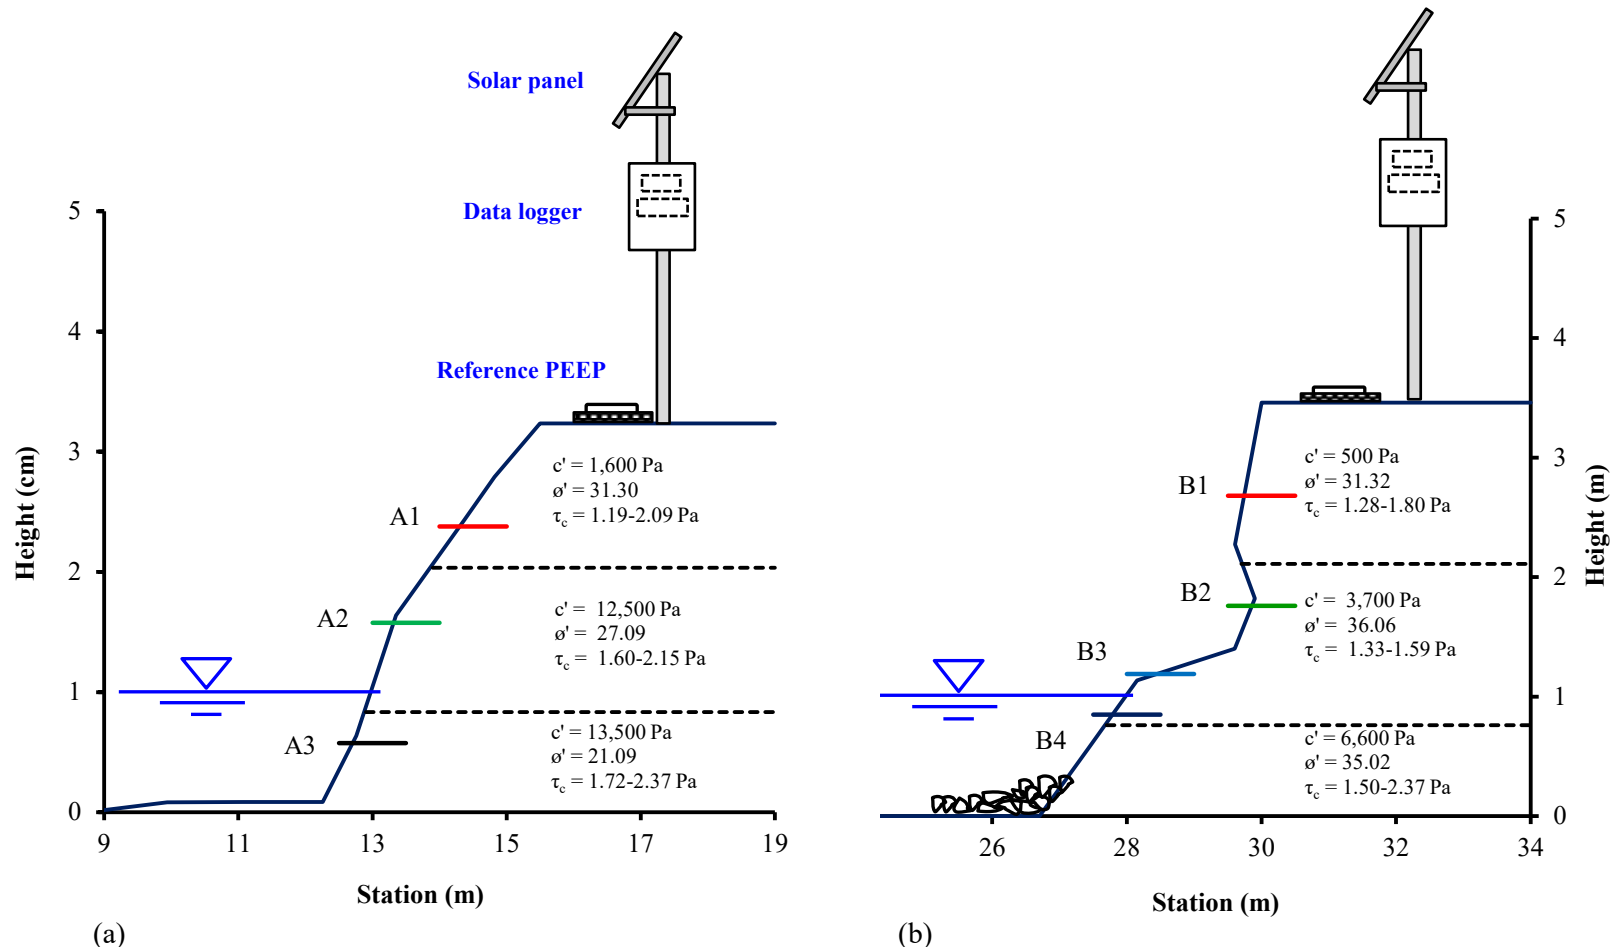
Figure 6.6 PEEP installation. (a) Site 1. (b) Site 2

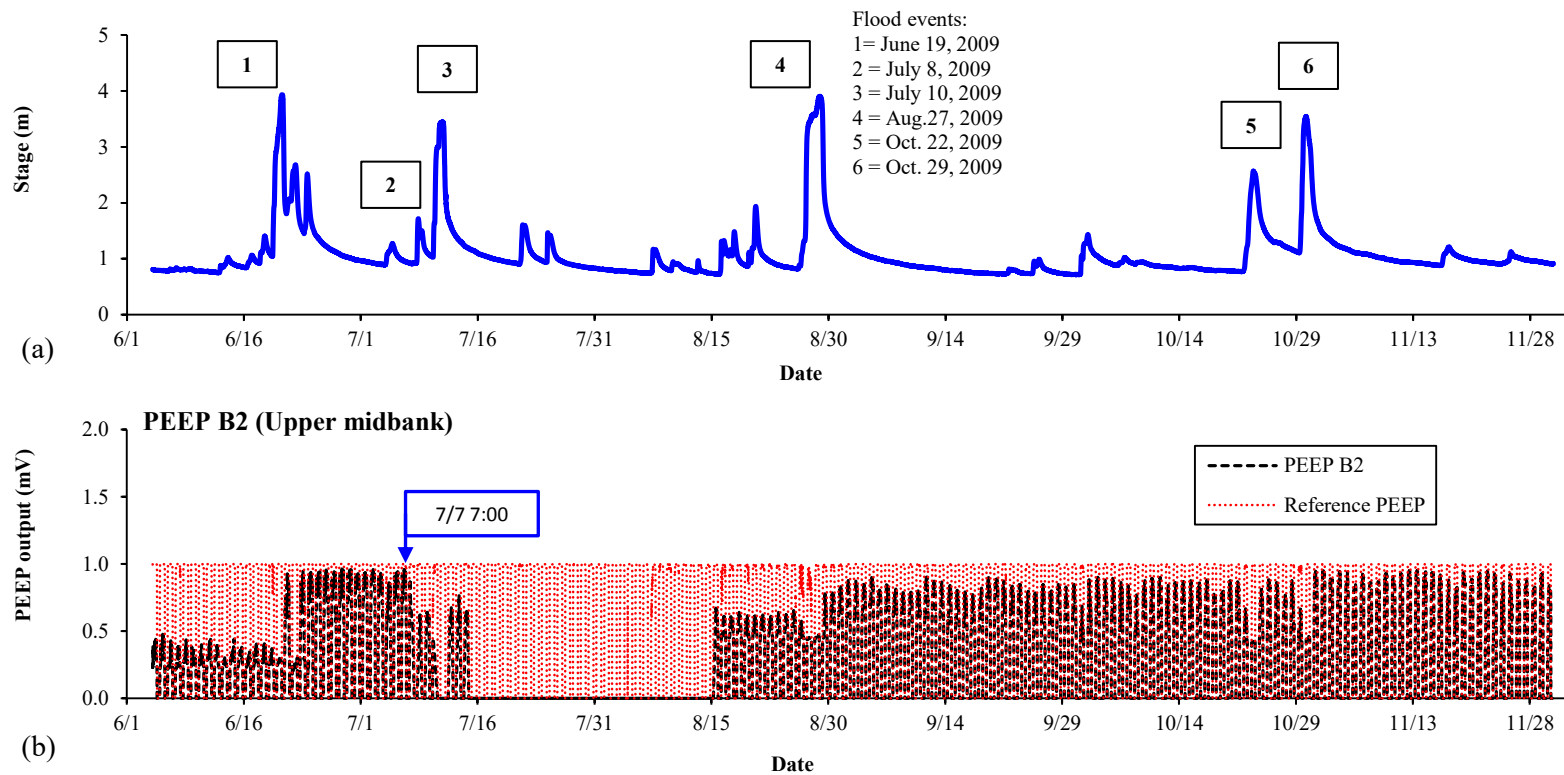
Figure 6.7 Time series of water stage and PEEP outputs deployed at site 2. (a) Water stage. (b) Outputs from PEEP B2,  $V_{CS}$ , (black dashed line) and the reference PEEP,  $V_{RP}$ , (red dashed line).

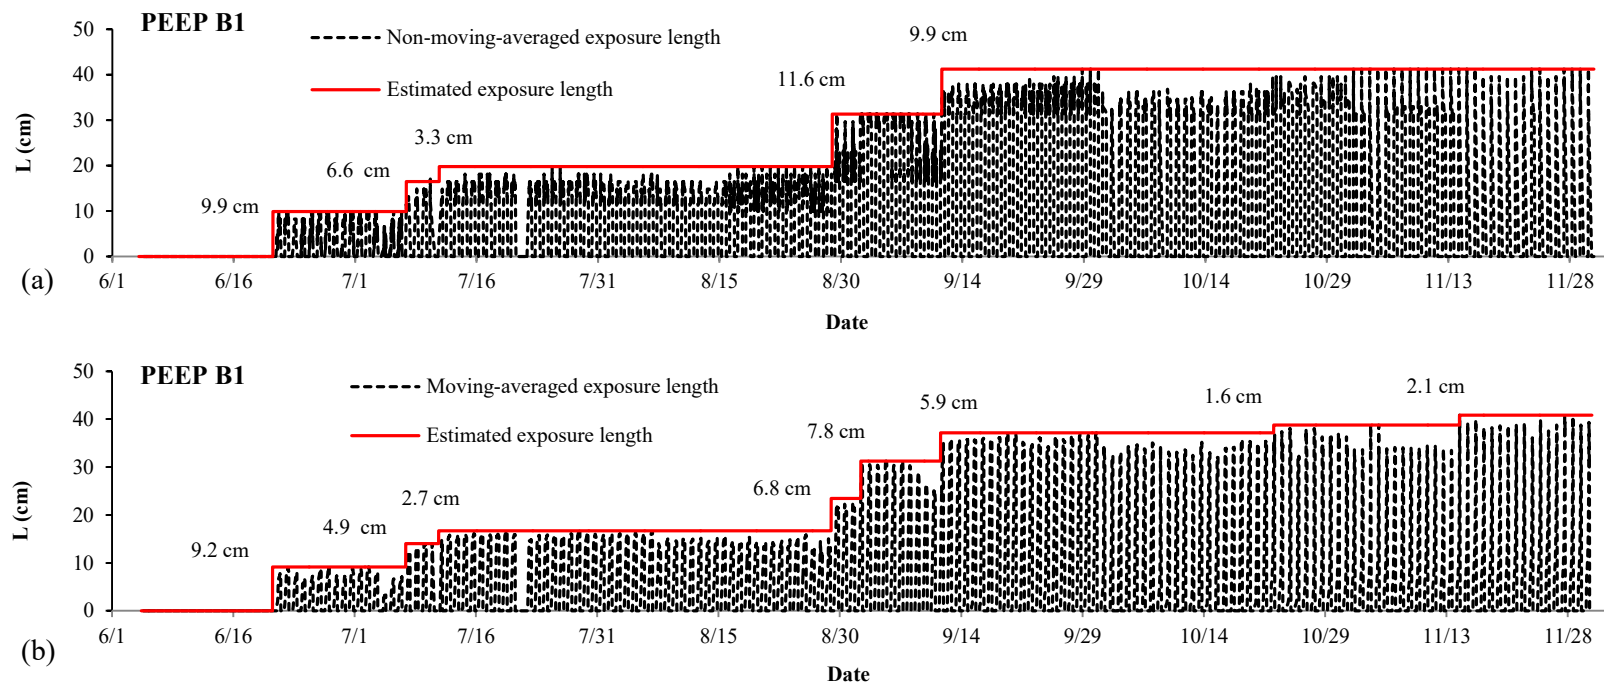
Figure 6.9 Comparison between non-moving-averaged and moving-averaged exposure length. (a) Time series of exposure length without performing moving-average analysis. (b) Time series of moving-averaged exposure length.

To minimize the variability in daily peak values of the time series of exposure lengths (black dashed line in Figure 6.9a), a “*smoothing*” procedure was performed using the concept of moving average (Whittaker and Robinson, 1967). The time series was first smoothed with an 8-hour interval moving average. The 8-hour moving interval was used herein since larger time intervals would provide similar results, based on our analysis with 11-hour and 24-hour moving intervals (Bertrand, 2010). This moving-average approach was effective as it resulted to more stable daily peaks and more visible erosion-related increases (black dashed line in Figure 6.9b) comparatively to the non-moving-averaged  $L$  (black dashed line in Figure 6.9a). However, further smoothing was

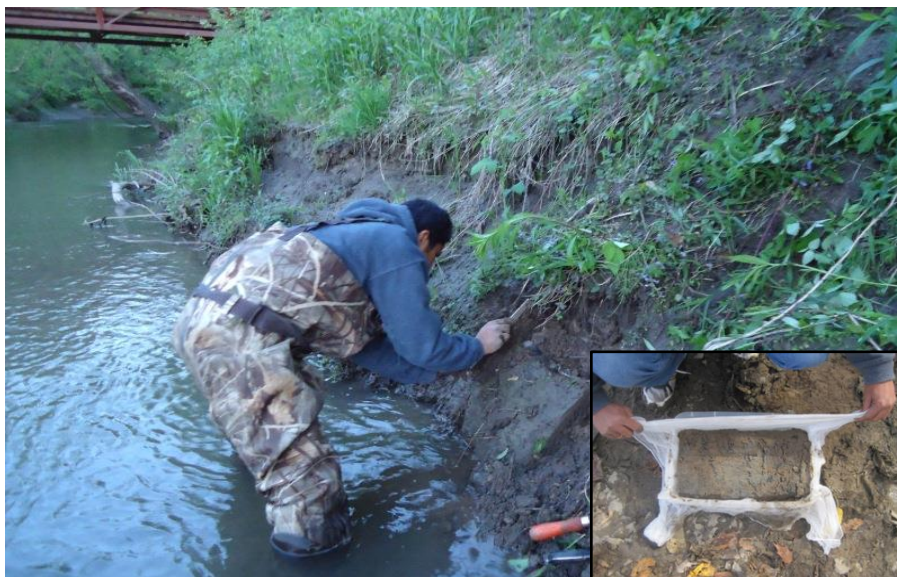
Figure 6.10 Sample extractions. (a) A sketch of the sample extraction scheme applied for the left and right banks at site 1 and 2. Figure not to scale. (b) Extraction of soil blocks from the right bank, cross section CC 1 at site 2. Inset: Soil was wrapped in cheese cloth before being transported from the field to the laboratory.

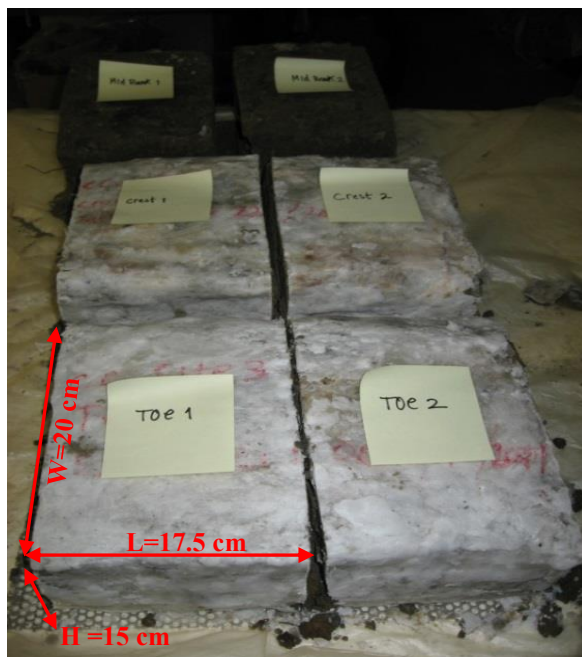
Figure 6.11 Gamma attenuation test. (a) Selective soil samples, from the crest, midbank, and toe of the right bank, cross section CC 1 at site 2. (b) The radioactive source emitted collimated gamma radiation through the sample. The radioactivity was attenuated as it passed through the soil sample. The detector received this attenuated signal, which was a function of the sample bulk density.

To assess the degree of soil heterogeneity, twelve (12) soil samples from the crest, midbank and toe of the banks at site 1 and 2 were cut in half length wise (i.e., length = 17.5 cm; width = 20 cm; height = 15 cm) (Fig. 6.11a) so they could fit into the gamma attenuation detector set-up (Fig. 6.11b) and enable bulk density profile measurements throughout the entire samples. The bulk density measurements were conducted using an automated gamma radiation scanning system that consisted of a 550-mCi Americium (Am-241) gamma radiation source (measured at 60keV) and a Harshaw 6S2/2-X NaI(Tl) detector (Fig. 6.11b) with an integrated photomultiplier for detecting of the attenuated radiation. The signal from the detector was amplified and then passed through a single-channel analyzer (Harshaw NC-22) operated in windowed mode to filter out noise. Collimation was provided by a lead plate that was 9.5-mm thick with a 6.35-mm circular hole for the source beam and a 0.889 x 36.8-mm slit for the detector, machined in a 31.8-mm deep block of lead. The same system was also used in Papanicolaou and Maxwell (2006). A QuickBASIC program controlled the stepper motor and gamma counter; the

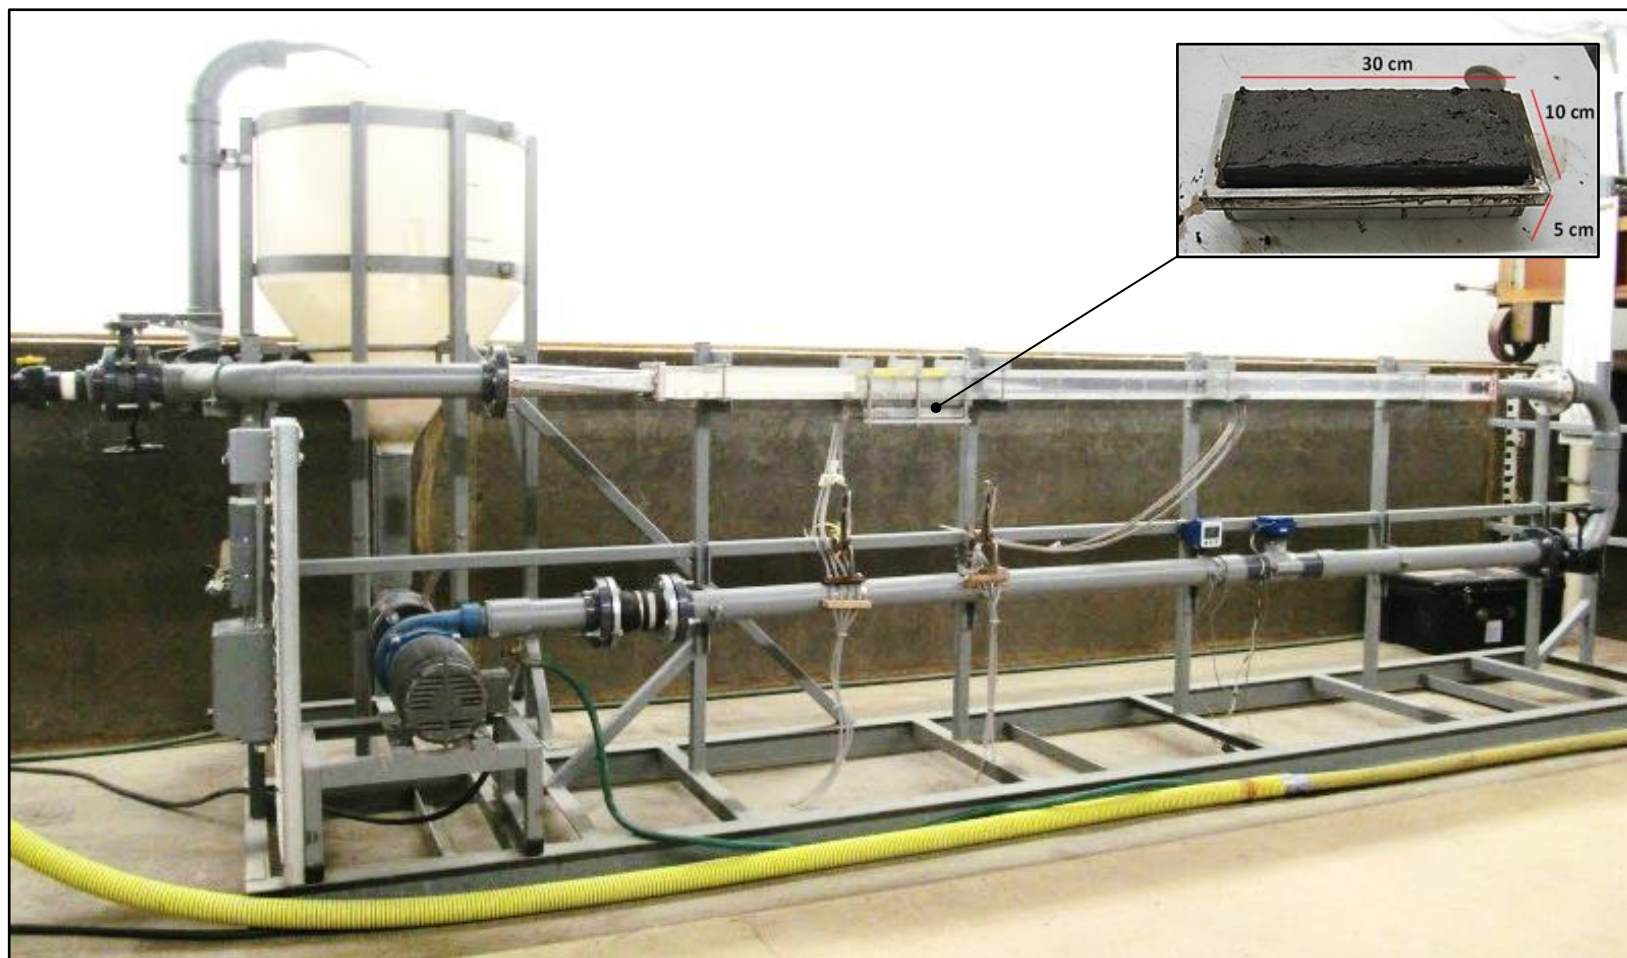
Figure 6.12 A photograph showing the conduit flume used in the present study.

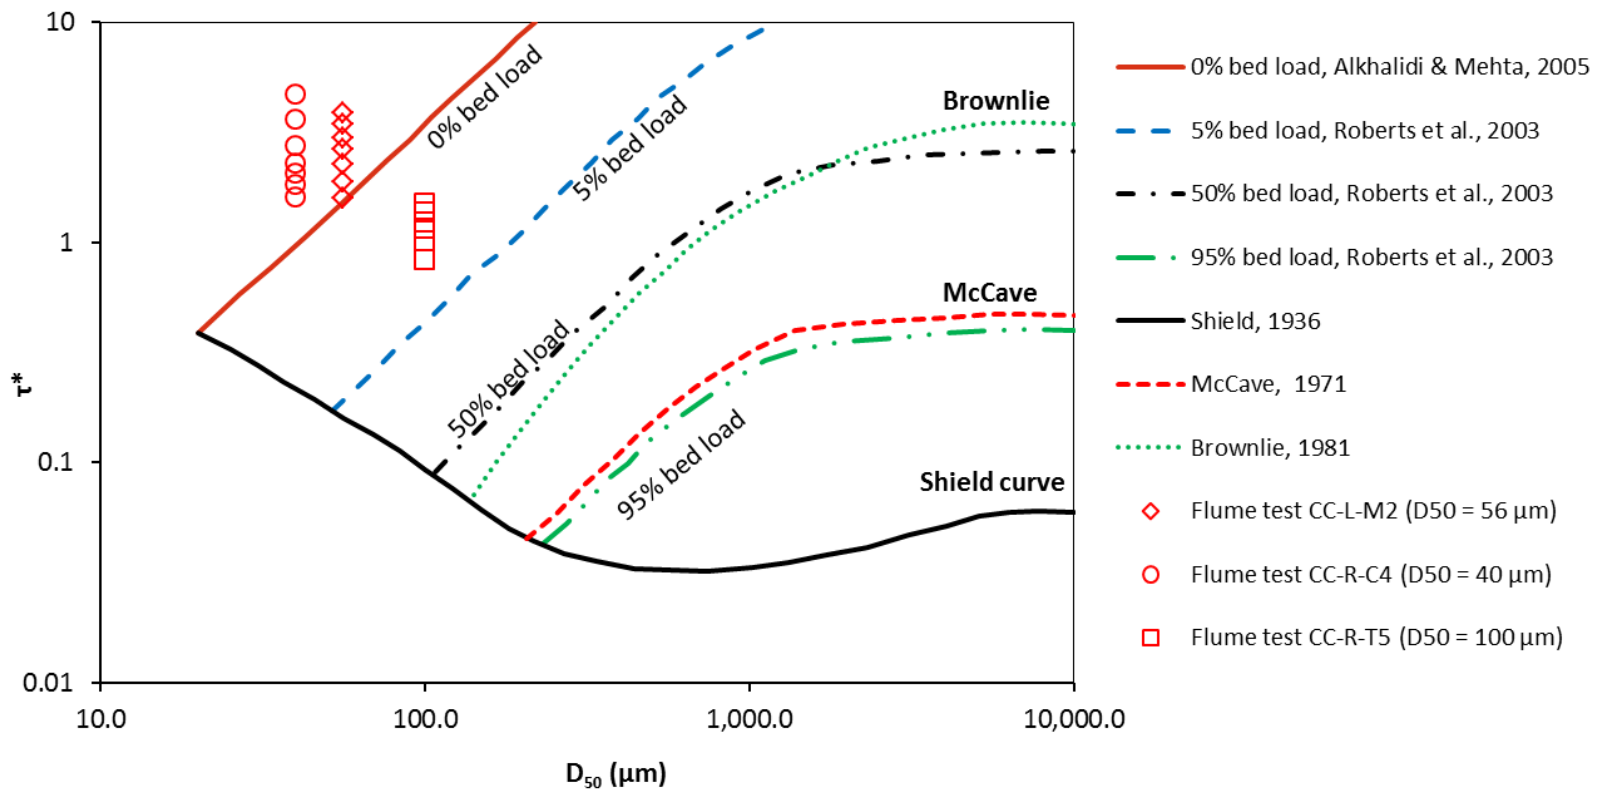
Figure 6.14 Bed load fraction as a function of particle diameter,  $D_{50}$ , and dimensionless shear stress,  $\tau^*$ . Shield curve defines the initiation of motion. McCave and Brownlie represent the initiation of suspension. The 95%, 50%, and 5% bedload threshold curves were based on Roberts et al. (2003). The 0% bed load threshold curve was originated from Alkhalidi & Mehta (2005).

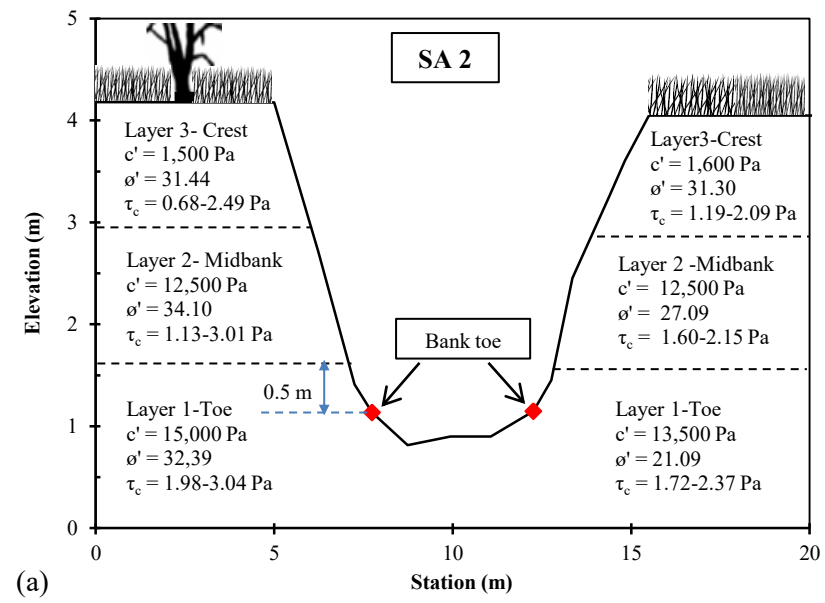
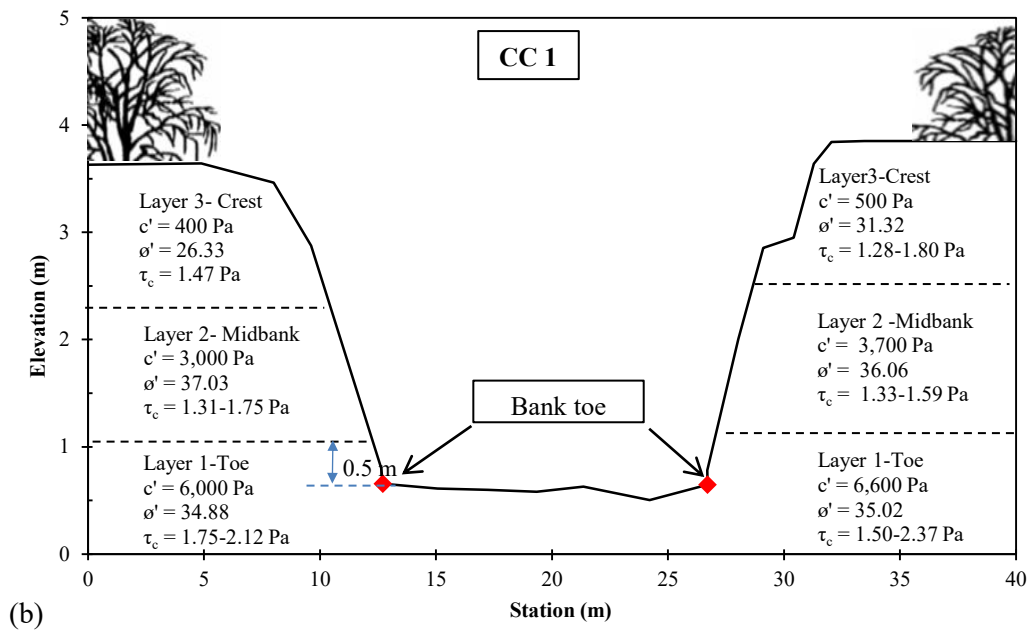
Figure 6.15 Representative cross-sections (facing downstream) with average bank soil properties: (a) Cross section SA 2, site 1. (b) Cross section CC 1, site 2.

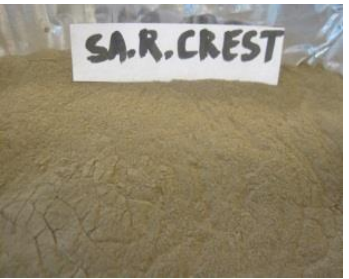
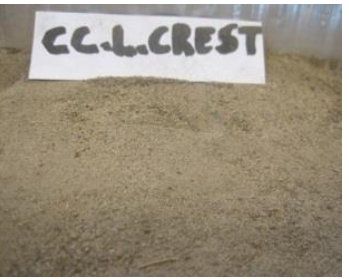
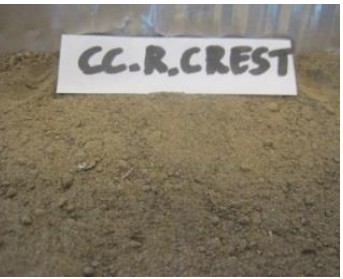
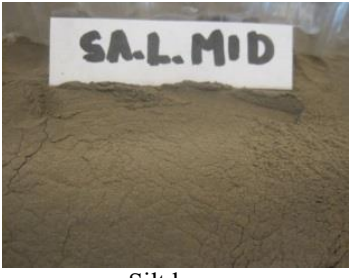
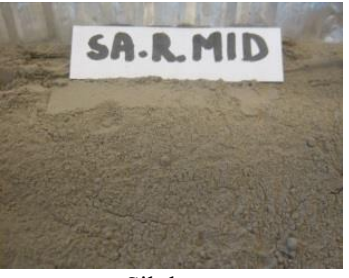
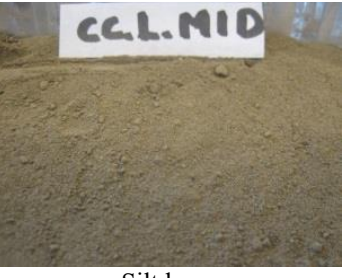
Figure 7.1 Twelve (12) oven-dried bank soil samples from site 1 and 2.

In general, the bank soils at the headwaters site (site 1) were predominantly silt ( $61.55 \pm 6.23\%$ ) with lesser amounts of clay ( $17.62 \pm 5.46\%$ ) and sand ( $20.84 \pm 7.37\%$ ) (see Table 7.1, column 1-3, and Fig. A.1). Thus, they were classified as silt loams based on the USDA classification system (Fig. 7.1 and A.2). Unlike the samples at site 1 in which silt was dominant, the bank soils at the mouth site (site 2) had more equal portions of sand ( $52.79 \pm 11.43\%$ ) and silt ( $39.44 \pm 10.43\%$ ) with a low portion of clay ( $7.77 \pm 2.30\%$ ) (see Table 7.1, column 1-3, and Fig. A.1). The crest and toe soils were classified as sandy loams while the midbank soils were silt loams based on the USDA classification system (Fig. 7.1 and A.2). The sand fraction was slightly dominant at the toe and more specifically at the crest where sand was deposited during a June 20, 2009 flood event (Fig. 7.2). The plasticity index  $PI$  for both sites (Table 7.1, column 8) ranged from 12 to 19; the prevalent clay type based on XRD analysis is illite (Clay Mica) - smectite, with the average surface activity,  $A_c$ , values (Table 7.1, column 9), being 0.75 and 1.37, respectively, for sites 1 and 2 (Theregowda et al., 2006).

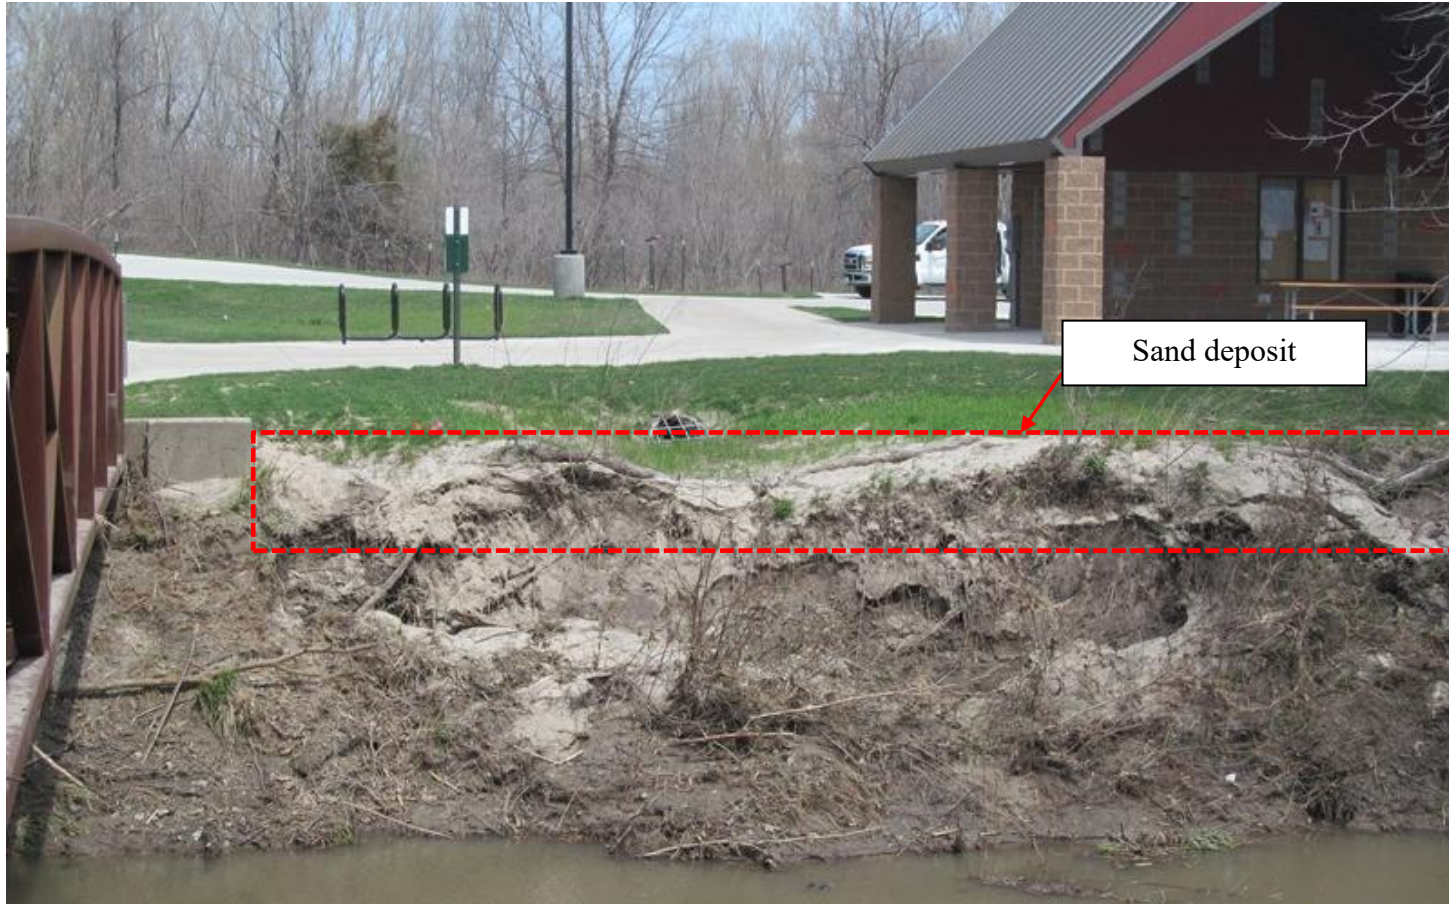
Figure 7.2 Clear Creek bank soils. Fresh sand was deposited on the flood plain at site 2 after a flood event.

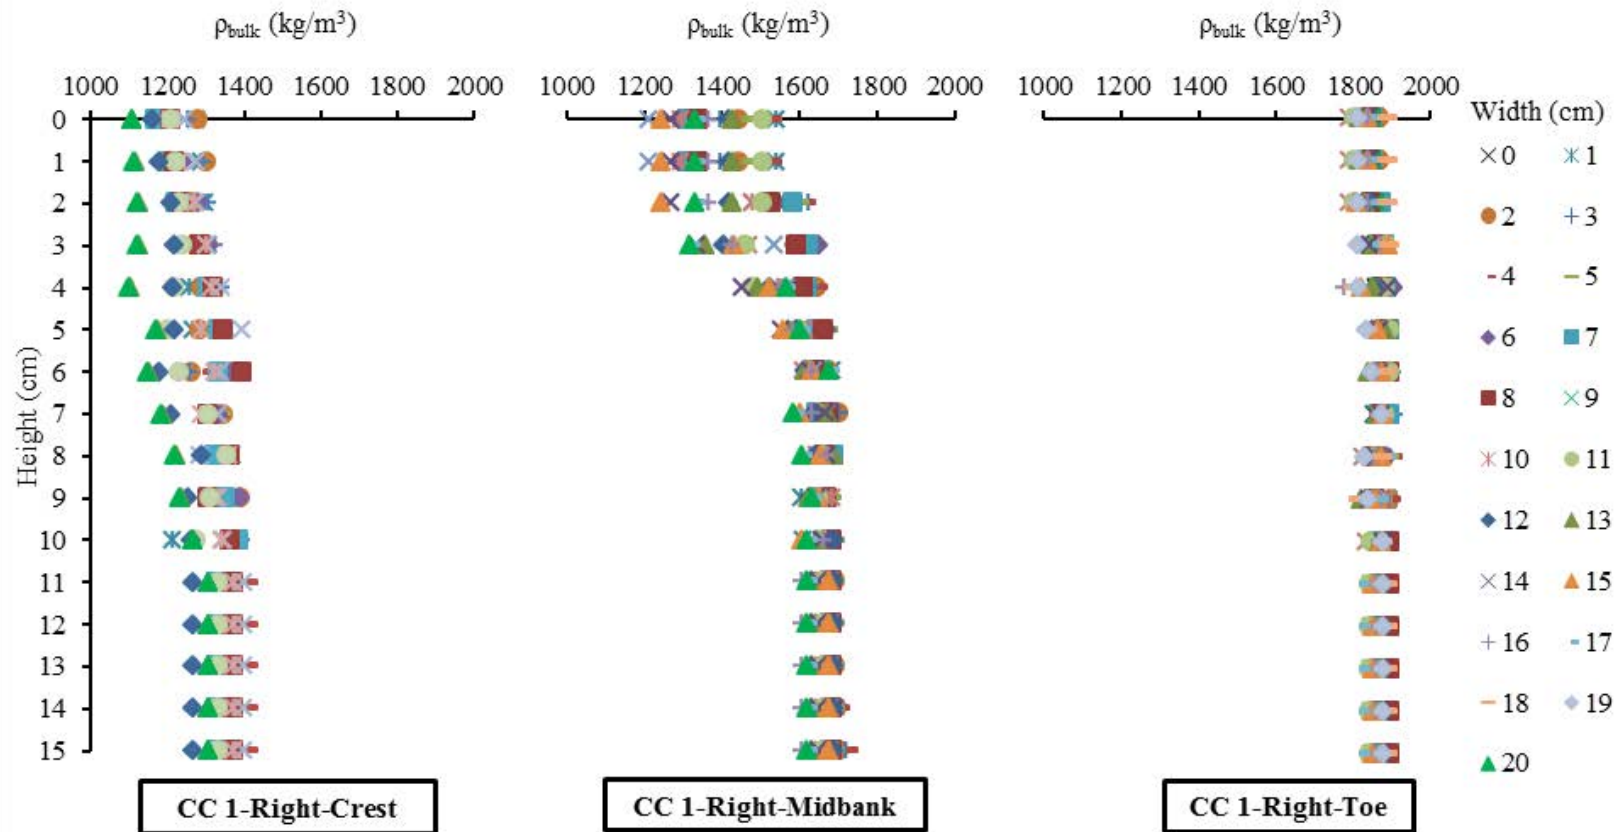
Figure 7.3 Bulk density profile obtained from gamma attenuation analyses. Representative samples from the right bank, cross section CC1 at site 2, were analyzed using gamma attenuation to measure bulk density. The height and width are the distance from the top and side of soil sample, respectively, to the measurement point. The scatter in the data points for the crest and midbank samples demonstrates heterogeneity in bulk density. In contrast, the toe soil exhibited a collapse of data points signifying the homogeneity in bulk density.

Figure 7.3 shows examples of the bulk density profiles measured with gamma attenuation for three representative samples from the crest, midbank, and toe of the right bank at cross section CC 1. The bulk density values measured with the gamma attenuation scanning system, when integrated over the sample height of about 15 cm, compared overall well with the bulk density values determined using standard methods (Table 7.1, column 5). Nonetheless, the density profiles over the height of 15 cm in Figure 7.1 revealed that soils from the crest and midbank exhibited higher heterogeneity as seen by the scatter in the attenuation data. The soil from the bank toe, however, had a fairly constant density profile thereby implying a rather homogeneous soil. A similar trend was found for samples at cross section SA 2 although the degree of heterogeneity among the three layers at the headwaters site was less comparatively to that at the mouth (i.e., CC 1). CC1 had a higher heterogeneity especially at the crest due to the finer fraction sand deposition during frequent flooding at this site (Fig. 7.2).

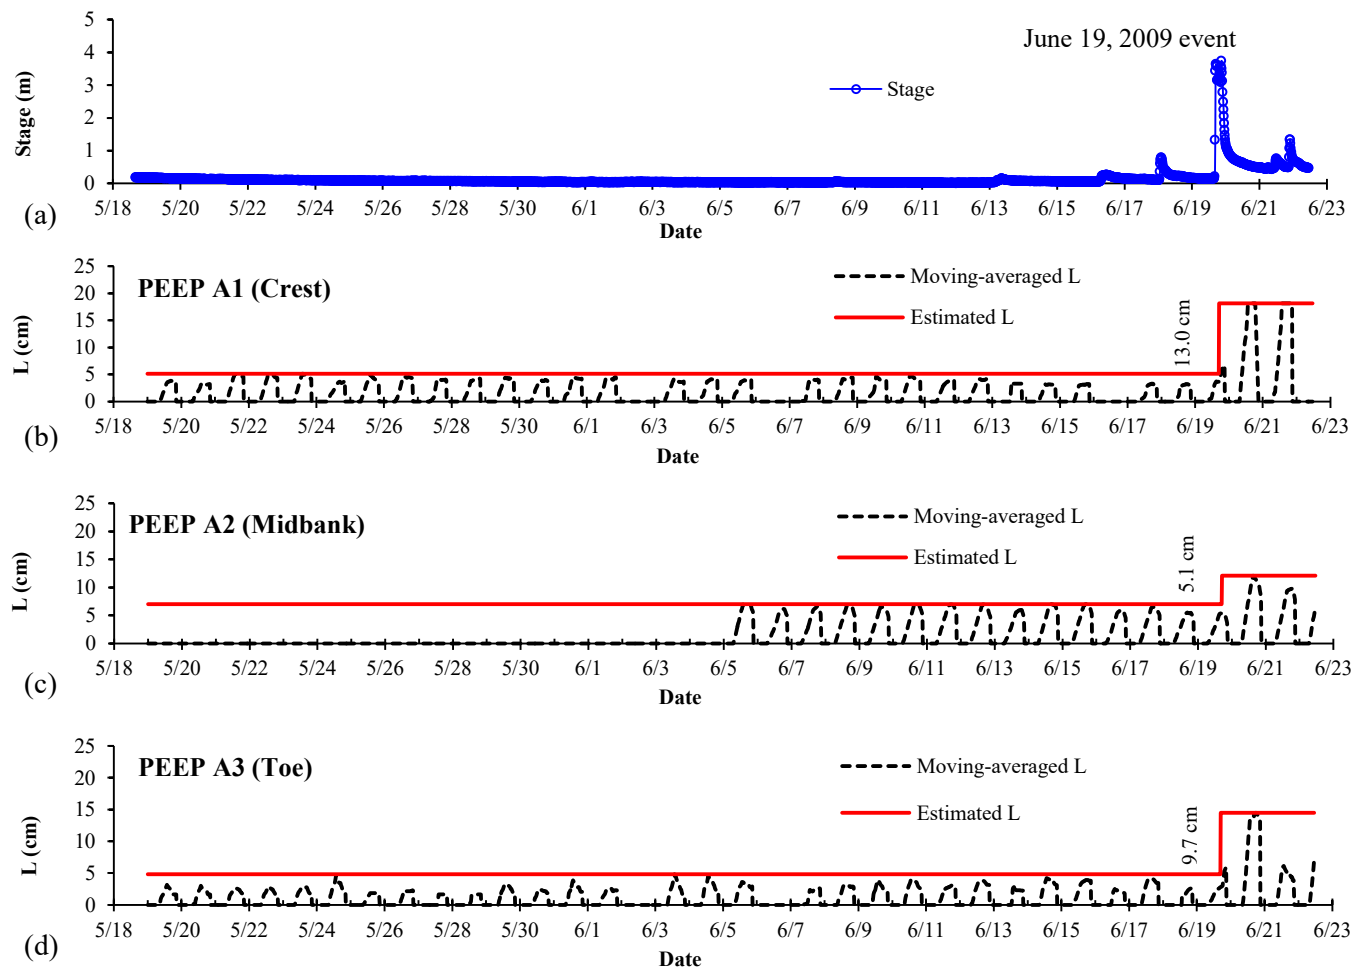
Figure 7.6 Time series of water stage and exposure length for PEEPs at site 1. (a) Water stage. (b) Moving-averaged and estimated exposure length for (b) PEEP A1, (c) PEEP A2, and (d) PEEP A3. The increases in estimated exposure length represent the erosion depths corresponding to erosion events.
