## Bank erosion processes in streams in the U.S. Midwest

**BANK EROSION PROCESSES IN STREAMS IN THE U.S.  
MIDWEST**

A thesis submitted in partial fulfillment  
of the requirements for the Doctor of  
Philosophy degree in Civil and Environmental Engineering  
in the Graduate College of  
The University of Iowa

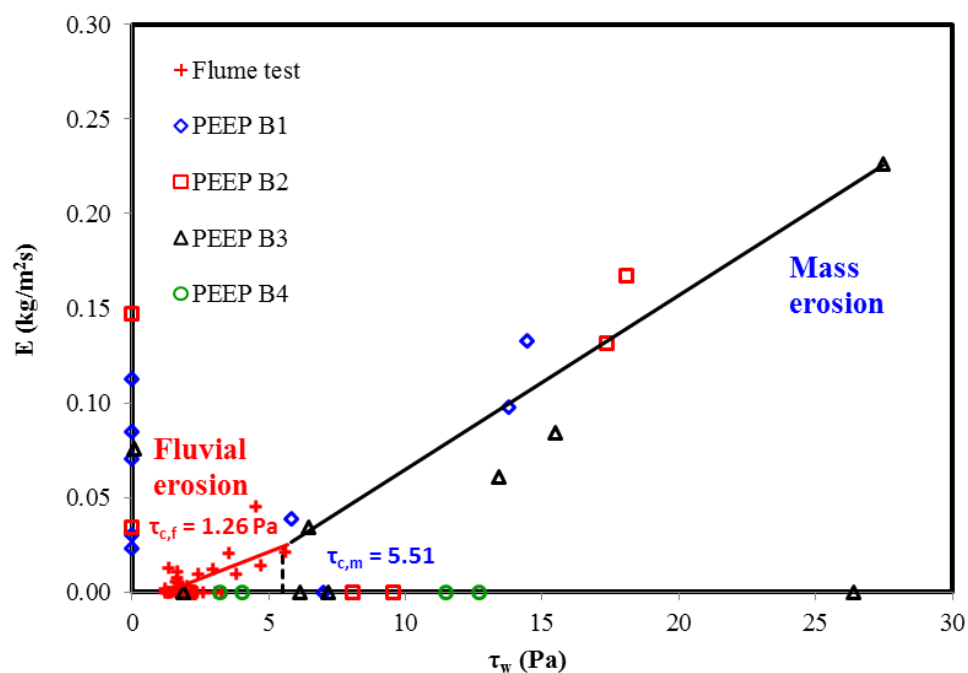
Figure 7.9 Determination of mass erosional strength,  $\tau_{c,m}$ . The  $\tau_{c,m}$  value was determined by drawing a fitting line on the plot of shear stress and erosion depth  $[\tau_w, \Delta L]$  data points obtained at the crest, upper midbank, lower midbank, and toe of the bank. The  $\tau_{c,m}$  value corresponds to the x-intercept of the fitting line.

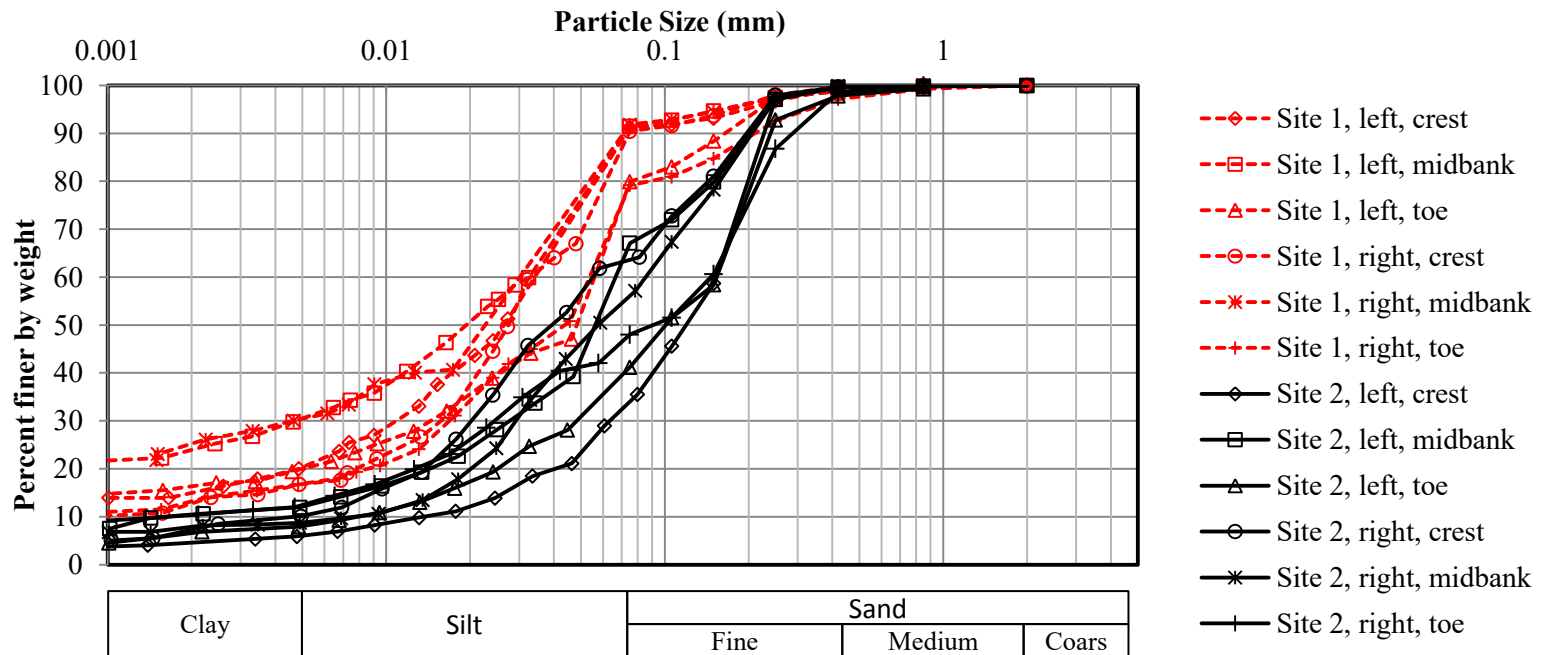
Figure A1. Size distribution for the bank soils extracted from site 1 and site 2.

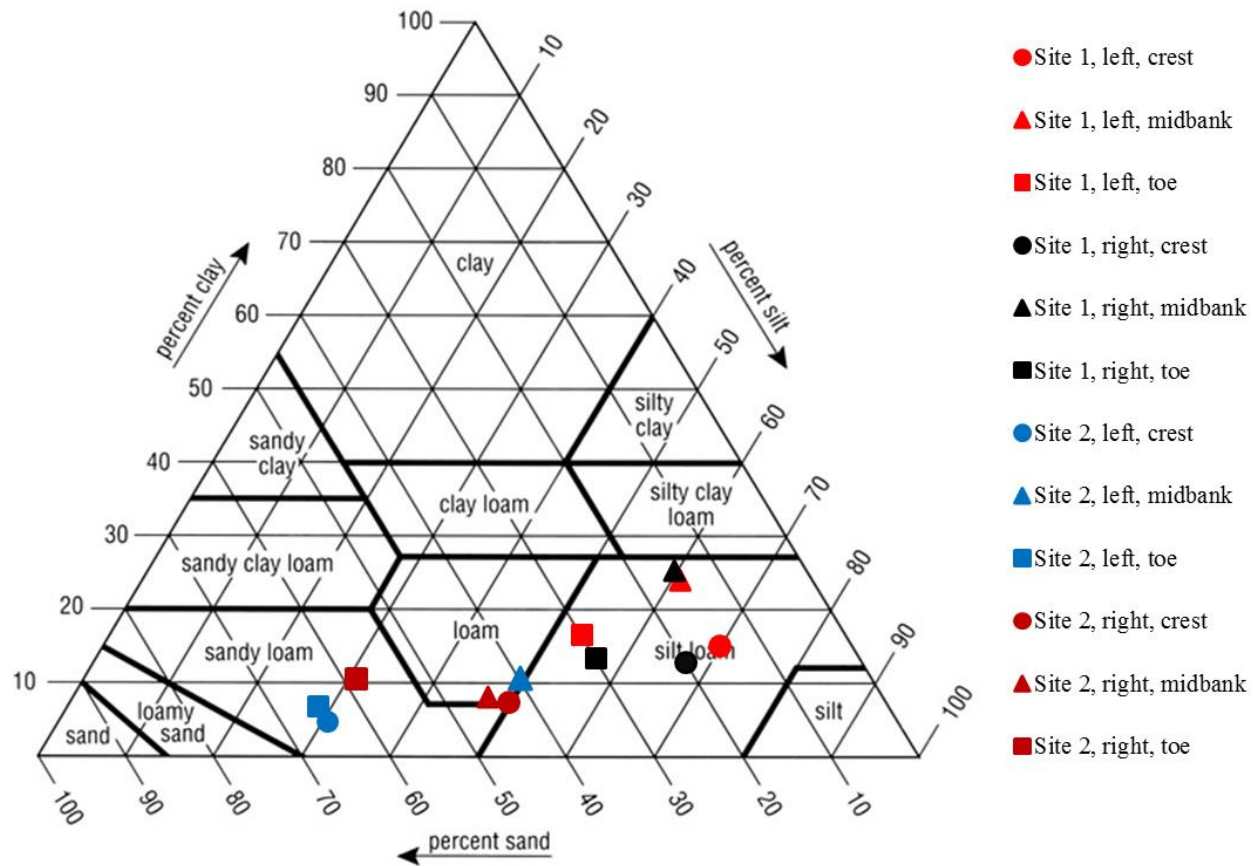
Figure A2. USDA textural classification for twelve (12) bank soil samples extracted from site 1 and 2.

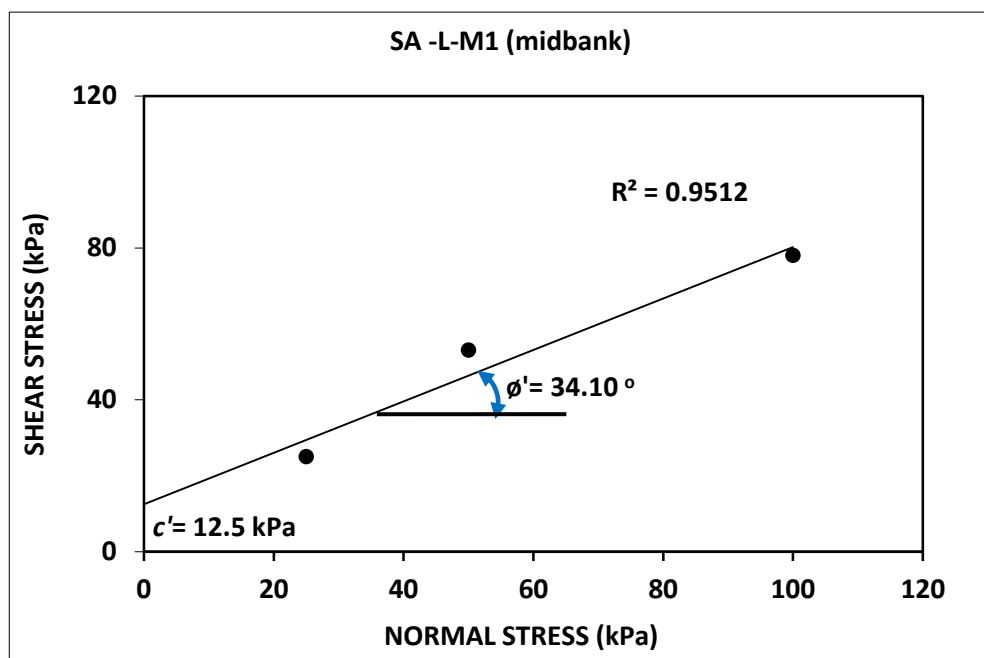
Figure B3. Result of direct shear test for soil sample originated from the midbank of the left bank, cross section SA2 at site 1.

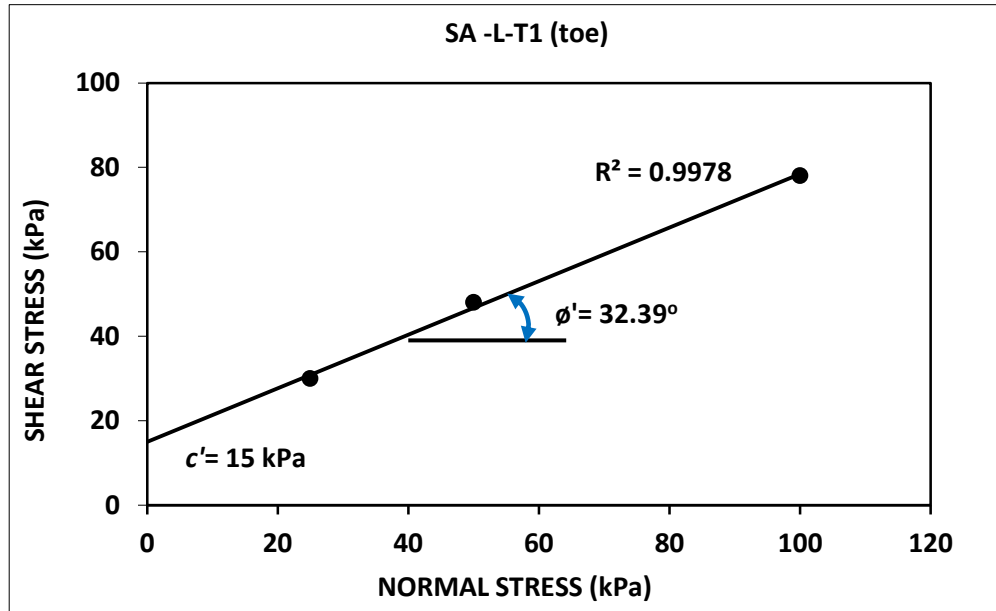
Figure B4. Result of direct shear test for soil sample originated from the toe of the left bank, cross section SA2 at site 1.

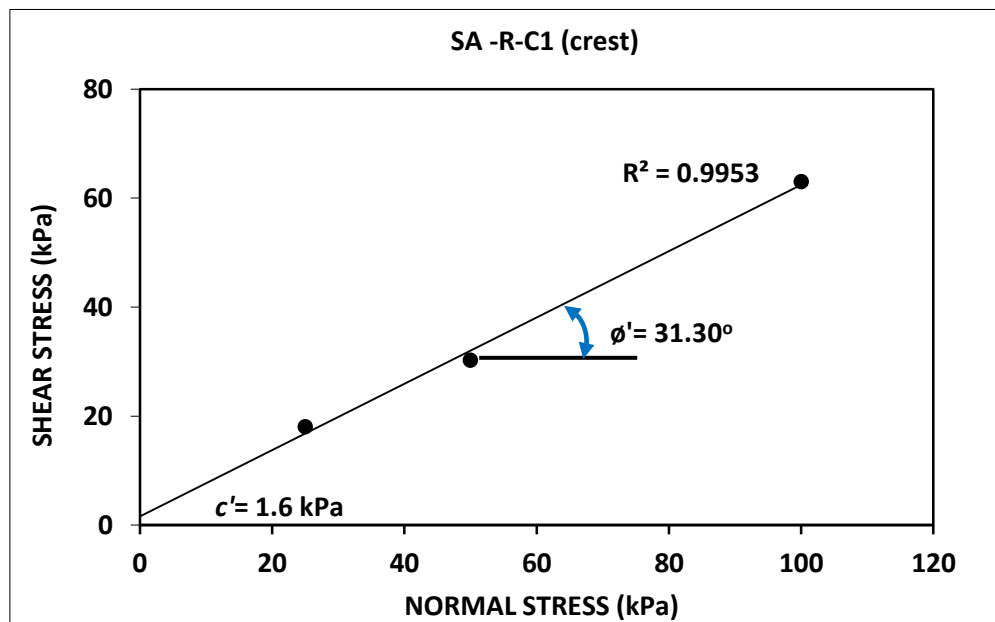
Figure B5. Result of direct shear test for soil sample originated from the crest of the right bank, cross section SA2 at site 1.

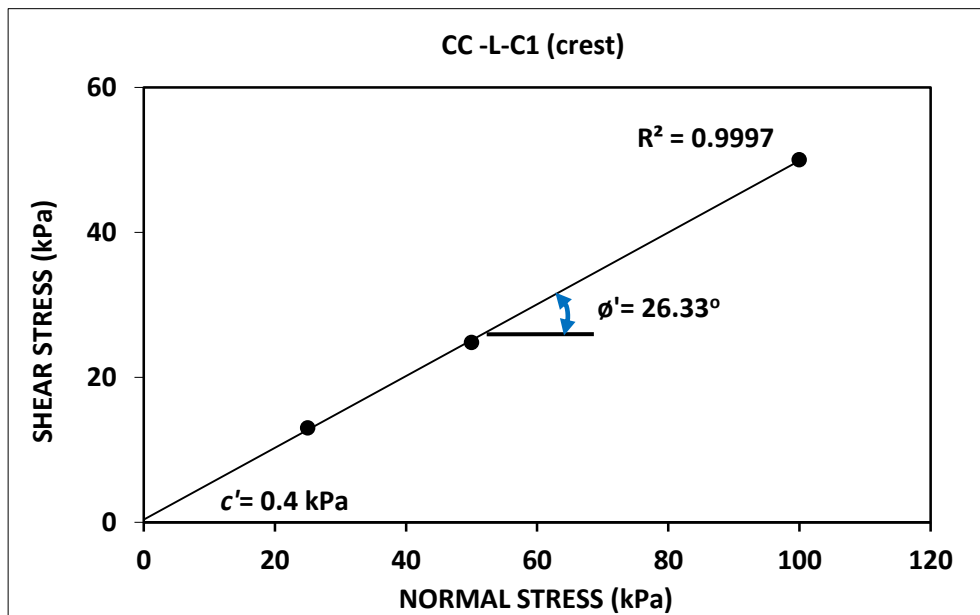
Figure B8. Result of direct shear test for soil sample originated from the crest of the left bank, cross section CC1 at site 2.

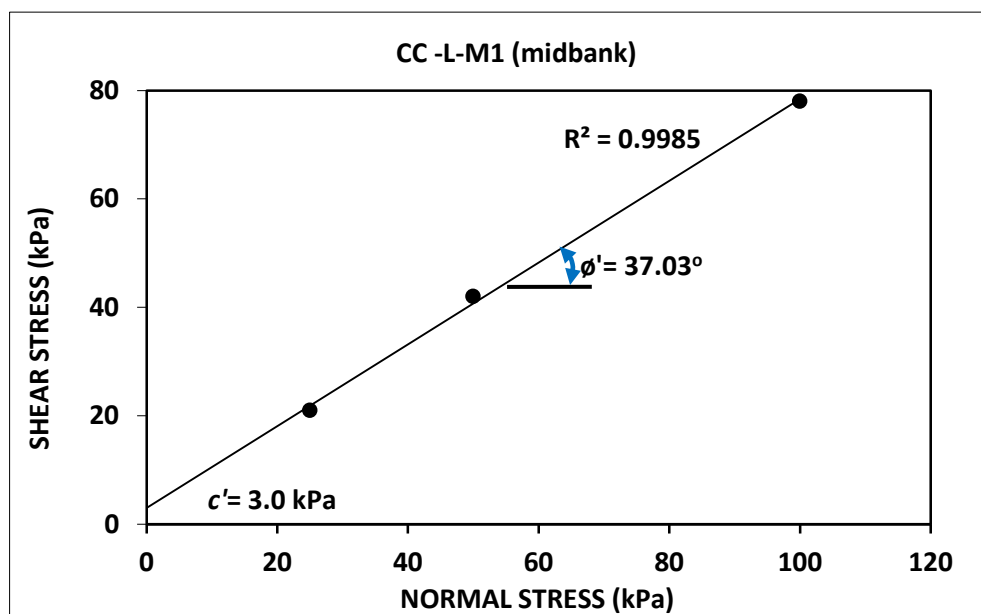
Figure B9. Result of direct shear test for soil sample originated from the midbank of the left bank, cross section CC1 at site 2.

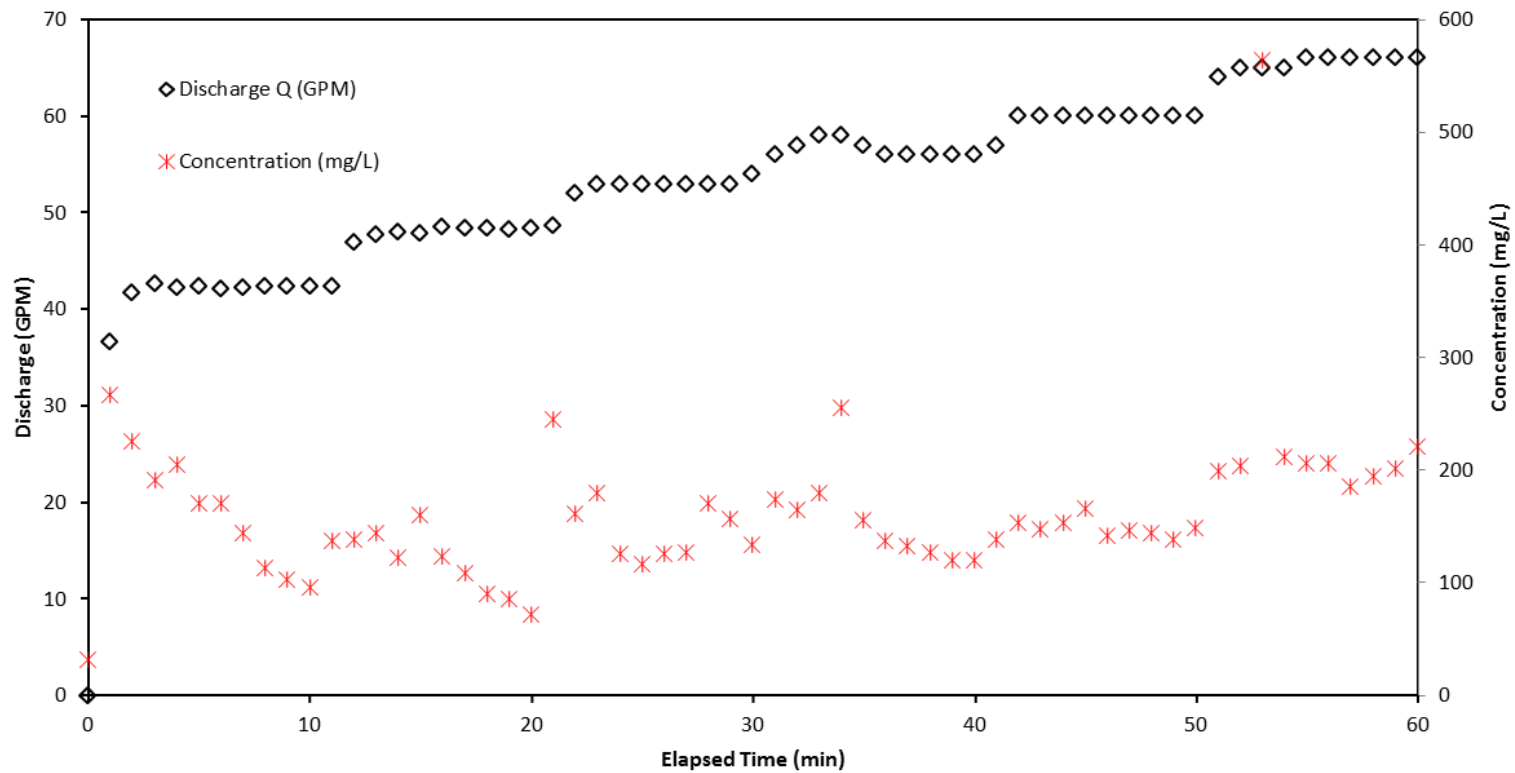
Figure C1. Water-concentration response to the increase of discharge in the conduit flume.

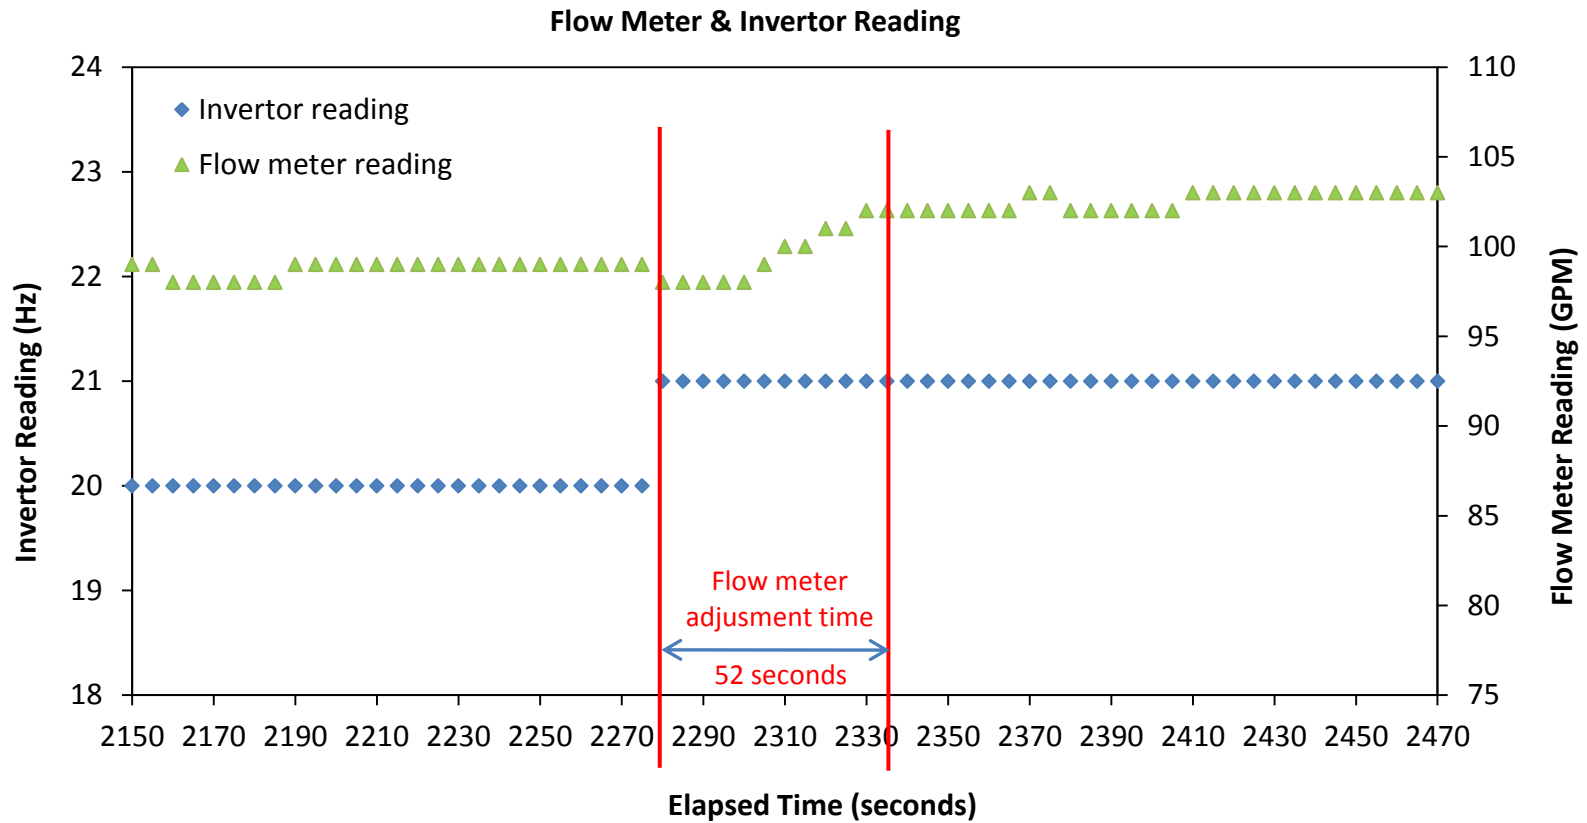
Figure C2. Preliminary conduit flumes run to determine the adjustment time for flow meter due to flow increment.

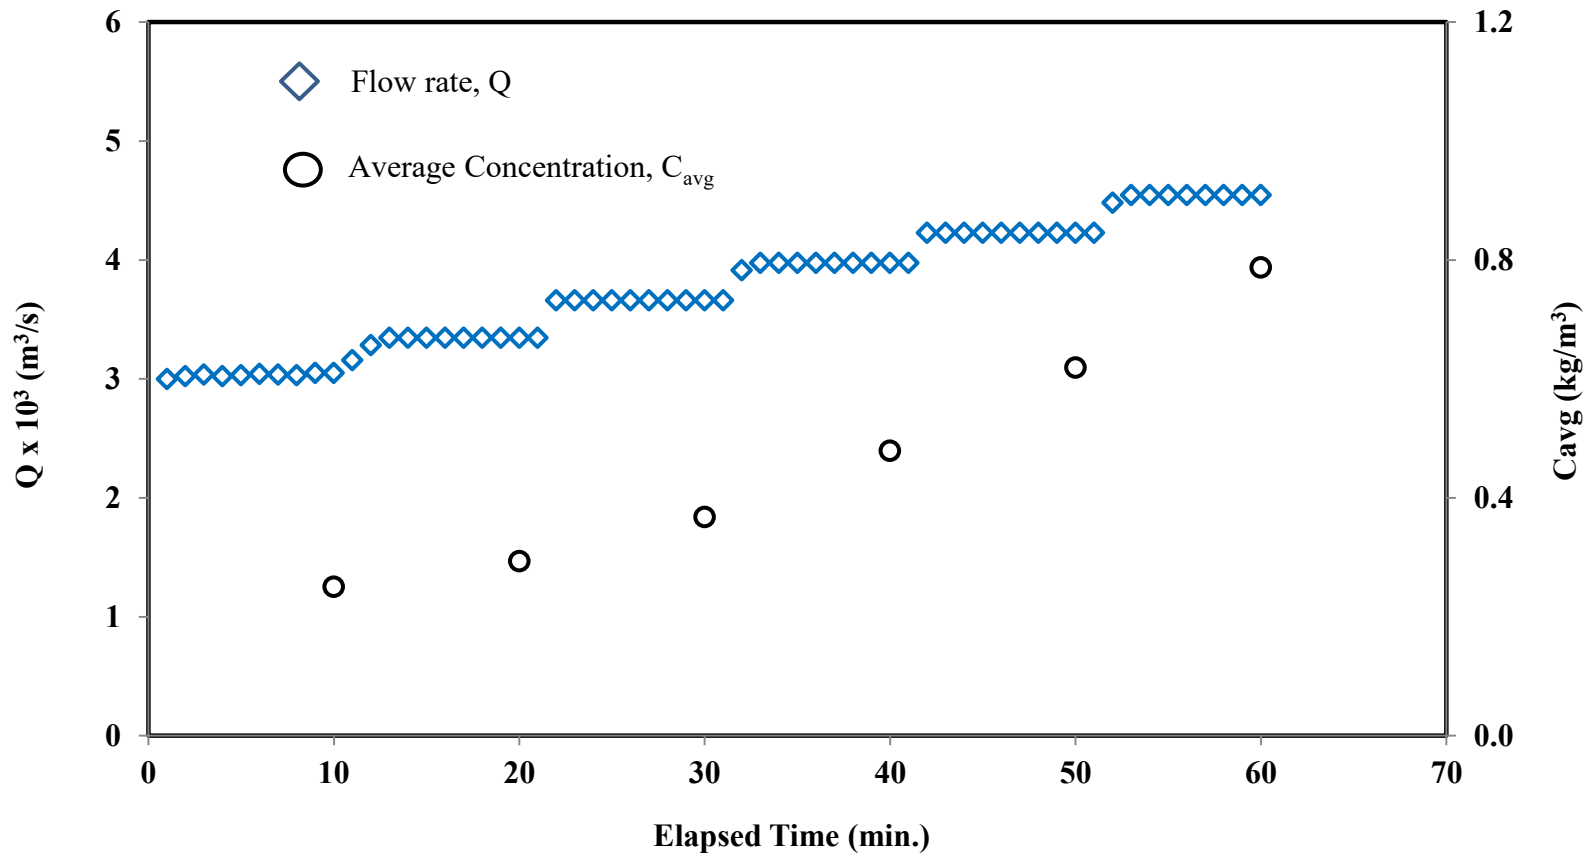
Figure C3. An example of conduit flume run. Flow rate and sediment concentrations were measured during an example 60-minute conduit flume run. Flow rate was increased every 10 minutes resulting in 5 shear stress increments. Sediment concentrations were obtained for each applied flow rate.

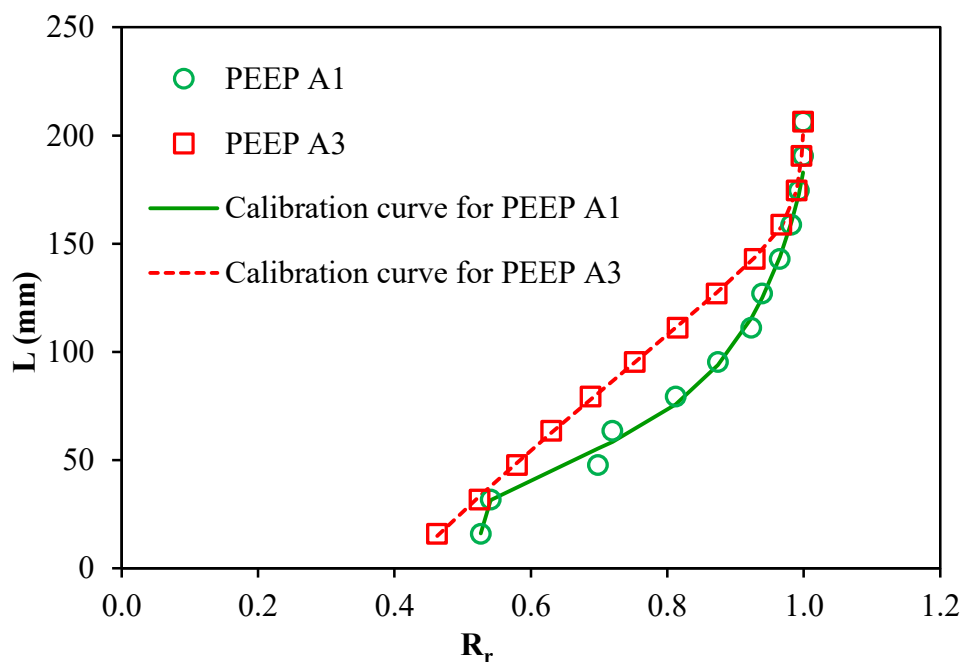
Figure F1. Relation between normalized cell series output,  $R_r$ , and PEEP exposure length,  $L$ , for PEEPs installed at site 1.

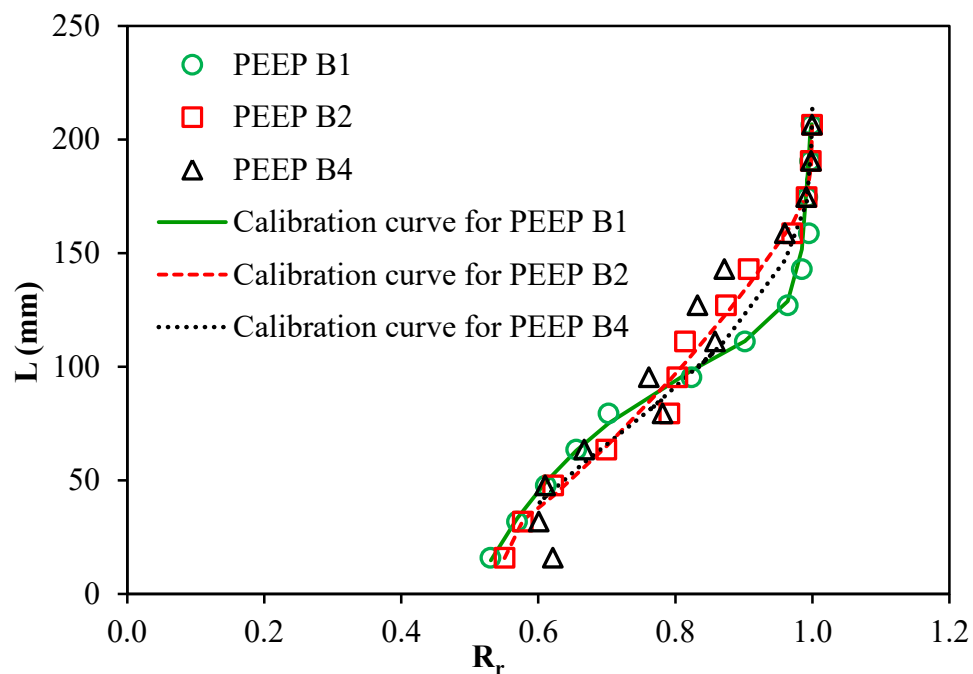
Figure F2. Relation between normalized cell series output,  $R_r$ , and PEEP exposure length,  $L$ , for PEEPs installed at site 2.

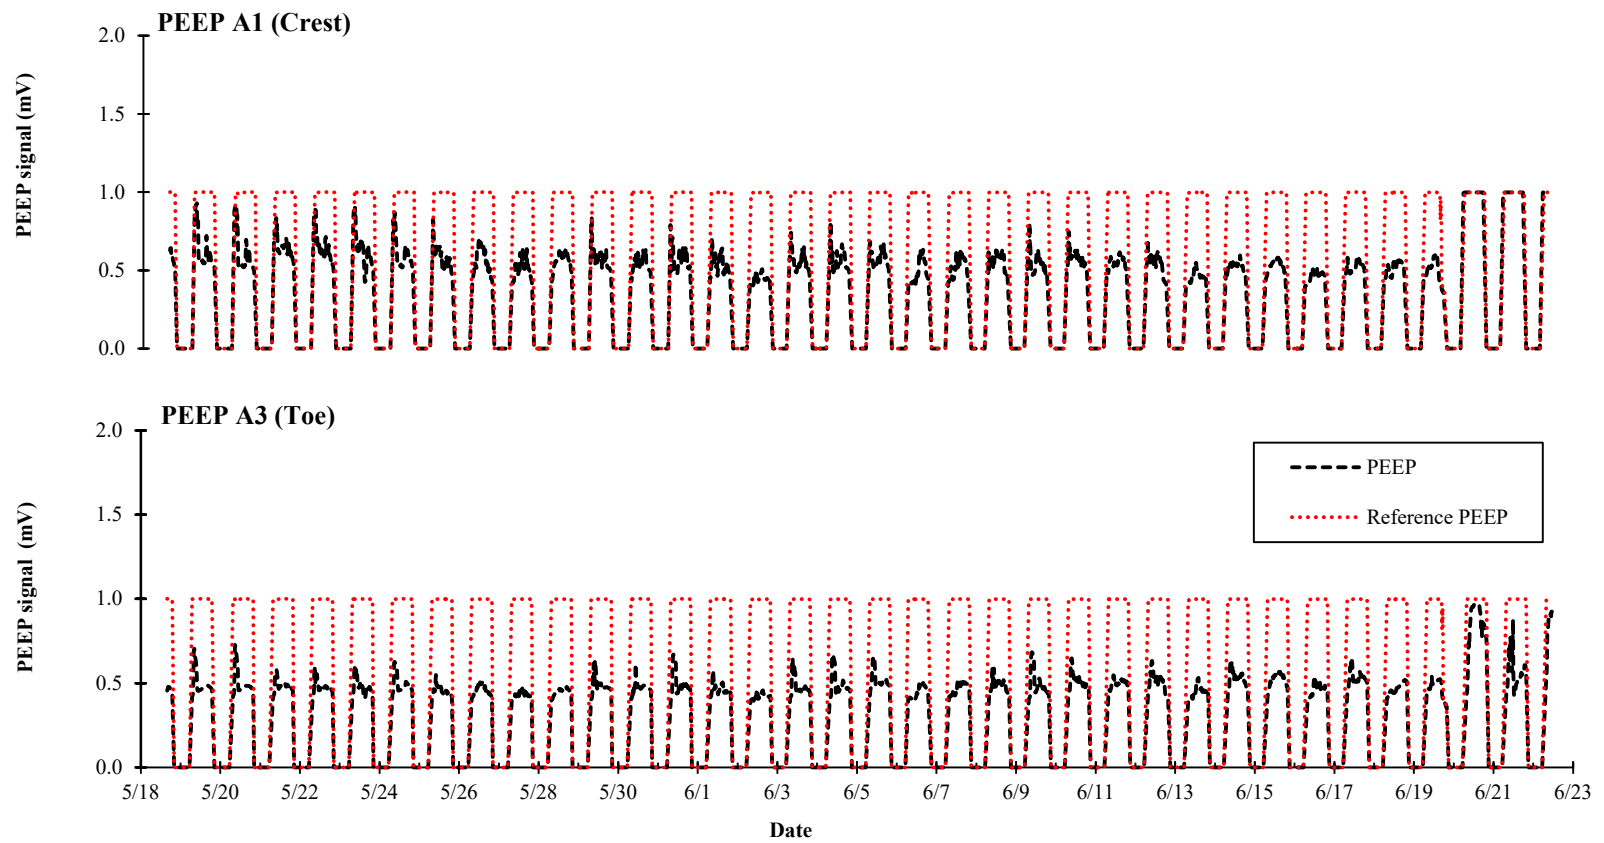
Figure F3. Voltage signal recorded from PEEP A1, A3, and reference PEEP at site 1 during deployment period.

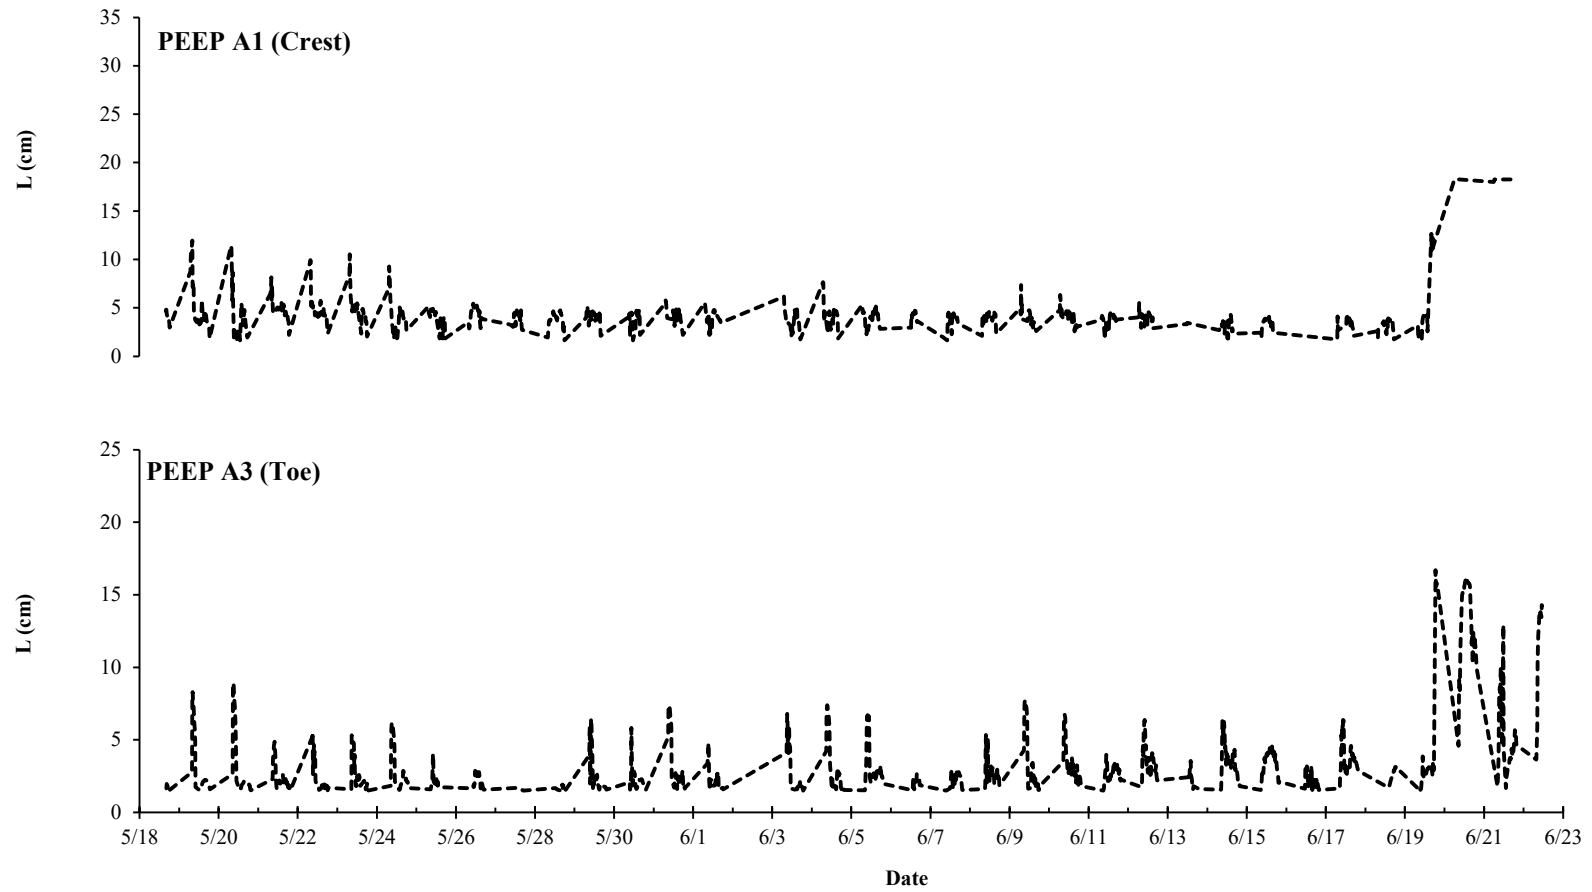
Figure F4. Unprocessed exposure length recorded from PEEPA1 and A3 at site 1 during deployment period.

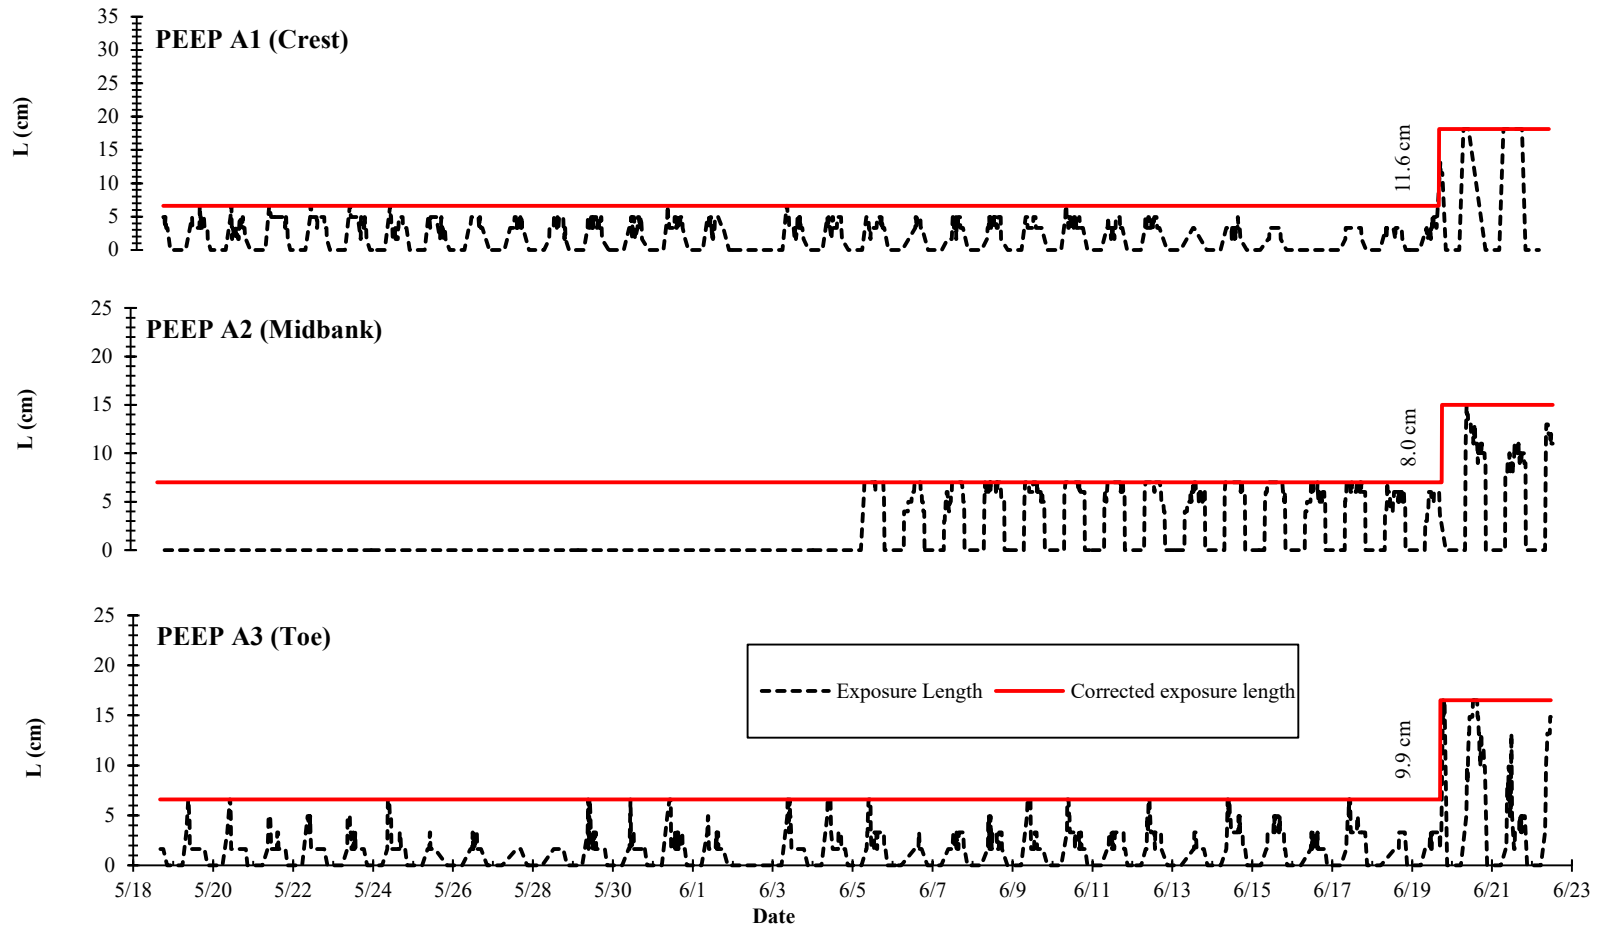
Figure F5. Processed exposure length without moving average analysis for PEEP A1 and A3 at site 1 during deployment period.

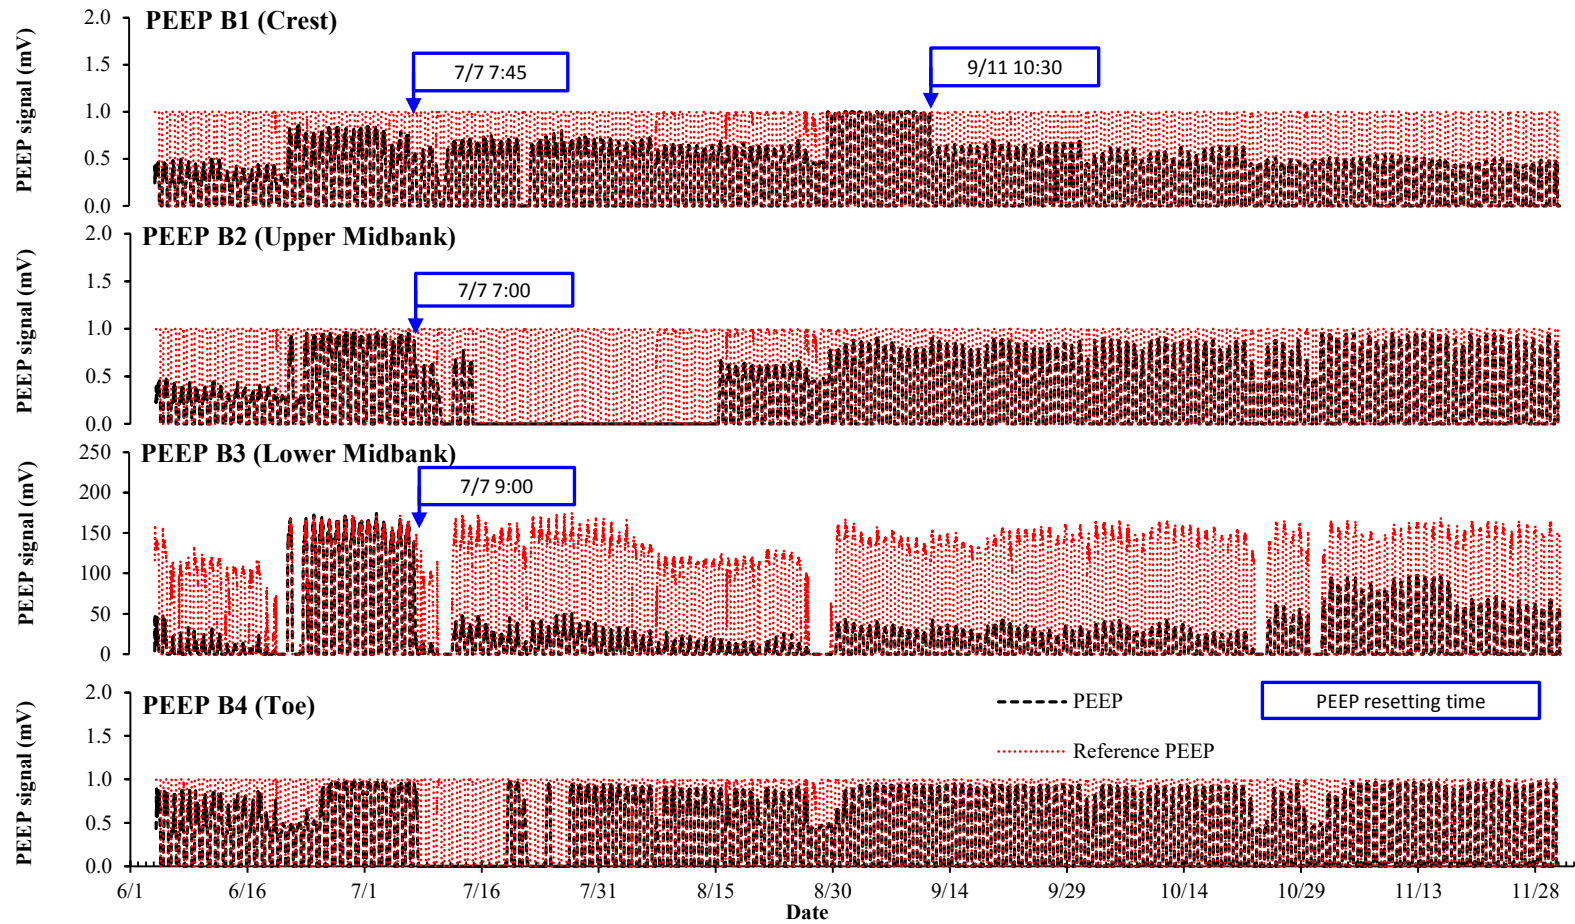
Figure F6. Voltage signal recorded from PEEP B1, B2, B3, and B4 along with their reference cells at site 2 during deployment period.

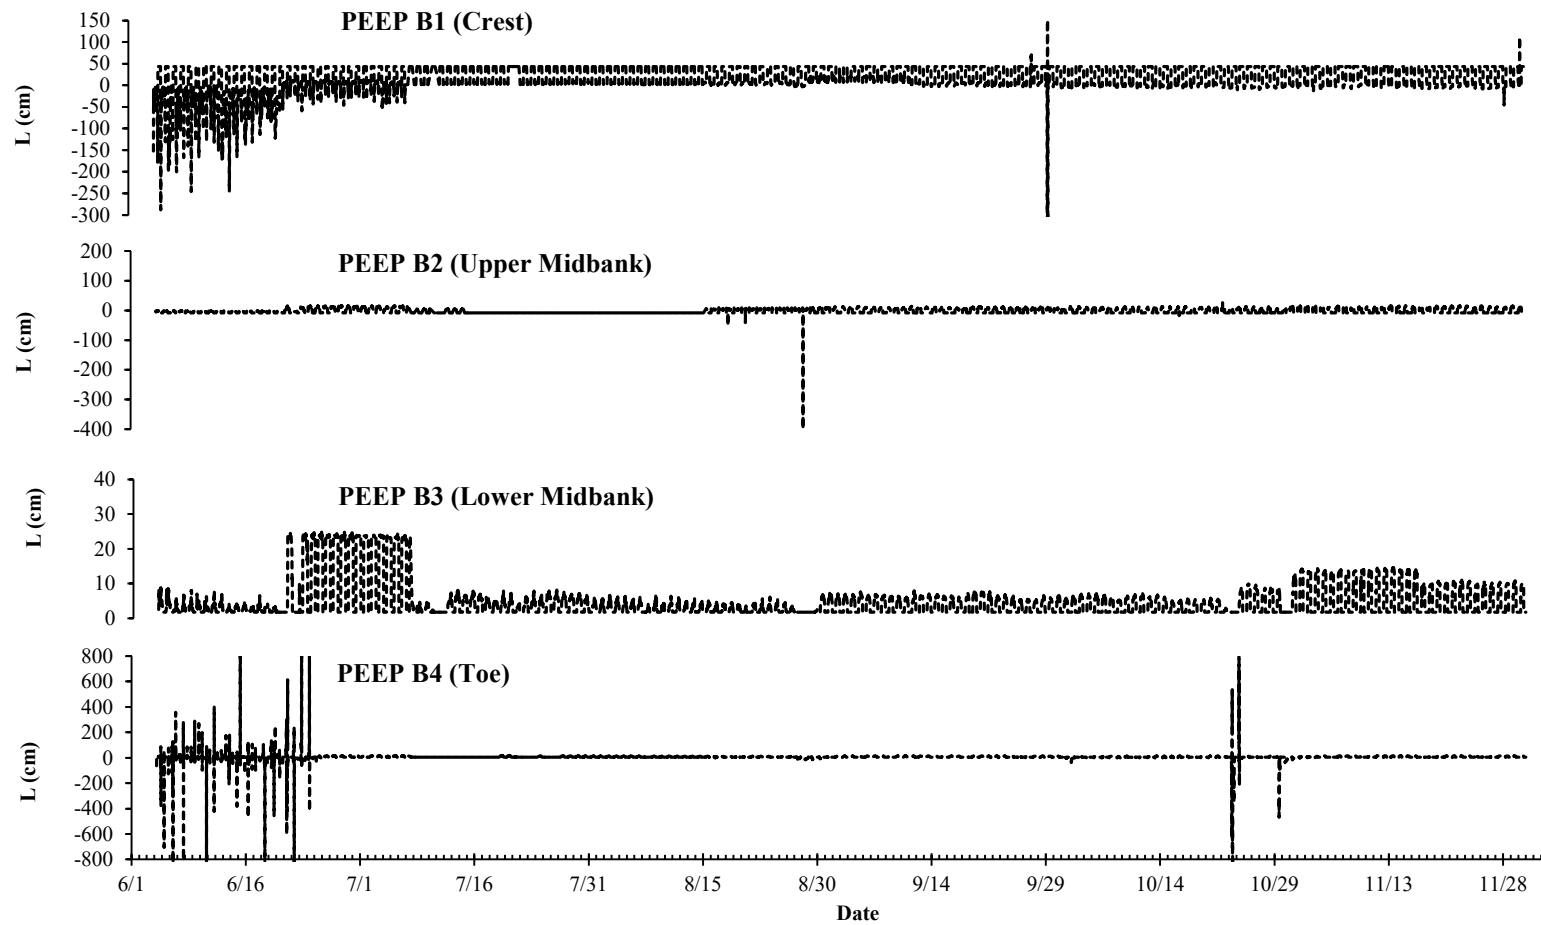
Figure F7. Unprocessed exposure length recorded from PEEP B1, B2, B3, and B4 at site 2 during deployment period.

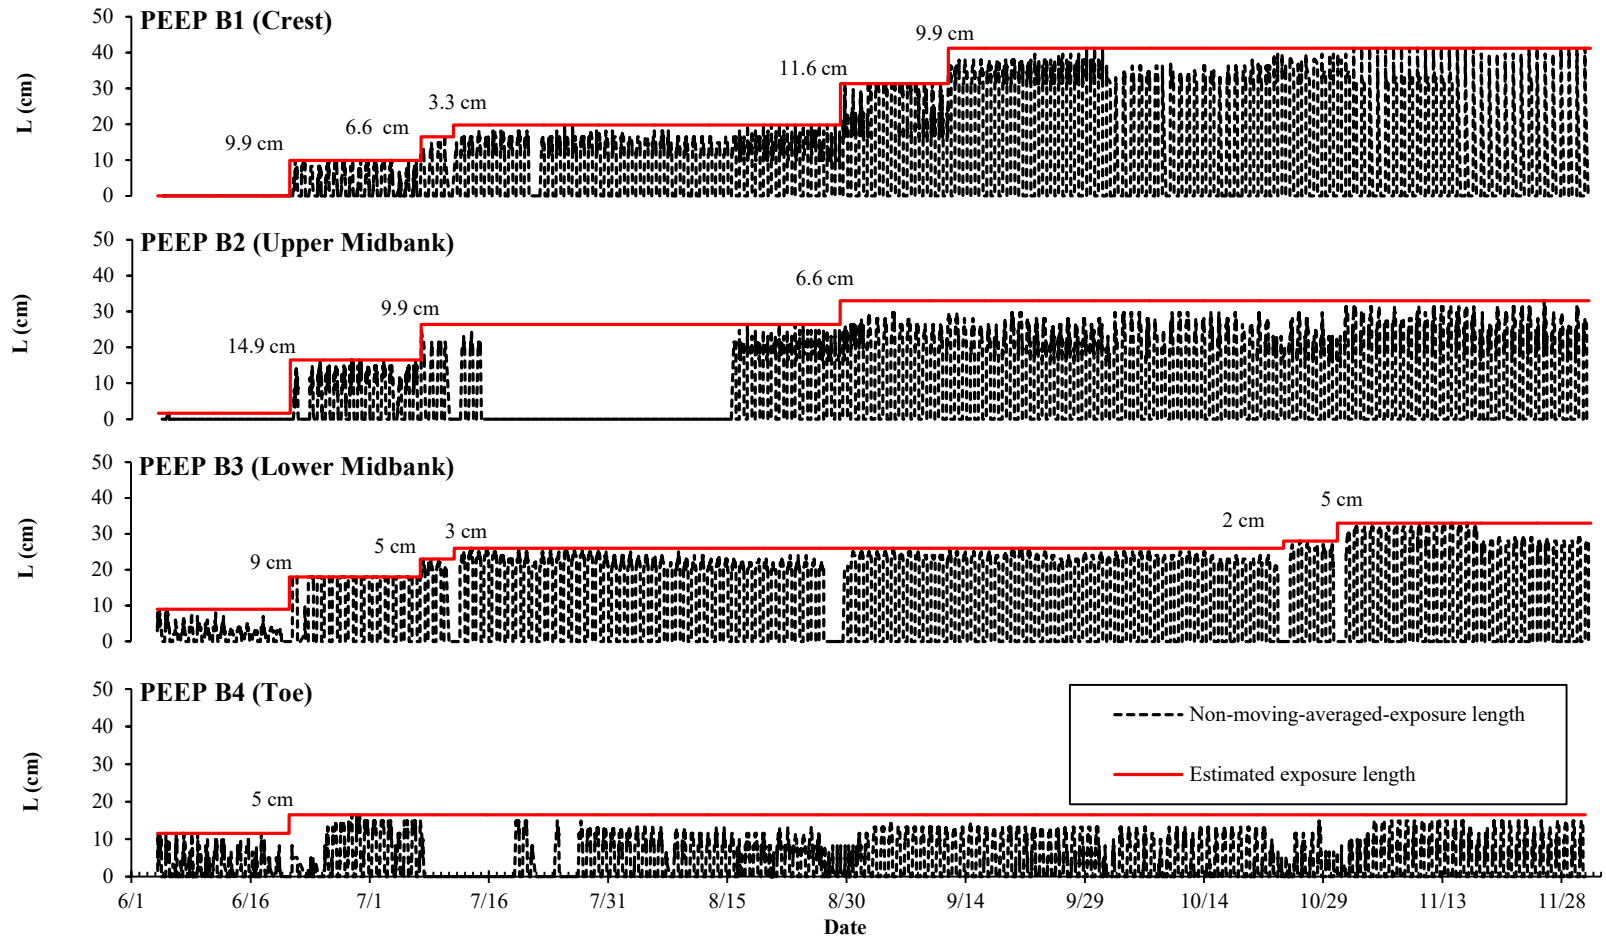
Figure F8. Processed exposure length without moving average analysis for PEEP B1, B2, B3, and B4 at site 2 during deployment period.

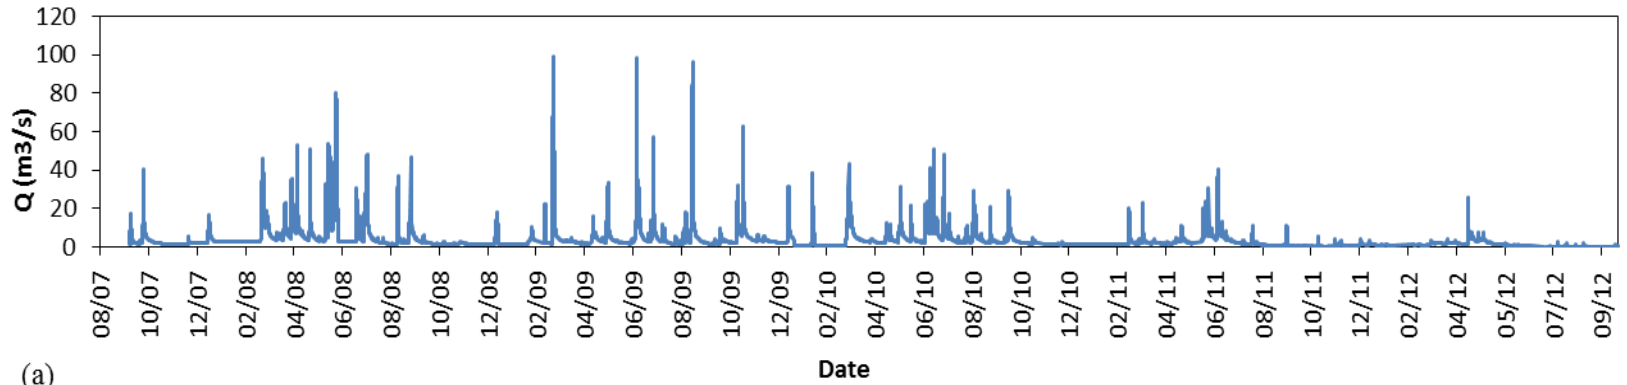
Figure G1. CONCEPTS inputs. (a) Hydrograph. (b) Water level.

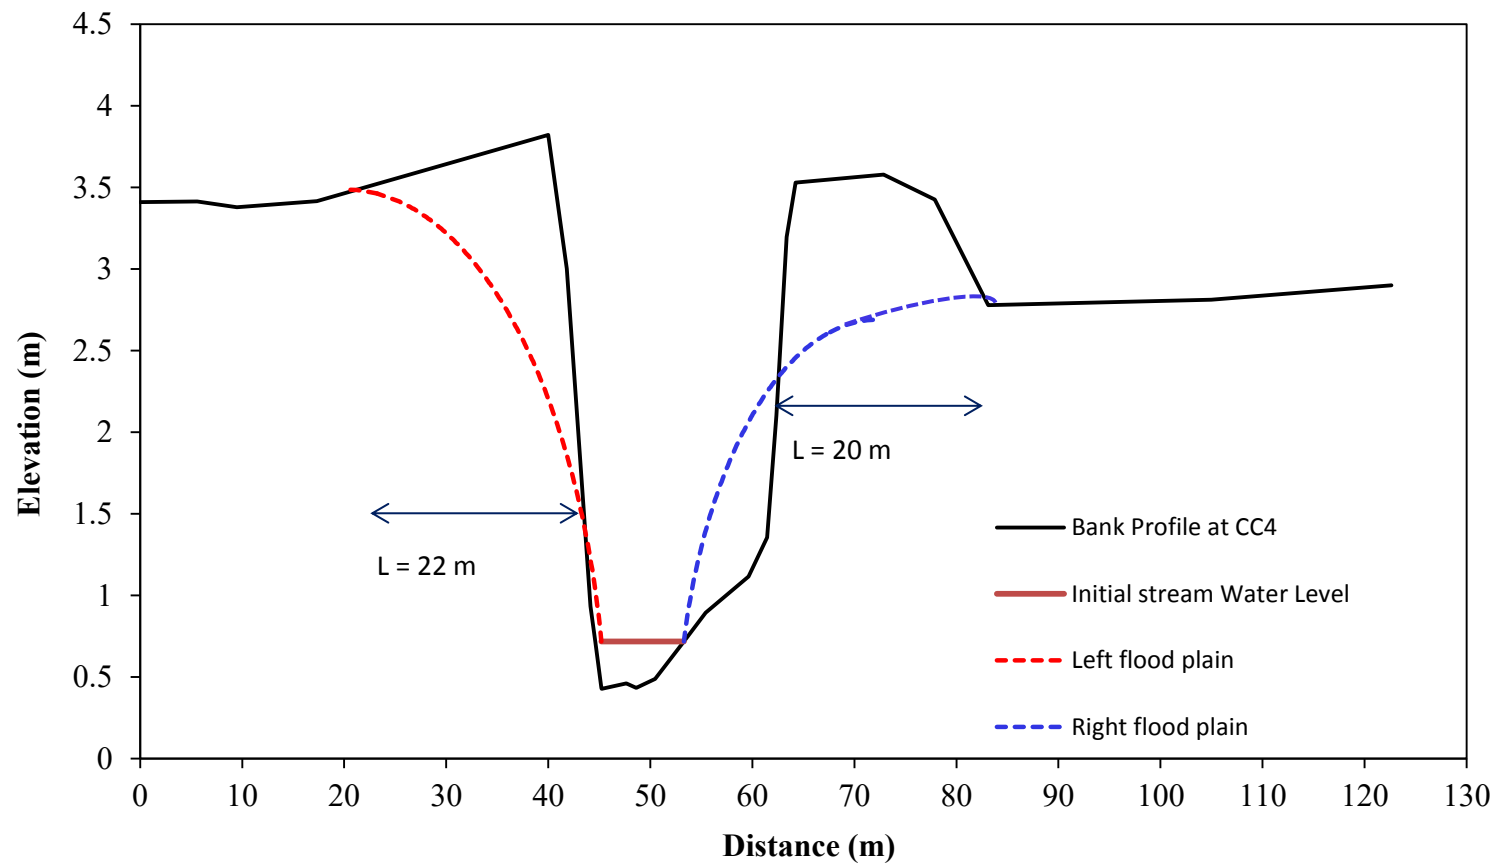
Figure G2. Initial groundwater profile based on Liang and Zang (2012) near the bank at site 2.
