## Bank erosion processes in streams in the U.S. Midwest

**BANK EROSION PROCESSES IN STREAMS IN THE U.S.  
MIDWEST**

A thesis submitted in partial fulfillment  
of the requirements for the Doctor of  
Philosophy degree in Civil and Environmental Engineering  
in the Graduate College of  
The University of Iowa

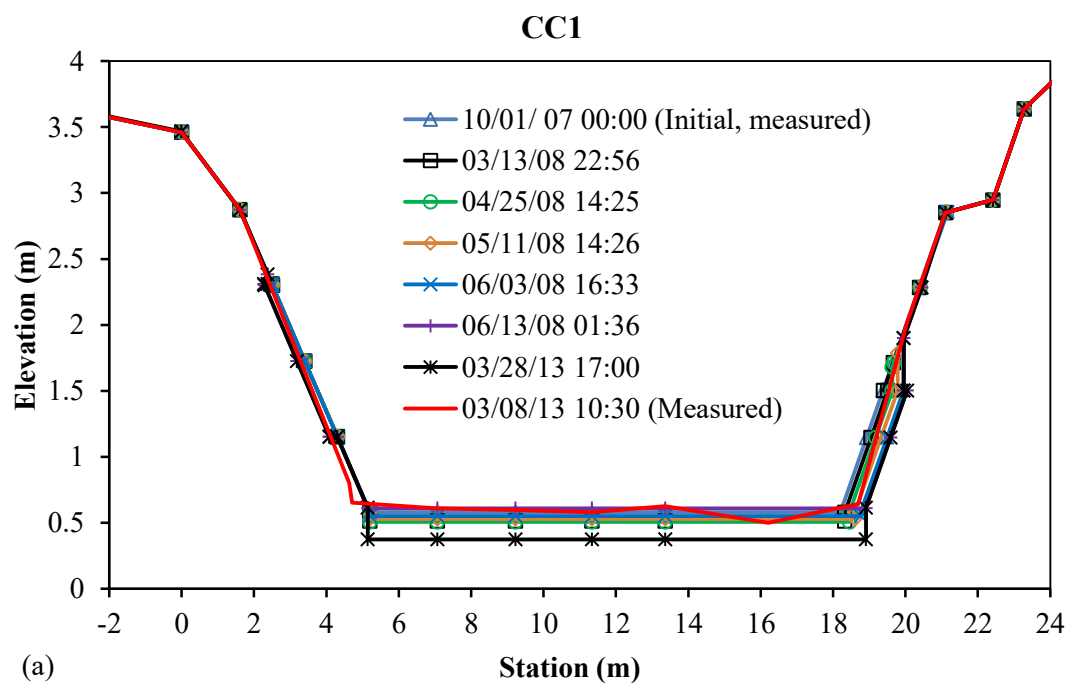
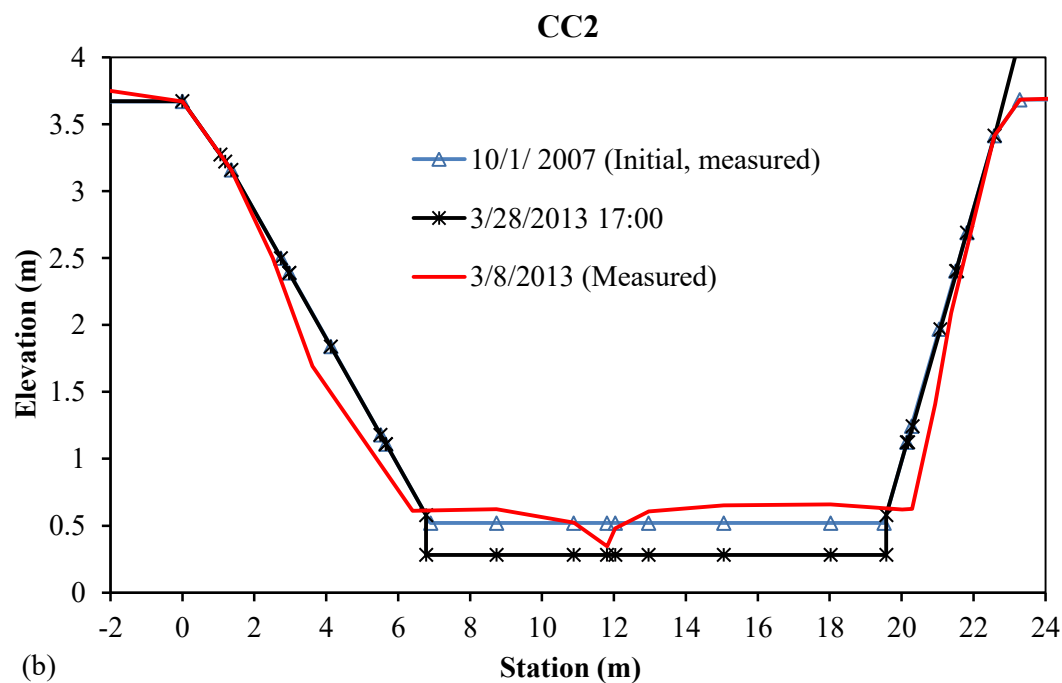
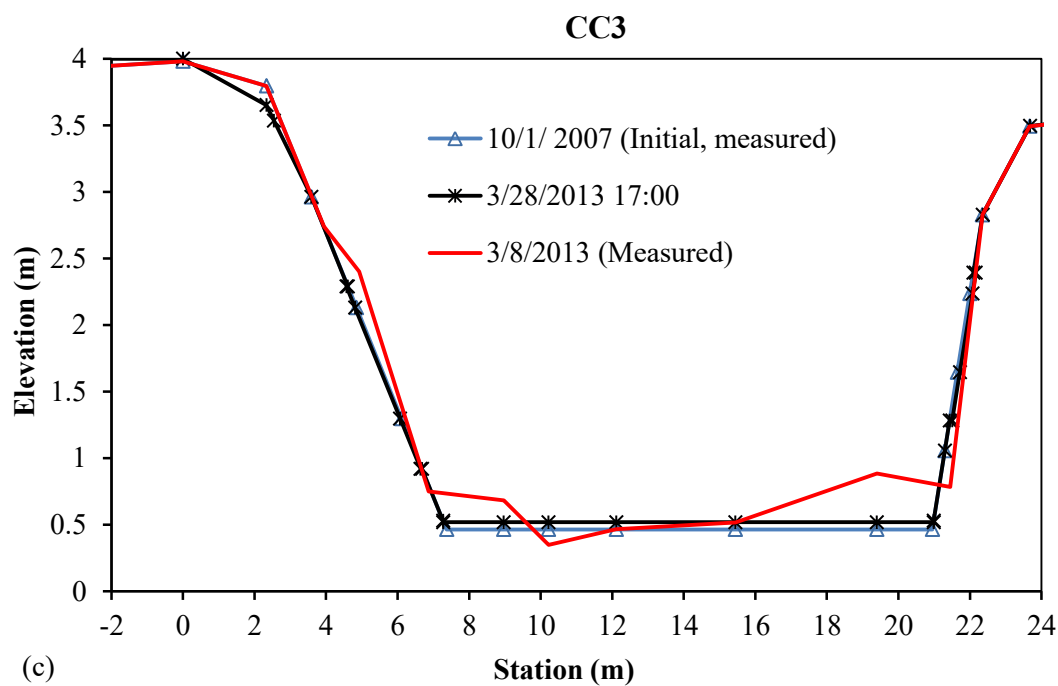
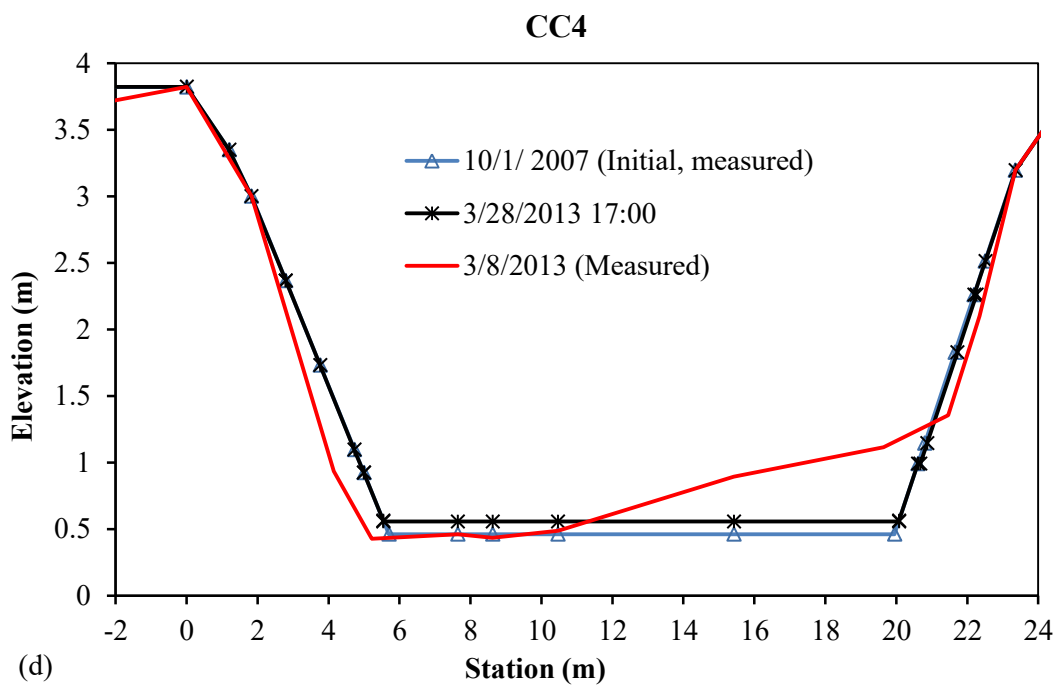
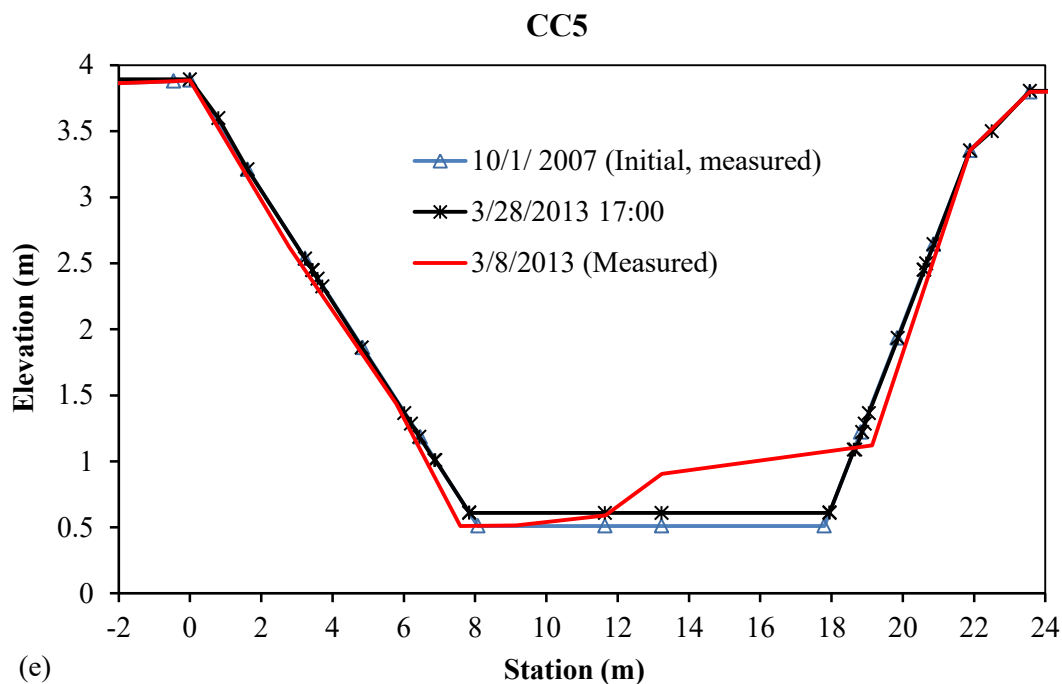
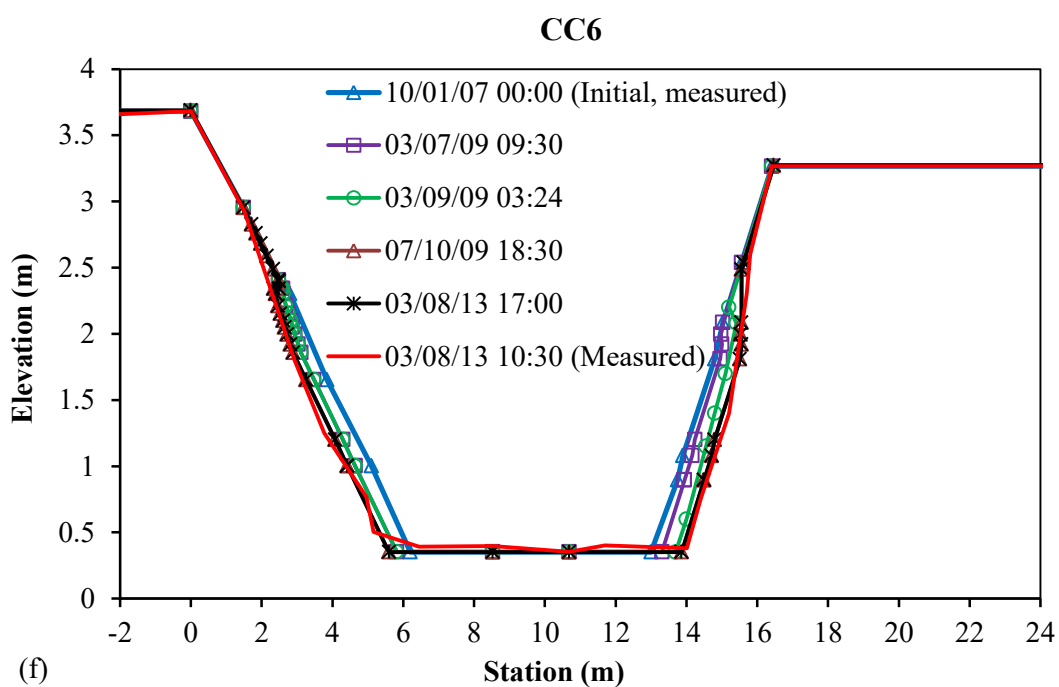
Figure G5. Measured and model-predicted bank cross sections for site 2. (a) Cross section CC1. (b) Cross section CC2. (c) Cross section CC3. (d) Cross section CC4. (e) Cross section CC5. (f) Cross section CC6.
