Behavior of staged externally bonded carbon fiber reinforced polymer sheets for improved ductility

A THESIS

MASTER OF SCIENCE IN CIVIL ENGINEERING

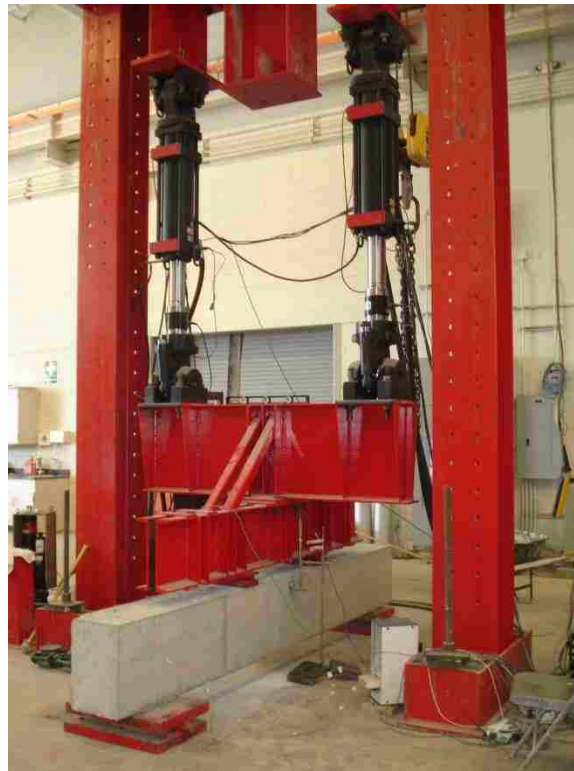
Figure 4.6. Beam Test Setup

center to center and the load points were 3 ft center to center. Two actuators provided the loading rate of 0.05 in/min. All of the strain gages on the steel rebar and FRP sheets were recorded throughout the test. In addition to the strain gages, 2 DCVTs measured deflection at the center of the beam. At various levels of loading, cracks were marked on the beams to show the progression over time.

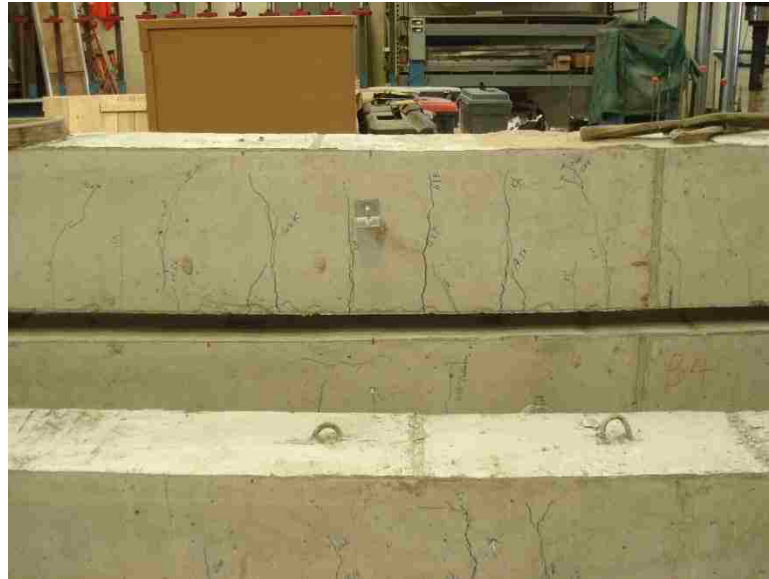
Figure 4.10. Failure of Beam 1

4.6.1. Control Beam. Beam 1 was the control beam without FRP. The failure is seen in Figure 4.10. The load-displacement curve, Figure 4.11, shows that the beam was cracked around 15 k and began yielding around 54 k. The maximum load reached was 73 k. The load-strain graph for the steel rebar in the control beam is found in Figure 4.12.

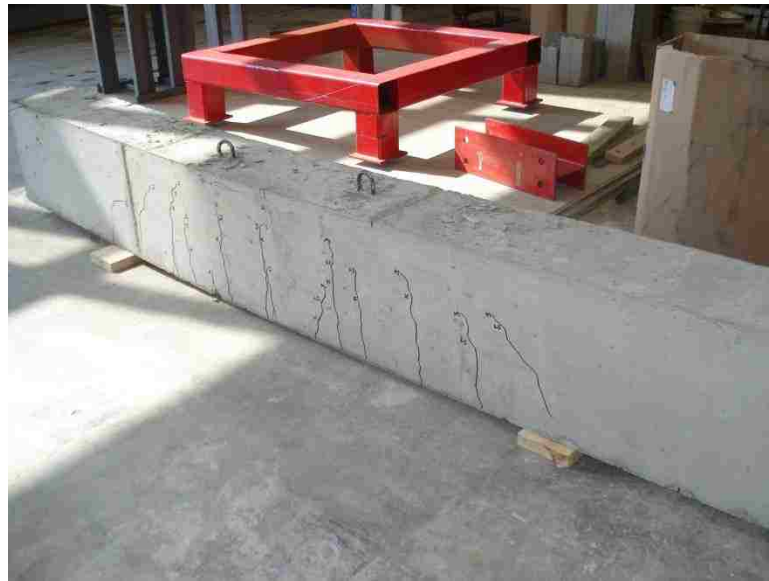
Figure 4.31. Failure of Beam 1

4.9.1. Control Beams. The failure of Beam 1 is seen in Figure 4.31. The yielding and deflection were similar to the other control beams tested. This beam began yielding at 58 k as shown in the load-deflection curve in Figure 4.32. The maximum load achieved was 77 k. Concrete crushing occurred at 1.5 in deflection causing a drop in the load. The load-strain graph of the steel rebar is seen in Figure 4.33.

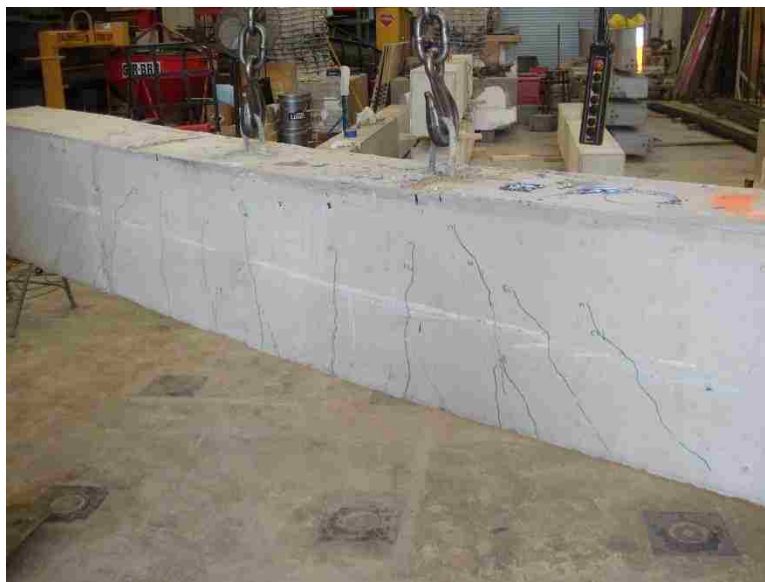
Figure 4.34. Failure of Beam 2

Beam 2 was the control beam from the second concrete pour. The failure of this beam can be seen in Figure 4.34. Shown in the load-deflection curve, Figure 4.35, the steel began yielding at 58 k. Beam 2 reached an ultimate load of 73 k. The load-strain curve for the steel rebar is shown in Figure 4.36.
