CFT Column-to-Cap Beam Connections for
Accelerated Bridge Construction in Seismic Regions

A thesis submitted in partial fulfillment of the
requirements for the degree of

Master of Science in Civil Engineering

Abstract

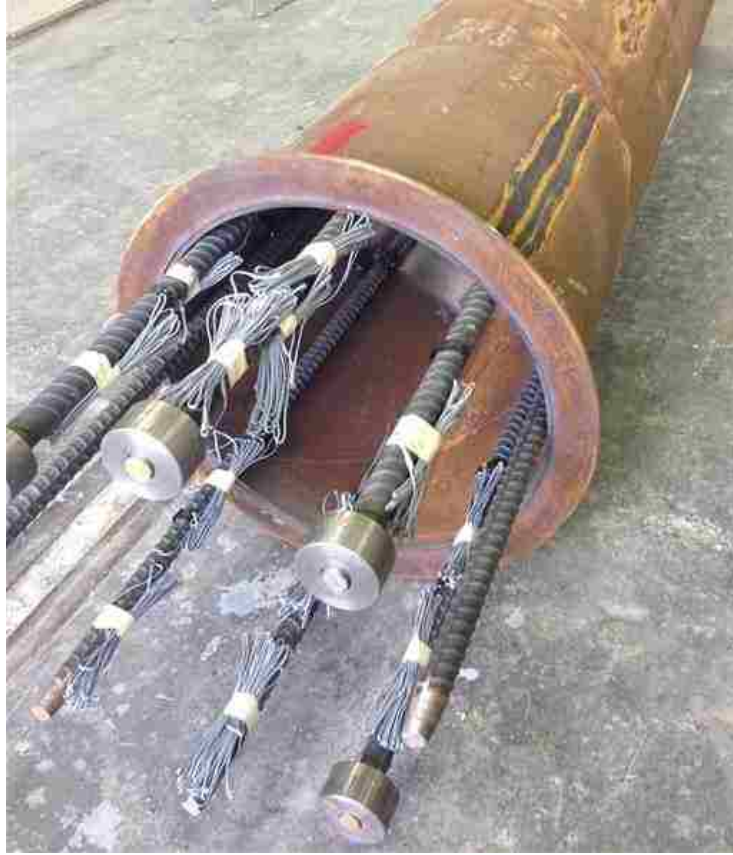
As the concrete cured, the annular ring was welded to the base of the steel tube using a ¼-in. fillet weld, and the longitudinal reinforcing bars were welded to the inside of the steel tube such that the heads of the bars projected 15.5-in. from the end of the column. This projection accounts for the 14-in. embedment into the cap beam, as well as the 1.5-in. grouted soffit. Figure 4.11 shows Specimen WRC after the annular ring and reinforcing bars had been welded to the steel tube.

Figure 4.11: Specimen WRC annular ring and reinforcing bars

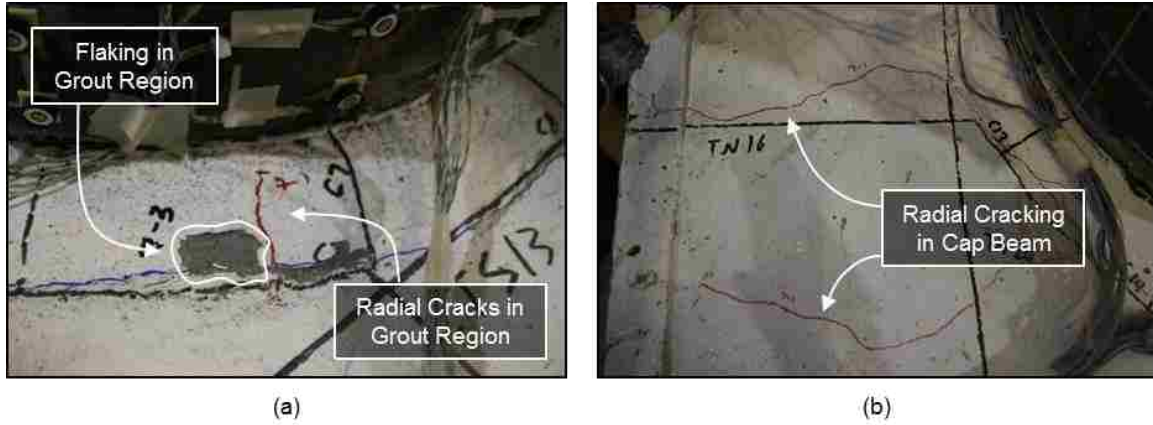
grout that flaked off ranged between ½-in. and 1-in. in diameter, and were less than ¼-in. in thickness.

Figure 5.6: EMB80 Radial cracking at 1.45% drift in (a) grout region, and (b) cap beam

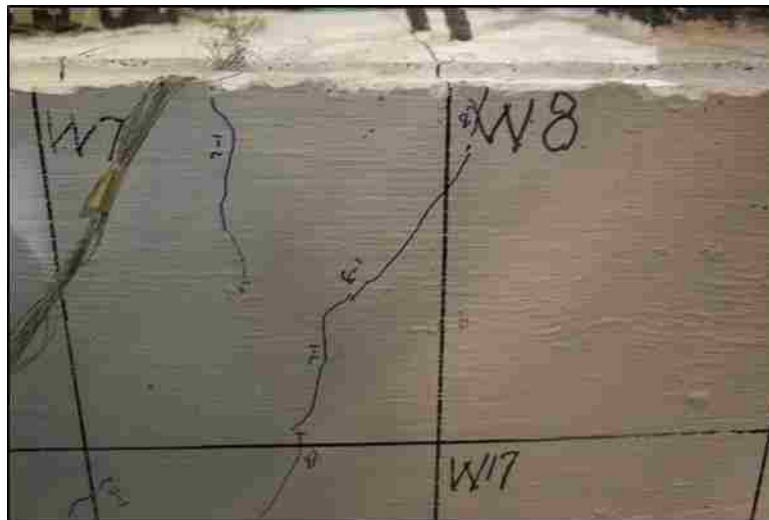
During the 8th load set, additional hairline cracks continued to develop radially from the column and diagonally down the East and West sides of the cap beam. Figure 5.7 shows cracking on the west side of the cap beam after the column was subjected to 2.25% drift in the North direction.

Figure 5.7: EMB80 hairline cracking on the west side of the cap beam at 2.25% drift

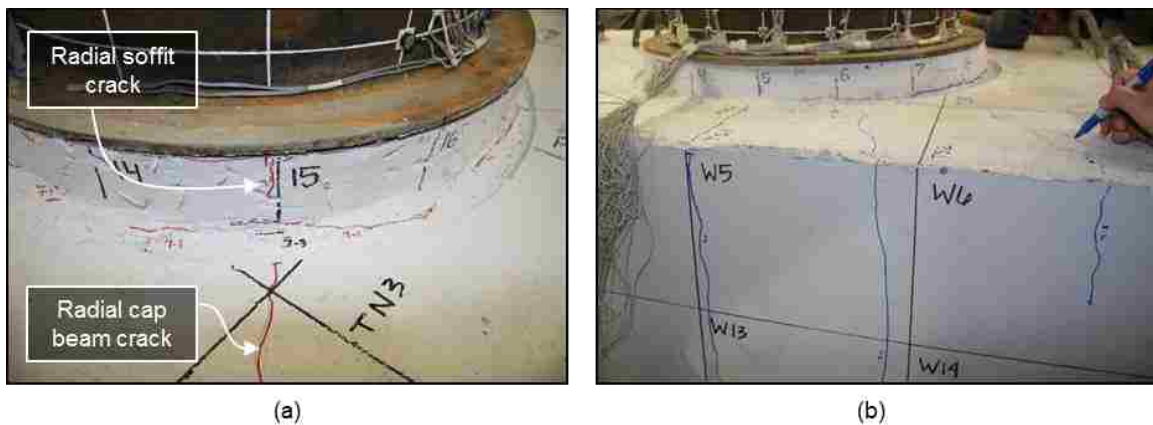
During the same drift set, hairline cracks initiated radially in the grouted soffit, as well as in the cap beam. The cap beam cracks formed at approximate angles of 30-45° of one another, and continued vertically down the East and West faces of the cap beam. Figures 5.18a and 5.18b show the radial cap beam cracking on the North and South sides of the specimen, respectively.

Figure 5.18: WRC radial cracking on (a) North side of column at 1.48% drift, and (b) south side of column at 1.62% drift

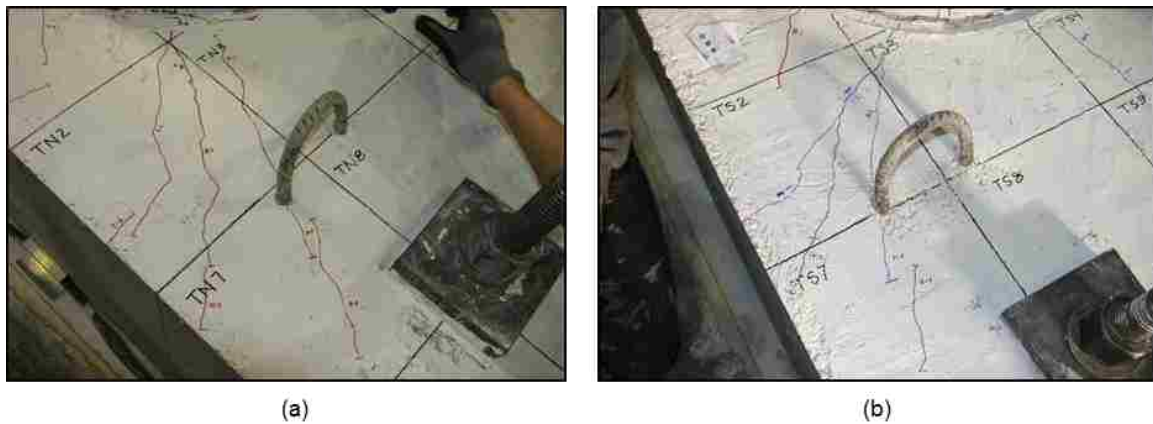
During the 11th cycle level, new hairline cracks developed radially from the column towards the rebar lifting loops located in the four corners of the cap beam, shown in Figures 5.23a and 5.23b.

Figure 5.23: WRC cap beam cracking during the 11th cycle level (a) North side of specimen, (b) South side of specimen

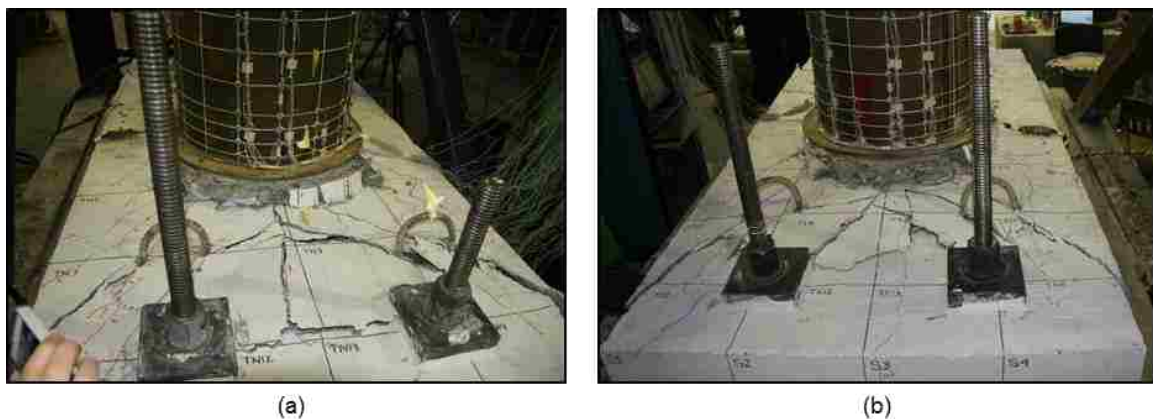
Figure 5.36: WRC (a) North, and (b) South cap beam damage after test termination

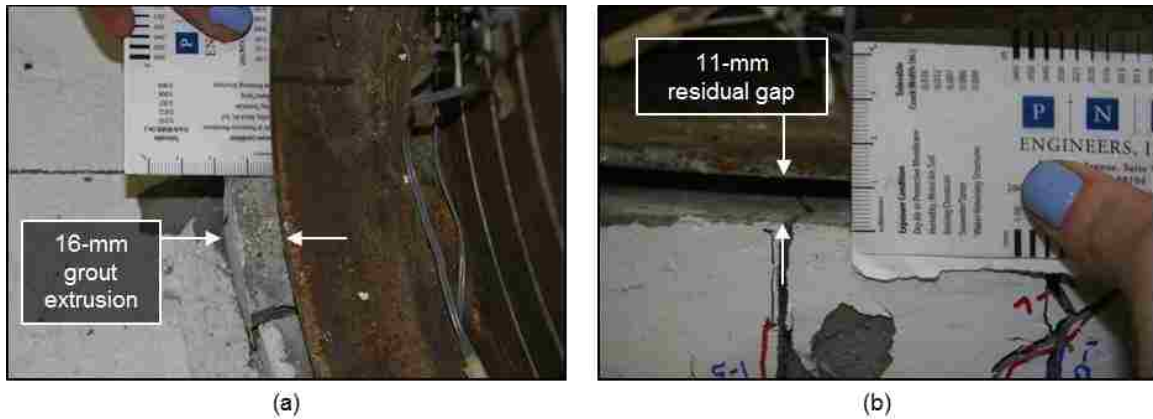
Figure 5.44: WRCUB (a) grout extrusion, and (b) residual soffit-flange opening after 13th cycle level

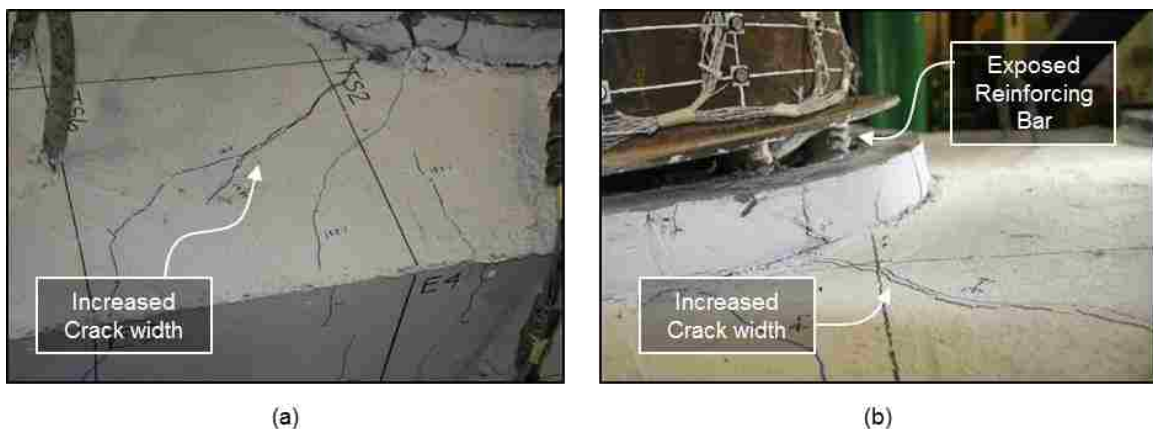
Figure 5.45: WRCUB South (a) cap beam cracking, and (b) exposed reinforcing bar at 8.19% drift North

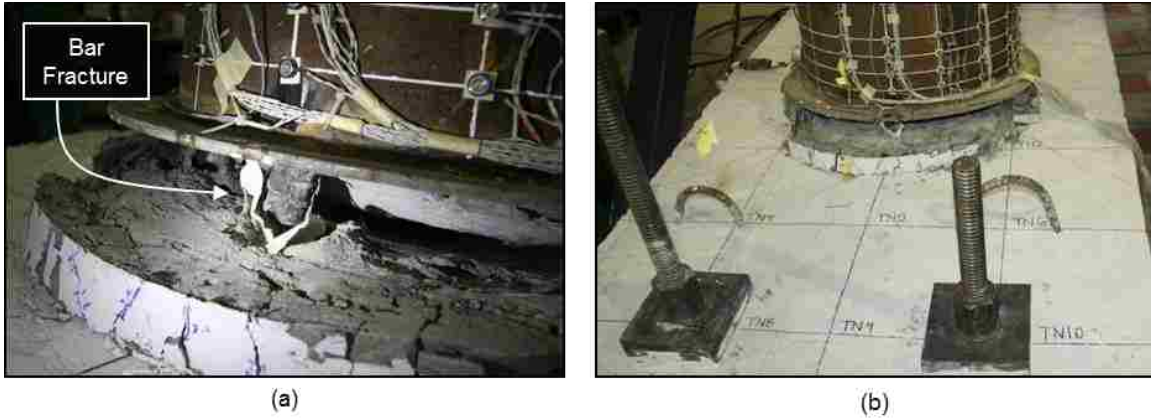
Figure 5.48: WRCUB (a) North bar fracture, and (b) North cap beam damage at 12.27% drift South

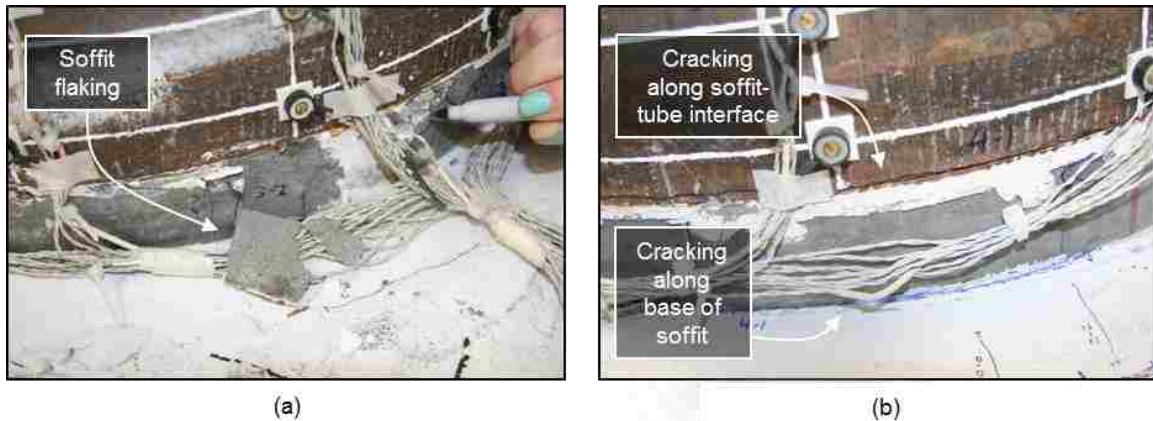
Figure 5.52: WRC (a) Soffit spalling at .28% drift, and (b) Soffit cracking at .44% drift

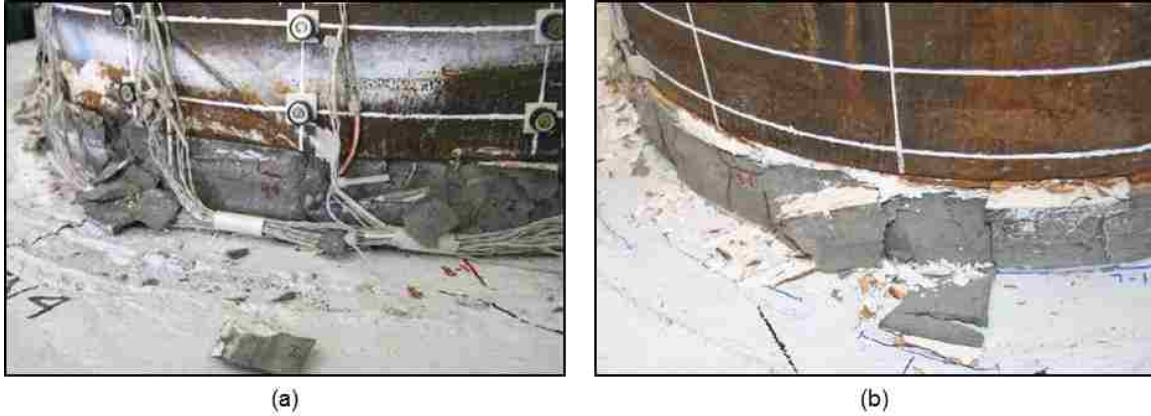
Figure 5.54: WRC Soffit crushing (a) North side of specimen, (b) South side of specimen

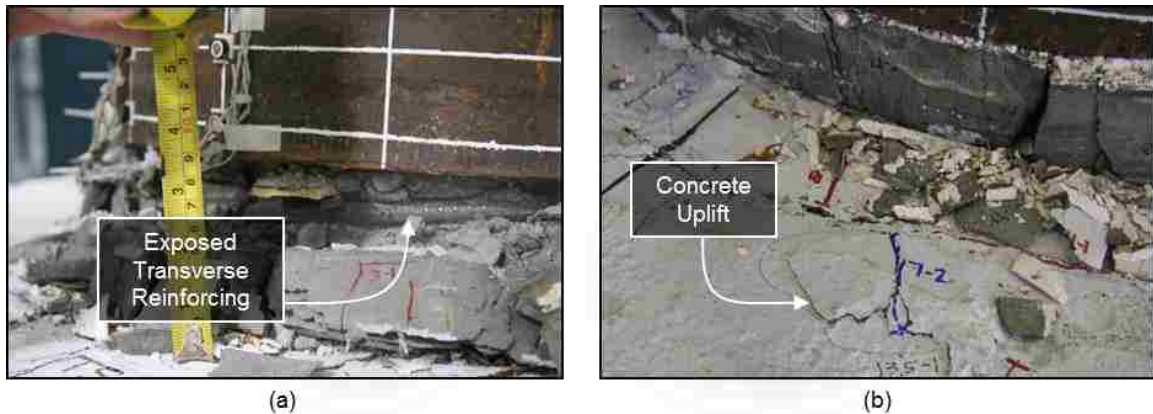
Figure 5.58: WRC (a) South transverse reinforcing, and (b) North concrete uplift at 8.15% drift

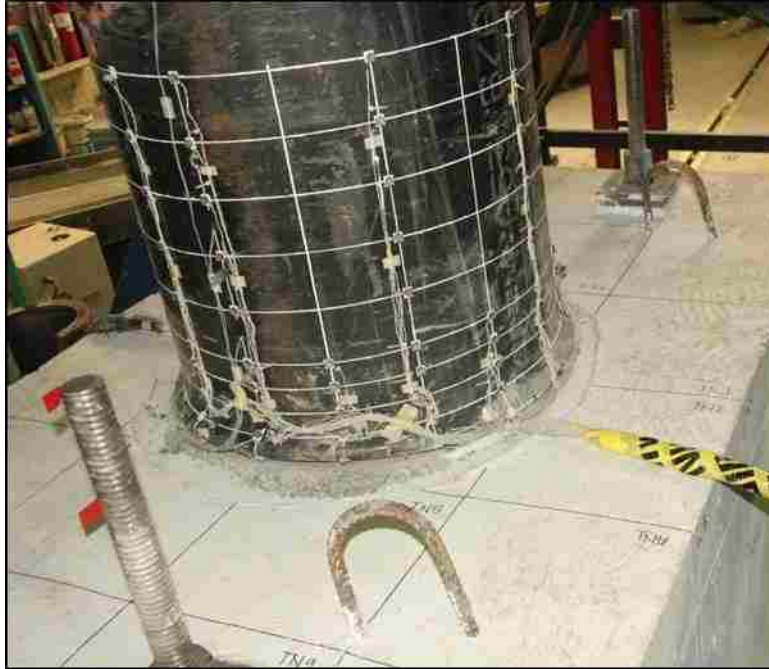
Figure 5.73: EMB96 Specimen damage at termination of test
