CABLE MEDIAN BARRIER
FAILURE ANALYSIS AND REMEDIATION

by
Cody S. Stolle

A DISSERTATION

Major: Civil Engineering
Structural Engineering

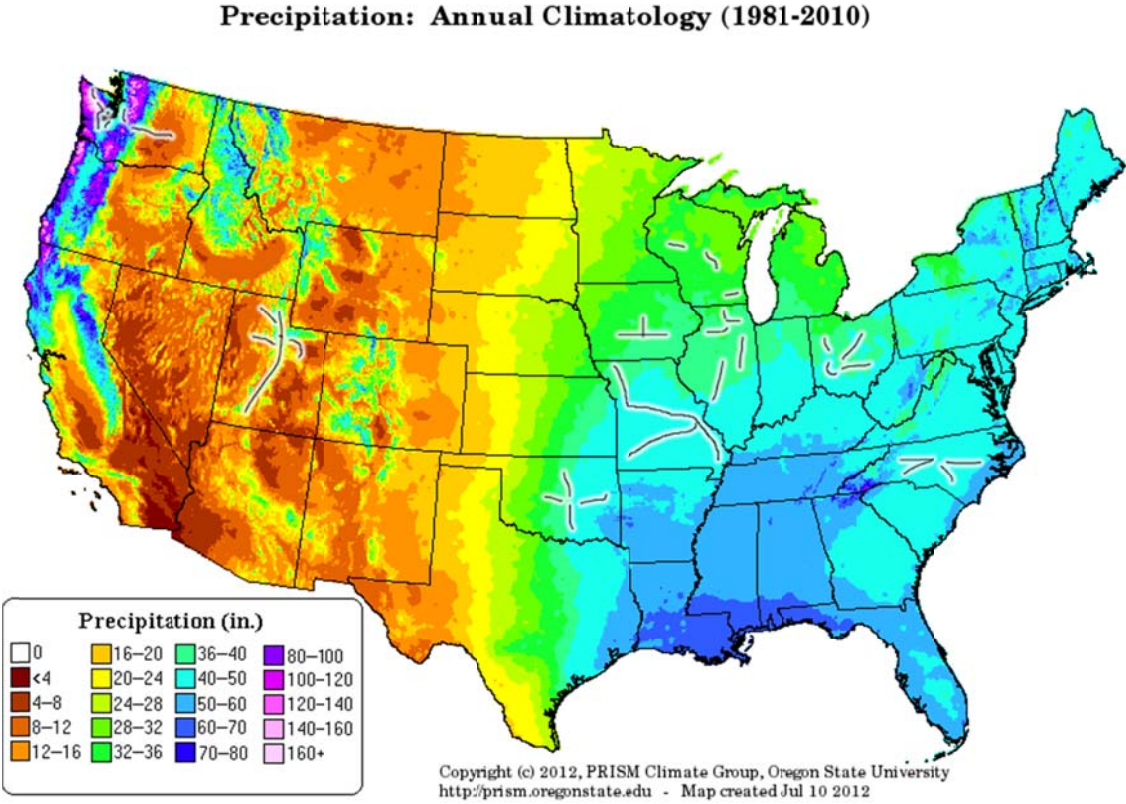
Besides Ohio, both Washington and North Carolina experienced higher cumulative precipitation than other states in this survey. Both Washington and North Carolina are coastal states which experience significant rainfall, without much snowfall in the areas around cable barrier locations. In contrast, Utah was largely dry, except for the I-15 corridor. However, the I-15 corridor was also the site of much of the cable median barrier installed in Utah. A map of the precipitation of the continental United States with approximate locations of selected cable median barriers which were examined is shown in Figure 1.

Figure 1. Selected Approximate Barrier Locations with Annual Precipitation Estimates [15]

Along the I-15 corridor in Utah, annual snowfall totals can exceed 200 in. (5,080 mm) per year, more than 10 times greater than the state average. The precipitation totals along I-15 are much higher than the remainder of the state, as shown in Figure 1. More than 50% of all crashes reported in Utah involved snowfall. This was more than twice as large as the snow representation in Washington. Although some locations in Washington received high snow totals, particularly at higher-elevation locations near the mountains,

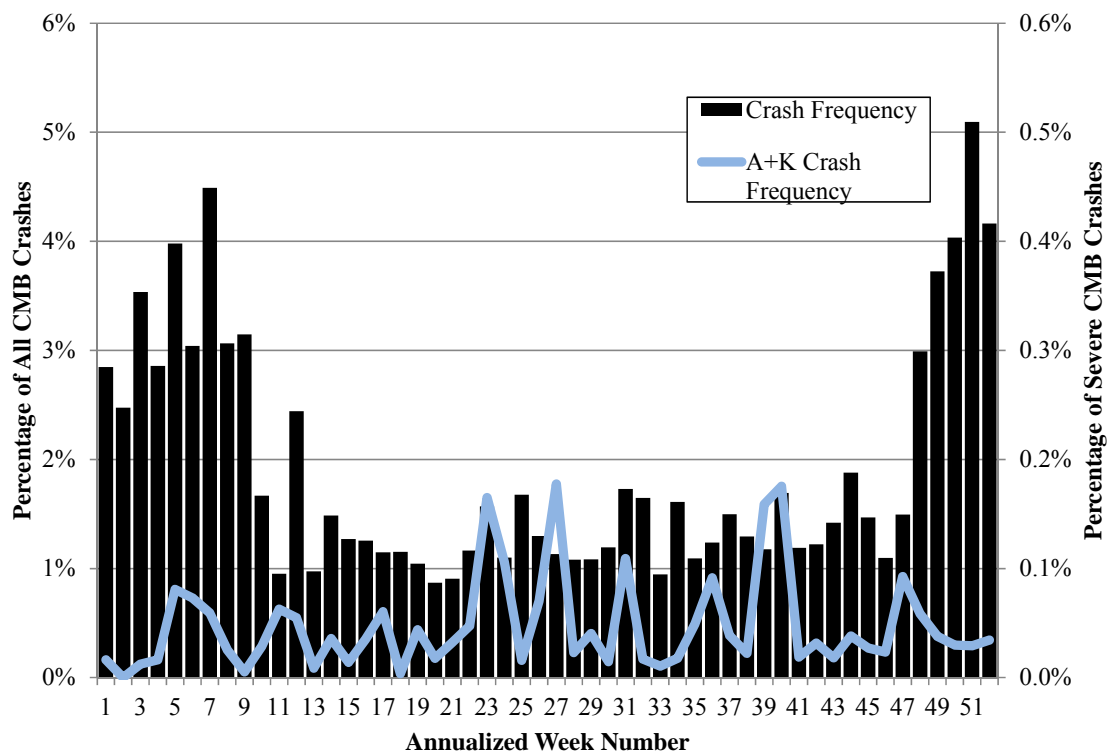
Figure 2. Crash Frequency and Severity by Week Number

For a different perspective, crash severity was also plotted by month, as shown in Figure 3. The number of crashes was significantly higher in the winter months, especially in December, when the first snows of each winter season usually fell. Monthly averages of fatalities were approximately constant between January and April, with increased numbers of fatalities in June, July, and September. This is likely the result of summer vacations and travel which is more common in the summer. The analogous drop in fatalities and crashes in August is likely due to the end of summer travel and vacations and correspond to the impending start of the school year.

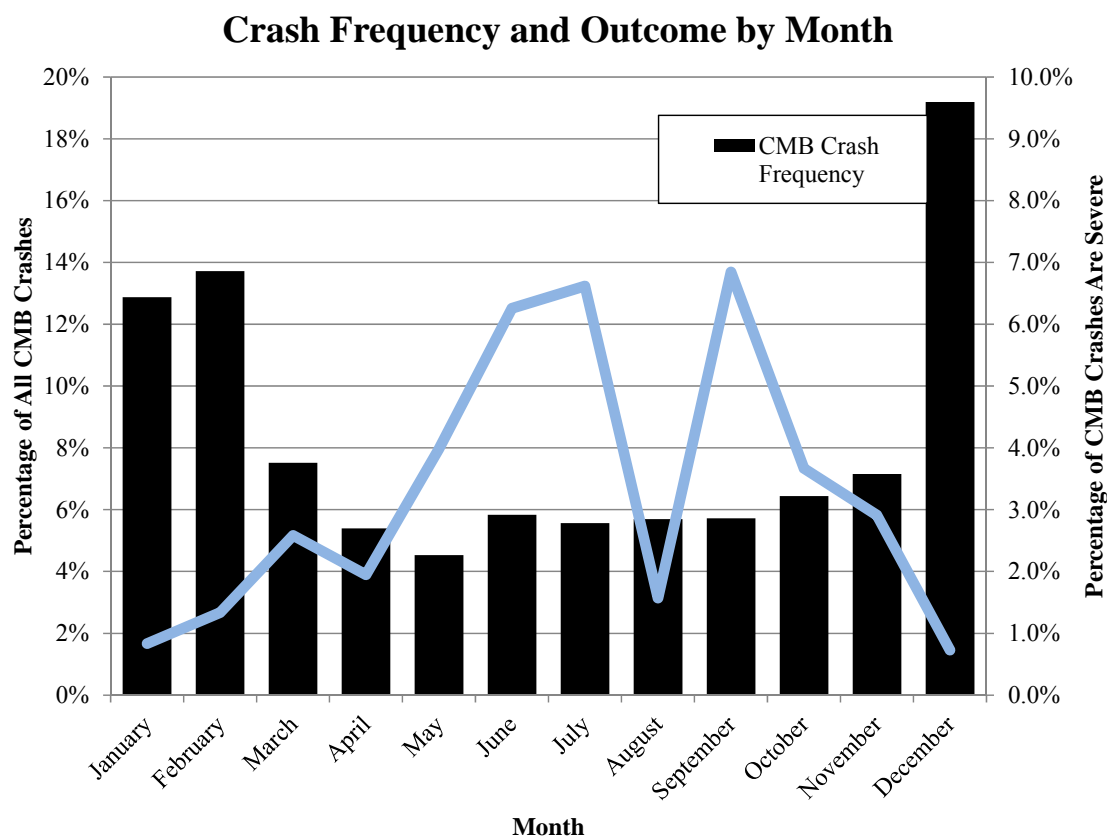
Figure 3. Crash Frequency and Severity by Month

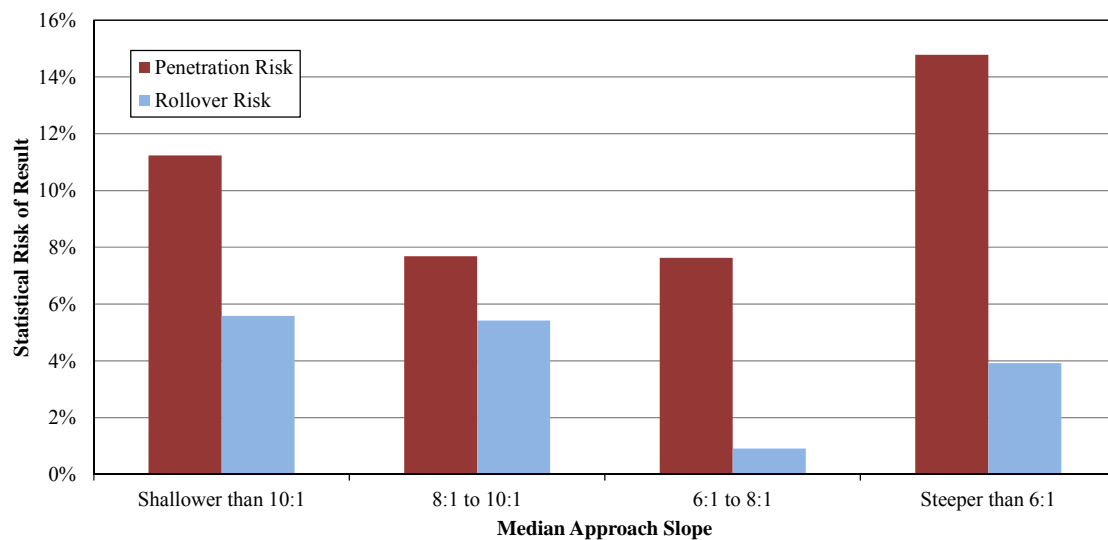
Further investigation of the correlation demonstrated two trends which were supported by crash data in all of the participating states. In general, the highest risk of barrier penetration and rollover risk either occurred on slopes steeper than 6:1 or slopes flatter than 10:1. When the relative risk of rollover in each category was plotted against slope steepness, an asymptotic-like relationship was obtained in both system failure types. The penetration and rollover risk plots and interpolated risk curves obtained from this effort are shown in Figures 4 through 6. The lowest risk for both penetration and rollover combined occurred on median slopes between 7:1 and 6:1, and the risk increased for both steeper and flatter slopes. Rollovers were more frequent on level ground than on steep slopes in this study, although there were a limited number of very steep slopes in this database. Penetrations were much more frequent on steeper slope rates; this was

Figure 4. Statistical Analysis of Penetration and Rollover Risk by Median Slope

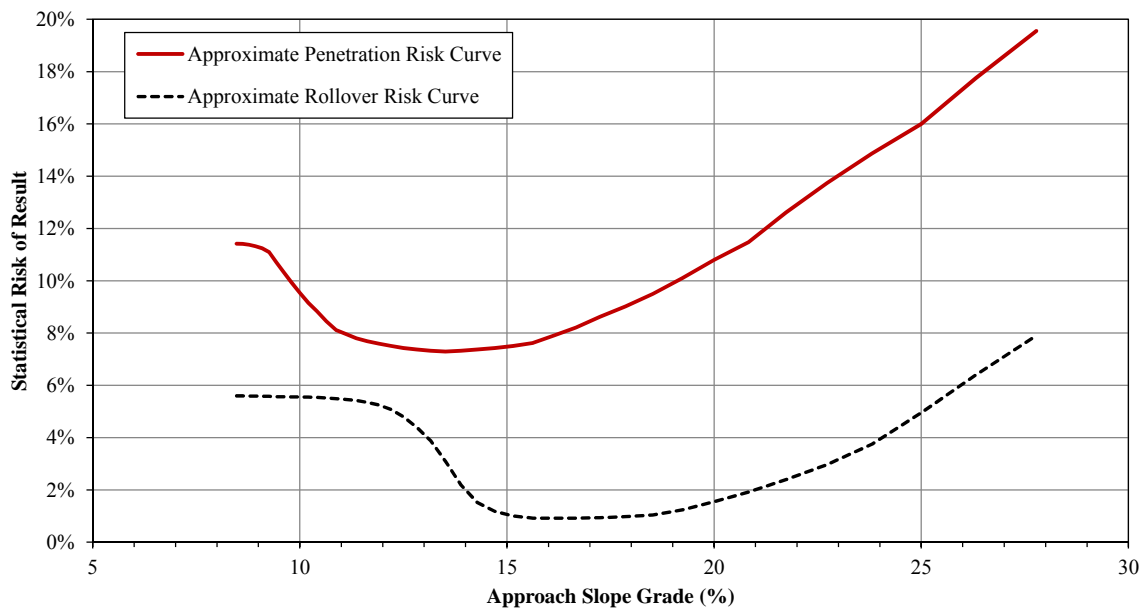
Figure 5. Estimated Ohio Median Approach Slope Risk Curves by Approach Slope Grade (Relative to Nucor Systems)

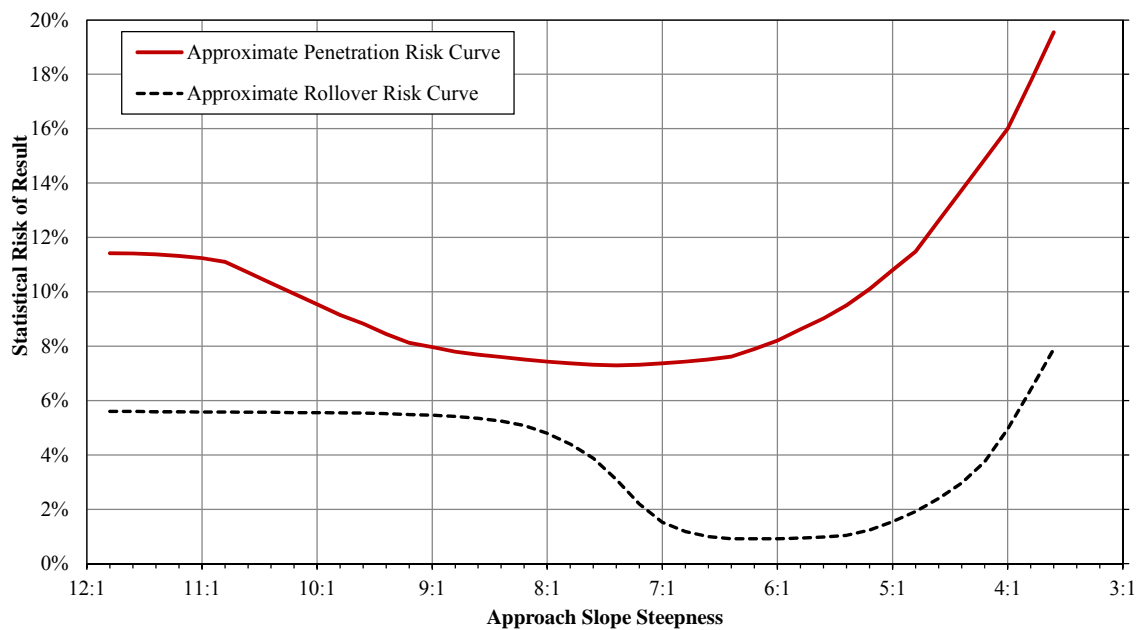
Figure 6. Estimated Ohio Median Approach Slope Risk Curves by Approach Slope Steepness (Relative to Nucor Systems)

In Utah, with larger medians and relatively flat slopes (most slopes were between 6:1 and 10:1), a higher proportion of impacts occurred on the median slopes with lowest risk of penetration than in Washington, based on the median slope results shown in Figure 6. Site-specific estimates in Washington indicated that the roads with the highest rates of penetration were sites with either fairly flat (i.e., flatter than 8:1) or steep (i.e., greater than 6:1) median slopes. The two roads with the lowest rates of penetration had estimated slope rates of between 6:1 and 8:1 over much of the protected length, and much of that roadway was at 8:1.

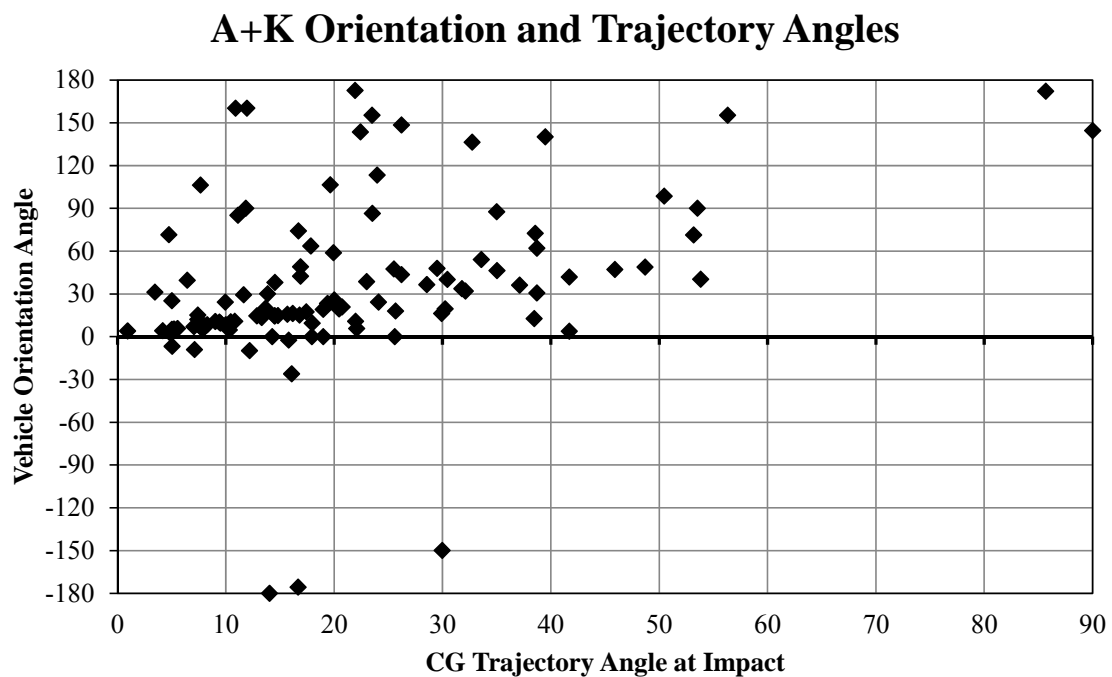
Figure 7. CG Trajectory and Orientation Angles in Severe Cable Median Barrier Crashes

Trajectory angles were plotted by orientation angle and sideslip angle, and are shown in Figures 7 and 8. Although sideslip angles between the path of the vehicle and heading can exceed 90 deg, high sideslip angles were generated by non-zero yaw rates; this is assumed to be an effectively non-tracking impact condition. Moreover, if the driver was conscious and aware to steer the vehicle in avoidance maneuvers, a large number of drivers will also instinctively apply the brakes and attempt to stop an errant vehicle, which further contributes to non-tracking behavior. The threshold between when a vehicle was considered tracking and non-tracking was determined to be approximately 20 degrees based on analysis of non-tracking behavior on crash results [20].

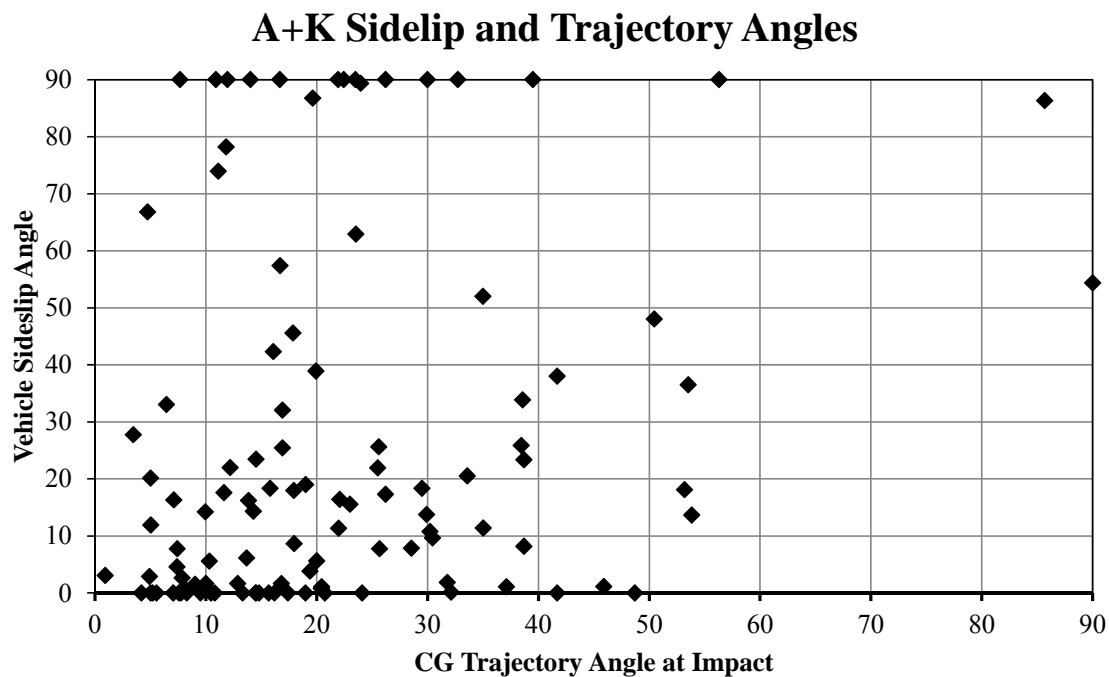
Figure 8. CG Trajectory and Sidelip Angles in Severe Cable Median Barrier Crashes

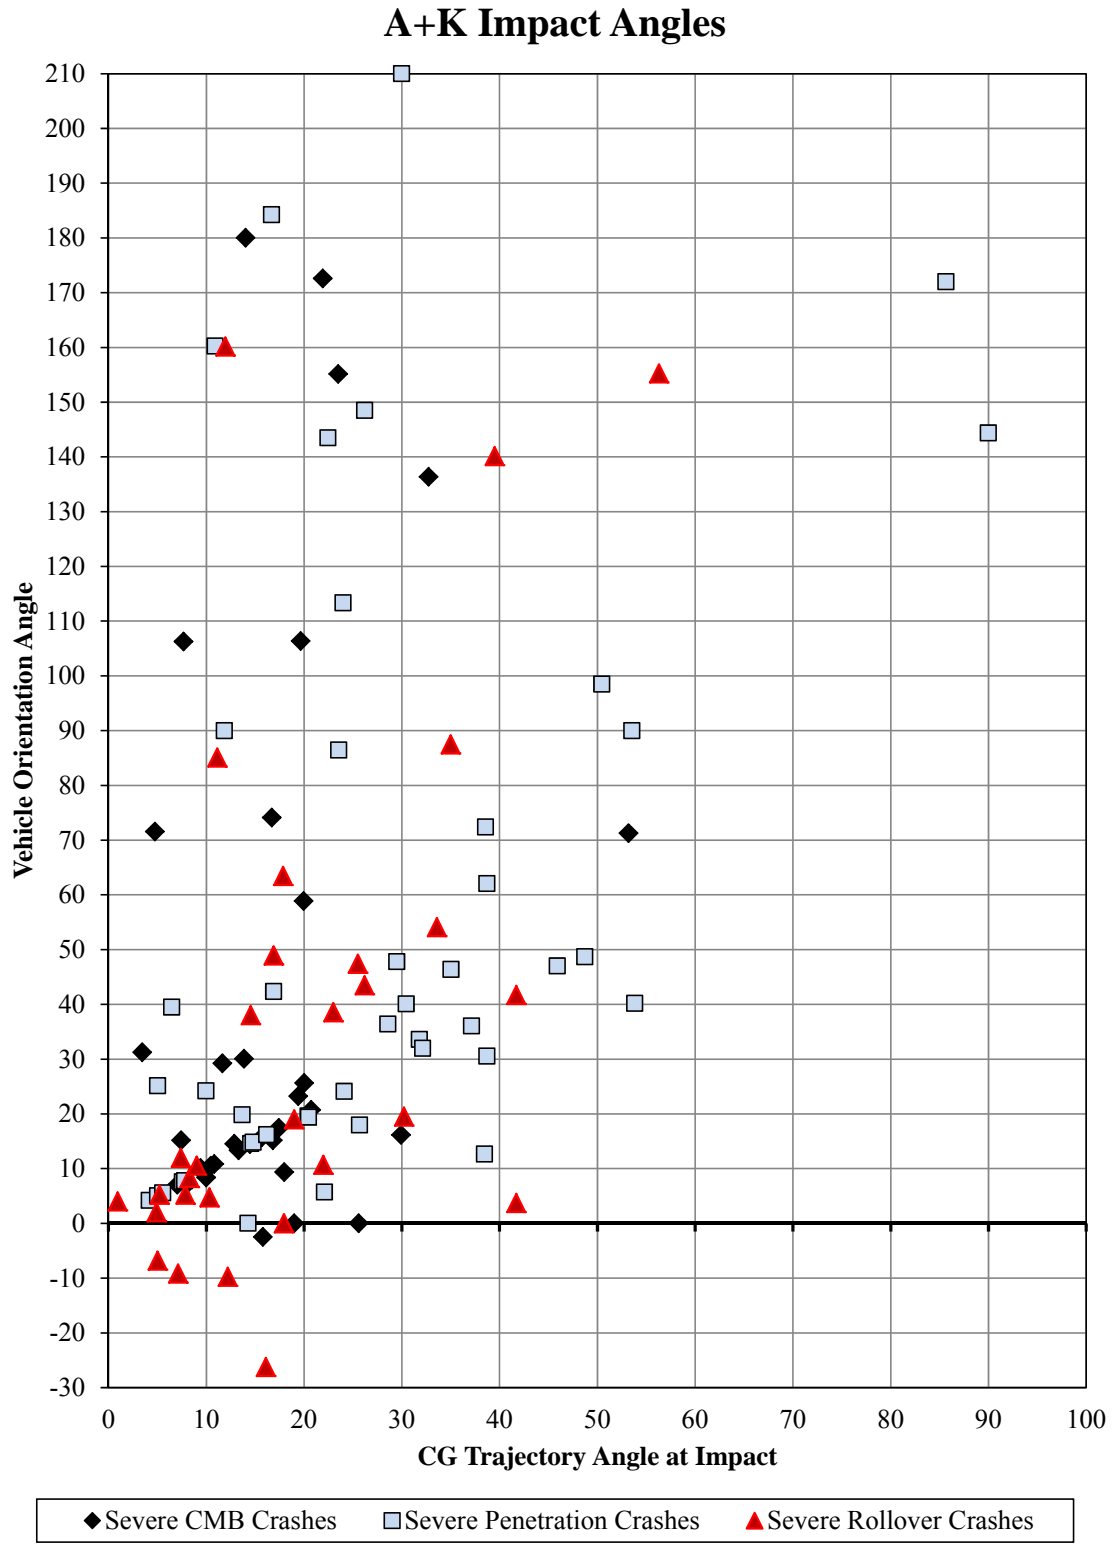
Figure 10. CG Trajectory and Orientation Angles by Crash Result

The CG trajectory and orientation angle plot was segregated by crash result into “Penetration”, “Rollover”, or “Other” categories. The segregated database is shown in Figure 10, and a detail view for vehicle orientation angles greater than -10 degrees is shown in Figure 11.

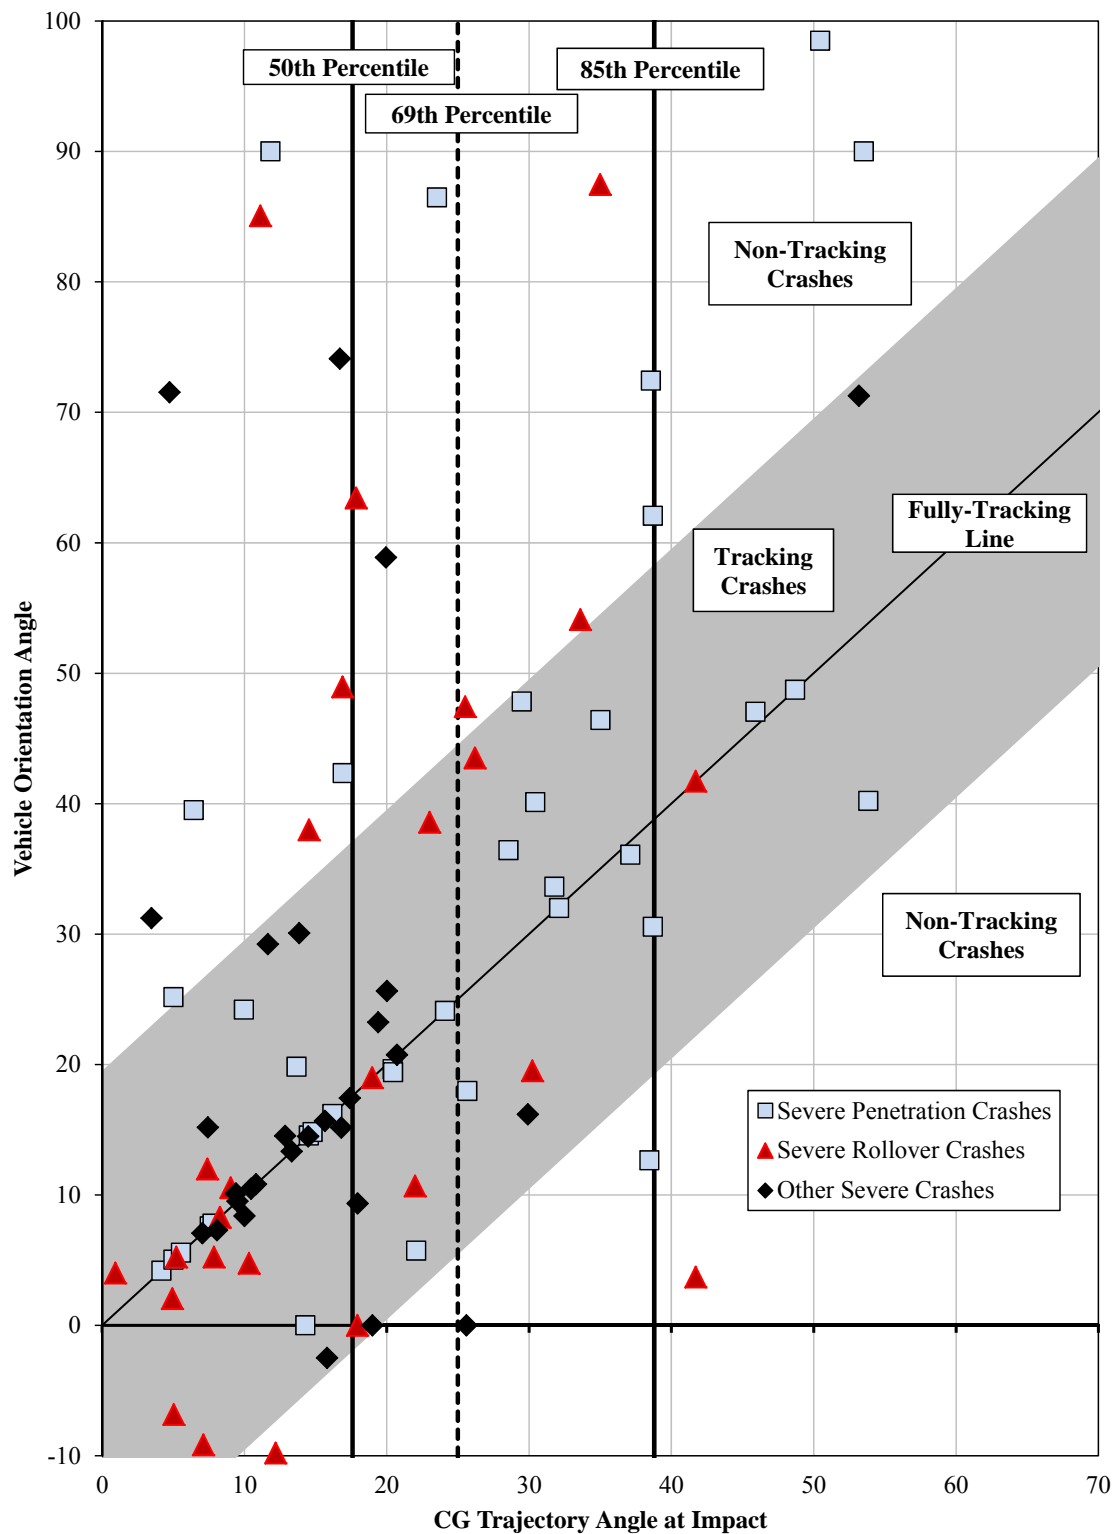
Figure 11. Detail View of Severe Crash CG Trajectory and Orientation Angles in Missouri

Of all the severe cable median barrier crashes, 43% occurred with sideslip angles in excess of 20 degrees. Approximately 40% of penetration crashes were non-tracking at impact with the barrier. Severe penetrations occurred more commonly at higher CG trajectory angles than severe rollovers. The median CG trajectory angle in severe penetration crashes in Missouri was 24 degrees, and the 85th percentile angle was 46 degrees.

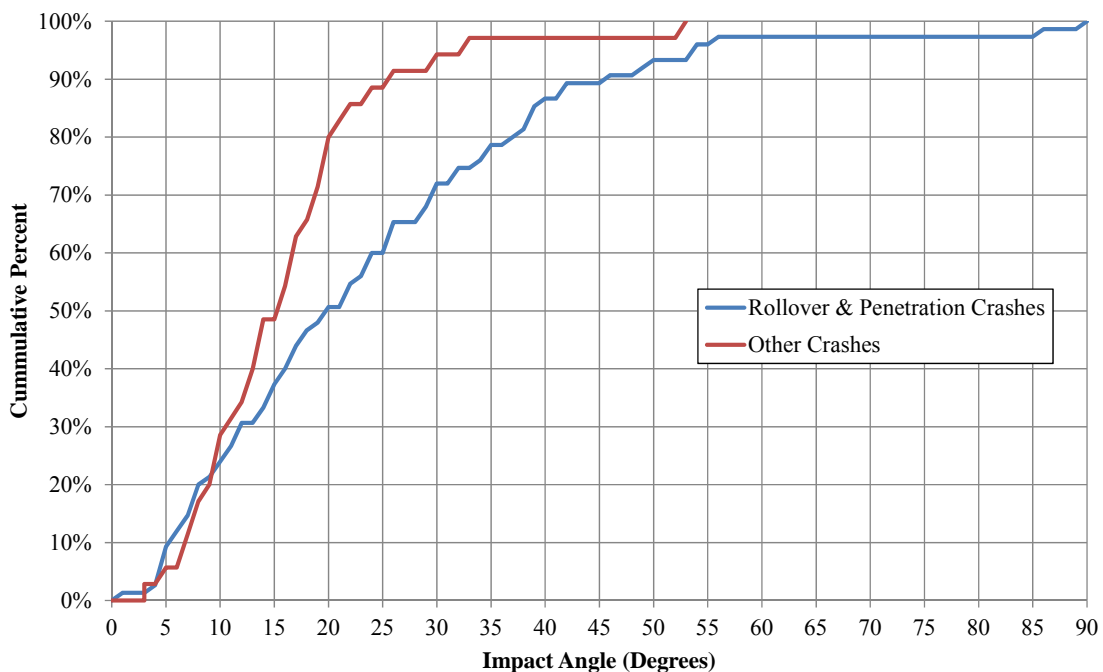
The crash set was further evaluated by considering the relationship between CG trajectory angle and containment rate for severe crashes. A cumulative distribution plot of CG trajectory angle for severe penetration and rollover crashes as well as severe non-penetration, non-rollover crashes is shown in Figure 12. A statistical analysis was conducted on the CG trajectory angle distributions, and a probability curve for likelihood of penetration or rollover crash results in severe cable median barrier crashes is shown in Figure 13.

Figure 12. Cumulative Distribution of CG Trajectory Angles by Severe Crash Result

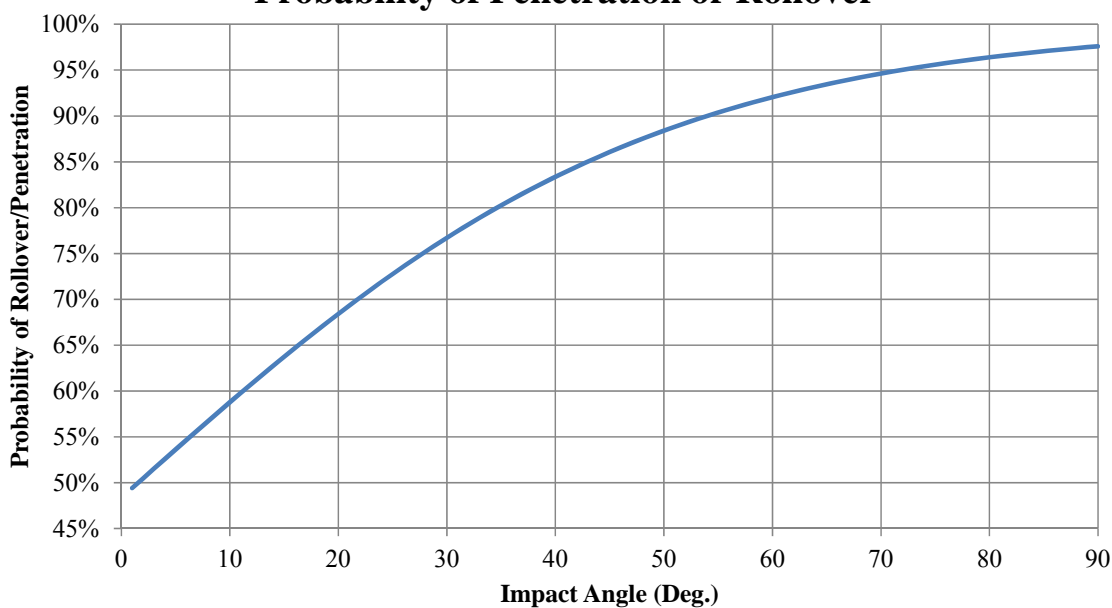
Figure 13. Probability Distribution of Containment Failure in Severe Crashes

In all severe crashes, there was a minimum of a 49% risk of penetration or rollover at very small CG trajectory angles to a high risk of penetration or rollover at large CG trajectory angles. As the CG trajectory angle approached 90 degrees, the risk of penetration or rollover crash results in severe cable median barrier crashes approached 100%, indicating that with a 90 degree CG trajectory angle and a severe crash result, every crash would be expected to be either a penetration or rollover.

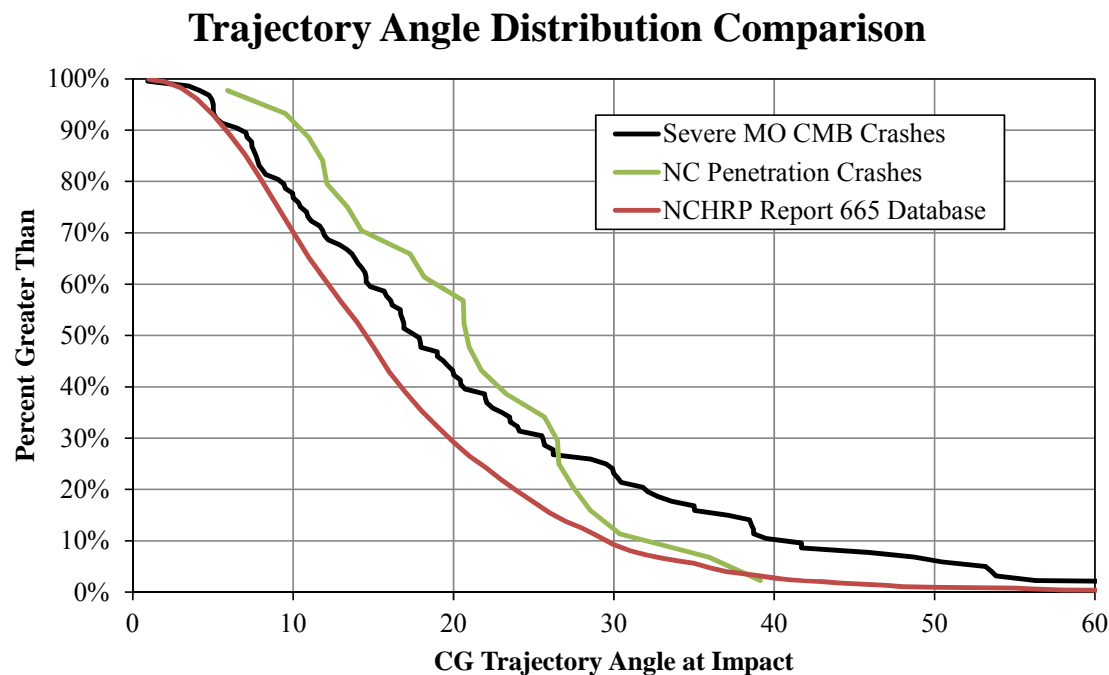
The subset of crashes investigated, totaling 22 in all, were plotted in a distribution and compared with the severe crashes in Missouri, as shown in Figure 14. The North Carolina sample also tended toward higher angles than the NCHRP 665 crashes, but the sample size was too small to make judgments about the distribution. Preliminary attempts to determine correlations using chi-squared tests were not statistically significant but

Figure 14. Comparison of North Carolina, Missouri, and NCHRP Crashes

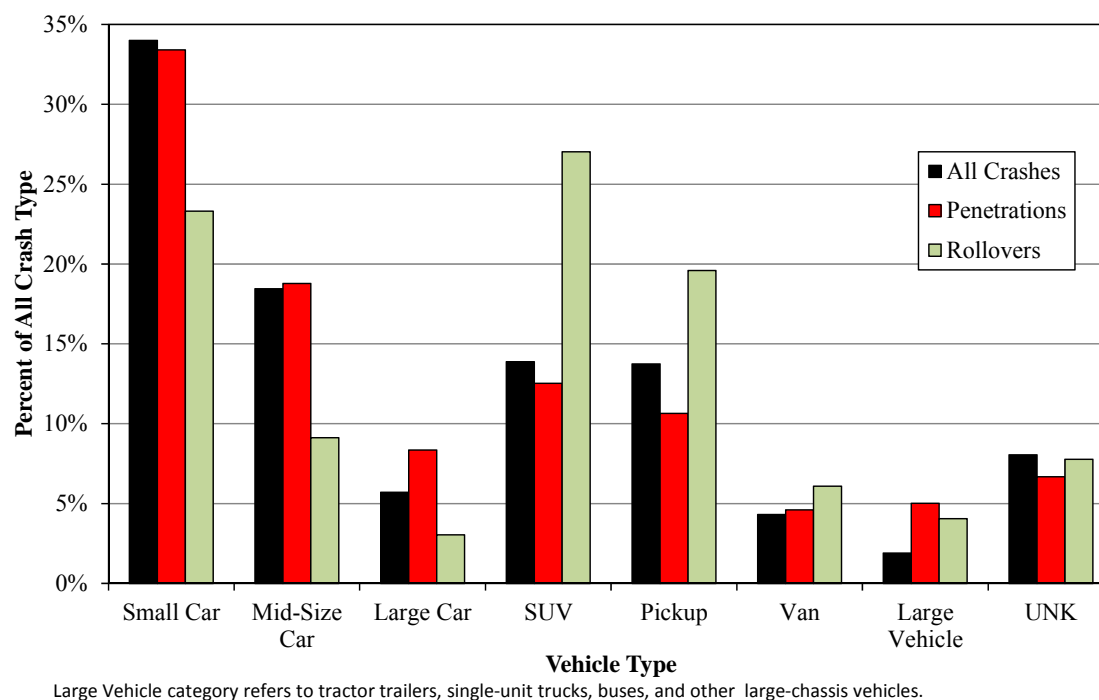
Figure 15. Vehicle Types Involved in Cable Barrier Crashes

and penetrations, but were involved in fewer rollovers than small cars, SUVs, and pickups, in terms of total crashes.

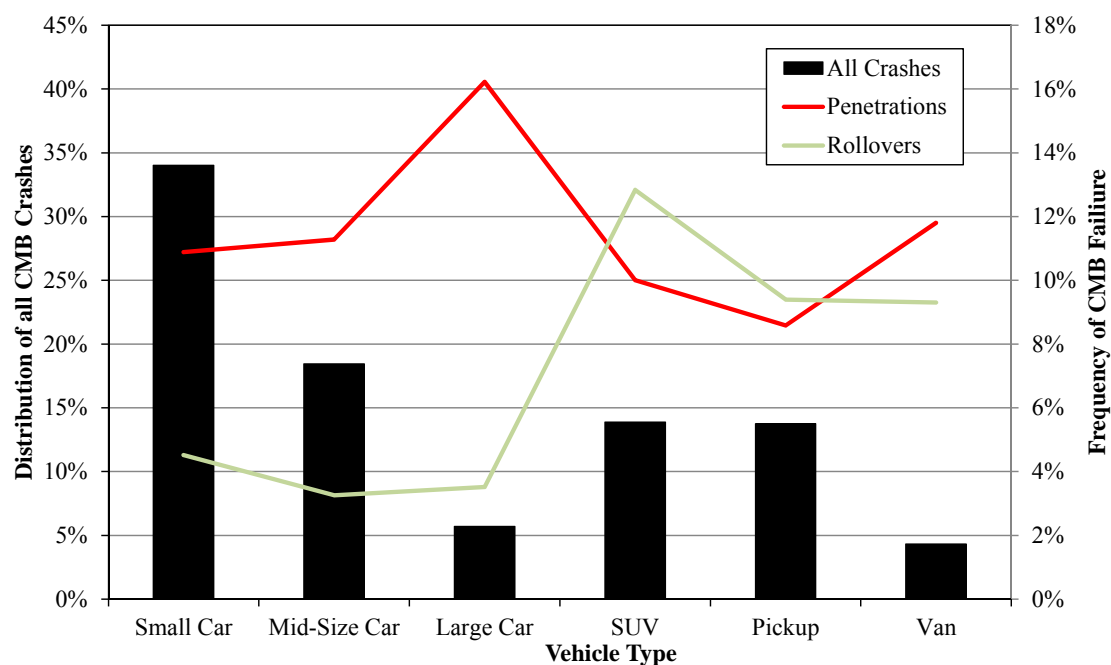
Figure 16. Frequency of Barrier Failure by Vehicle Type

By comparison, rates of vehicle penetration and rollover on a per-crash basis are shown in Figure 16. Large cars were involved in the highest frequency of penetration crashes, followed by vans, mid-size cars, and small cars. Surprisingly, pickups had the lowest rates of penetration of any vehicle type. Although some pickup models were identified which had a higher susceptibility to penetration crashes, as discussed later, generally pickups were not prone to penetrating through cable median barriers. Rollovers were infrequent with all passenger car types, but were common for larger vehicles, averaging more than 10% of all pickup, SUV, and van crashes combined.

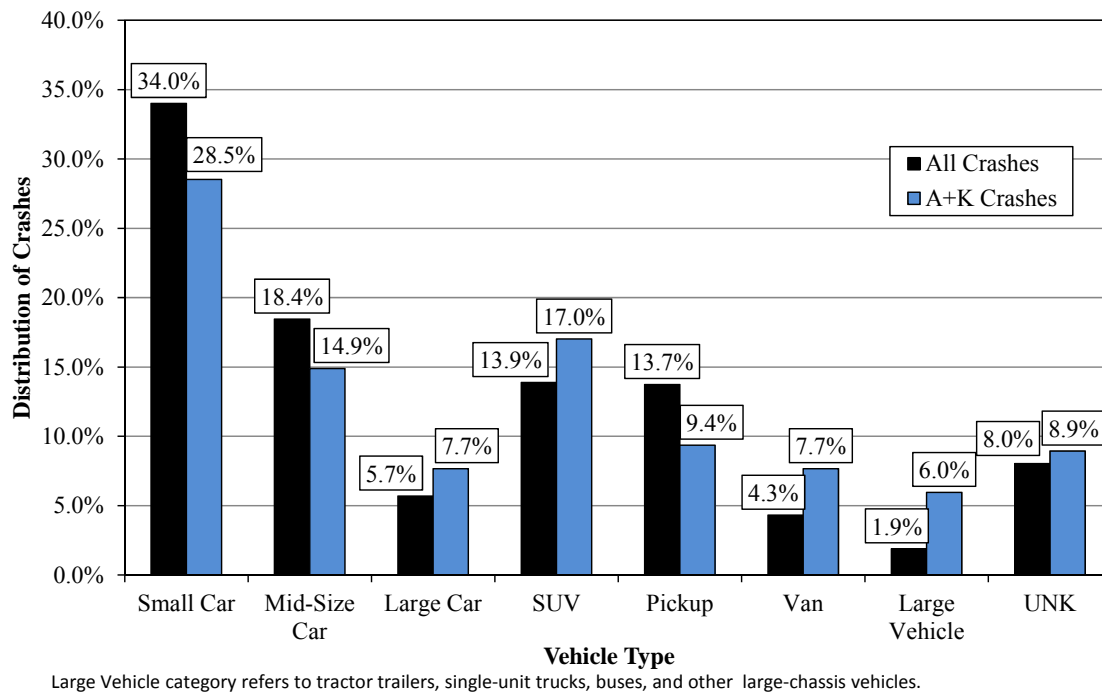
Serious injury and fatal crashes were distributed between all vehicle classes, as shown in Figures 17 and 18. Large car and SUV crashes were more severe in general than small car, mid-size car, or pickups. Vans had the highest rate of severe crashes. A high number of severe crashes occurred involving vans. Tractor-trailer crashes involved a high number of cross-median crashes and rollovers which contributed to the increased average crash severity.

Figure 17. Risk of A+K Crash by Vehicle Type

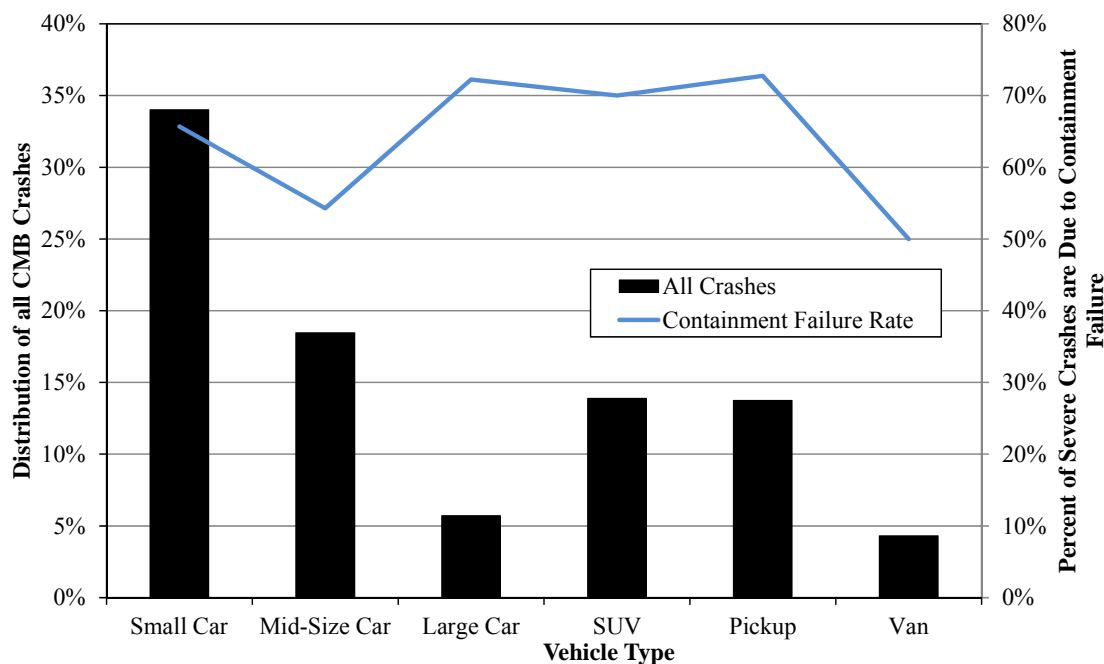
Figure 19. Percentage of Severe Crashes Related to Containment Failures

An analysis of severe crashes based on barrier containment rates indicated that the majority of severe crashes were associated with barrier containment failures, as shown in Figure 19. The highest frequencies of severe crashes based on containment failures occurred with large cars, SUVs, and pickups. Not surprisingly, vans had the lowest rate of severe injuries related to barrier containment failures, since the penetration and rollover rates for vans were not extremely high while the severe crash rate was conversely very high. Also, mid-size cars were involved in more crashes in which the vehicle became entrapped in the cables and cables crushed the hood, roof, or windshield, or penetrated into the occupant compartment of convertibles. As a result, more non-containment failure related crashes were severe involving mid-size cars than other vehicle types.

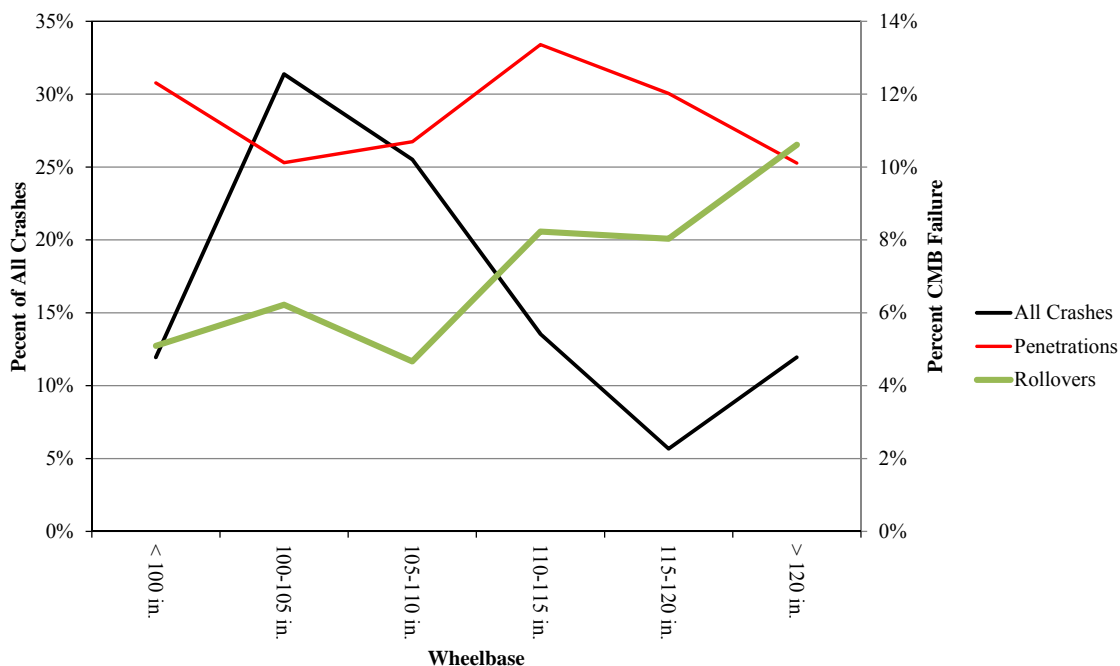
Figure 21. Crash Result Based on Wheelbase

rollover curve reached a minimum in the mid-size car wheelbase range of 4.7% of crashes.

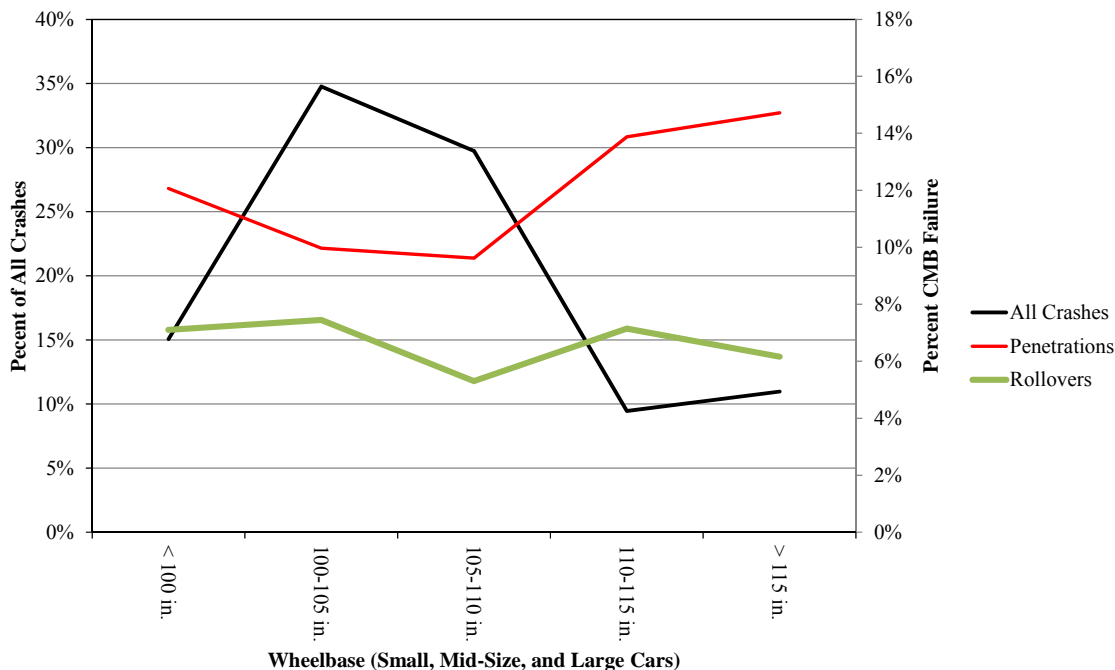
The wheelbase distribution was further segregated by vehicle type. Small car, mid-size car, and full-size car classes were segregated into one group, and SUVs, vans, and pickups were segregated into a second group. Plots of the two groupings are shown in Figures 22 and 23. Rollover rates were relatively flat when segregated by vehicle type, which indicated that wheelbase alone was not a causative factor in rollover crashes.

Figure 22. Crash Result Based on Wheelbase, Small, Mid-Size, and Large Cars

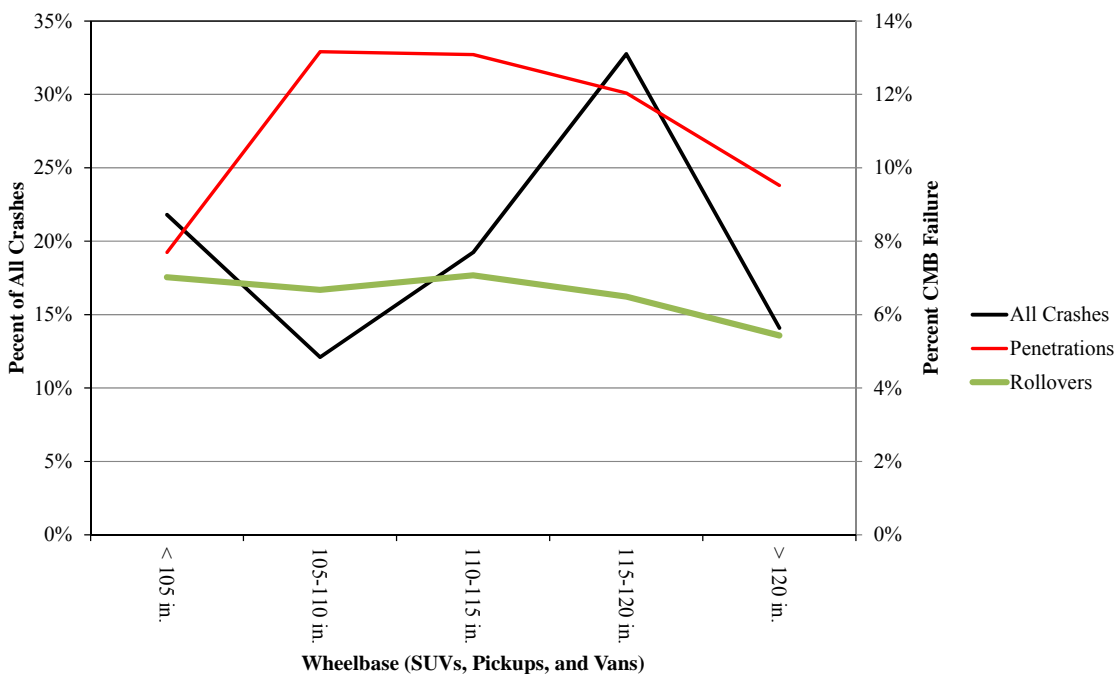
Vehicle type was a controlling factor. Alternatively, mid-length SUVs, pickups, and vans had high penetration rates, whereas mid-length cars had the lowest penetration rates.

Figure 23. Crash Result Based on Wheelbase, SUVs, Pickups, and Vans

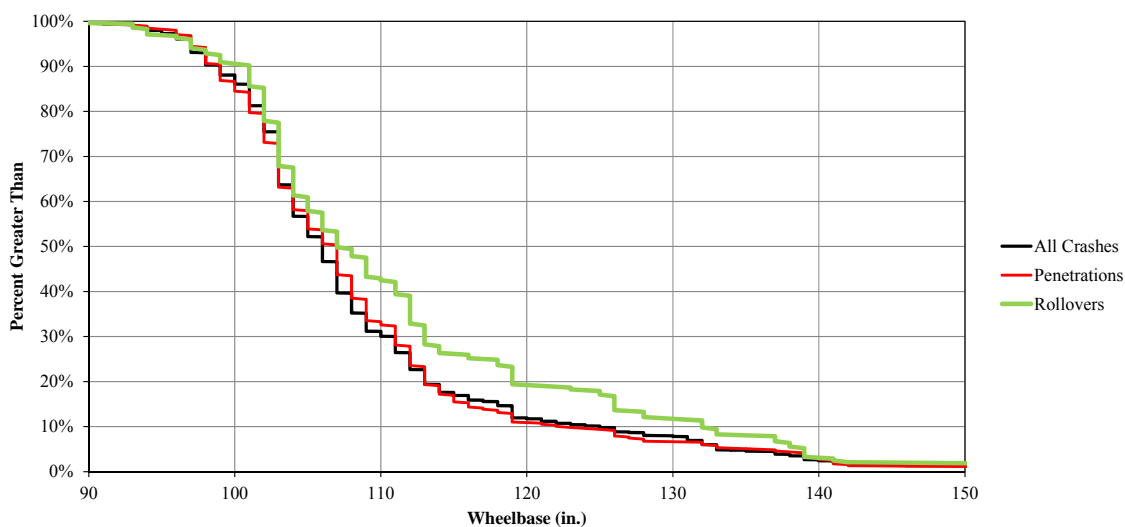
The distribution of wheelbase lengths is shown in Figure 24. The distribution was stepped, because wheelbase numbers were tabulated by whole inches in the AutoStats program. An attempt was made to smooth the distributions by capturing the median percentile for each wheelbase increment. The smoothed plot of the distribution is shown in Figure 25.

Figure 24. Distribution of Vehicle Wheelbase in Cable Median Barrier Crashes

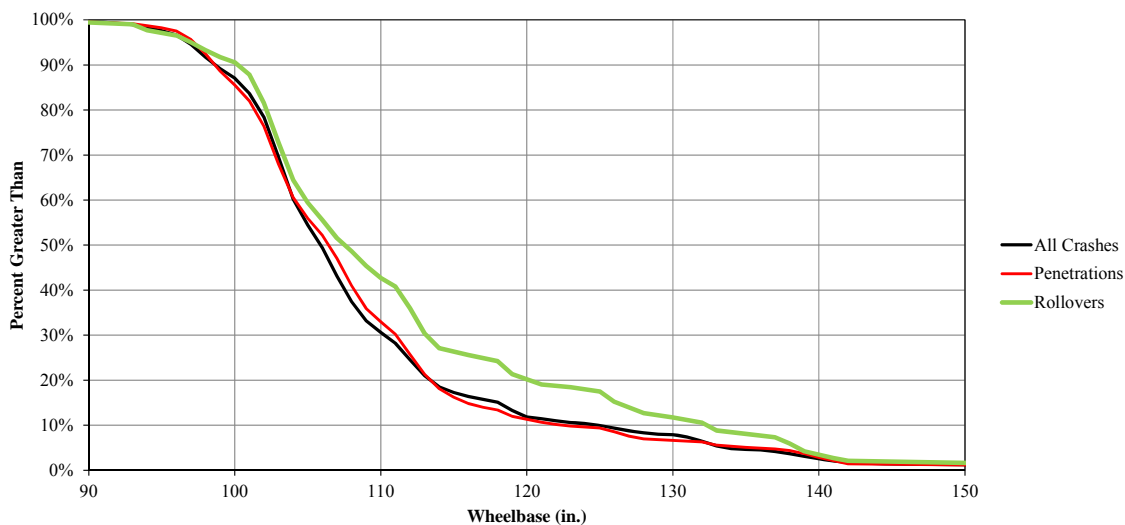
Figure 25. Smoothed Distribution of Vehicle Wheelbase in Cable Median Barrier Crashes

The distribution of wheelbase by crash result for all vehicles suggested that large wheelbase vehicles were involved in more rollovers than small-wheelbase vehicles. This was confirmed in Figure 21. There were no obvious differences between the penetration and composite distributions.

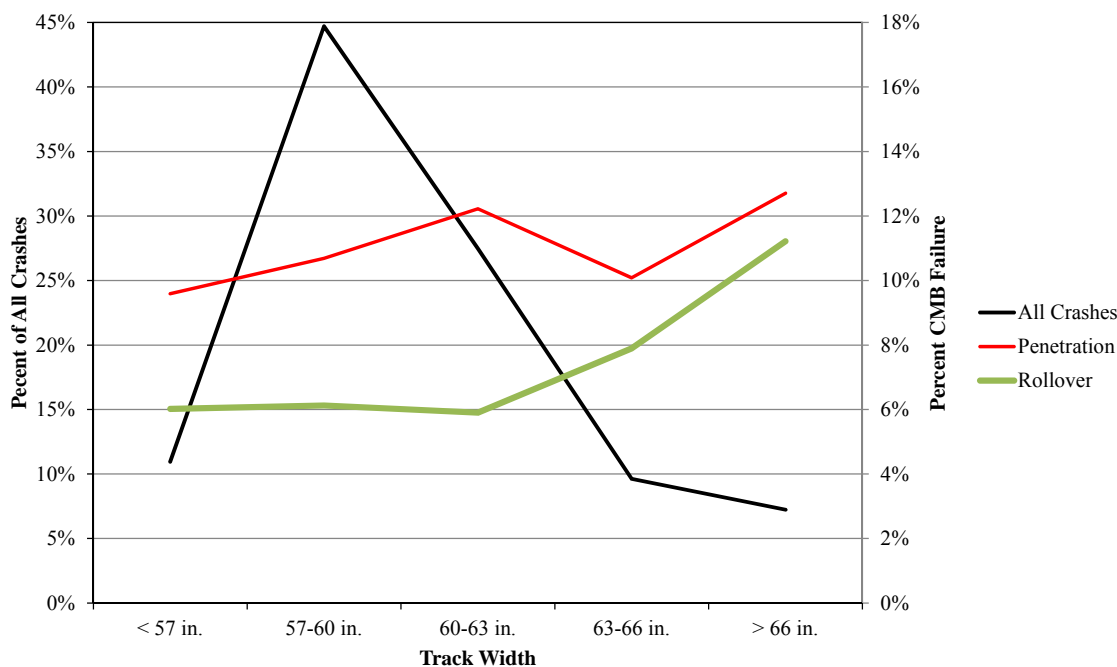
Figure 27. Crash Result Based on Track Width

Track widths were also plotted to identify potential relationships, as shown in Figure 27. Generally, rollovers were more prevalent with larger track widths. This was expected, because SUVs, pickups, and vans, which are involved in more rollovers than cars, also typically have larger track widths.
