CABLE MEDIAN BARRIER
FAILURE ANALYSIS AND REMEDIATION

by
Cody S. Stolle

A DISSERTATION

Major: Civil Engineering
Structural Engineering

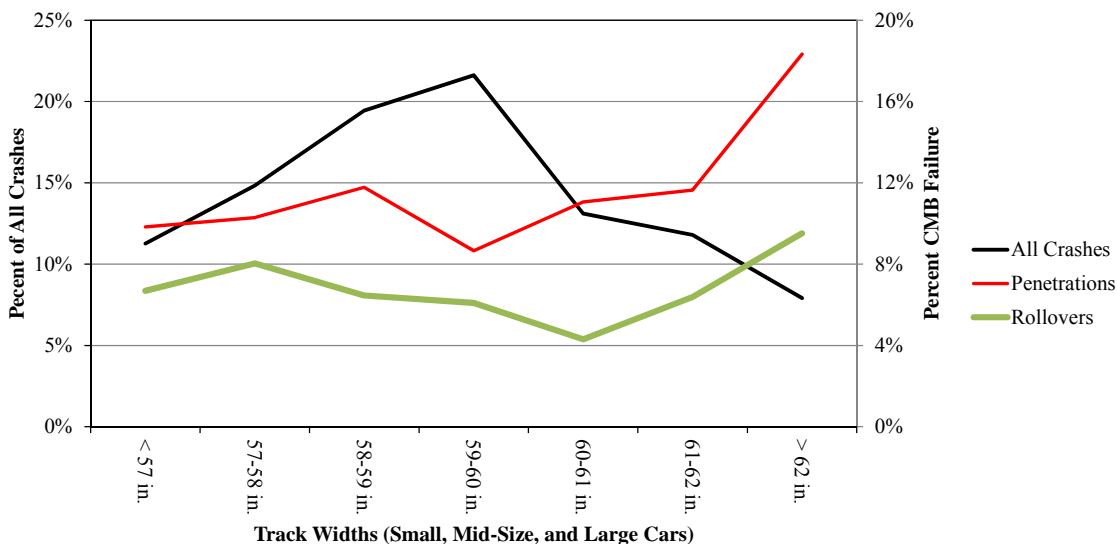
Track widths were segregated by vehicle type as shown in Figures 28 and 29. The distributions were compared by crash outcome. Segregation by vehicle type indicated a strong relationship between track width and penetration rates for passenger cars, whereas statistically significant differences in penetration rate were not observed for SUVs, pickups, and vans. Penetrations were infrequent with small track width utility vehicles, but remained relatively constant for vehicles with track widths greater than 60 in. (1,524 mm). Rollover rates were not strongly related to track width in either vehicle grouping. Further analysis of track width with respect to CG height is discussed in Section 7.3.4.

Figure 28. Crash Result Based on Track Width, Small, Mid-Size, and Large Cars

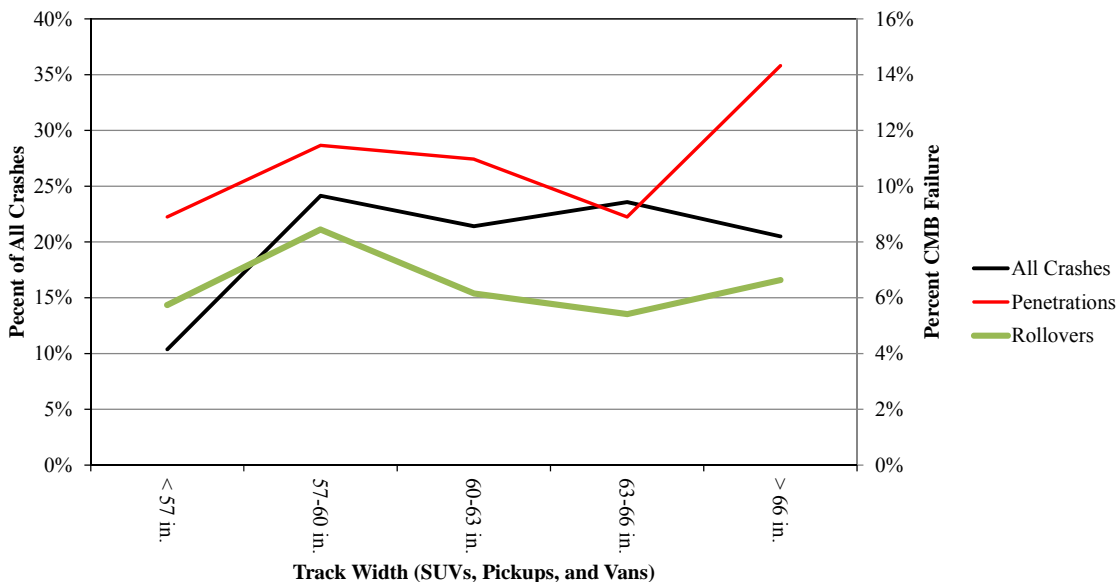
Figure 29. Crash Result Based on Track Width, SUVs, Pickups, and Vans

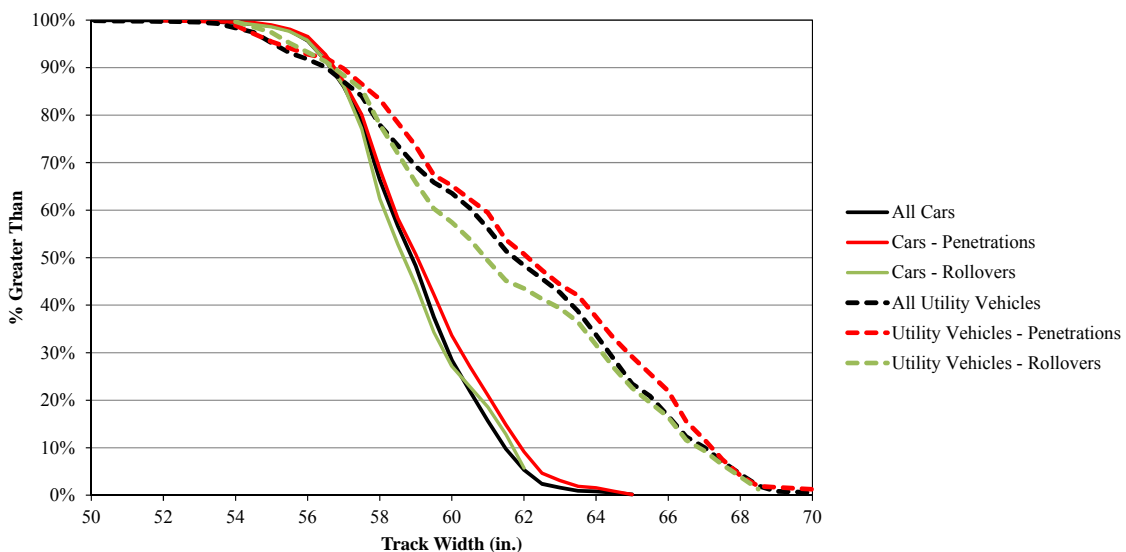
A smoothed distribution of crash result by track width is shown in Figure 30. The penetration distribution favored larger-track width passenger cars. The 85th percentile track width in all car crashes was 63.3 in. (1,608 mm), whereas the 85th percentile track width for cars involved in penetration crashes was 63.8 in. (1,621 mm).

Figure 30. Smoothed Distribution of Track Width by Vehicle Type and Crash Result

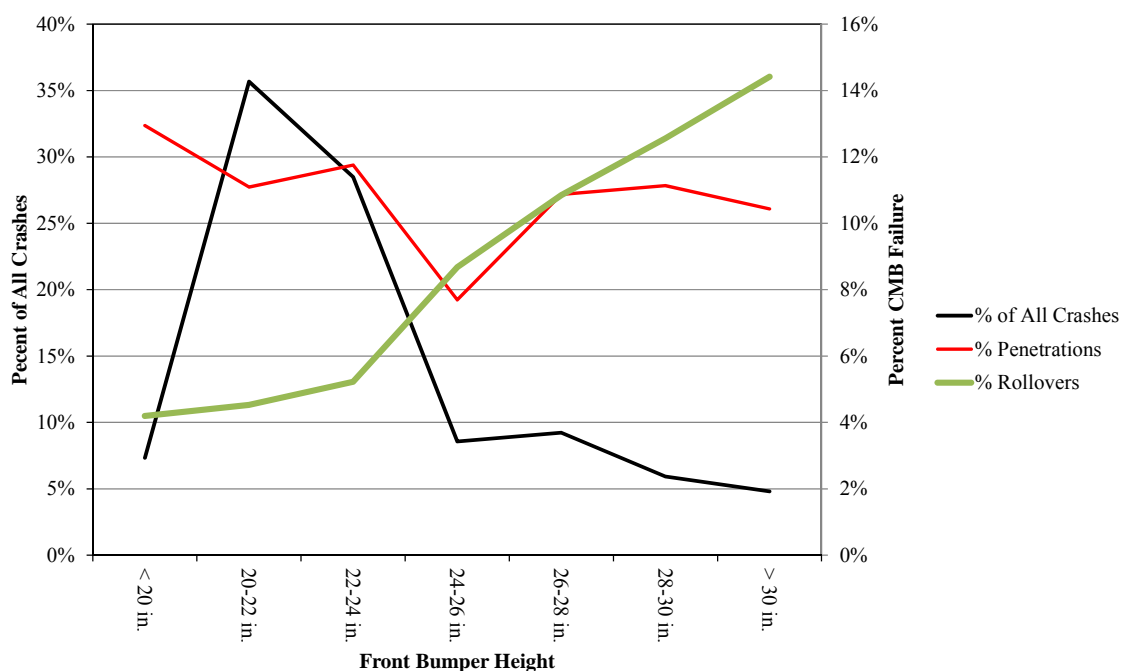
Figure 31. Crash Result Based on Top of Front Bumper Height

Crash results based on front bumper height were plotted and are shown in Figure 31. There was an unmistakable increasing trend toward higher rollover rates with increasing bumper height. Surprisingly, this correlation appeared nearly linear with bumper height. A similar relationship could not be determined for penetration crashes. The overall distribution of vehicles involved in the crashes had no discernible trend in penetration rates.

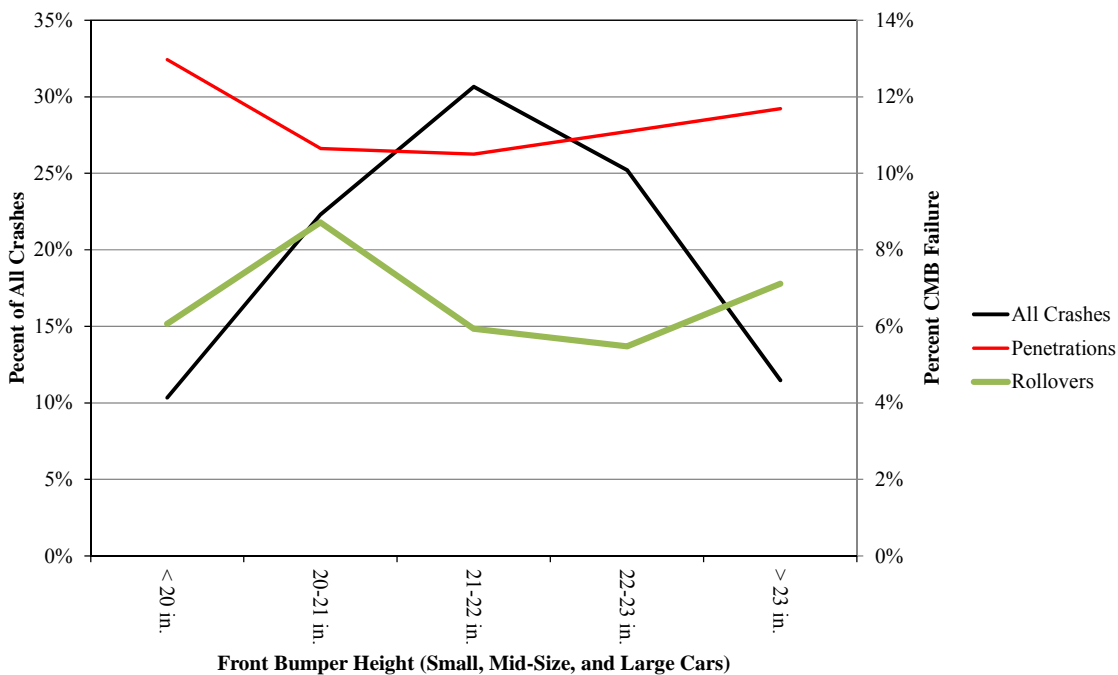
Figure 32. Crash Results by Front Bumper Height, Small, Mid-Size, and Large Cars

The penetration distributions were not independent of bumper height in either vehicle group subset; in fact, the passenger car penetration distribution was statistically similar to the distribution of all passenger car crashes. This result was surprising, since it is widely known that lower bumper heights can contribute to higher penetration rates for low-profile cars.

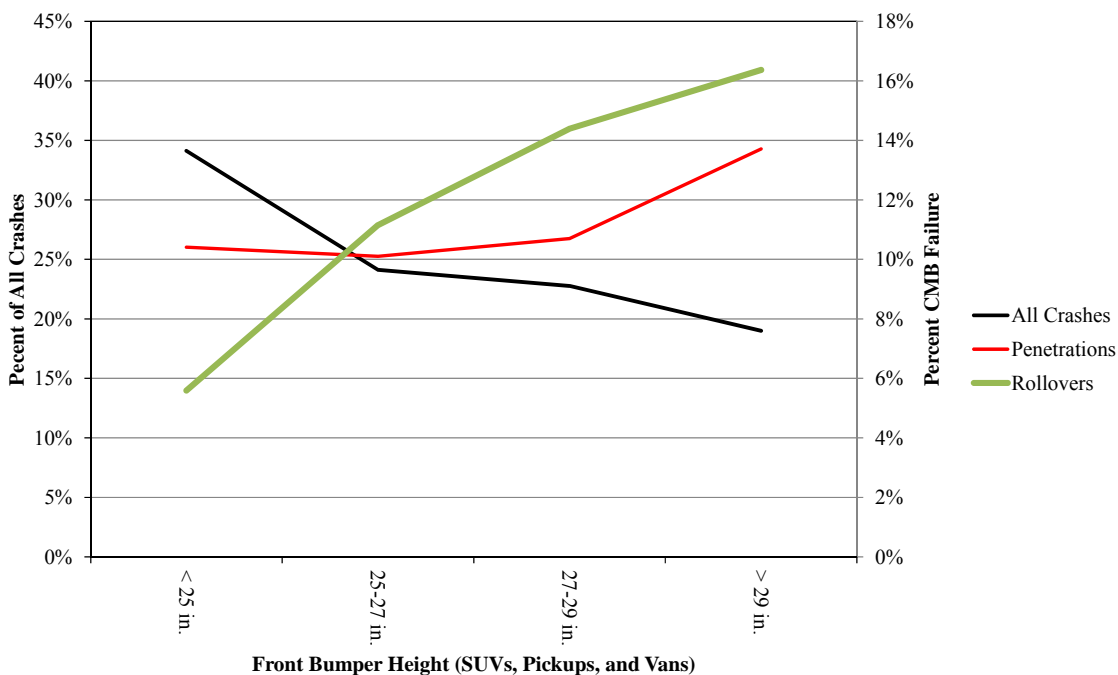
As with wheelbase and track widths, the crash results were segregated by vehicle type and plotted separately. The plots are shown in Figures 32 and 33. Although rollover rates were very strongly related to front bumper heights when all vehicles were compared together, comparisons by classes revealed mixed results. Passenger cars had no strong correlation between rollover rates and front bumper heights. A strong correlation was observed between SUV, pickup, and van rollover rates and front bumper heights.

Figure 33. Crash Result by Front Bumper Height, SUVs, Pickups, and Vans

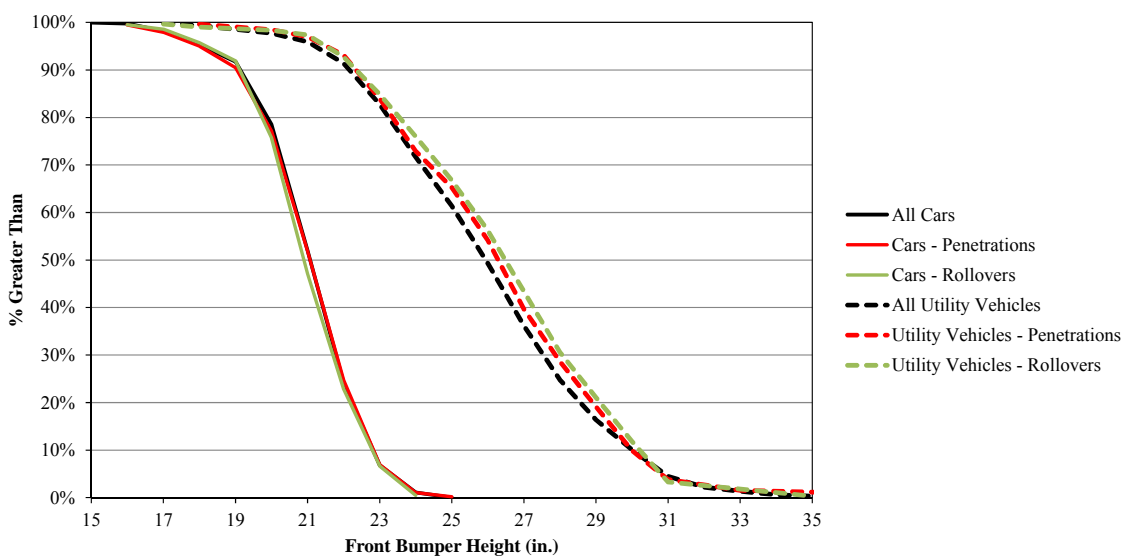
A smoothed distribution of bumper heights by vehicle class and crash result is shown in Figure 34. The distributions of bumper heights indicated significant differences between car and utility vehicle bumper heights, but very little difference in car bumper heights. It is likely that because the distribution of passenger car bumper heights indicated that 85% of all passenger car bumper heights were between 19 and 23 in. (483 and 584 mm), the differences in suspension characteristics, such as stiffness and travel, were more significant than differences in bumper heights for these cars. This also indicated that impact conditions may be more important than bumper heights for passenger car impacts, with respect to the propensity to penetrate through the barrier.

Figure 34. Smoothed Distribution of Bumper Height by Crash Result and Vehicle Type

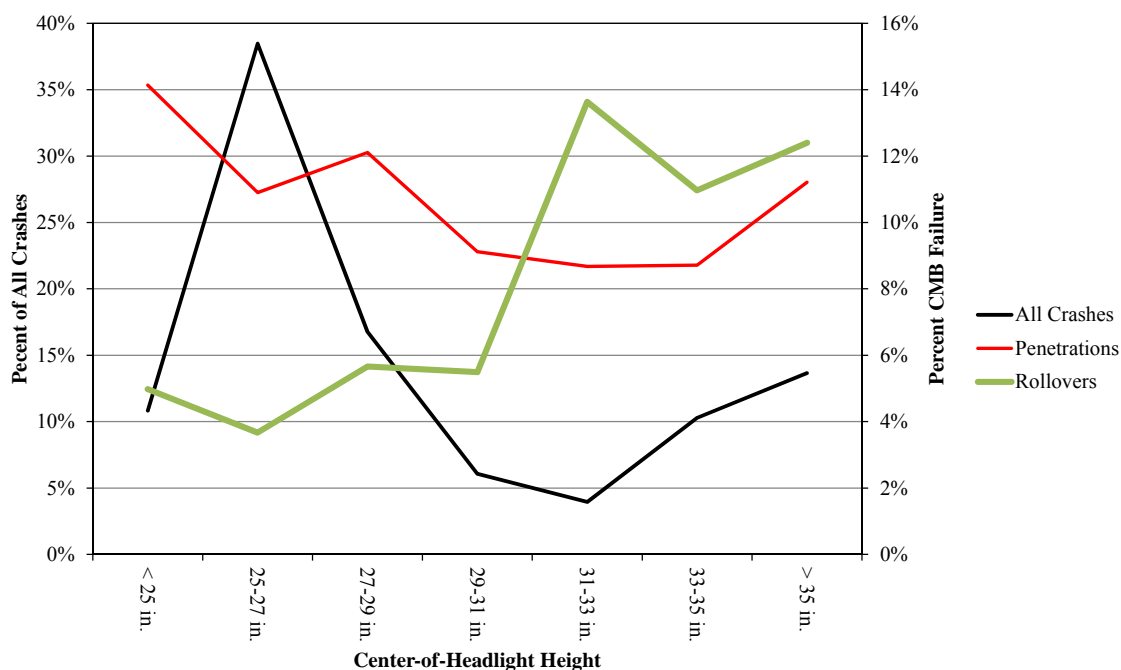
Figure 35. Crash Result by Center-of-Headlight Height

expected because higher rollover rates were associated with pickups, vans, and SUVs, all of which had higher average center-of-headlight heights than passenger cars.

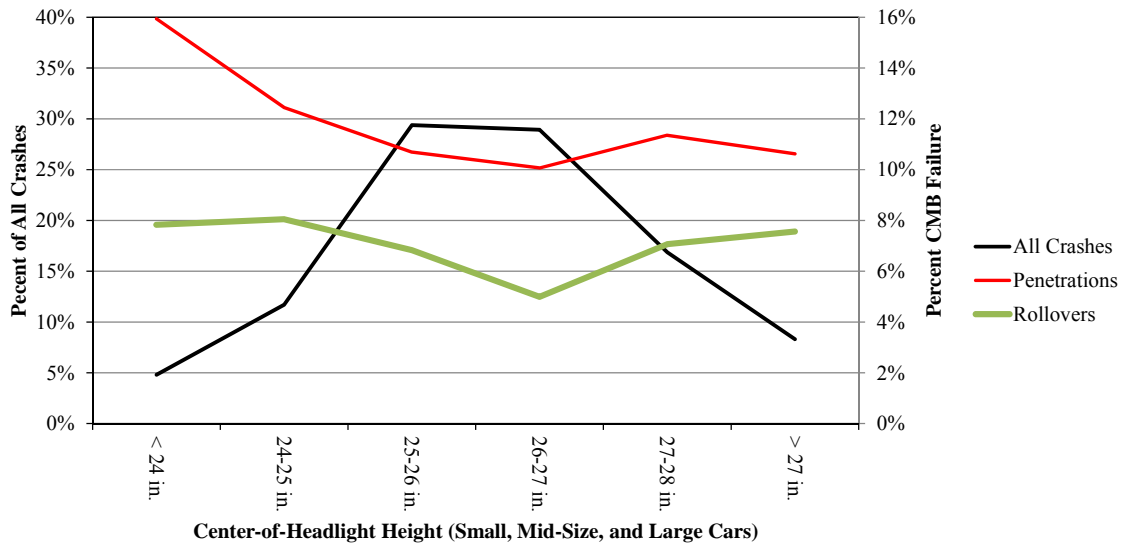
When compared by vehicle types, rates of penetration and rollover were less significant as was observed in the composite distributions, as shown in Figures 36 and 37. However, a generally decreasing trend in penetration rates was observed for passenger cars, as shown in Figure 36. This was intuitive; very low front bumper height vehicles were involved in more penetration crashes than other passenger cars due to an increased propensity to underride. No significant correlations were observed with respect to SUVs, pickups, and vans.

Figure 36. Crash Result by Center-of-Headlight Height, Small, Mid-Size, and Large Cars

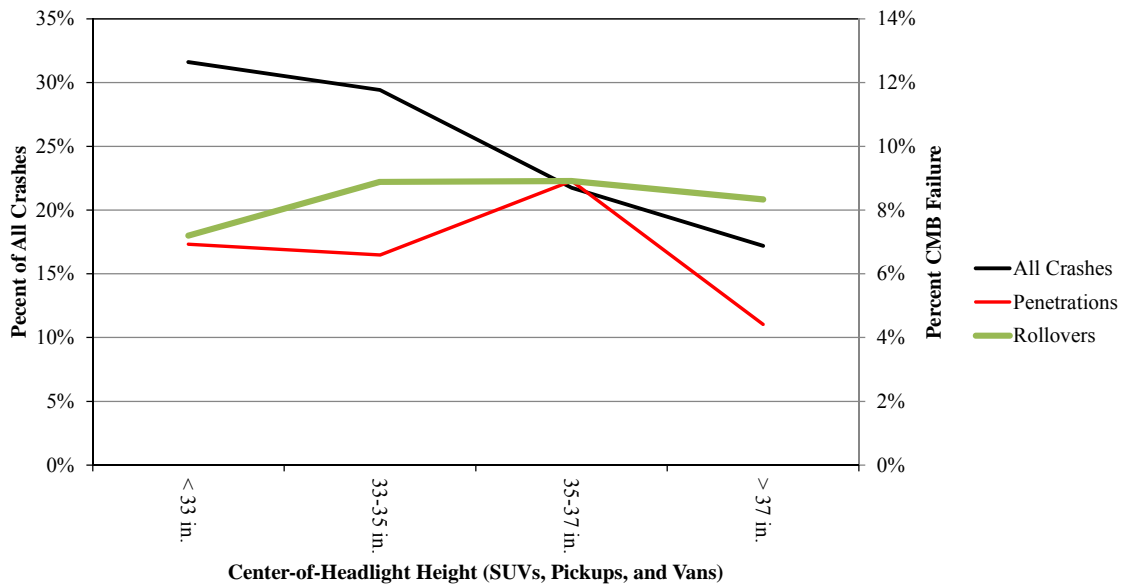
Figure 37. Crash Result by Center-of-Headlight Height, SUVs, Pickups, and Vans

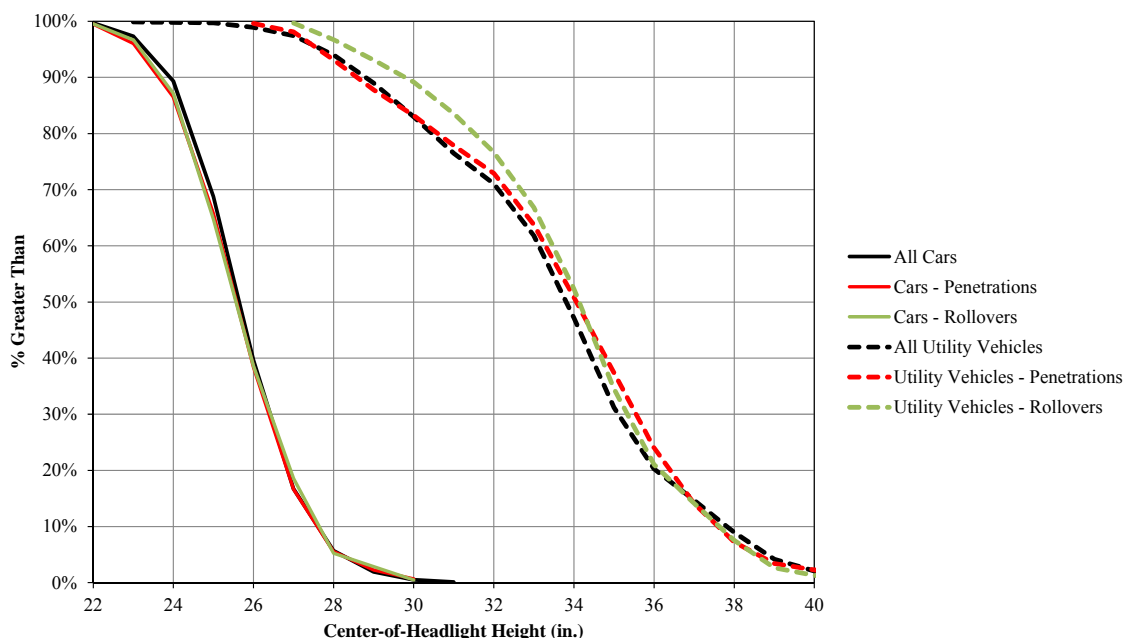
The distribution of center-of-headlight heights was plotted and is shown in Figure 38. The deviation of the rollover dataset of SUVs, pickups, and vans was clearly visible. A significantly reduced proportion of rollover crashes occurred when vehicles with

center-of-headlight heights between 28 and 32 in. (711 and 813 mm) crashed into the cable barriers. However, most differences were within the margin of error.

Figure 38. Smoothed Distribution of Center-of-Headlight Heights by Crash Result and Vehicle Type

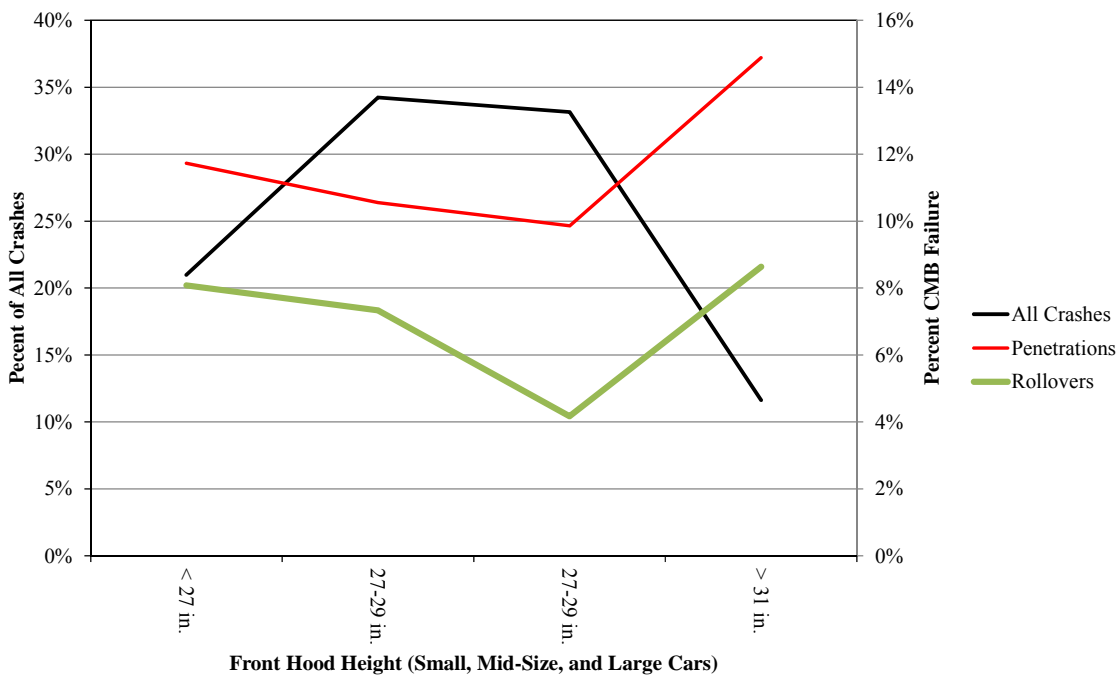
Figure 40. Crash Result by Front Hood Height, Small, Mid-Size, and Large Cars

In both classes, the middle front hood heights had the lowest rates of penetration. Higher rates were observed at both lower and higher hood heights. Also, the highest front hood heights for both cars and utility vehicles had the highest rates of rollover.

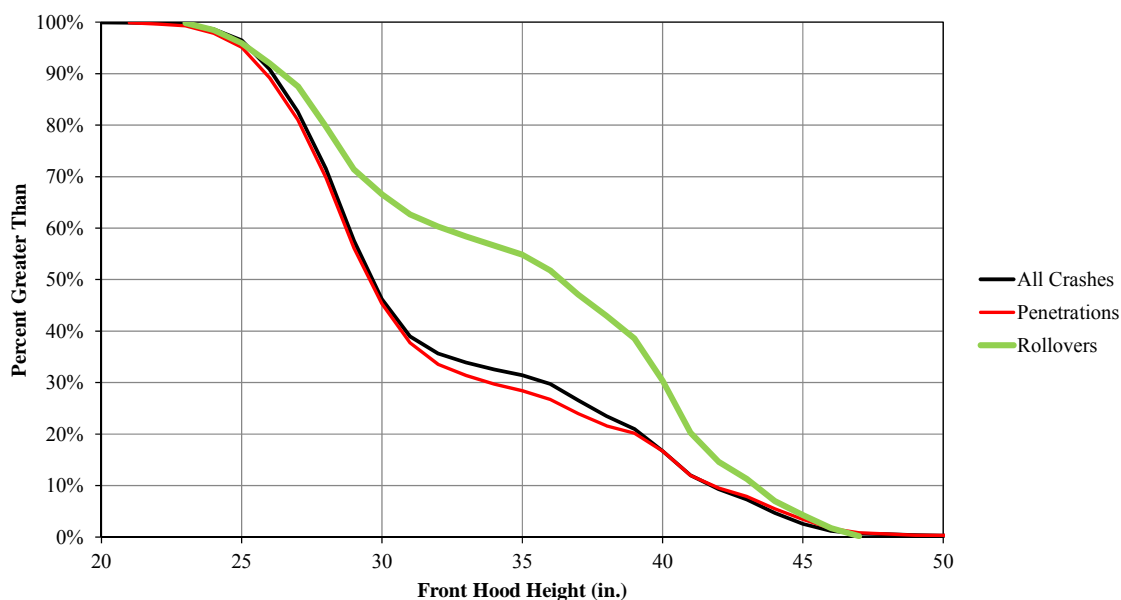
The smoothed distribution of front hood heights of all vehicles is shown in Figure 42. The difference between the composite and rollover datasets is clearly visible, particularly with hood heights between 30 and 40 in. (762 and 1,016 mm). A surprising trend was observed that very few rollover crashes involved vehicles with front hood heights between 30 and 35 in. (762 and 889 mm). Over 65% of all cable median barrier crashes occurred involving vehicles with front hood heights less than 32 in. (813 mm), whereas 55% of all rollovers involved vehicles with front hood heights greater than 35 in. (889 mm). The distribution of front hood height by crash result and vehicle group did not generate meaningful identities, thus it was not shown here.

Figure 42. Distribution of Front Hood Heights in CMB Crashes

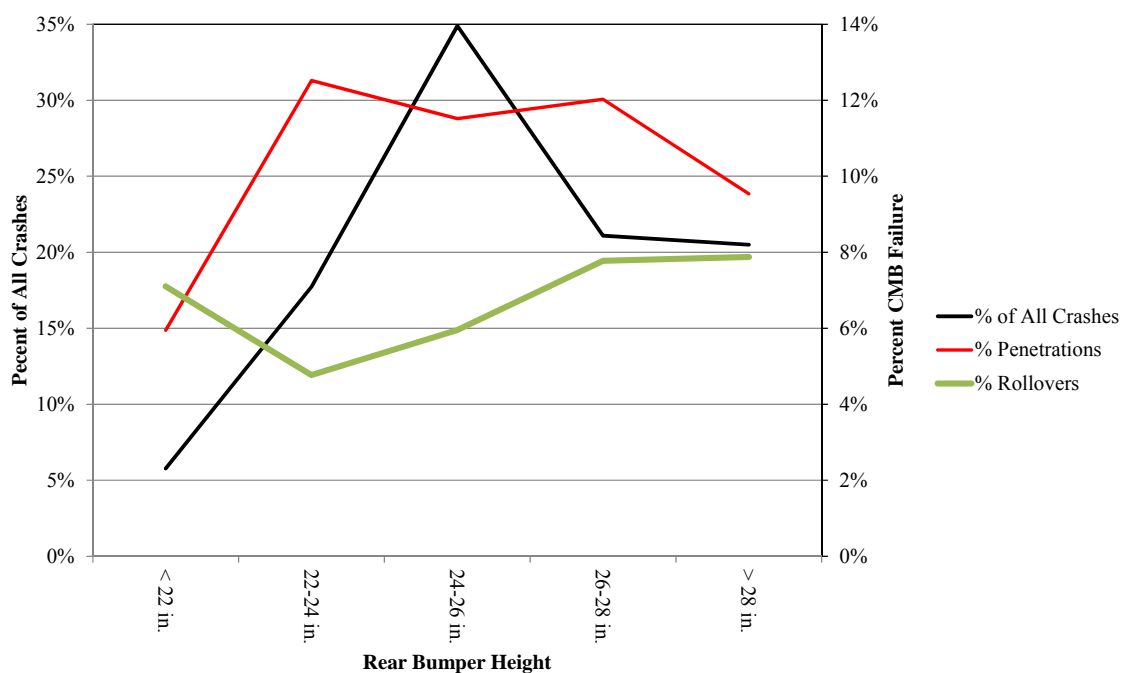
Figure 43. Crash Results by Rear Bumper Height

Rear bumper heights were compared to the composite and plotted, as shown in Figure 43. The penetration frequencies peaked between 24 and 28 in. (610 and 711 mm), and was reduced at both lower and higher rear bumper heights. Rollovers reached a minimum between 22 and 24 in. (559 and 610 mm) rear bumper height. Both distributions were statistically independent of the composite distribution.

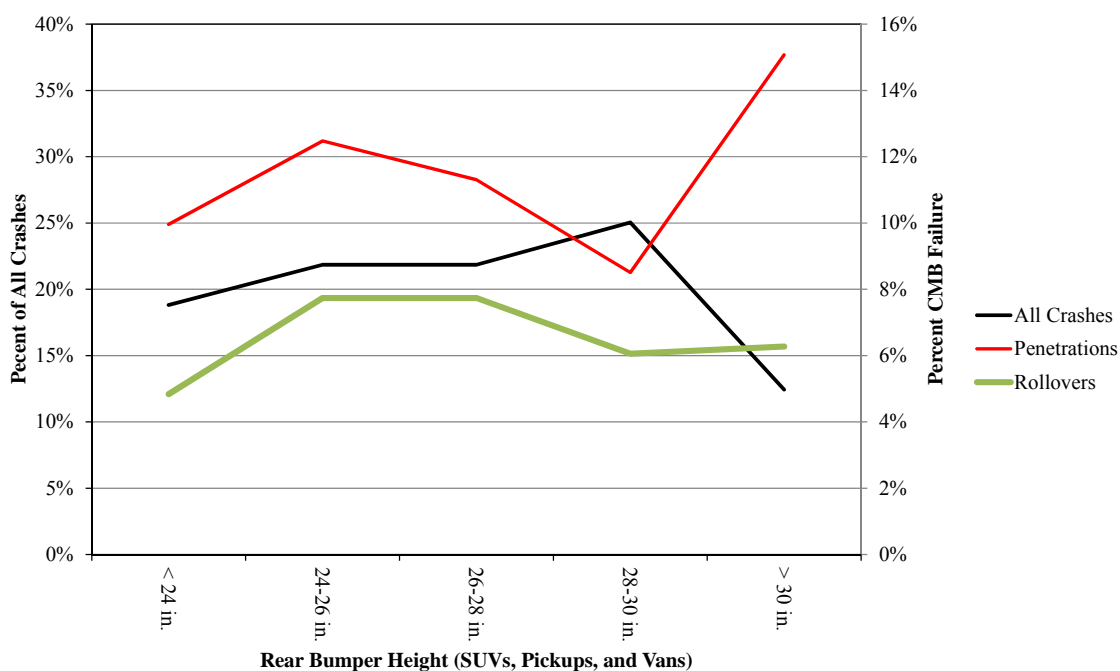
Rear bumper heights were plotted by crash result and vehicle class, and are shown in Figures 44 and 45. Although results were not statistically independent for either rollover or penetration crashes for either dataset, the penetration dataset for passenger cars approached statistical independence from the composite distribution. The penetration rates varied significantly between bumper heights of 25 and 27 in. (635 and 686 mm). However, penetration rates for rear-tracking impacts, which were not distinguished in this data analysis, were higher for both lower and higher bumper heights. Although evidence of this claim is currently limited to anecdotal observations, the author is currently involved in a research venture to further validate this statement.

Figure 45. Crash Result by Rear Bumper Height, SUVs, Vans, and Pickups

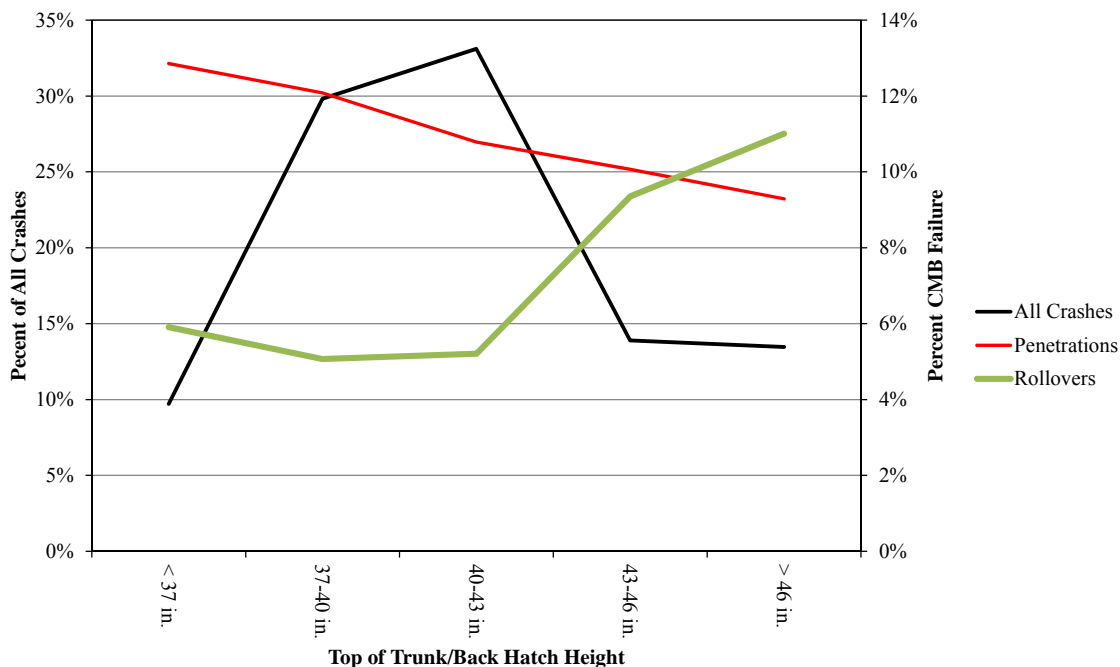
Top-of-trunk heights were related to both penetration and rollover rates. The top-of-trunk height plots for all vehicles are shown in Figure 46. Penetration rates generally declined with increasing rear trunk heights. This was intuitive: higher rear trunk heights were associated with greater vertical capture area and higher energetic requirements to underide the barrier. As the trunk or hatch height increased, underide penetrations were virtually eliminated, which decreased the overall penetration rate. However, a competing effect due to increased CG and bumper heights tended to increase the rate of override for higher trunk or hatch heights as well, though this effect was less pronounced.

In addition, rollover rates increased with increasing trunk or hatch height, but this was expected based on vehicle dimensions of the typical vehicles involved in rollover crashes. Trunk or hatch heights were determined to not be causatively linked to rollover frequency.

Figure 46. Crash Result by Top of Trunk/Rear Hatch Height

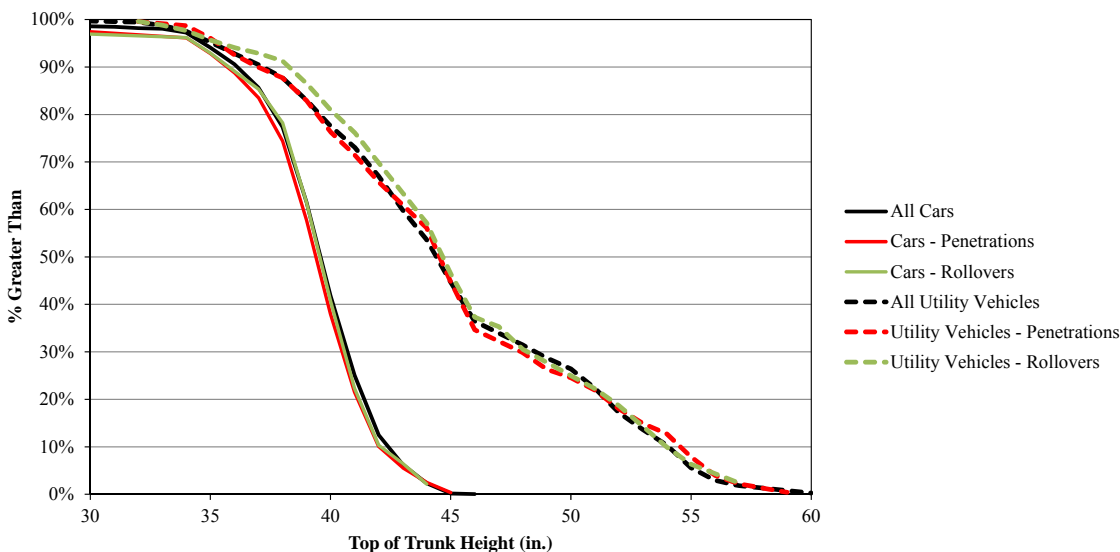
Figure 47. Smoothed Distribution of Top of Trunk/Rear Hatch Heights

A smoothed distribution of trunk and hatch heights based on crash results and vehicle groups is shown in Figure 47. The distributions were each virtually identical to the composite for each respective vehicle group.

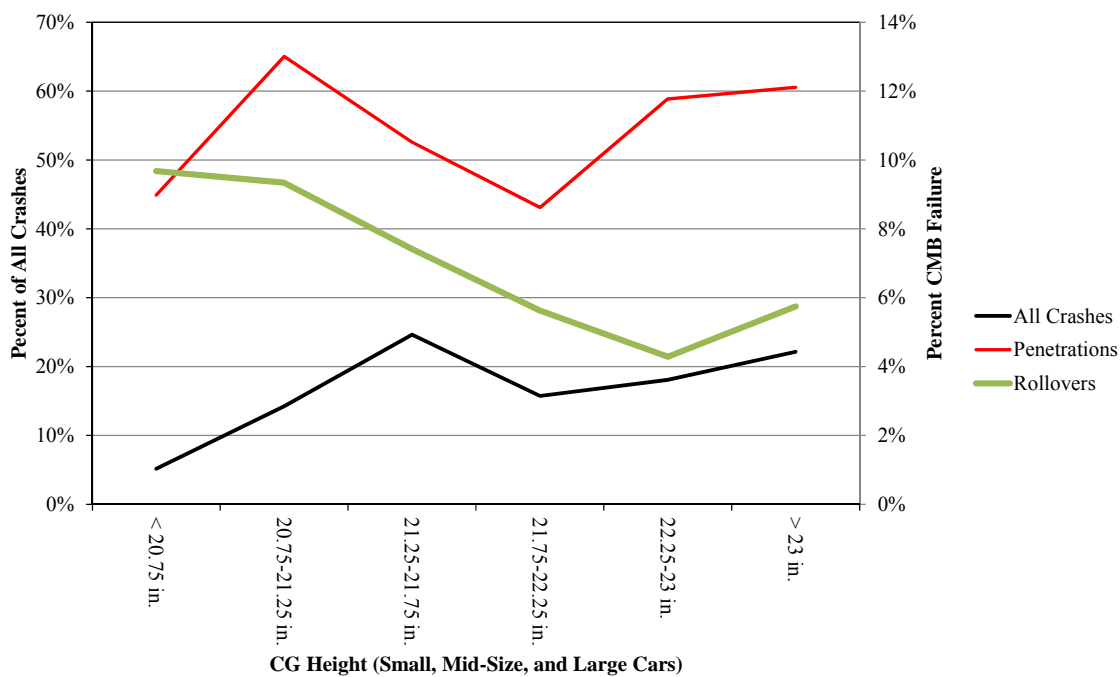
Figure 49. Crash Result by CG Height, Small, Mid-Size, and Large Cars

CG height distributions based on crash result and vehicle type indicated strong correlations between penetration and rollover rates based on vehicle CG. Plots of CG heights for passenger cars and SUVs, pickups, and vans are shown in Figures 49 and 50.

Passenger cars had a mixed rate of penetrations with CG height, with a maximum between 20.75 and 21.25 in. (527 and 540 mm). The minimum occurred between 21.75 and 22.25 in. (552 and 565 mm). Rollover rates demonstrated a much more linear relationship, generally declining with increasing CG height through 23 in. (584 mm). Results of all these factors were on the bounds of statistical significance, but the small differences between the passenger car CG height distribution would be erased if a vehicle entered a sloped median and struck the cable median barrier at any height other than nominal level. Thus, although CG height had an effect, particularly on stability, overall CG height did not have a causative relationship in cable median barrier containment performance within the indicated vehicle groupings.

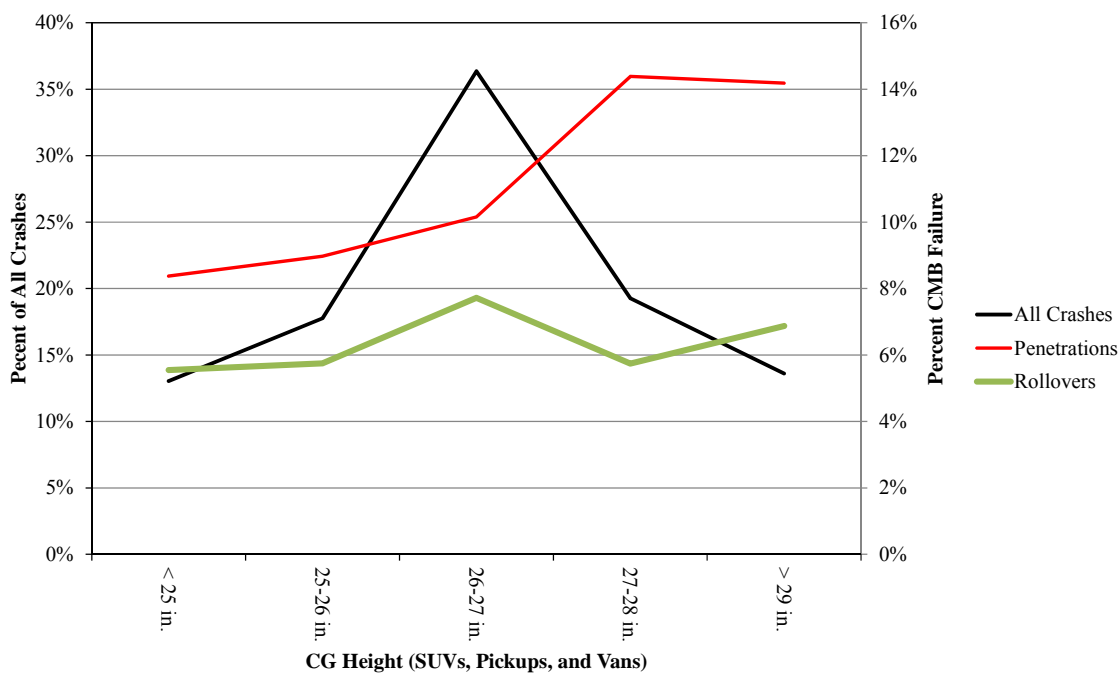
Figure 50. Crash Result by CG Height, SUVs, Pickups, and Vans

CG heights were not strongly correlated with rollover rates for SUVs, pickups, and vans. This result suggested that these types of vehicles were susceptible to rollover independent of the CG heights. However, penetration rates were strongly correlated with CG heights, as penetration rates increased with increasing CG height.

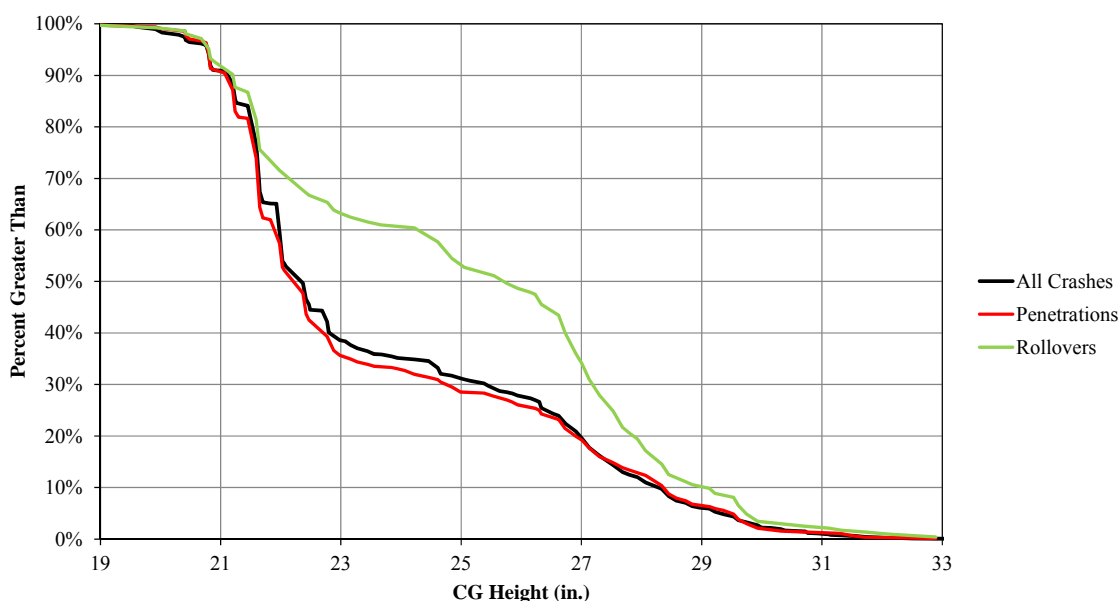
Figure 51. Smoothed Distribution of CG Heights in Cable Barrier Crashes

The smoothed distribution of CG heights in cable barrier crashes is shown in Figure 51. Over 60% of all crashes occurred with CG heights less than 23 in. (584 mm), but approximately 9% of crashes and penetrations occurred with CG heights between 23 and 26 in. (584 and 660 mm). The 85th percentile CG heights for the composite, penetration, and rollover data sets were 21.6, 20.7, and 25.8 in. (548, 525, and 654 mm), respectively.

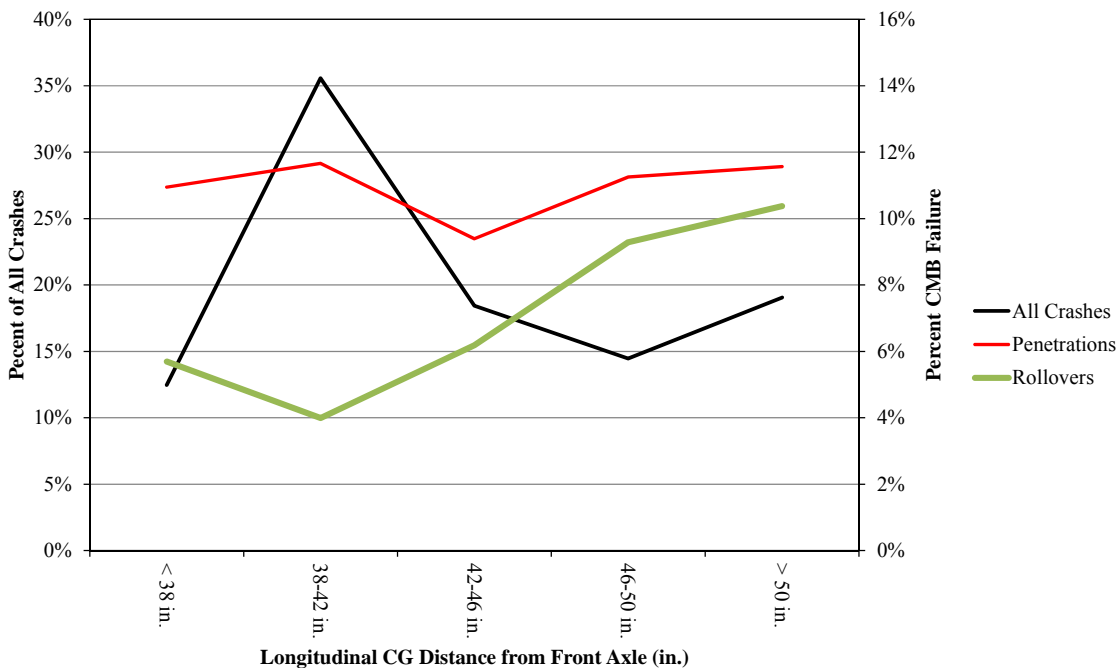
Figure 52. Longitudinal CG Distance from Front Axle by Crash Result

A comparison of the longitudinal CG location relative to the front axle was plotted and is shown in Figure 52. Penetration rates were relatively independent of the longitudinal distance between the CG and the front axle, but rollover rates tended to increase as the CG distance from the front axle increased. Historical tests with cable median barriers has indicated a higher proportion of large yaw displacements using rear engine mount cars with CGs located far from the front axle [31, 32]. The yaw displacement following redirection may contribute to vehicle instability.

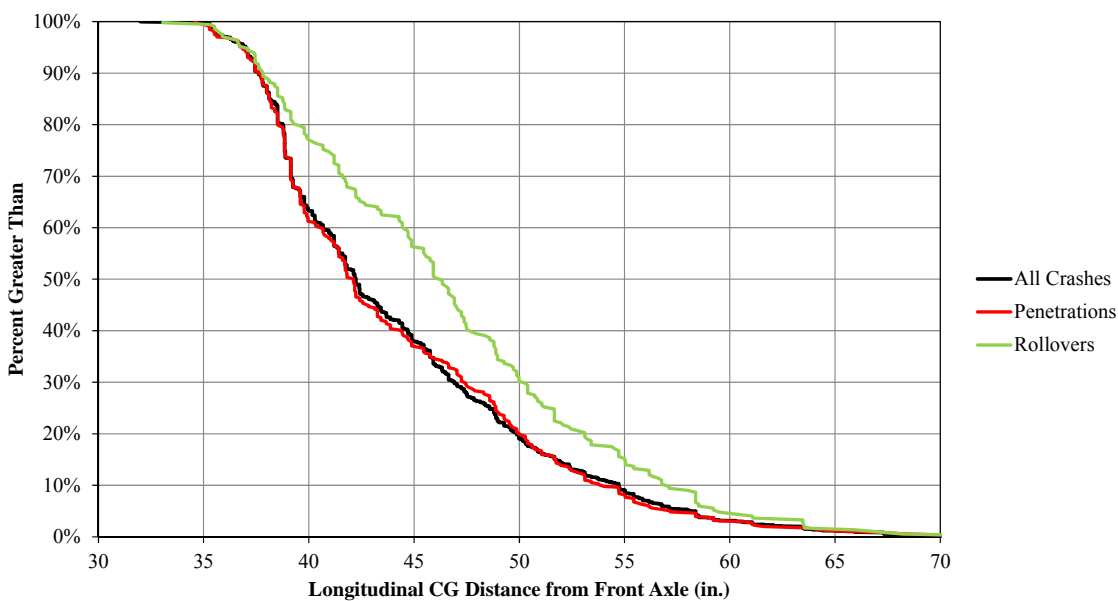
Figure 53. Distribution of Longitudinal CG Location Relative to Front Axle

The distribution of longitudinal CG locations is shown in Figure 53. The distribution of longitudinal CG location suggested that both penetration and rollover crashes tended to occur more frequently with vehicles with CGs located further from the front axle, but closely mimicked the distribution of all crashes for longitudinal distances less than 40 in. (1,016 mm). The 85th percentile longitudinal CG locations for the

composite, penetration, and rollover databases were 51.7 in., 52.5 in., and 54.5 in. (1,313 mm, 1,333 mm, and 1,384 mm), respectively.

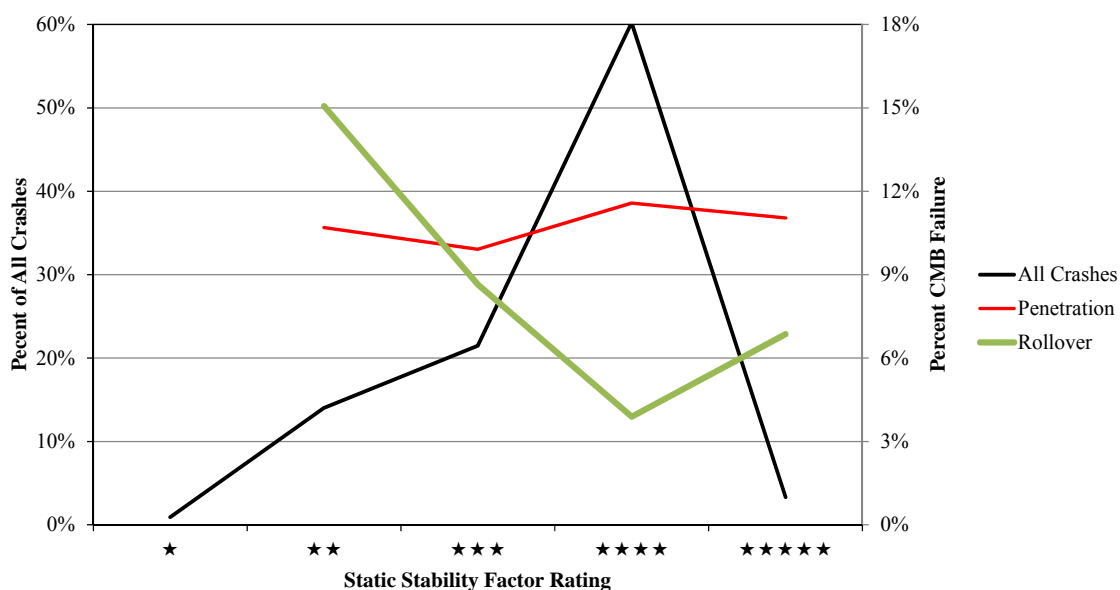
Figure 54. Crash Result Based on Track Width and CG Height (SSF)

was used to segregate crash outcomes. Results are plotted in Figure 54. The SSF is a statistical measure of the likelihood of rollover, based on the slope angle that would cause a static vehicle to tip over. SSF star ratings and the probability function ranges of estimated rollover rates is shown in Table 25.

Although end effects were present at the 1- and 5-star ratings since less than 100 crashes involved either 1-star or 5-star rated vehicles, generally rollovers decreased with higher SSF ranking. These results are not surprising, but reinforce what is known about rollover stability with relation to CG position and track width.

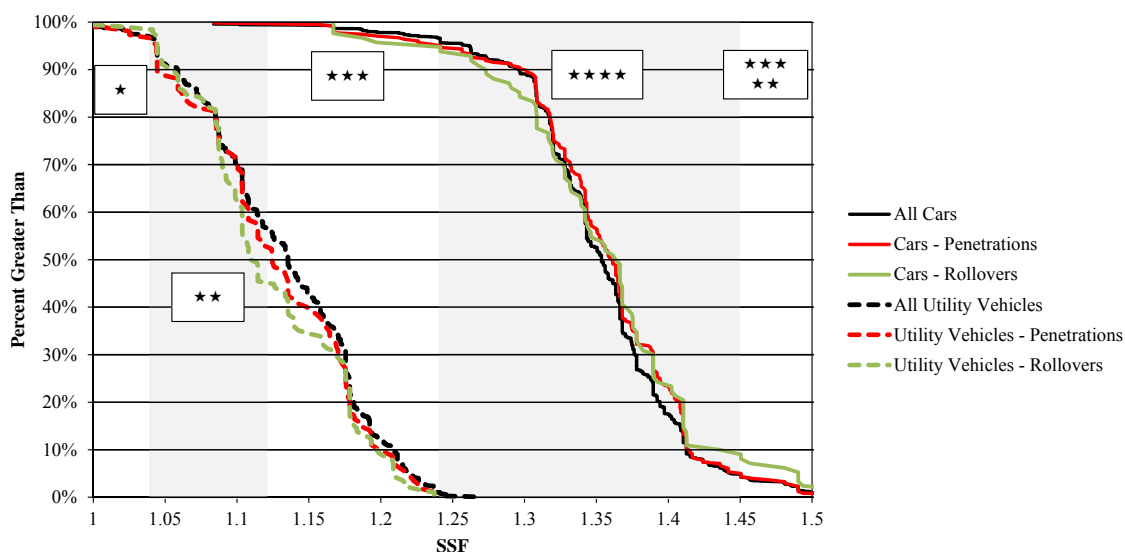
Figure 55. Distribution of Crash Result by SSF and Vehicle Type

Whereas a very strong relationship between rollover and SSF was observed with respect to all vehicles, when the data was segregated into subsets by vehicle types, differences largely vanished. Distributions were statistically independent at the 5% confidence level but functionally distributions were not unique. Penetrations and rollovers were both more common with lower SSF values for SUVs, pickups, and vans, but were more common at higher SSF values for much of the passenger car distribution.

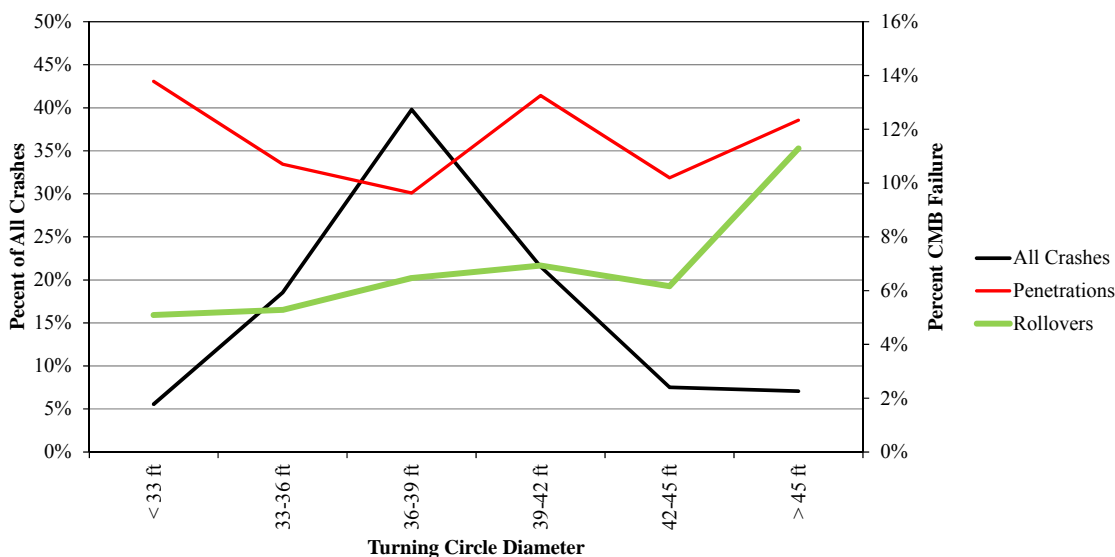
Figure 56. Crash Result by Turning Circle Diameter

Crash results by minimum turning circle diameters were also plotted and evaluated. The plot is shown in Figure 47. The minimum turning circle is a measure of the maximum steering angle and reaction of the wheels and suspension to driver steering input. As a result, it was expected that smaller turning circles, corresponding to higher cornering rates and larger maximum steering angles, would be associated with more rollovers and penetrations due to a more rapid increase in CG trajectory angle.

In general, larger turning circles corresponded to higher rates of rollover. This did not match intuitive expectations. However, vehicle manufacturers have historically utilized larger track widths, active suspensions, and lower maximum steering angles to reduce rollover risk and improve stability. Vehicles which were more unstable were thus designed with larger maximum turning circle diameters. This effect may have contributed to the weak but increasing trend.

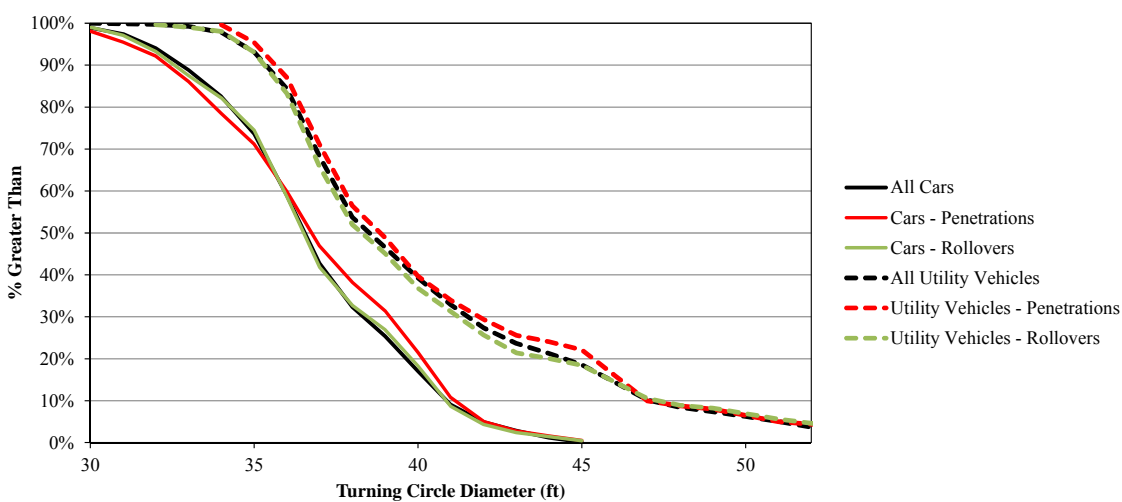
Figure 57. Smoothed Distribution of Turning Circle Diameter by Crash Result and Vehicle Type

Penetration and rollover rates were not clearly related to turning circle diameter, as shown in Figure 57. A large portion of car penetrations occurred with turning circle diameters between 38 and 45 in. (96 and 1,143 mm). This class of passenger car corresponded to sports-type cars, such as the Chevrolet Camaro, Dodge Charger, Pontiac Firebird/Trans Am, and Dodge Viper, in addition to imported sports cars.

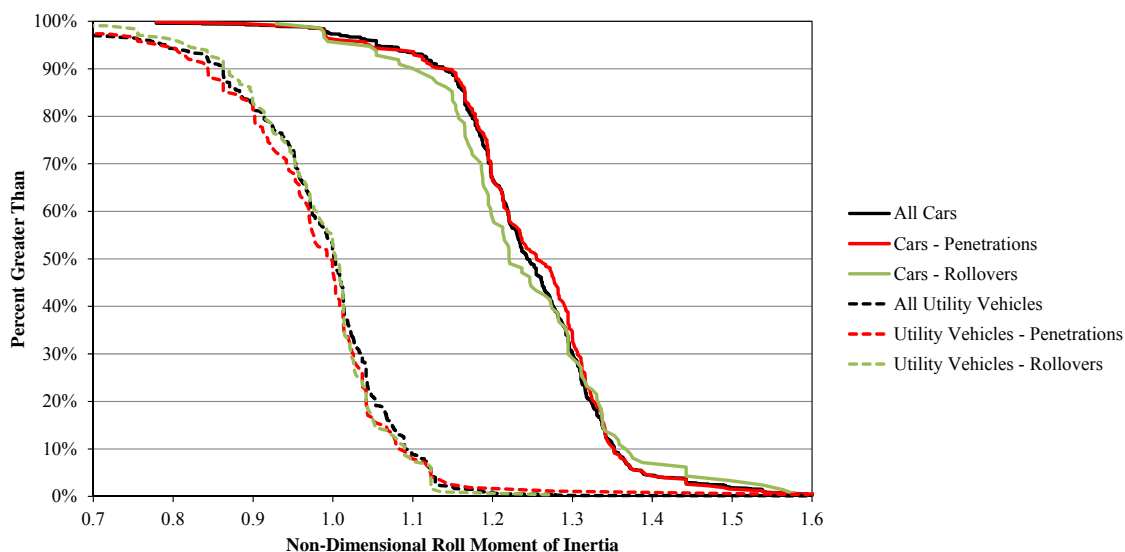
Figure 59. Distribution of Non-Dimensionalized Roll Moments of Inertia by Crash Result and Vehicle Type

Roll moments of inertia were non-dimensionalized by dividing by the mass and CG height. Results are plotted in . By non-dimensionalizing the rollover distribution of SUVs, pickups, and vans, the rollover distribution was altered from bordering statistical

independence to boardering statistical similarity, with a p-value of 0.83. None of the other distributions had statistically significant differences to the composite.
