CABLE MEDIAN BARRIER
FAILURE ANALYSIS AND REMEDIATION

by
Cody S. Stolle

A DISSERTATION

Major: Civil Engineering
Structural Engineering

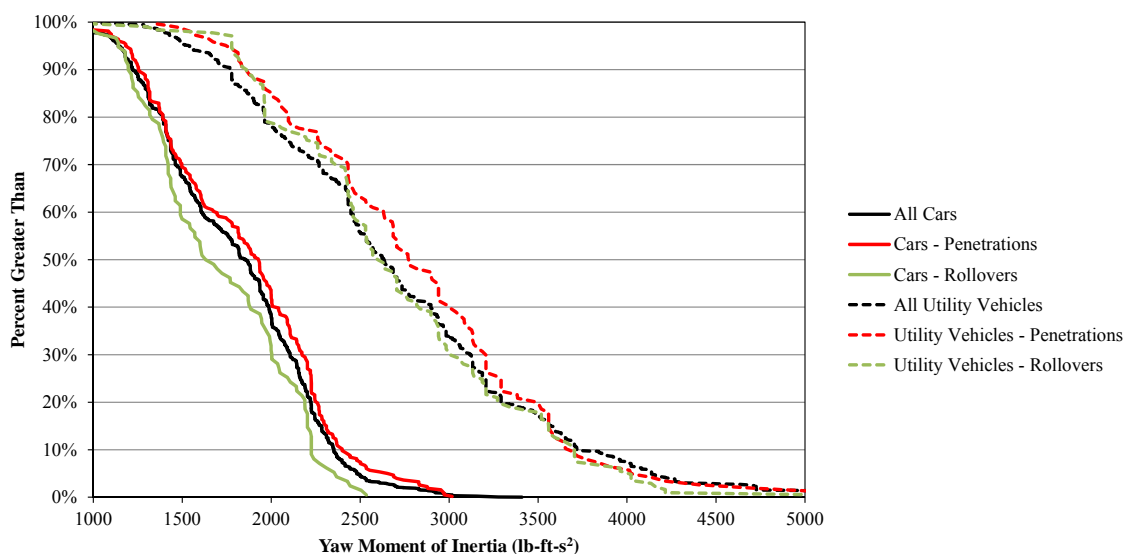
Figure 60. Distribution of Yaw Moments of Inertia by Crash Result and Vehicle Type

Likewise, the distribution of the yaw moments of inertia of vehicles involved in cable barrier crashes is shown in Figure 60. As with roll moments of inertia, higher yaw moments of inertia were associated with higher rates of penetration. Higher yaw moments of inertia were correlated with higher rollover frequency for SUVs, pickups, and vans through 2,500 lb-ft-s² (1,033 kg-m²), but converged to the composite distribution at higher yaw moments of inertia, similarly to the roll moments-of-inertia distribution. Additionally, lower yaw moments of inertia were associated with higher rollover rates for passenger cars.

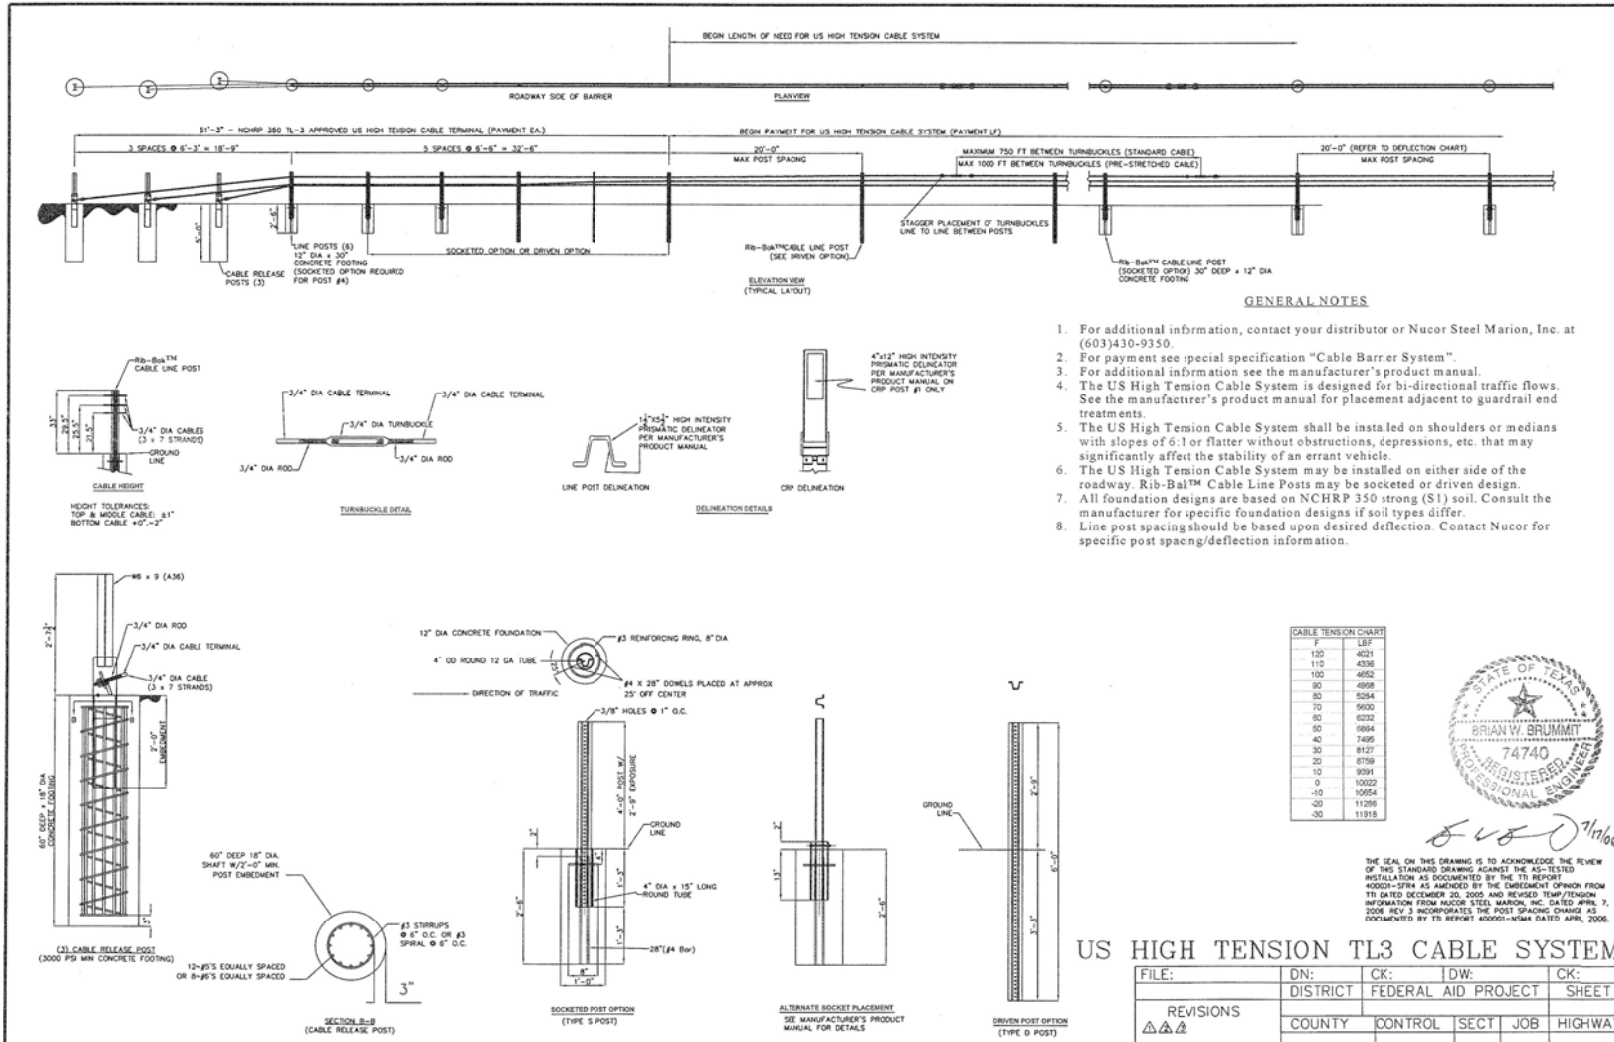
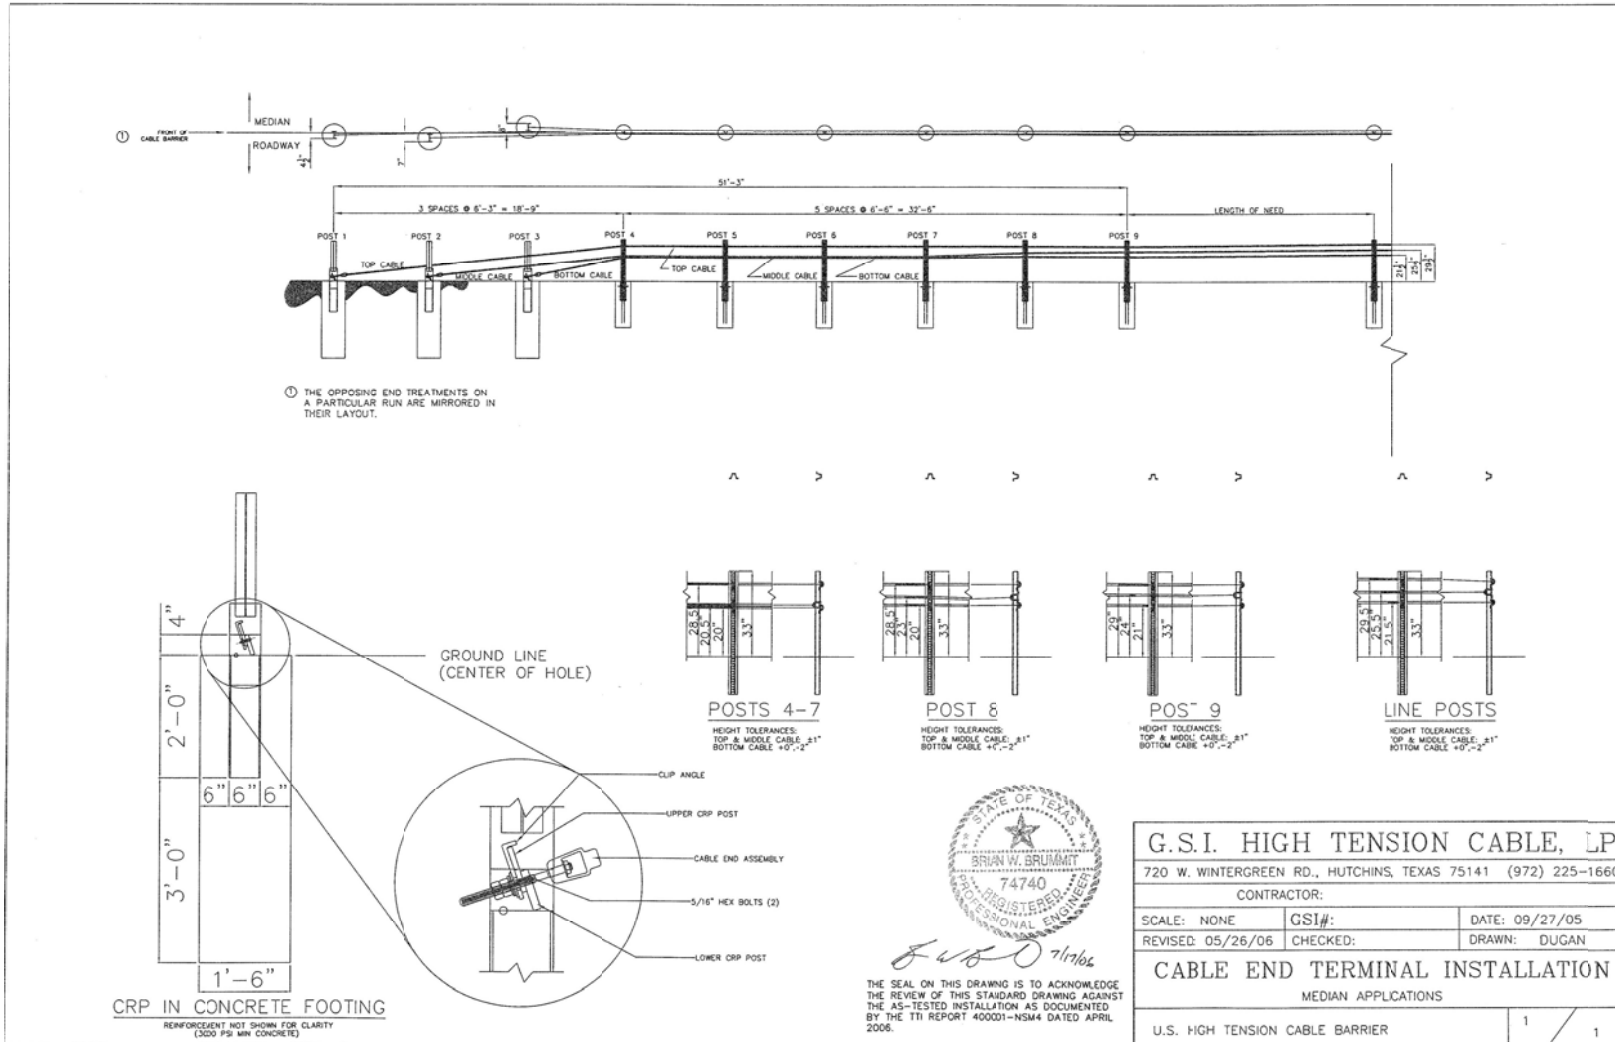
Figure 61. Nucor Cable Barrier Design Details [35]

The cable-to-post attachment used by Nucor was very strong compared to all other barrier systems, and is shown in Figures 61 through 64. This cable-to-post attachment is also used in the Trinity CASS barrier near end anchorages and terminations.

The clips were fastened to the post by inserting the bent upper leg into the appropriate hole on the flanged U-channel, and then were locked in place with a nut threaded onto the bottom clip threads. Holes in the flanges were spaced approximately 1 in. (25 mm) on center vertically through the centerline of the flange. Many posts were 4 lb/ft (6 kg/m) flanged U-channel with Rib-Bak construction, though some installations utilized the 5 lb/ft (7 kg/m) posts. The median barrier configuration for this post utilized two short clips, shown in Figure 64, for the top and bottom cables, and one long clip, shown in Figure 63, to support the middle cable.

Since the attachment had a 60 ksi (414 MPa) minimum ultimate strength requirement, the resulting minimum tensile load required to cause rupture of the shank was 4.6 kip (20.5 kN) through a single leg. The clip appeared to be designed to dissipate energy through the bending deformation of the upper leg of the clip. During vertical pullout loading conditions, the curved clip construction contributed to friction wedge locking of the bent leg in the top hole. Due to vertical forces, the couple applied to the clip tended to aggravate the locking tendency. A schematic of the vertical release problems identified is shown in Figure 65. The friction lock prevented the upper leg from bending and releasing from the post, frequently resulting in large applied tensile loads carried by both legs of the clip until the clip fractured, the post was pulled vertically out of the ground or post socket, or the post fractured. The vertical loading resulted in post pullout in most crashes.

Although the clip would perform adequately in horizontal pullout with stiff posts, the flange-channel U-post does not have the rigidity necessary to resist bending and buckling or fracture. During horizontal pullout loading, the post deflected with the cable load, and the horizontal load applied transitioned to a mixed horizontal and vertical loading. As the loading transitioned to vertical pullout, the posts were again pulled upward and out of the ground or fractured in many crashes. Relatively few crashes were observed in which the cable-to-post attachments released as intended.

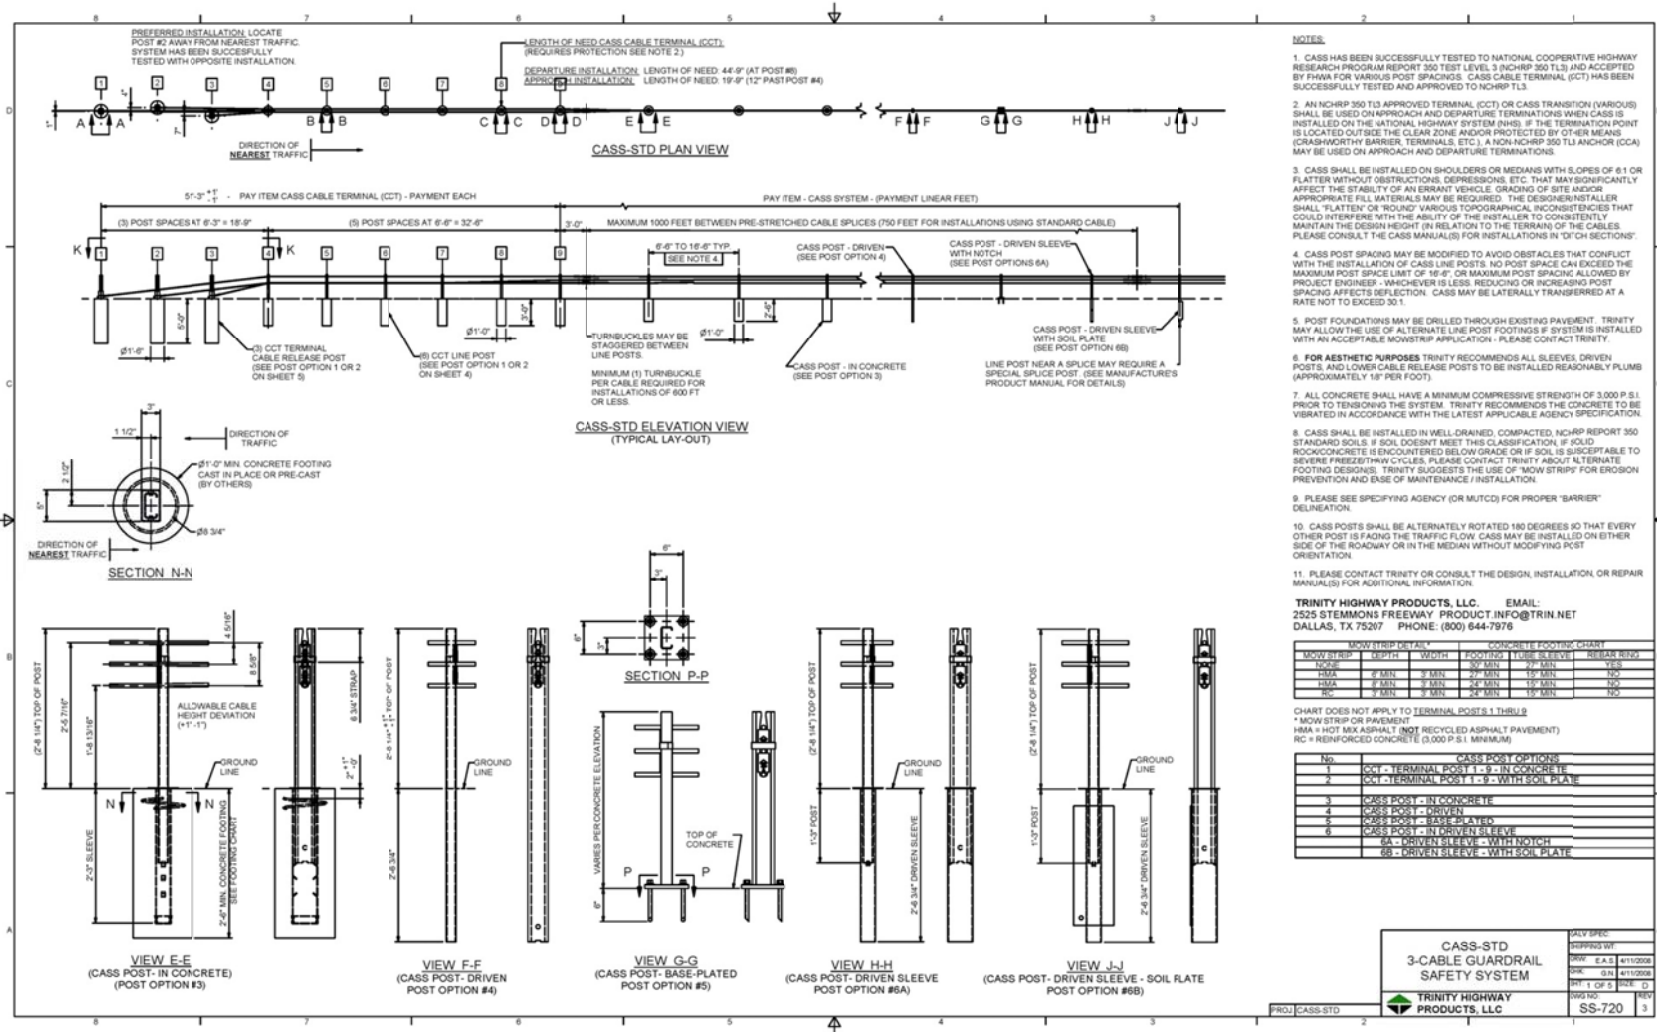
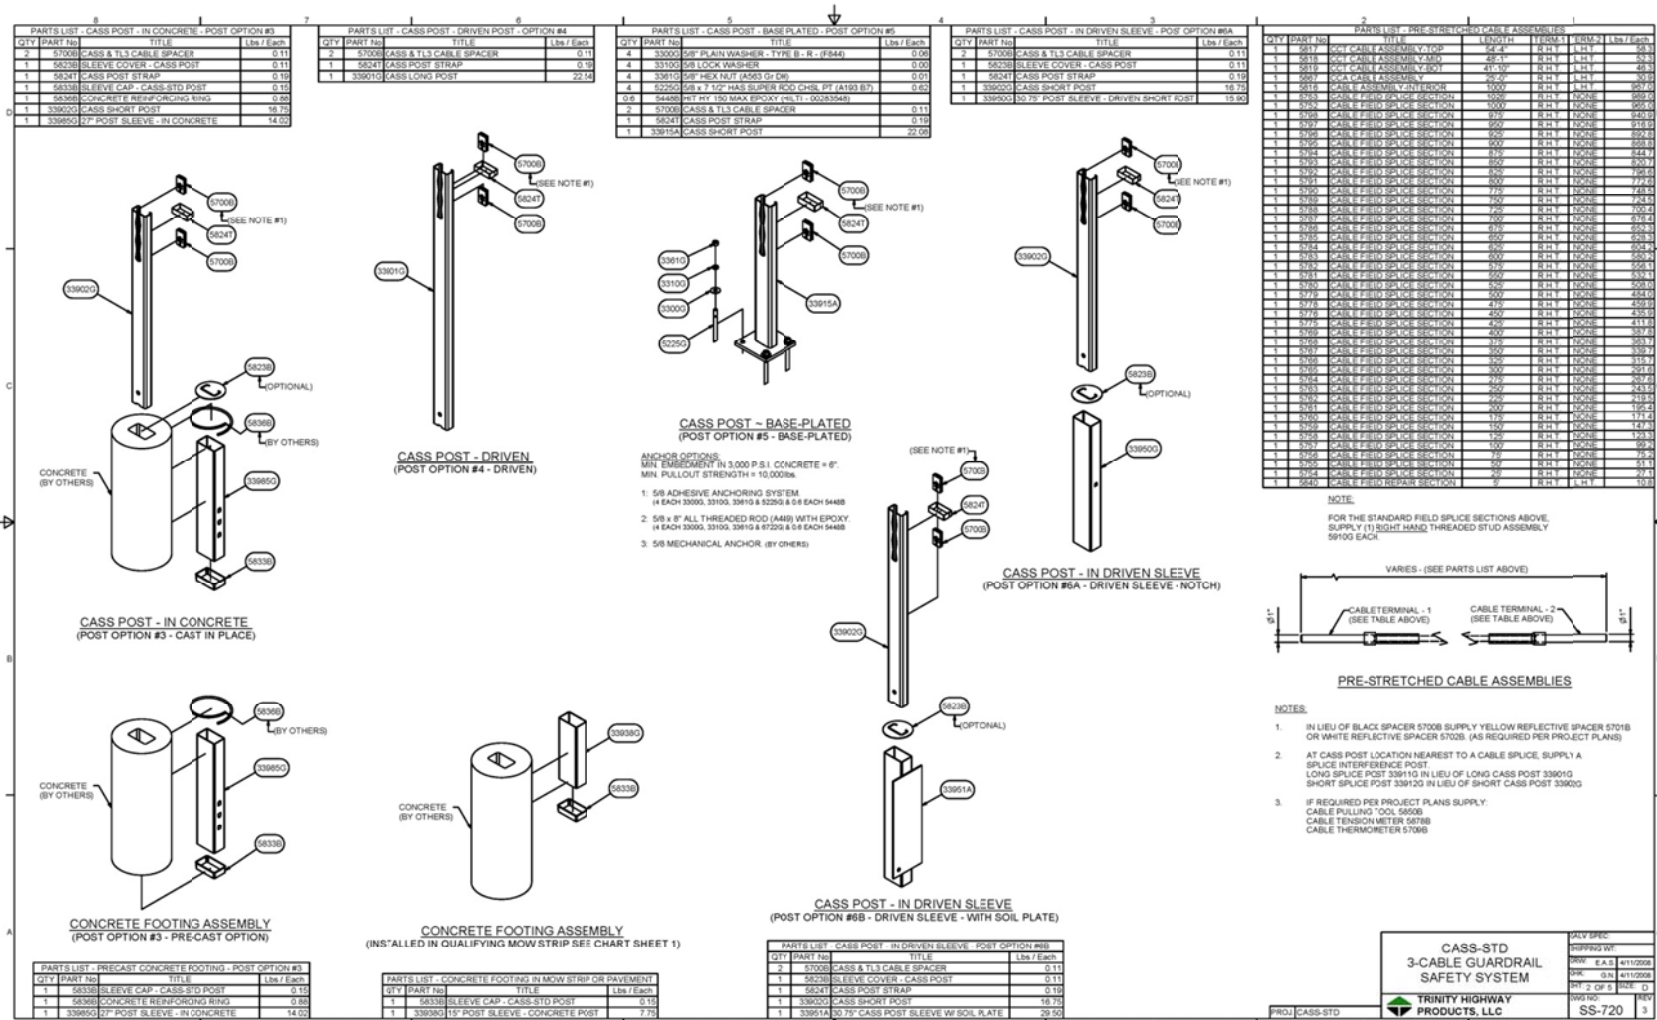
Figure 66. Trinity CASS C-Shape Post System Details [37]

Like the Nucor TL-3 3-cable barrier on flange-channel posts, the Trinity CASS 3-cable barrier installed on C-shaped posts had a large installed base in the United States. CASS installations were present in such states as Iowa, Ohio, Oklahoma, Utah, and Washington, as well as many others. Details of the C-channel and S-post versions of the TL-3 CASS system are shown in Figures 66 through 69.

The direction of the channel in the C-shaped posts was alternated, per construction design. As a result, the radius of gyration to the weak axis was different when the posts were struck on the channel or continuous sides. Alternatively, the S-shape posts were comprised of S4x7.7 (S102x11.5) shape sections, with two $1^{11}/_{16}$ -in. (17-mm) holes in each flange. Researchers estimated that weakening holes decreased the strong-axis section modulus from 3.03 in.³ to 2.54 in.³ (49,652 mm³ to 41,623 mm³), and

All of the cables in the Trinity CASS systems were located in a slot in the top of the post. Cable spacers and retainers were used to prevent the cables from slipping out of the posts in nuisance impacts. A sleeve tie was also used to retain the lower cable with a higher vertical release load and to stiffen the flanges where the web was cut. Driven and socketed options were available. The S-post TL-3 system had cables mounted at 29½, 25³/₁₆, and 20⁷/₈ in. (749, 640, and 530 mm) and are shown in Figure 68. Cables in the TL-3 C-shape post system were 1/16 in. (2 mm) lower than in the S-post system. The TL-4 system had cables mounted at 38¹/₈, 29½, and 20⁷/₈ in. (968, 749, and 530 mm).

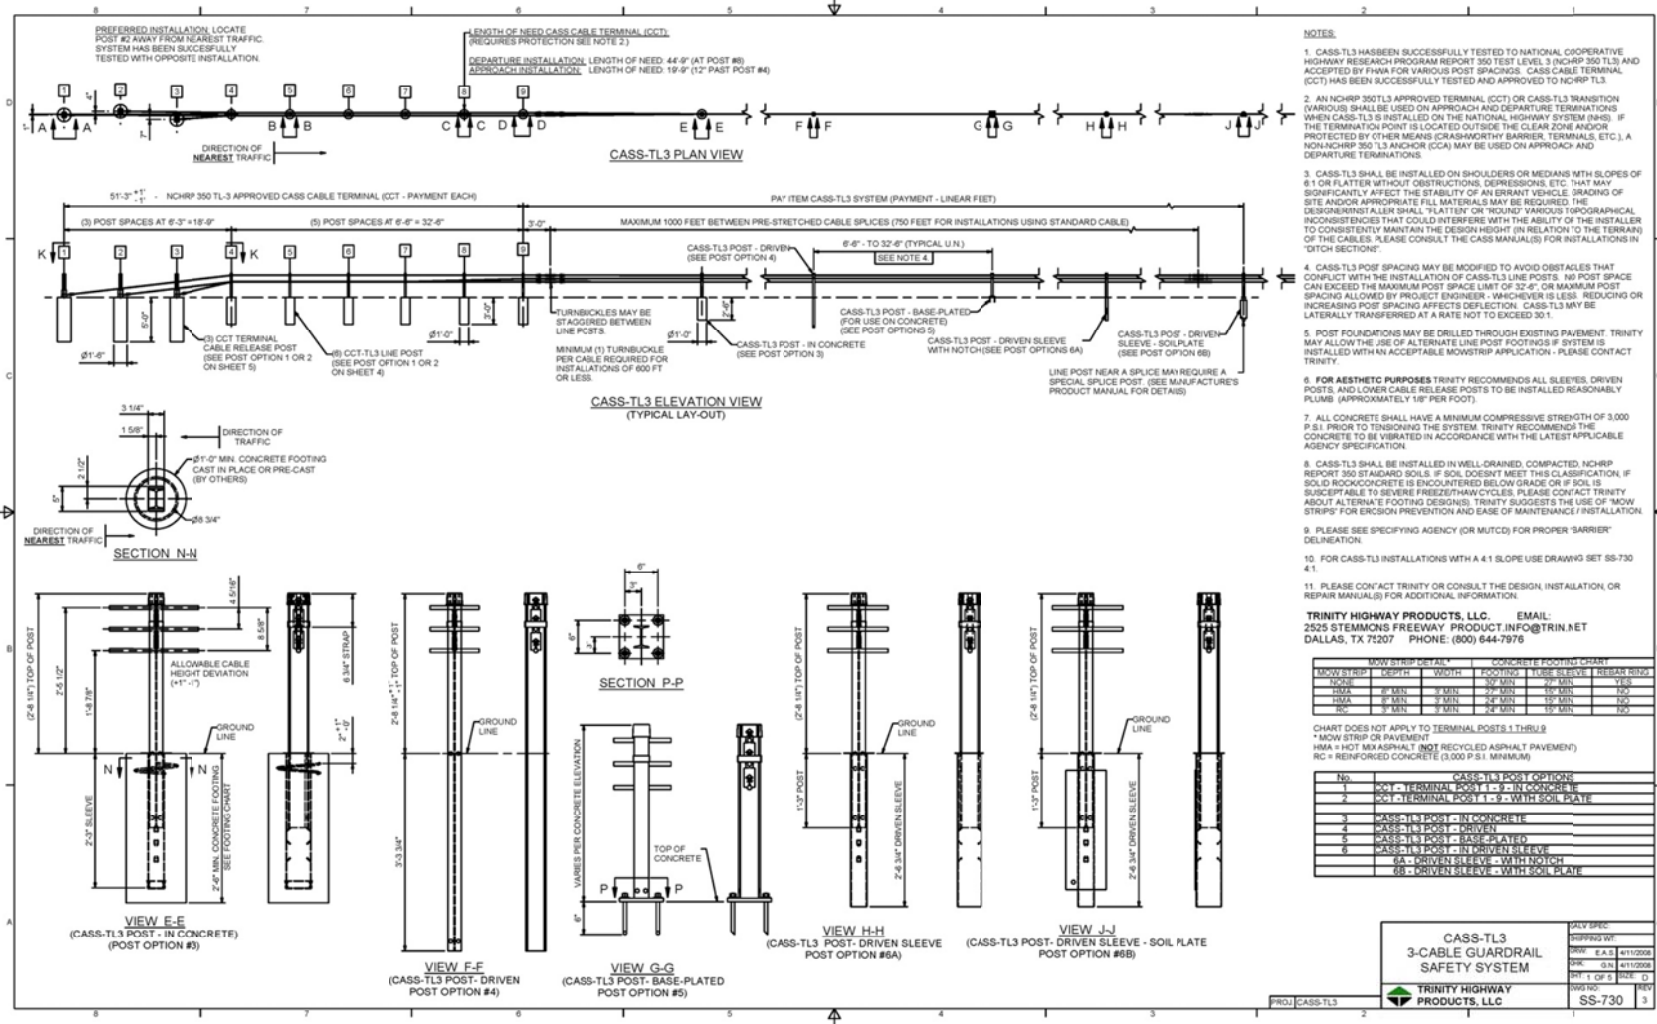
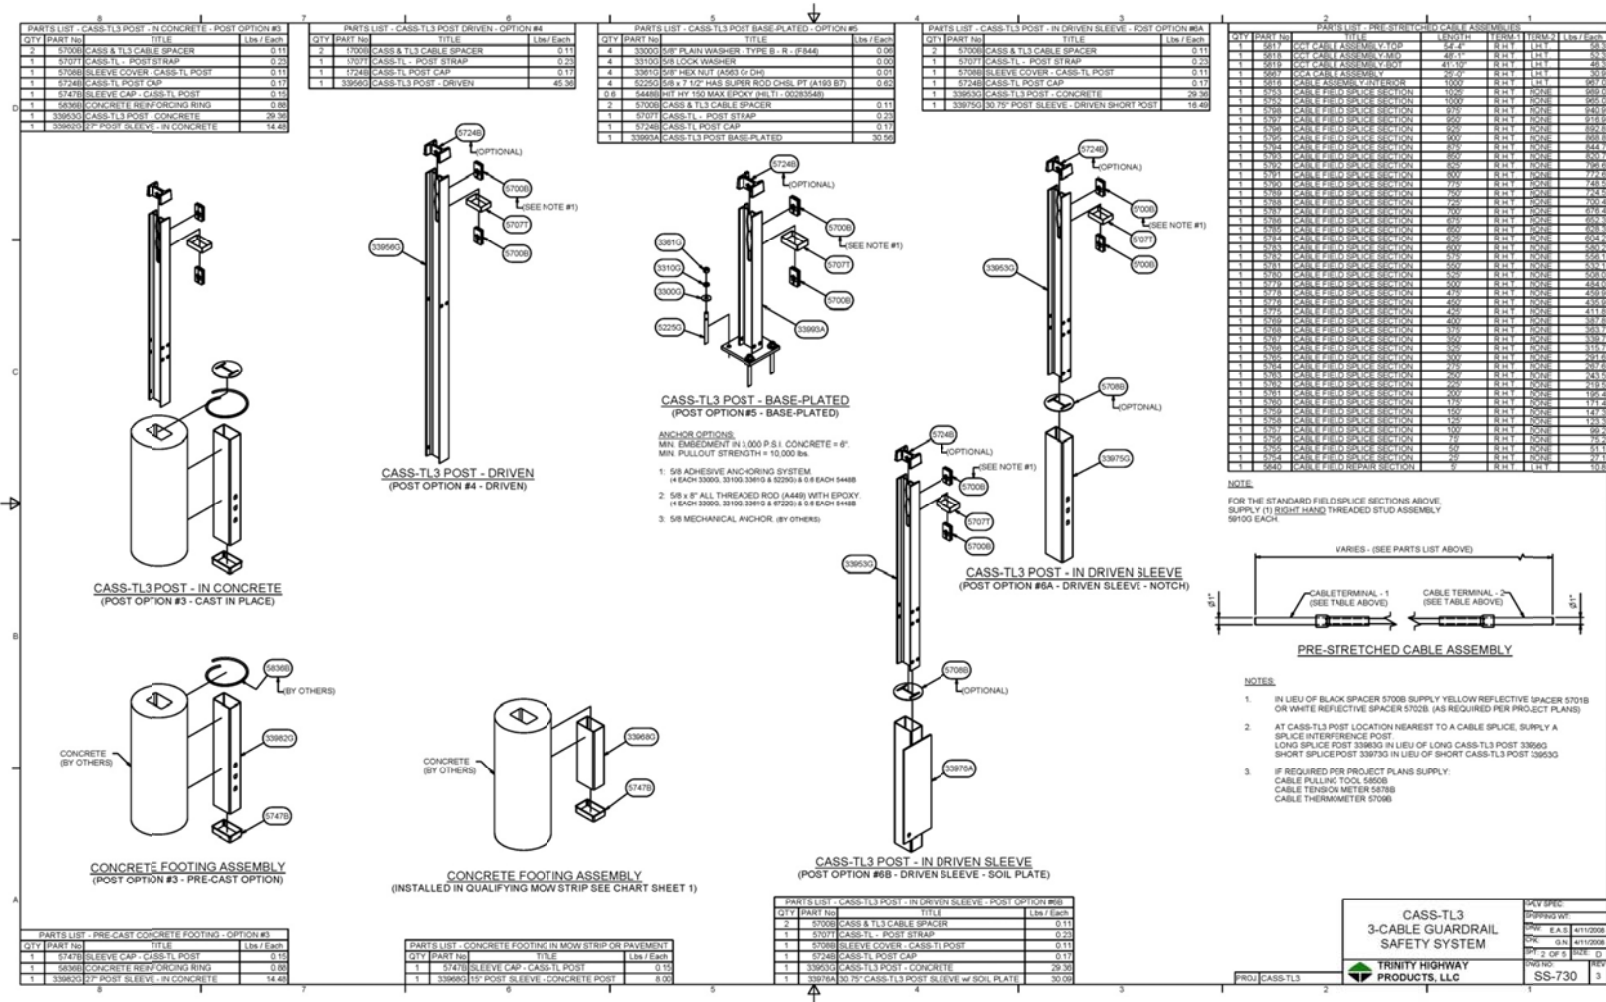
Figure 68. Trinity CASS TL-3 S-Post System Details [38]

decreased the weak-axis section modulus from 0.562 in.³ to 0.368 in.³ (9,210 mm³ to 6,030 mm³). By comparison, a standard S3x5.7 post has a strong-axis bending modulus of 1.67 in.³ (27,366 mm³), and a weak-axis bending modulus of 0.383 in.³ (6,276 mm³).

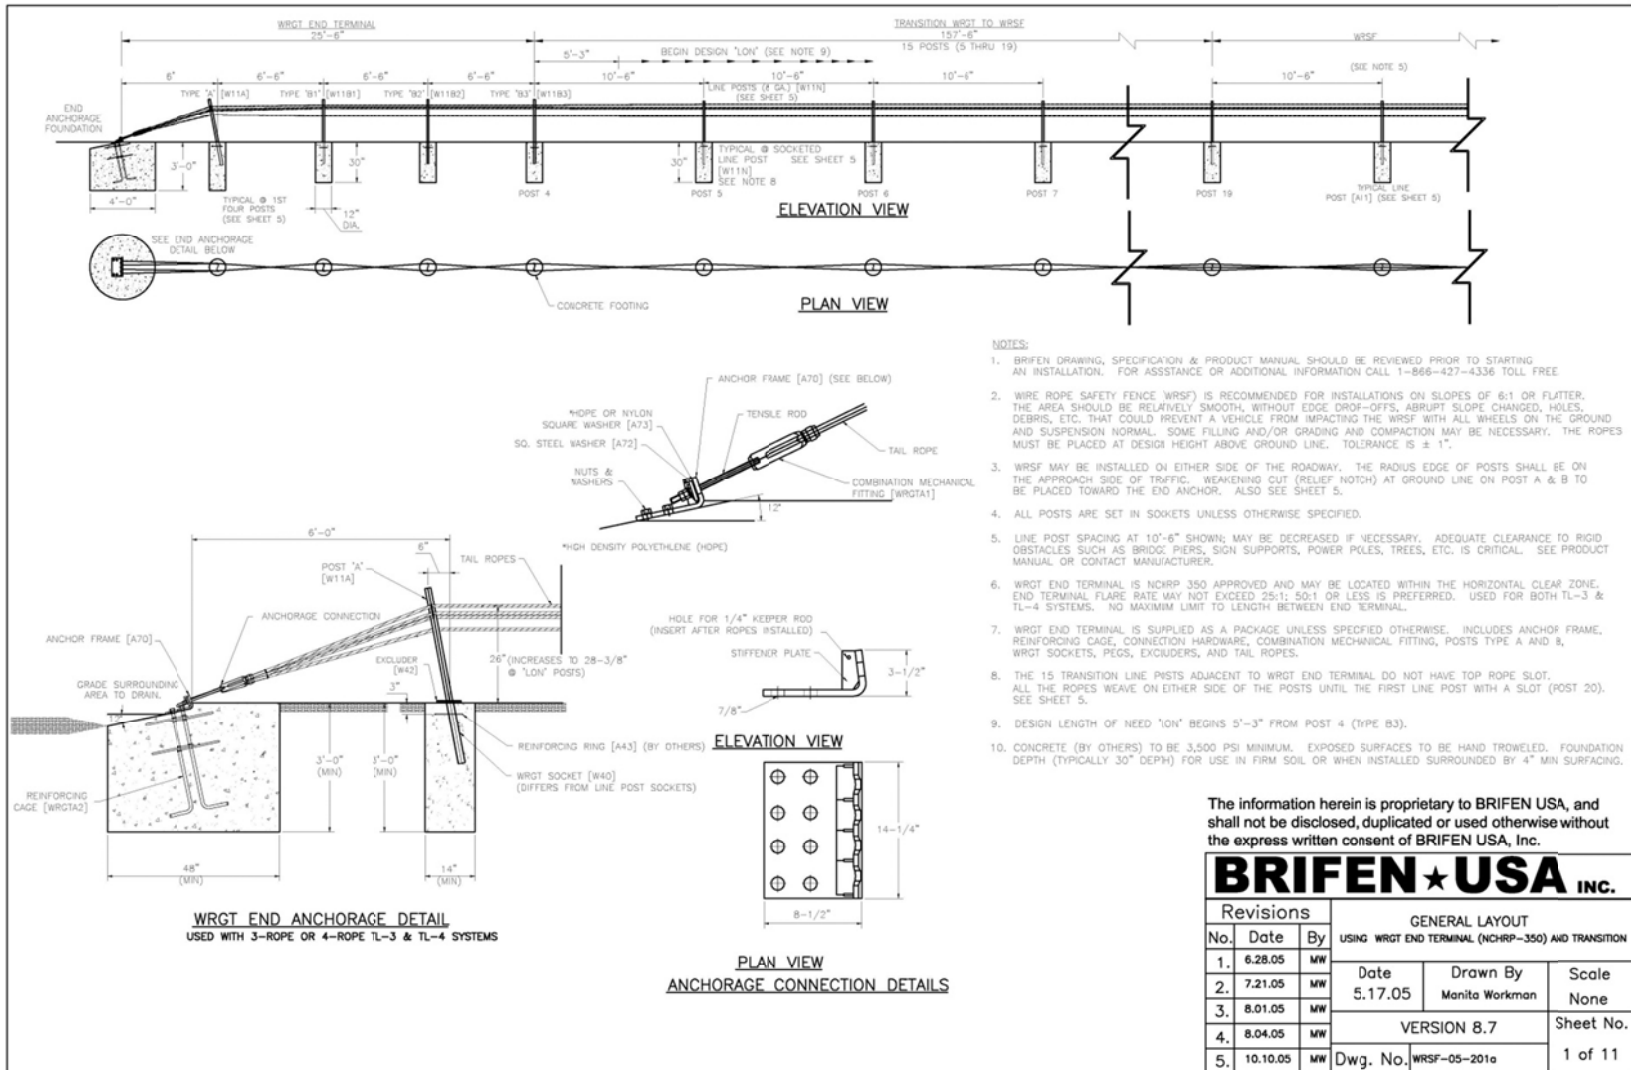
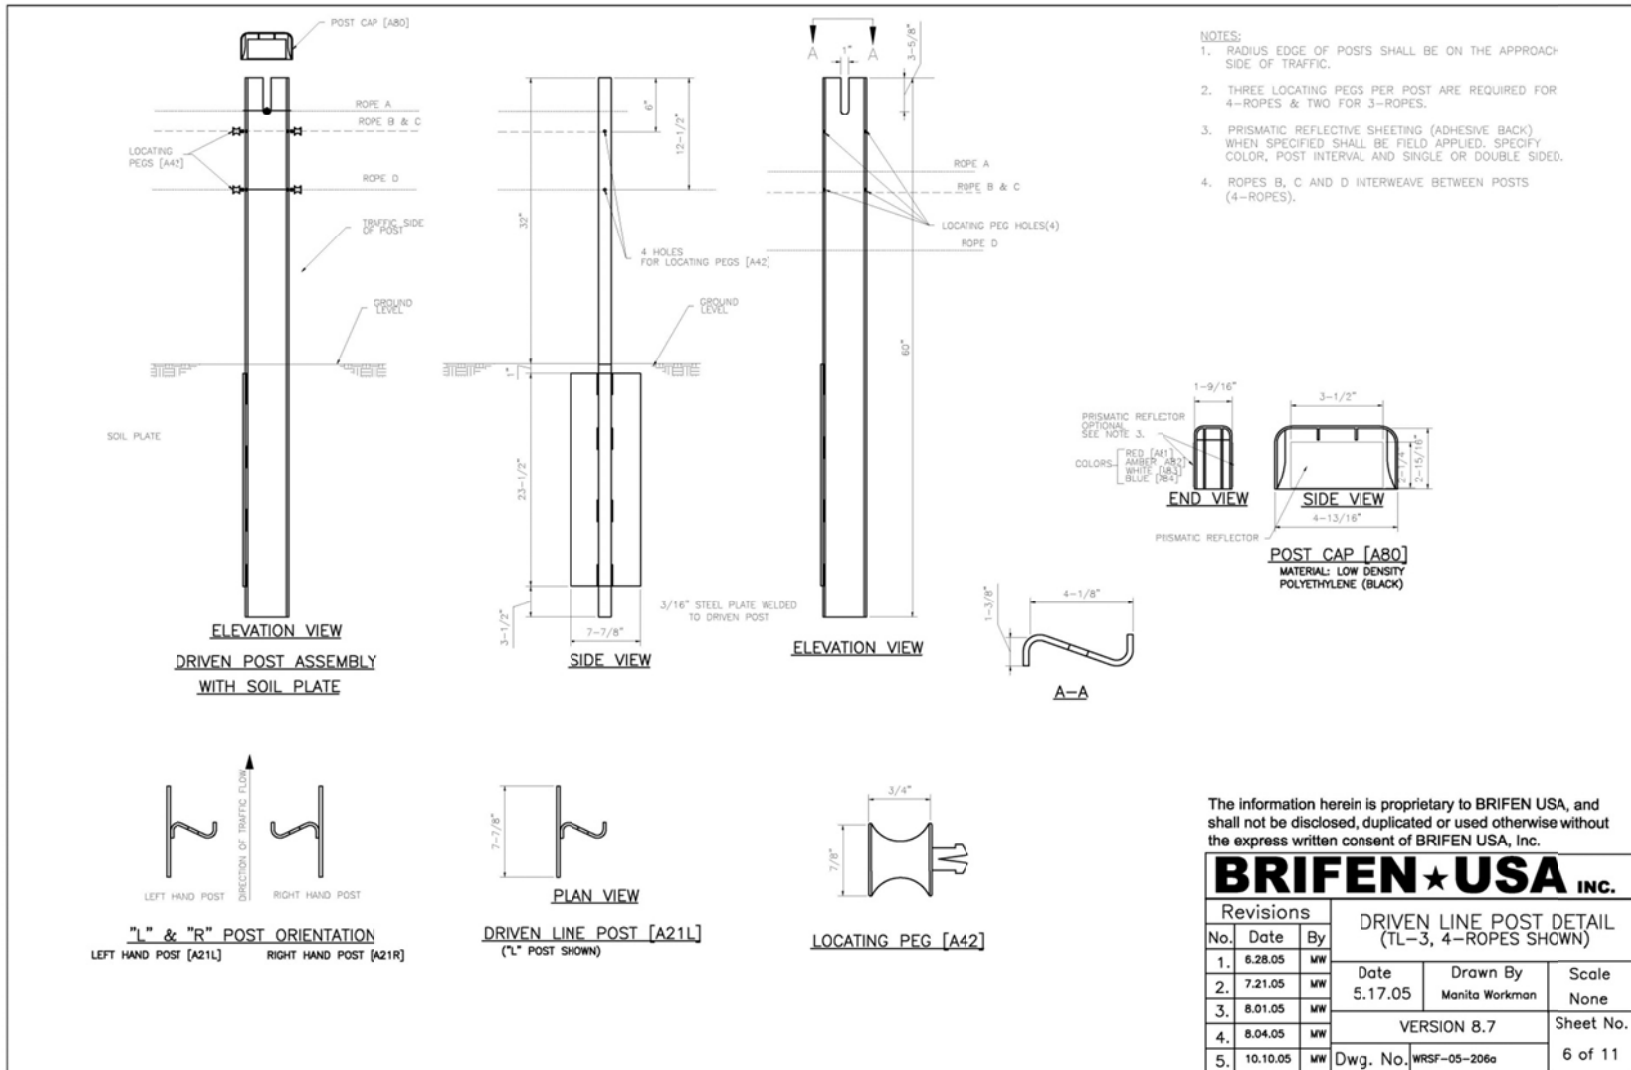
Figure 70. Typical TL-3 Brifen WRSF Design Details [39]

The TL-3 Brifen WRSF is typically comprises proprietary Z-posts with rollers supporting the cables vertically, as shown in Figures 70 through 72. Virtually all Brifen systems utilize

ground sockets for easy post replacement, though a post with soil plate option was also available. Four cables are used in the system, with one cable woven around the posts and mounted at 19 ½ in. (495 mm), two cables cross-woven and mounted at 26 in. (660 mm), and an additional cable in a slot cut in the top of the post, mounted at 28 ¾ in. (720 mm).
