CABLE MEDIAN BARRIER
FAILURE ANALYSIS AND REMEDIATION

by
Cody S. Stolle

A DISSERTATION

Major: Civil Engineering
Structural Engineering

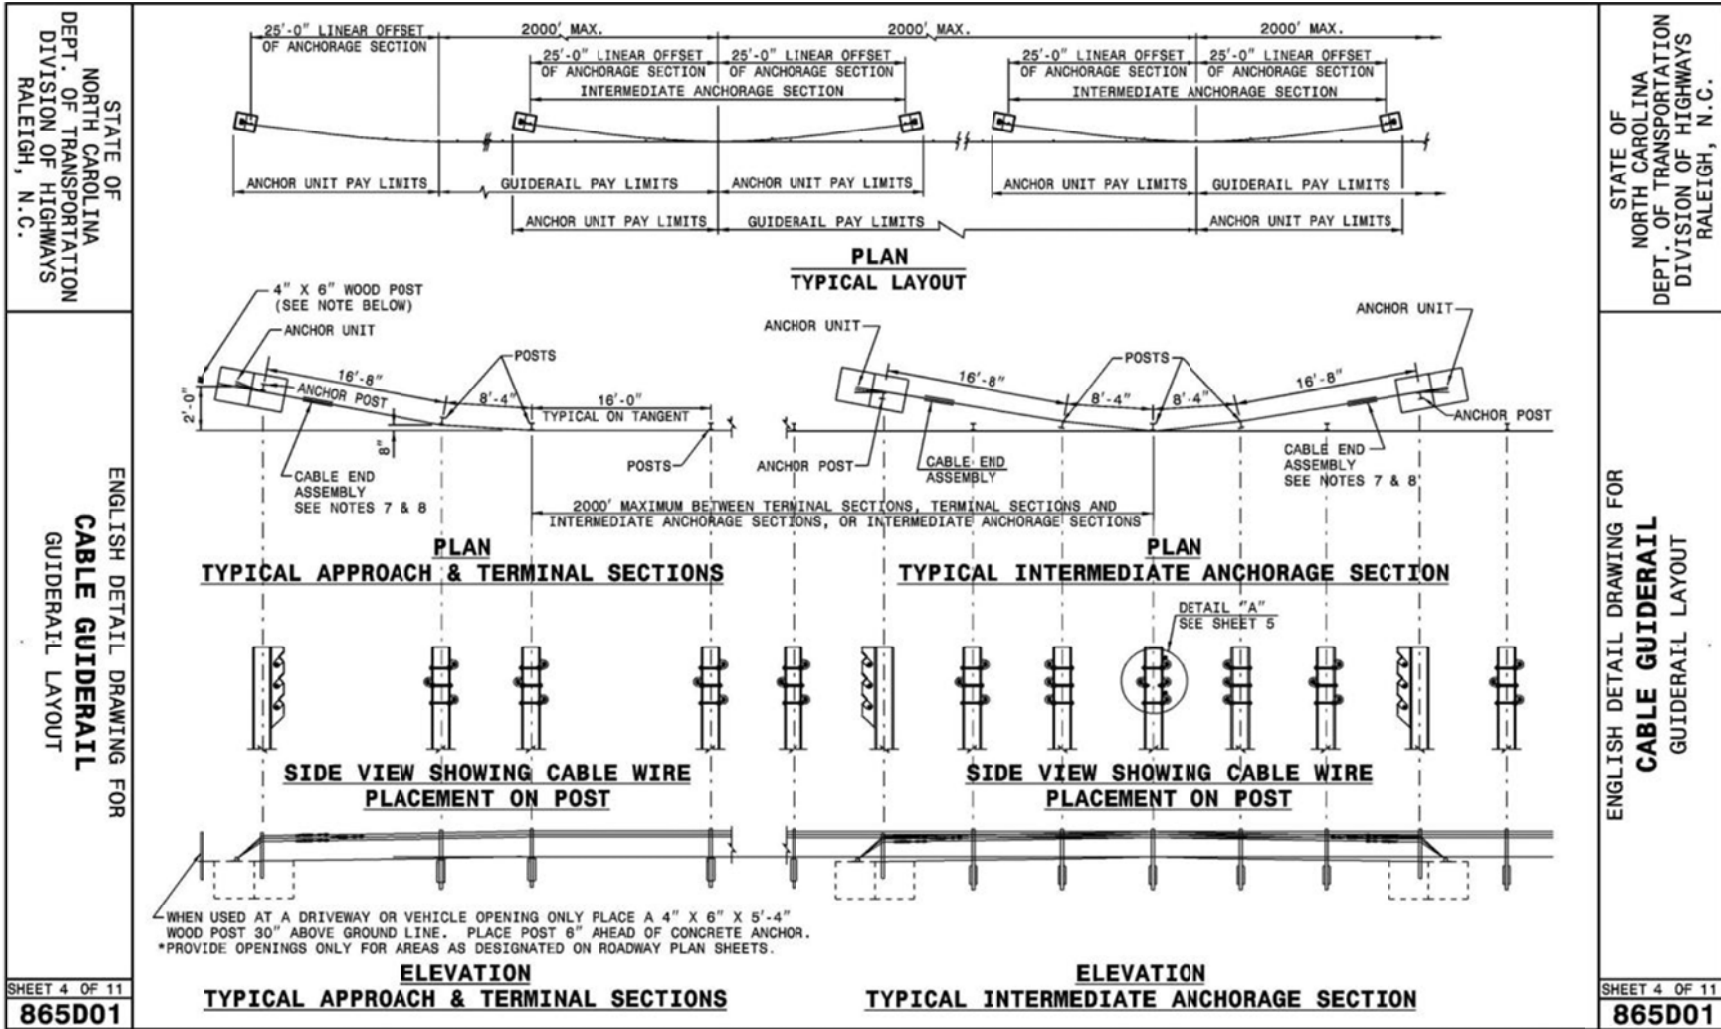
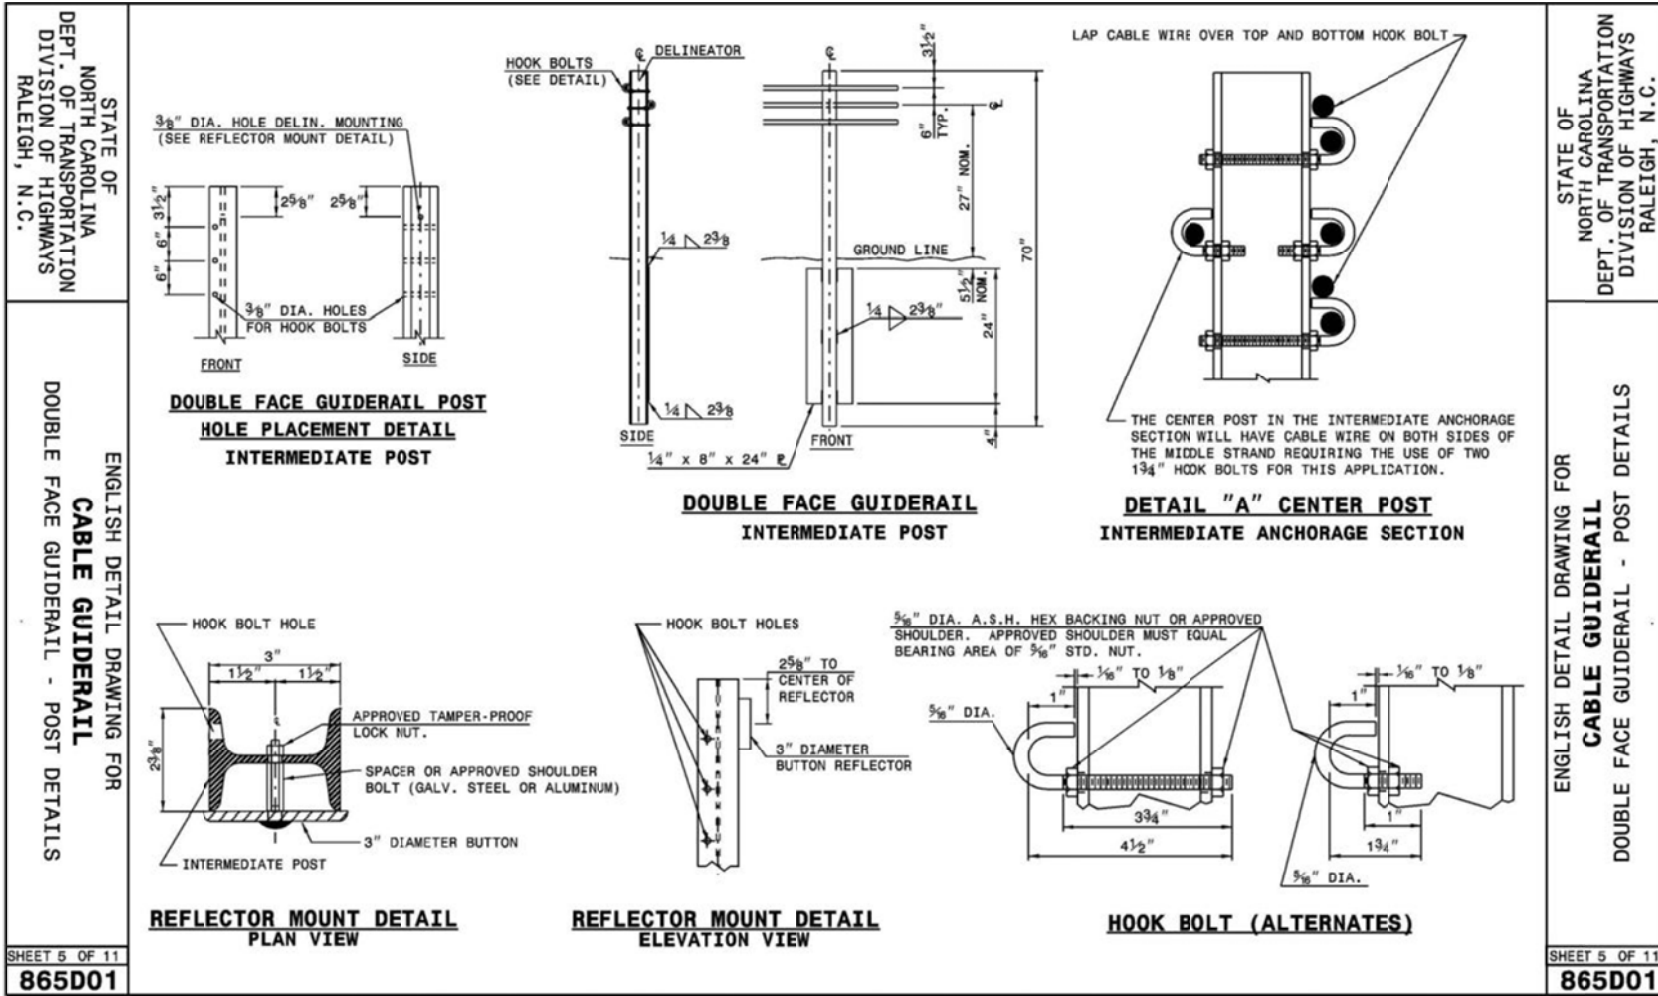
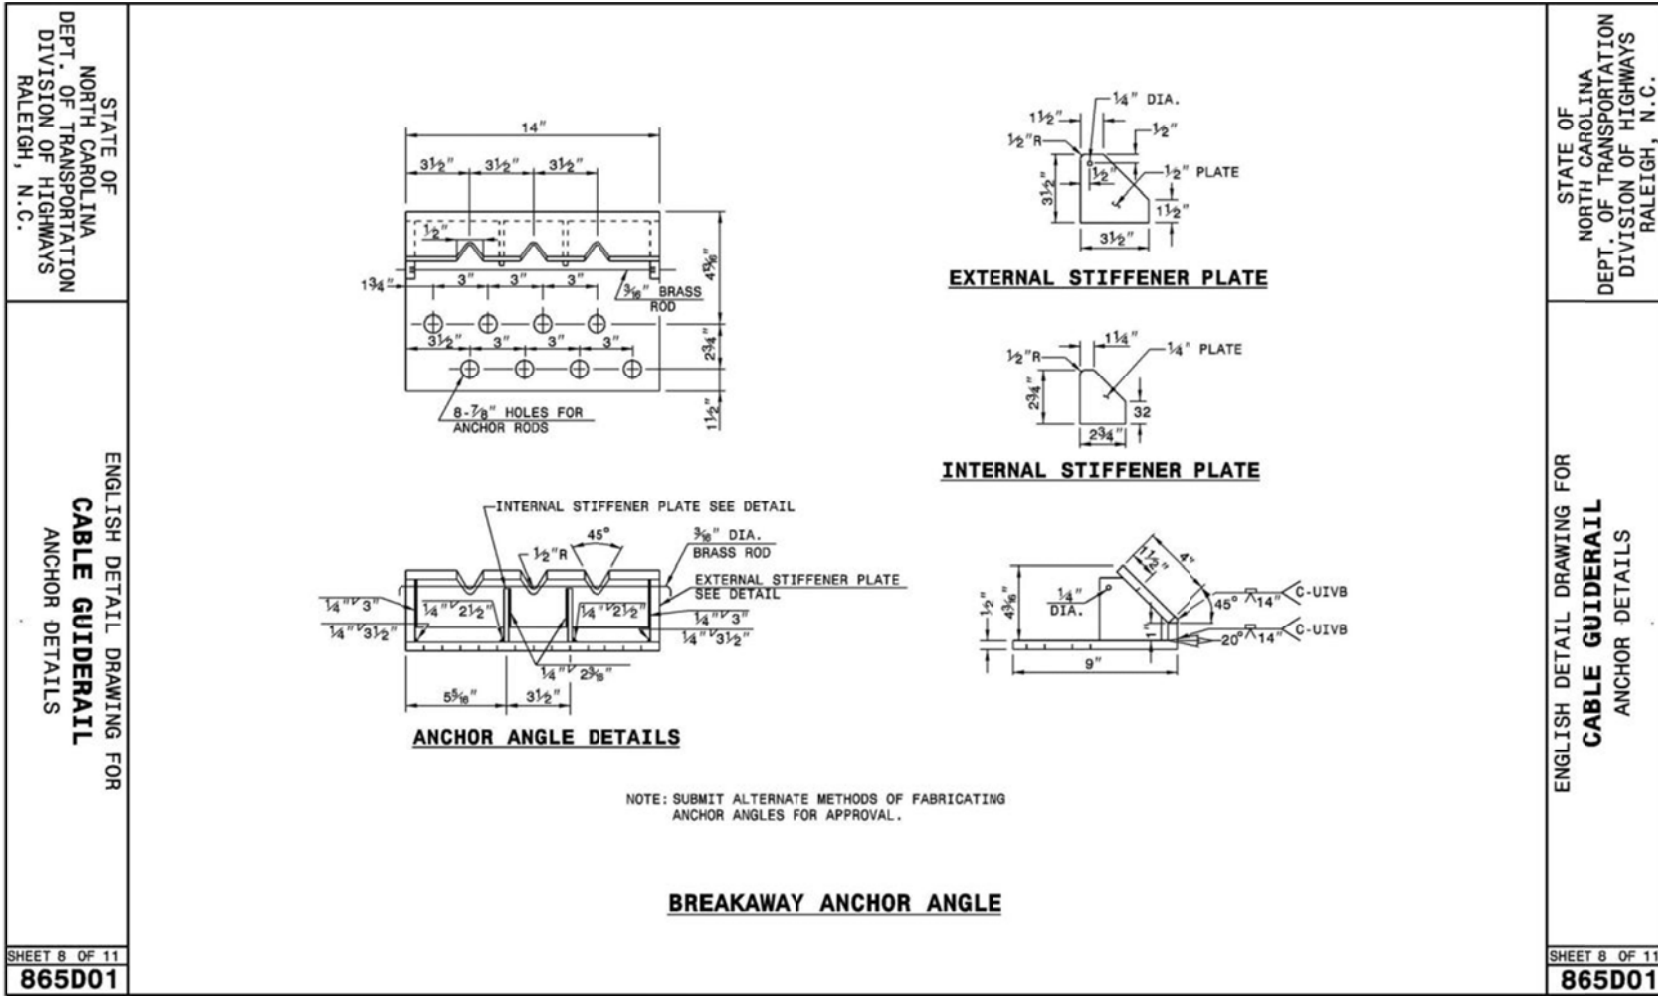
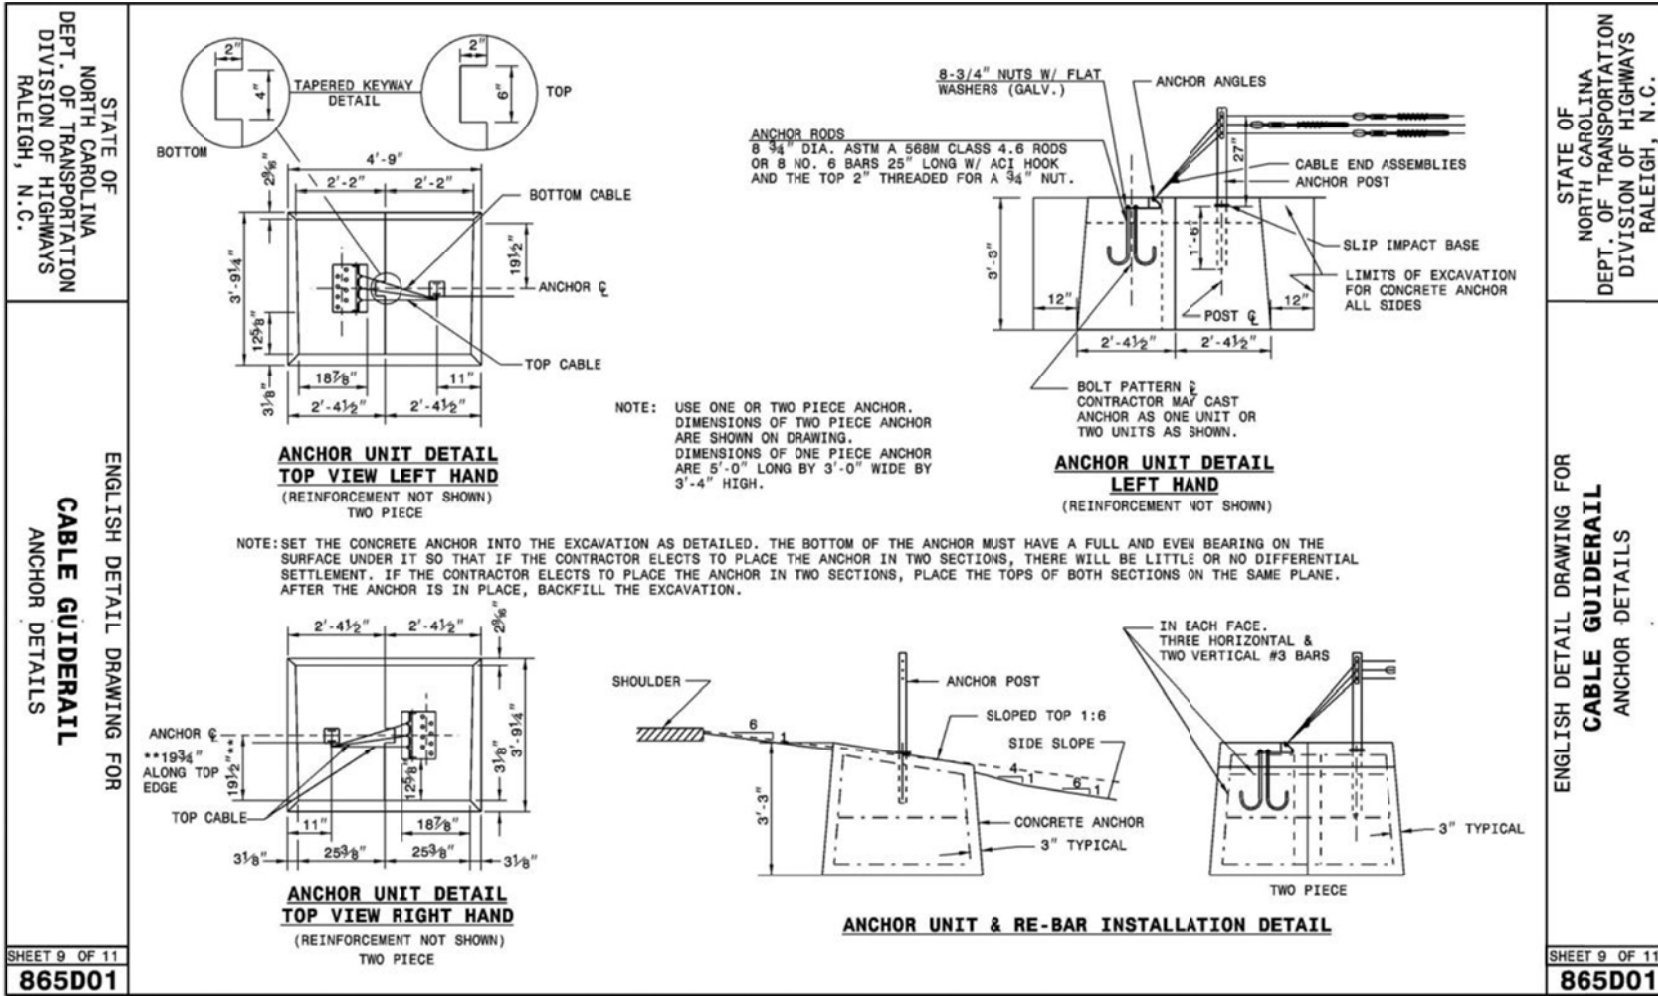
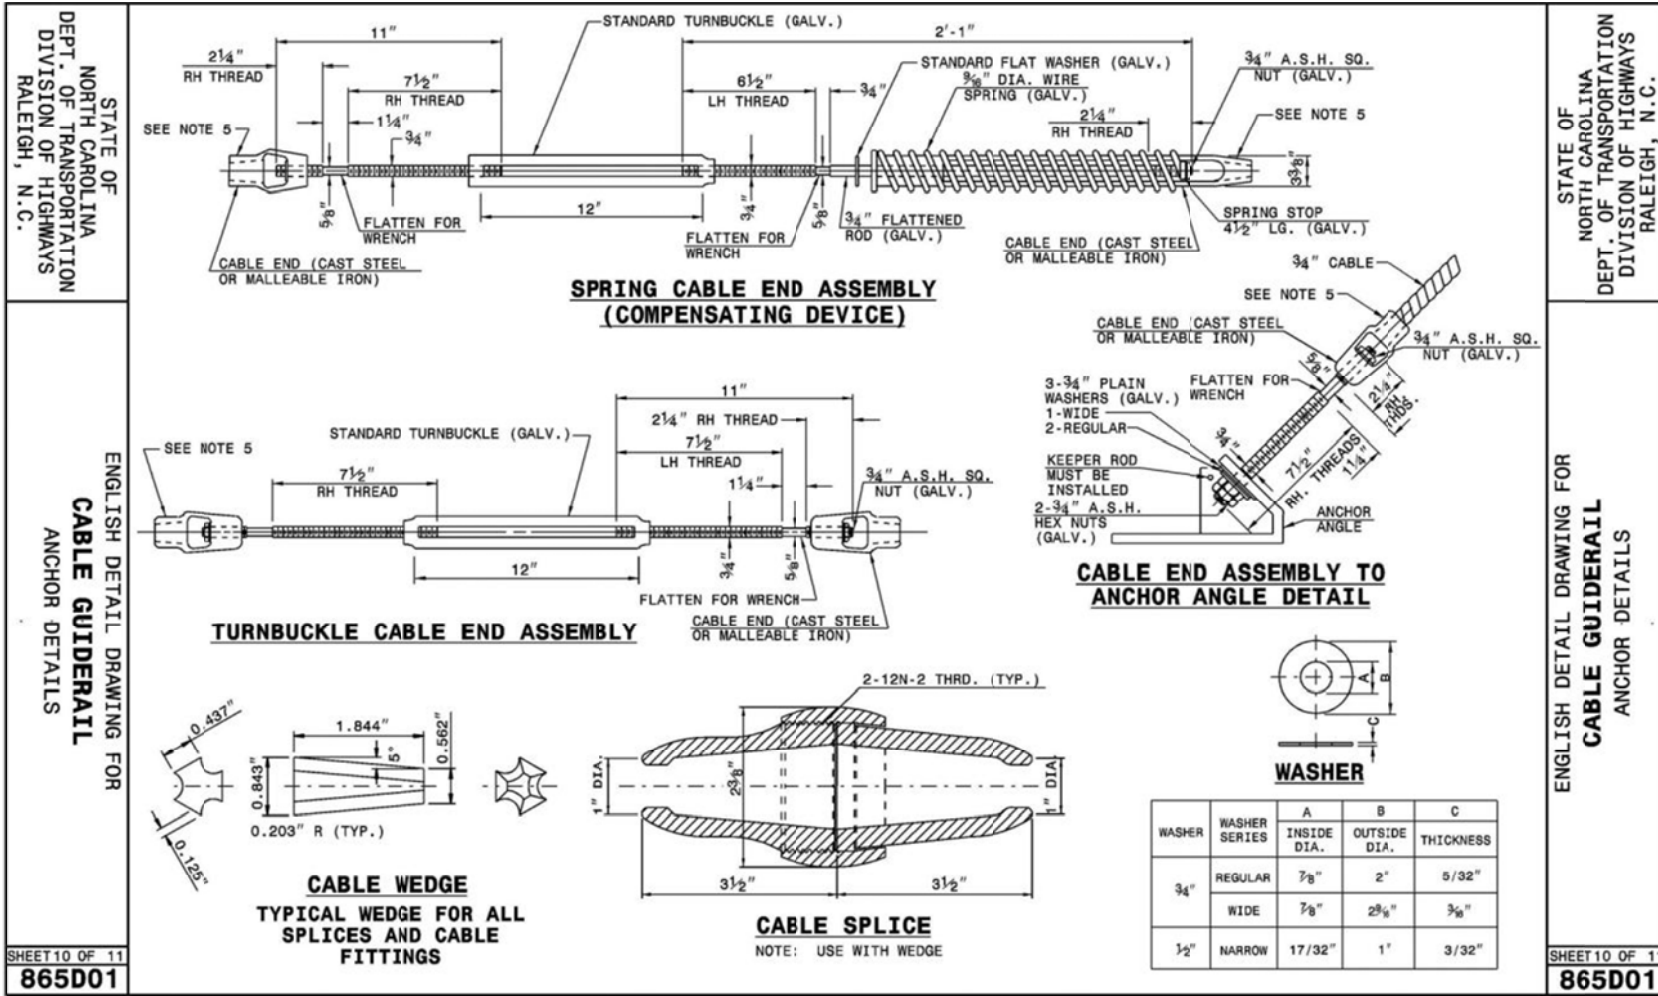
Figure 74. Low-Tension 3-Cable Median Barrier Standard Plans, North Carolina DOT, 2002

The low-tension, 3-cable median barriers installed in Missouri, Washington, and North Carolina were very similar. Examples of the North Carolina's low-tension, 3-cable median barrier standard plans implemented in 2002 are shown in Figures 73 through 78. In each of the low-tension, non-proprietary designs, tension spring compensators were used to retain tension in the cables during very warm weather and to prevent excessive tension increases during very cold weather. The cables were tensioned to between 900 and 950 lb (4.0 to 4.2 kN) at approximately 70° F (21° C), and frequently used wedge splitter cable splice connections, as shown in Figure 76. End anchors for these designs frequently used the end terminal developed by New York, which was approved under the guidelines presented in NCHRP Report 350 [42]. North Carolina later modified the standard cable median barrier plans in 2006 to address penetration concerns after conducting some performance improvement studies [43].

The final crash simulated involved a low-tension, 3-cable median barrier constructed similarly to the system drawings shown in Figures 73 through 78. Posts used in the system were 6 ft-3 in. (1,600-mm) long, S3x5.7 posts with holes drilled in the flanges to accommodate 5/16-in. (8-mm) diameter J-bolts which supported the cables. Nominal cable mounting heights were at 21, 27, and 33 in. (533, 686, and 838 mm).

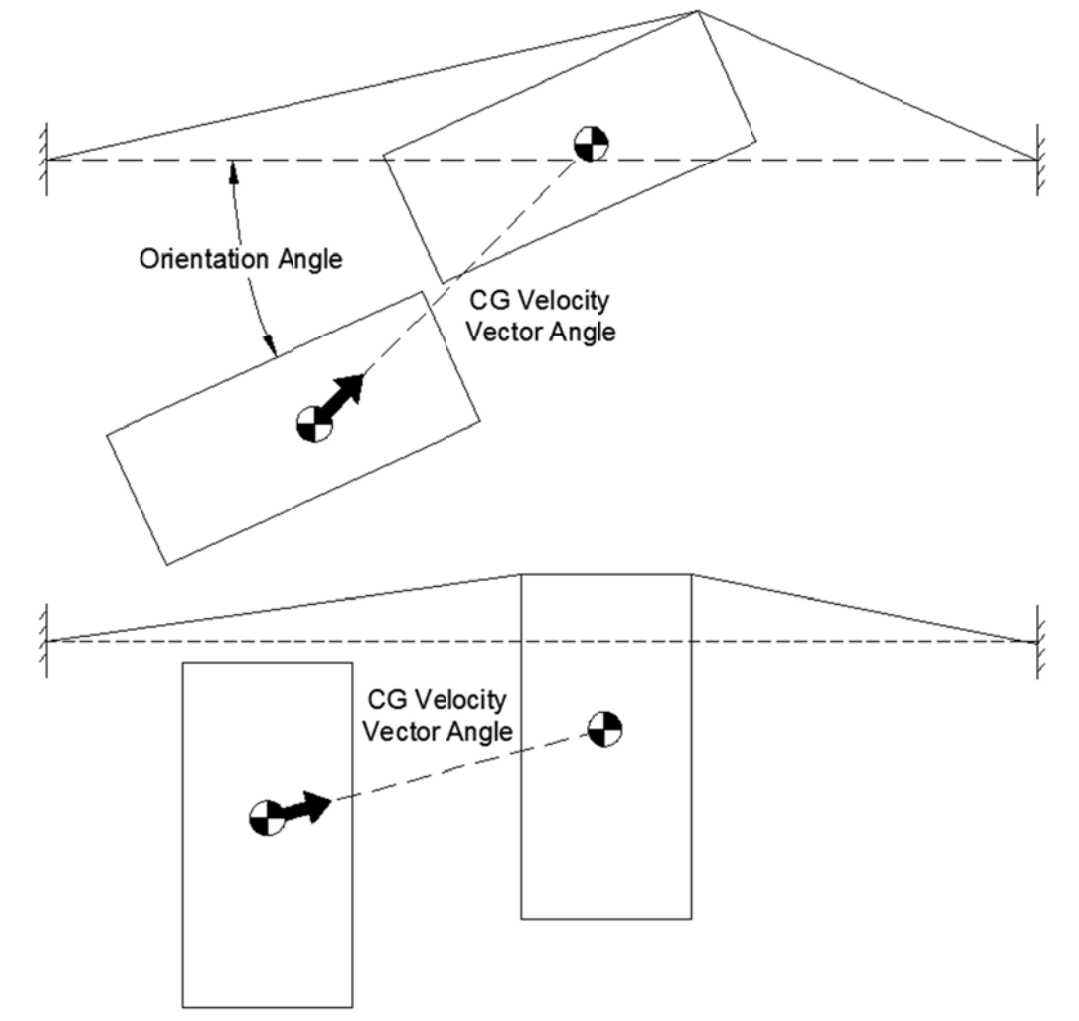
Figure 79. Approximate Equivalent Vehicle Profile Concept

High orientation angle crashes which resulted in penetrations were found to share many common features between all proprietary high-tension barriers. Narrow-profile vehicles or vehicles with smooth front ends alter the expected interaction between the vehicle's front end and the cable barrier during high-orientation angle crashes. As the orientation angle approached either 90 or 270 degrees to the barrier system, differences arose as the vehicle engaged the cable barrier system with the entire front or back surface instead of a concentrated impact at a corner. Impacts occurring along vehicle corners could be approximately equivalently simulated as a wireframe object with corresponding roll, pitch, and yaw moments of inertia impacting the cable barrier. Front- or rear-leading impacts instead engaged the cable barrier with an entire surface, which had a contour corresponding to a cross-section of the vehicle at a given time. This concept is illustrated in Figure 79.

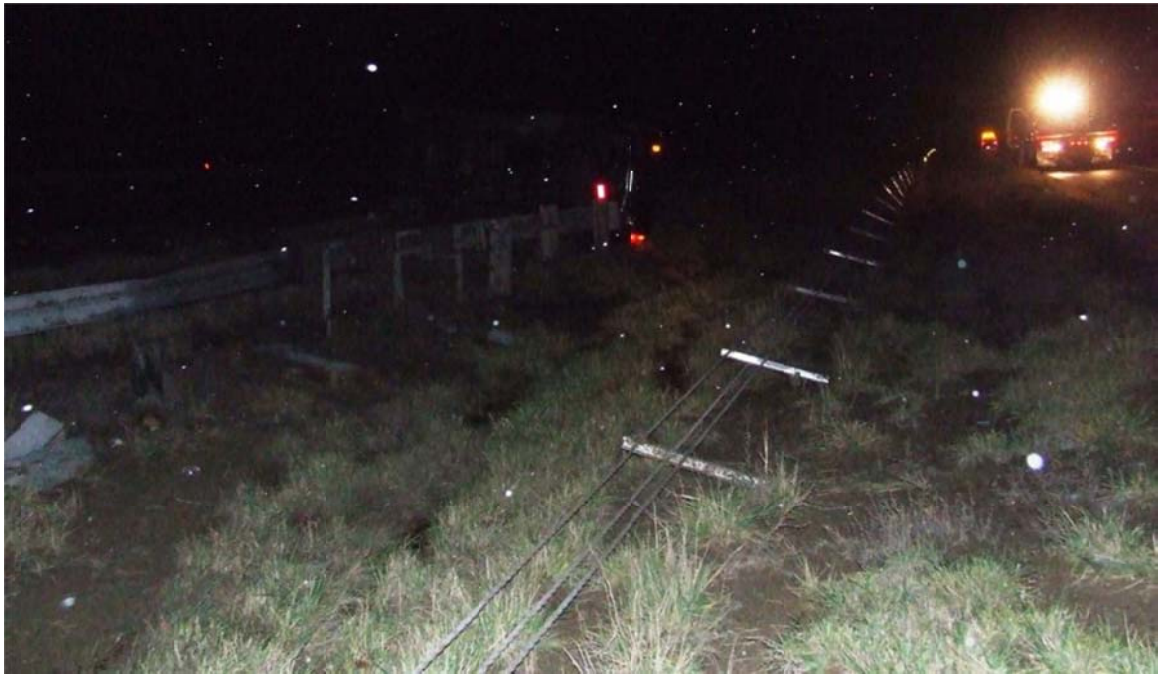
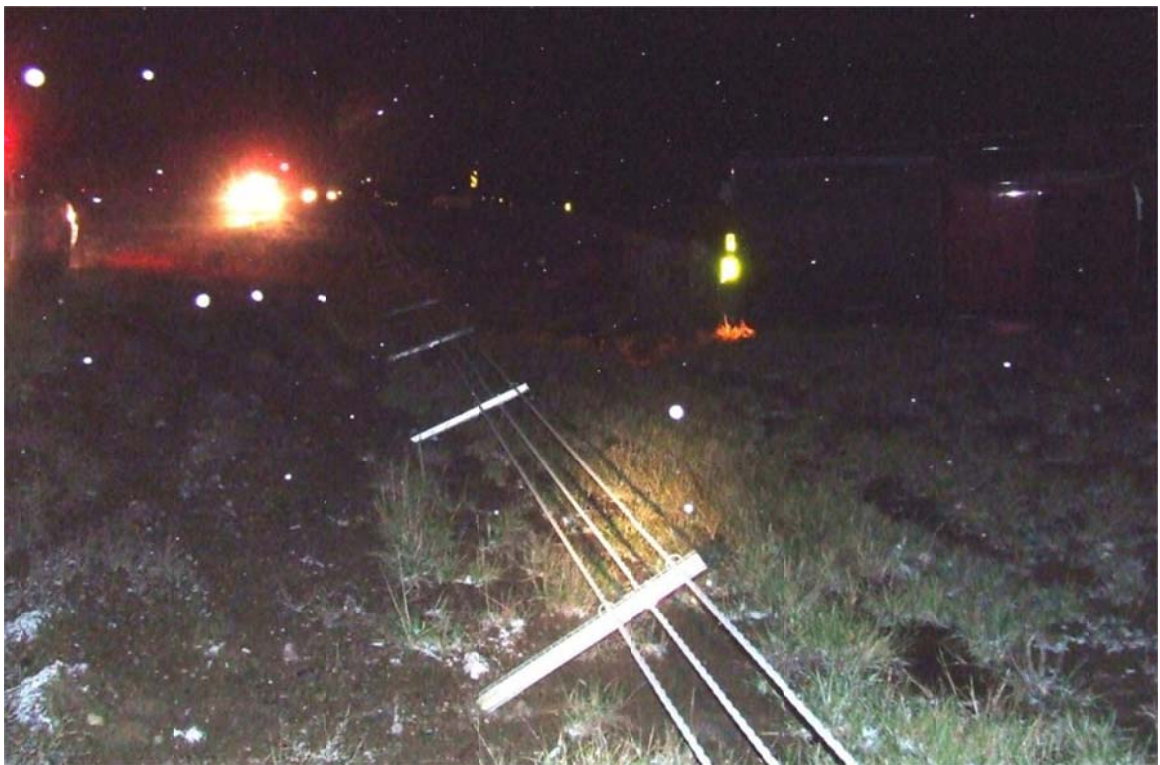
Figure 81. Penetration Crash Caused by Strong Cable-to-Post Attachment

An example of a crash in which the strong cable-to-post attachments contributed to vehicular penetration through the barrier is shown in Figures 81 and 82. In this crash, an impacting pickup lost control due to slick roadways and departed the roadway into the median. The CG trajectory angle was approximately 24 degrees, and the orientation angle of the vehicle at impact was approximately 110 deg. The vehicle impacted the cables and began to redirect. The first few impacted posts were pulled out of the ground as the pickup was redirecting, and the strength of the cable-to-post attachments retained the posts on the cables. Due to the high orientation angle at impact, the cables did not locally

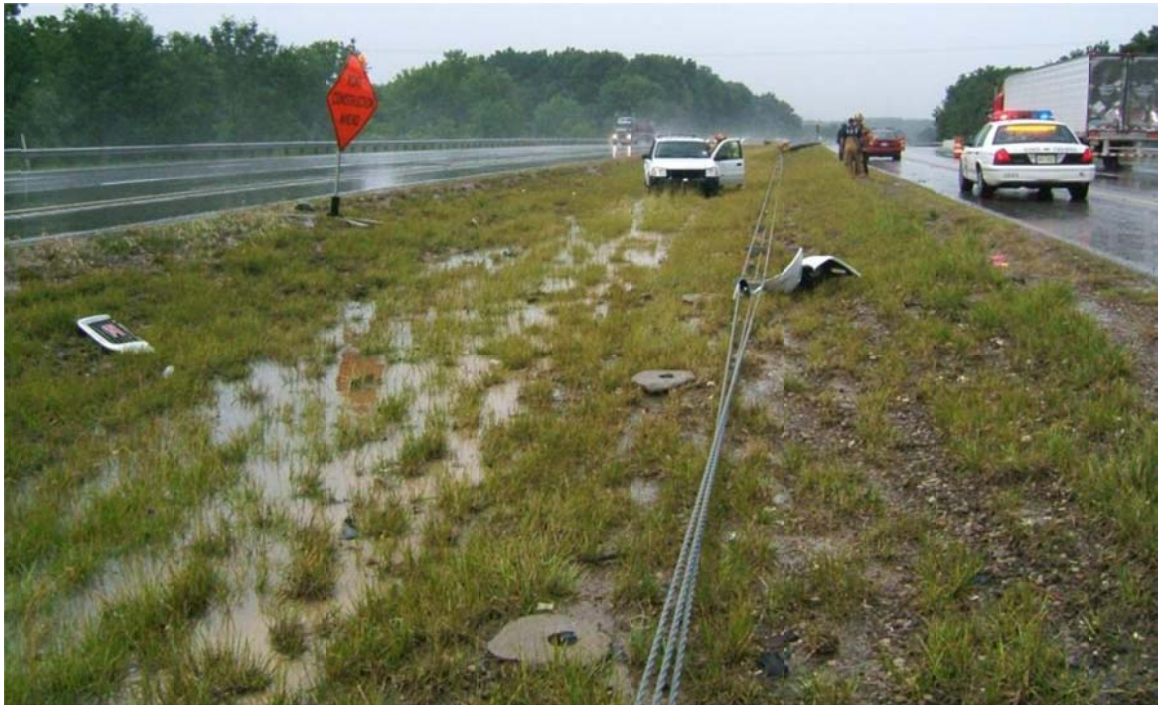
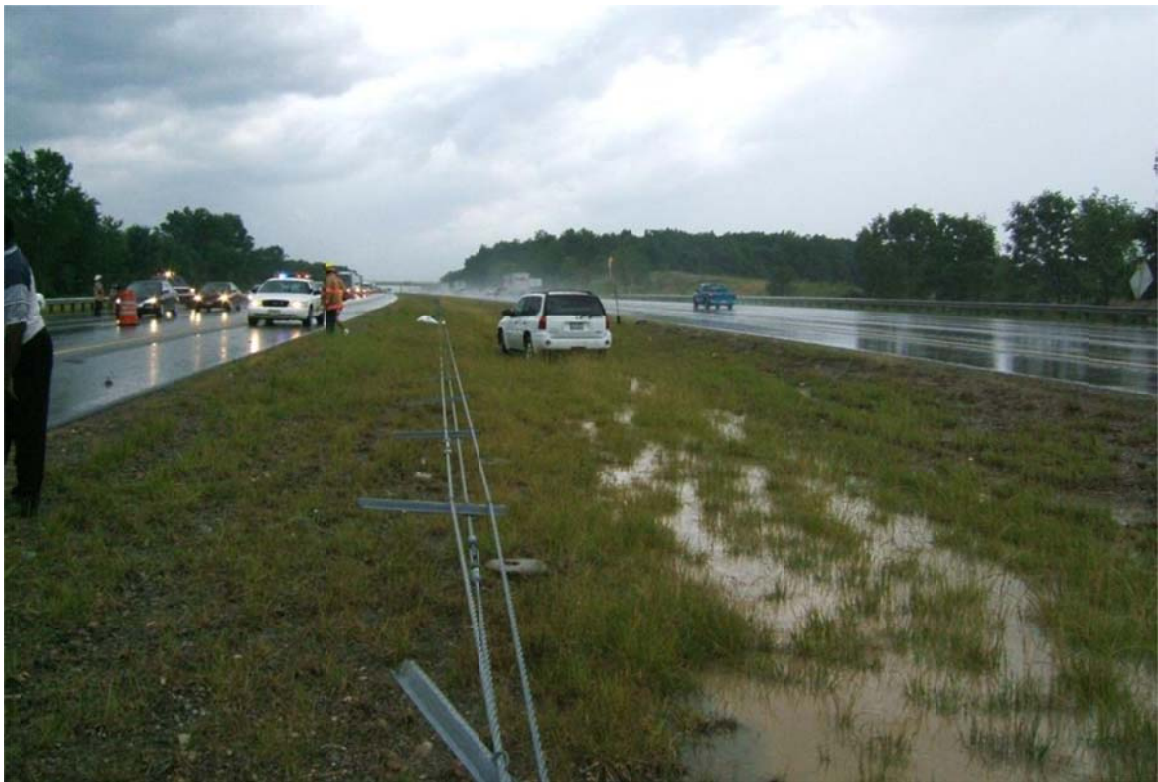
Figure 83. Override Penetration Crash Caused by Strong Cable-to-Post Attachment

The penetration event occurred due to a combination of the following three factors: (1) sequential impacts with posts in the system caused post fracture in the socketed foundations with virtually no plastic deformation of the post; (2) the cable-to-post attachments remained firmly attached to the cables, causing the fractured posts to accumulate in front of the vehicle, while downstream posts fractured and were displaced back with the impacting vehicle; and (3) a long, unsupported length of cable combined with the weight of displaced posts tended to pull the cable downward, causing separation of the bumper cover of the vehicle and marginalizing the "capture zone." In this reference, capture zone (CZ) refers to the front area of the vehicle between the upper bumper surface and the lower edge of the hood. This area frequently corresponds to a blunt surface concealing cavities in the vehicle made for headlights, the radiator, and the engine compartment. The CZ concept has frequently been invoked when discussing cable barrier placement in V-ditches and explaining both failures and successes of certain cable barrier systems, though a formal characterization has never been given to this region of the vehicle.

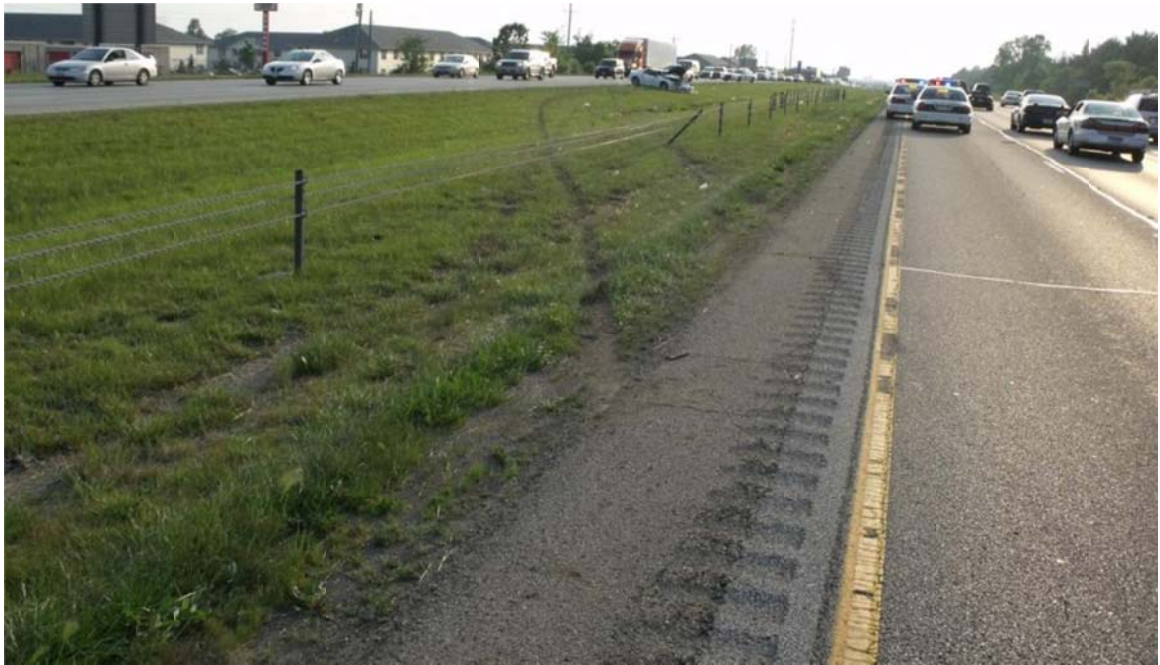
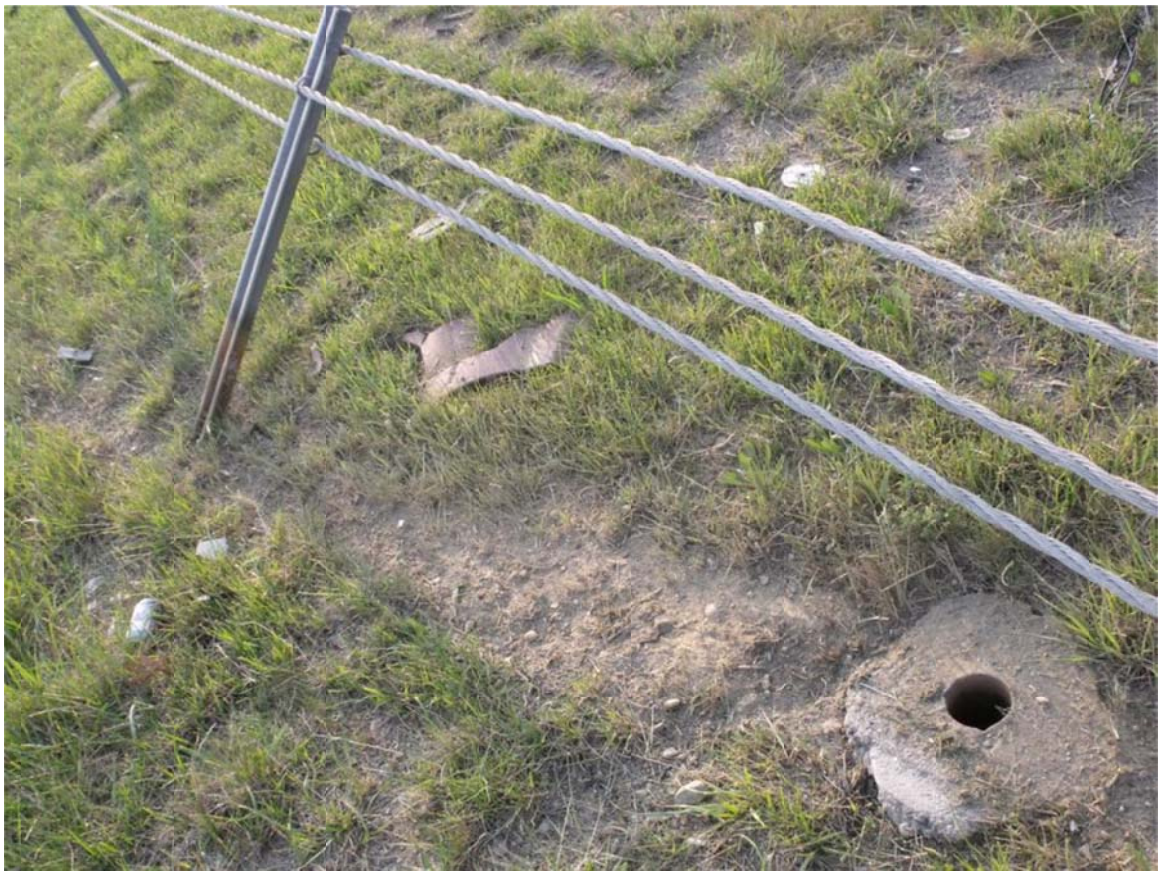
Figure 85. Prying Penetration Crash on Nucor NU-CABLE Barrier

In a second prying case, a 1994 Chevrolet Camaro impacted the Nucor system with a sideslip angle of approximately 90 degrees. The vehicle entered a broad-side skid in an overcorrecting condition, striking a TL-3 3-cable Nucor barrier system with 20 ft (6.1 m) post spacing. The CG trajectory angle at impact was approximately 32 degrees, and the heading angle was approximately 118 degrees. Photos of the impact are shown in Figures 85 and 86.

The driver was able to regain control of the vehicle path briefly, but overcorrected in the median and slid to a stop with an orientation angle of approximately 245 degrees. The vehicle engaged one post along the right side, and pushed the post downstream. The post remained attached to the cables after the vehicle passed underneath.

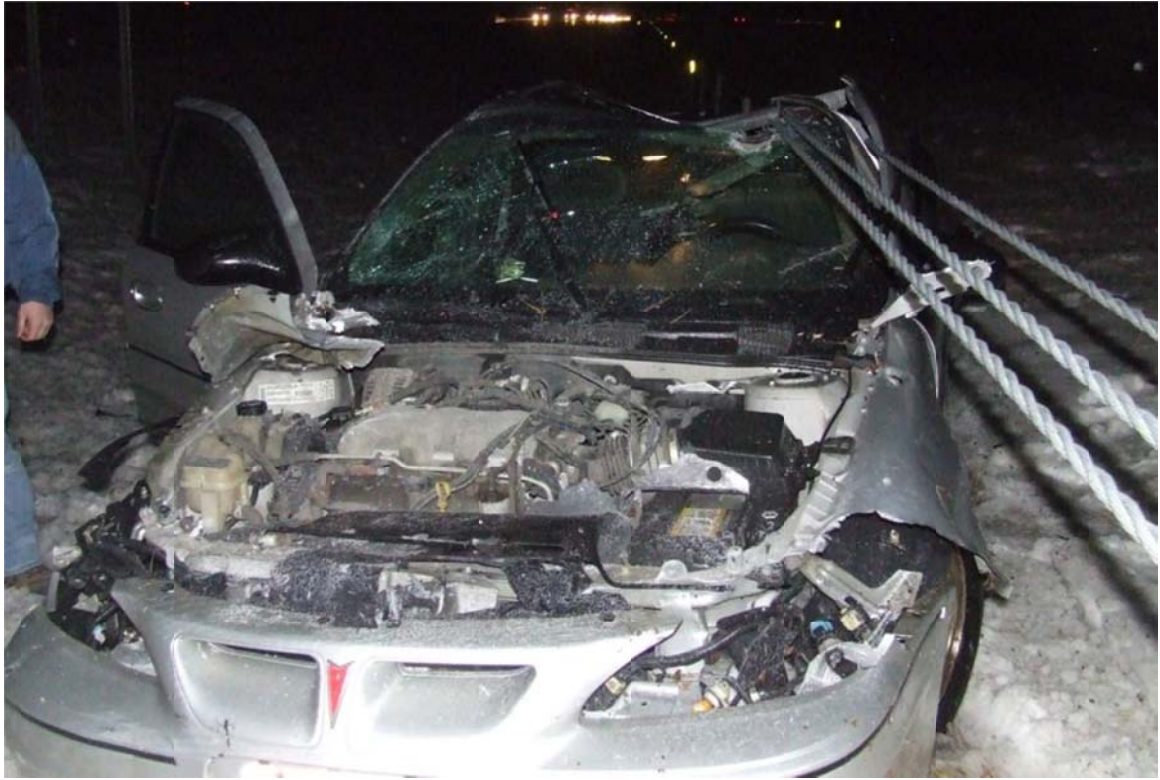
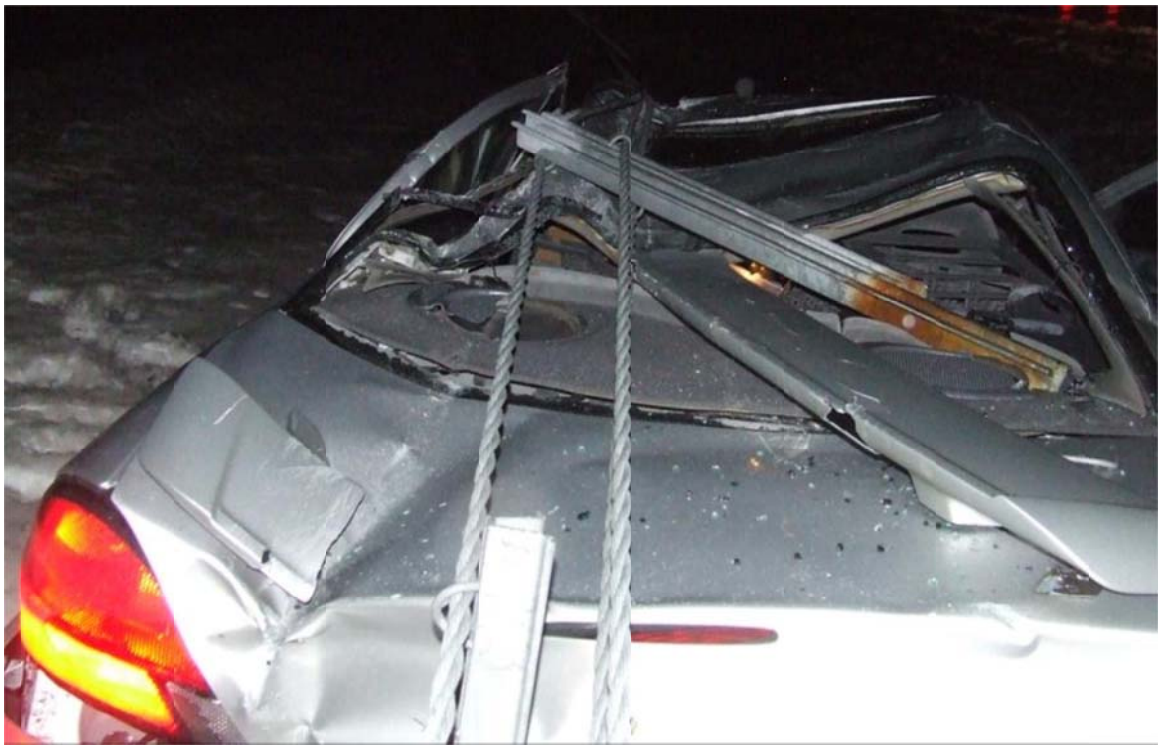
Figure 87. Potential Penetration Crash on Nucor NU-CABLE Barrier

Although the vehicle was brought to a stop in the median, the strong cable-to-post attachment could have seriously injured or killed an occupant in the back seat of the vehicle in this crash because of the retention of the post. Fortunately, no occupants were present in high-risk seat locations, and this crash resulted in only property damage. This crash result further served to illustrate that lower cable release loads and better post-soil and post-socket engagement is necessary to improve barrier performance. By improving these features of Nucor's barrier design, performance in prying situations would be expected to improve.

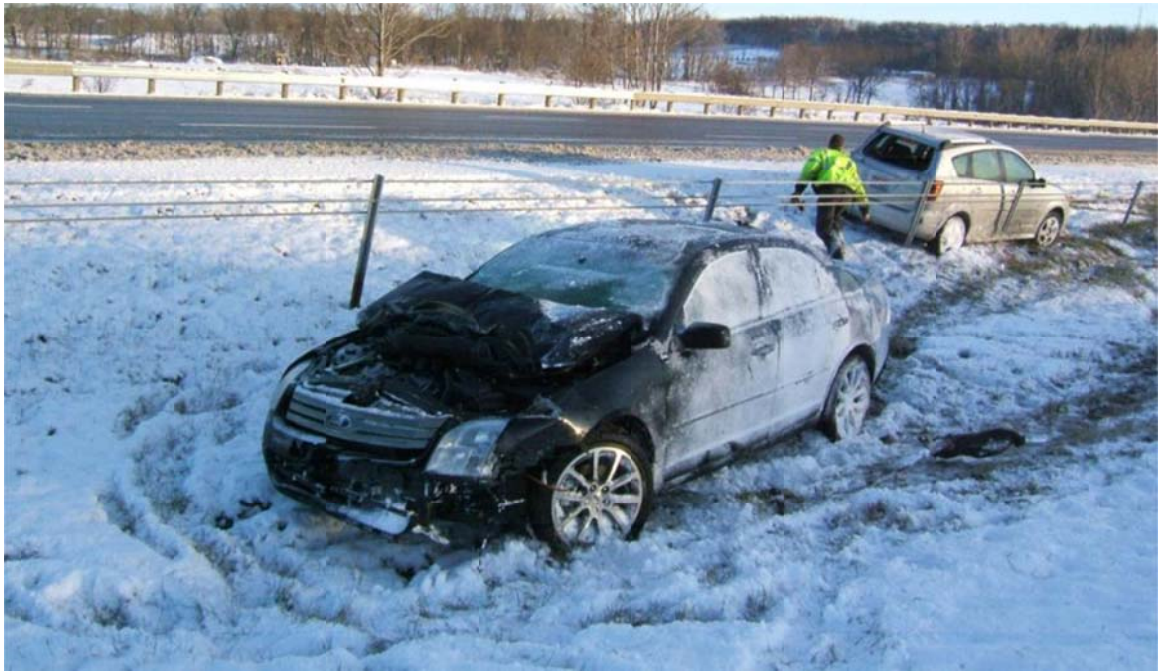
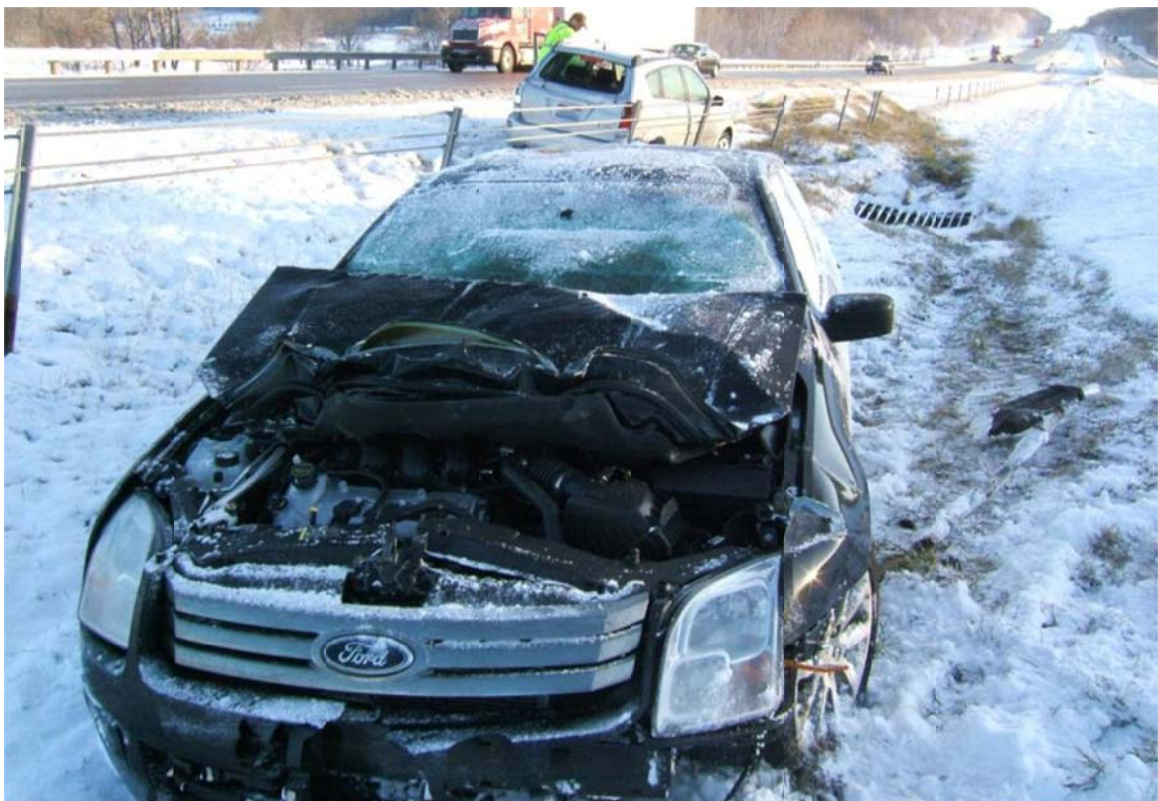
Figure 88. Diving Underride Penetration Crash on Nucor NU-CABLE Barrier

One such diving crash that resulted in a penetration involved a 2009 Ford Fusion. Photographs of the crash are shown in Figure 88. A collision occurred with a second vehicle in adjacent travel lanes, causing the Fusion to veer off of the roadway into the median. The vehicle was oversteering as it entered the median, but the vehicle's front suspension compressed as it interacted with the 5.2:1 approach slope, and the vehicle dove beneath the lower cables. Suspension rebound lifted the cables up, crushing and folding the hood and crushing the windshield. Many posts upstream and downstream from impact were pulled out of the ground due to the underride collision, rendering the system inoperable for subsequent impacts.

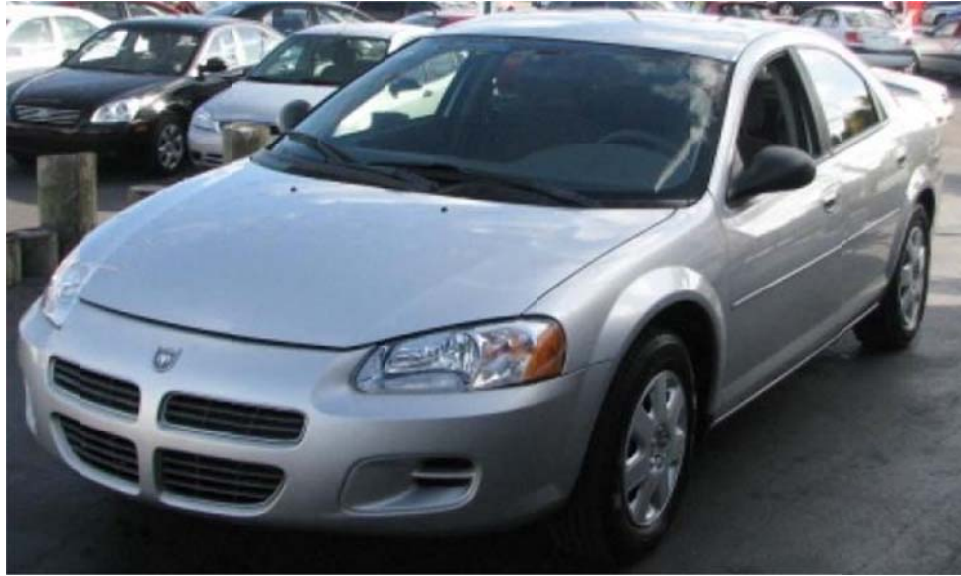
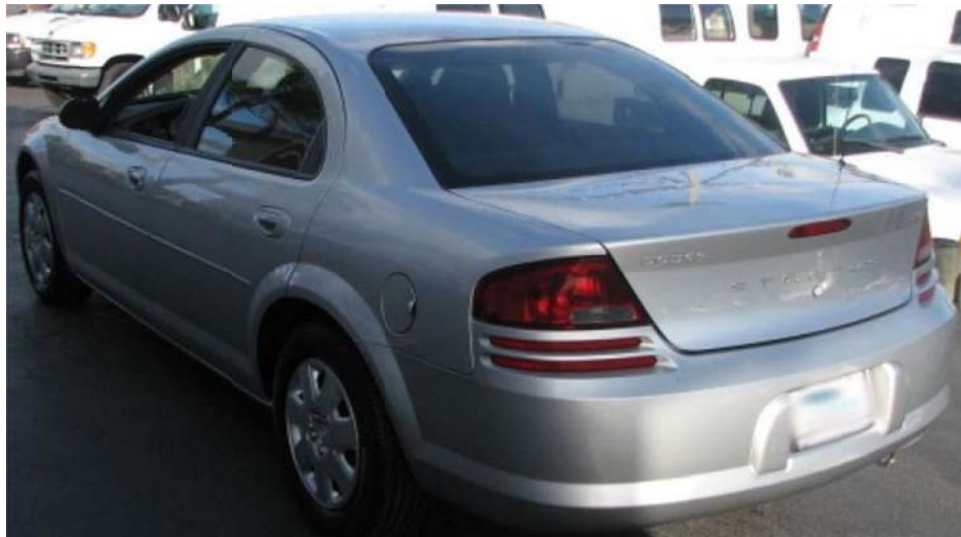
Figure 91. 2002 Dodge Stratus Similar to Vehicle Involved in High-Orientation Angle Penetration Crash [44]

Most light to mid-size SUVs and some full-size cars were not typically involved in penetration crashes, since the broad front end combined with large bumper protrusions typically resulted in capture or rollover. One vehicle which was involved in 21 cable median barrier crashes, but only one penetration crash, was a Dodge Stratus. The scene diagram from the penetration crash involving the 2002 Dodge Stratus is shown in Figure 90. Photographs of a 2002 Dodge Stratus, which was similar to the vehicle involved in the impact, are shown in Figure 91.

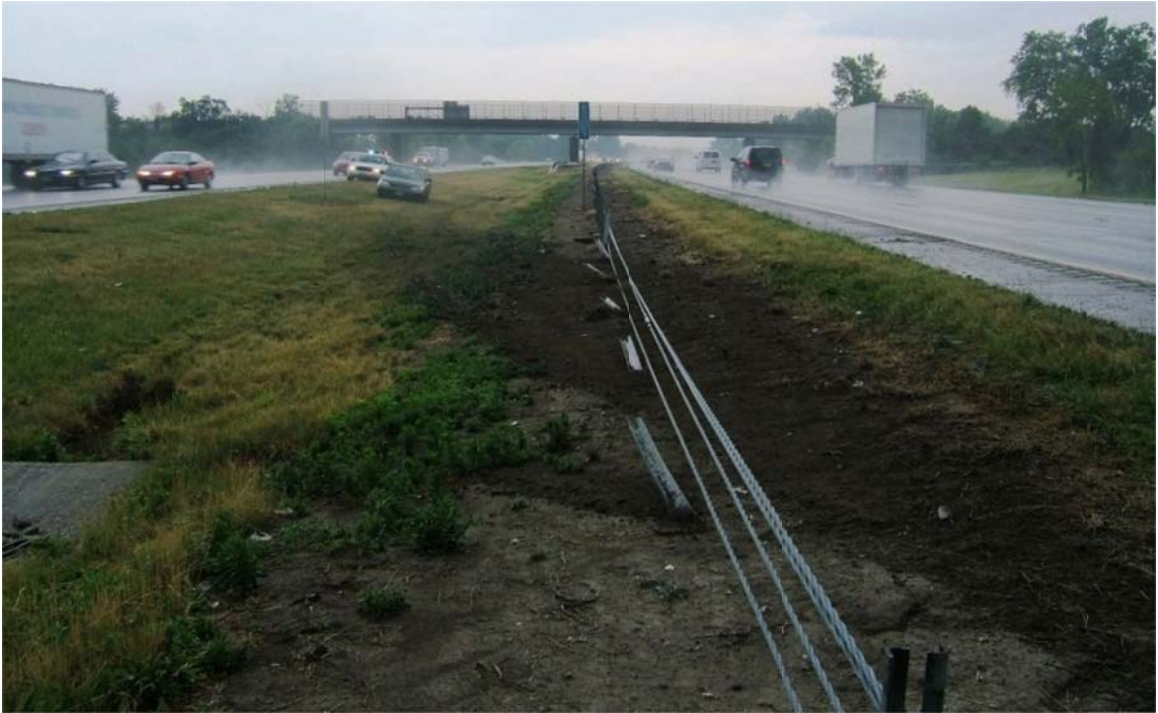
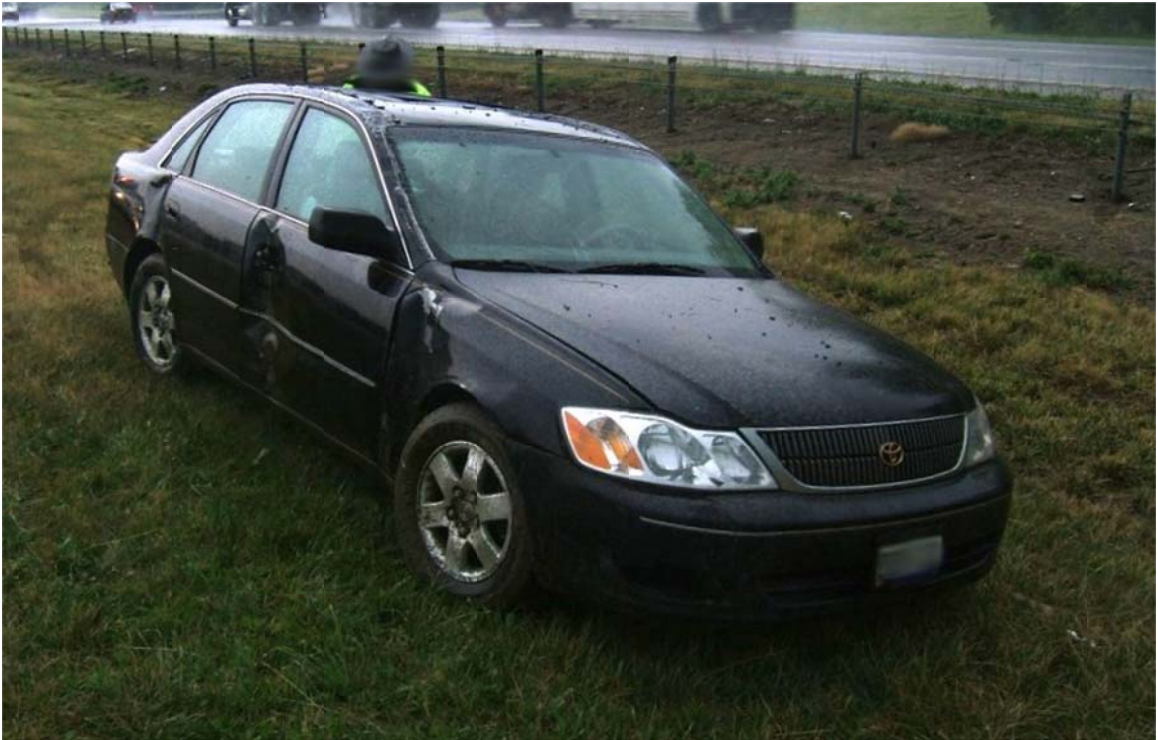
Figure 92. Prying Underride Failure on Brifen WRSF

Immediately after impact, the force of the redirection caused the vehicle to yaw with the right-rear corner turning into the barrier. These forces were eccentric to the vehicle's CG and thus were relatively low to cause yawing. As a result, the forces never exceeded the breaking strength of the front headlight glass casing and the cables did not crease into and engage the vehicle. As the vehicle's back end rotated into the barrier, the cables slipped over the front bumper and hood corner due to the prying force and the vehicle penetrated under the barrier. The sunroof was shattered due to contact with the cables.
