CABLE MEDIAN BARRIER
FAILURE ANALYSIS AND REMEDIATION

by
Cody S. Stolle

A DISSERTATION

Major: Civil Engineering
Structural Engineering

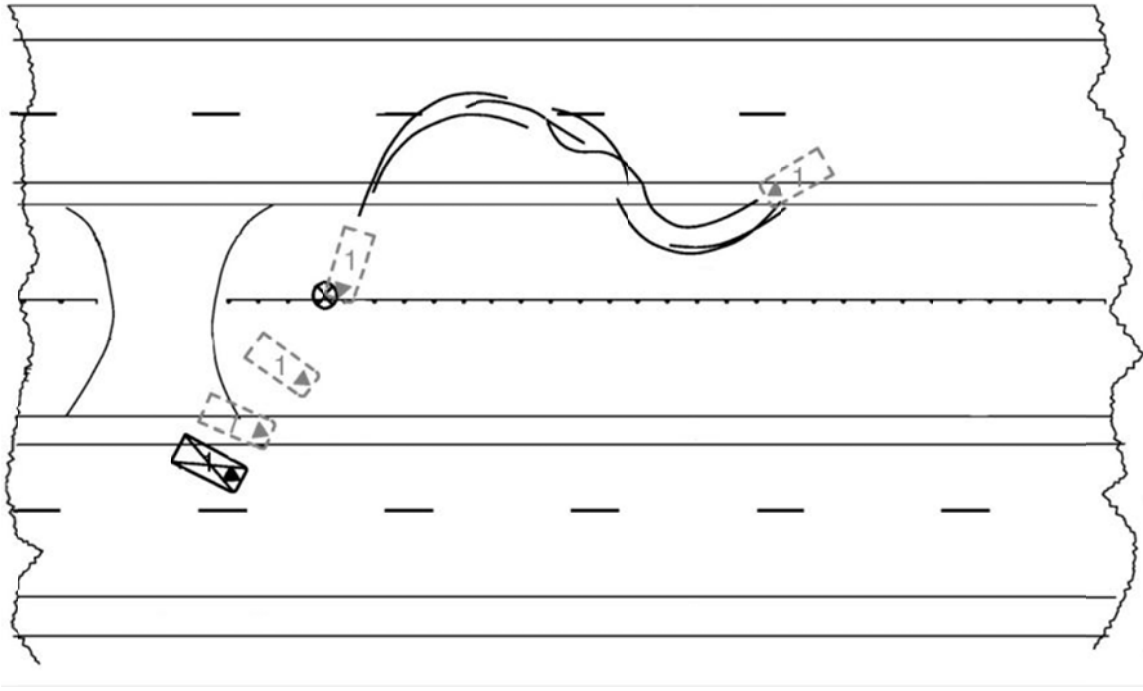
Figure 93. High-Angle Override Penetration Crash Example

The 3 other override penetration crashes consisted of very low CG trajectory angle, low orientation angle crashes. In two crashes, the impacting vehicles were pickup trucks, and in one crash, the vehicle was a passenger car. The vehicles impacted the barrier on relatively steep approach slopes, with unmeasured slopes likely between 4:1 and 6:1 based on visual estimation. The vehicles impacted the cable median barrier, sequentially bending the S3x5.7 (S76x8.5) support posts downstream, then overrode the cables. The override was likely due to the following two factors: (1) the low tension in the cables was insufficient to prevent sagging when multiple support posts were

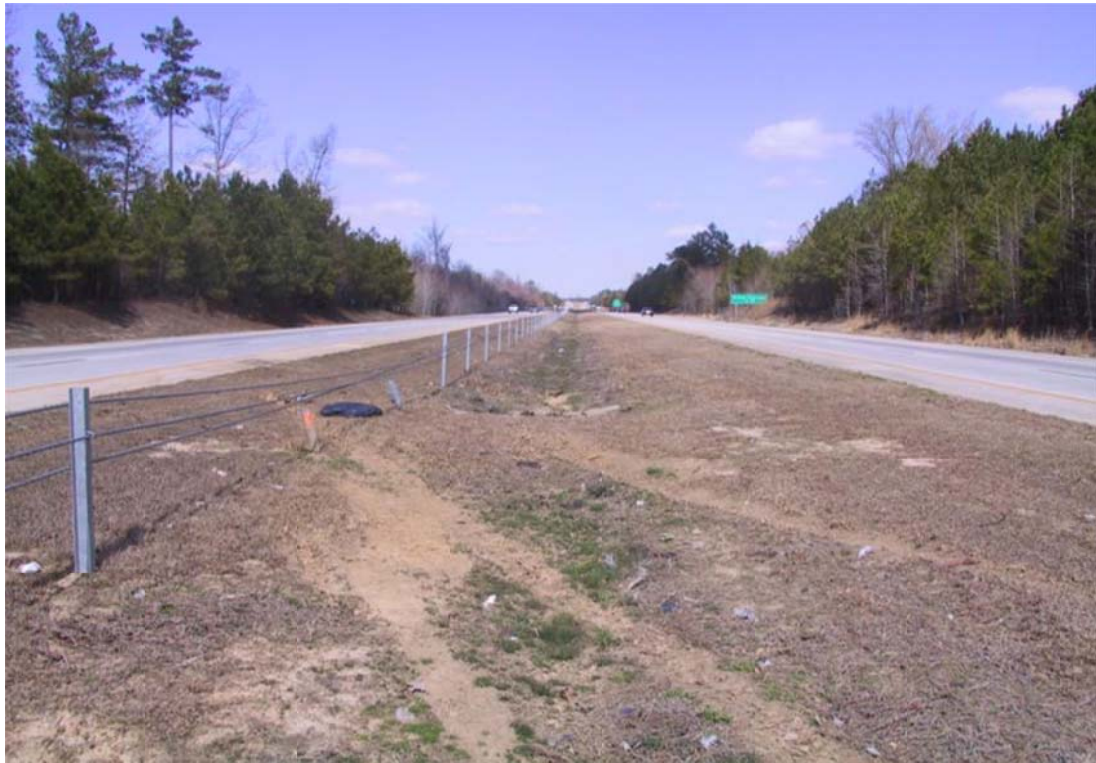
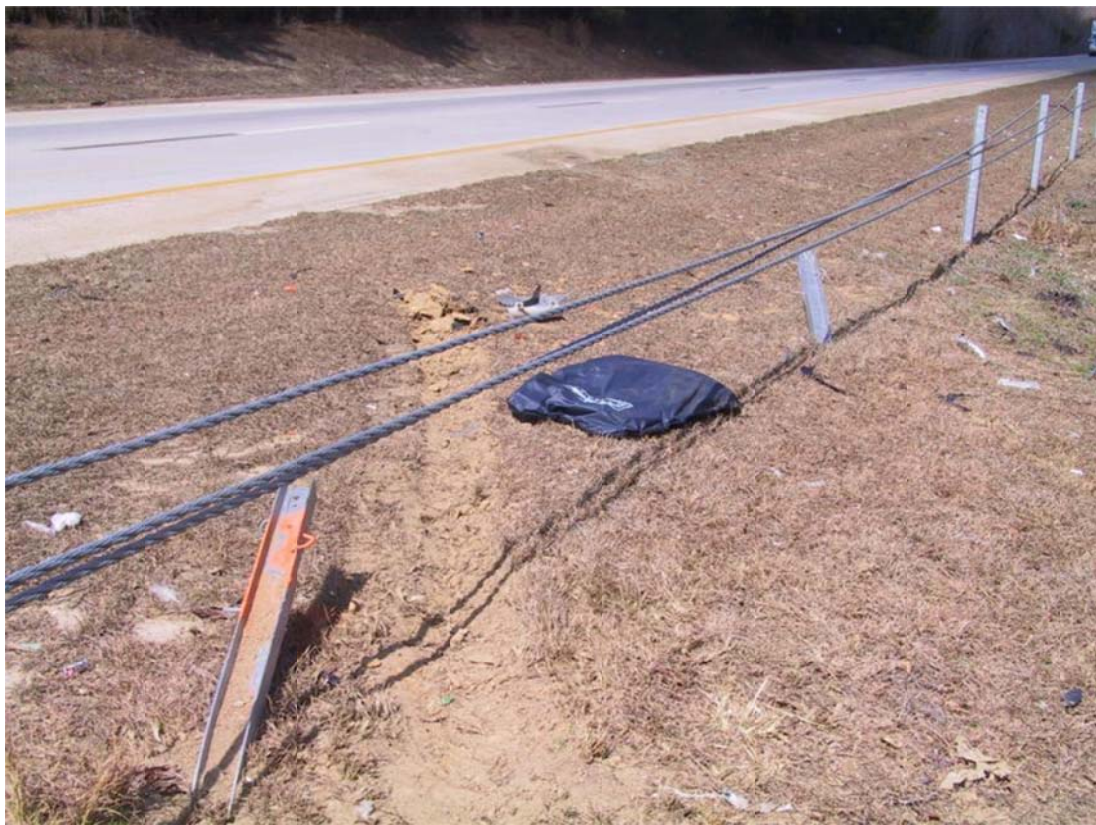
Figure 94. Diving Underride Penetration Crash in North Carolina

Although photographs were not available for crashes in the state of Missouri, and thus no rutting analyses were possible, median profiles were estimated based on site-specific analysis and limited photogrammetric reconstruction. In each Missouri diving underride crash, the median slope was steeper than or equal to 6:1, and the back-side slopes were also steeper than or equal to 6:1. In every diving underride crash in the database, back-side slopes were as steep as or steeper than the approach slopes into the median. This suggested that the approach slope steepness has a significant effect on the propensity to compress the suspension. However, the back side slopes had the

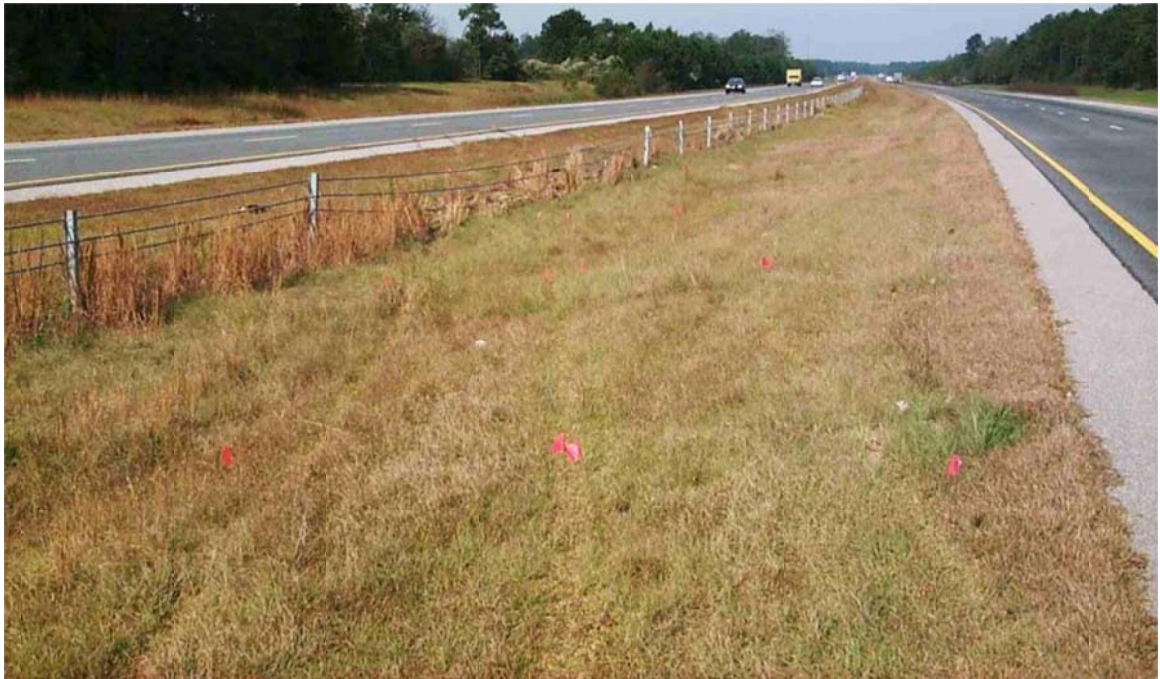
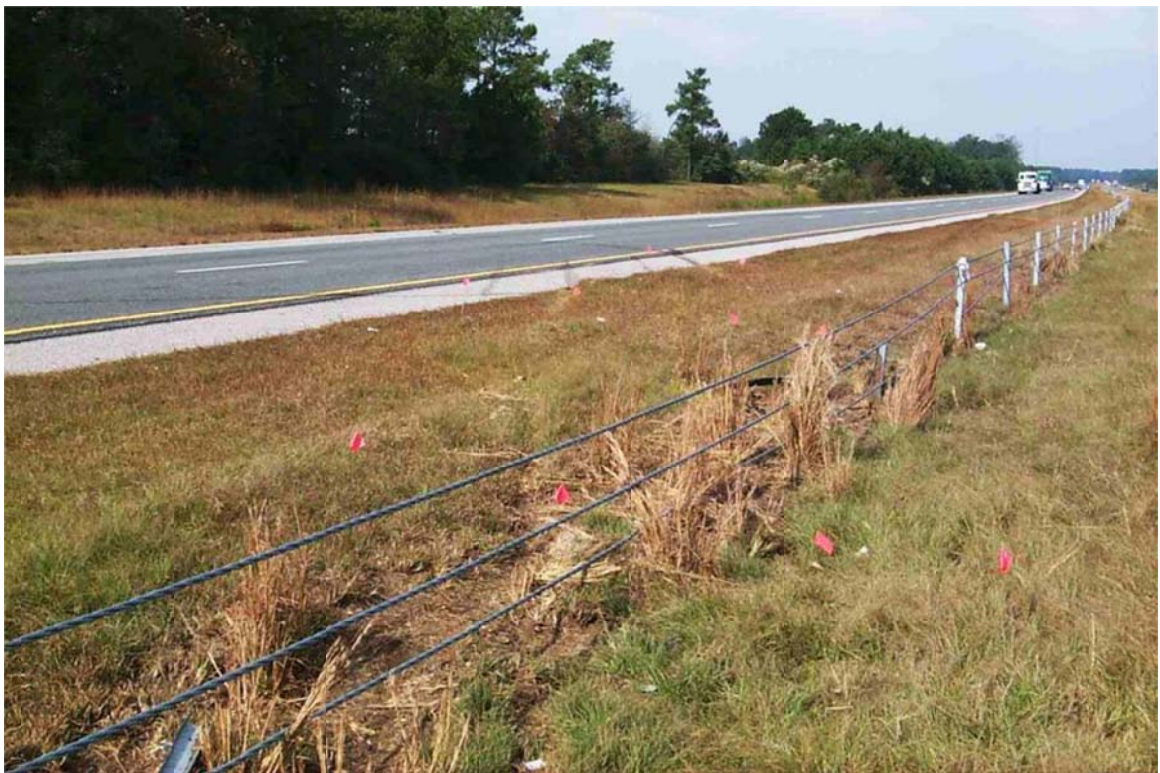
Figure 95. Additional Example of Diving Penetration Crash

Despite the effect of suspension compression on the propensity for vehicle penetration through the barrier, the weak lower cable-to-post attachments strongly increased penetration propensity. The attachments disengaged from the posts at low loads and allowed the cables to slip above or below the vehicle. It was believed that in every recorded diving cable median barrier crash in this database, the diving tendency would be significantly reduced or eliminated if the bottom cable-to-post attachment strength was increased. This could have reduced diving penetrations by as much as 50%. Increasing the release load of the bottom cable would likely increase contact forces between the impacting vehicle and bottom cable, which could result in better engagement and formation of the familiar cable crease observed on vehicles involved in successful redirections. Additional examples of diving underride crashes are shown in Figures 95 and 96.

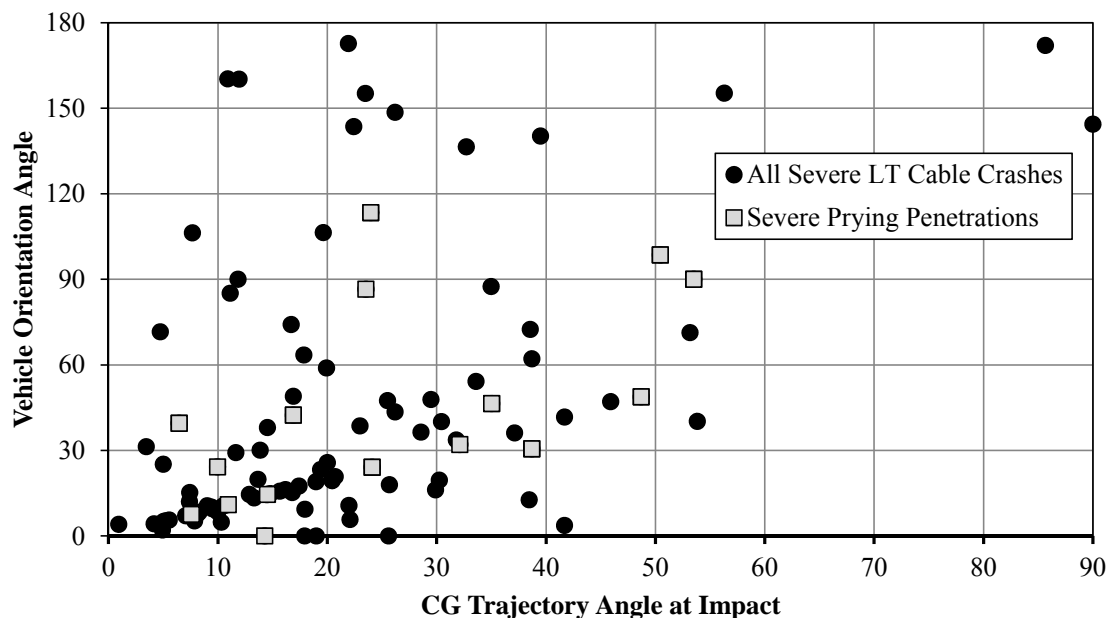
Figure 97. Comparison of Prying Penetration CG Trajectory and Orientation Angles

Frequently, at least two prying risk factors were present in prying penetration crashes. Prying penetrations occurred when cables were lifted or separated and failed to engage the vehicle. As with the high-tension cable median barrier systems, prying penetrations were sensitive to impacting vehicle orientation angles. These angles were cross-plotted against all severe cable median barrier crashes in Missouri, as shown in Figure 97. No clear distinction could be made between the two crash distribution data sets. Oversteering impacts, in which the vehicle orientation angle was greater than the CG trajectory angle, were 5 times more common for prying penetration crashes.

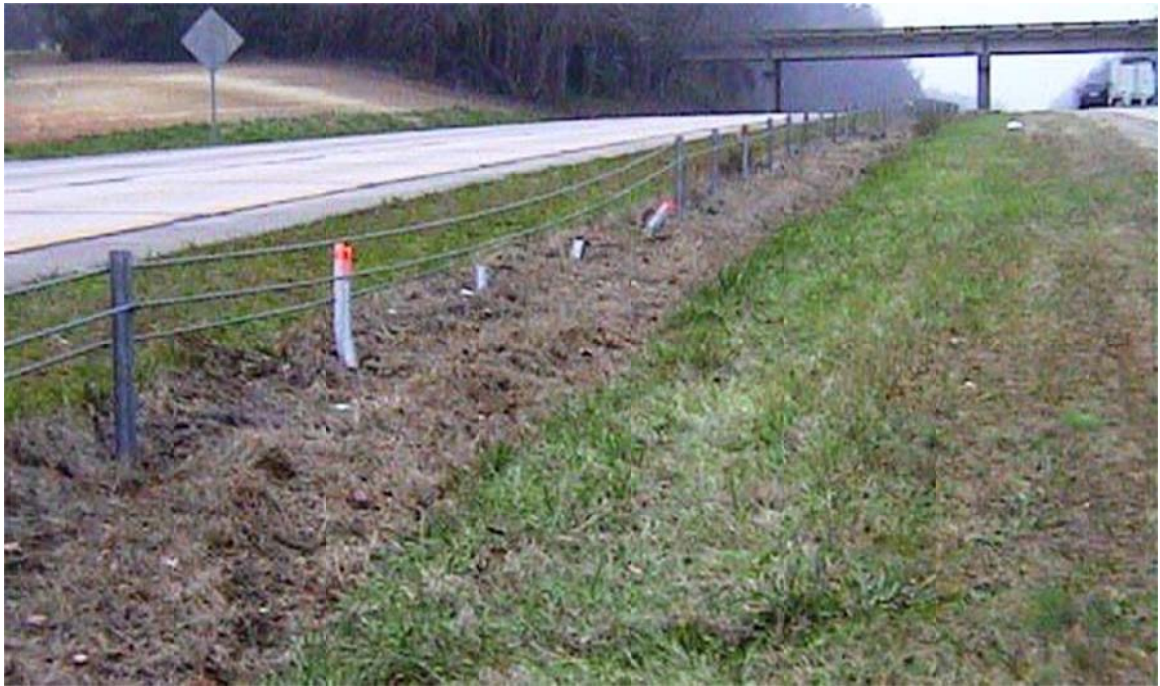
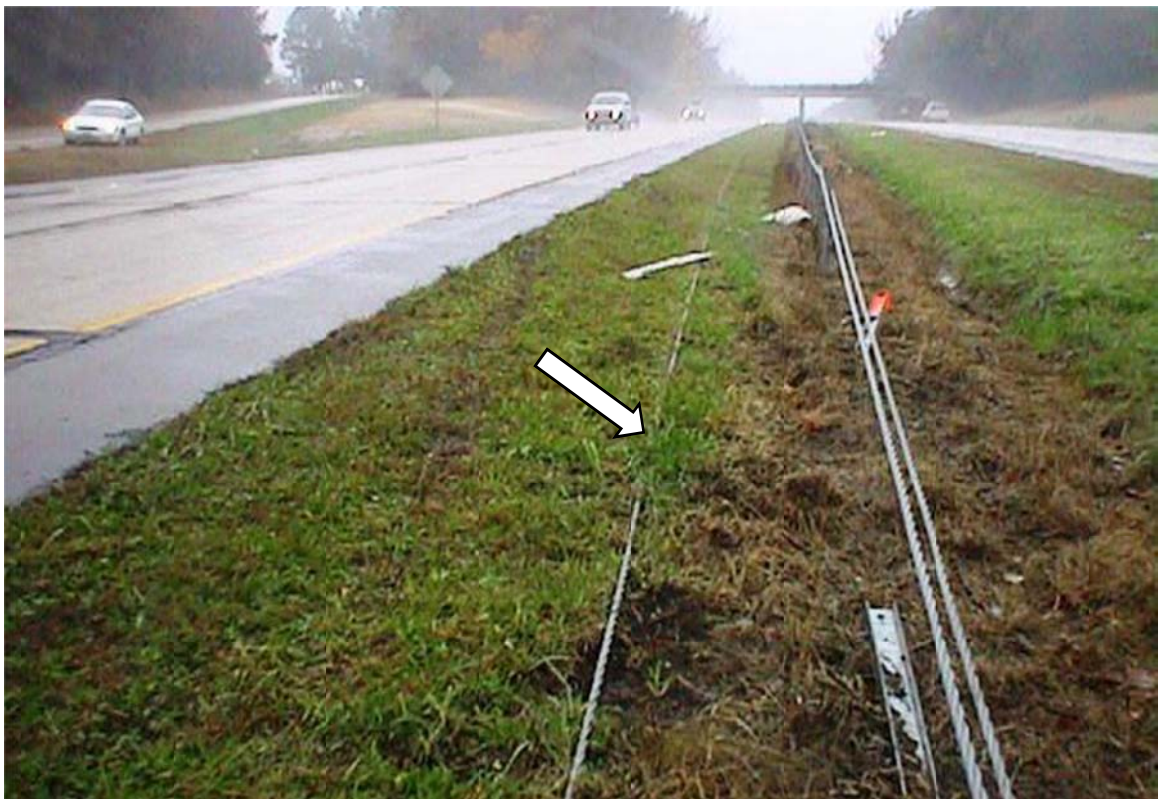
Figure 98. Back Side (Middle) Cable Release from Many Downstream Posts Resulting in Penetration

Prying penetration crashes typically occurred via a combination of the following factors: (1) cables located on the back side of the post released from many posts because lateral forces exceeded cable-to-post attachment strengths; (2) large orientation angles promoted bumper protrusion between or below the cables contributing to underride or through-cable penetration; and (3) low contact forces prevented beneficial body panel crushing or headlight fracture, causing poor cable-vehicle engagement. Back-side cable release most commonly occurred when other cables failed to adequately engage the vehicle, so the entire redirection load was applied by one back side cable. Examples of penetration crashes in which the impacted back-side cable was removed from more than 10 posts downstream from impact are shown in Figures 98 and 99.

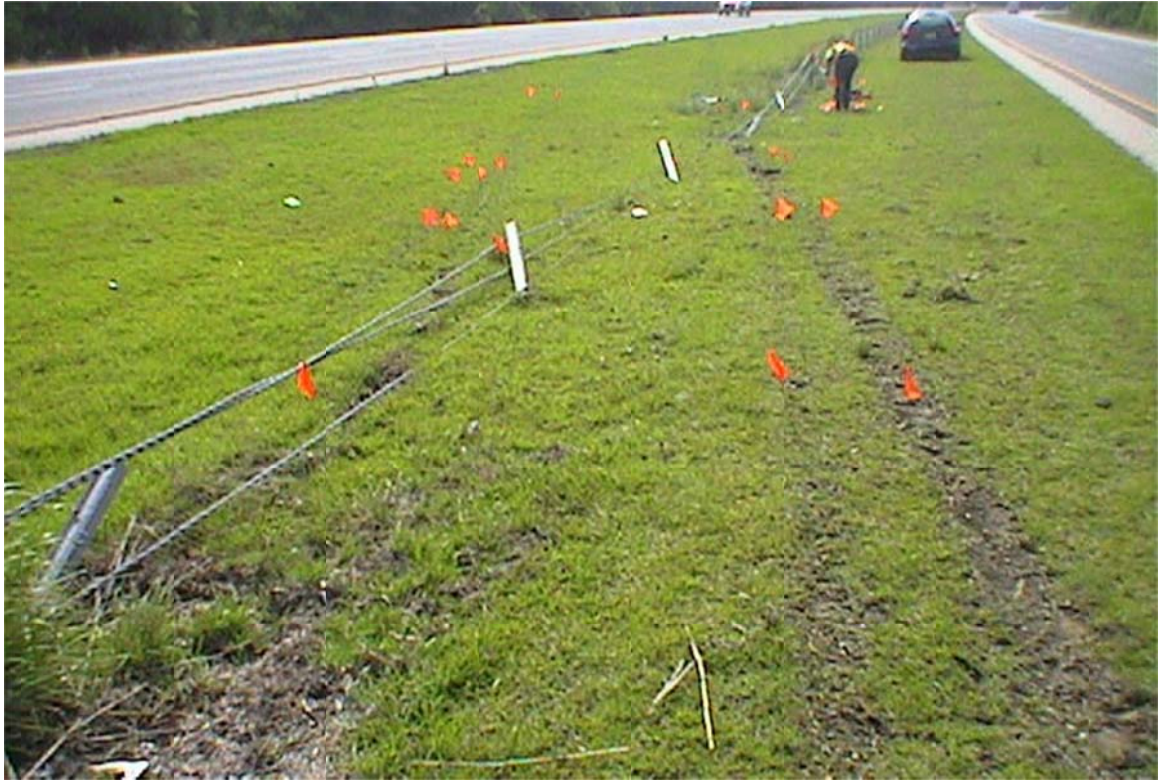
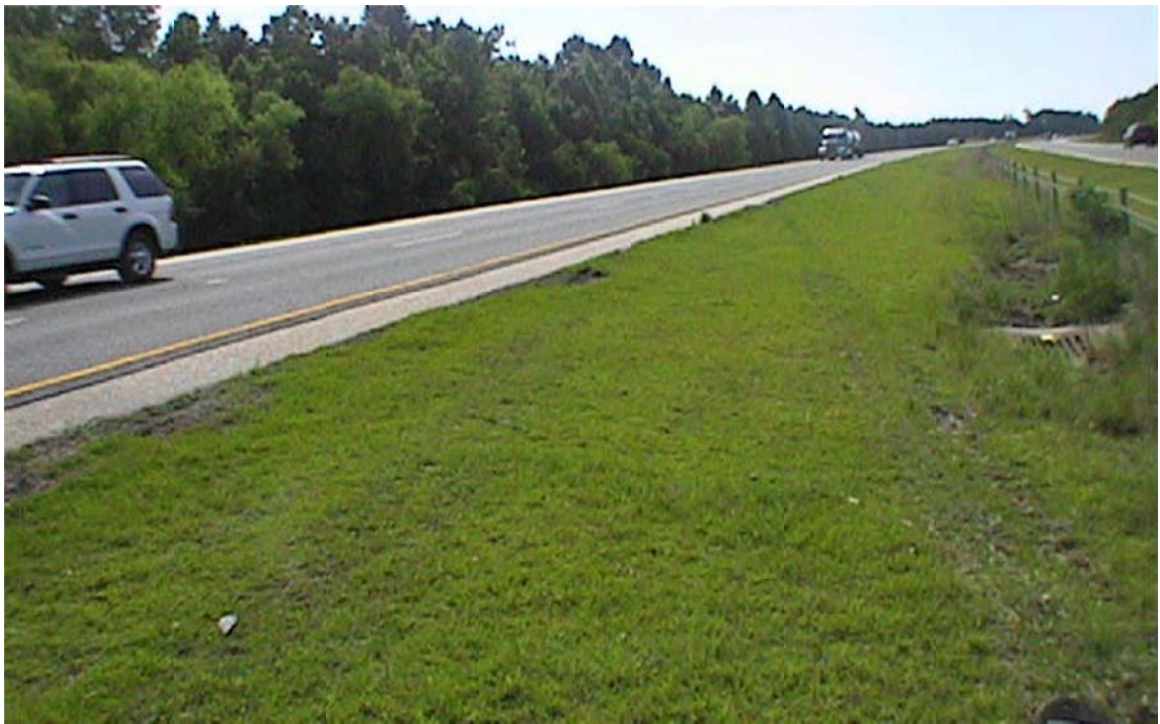
Figure 100. Prying Penetration Failure with SUV Caused by Brush Guard

Such an event was anomalous because very few impacting vehicles were equipped with these guards. However, the effect of the brush guard in this crash was a microcosmic representation of the effect of weak cable-to-post attachments on strong posts. Even large vehicles, which were typically excellent candidates for redirection on cable median barriers, were at increased risk of prying penetration crashes at high orientation angles. This further supports the conclusion that orientation angles can alter the energetically preferential interaction of vehicles with cable median barriers. If a sufficient contact groove was not made before the impacted cables began to slip on the vehicle, the likelihood of redirection was very low.

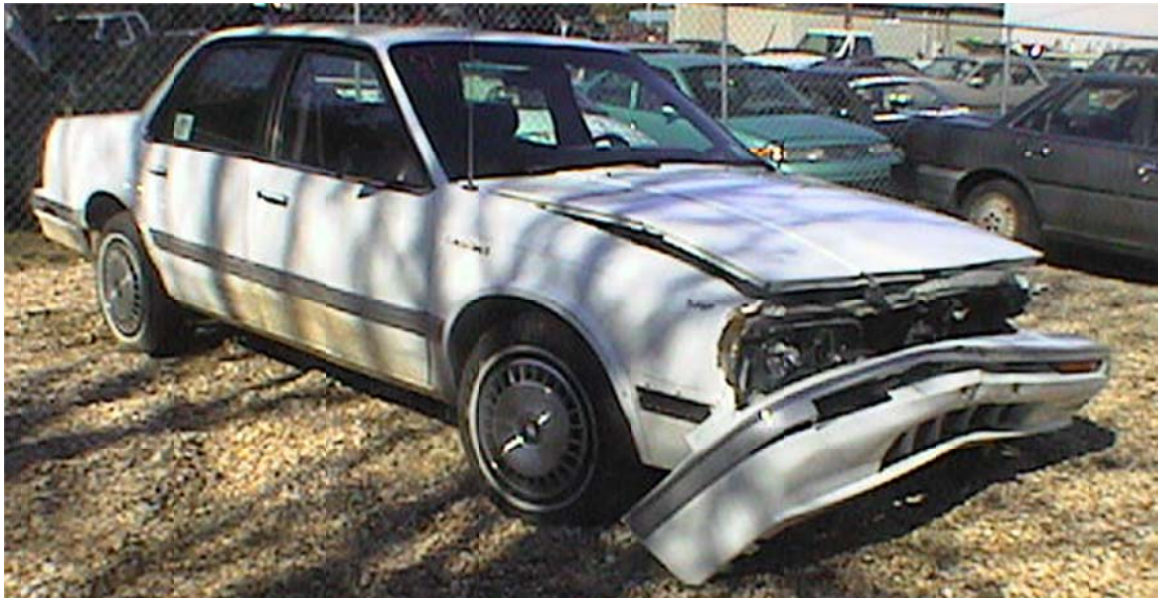
Figure 103. High-Tension Splice Tearout Penetration

Two cases of system failures were noted in the low-tension cable median barrier penetration database. In both crashes, the vehicle adequately engaged the tensioned cables and at least one cable formed a contact groove, fracturing the impacting corner headlight casing and collapsing the grill and fender around the cable. However, in both crashes, the low-tension cable splice failed, allowing the tensioned cable to rebound away from the vehicle. In one crash, the back-side bottom cable engaged the grill and headlight. As the cable was deflected with the vehicle, large tensions were developed in the cable and exceeded the strength of the cable splice. Similarly, in the other crash, the back-side middle cable engaged the bumper and grill of the impacting vehicle, crushing the fender and grill, characteristic of good capture behavior. As the cable was deflected with the vehicle into opposing travel lanes, high tension was developed in the cable and exceeded the splice limits. In both crashes, weak cable-to-post attachments contributed to splice failure. Photographs of the first crash are shown in Figures 102 and 103.

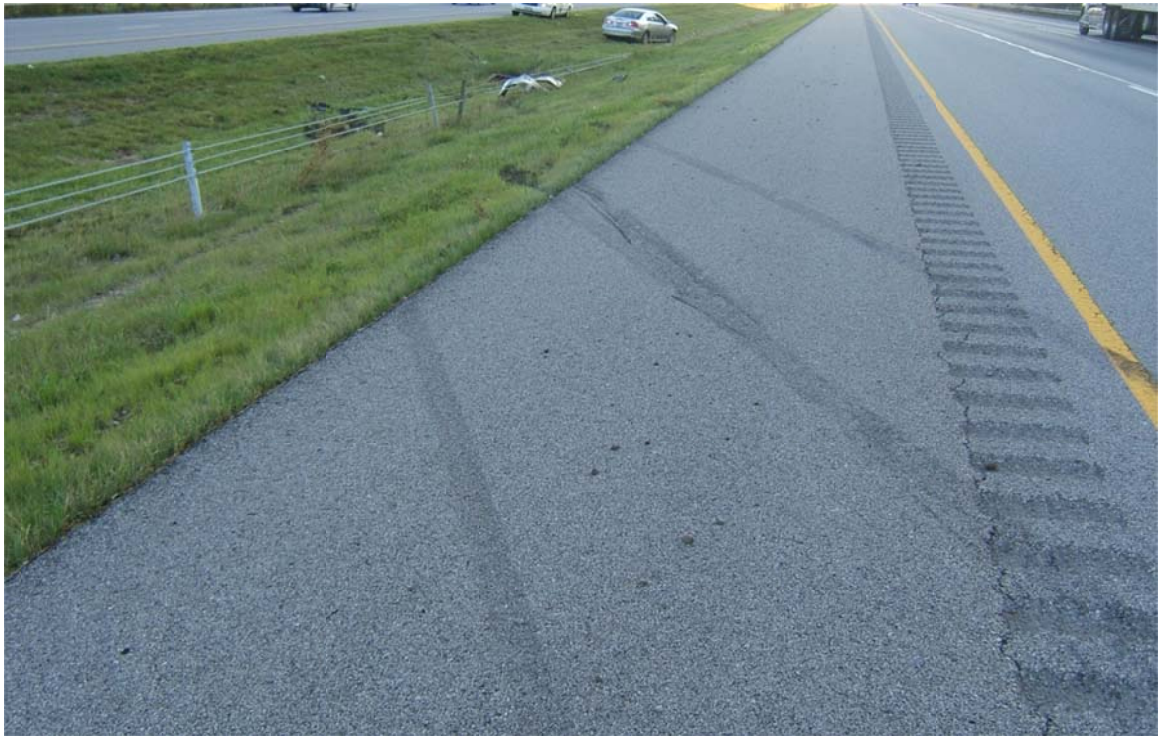
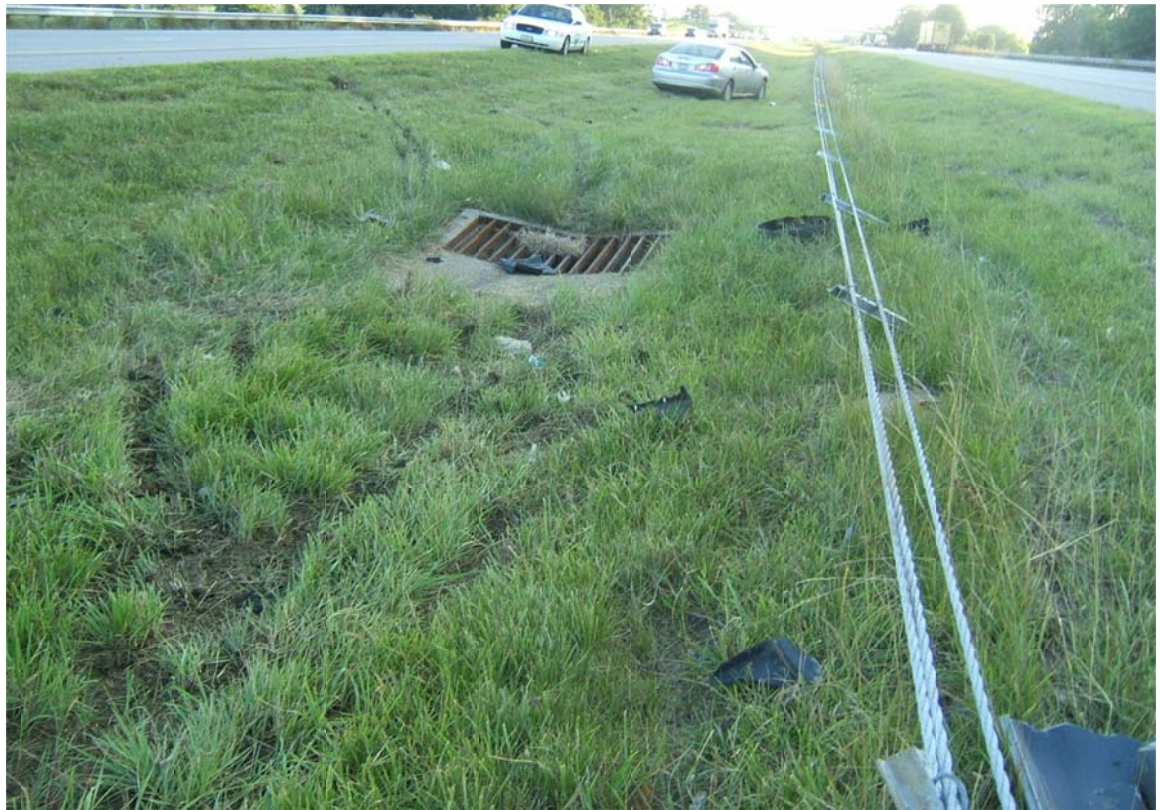
Figure 104. Crash Scene Photographs, Simulation No. 1

The crash sequence was initiated when the impacting vehicle lost control, swerving off of the road into the median. The vehicle departed the road with a CG trajectory angle of 32 degrees and an orientation angle of 62 degrees relative to the roadway. Based on a rudimentary crash reconstruction, the speed of the vehicle at the point of departure from the lane was determined to be approximately 58.1 mph (25.6 m/s), based on skid marks on the road and shoulder, tire marks in grass, post deformations, and vehicle damage energy estimates. Photographs of the crash site are shown in Figures 104 and 105.

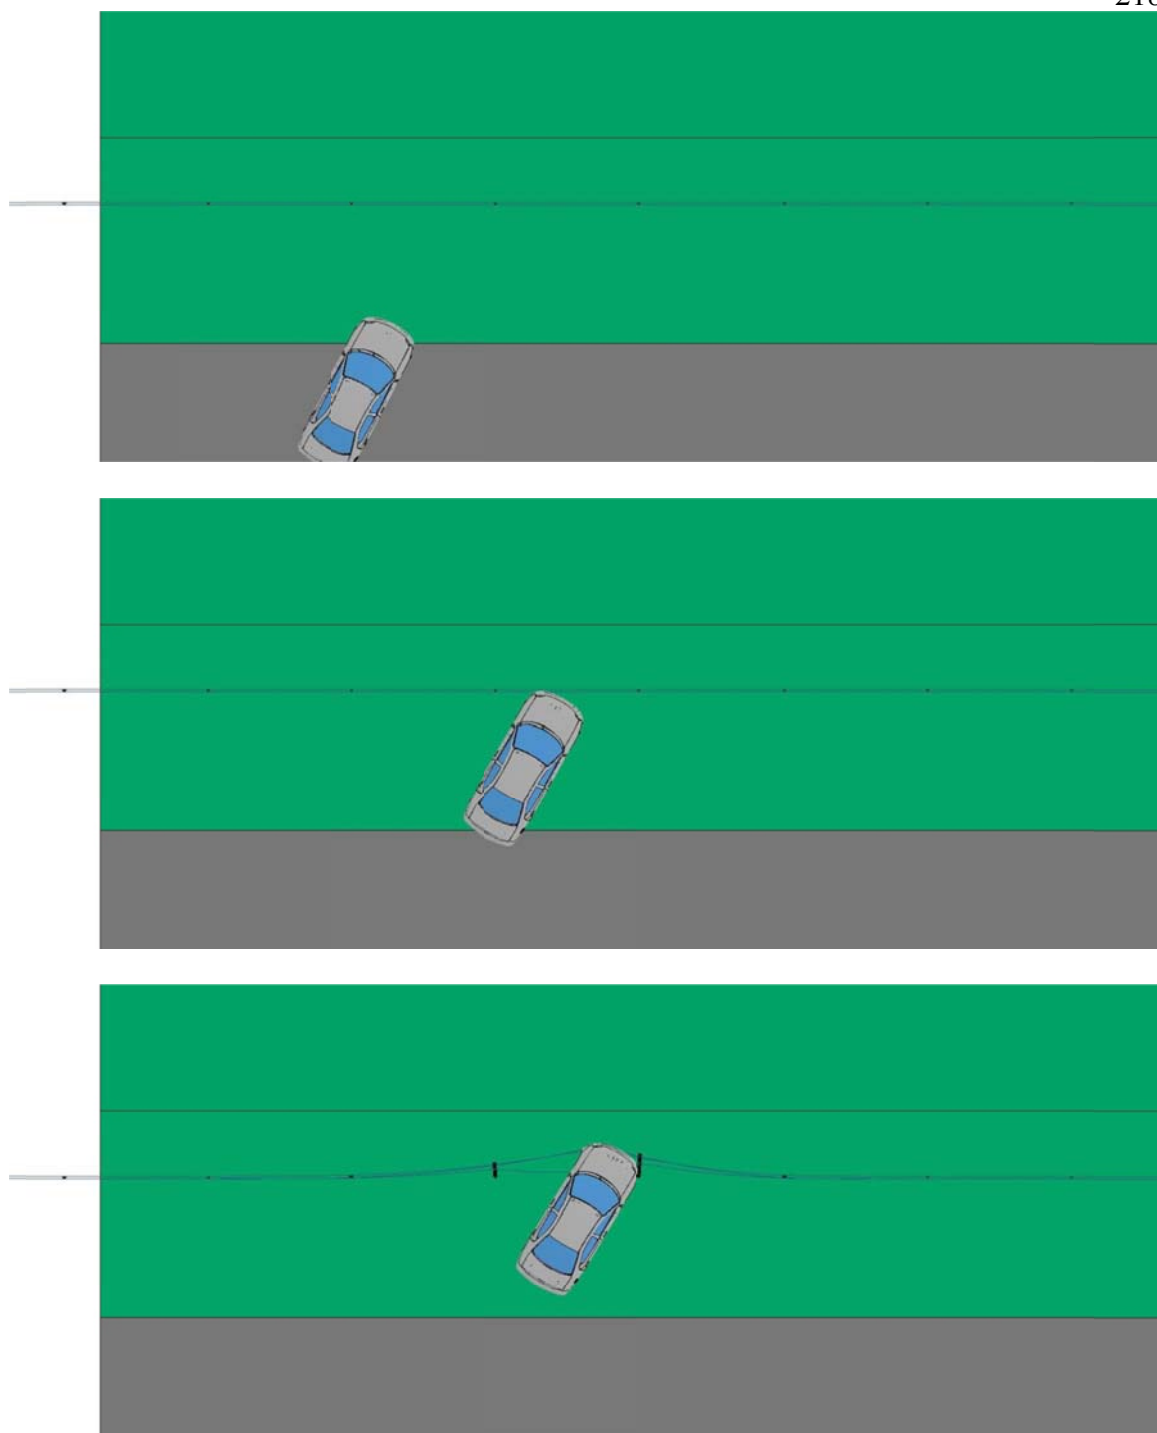
Figure 106. Overhead Sequentials, Simulation 1

Most events in the simulation matched physical evidence on the scene. The vehicle projected over the slope and overrode the cable; however, in the crash, the downward pull of the cables deformed the bumper cover attachments, and ultimately tore the bumper cover off of the vehicle. The bumper cover deformed and the rebounding

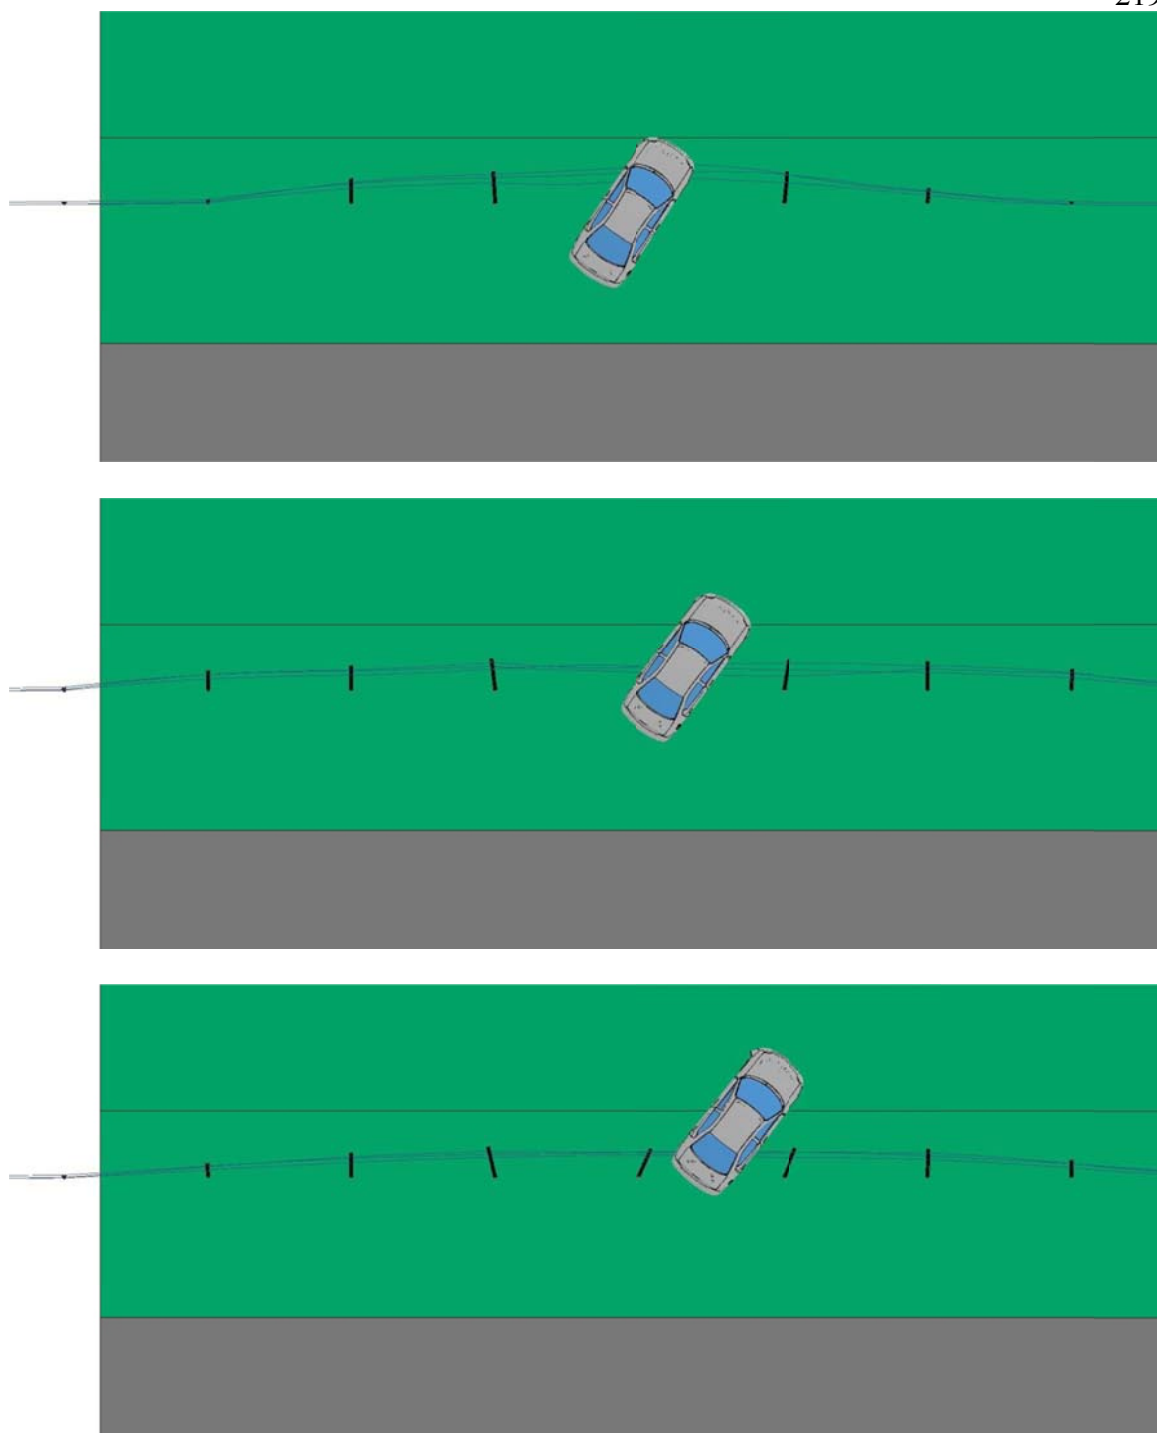
Figure 106 (cont). Overhead Sequentials, Simulation 1

Sequential photographs of simulation no. 1 are shown in Figures 106 through 109. The vehicle projected over the top of the slope break point and struck the cable median barrier while airborne. The top cable of the Nucor system contacted the vehicle's bumper and was forced below the bumper. The high tension in the cable pulled the bumper cover downward and pulled against the attachments supporting the bumper cover. As the cable deflected, lateral force from the cables caused the second cable to rebound, followed by the first. The vehicle then contacted the back slope and rebounded upward, and the steering linkage was torqued, causing the vehicle to redirect downstream. The rear tires contacted the cables and fractured posts and continued to deform the cables downward.

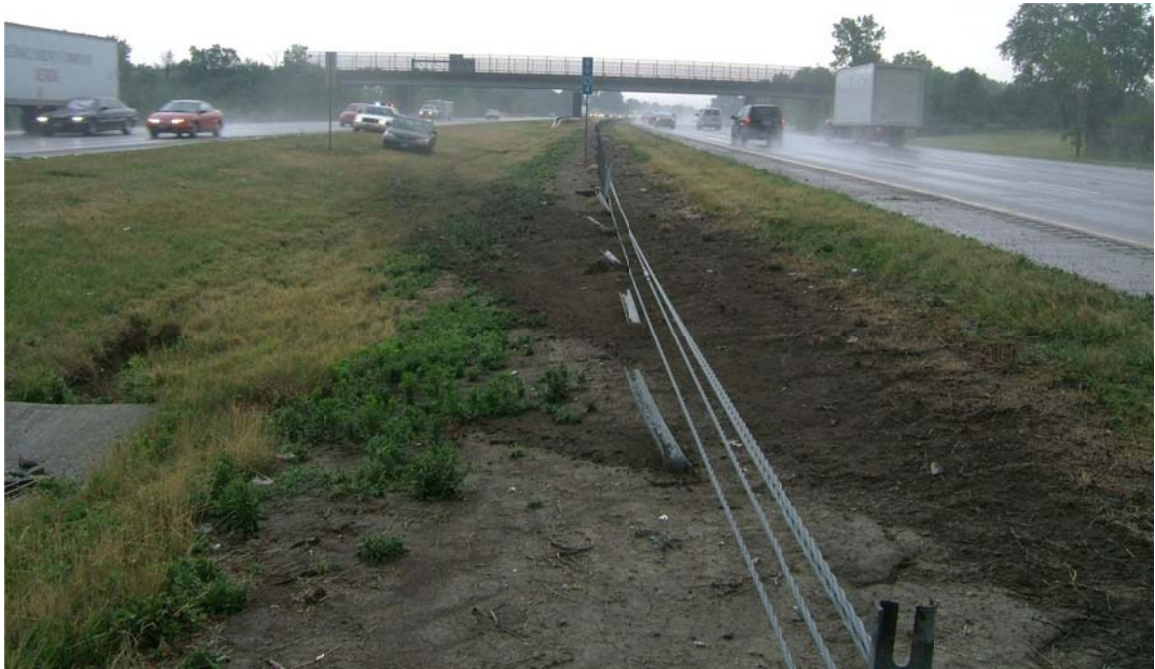
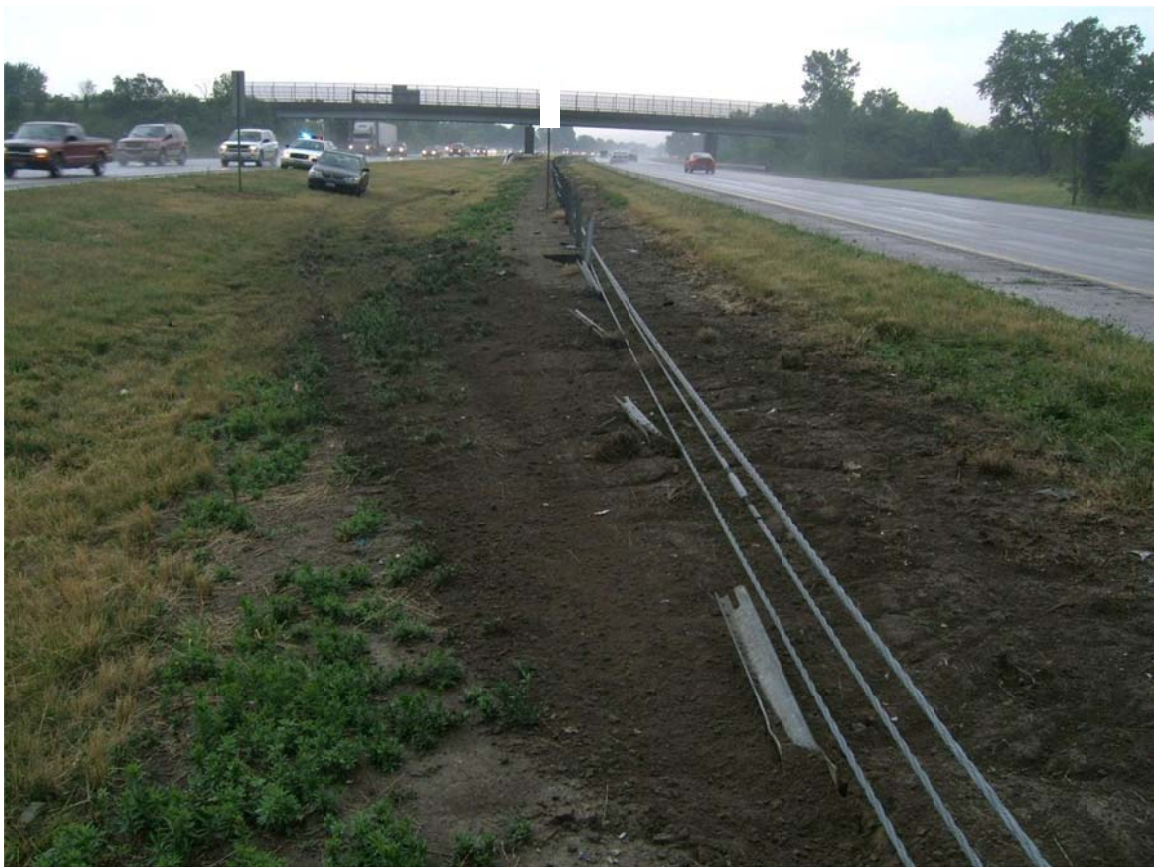
Figure 110. Crash Scene Photographs, Simulation No. 2

The Brifen system, as previously detailed, involved 0.24-in. (6-mm) thick S-posts. roller cable supports locked on the sides of the posts, woven cables between posts, and posts placed in sleeves. The cable heights were at 19.7, 26.0, and 28.3 in. (500, 660, and 720 mm), with two cables woven on opposite sides of the post at 26.0 in. (660 mm). The vehicle, a 2000 Toyota Avalon, struck the cable median barrier with CG trajectory and orientation angles of 16 and 152 degrees. Photographs of the crash scene are shown in Figures 110 through 112. This vehicle never departed the ground during impact, and the low CG trajectory angle and relatively flat approach slope enabled a straightforward crash reconstruction. Based on frictional values and post deformation energies, researchers estimated that the impact speed was approximately 50.7 mph (81.6 km/h).

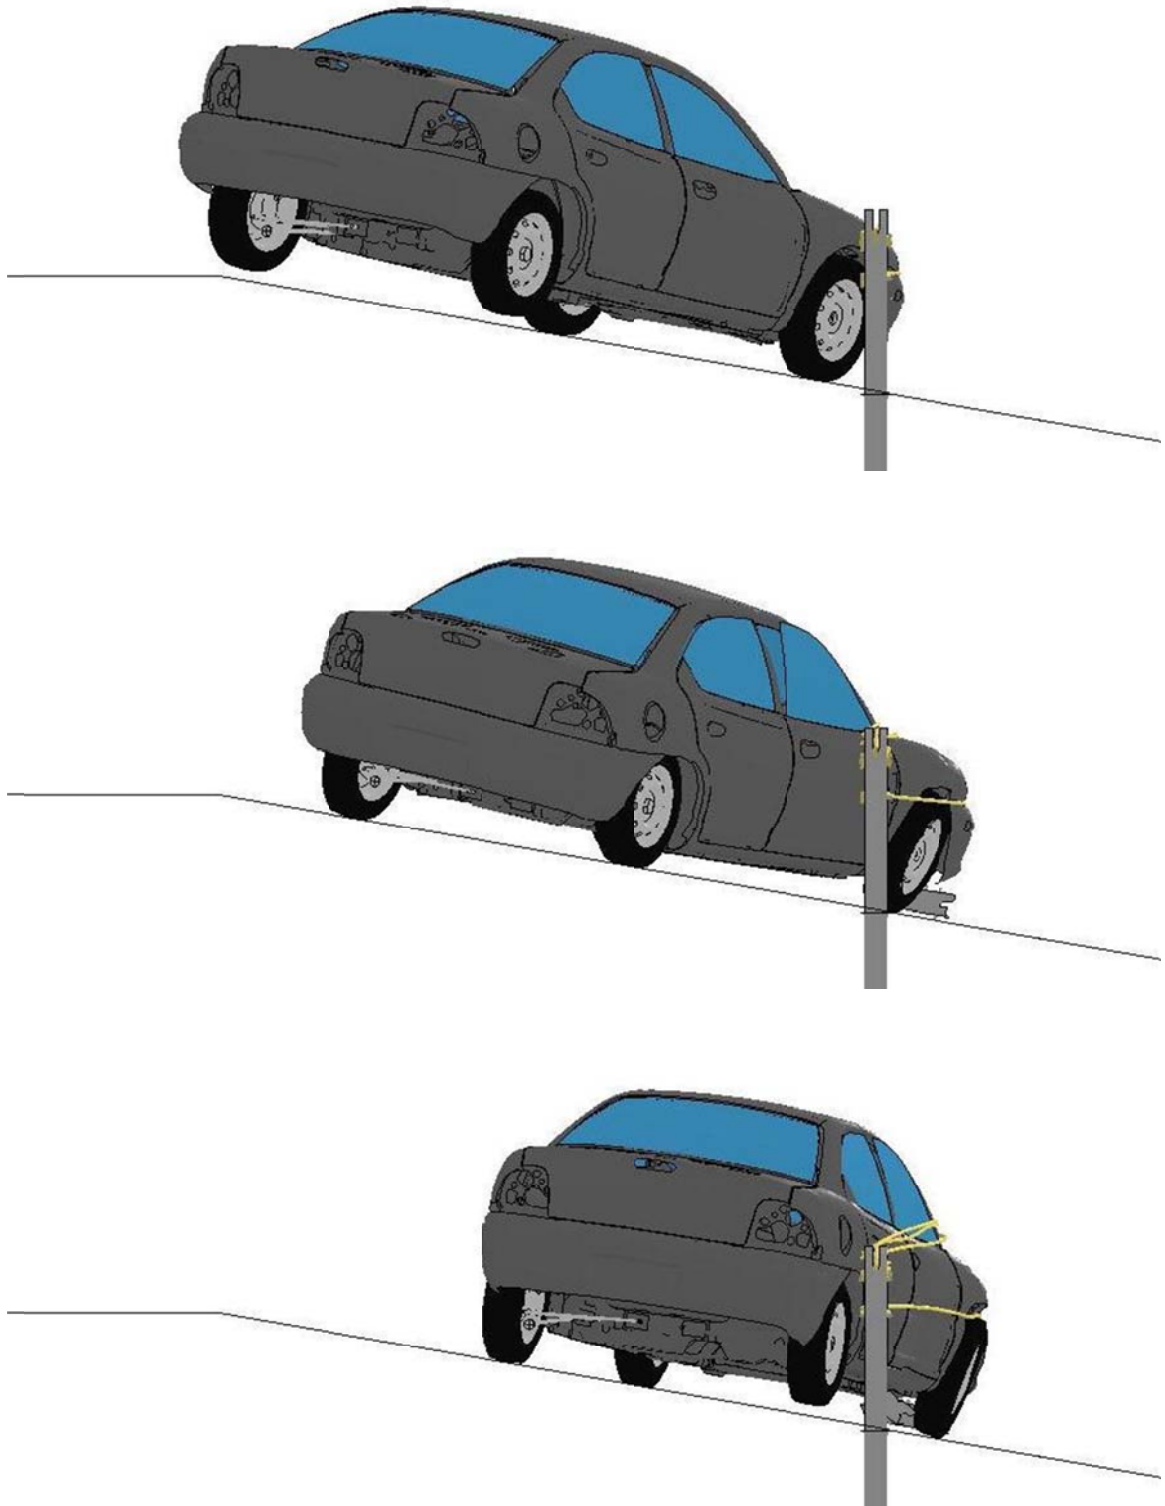
Figure 113. Downstream Sequentials of Redirection Simulation, Simulation No. 2

Initial simulation results showed vehicle capture instead of penetration. The vehicle struck the cable median barrier and the cables deformed the right-front fender inward toward the headlight housing. The low vehicle mass and yaw moment of inertia caused the vehicle to rotate around the right-front corner, enabling the back of the vehicle to strike the system. The vehicle was redirected and did not rebound into adjacent travel lanes. Sequential photographs of the vehicle redirection event are shown in Figures 113 and 114.

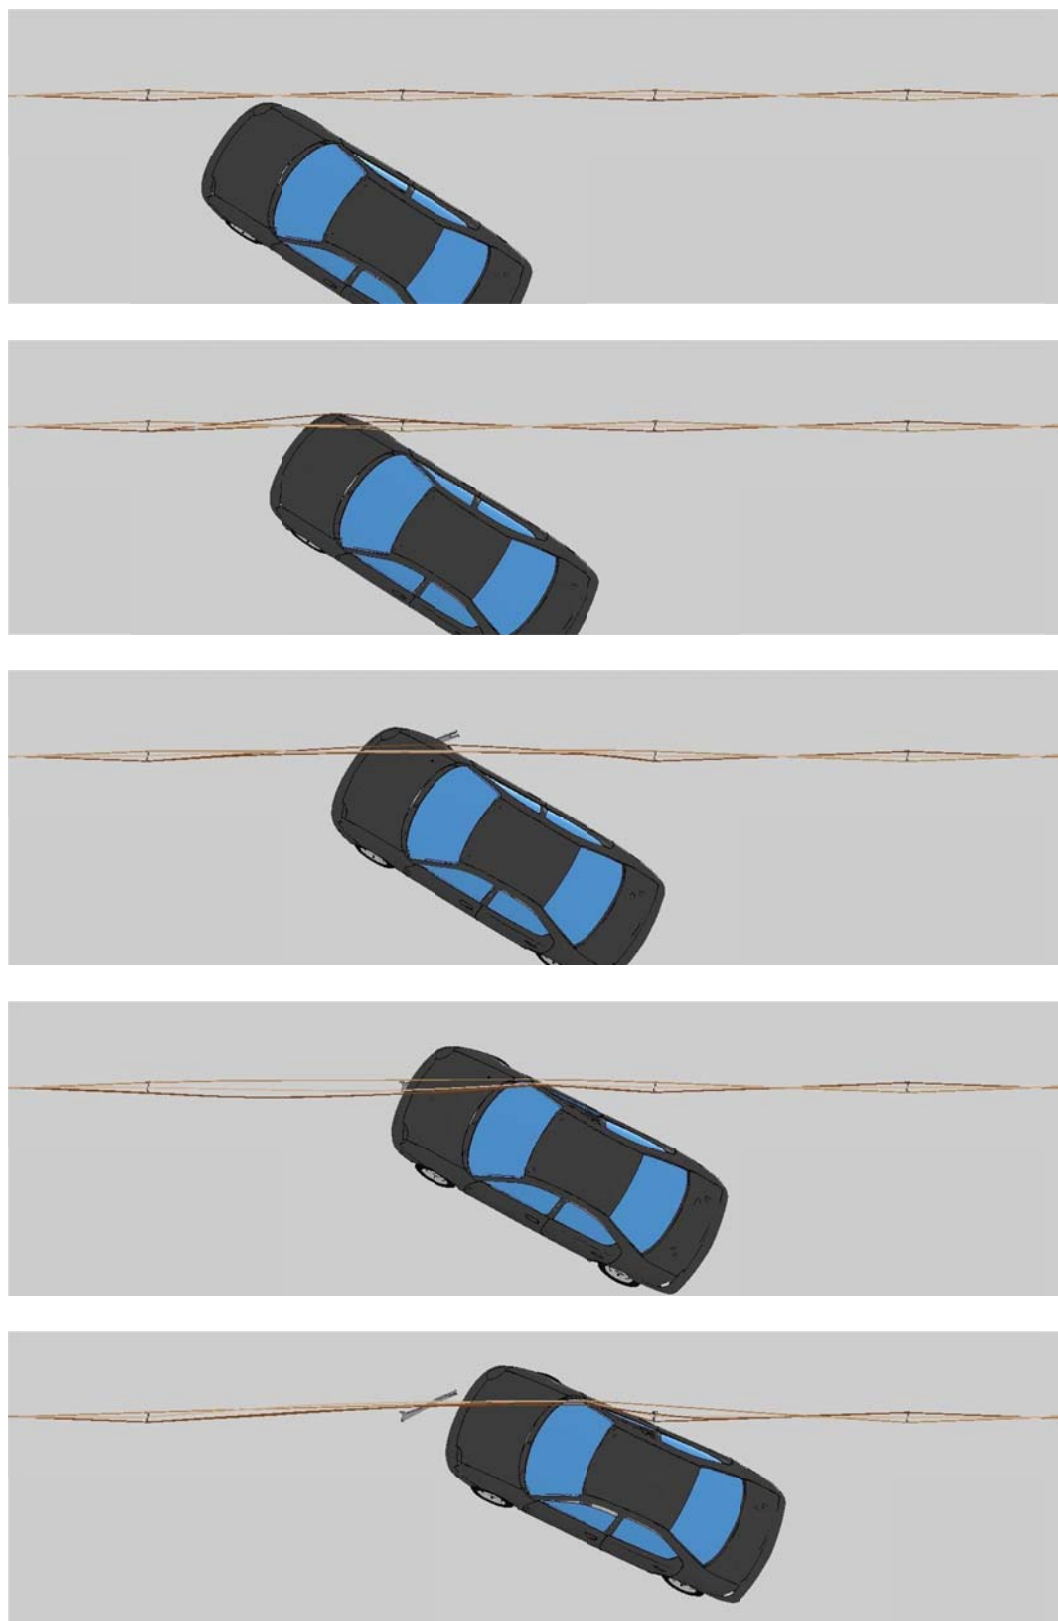
Figure 115. Overhead Sequentials of Penetration Simulation, Simulation No. 2

The updated simulation results are shown in Figures 115 through 117. The Neon projected over the 9:1 slope and into the cable median barrier. The vehicle struck the barrier with the right-front corner. The front headlight struck the bottom cable first, lifting the cable over the top of the right-front headlight, and over the right-front corner of the hood. The remaining three cables struck the right-front fender and hood and were also
