CABLE MEDIAN BARRIER
FAILURE ANALYSIS AND REMEDIATION

by
Cody S. Stolle

A DISSERTATION

Major: Civil Engineering
Structural Engineering

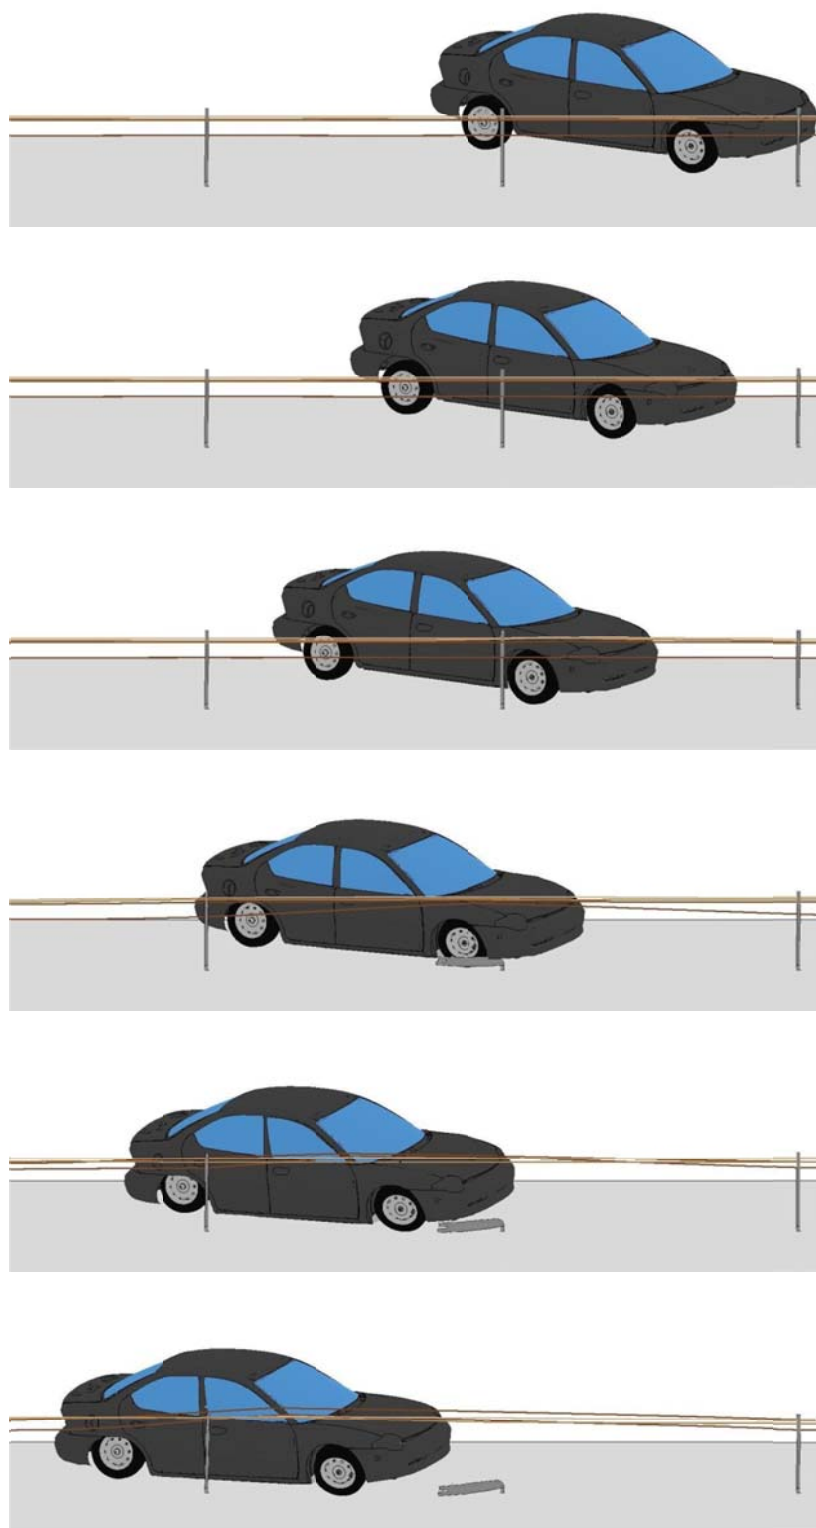
Figure 116. Behind-Barrier Sequential of Penetration Simulation, Simulation No. 2

The updated simulation results are shown in Figures 115 through 117. The Neon projected over the 9:1 slope and into the cable median barrier. The vehicle struck the barrier with the right-front corner. The front headlight struck the bottom cable first, lifting the cable over the top of the right-front headlight, and over the right-front corner of the hood. The remaining three cables struck the right-front fender and hood and were also

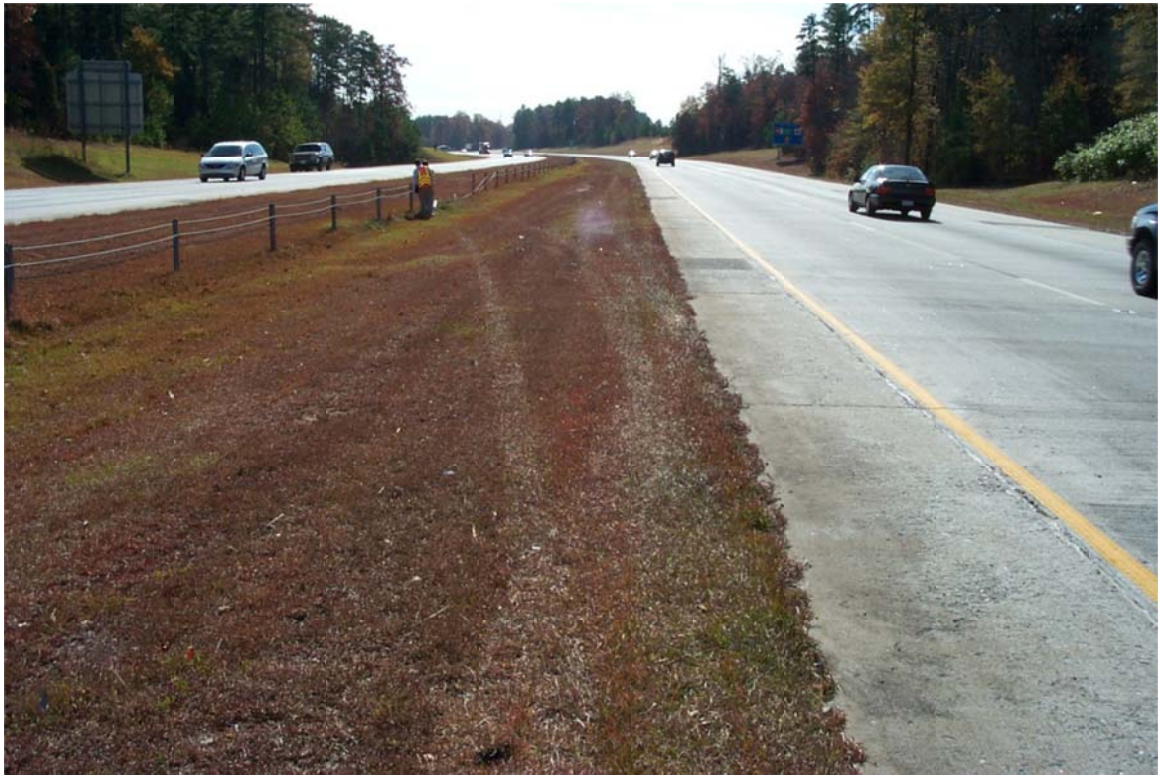
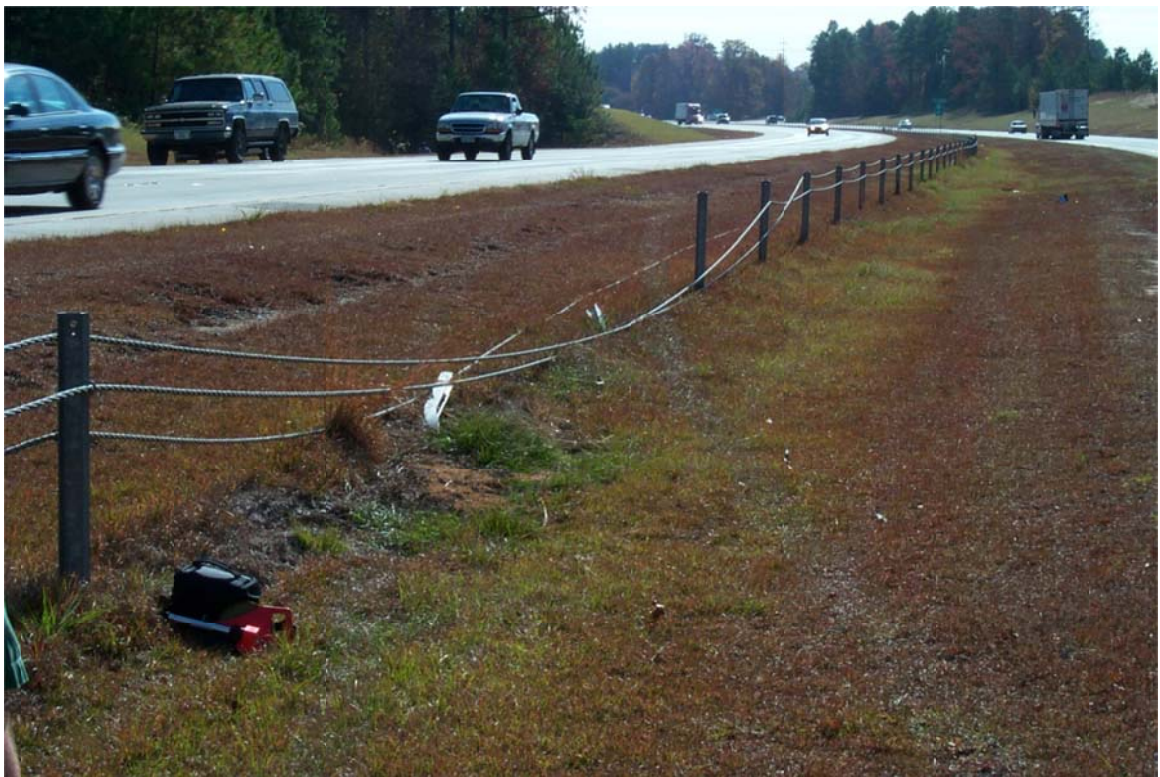
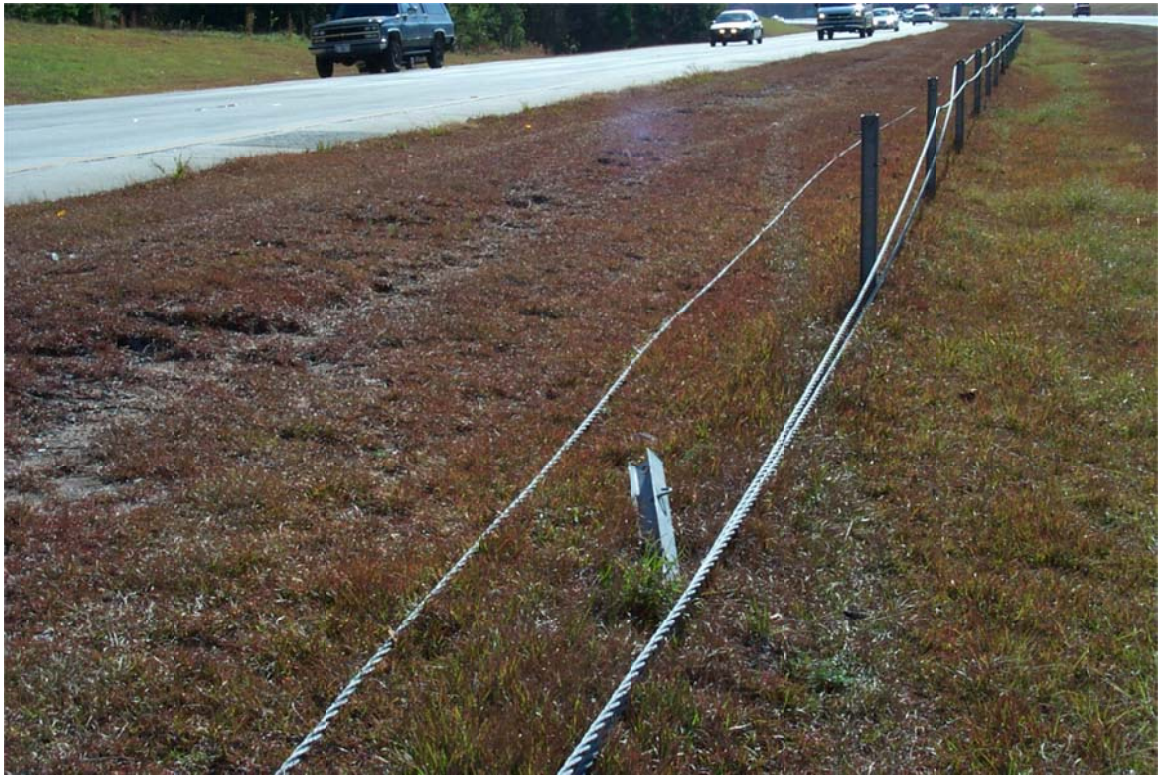
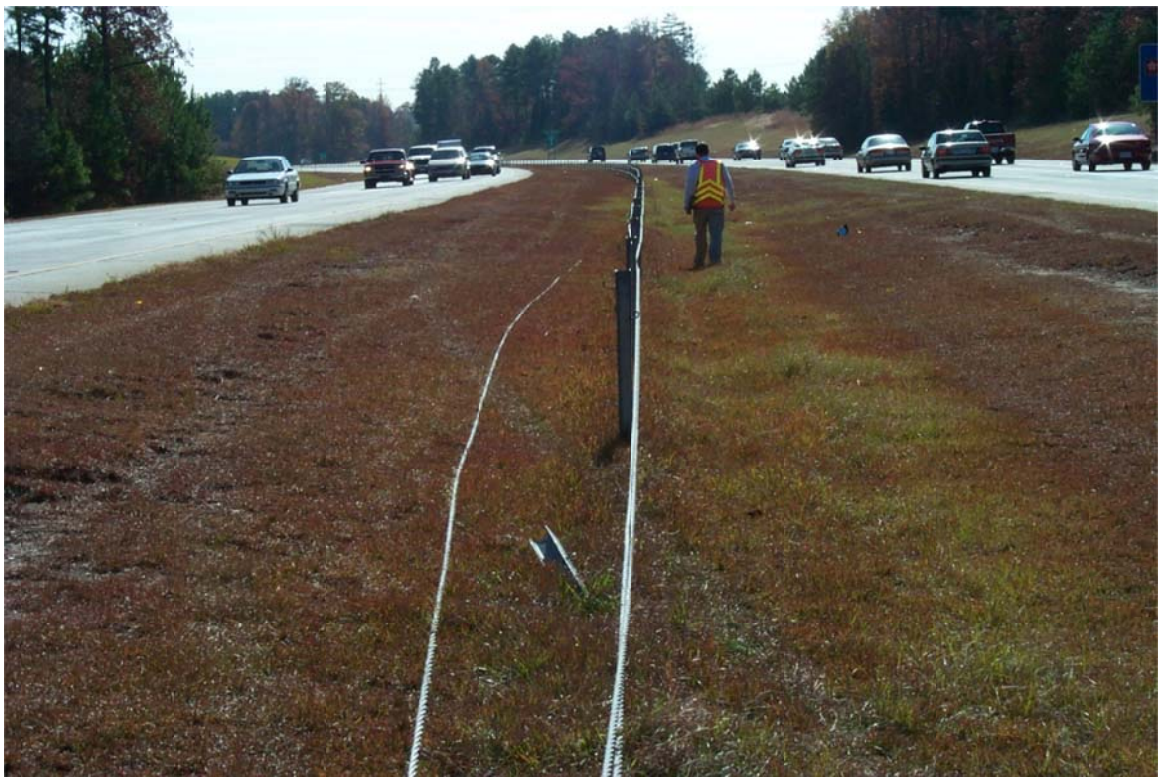
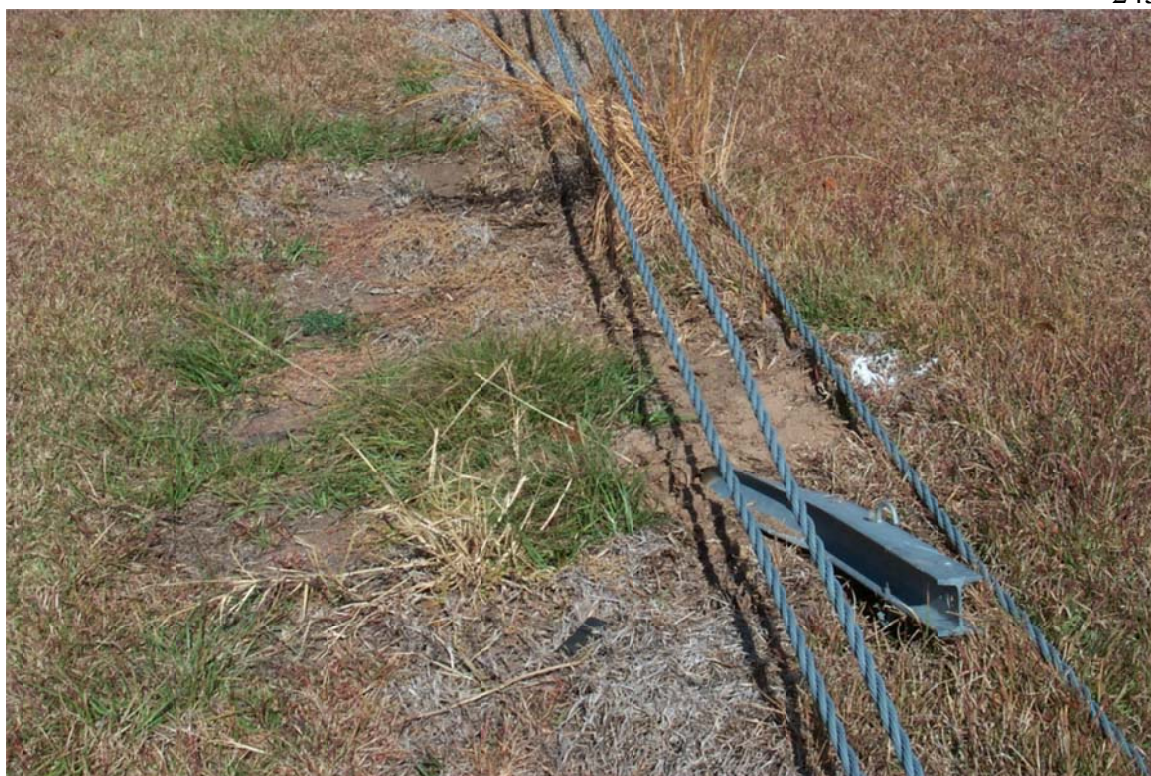
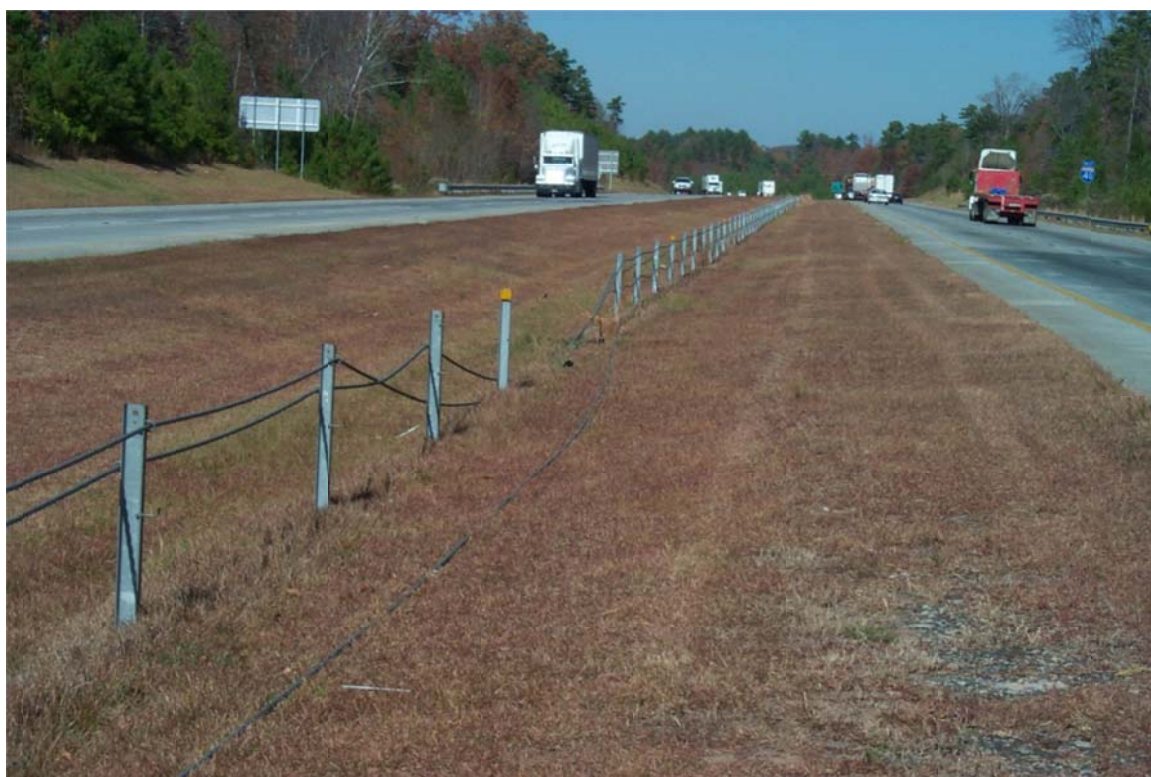
Figure 118. Crash Scene Photographs, Simulation No. 3

Post-crash photographs are shown in Figures 118 through 120. Based on scene diagram and trajectory information, it appeared that the driver either became incapacitated or fell asleep. The vehicle, a 2000 Mercury Grand Marquis, drifted off of the roadway with a CG trajectory and orientation angle of 7 degrees. There were no visible signs of braking or steering throughout the departure event. The vehicle passed through the bottom of the ditch, gradually increasing the CG trajectory angle to 11 deg prior to impact due to some left steering input. The vehicle remained engaged with the bottom cable for a sufficient amount of time to remove the bottom cable from more than 15 posts downstream of impact with a small steering angle to the left, before the vehicle redirected up the back slope and collided head-on with a different vehicle in the opposite travel lanes.

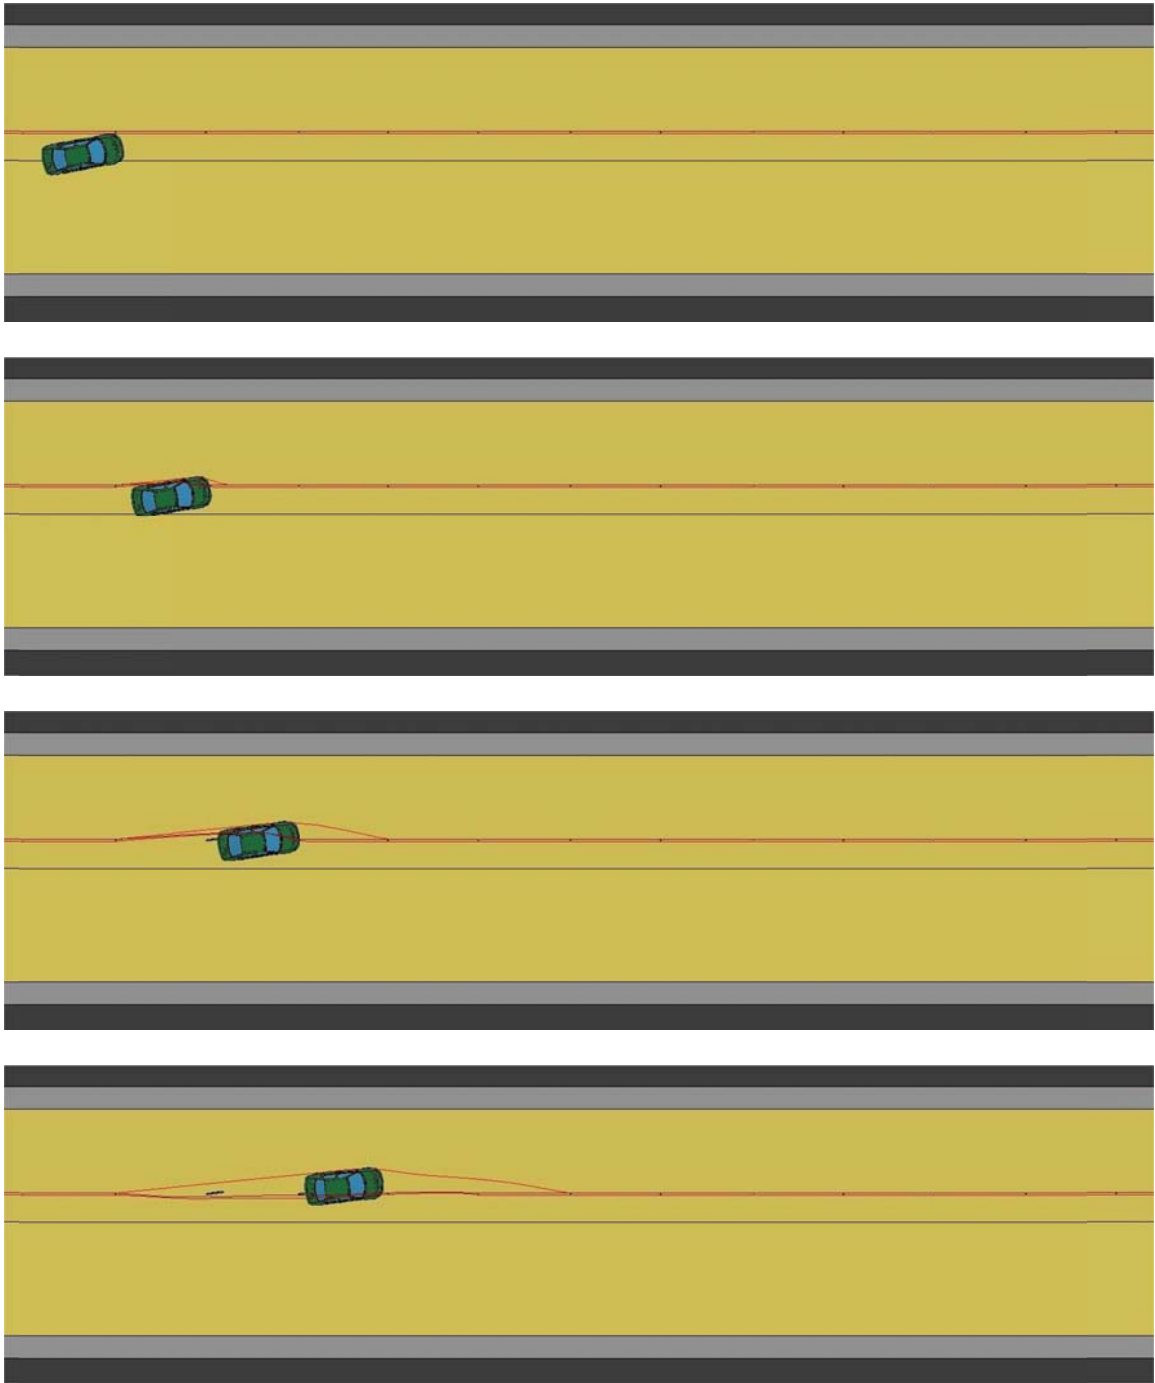
Figure 121. Overhead Sequentials, Simulation No. 3

Differences between the crash test and the simulation caused some variation in the end result of the simulation. The primary difference was that no steering input was applied to the simulated vehicle as was observed in the crash, which was evident in the increasing CG trajectory angle of the errant vehicle on the traffic-side approach slope. Additionally, there were differences between the wheelbase and overall vehicle weight, in addition to suspension spring stiffness and vehicle crush stiffness. Despite these differences, the model closely replicated the failure mechanism observed in the crash.

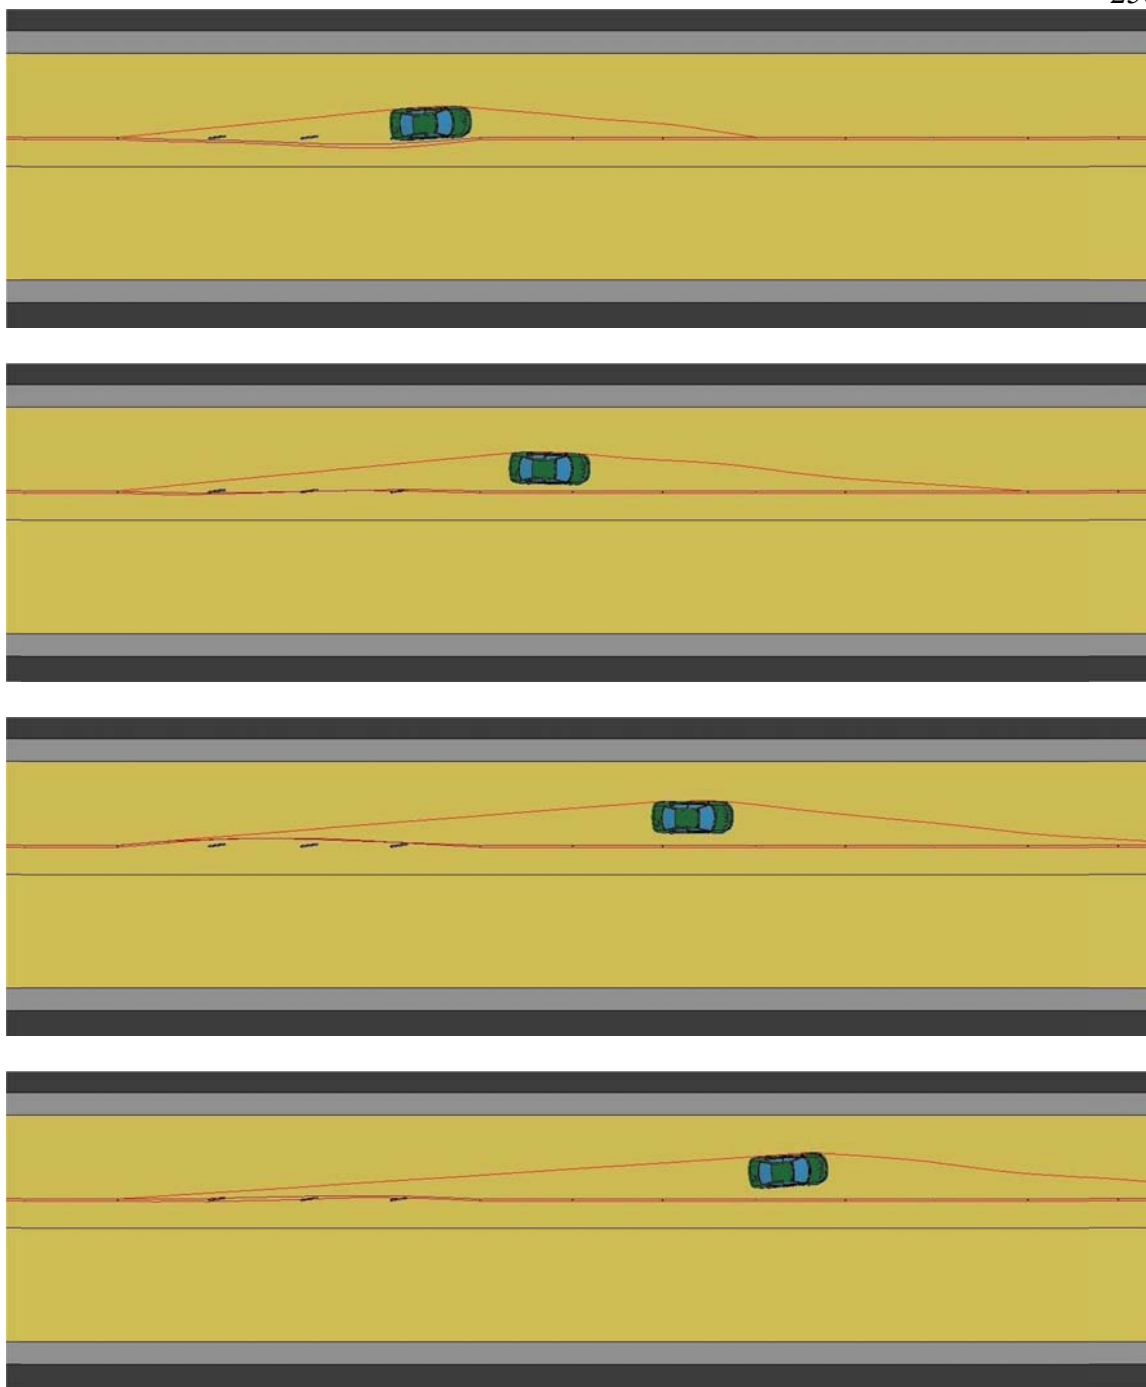
Figure 121 (cont). Overhead Sequentials, Simulation No. 3

Sequential photographs of simulation no. 3 are shown in Figures 121 through 124. After initial simulations in which the vehicle was captured by the barrier, the simulated vehicle mass was increased such that the weight of the vehicle in the model was equal to the curb weight of the vehicle, as reported by Expert AutoStats. The vehicle followed a similar trajectory as the vehicle involved in the penetration crash. Upon impact, the middle and upper cable were pried upward and over the hood, as the bottom cable engaged the vehicle at the headlight location. The bottom cable crushed into the front fender less than 1 in. (25 mm) as it was displaced laterally by the vehicle. The cable was removed from 10 posts downstream of impact before the vehicle redirected parallel with the system, and the bottom cable slipped down the vehicle bumper and fender, and was eventually run over by the tires.

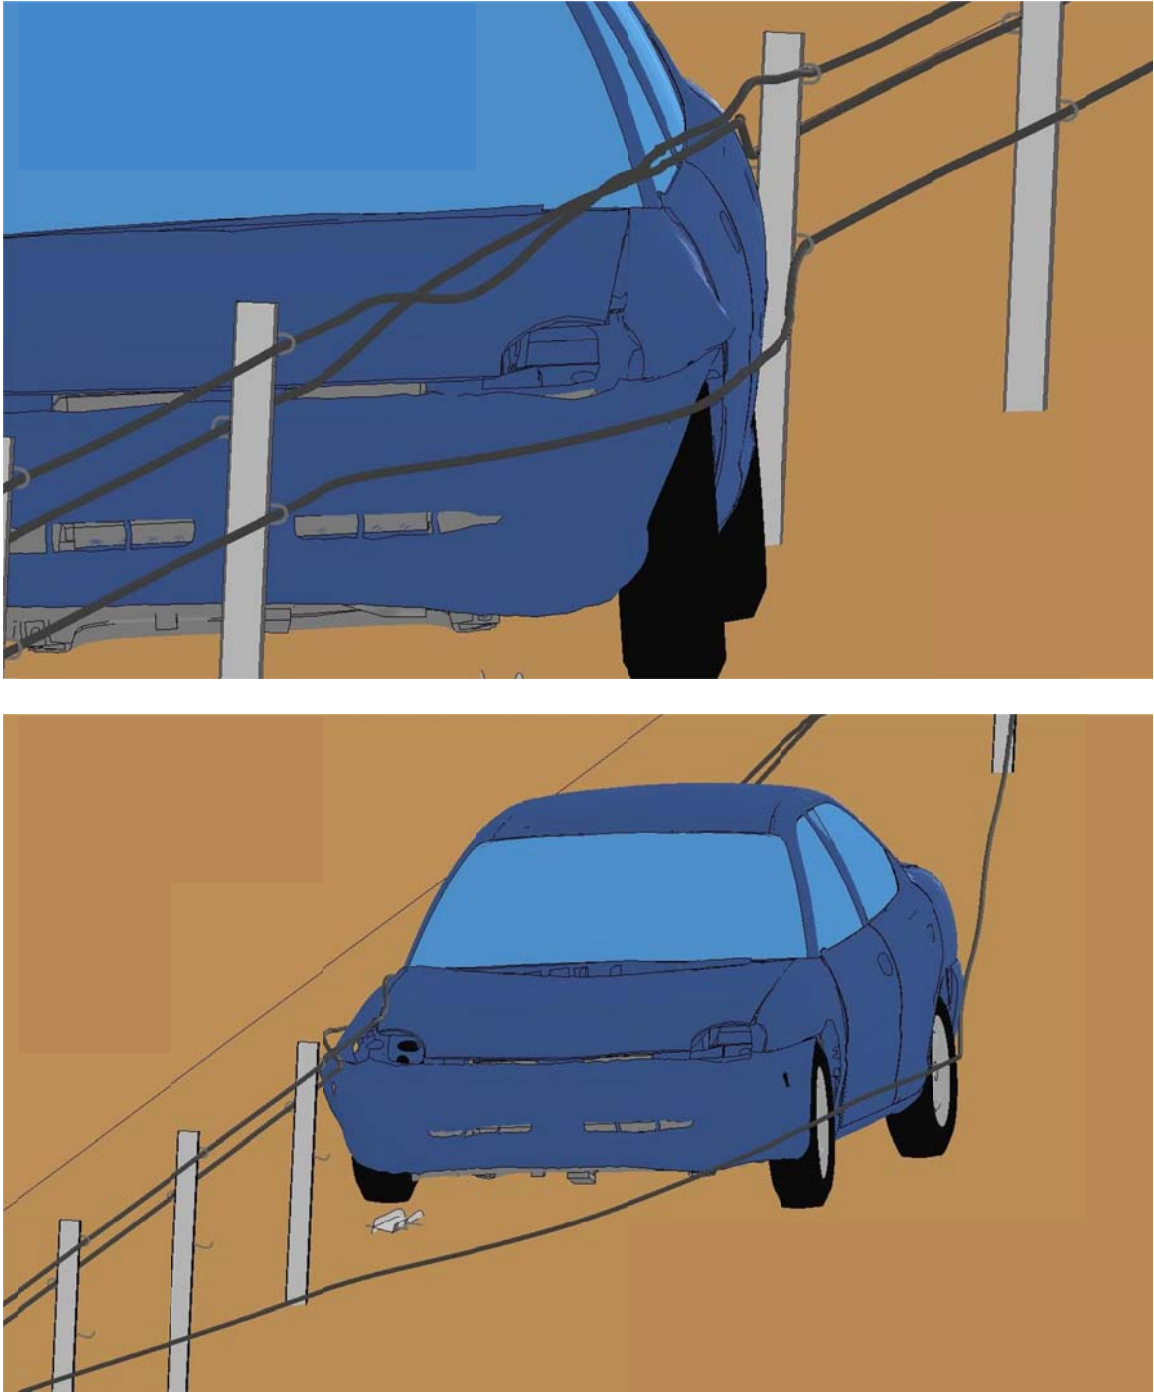
Figure 124. Critical Events Occurring in Both Simulation and Real-World Crash

Despite these differences, critical features of the simulation and crash test were similar. The vehicle passed through the ditch bottom with some suspension displacement not exceeding 2 in. (51 mm) at the point of contact with the cable median barrier. The middle and upper cables slipped over the hood due to similar bumper-to-hood separation distances, and the bottom cable engaged the vehicle at the left-front fender corner. The bottom cable was removed from enough posts downstream of impact to allow the cable to droop when the vehicle trajectory became parallel with the system. The vehicle overrode the bottom cable, resulting in penetration, and became free-wheeling.

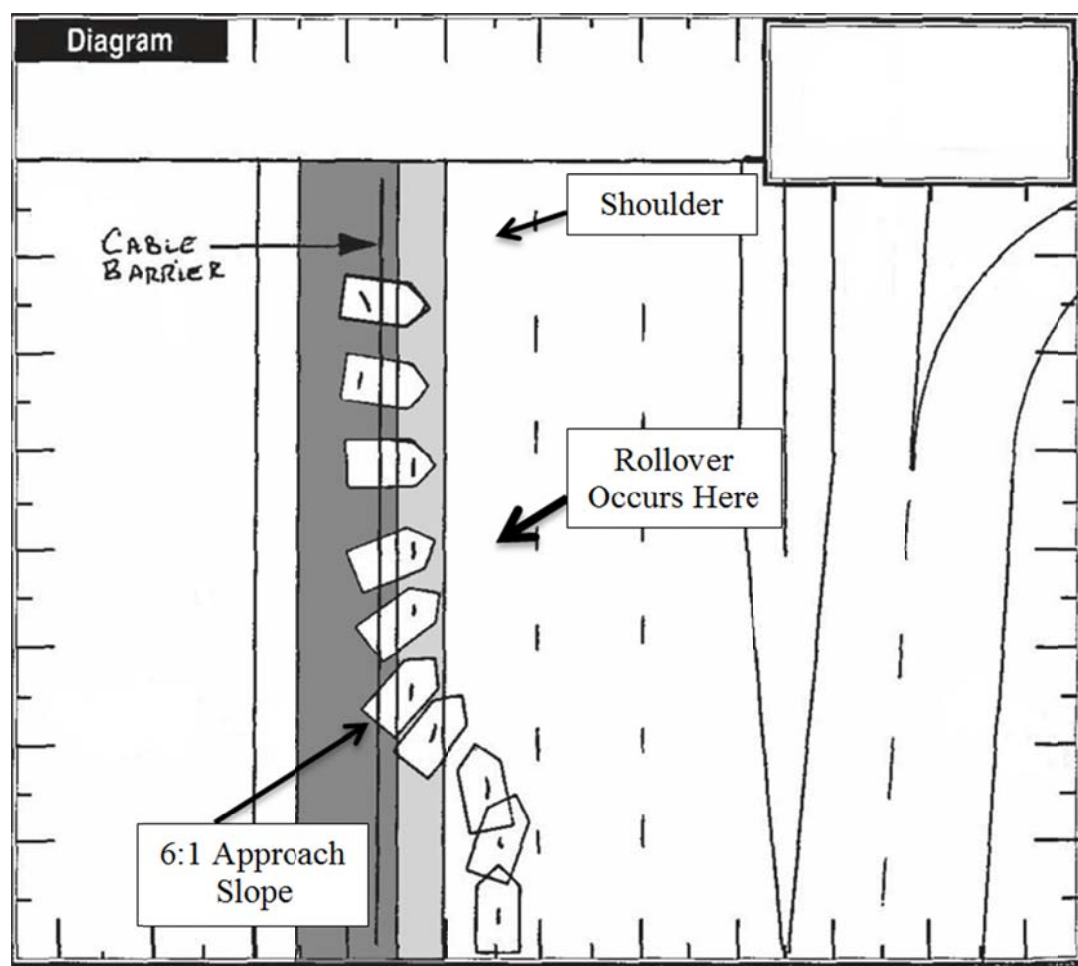
Figure 125. Entrapment Rollover Crash in which Vehicle Extends Over SBP of 6:1 Slope

The second slope-related rollover failure type was due to vehicle orientation near the center of a steep V-ditch. Vehicles were also captured during this type of rollover, but redirection frequently resulted in yaw displacement of the vehicle around the impacting end. Wheels on the other end of the vehicle were forced to climb the median approach slope which had been traversed during yaw rotation, which generated large, dynamic vertical and sideslip forces. Due to a combination of large trip forces, vehicle instability, digging in to the slope, post impact, or rough median terrain, the vehicle then tripped and rolled.

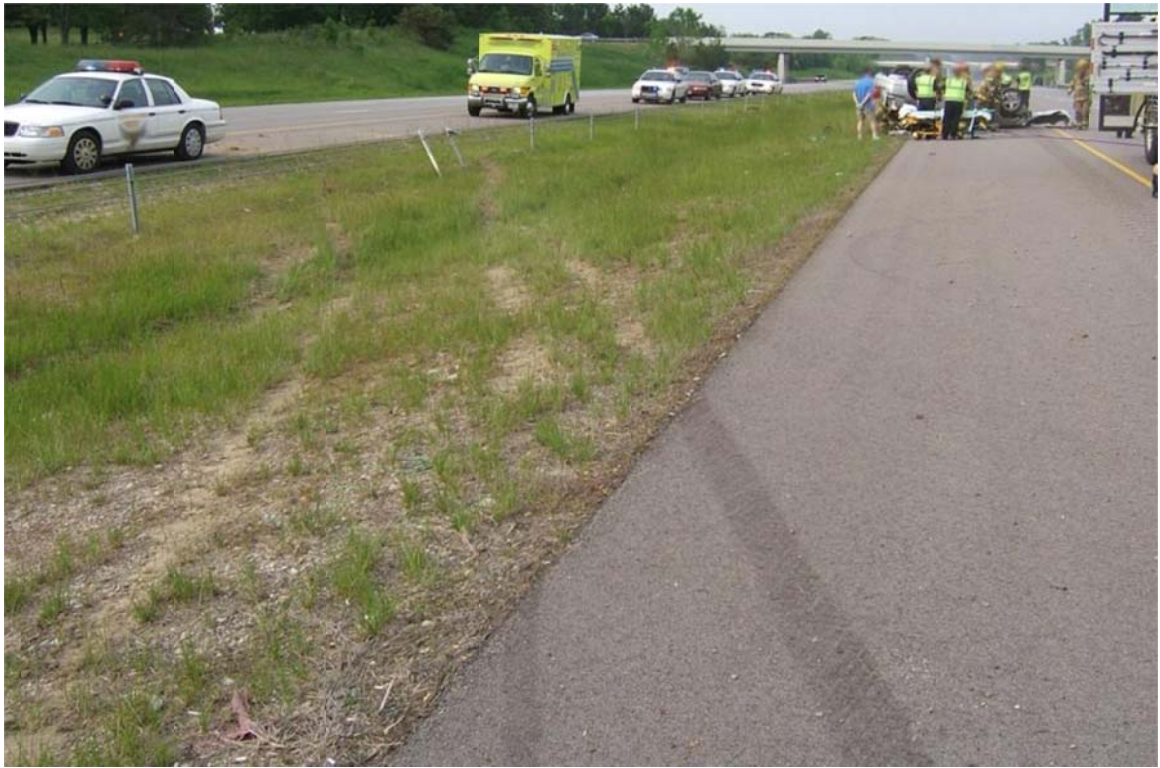
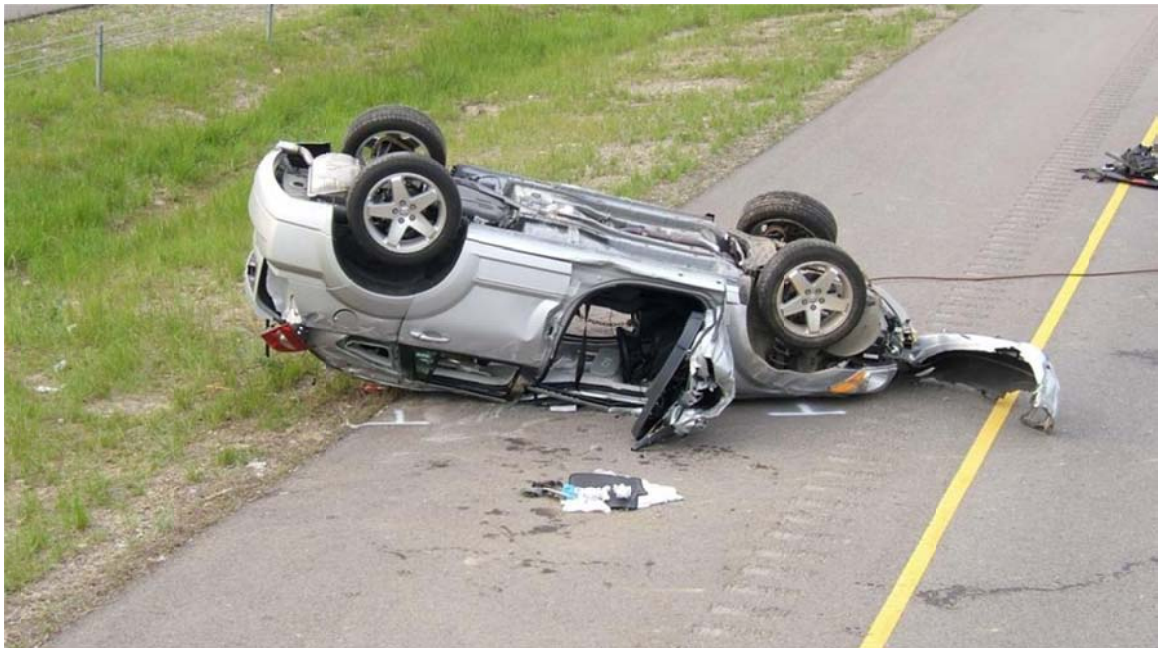
Figure 126. Example Rollover Crash Caused by High Redirection on Back Slope

Pickup trucks, vans, and SUVs were found to be the most susceptible to the median slope-related crashes in which the wheelbase and suspension stroke were large. Passenger cars were involved in only 4 out of the 25 potential median slope-related rollovers. Of these, two were full-size cars, one was a mid-size “crossover” class vehicle, and one was a compact car. Also, it should be noted that a large oversteering angle was present in most of these crashes. A distinction was made between steep median slope rollovers and oversteering rollovers based on the largest contributing circumstance. Steep median slope rollovers were identified as crashes in which the vehicle “bounced” or compressed on the suspension due to the median slope, and the suspension compression and possible wheel entrapment on the slope were the largest contributors to rollover.

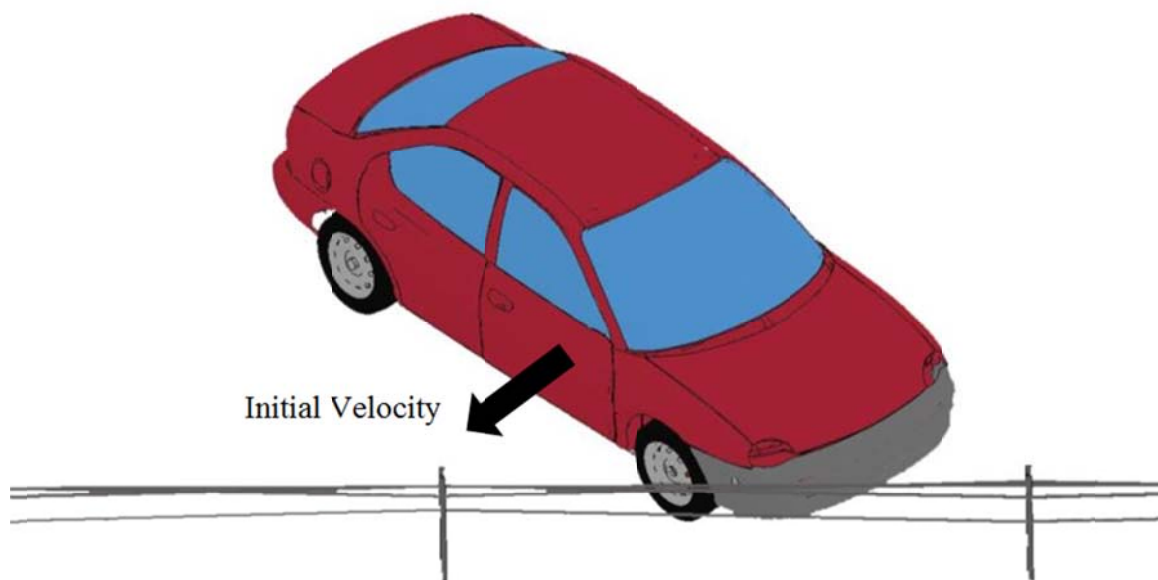
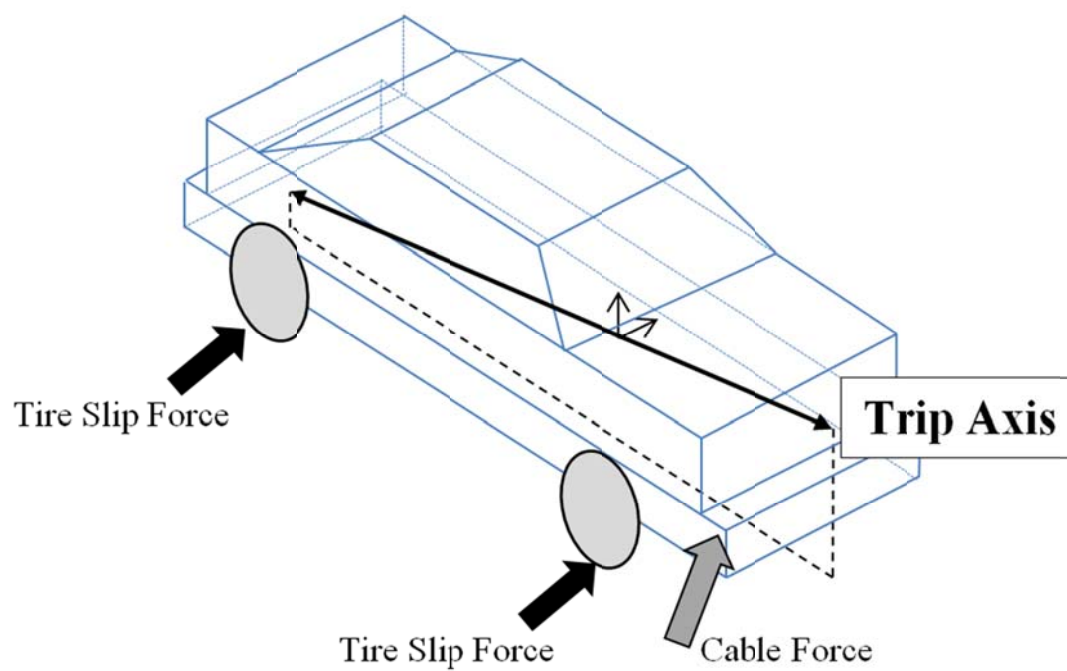
Figure 128. Impact at High Orientation Angle with Unbalanced Force Diagram

Vehicle impacts at high orientation angles contributed to vehicle instability by increasing the overturning moment applied to the vehicle frame. A model and schematic diagram of the force interaction in a high-orientation angle crash is shown in Figure 128. During rollover crashes, new, energetically-favorable roll axes were generated through which the applied moments to the vehicle were maximized. The new roll axis was rotated with respect to the longitudinal axis of the vehicle to incorporate the contribution of a small pitch moment at the cable impact location.

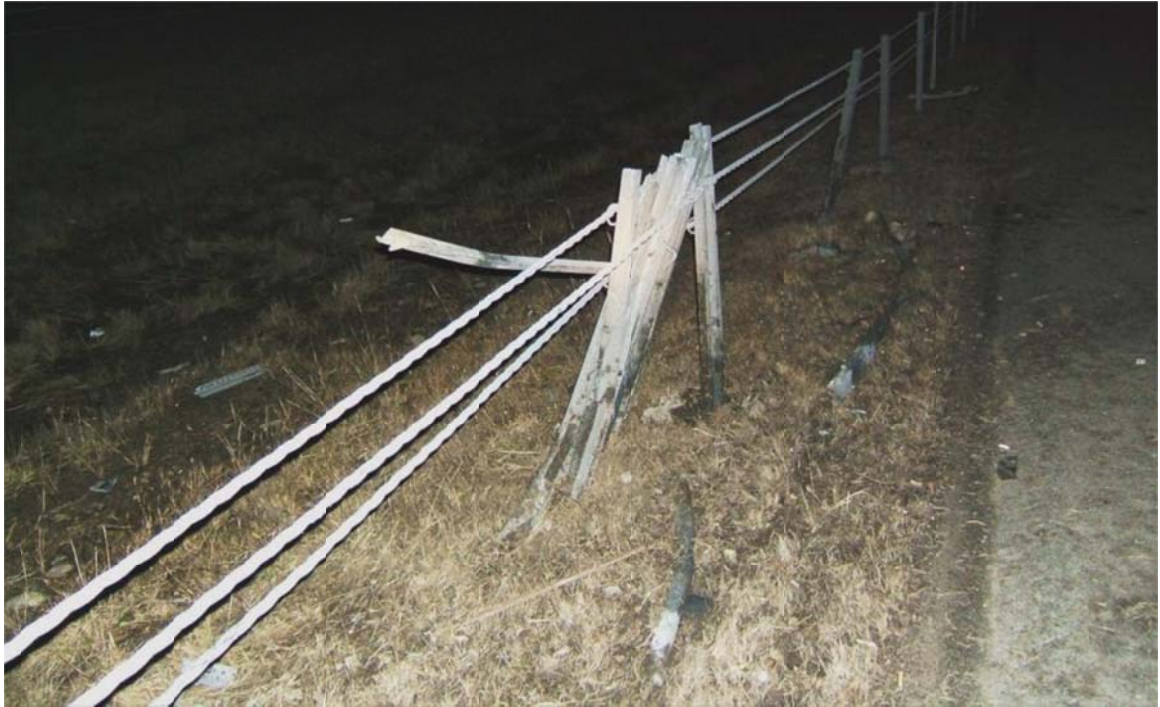
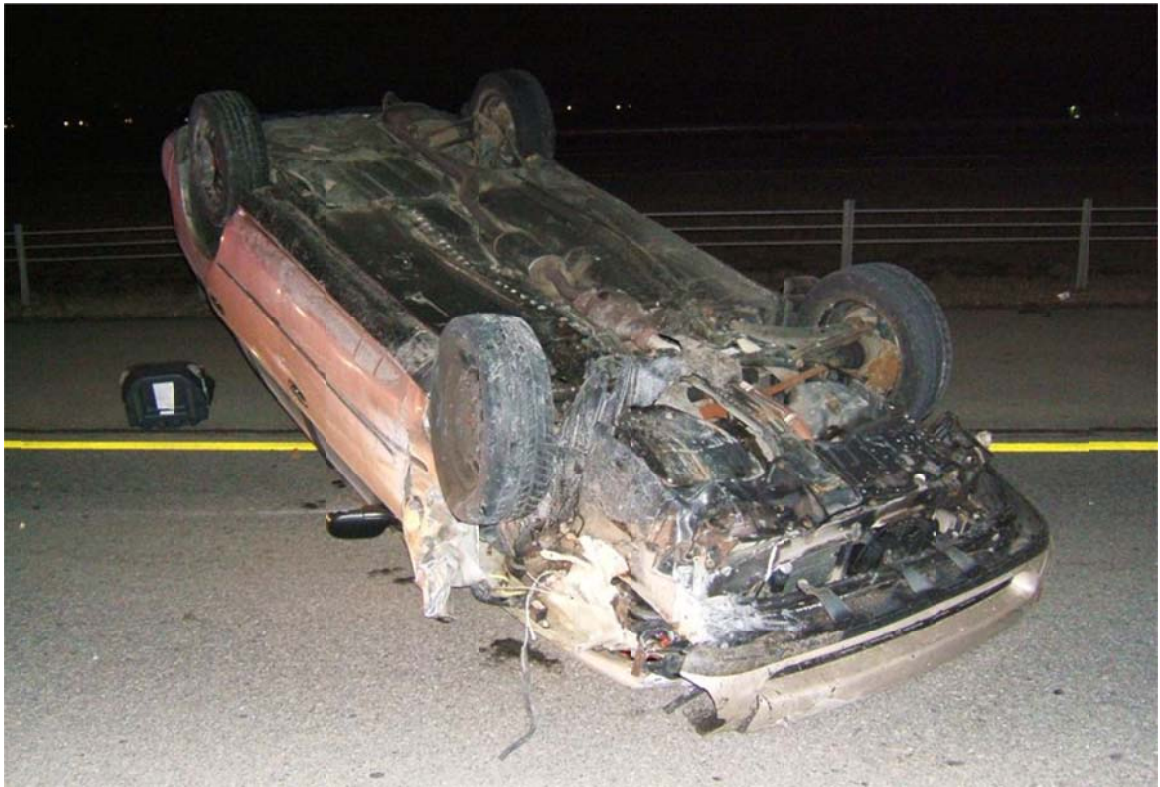
Figure 132. Example of Post Snag Rollover Crash

Considering the large number of factors contributing to rollover events, these results suggested that there may be a strong relationship between post strength in bending along an axis parallel with the roadway and the frequency of rollover crashes. These results also indicate that post bending strengths along axes perpendicular to the roadway (i.e., the Y-axes) do not have a strong correlation with rollover frequency. Some subjective estimates for causes of rollovers estimated that weak-axis post bending strength would be more strongly related to rollover than strong-axis bending strength.

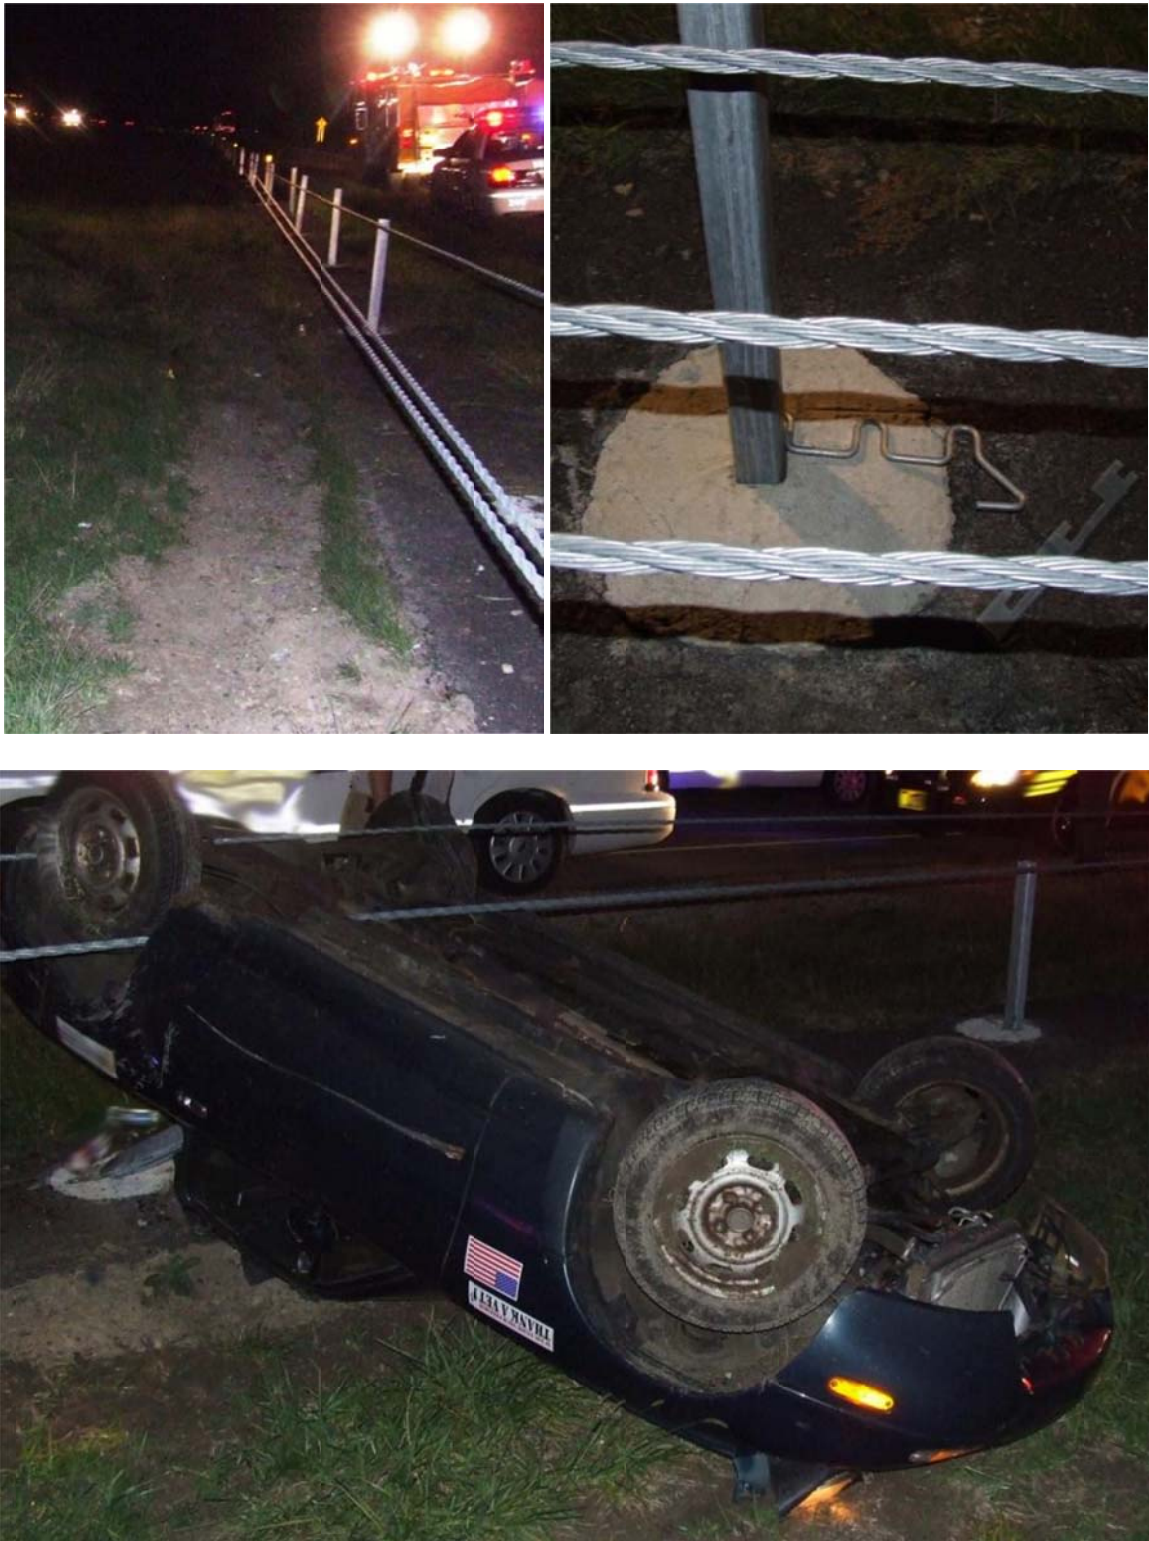
Figure 133. Example of Post Snag Rollover Crash

to vehicle instability, which was noted historically [52]. Examples of post snag rollover crashes are shown in Figures 132 and 133.

underride penetration crashes. Vehicles impacting at the location of a post on the opposite side of the cables can cause complete post disengagement. Although the hairpin cable-to-post attachment was relatively strong, as shown in Figure 137, upward vertical bracket release could occur during impacts with low-height, sharp-nosed and narrow front-profile vehicles, as shown in Figure 133.

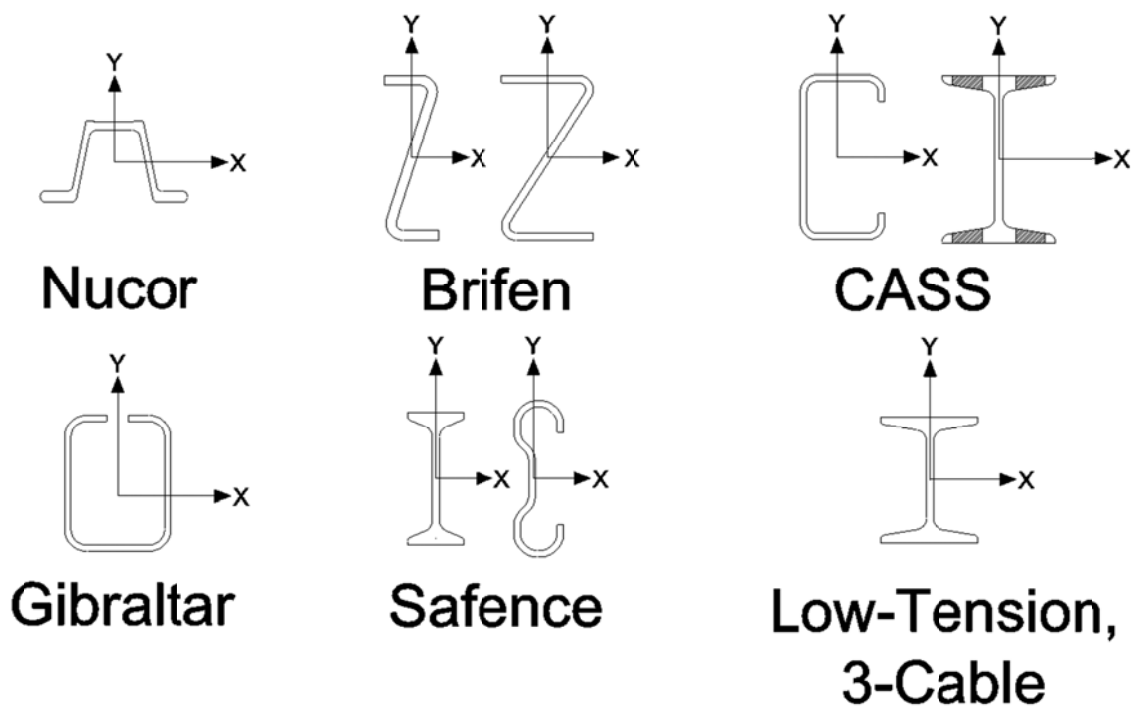
Figure 134. High-Tension Post Section Shapes

Contact with post rollovers were the most sensitive to the make of cable barrier struck, since post strengths were critical to facilitating rollover. Post shapes and cable tensions are shown in Tables 33 and 34, and the several post section shapes are shown in Figure 134.

The cumulative rate of vehicle rollover on each system was plotted against calculated yield moments about the X and Y axes shown in Figure 134. Bending moments were calculated based on the assumption that no torsional warping occurred and that all loading occurred through each post section shear center. Scatter in the weak-axis bending moment direction appeared to be randomly distributed, as shown in Figure 135. However, a possible correlation was observed when rollover frequency was plotted against yield moments about the X direction, as shown in Figure 136.
