CABLE MEDIAN BARRIER
FAILURE ANALYSIS AND REMEDIATION

by
Cody S. Stolle

A DISSERTATION

Major: Civil Engineering
Structural Engineering

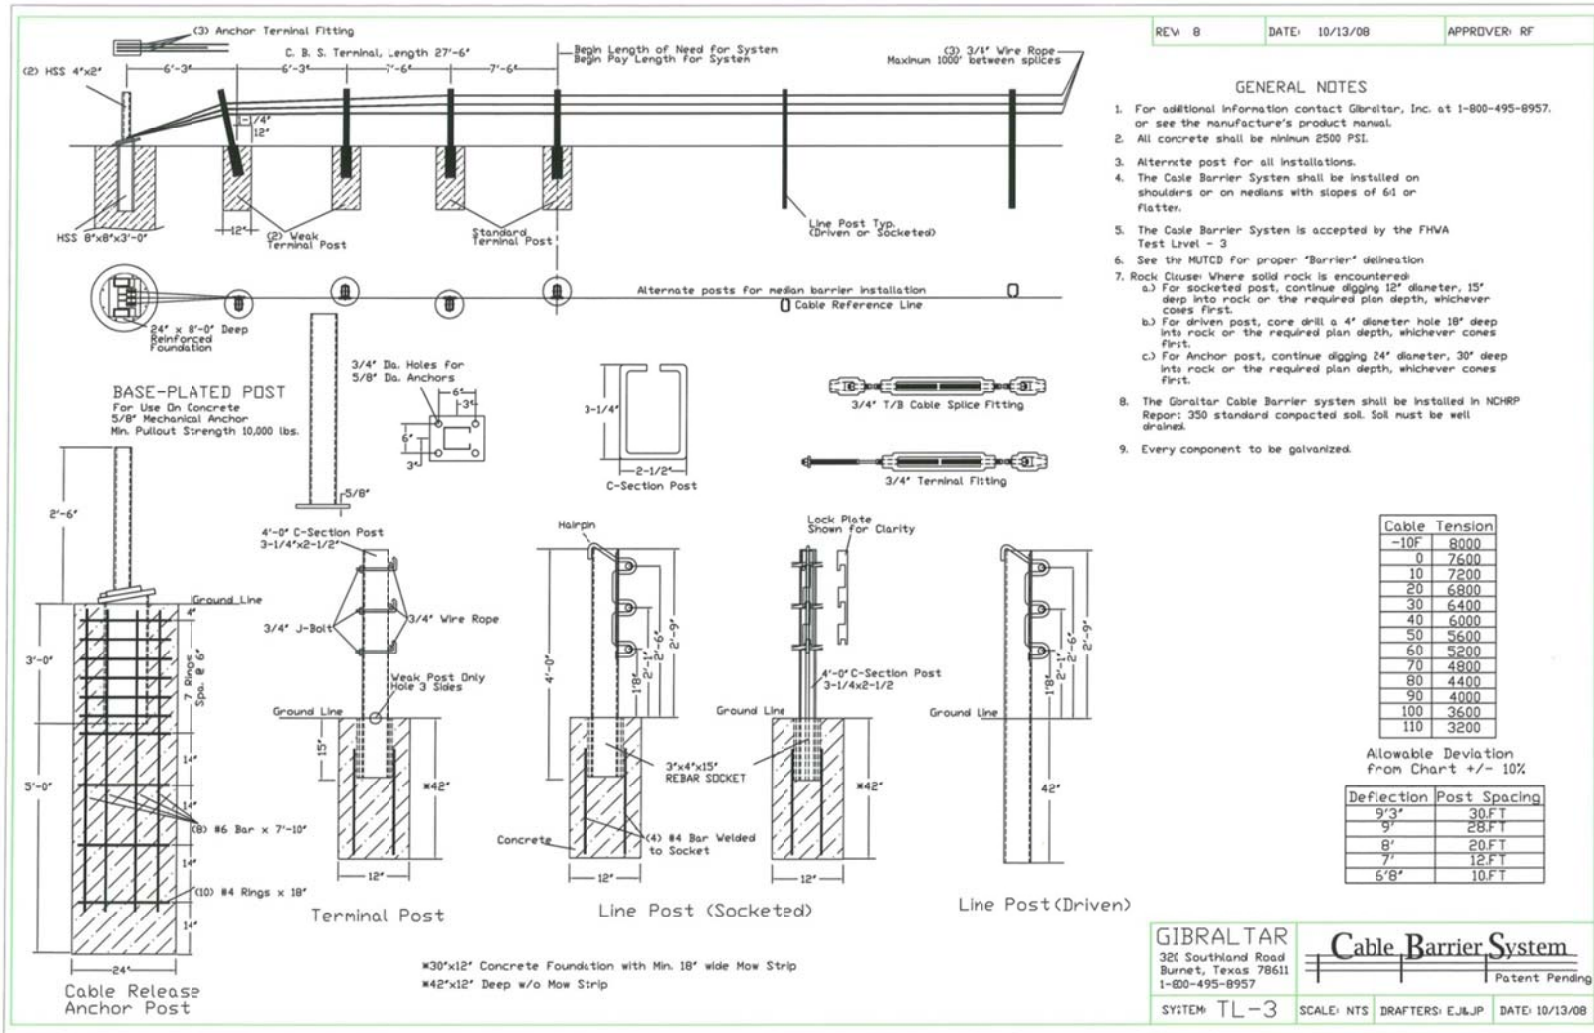
Figure 137. Gibraltar System Details, TL-3 System [53]

Whereas the Gibraltar cable barrier system may be more prone to underride in some crash configurations, the vertical release load of the cable-to-post attachment may be sufficiently small to prevent override penetrations. Based on a preliminary analysis, the hairpin bracket should vertically release away from the posts when posts deflect laterally, and impacts at posts will less frequently cause the cables to be pulled down by the deflected posts. More analysis will be necessary to conclusively determine the accuracy of this estimate.

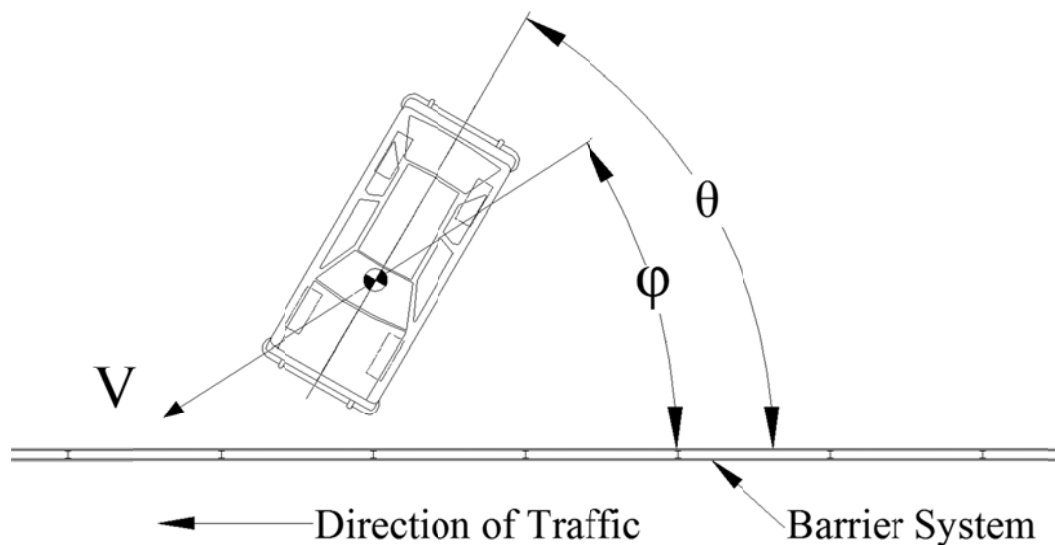
Figure 139. Representative Crash Testing Impact Diagram

These crash tests are recommended to replace the current TL-3 MASH crash test nos. 3-10 and 3-11 which are required for cable barrier systems and should be conducted
