Categorization and experimental evaluation of anchorage systems for fiber-reinforced polymer laminates bonded to reinforced concrete structures

A THESIS

MASTER OF SCIENCE IN CIVIL ENGINEERING

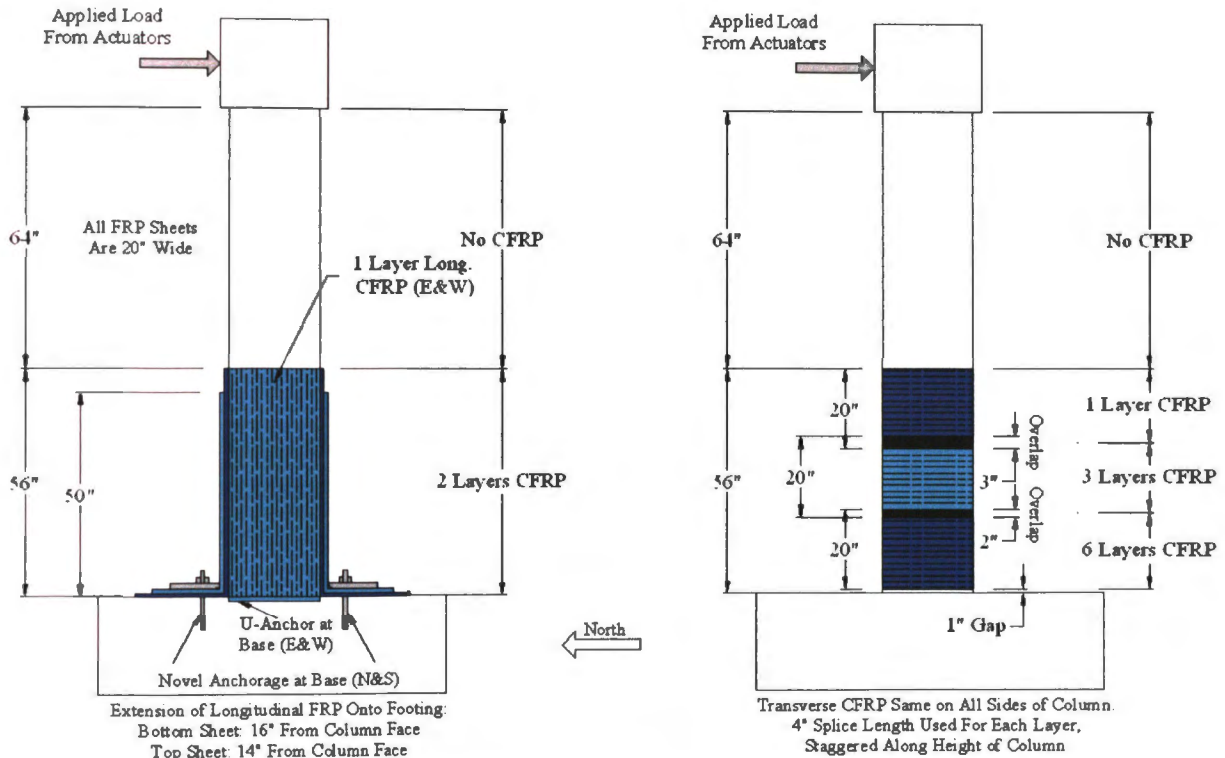
Figure 4.6. Repair Design Drawing for Column #3

4.5.3. Column #3 Design. Column #3 was designed with two layers of longitudinal FRP on the North and South column faces, and one layer of CFRP on the East and West column faces. As with Column #2, longitudinal CFRP was present on the East and West column faces primarily to help restore the torsion capacity. A varying number of transverse CFRP wraps were placed around the column to a height of 56 in. No longitudinal or transverse CFRP was placed above the height of 56 in. The anchorage systems for this column, described in Section 4.6, included the novel anchorage system at the column-to-footing interface on the North and South sides, as well U-Anchors at the interface on the East and West sides. All longitudinal CFRP sheets were placed first, followed by transverse CFRP wraps. Every sheet of CFRP placed on the column was 20 in. wide. The repair design for Column #3 is shown in Figure 4.6.

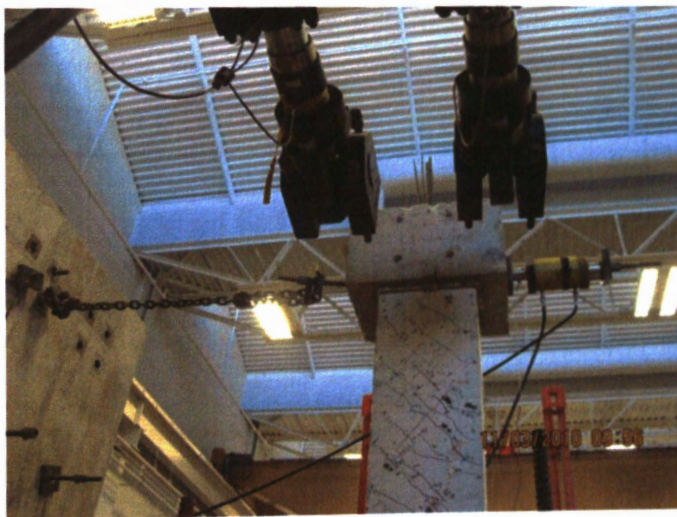
Figure 4.15. Column Straightening Setup For Columns #2 and #3

deformations were deemed minimal. Straightening in the East/West direction for Columns #2 and #3 was performed by attaching a chain between the column cap and the reaction wall. A hydraulic jack was used to apply a tensile force to the chain, which pulled the column in the direction of the strong wall. The load was applied and released several times until the column appeared to be visibly straightened. Columns #2 and #3 were repaired under a condition of zero horizontal force.

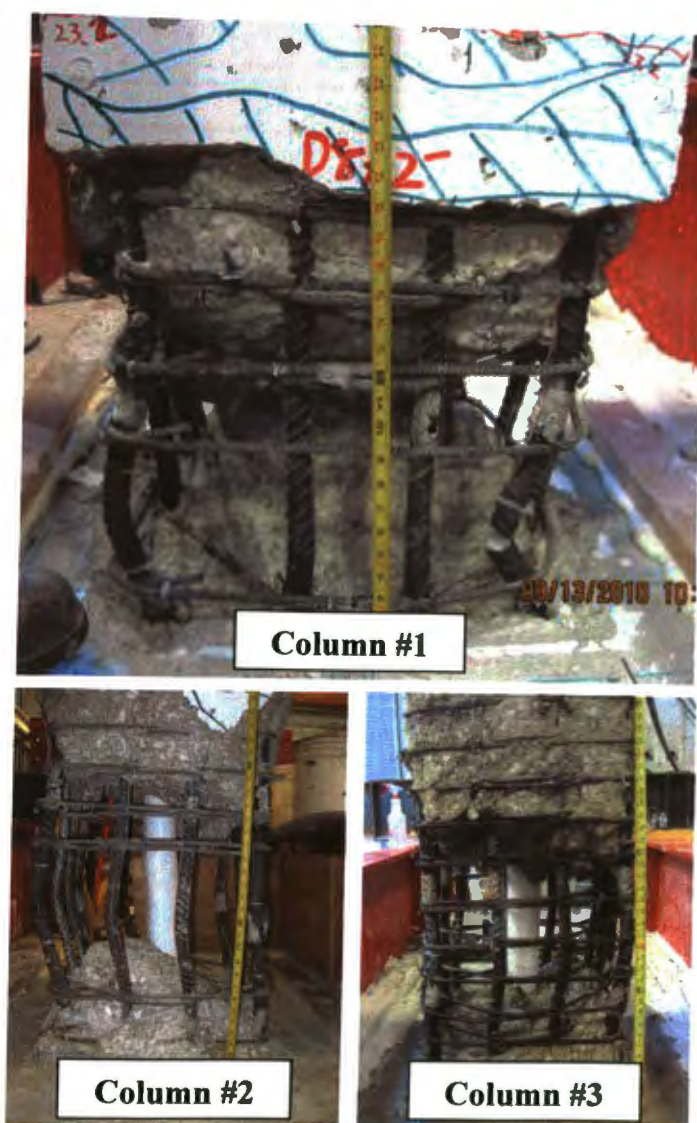
Figure 4.16. Columns After Removal of Loose Concrete

4.7.2. Removal of Loose Concrete. The “rapid repair” procedure began when loose concrete was removed from the damaged columns. Loose concrete was removed with a chisel and hammer until light tapping with the hammer on the chisel would not cause further concrete to be removed. The dense crack networks caused by the severe damage could have allowed for more concrete to be removed with more aggressive hammering, but given the large amount of concrete that was removed with only light hammering, the research group determined that removal of additional concrete would not have been advantageous. Additionally, if damaged or opened ties were in position to interfere with the placement of formwork, they were removed at this time. Figure 4.16 shows the conditions of Columns #1, #2, and #3 after removal of the loose concrete.

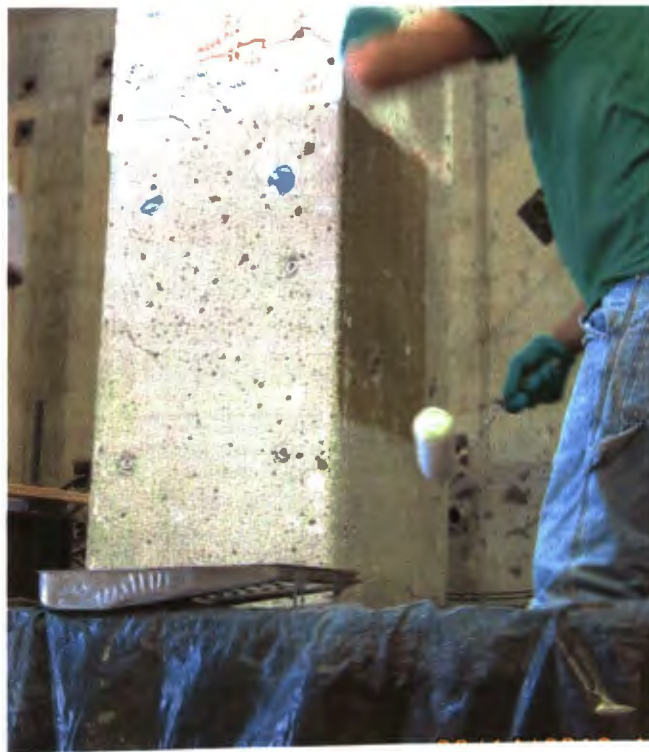
Figure 4.19. Application of MBrace[®] Primer

4.7.5. Installation of FRP. After the surface preparation, the first step in the installation process of the MBrace[®] CF 130 Composite Strengthening System was the application of MBrace[®] Primer to the faces of the column and footing that were to be overlaid with CFRP. The Primer was mixed per manufacturer's recommendations and applied to the surface using a 3/8 in. nap roller. Application of MBrace[®] Primer is shown in Figure 4.19.

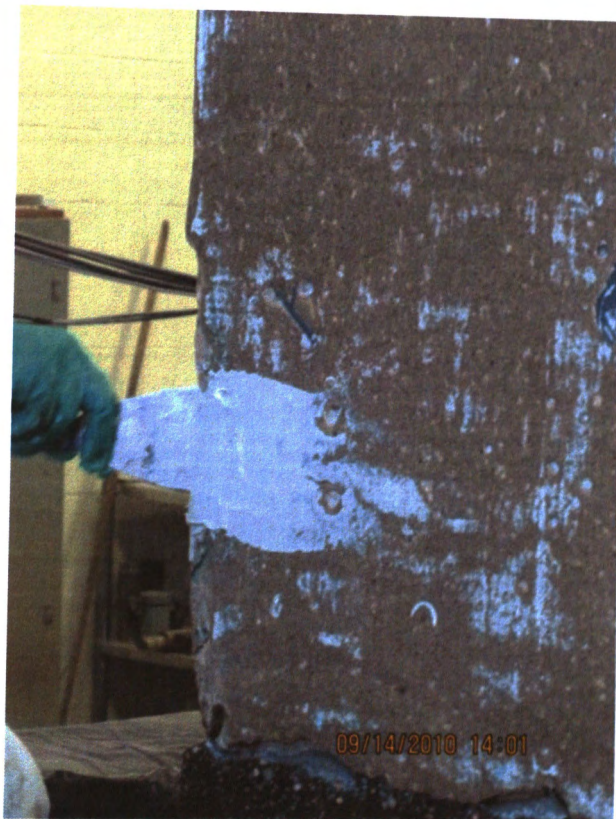
Figure 4.20. Application of MBrace[®] Putty

After the Primer became tacky on the concrete surfaces, MBrace[®] Putty was mixed per manufacturer's recommendation and applied to the surface using drywall taping knives. The Putty was applied lightly to all surface to fill the small voids. In some cases where a larger discontinuity in the flat concrete surface was present, the Putty was applied more liberally to flatten the surface. Application of MBrace[®] Putty is shown in Figure 4.20.

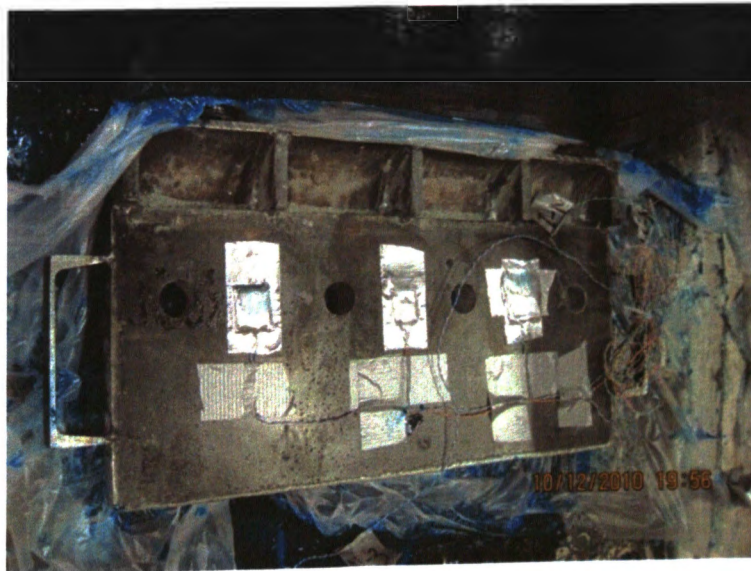
Figure 4.22. Temporary Placement of Anchorage Over “Wet” Saturant

4.7.6. Installation of Anchorage. While the CFRP system remained “wet” and uncured, the anchorage plates were temporarily set into place on the footing. A thick layer of Saturant was placed over the area on the footing onto which the anchorage plate would be set. This was done to ensure a uniform bearing surface between the anchorage plate and the concrete surface, as well as to minimize the gap between the column-to-footing joint and the quarter-pipe portion of the anchorage system. A thin plastic sheet was placed between the anchorage system and the Saturant to ensure that the steel plate did not bond to the concrete surface via the epoxy Saturant. The photo in Figure 4.22 shows the temporary placement of the anchorage plate over the “wet” FRP system.

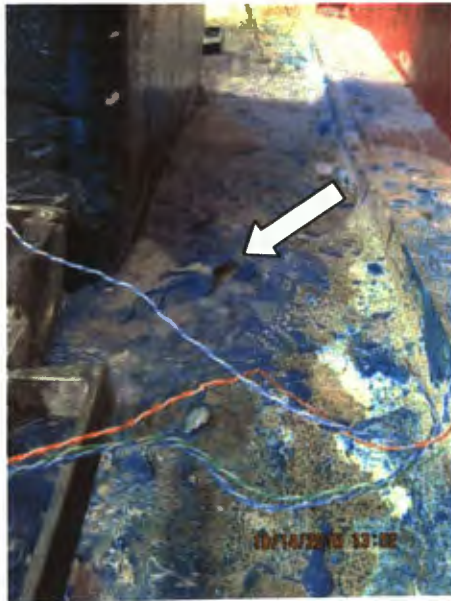
Figure 5.4. Pullout Failure of U-Anchors for Column #2

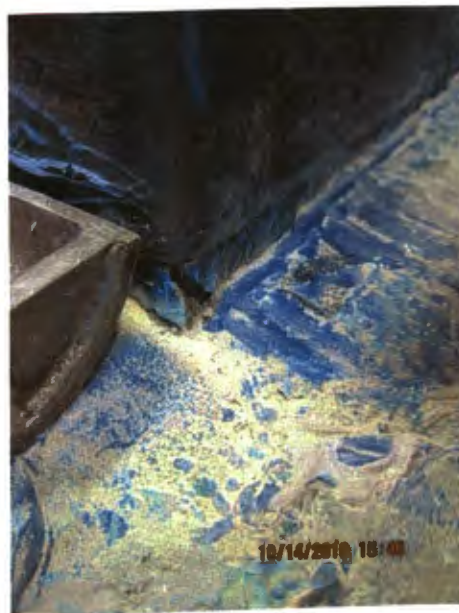
Figure 5.5. Rupture of Transverse CFRP at Base of Column #2

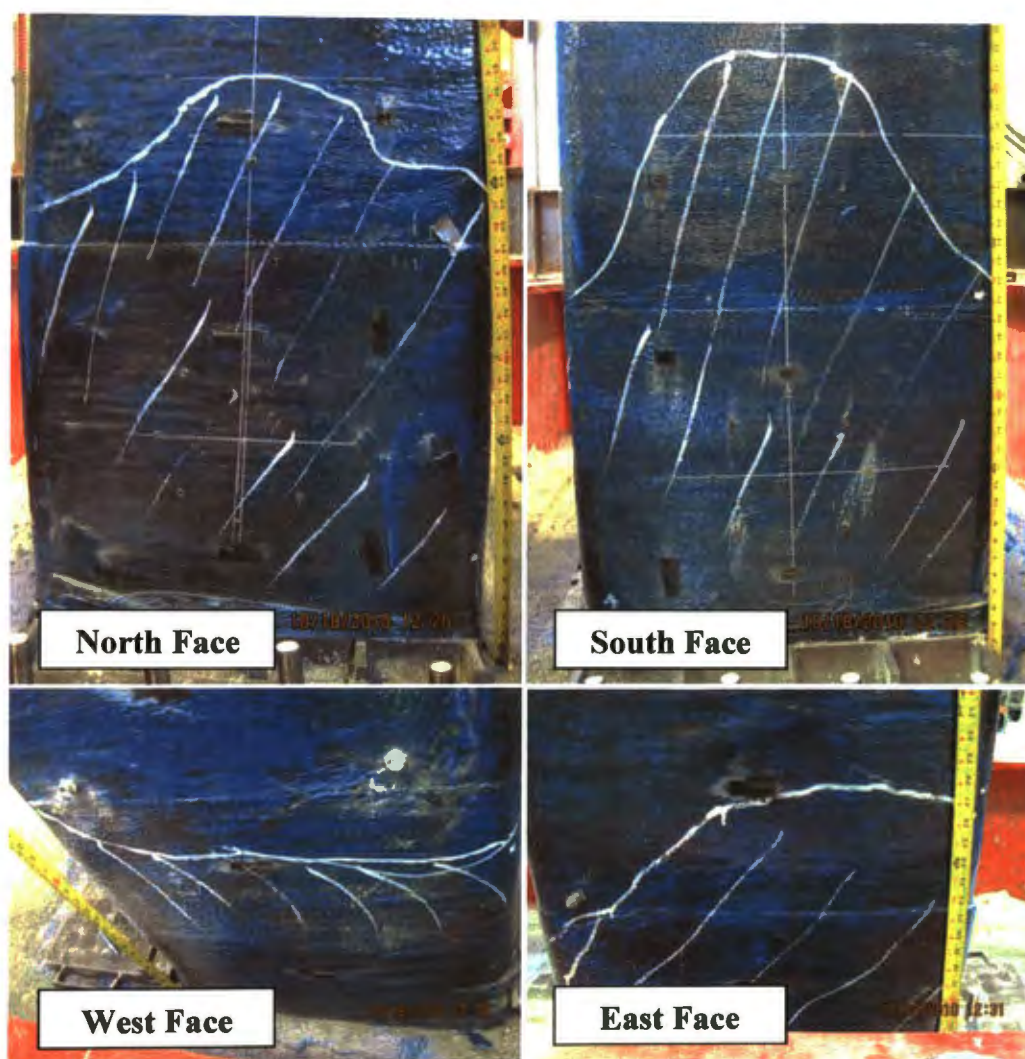
Figure 5.7. Debonded Areas of CFRP on Column #2 After Testing

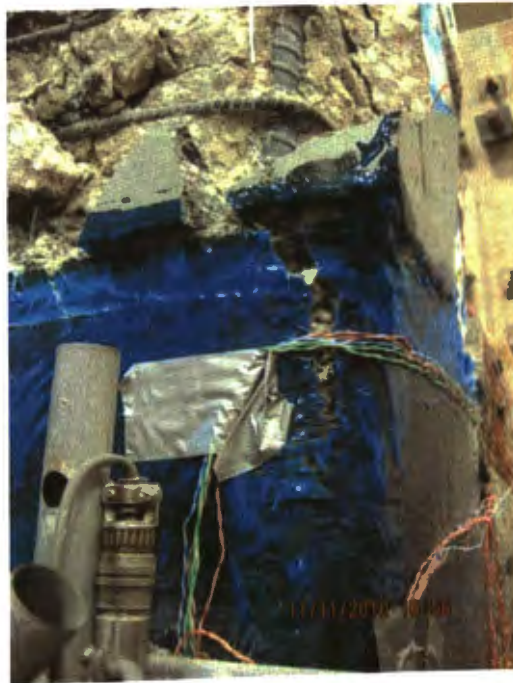
Figure 5.9. Rupture of Transverse CFRP on Southwest Corner of Column #3

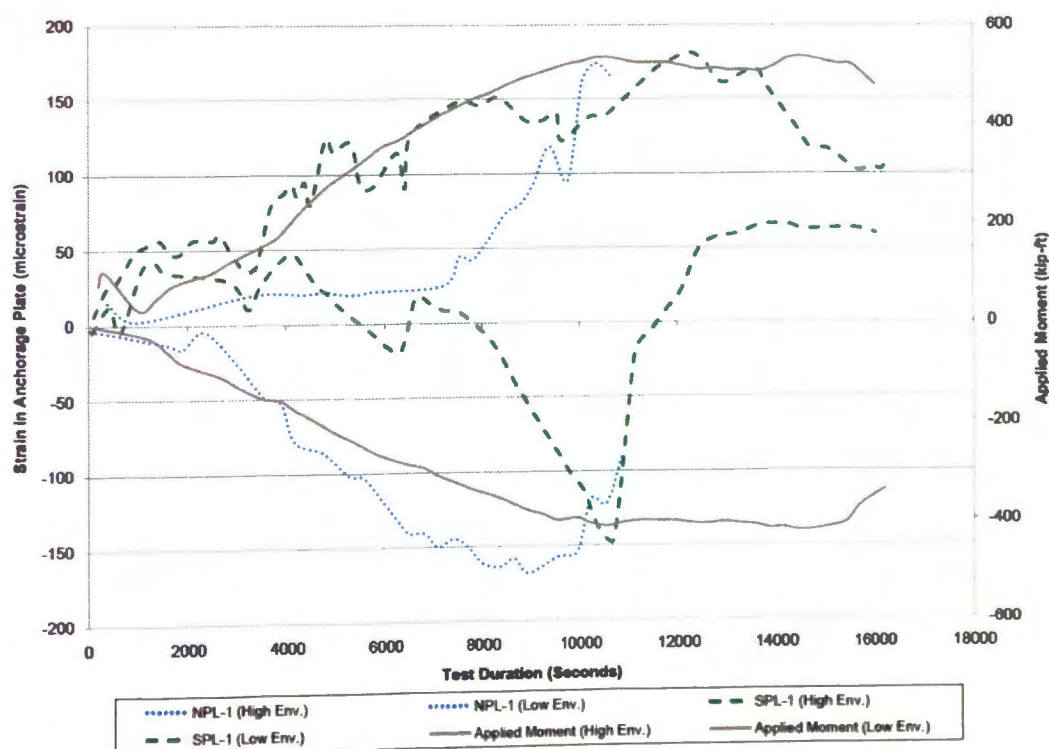
Figure 5.20. Strains Measured in Anchorage Plate for Column #1

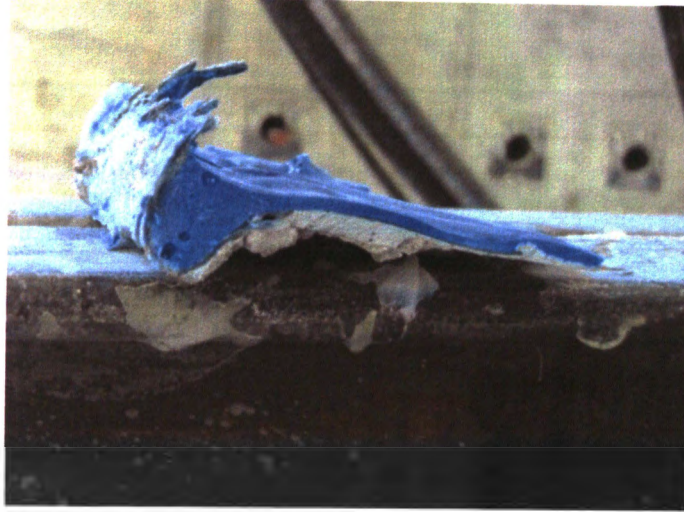
Figure 5.33. Failed U-Anchor After Removal From Groove

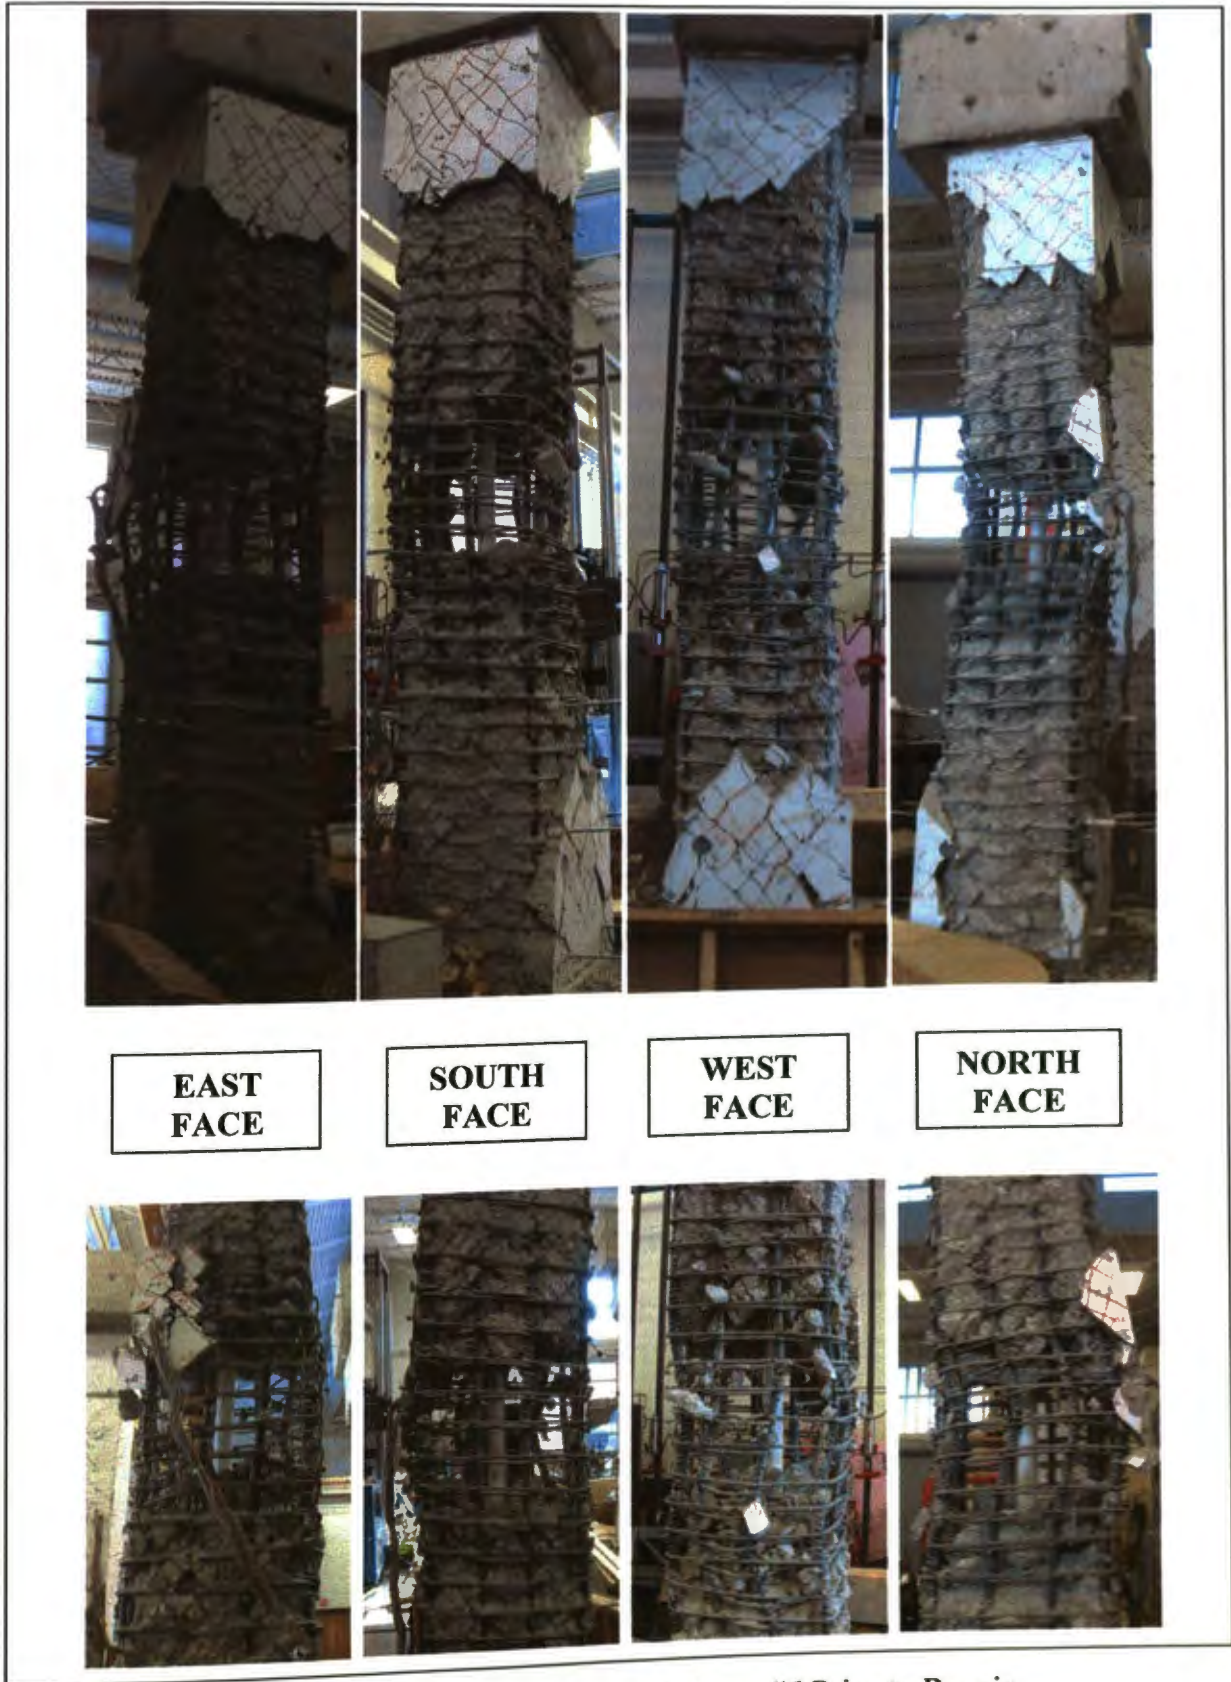
Figure A-6. Damage Photos of Column #6 Prior to Repair
