Characterization of carbon fiber polymer matrix composites subjected to simultaneous application of electric current pulse and low velocity impact

CHARACTERIZATION OF CARBON FIBER POLYMER MATRIX COMPOSITES
SUBJECTED TO SIMULTANEOUS APPLICATION OF ELECTRIC CURRENT
PULSE AND LOW VELOCITY IMPACT

A thesis submitted in partial fulfillment
of the requirements for the Master of
Science degree in Mechanical Engineering
in the Graduate College of
The University of Iowa

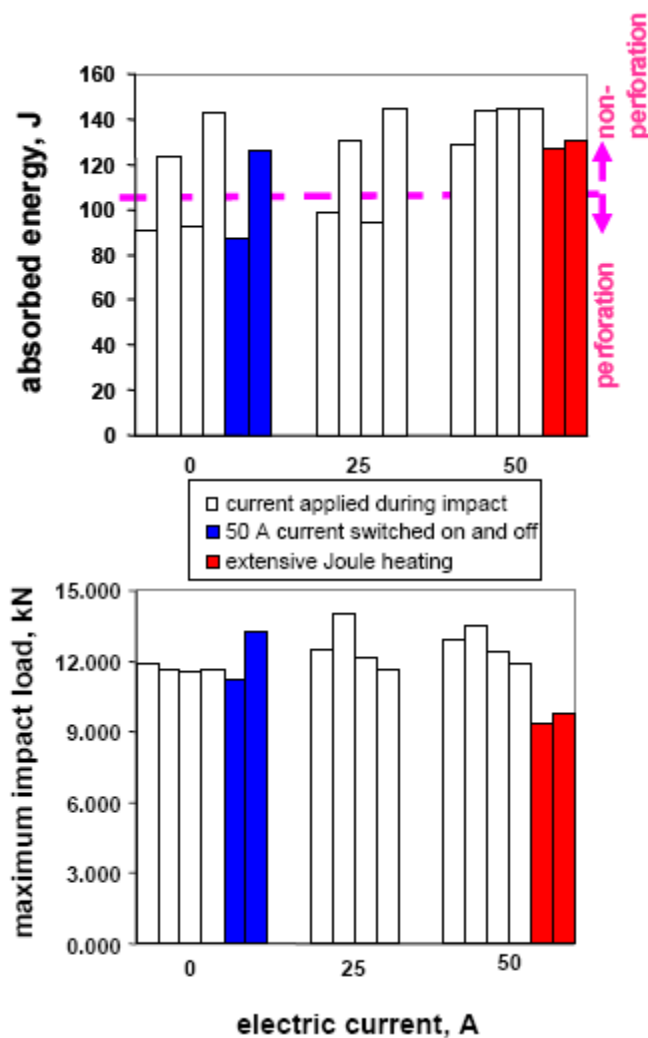
Figure 1.6: Impact Load and Absorbed Energy for Cross-Ply Plates (Sierakowski et al., 2007)

Figure 1.6 shows the influence of coordinated application of DC current with an impact event on 32 ply cross-ply composite plates. In cross-ply plates, it was determined that the peak load was not increased by the presence of electrical current. There was, however, a significant influence on damage by the applied current. As the current increased, the visible damage decreased to the point that the 50 A tests resulted in no visible damage. The absorbed energy in the cross-ply specimens increased as the magnitude of the applied current increased. The findings also reported that removing the electric field just prior to impact removed any of the positive effects of the electric current. In addition, prolonged current application decreased the peak load and absorbed energy. This phenomenon was caused by the detrimental effects of Joule heating (Sierakowski et al., 2007). The deformation of the composites due to the coupling of mechanical and electromagnetic fields (Zhupanska and Sierakowski, 2007) and/or changes in materials properties contribute to this phenomenon. This work focuses on multi-field interaction.

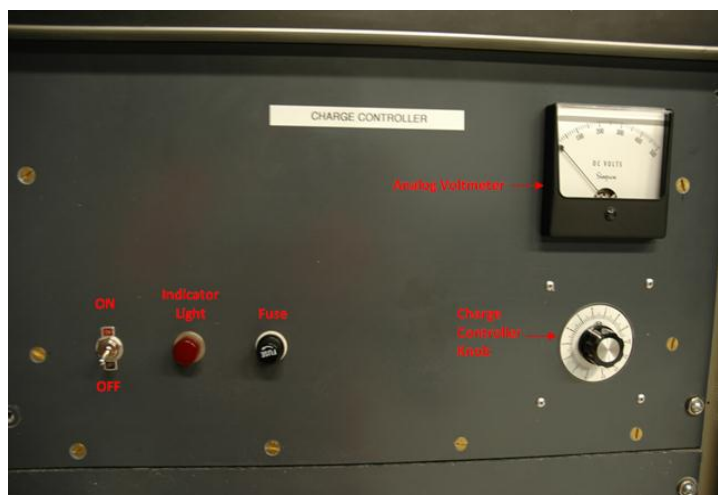
analog voltmeter, and N/A pushbutton are labeled in Figures 2.3 (a) and 2.3 (b). Finally, control of the system is based on a microcontroller circuit which allows for flexibility in future modification.

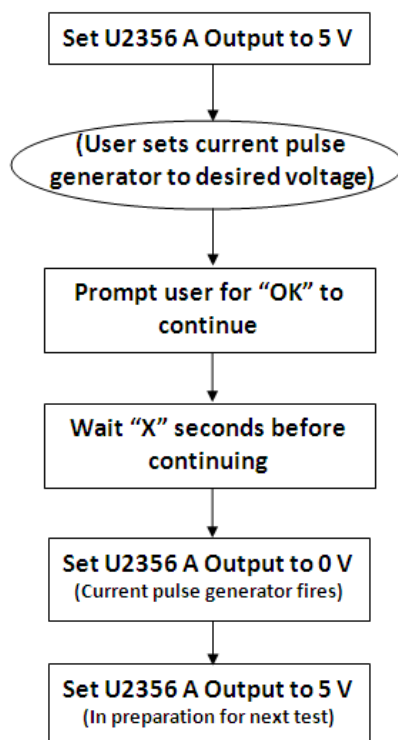
Figure 2.4: Program logic for current pulse generator trigger

The first step in the Agilent VEE Pro 8.5 program was to set the voltage output of the Agilent U2356A to 5 V. Next, the user follows the 5 step process outline in section 2.3.1 in order to set the current pulse generator to the desired settings. After the current pulse generator is set, the user must press “OK” button in Agilent VEE Pro 8.5 program to alert the program that the system is ready to fire. The program waits “X” seconds, as specified by the user, before continuing with the program. Next, the program sets the output of the Agilent U2356A to 0 V. This steps the output signal from 5 to 0 V, as shown in Figure 2.5. This change in voltage triggers the current pulse generator to fire. Finally, the Agilent VEE Pro 8.5 program sets the voltage output back to 5 V to prepare the system for the next test.

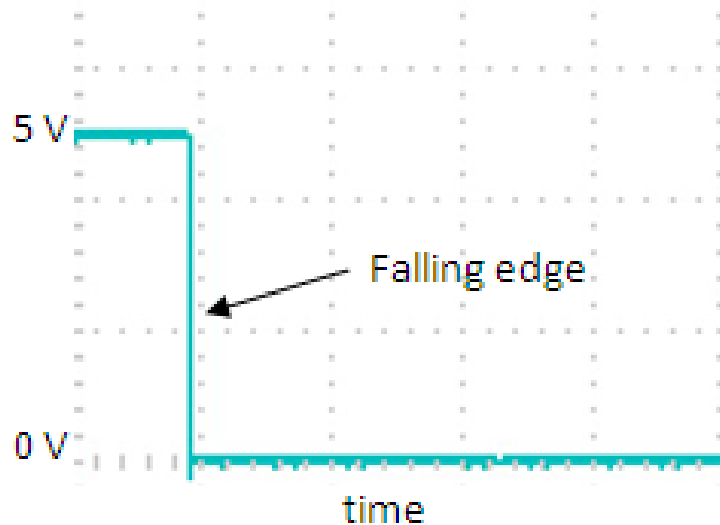
Figure 2.5: Trigger signal for current pulse generator

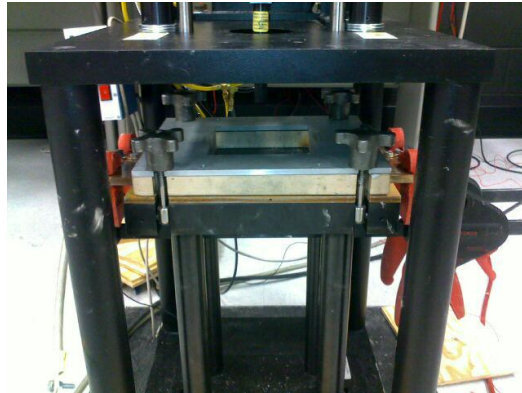
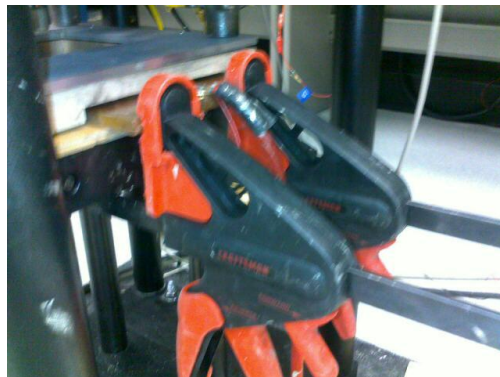
Once the composite specimen was aligned with the tup, the top plates were clamped onto the specimen and the copper electrodes were clamped onto the specimen. Figure 2.8 (a) shows the top plate clamped onto the specimen, and Figure 2.8 (b) shows the clamps used to secure the copper electrodes to the specimen. All clamps were tightened by hand to the minimum torque such that the specimen and electrodes were secure, but were not tightened unnecessarily. This was to ensure that the stresses induced by the clamps would have as little effect on the experimental results as possible.

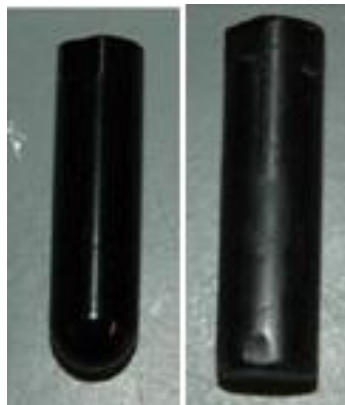
Figure 2.10: Tool steel (left) and DELRIN® (right) tup inserts (Zantout, 2009)

conductive tup could create potentially dangerous conditions during an electrified test for both the equipment as well as the user. Zantout (2009) designed a tup insert machined from DELRIN®. This material was chosen, since DELRIN® is dielectric and has excellent impact properties. The standard tool steel and DELRIN® tup inserts are shown side by side in Figure 2.10.

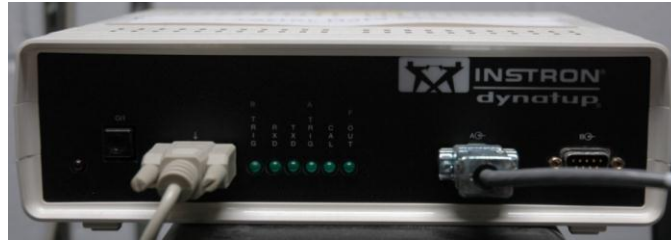
Figure 2.12: Impact Data Acquisition Unit

The signals from the velocity detector and tup are conditioned and filtered by the data acquisition unit and are then interpreted by the Instron Dynatup Impulse software.

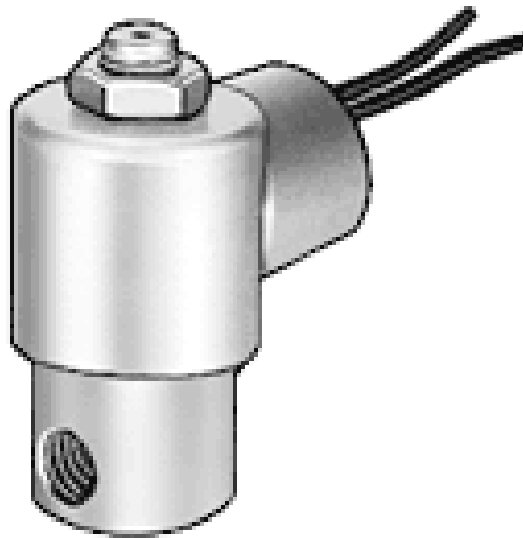
Figure 2.14: Electric Air Solenoid Valve (McMaster-Carr, 2011)

In order to control the release of compressed air into the air actuated cylinder, an electric air solenoid was placed in line between the compressed air supply and the air actuated cylinder. The electric air solenoid implemented in the system requires a 12 V DC power supply and draws 0.67 Watts of power (McMaster-Carr, 2011). The solenoid purchased from McMaster-Carr is shown in Figure 2.14.

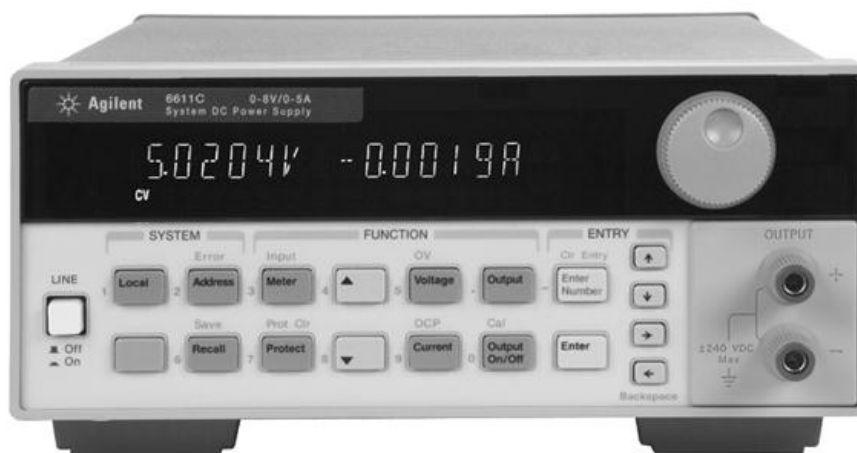
Figure 2.15: Infrared Thermocouple Power Supply (Agilent, 2011)

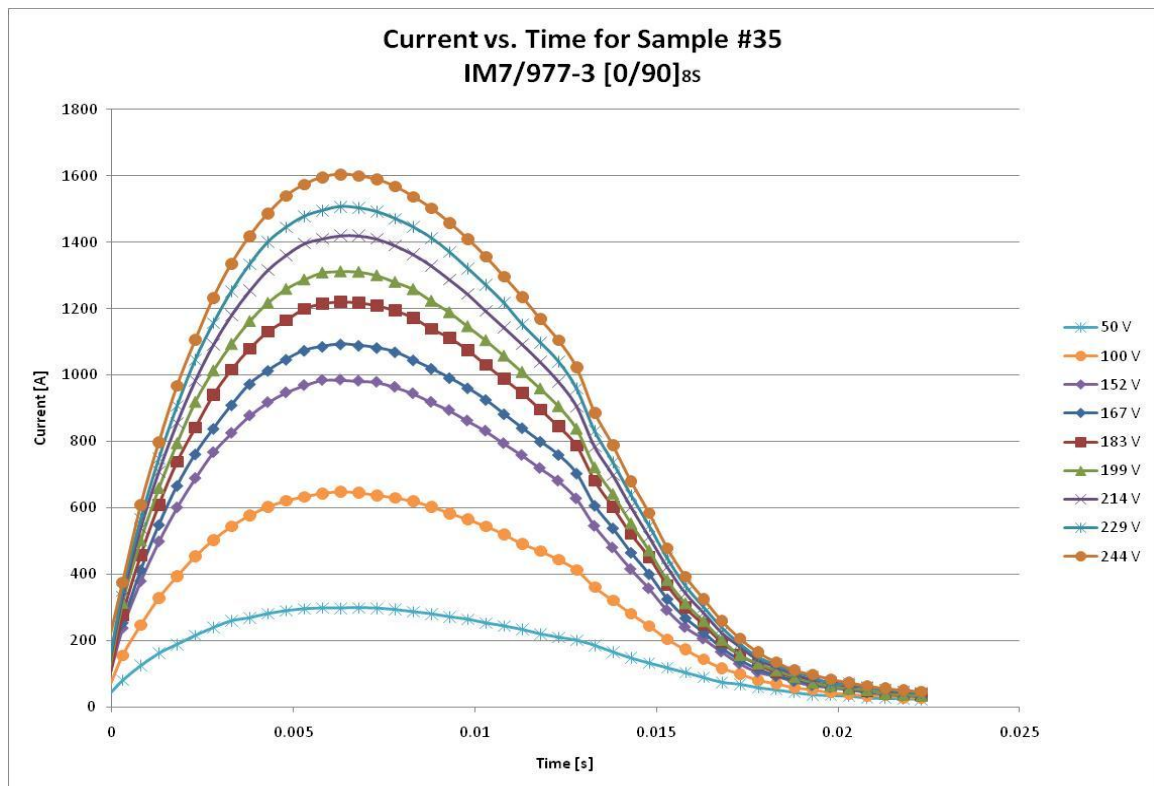
Figure 3.6: Current versus Time for Electrical Characterization of Sample 35

Initial electrical characterization tests were performed at analog voltage levels of 50 V and 100 V. Next, it was desired to determine if it was possible to accurately predict the required analog voltage to produce a given current using an interpolation of only two points. The linear approximation of the maximum current versus analog voltage was determined using the method of 2.3.5, and the analog voltages were determined for desired current values of 1000 A and 1100 A as 152.5 V and 168.4 V, respectively. Similar to specimen 34, the electrical characterization of sample 35 testing began at 50 V and 100 V and was increased successively thereafter. Electrical characterization results are shown in Figure 3.6.

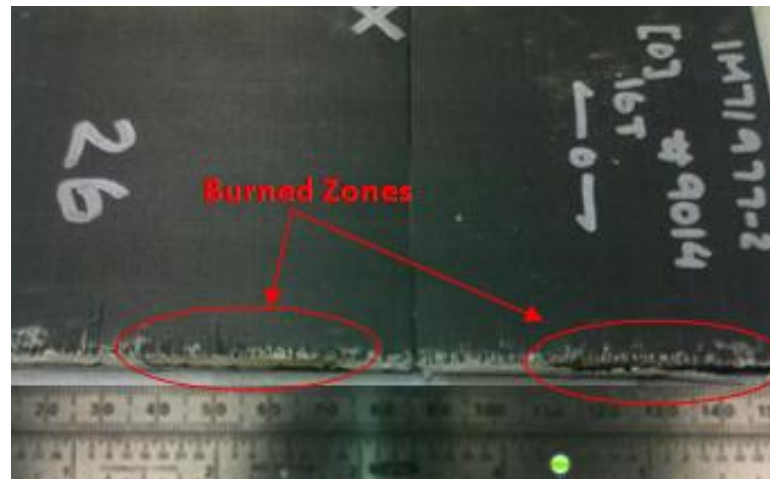
Figure 3.8: Burned Edges of Sample 26

Current pulse tests were carried out successfully at analog voltage level of 20 V, 50 V, and 100 V. For the 150 V test, there was significant burning on the edge of the specimen at the composite/electrode interface, as shown in Figure 3.8.

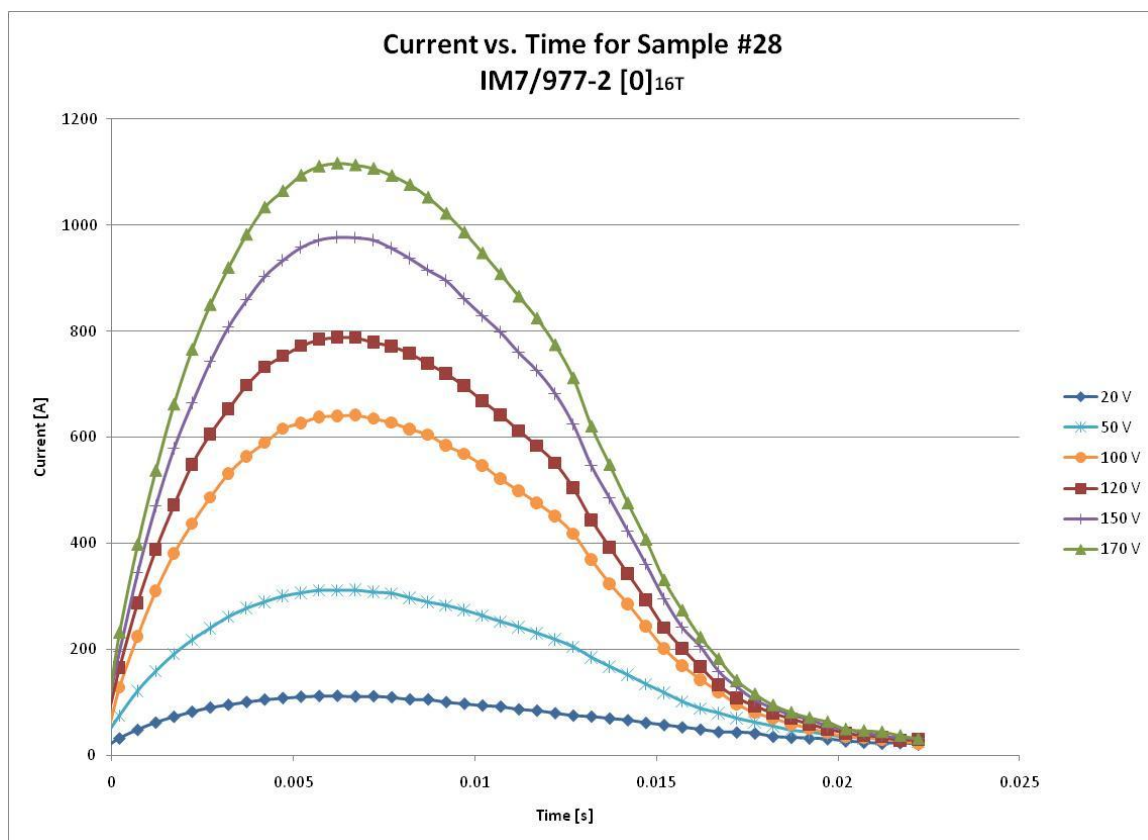
Figure 3.9: Current versus Time for Electrical Characterization of Sample 28

For sample 28, pulse tests were successful at analog voltage level of 20 V, 50 V, and 100 V. Since sample 26 failed at a voltage level of 150 V, it was decided to test

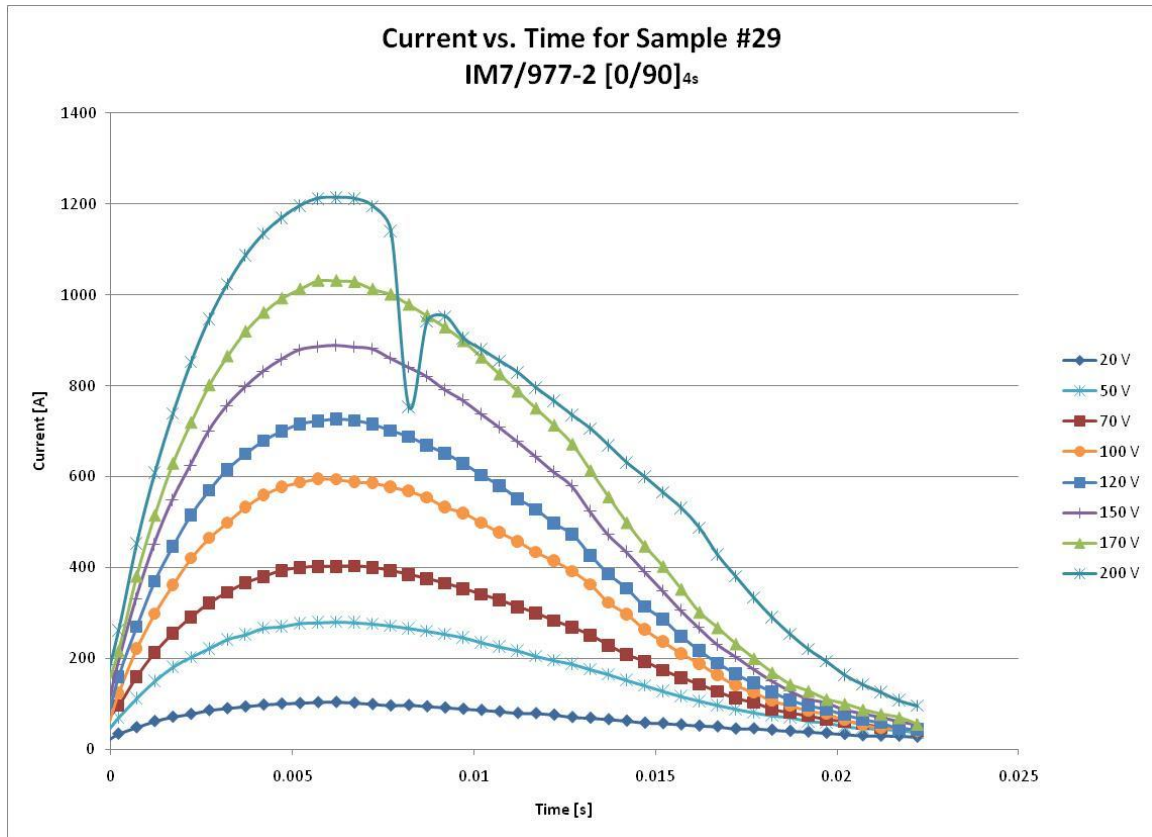
Figure 3.11: Current versus Time for Electrical Characterization of Sample 29

Successful current pulse tests were carried out at analog voltage levels of 20 V, 50 V, 70 V, 100 V, 120 V, 150 V, and 170 V on sample 29. The results from the 200 V pulse test were strange in that a drop in current occurred at approximately 8 milliseconds. The cause of the drop in current was identified as arcing, since burn marks were left on the surface of the composite at the interface between the specimen and electrode, as shown in Figure 3.12.

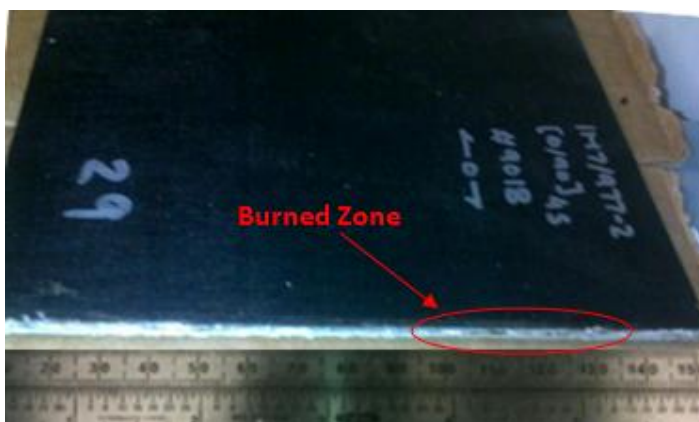
Figure 3.12: Burned Edges of Sample 29

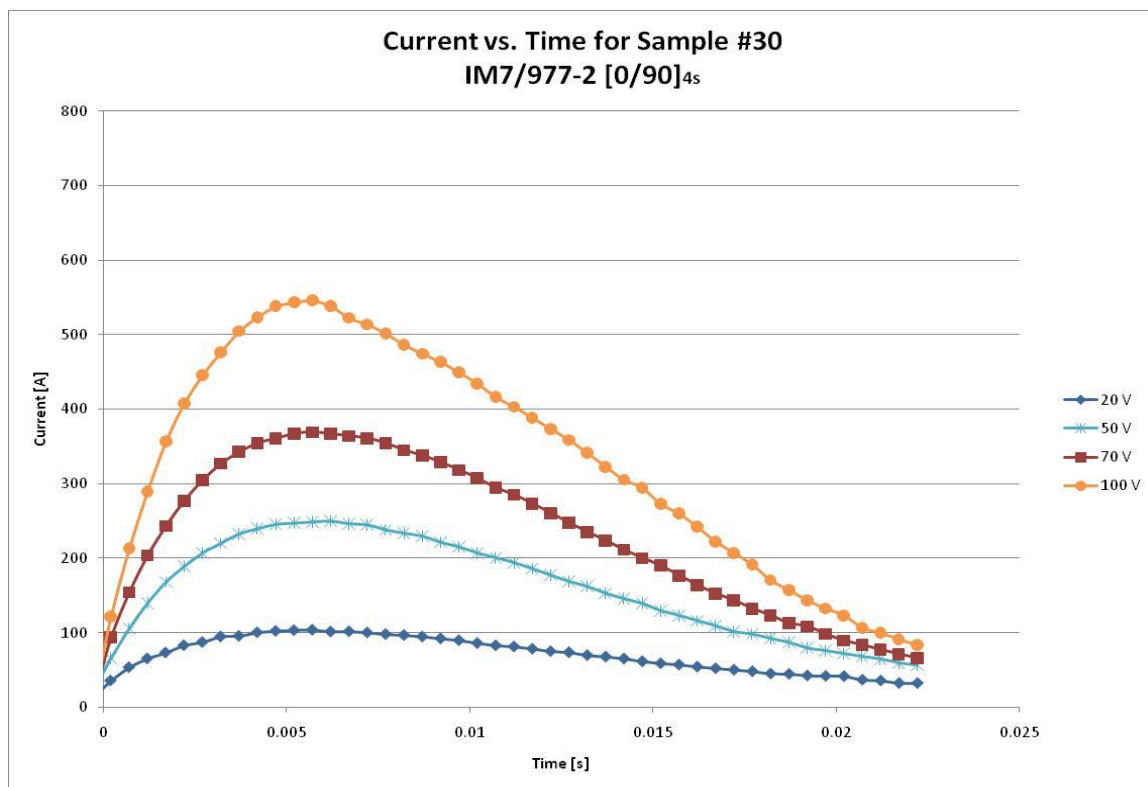
Figure 3.13: Current versus Time for Electrical Characterization of Sample 30

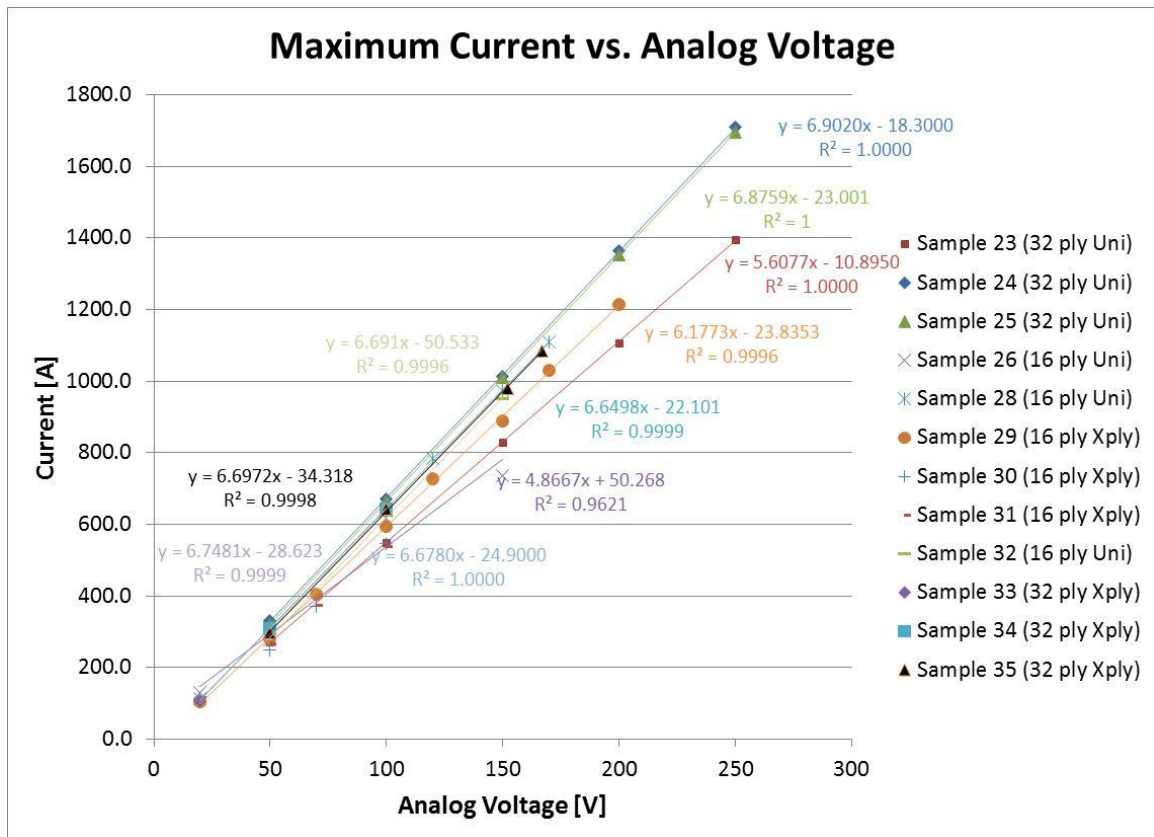
Figure 3.15: Maximum Current versus Analog Voltage for Electrical Characterization

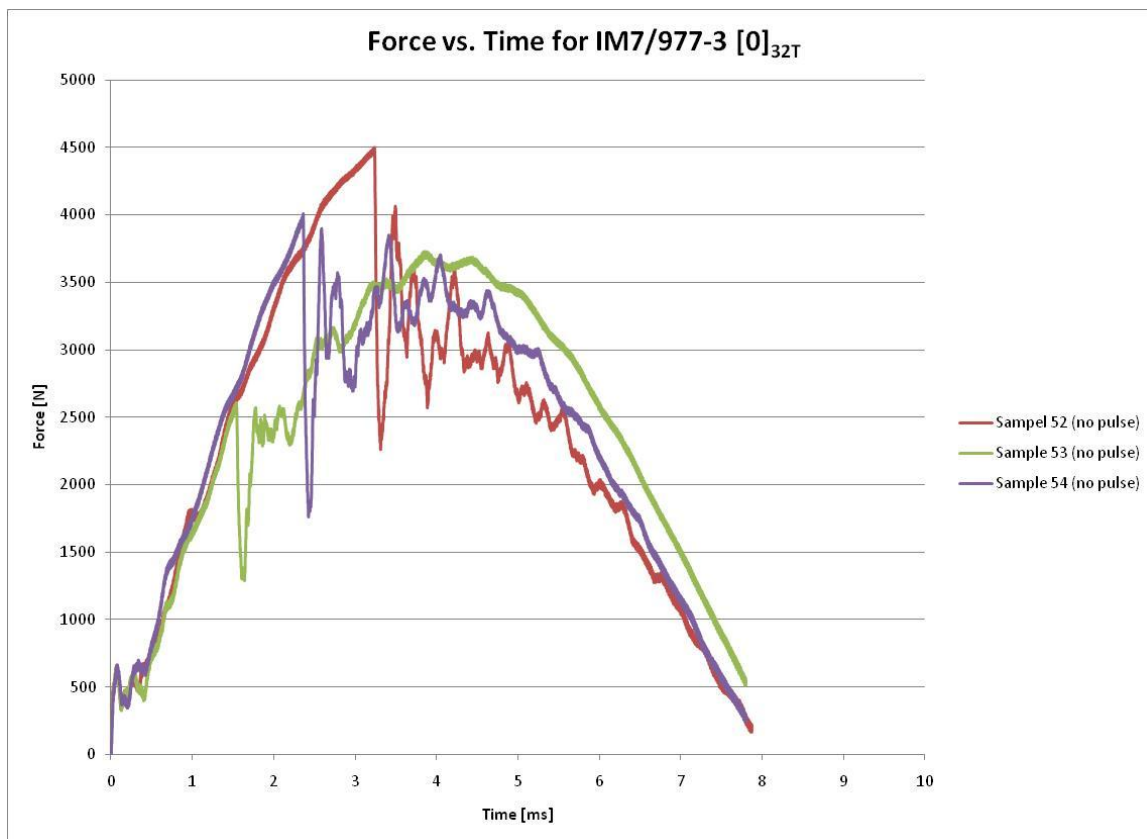
Figure 3.16: Force versus Time for Impact Characterization of Samples 52, 53, & 54

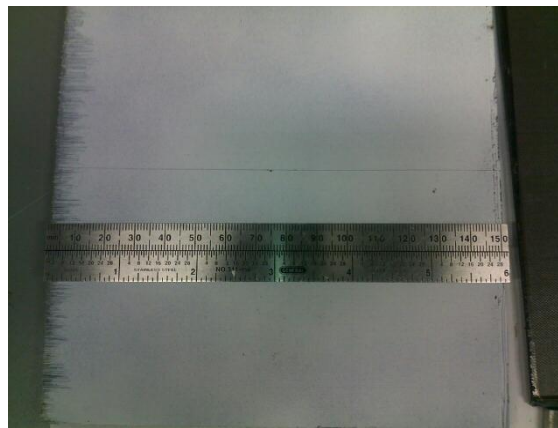
Figure 3.18: Visible Damage on the Back Side of Sample 52

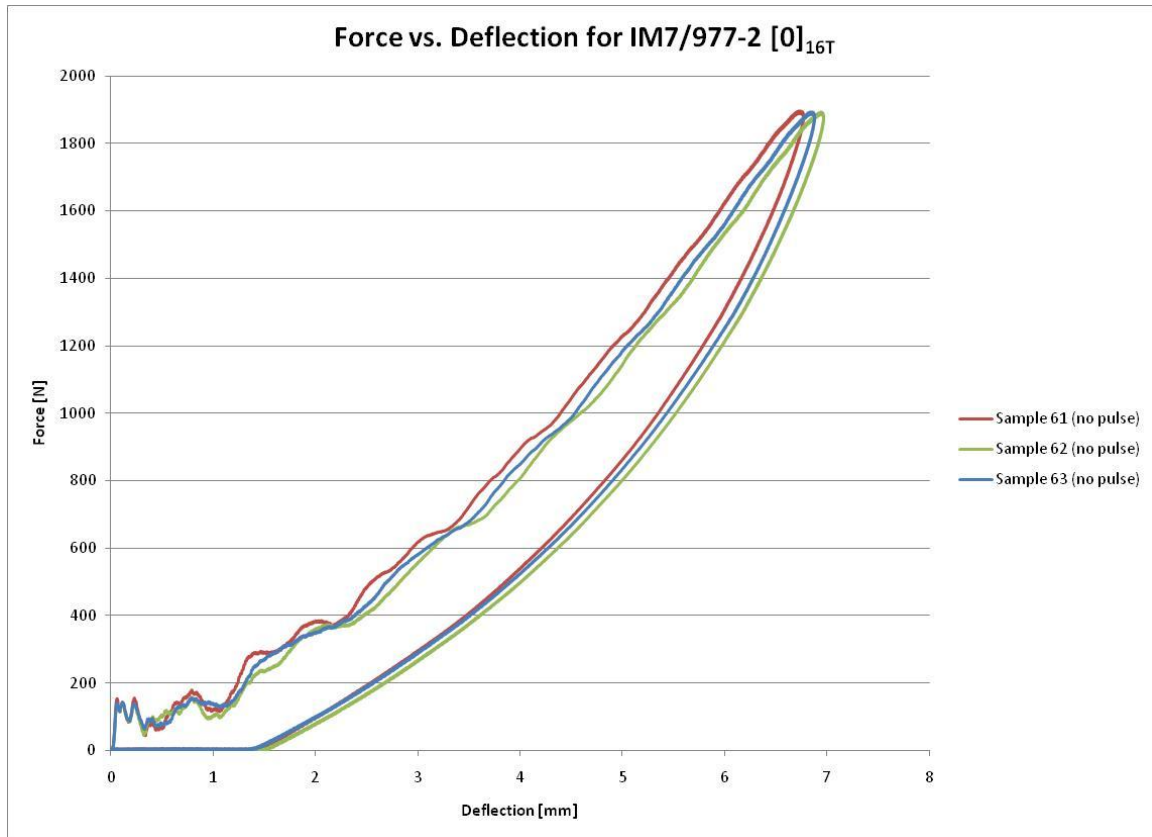
Figure 3.20: Force versus Deflection for Impact Characterization of Samples 61, 62, 63

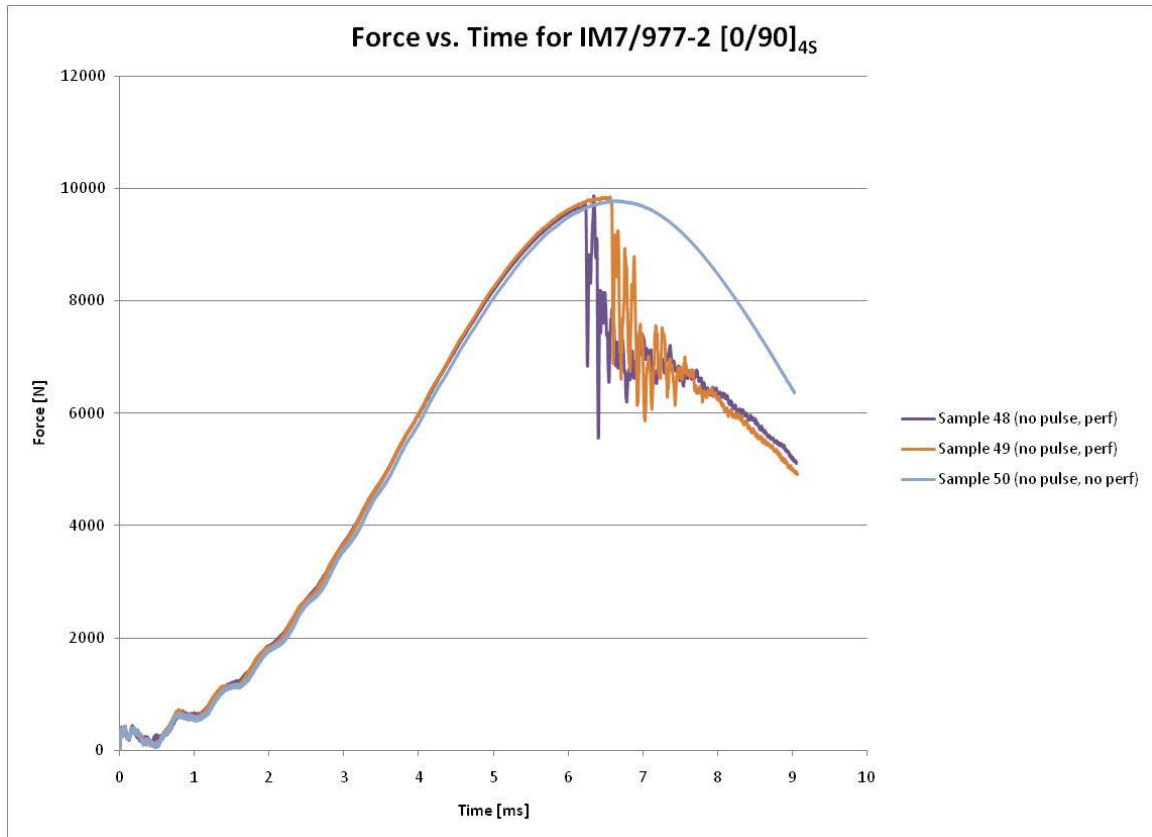
Figure 3.21: Force versus Time for Impact Characterization of Samples 48, 49, & 50

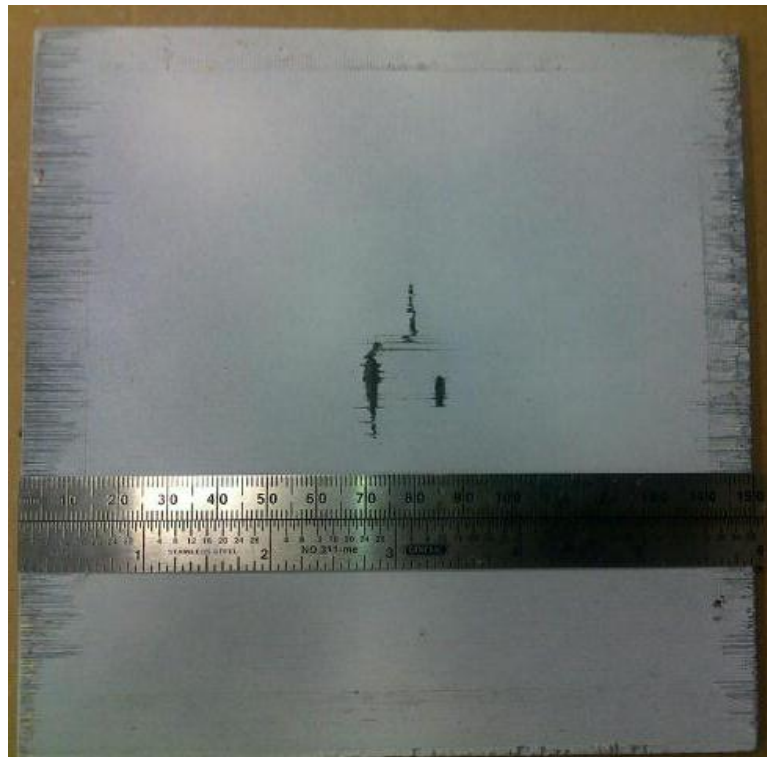
Figure 3.23: Visible Damage on the Back Side of Sample 48

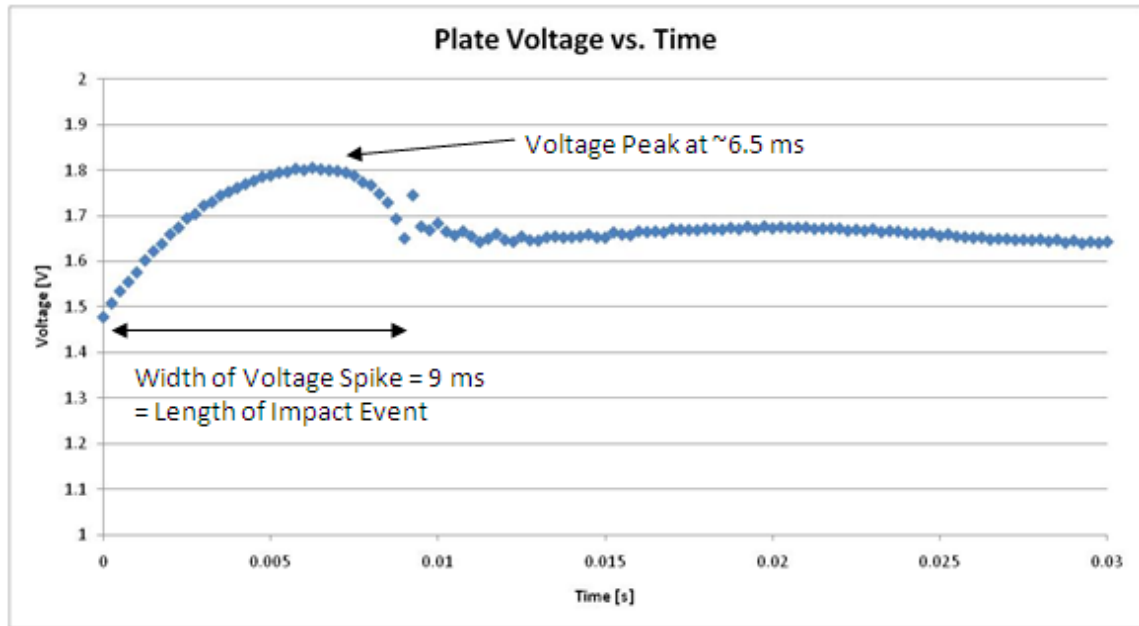
Figure 3.24: Voltage versus Time Plot Showing Peak Voltage at 6.5 milliseconds

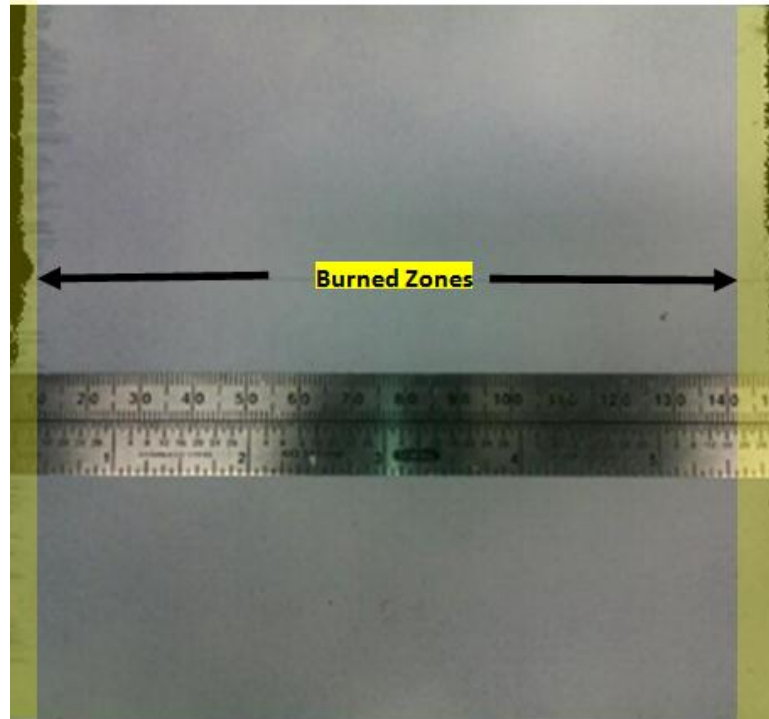
Figure 3.30: 16 Ply Unidirectional Sample 64 with Burned Zones Highlighted

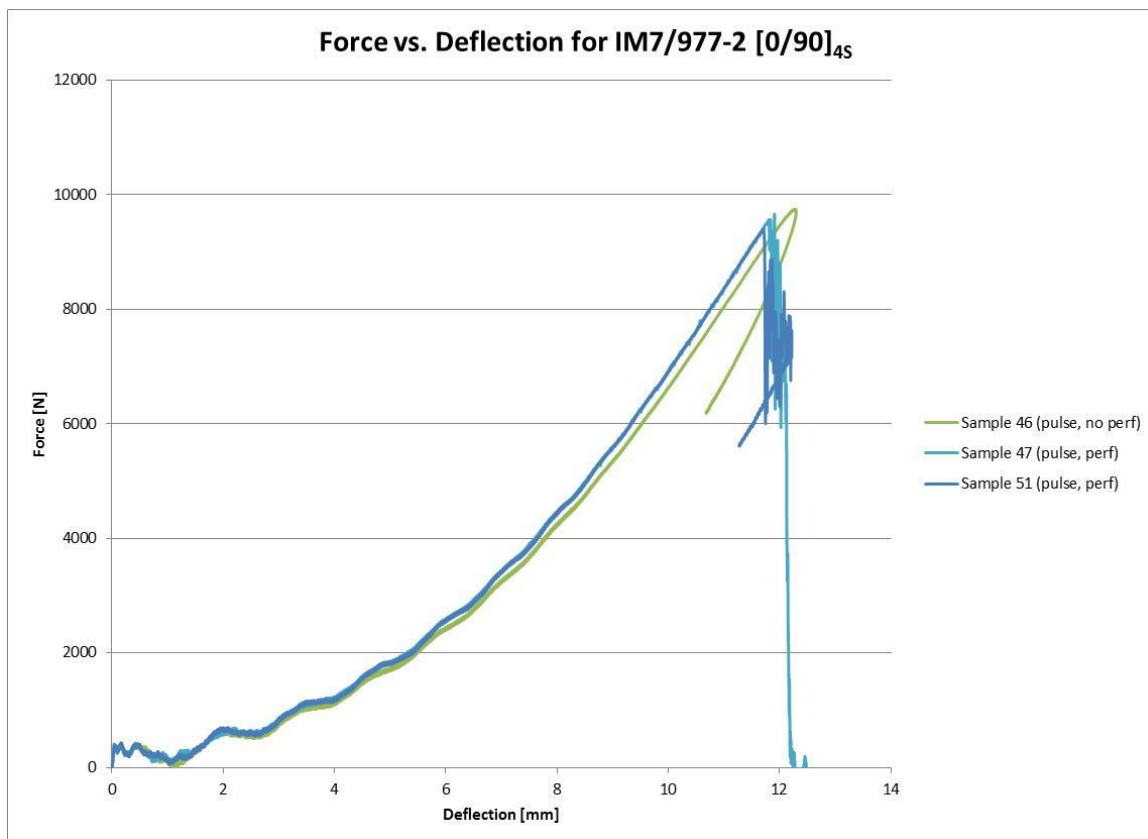
Figure 3.33: Force versus Deflection for 16 ply Cross-Ply Coordinated Impact

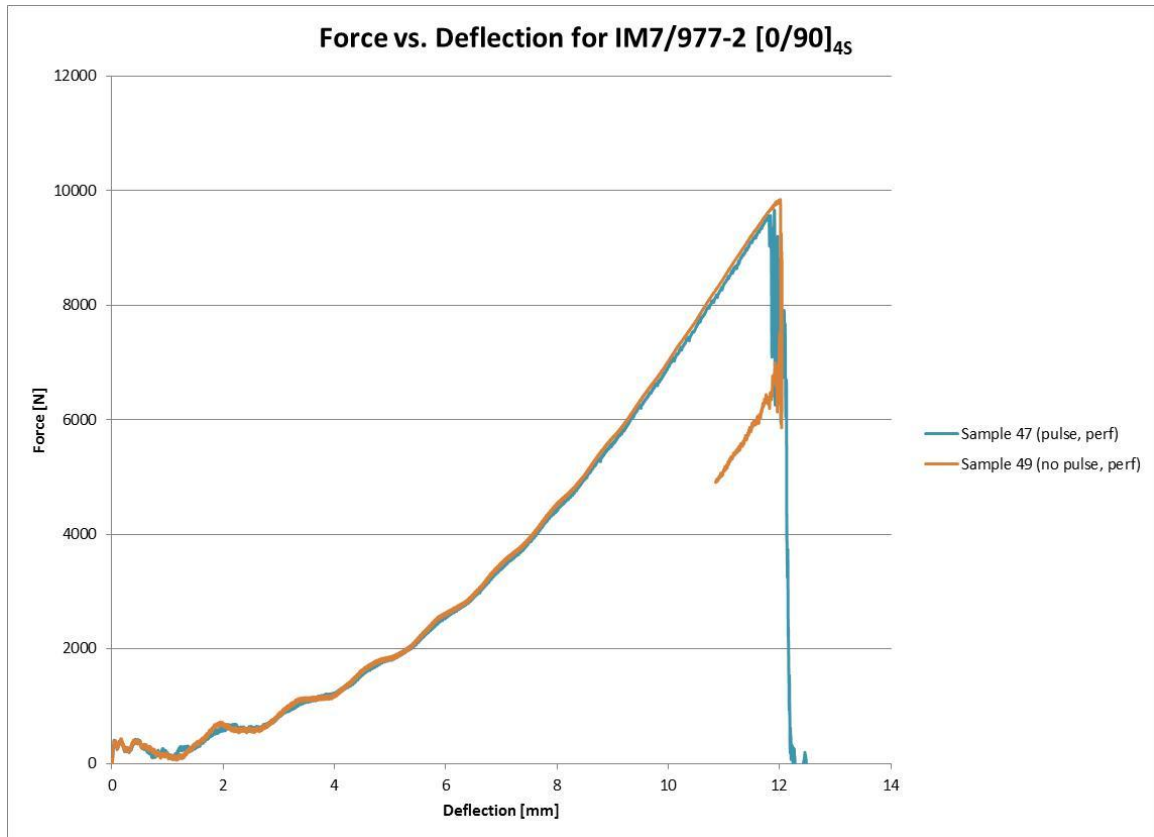
Figure 3.34: Force versus Deflection for 16 ply Cross-Ply Coordinated Impact

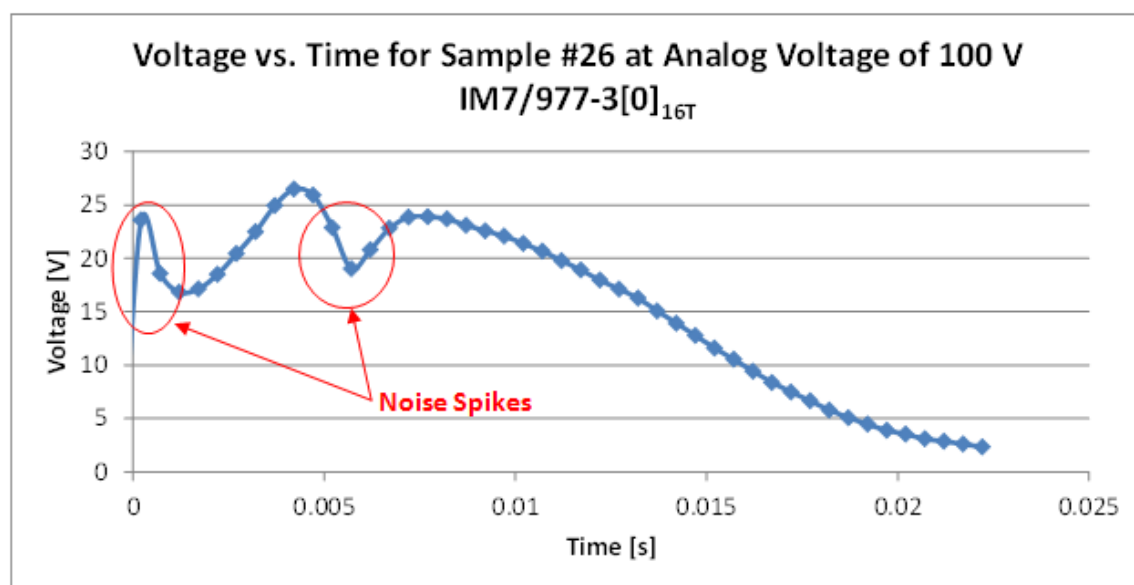
Figure A.3: Voltage versus Time for Sample 26 at 100 V Using Oscilloscope for DAQ

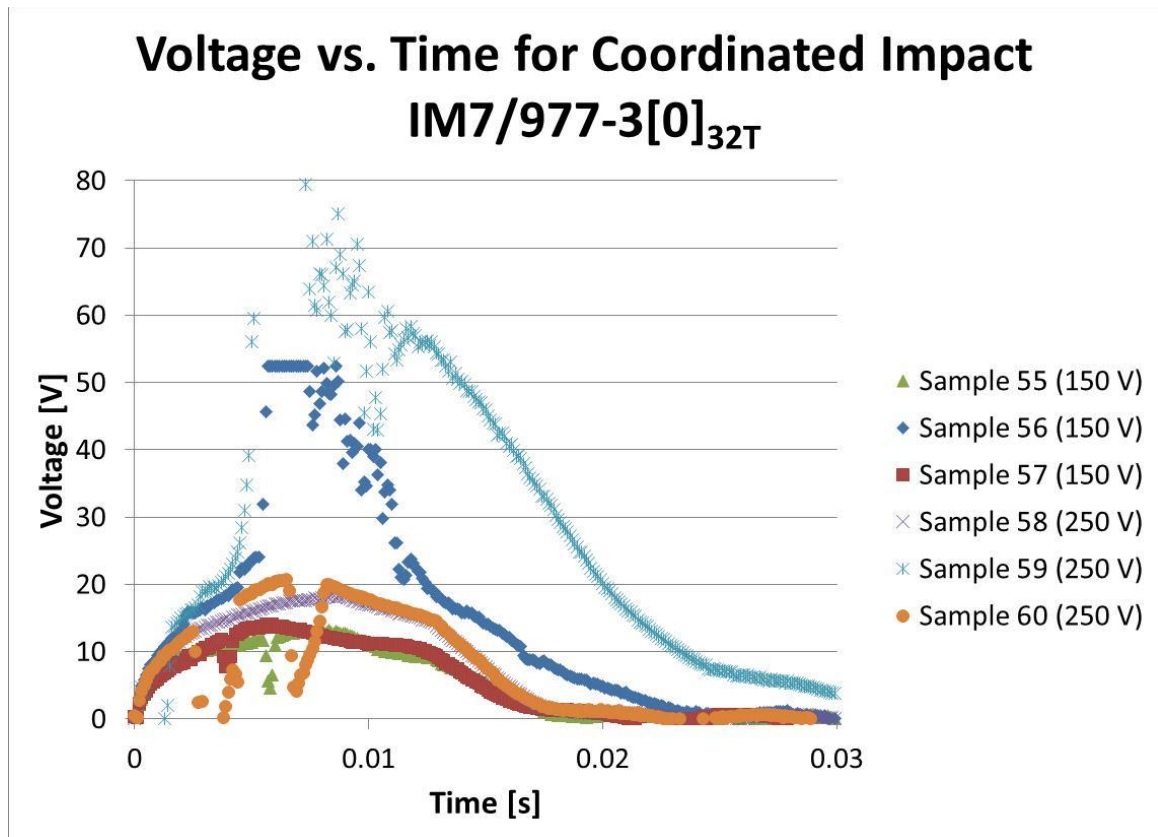
Figure B.2: Voltage versus Time for 32 Ply Unidirectional Coordinated Impact Tests

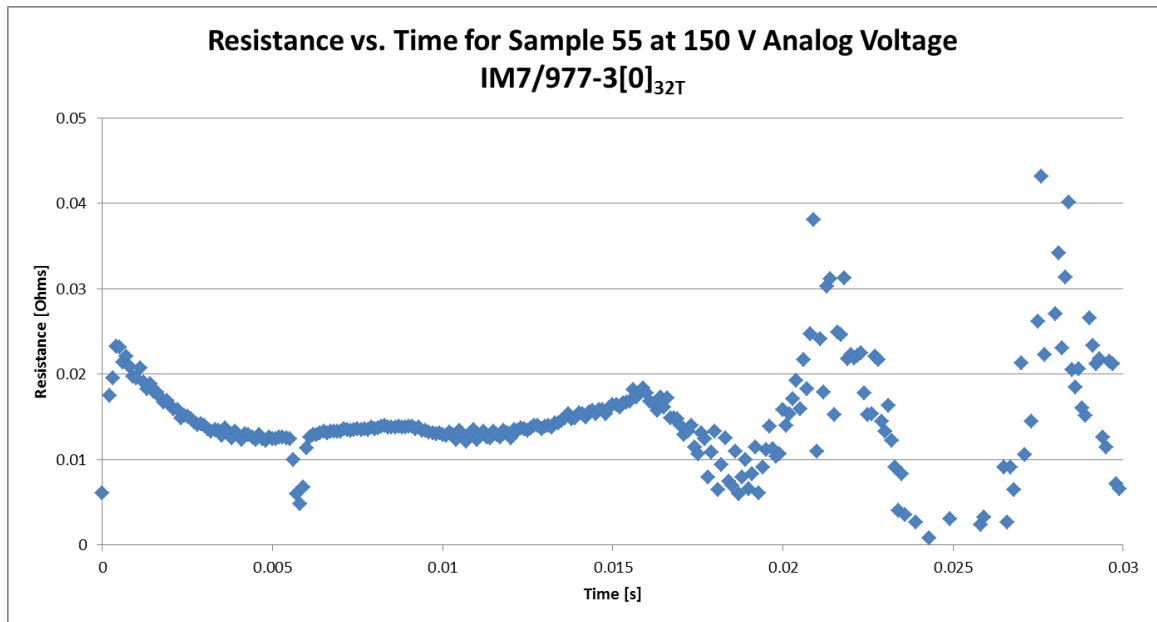
Figure C.1: Resistance versus Time for 32 Ply Unidirectional Specimen

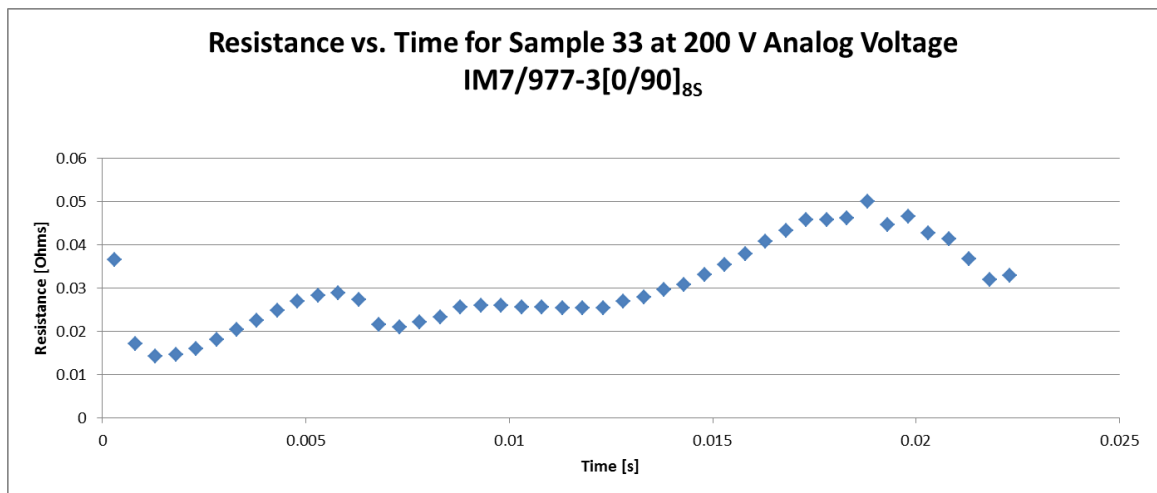
Figure C.2: Resistance versus Time for 32 Ply Cross-Ply Specimen
