Chemical and Acoustic Emission Evaluation Studies of Concrete Bridge in Marine Environment

A DISSERTATION

A field investigation of the Fair Isle Bridge, Miami, Florida consists of a nondestructive evaluation program including physical and acoustic emission (AE) assessment. The bridge is situated in a marine environment and its deck consists of PC and RC sections. Chemical evaluation is performed prior to strengthening with CFRP laminates and consists of visual inspection, carbonation, pH evaluation, chloride content, and steel corrosion detection by half-cell potential. After repair, three additional physical assessments are performed: crack mapping, thermography, and AE. These combined techniques provide sufficient information to create layered maps to evaluate the condition of the bridge structure. Within the maps, areas of interest are explored and compared for high probability of corrosion and concrete damage. Through spatial analysis of physical and chemical evaluation data, areas with significant potential difference are identified. These areas are the focus of a load test while monitoring strain, load and AE. The AE program components consist of in-service traffic monitori

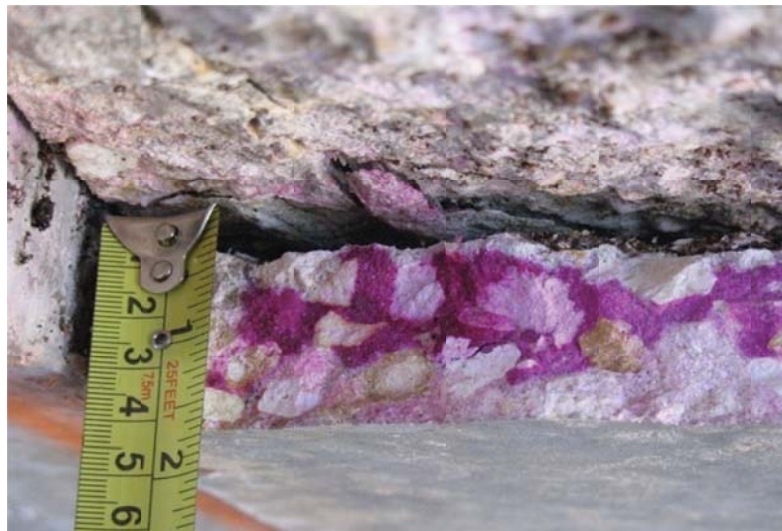
Figure 2.7 - Field exploration for carbonation detection

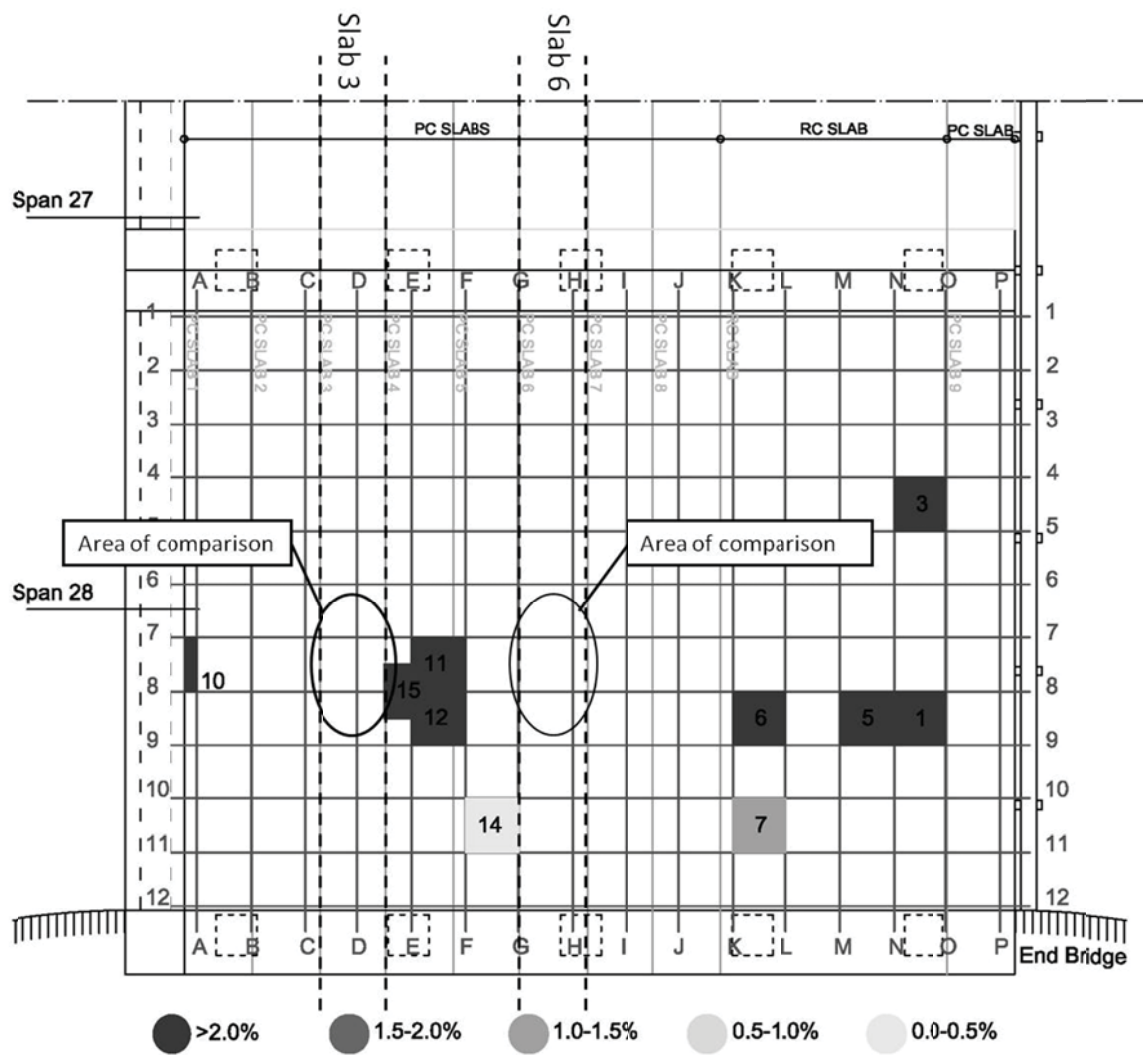
(E) Chloride content – Chloride content results were mapped for ten grid points in the fifth layered map (E) (Figure 2.11). All samples have chloride content above 2% of concrete mass, except sample 7 from the East side of the RC area, and sample 14 from PC slab 5. Results for material type, temperature of prepared specimen and chloride content are reported in Appendix I.B and are in agreement with case studies [Thomas, 2004; Lindvall, 2007], where values ranging from 2.0-3.5% were reported for samples taken at a depth of less than 0.4 in. [10 mm] with marine exposure for more than 10 years and tested at a temperature of about 62°F [20°C]. The resulting map contains a smaller number of samples compared to the other layered maps. This partial information doesn't contradict the collected data in the other assessments and confirms its location with high concentrations of chloride exposure. Samples in this case study showed comparable results at a depth of 3.0 in. [76.2 mm]. No samples were taken from slab 3 and 6 before repair.

Figure 2.11 - Layer (E): Chloride content map

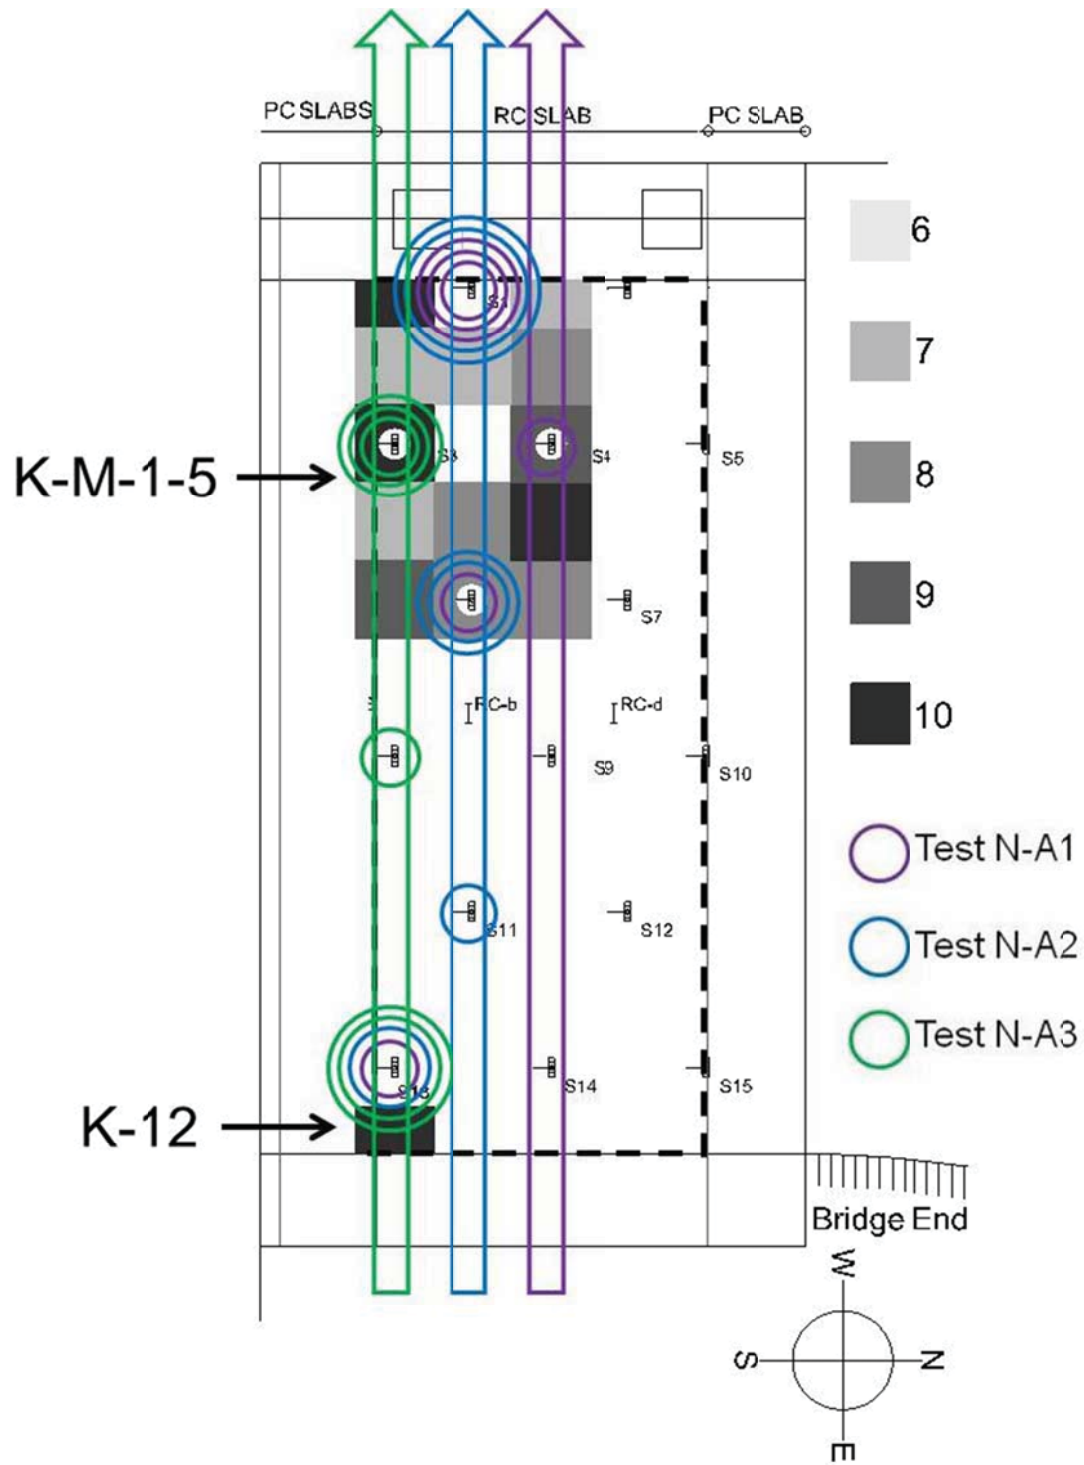
In overall perspective, the figure shows that with three equal travel paths at different locations, most activity was found in the clustered area K-M-1-5. Sensors 3 and 4 are on top of cells ranked at level 9 and 10 on scale 1 to 10 for damage potential where sensor 4 is the only sensor with high activity in the travel path going over sensor 4, 9 and 14.

Figure 3.32 - Most active sensors per crawl speed test

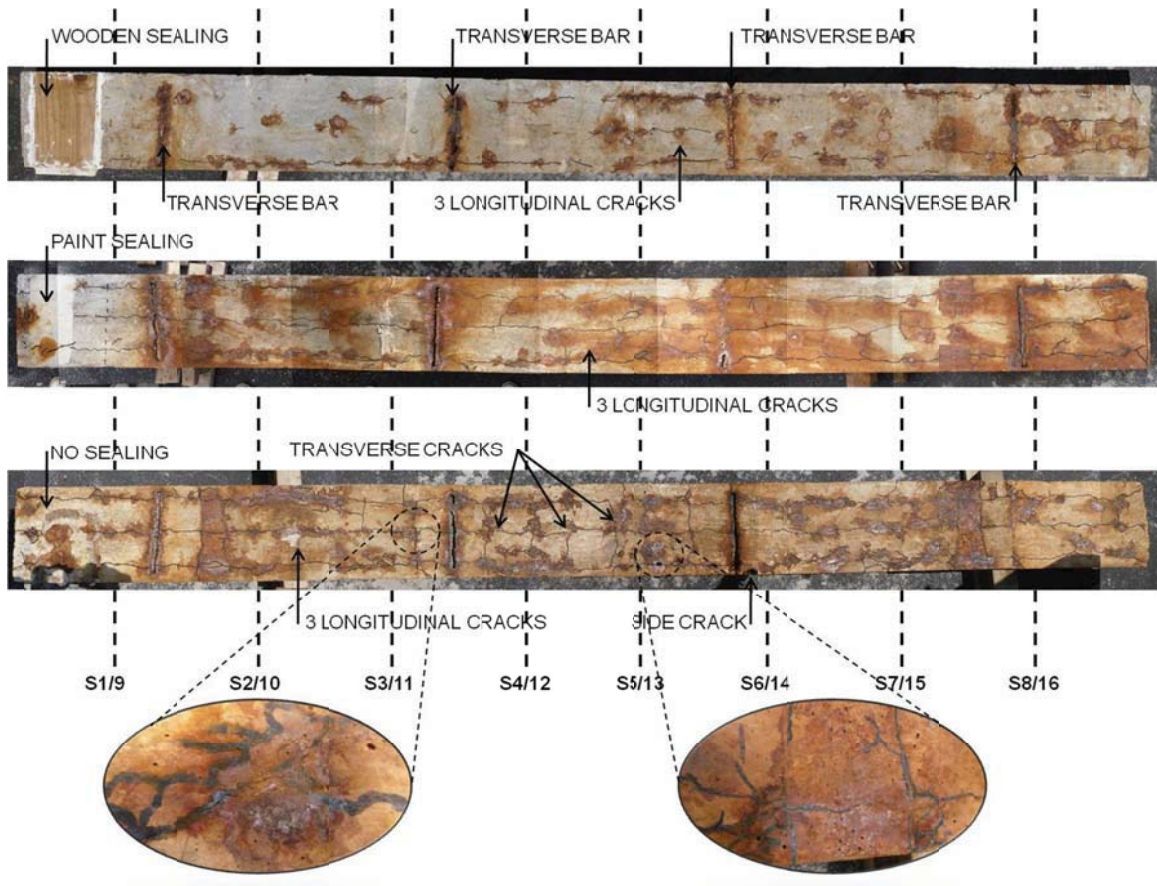
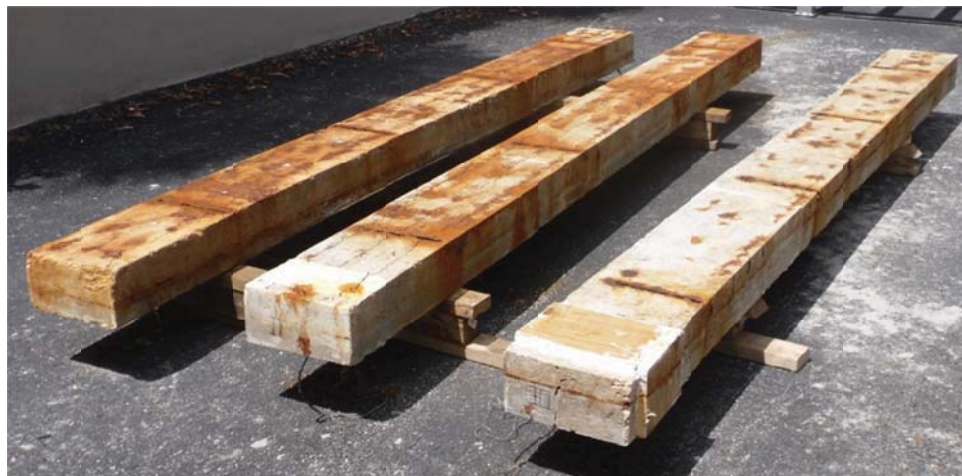
Each beam is visually inspected after corrosion conditioning. Surfaces were cleaned and rust removed to inspect for cracks. Figure 4.8 shows in order Beam B1 with 7.24%, Beam B2 with 12.14% and at the bottom Beam B3 with 19.90% steel mass loss. The specimens show transverse cracking and spall at the location of four transverse bars. The worst corrosion occurred on Beam B3 which shows longitudinal cracks throughout its length and transverse cracks at midspan. Focusing on Beam B3, sensor locations S11 and S14 were recognized with the highest AE Amplitude and Number of Hits. At sensor S14, the most severe corrosion was discovered and spall at the side surface showed that steel reinforcement was locally completely consumed. The transverse bar had more than half of its diameter dissolved and lay loose in the spall gap.

Figure 4.8 - Visual inspection after corrosion (B1 to B3)

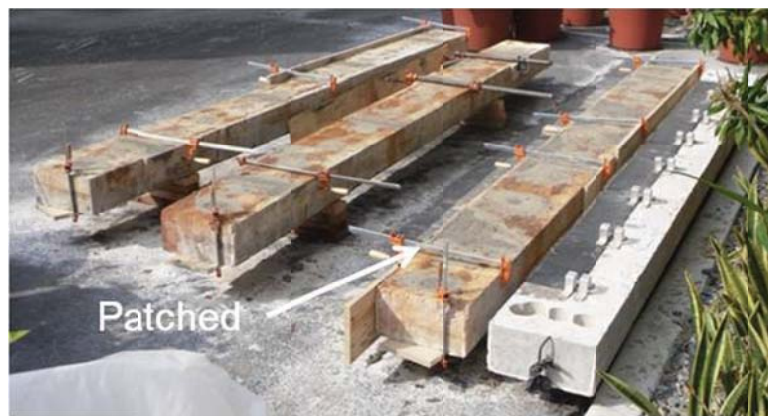
Figure 4.17 - Concrete patching chipped areas (B1 to B3)

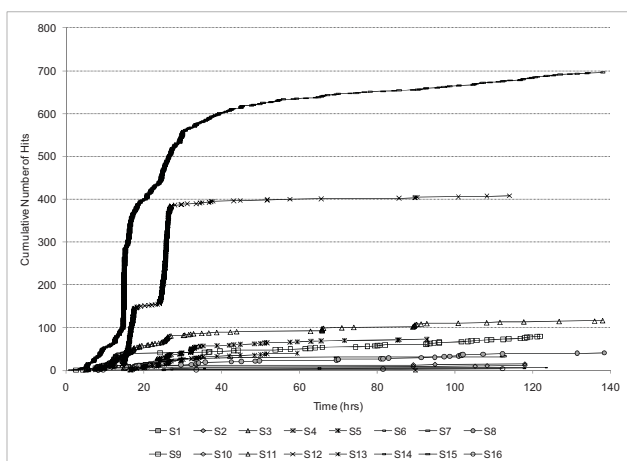
Figure III.C2b - AE Amplitude corrosion Beam B2

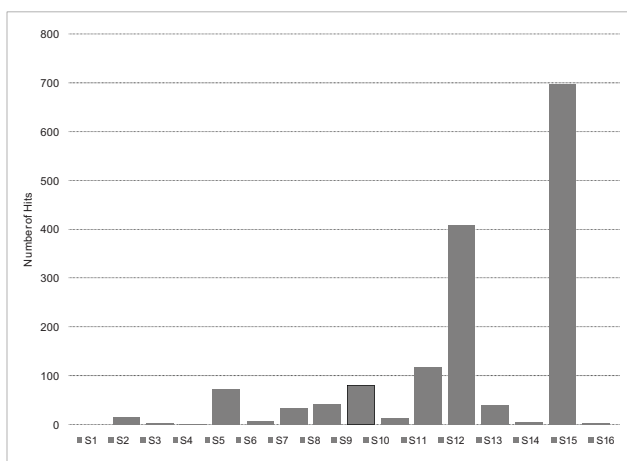
Figure III.C2c - AE Number of Hits Beam B2

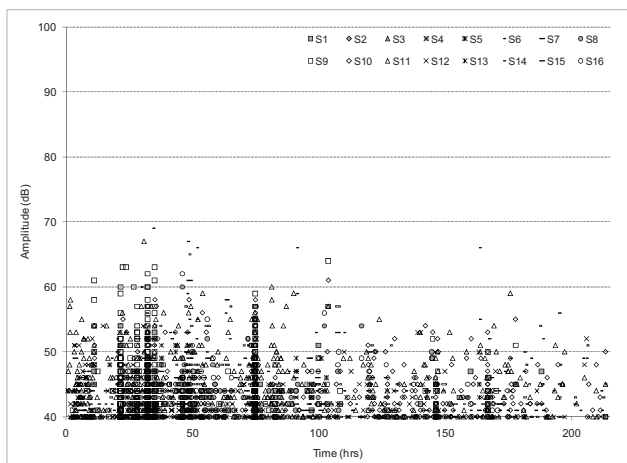
Figure III.C3a - AE Amplitude corrosion Beam B3

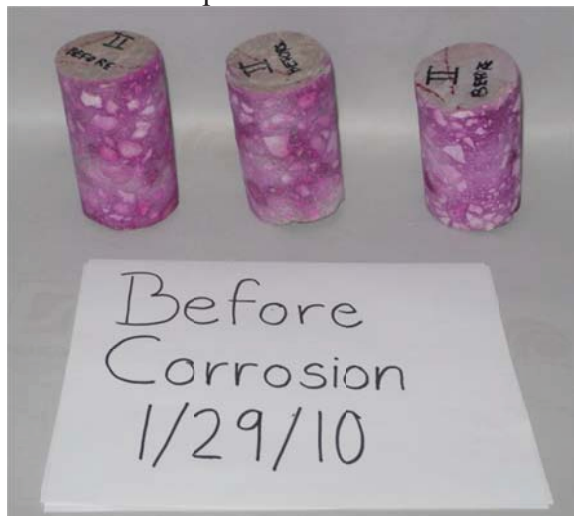
Figure III.D.2 - Core evaluation of concrete carbonation before corrosion
