# International Journal of Architectural Heritage

## Classical Temples and Industrial Stores: Survey Analysis of Historic Unreinforced Masonry (URM) Precincts to Inform Urban Seismic Risk Mitigation

Stacy Vallis, Francisco Gálvez, Moustafa Swidan, Caroline Orchiston & Jason Ingham

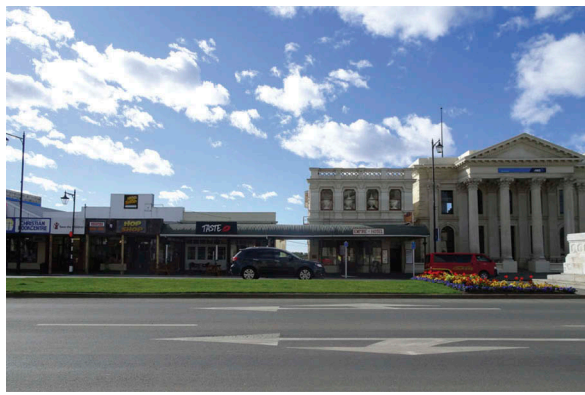
(a) Oamaru

Reviewing heritage assessment reports highlighted varying scales of the aforementioned precincts. The Oamaru Historic Area covers the Central Business District across approximately six urban blocks, in contrast to the Winton Great North Road Historic Area, which stretches only across four blocks (Figure 3a,b). However, the Invercargill Historic Areas consist of various building groups dispersed along the main Tay and Dee Streets (Figure 3c). The concentration of listed historic structures also offers clues to distinct patterns of historic urban development, warranting further research. While the Oamaru Historic Area features a dense concentration of nationally listed structures evident on both sides of the Thames, Harbour, and Tyne streetscapes, Winton's Great North Road Historic Area

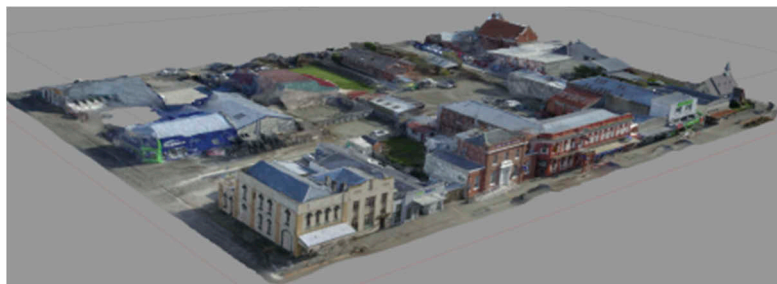
(b) Intersection Thames and Itchen Streets, Oamaru

(c) Great North Road, Winton

(d) Approximation of building heights using photogrammetry

**Figure 10.** Photogrammetry models produced during post-site processing phase.

A key aspect of the post-site processing phase entailed a discussion of the architectural characteristics integral to each of the chosen historic precincts (Figure 10a–d). The combination of photography, mapping, and 3D modeling assisted in the analysis of the three defined historic precincts, to potentially allow the selection and implementation of seismic retrofitting measures that are appropriate to the identified heritage context. Data collection focused on urban and architectural characteristics. Whereas the former category targeted the streetscape scale (e.g., scale, lot size, roofscapes, relationship between buildings, and open spaces), the latter theme highlighted the individual building scale (e.g., number of stories, architectural style, treatment of openings, interior configuration, construction materials) (Heritage New Zealand 2007b). Other categories of data pertaining to both of the above themes included evidence of any historic or existing retrofitting interventions. Overall, the value of photogrammetry

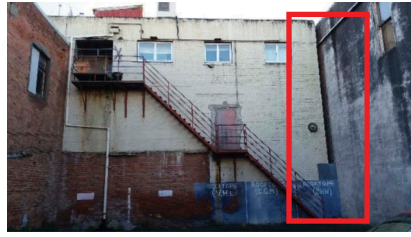
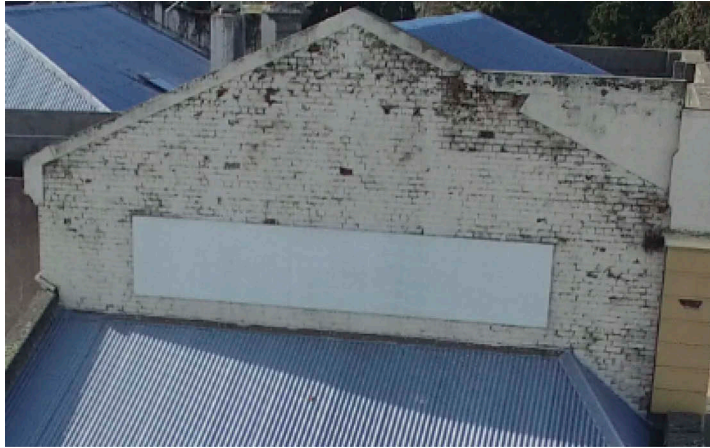
(a) Evidence of vertical separation gap, Invercargill

(b) Evidence of concrete structural elements, Invercargill

(c) Verification of brick masonry construction, compared with painted street elevation

**Figure 11.** Capturing exposed brick masonry construction at rear of buildings and verification of location via geocoded photography.

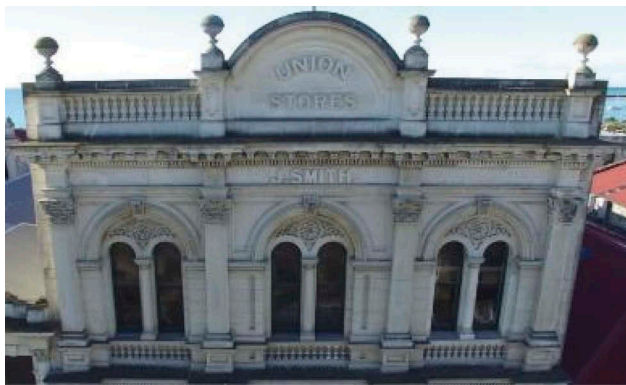
(a) Union Building, 7 Tyne Street, Oamaru

(b) Connell and Clowes, 5 Tyne Street, Oamaru

(c) AMP Building, 18 Itchen Street, Oamaru

(d) Star and Garter Hotel, 8 Itchen Street, Oamaru

**Figure 12.** Four distinct ornamental parapet forms, comprised of finials, pediments, balustrade, and stringcourse (Tyne and Itchen Streets).

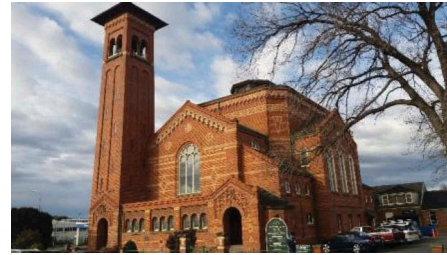
(a) Variation of painted masonry along streetscape

(b) Exposed and painted brick masonry

(c) Exposed brick masonry with timber detailing

(d) Exposed and painted brick masonry door/window surrounds

(e) Italo-Byzantine brick masonry

**Figure 13.** Varied architectural deployment of brick masonry, Invercargill CBD.

Converse to the argument articulated above, the Invercargill Historic Areas display a more varied architectural use of brick masonry across the historic building stock. Brick is used in load-bearing and non-load-bearing capacities, and especially to ornamental effect. Principal elevations such as those along Tay and Dee Streets (Invercargill CBD) are painted or feature the use of other materials in conjunction with brick (Figure 13). The streets are therefore characterized by an eclectic collection of facades, which vary in scale, color, and composition of building materials. The use of exposed, polychromatic brick masonry lend further variation, although there are fewer examples of this architectural use (Figure 14). In contrast to the Oamaru Historic Area, the streetscape of Invercargill presents ambivalent attitudes to the architectural use of brick masonry construction. Whereas Oamaru limestone was prized for its natural color and texture,

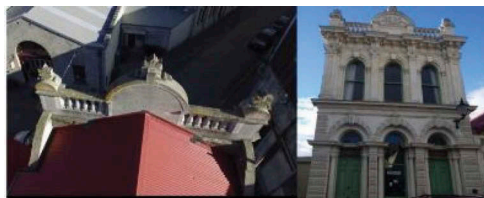
(g) Verification of no parapet restraints (Oamaru)

Figure 15. Verifying evidence of existing retrofitting via drone and geocoded photography, Oamaru and Winton.

Employing concealed seismic strengthening measures also suggests a design approach based on augmenting the buildings' intrinsic resistance to earthquakes, by integrating structural elements within the historic structural matrix vs. unnecessary addition of elements which may not utilize the building's existing structural properties (Robinson 2000). As such, the illustrated examples display improvement of primary interconnections (e.g., floors and roofs to walls), restraint of falling hazards such as parapets and wall stiffness. Overall, observed measures to improve structural behavior are confined to either strengthening specific structural elements versus addressing the building as a whole. Approximations of age and period of the undertaken retrofitting may also be gauged by the varying wall tie mechanisms and materials (e.g., wrought iron vs. steel) (Figure 15b, d).

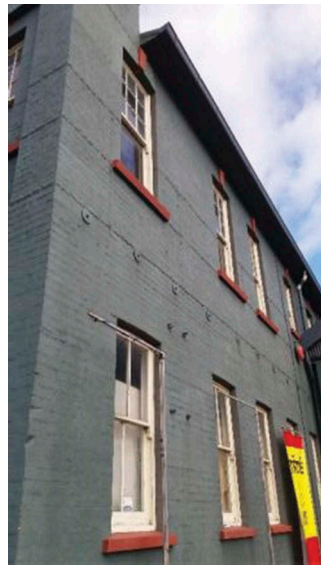
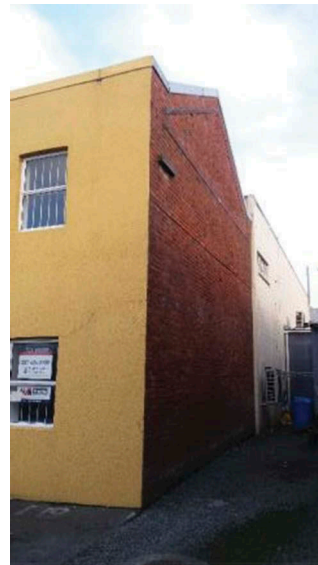
(a) Steel/wrought iron wall ties

(b) Steel strapping along gable

(c) Sealed openings and parapet balustrade

**Figure 16.** Evidence of existing retrofitting via geocoded photography, Invercargill.

Of the surveyed buildings within the designated Invercargill Historic Areas using geocoded photography alone, there proved to be little external evidence of existing seismic mitigation measures (Figure 16). Common solutions included the use of steel wall ties and sealing of openings such as windows as well as parapet balustrades (Figure 16). Location within an area of low seismic risk (Figure 1) may serve as the primary reason for previously relaxed attitudes to potential damage by earthquake.
