Computational and experimental biomechanics of total hip wear increase due to femoral head damage

COMPUTATIONAL AND EXPERIMENTAL BIOMECHANICS OF TOTAL HIP
WEAR INCREASE DUE TO FEMORAL HEAD DAMAGE

A thesis submitted in partial fulfillment
of the requirements for the Doctor of
Philosophy degree in Biomedical Engineering
in the Graduate College of
The University of Iowa

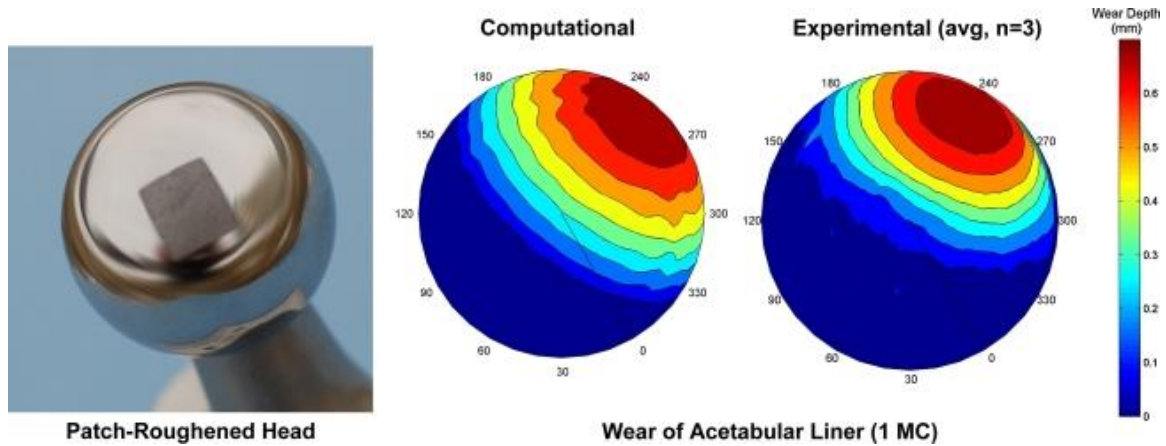
Figure 6: Validation trials for patch-roughening (by grit blasting) of otherwise undamaged femoral component heads showed close agreement with UHMWPE removal in a laboratory wear simulator ²⁷.

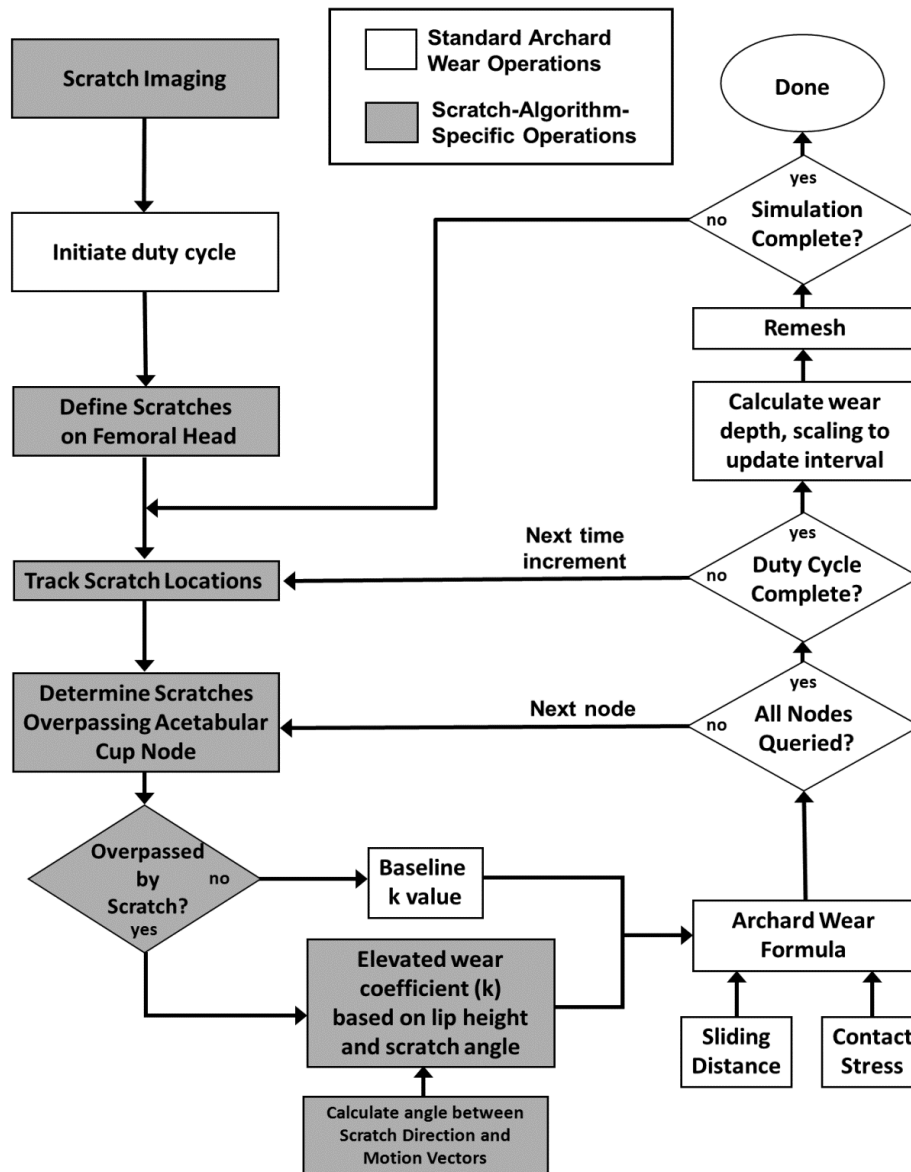
Figure 8: Flowchart of scratch-based FE wear model

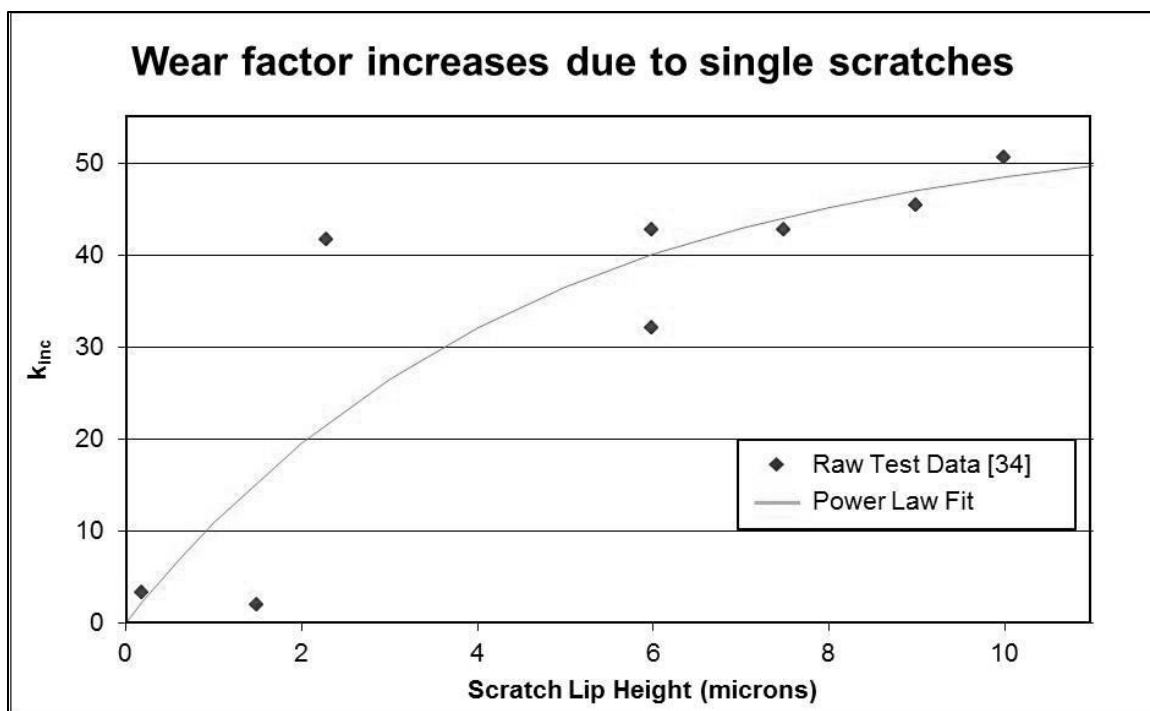
Figure 10: Single-scratch bench study data were used to generate a power law relationship between wear coefficient elevation and scratch lip height (as measured in microns.) Power law fit was performed by the author (KMK).

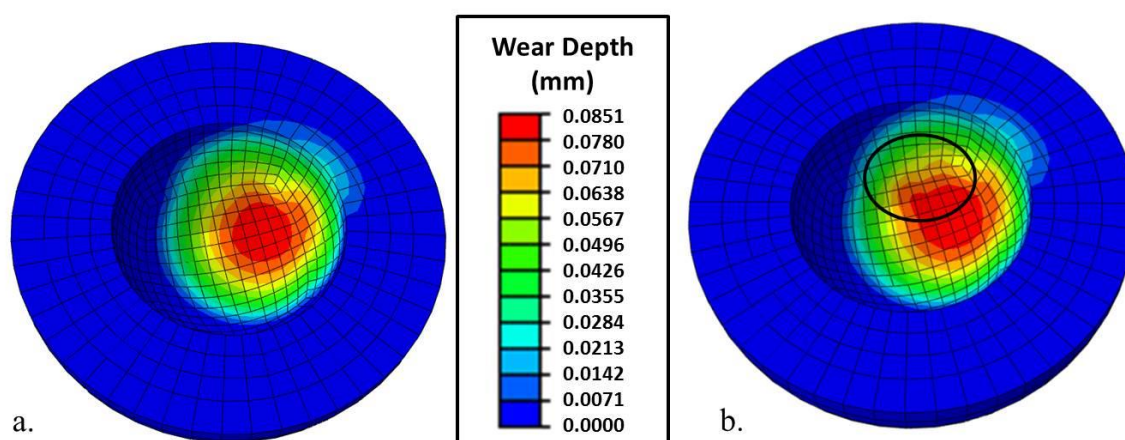
Figure 11: Functionality test for the scratch-based wear simulation algorithm. Wear of an UHMWPE acetabular cup (a) articulating against an undamaged femoral head, and (b) against a scratched femoral head was considered. The area of increased wear depth is indicated on the scratched head wear contour.

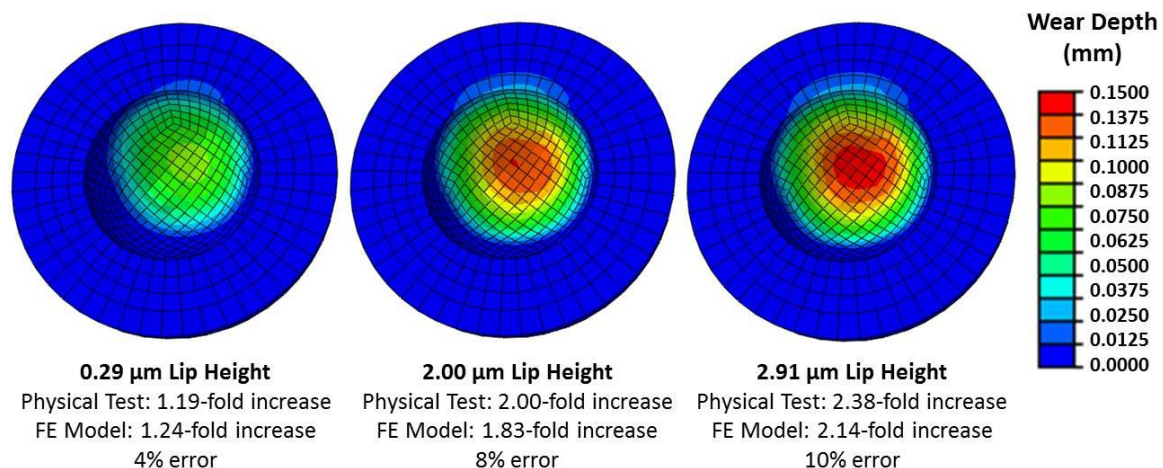
Figure 13: Computed distribution of linear wear and comparison to previously published physical wear tests. Physical wear test results had been reported by Barbour et al.⁸ for 0.29 μm and 2.91 μm cases and by Endo et al.⁶¹ for the 2.00 μm case.

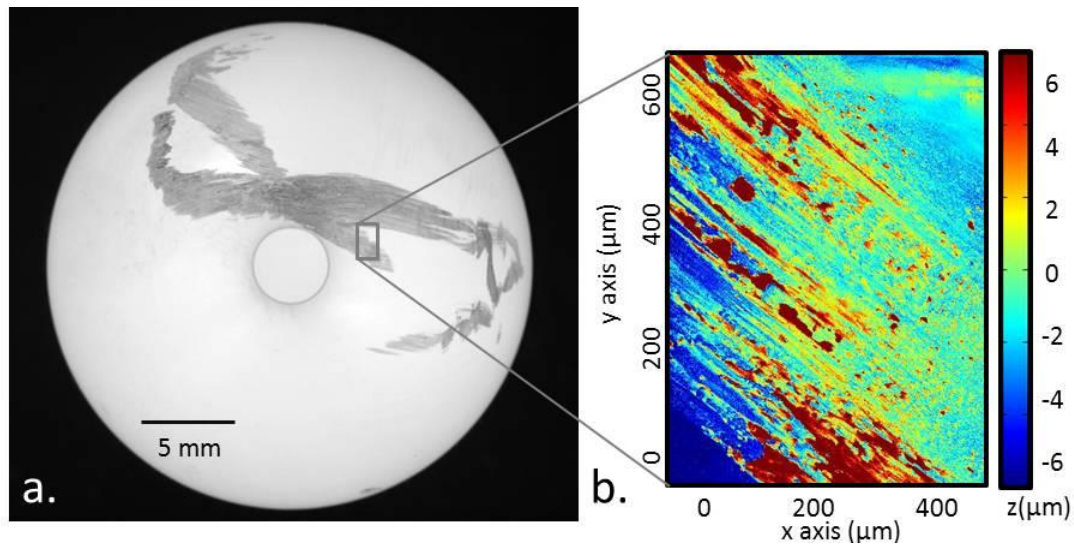
Figure 16: Example of scraped retrieval femoral head. (a) Global photograph. (b) OP scan displaying characteristic “micro”-scratch damage.

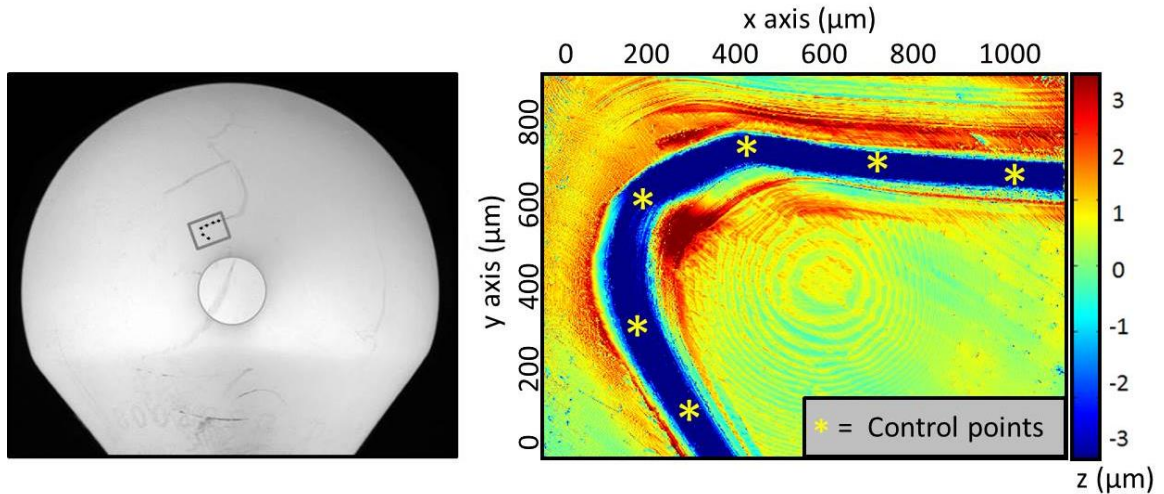
Figure 31: Global photograph and local OP scan of a selected region. The control points used to align the two datasets are indicated.

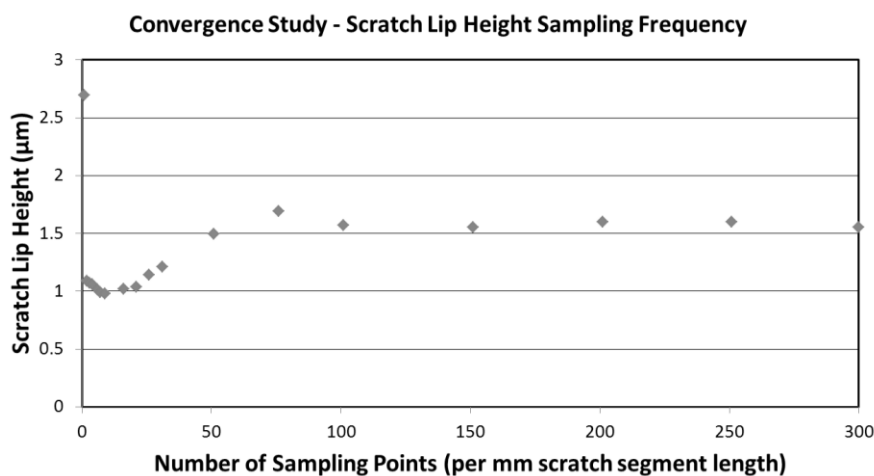
Figure 33: The results of a sampling convergence series, undertaken to determine appropriate sampling frequency.

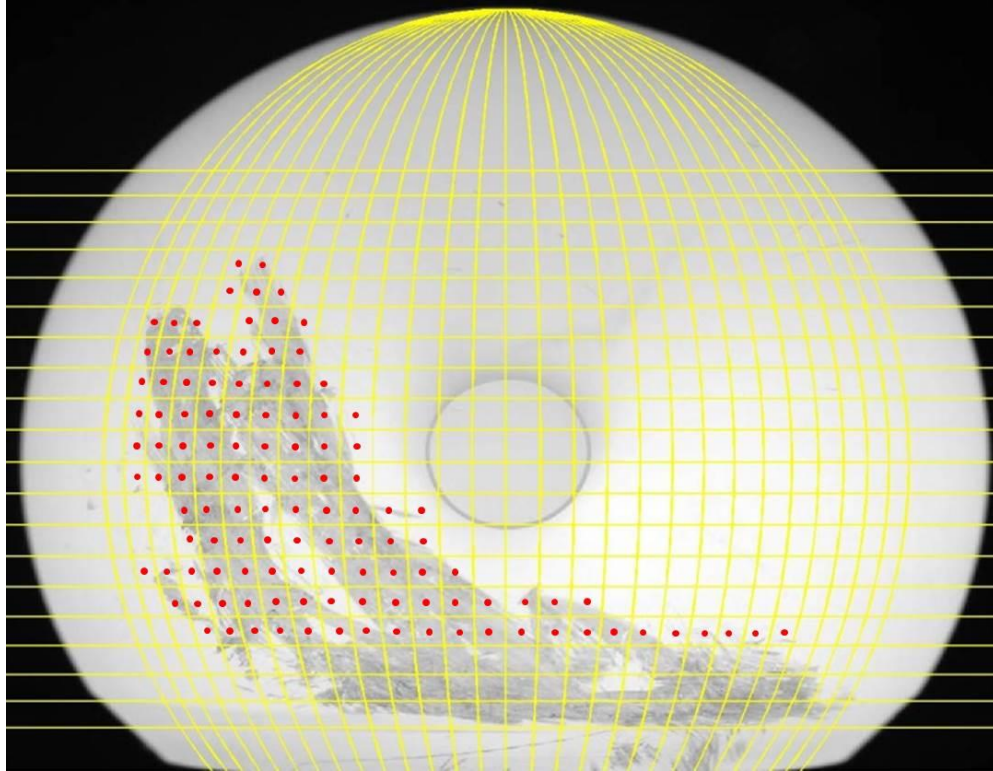
Figure 37: Global level femoral head photograph with grid indicating potential scan locations. The red dots indicate scan sectors that the damage detection program identified as containing damage. (Damaged areas above the indicated grid were captured in a polar view photograph.)

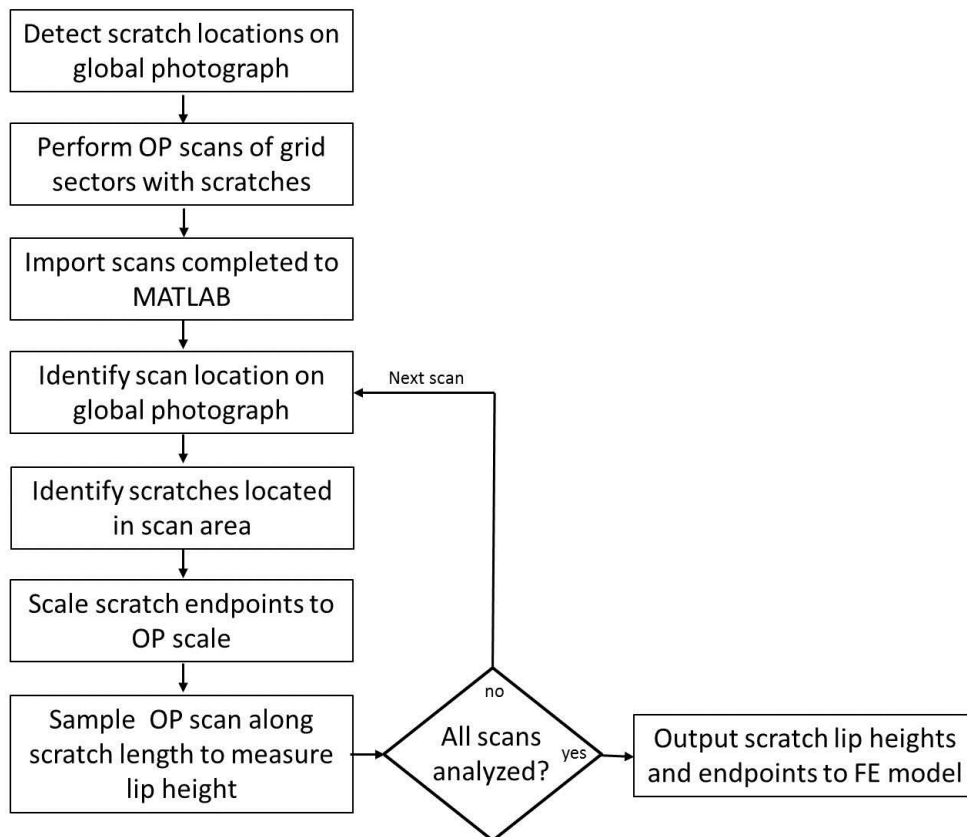
Figure 39: Flowchart of automated alignment program to measure scratch lip heights.

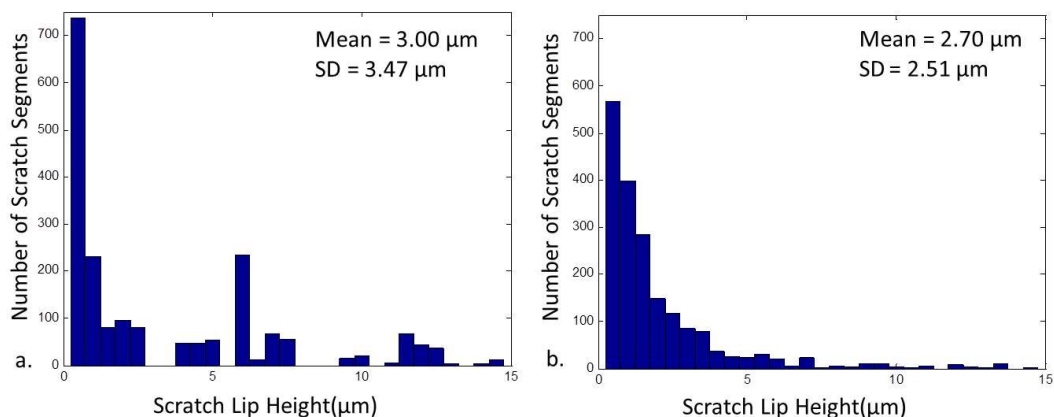
Figure 46: Scratch lip heights measured for Specimen A using (a) manual alignment and (b) automated alignment.

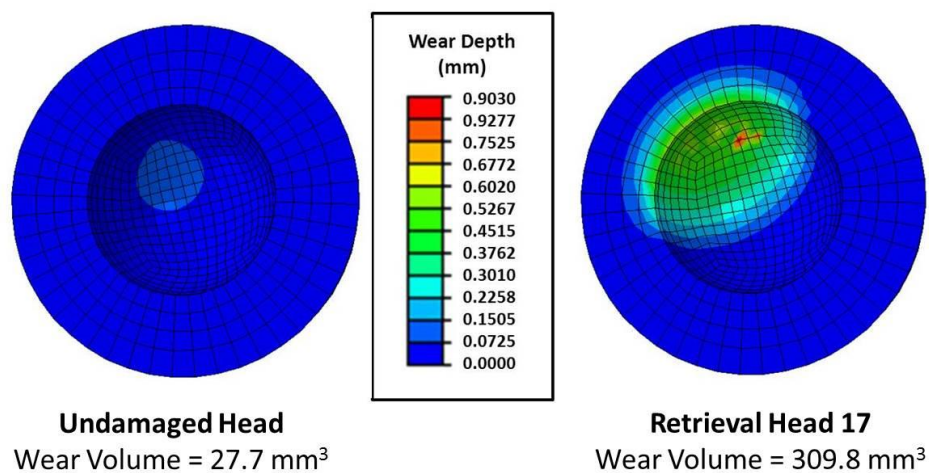
Figure 51: Comparison of wear depths for undamaged and representative retrieval femoral heads.

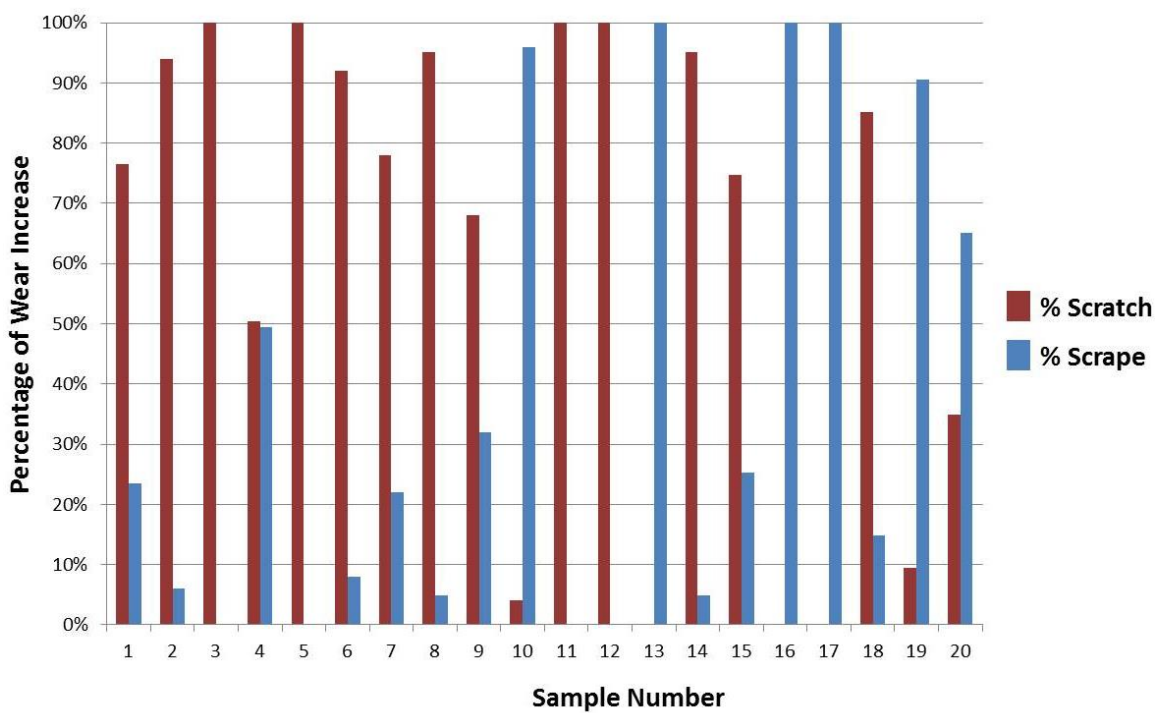
Figure 52: Results of FE analysis to isolate the wear acceleration potential of scratches versus scrapes on 20 retrievals.

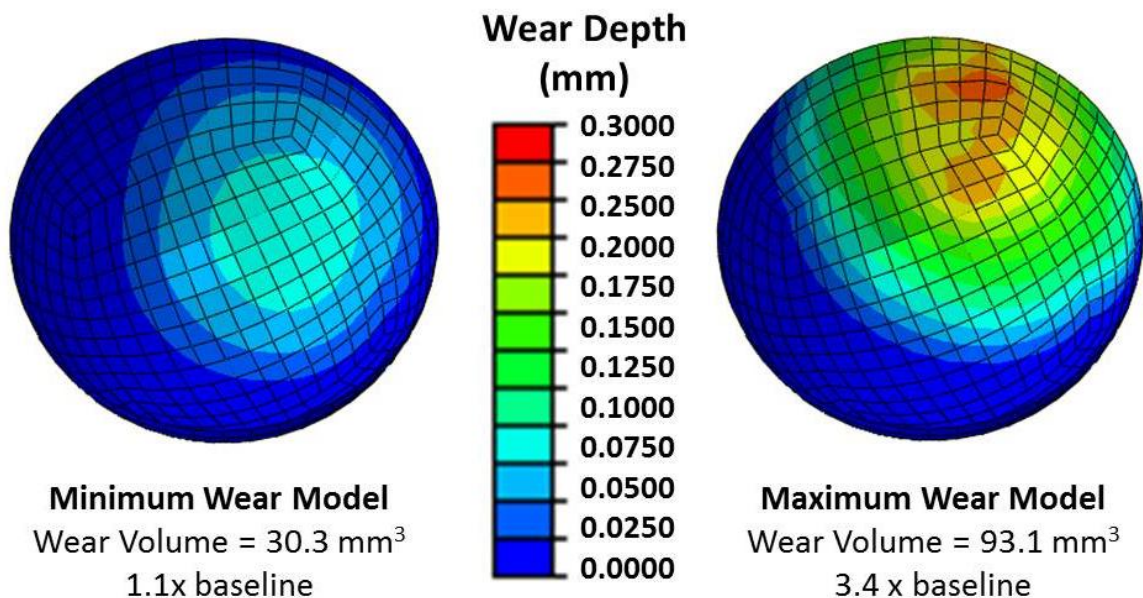
Figure 54: Volumetric wear depth plots for Specimen #8, for the rotational orientations having minimum (left) and maximum (right) volumetric wear.

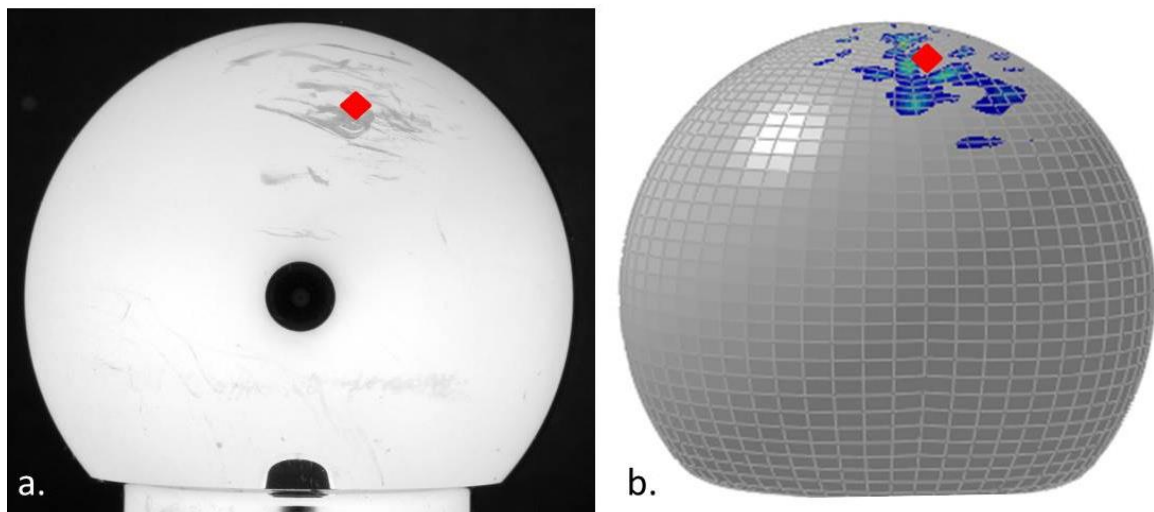
Figure 63: Damage centroid locations. a. Retrieval displaying characteristic scrape damage. The resultant centroid was 17° anterior to the sagittal midline. b. Wear scar result of FE model. The resultant centroid was 9° anterior to the sagittal midline, an 8° differential.

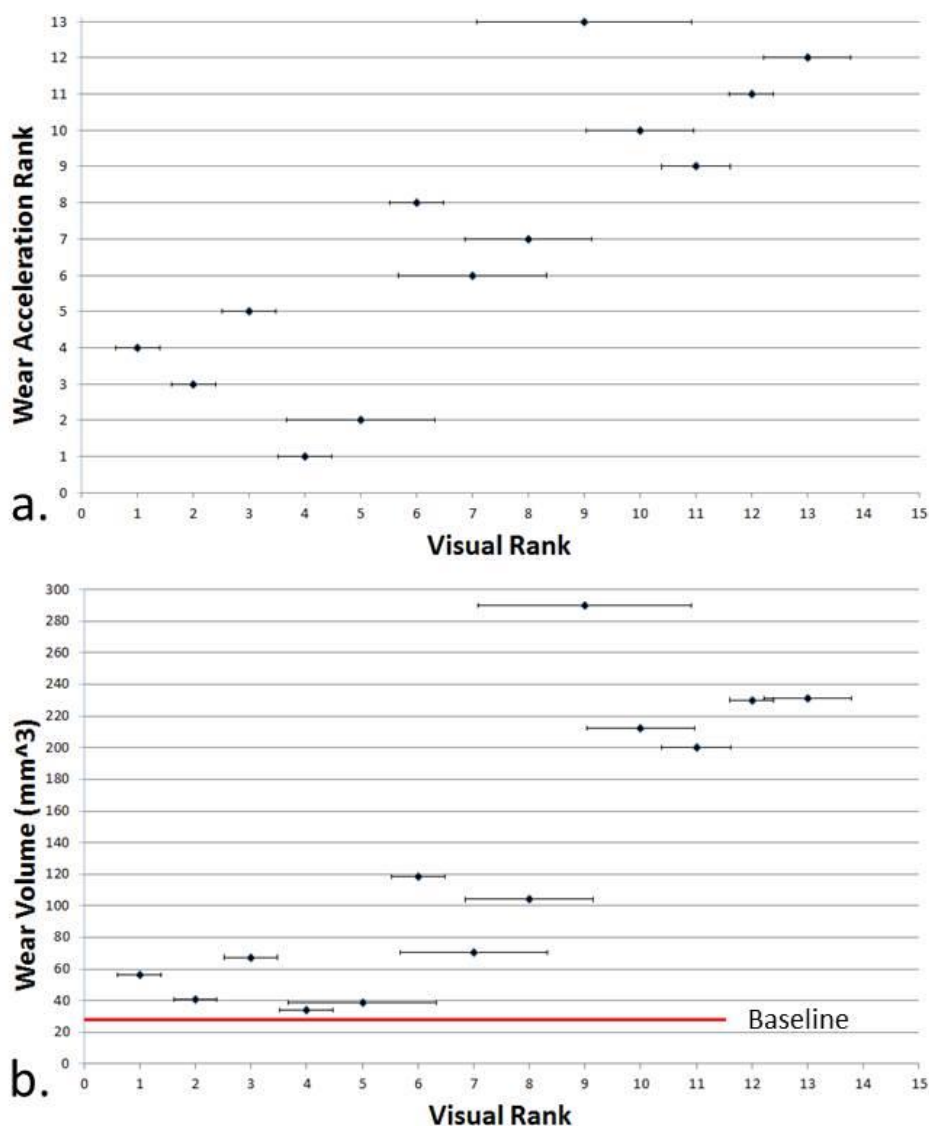
Figure 65: Comparison of femoral head ranking by visual assessment (95% confidence intervals) and computed wear acceleration. The concordance between the two rank orderings (b) was 0.82, indicating relatively strong rank association.
