Corrosion of Post-Tensioning Strands in UngROUTED Ducts - Unstressed Condition

A thesis submitted in partial fulfillment
of the requirements for the degree of
Master of Science in Materials Science and Engineering
Department of Chemical and Biomedical Engineering
College of Engineering
University of South Florida

Keywords: Wire Bending, Relative Humidity,
Seven-wire Steel Strand, Shallow Pitting, Marine Exposure

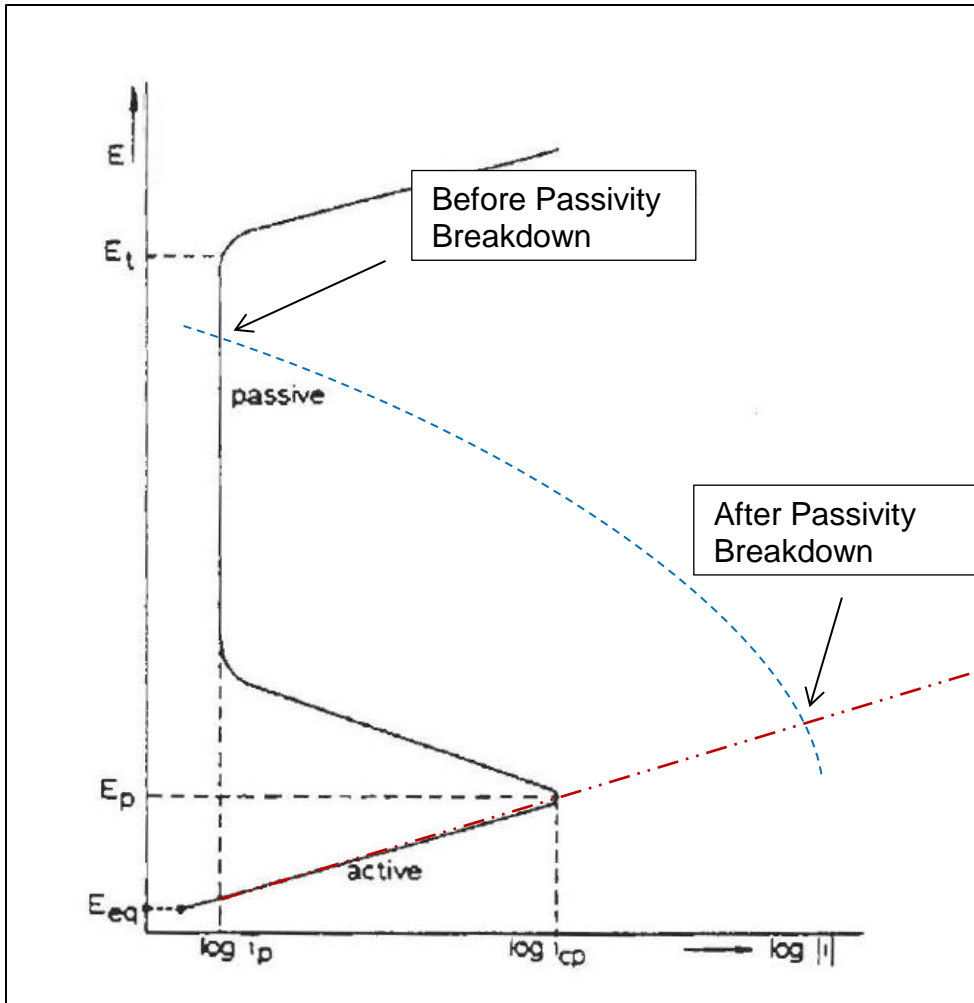
Figure 1 Anodic Polarization Curve of a Metal Which Can Passivate (Source: Gellings, Modified by Hutchison)

More information on this process is expounded on within the discussion. Steel placed in basic solutions (high pH) steel forms a protective oxide or oxyhydroxide film on its surface which impedes corrosion. This is called passivation. The protective film is referred to as a passive film or passive layer. This layer breaks direct contact from the steel and the electrolyte and thus stops or severely slows corrosion. As corrosion is an electrochemical process, corrosion rate is often expressed in terms of a current density. If the specific reactions are known, as well as the specimen size and current, a simple relationship relates the metal loss with the corrosion current density. Figure 1 demonstrates the corrosion reactions for a metal which can passivate. In Figure 1, the abscissa is the logarithm of the current density, where the ordinate is the electrical potential. The black curve is the anodic reaction which has a stable passive behavior above E_p . The red line represents the anodic reaction following passivity breakdown. The blue curve denotes the cathodic reaction (oxygen reduction). Without the use of an externally applied current, corrosion reactions must occur at intersections of these reaction lines. The current of the cathodic reaction must perfectly balance with the anodic reaction. From the figure it is demonstrated above that the corrosion current density, and consequently, the corrosion rate, is exponentially reduced when the metal becomes passive. Aggressive elements, such as chlorides, present in marine or deicing salt service environments, have been known to break down this passive layer in steels.

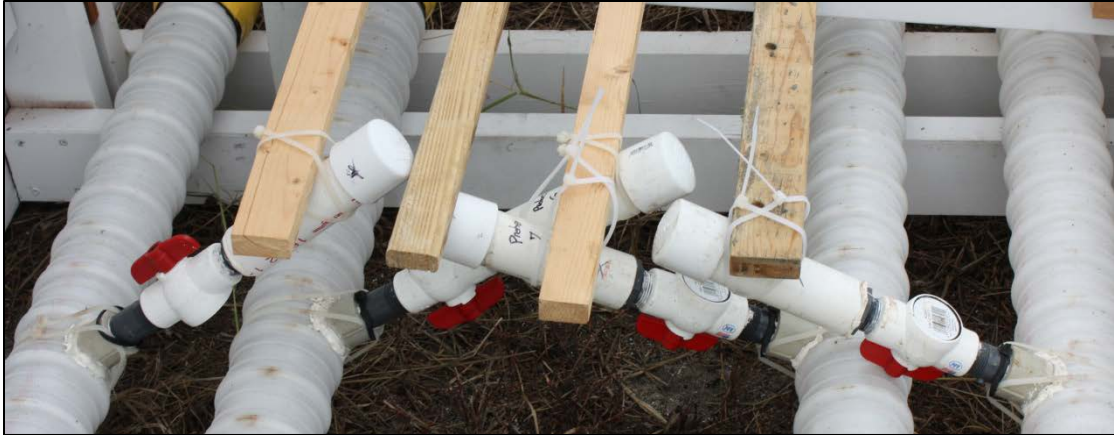
Figure 4 Relative Humidity & Temperature Probe Housings Attached to Ducts via Vent Port and Secured with Wood Boards and Zip-Ties

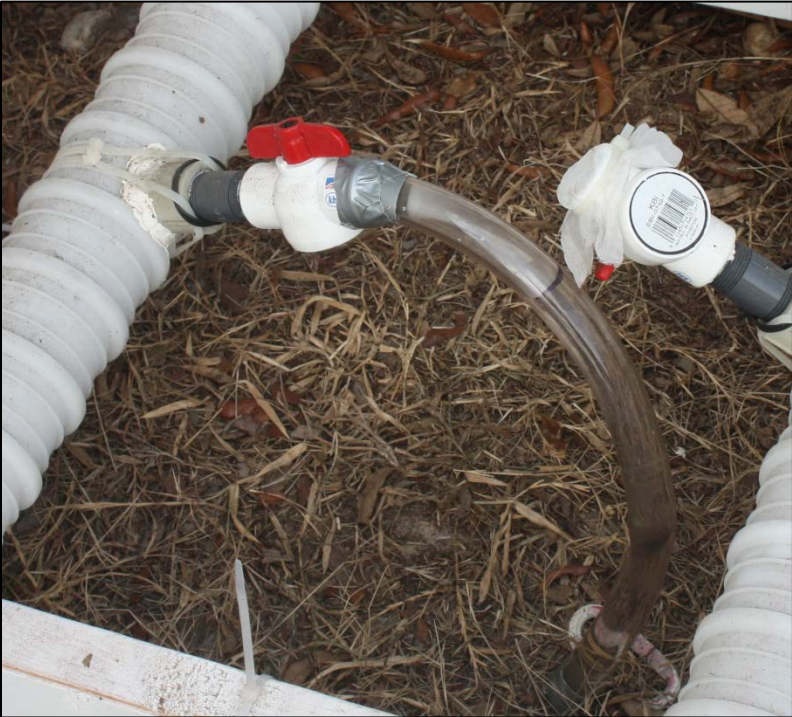
Figure 5 Water Reservoir Attached via Vent Port (left) and Closed Vent Port Covered with Bug Shield (Right)

Water level was marked and refilled as needed, as seen in Figure 5.

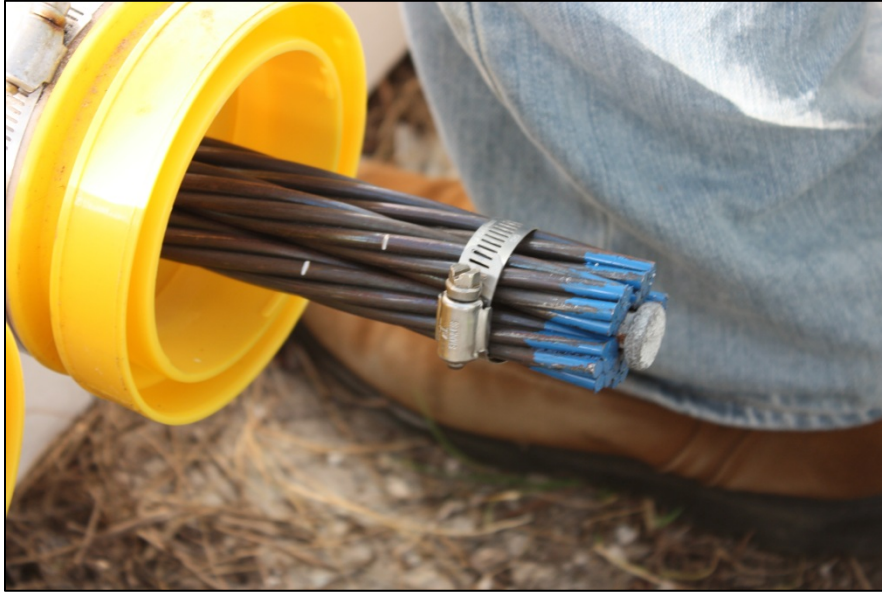
Figure 6 Strand Group Ready for Duct Insertion with Galvanized Spike Secured with Stainless Steel Hose Clamp

A galvanized nail was attached via a stainless steel hose clamp (Figure 6) to simulate the effects (if any) of a galvanized anchorage system on the corrosion propagation of the strands.

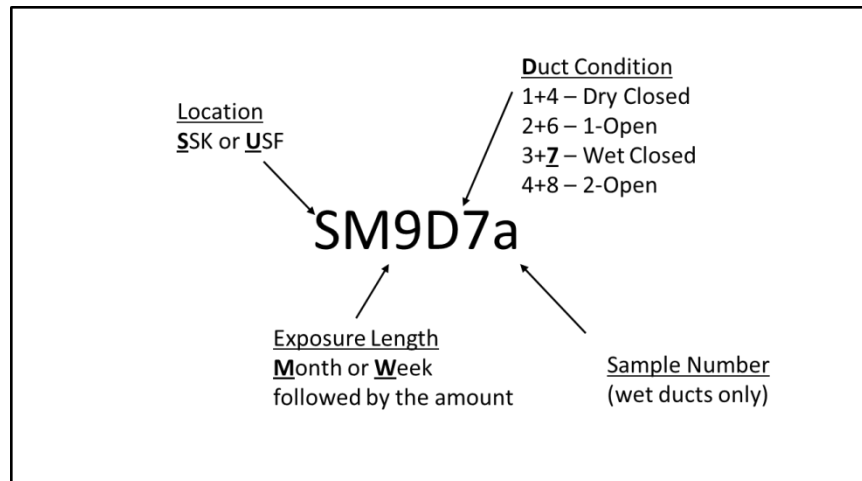
Figure 8 Strand Identification Code

A unique identification code was given to each strand to distinctly and quickly identify each strand and from which condition it was exposure to. Figure 8 demonstrates this code.

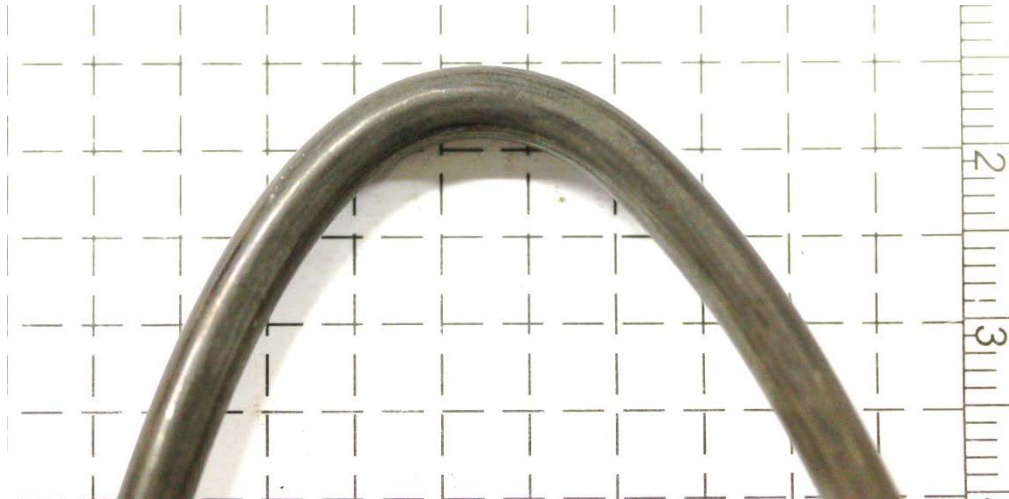
Figure 12 Typical Wire After Bending

The bent wires were then photographed on the exterior of the bend surface to look for any cracks large enough to see which may have been opened up through bending. Wires were subsequently prepared for metallographic examination. Metallographic evaluation was intended to reveal cracks or other features that were not visible to the unaided eye or visual photographic evaluation.

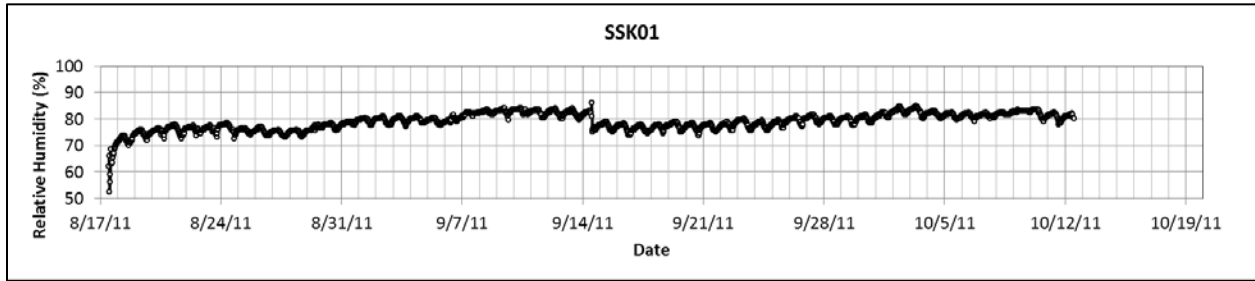
Figure 14 Relative Humidity of Duct 1 at SSK

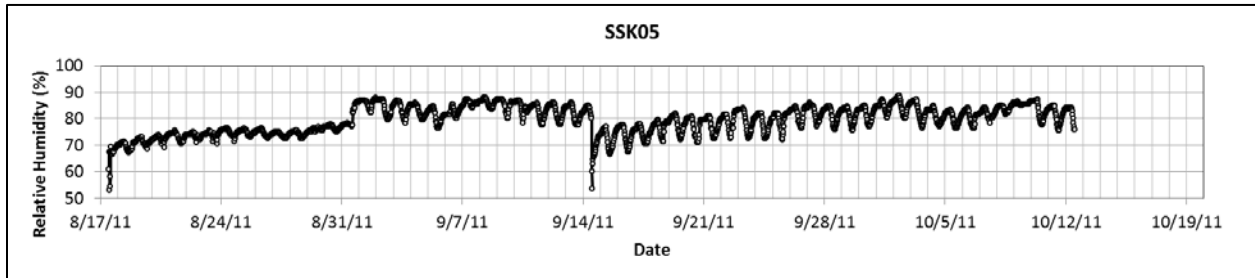
Figure 15 Relative Humidity of Duct 5 at SSK

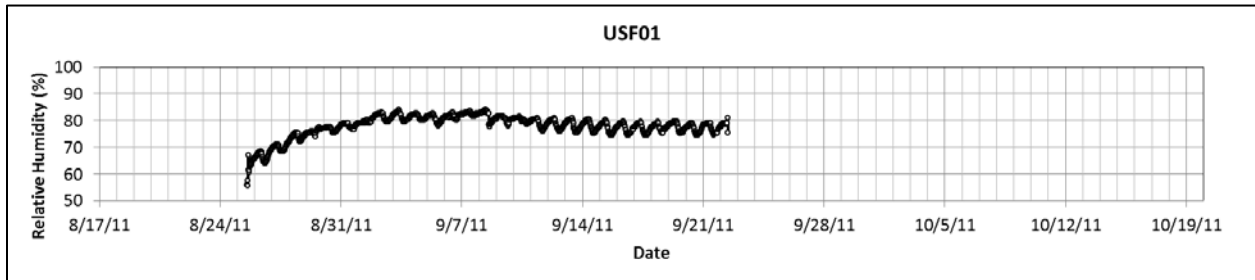
Figure 16 Relative Humidity of Duct 1 at USF

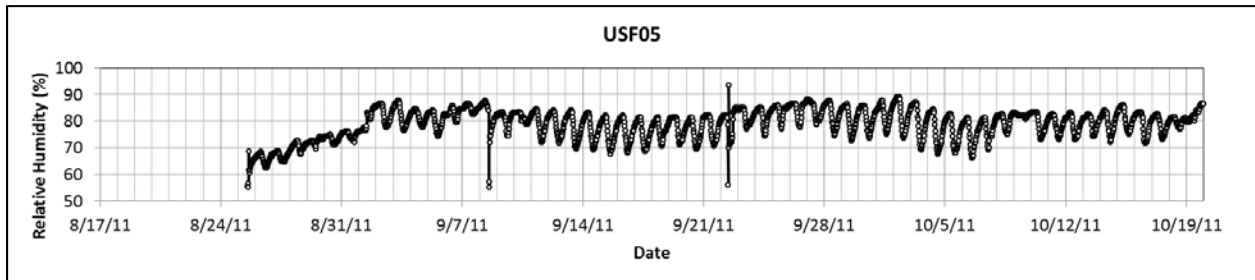
Figure 17 Relative Humidity of Duct 5 at USF

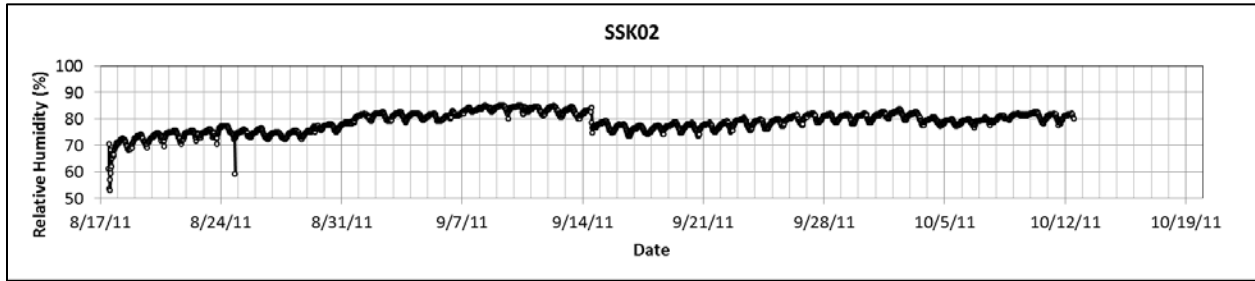
Figure 18 Relative Humidity of Duct 2 at SSK

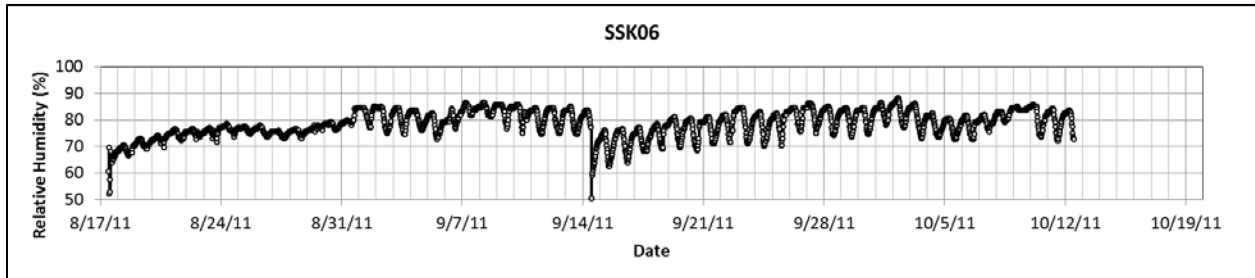
Figure 19 Relative Humidity of Duct 6 at SSK

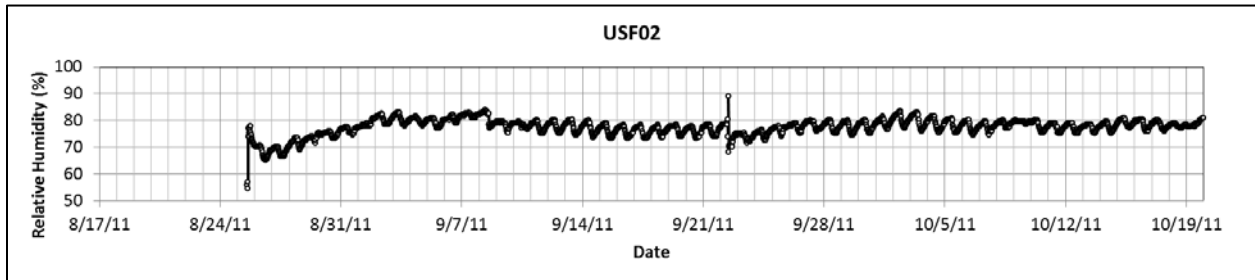
Figure 20 Relative Humidity of Duct 2 at USF

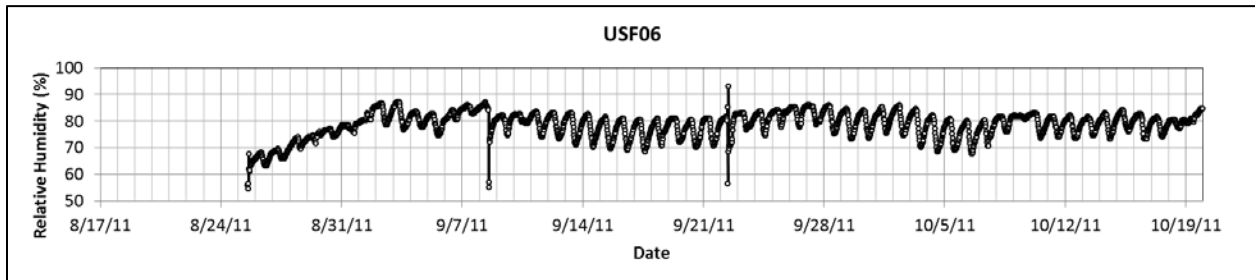
Figure 21 Relative Humidity of Duct 6 at USF

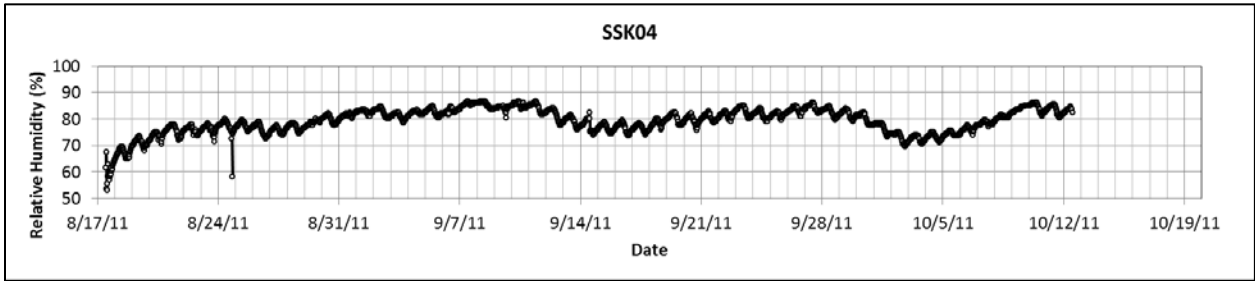
Figure 22 Relative Humidity of Duct 4 at SSK

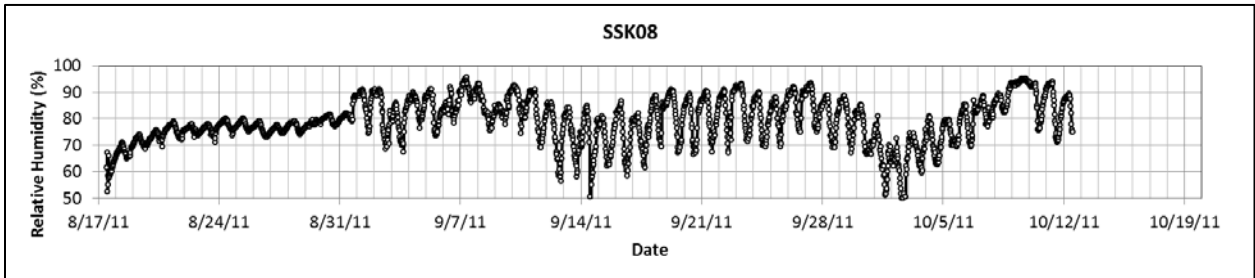
Figure 23 Relative Humidity of Duct 8 at SSK

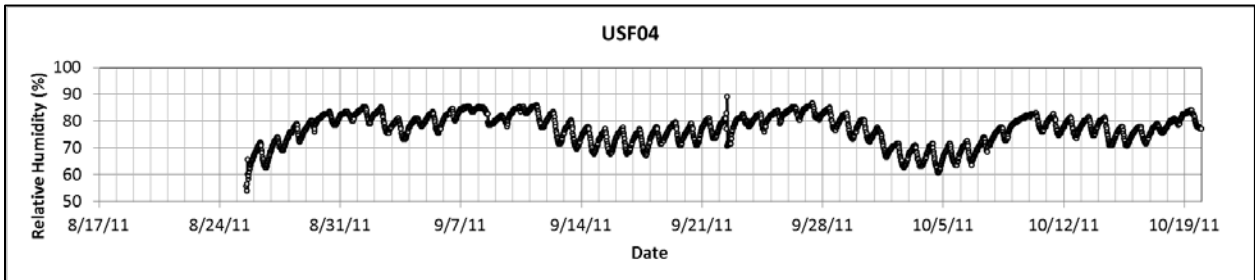
Figure 24 Relative Humidity of Duct 4 at USF

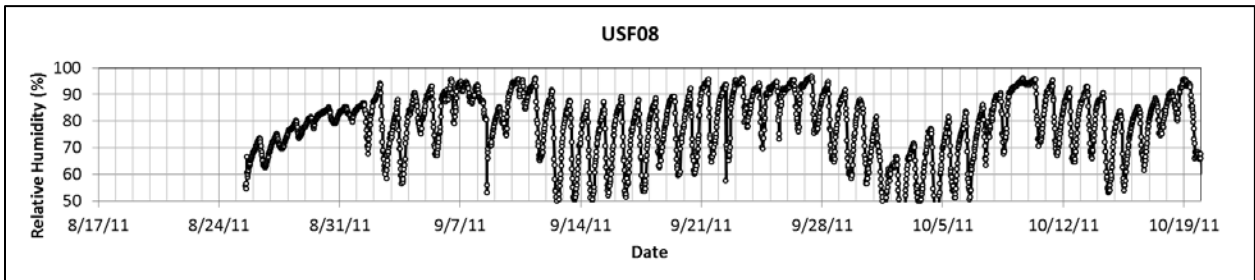
Figure 25 Relative Humidity of Duct 8 at USF

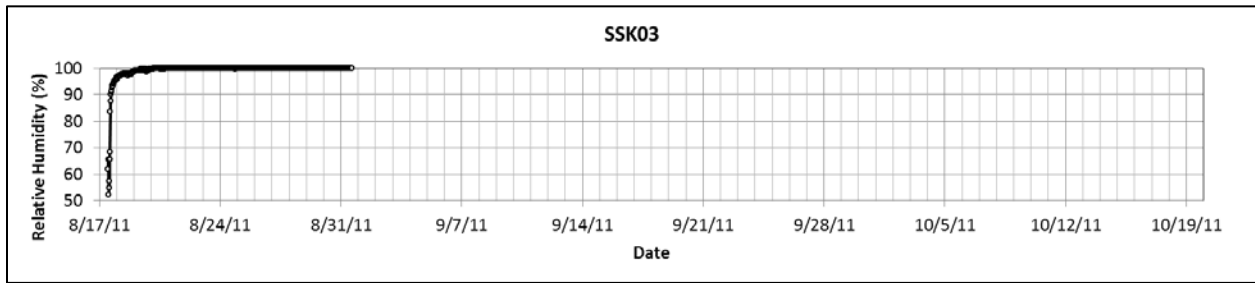
Figure 26 Relative Humidity of Duct 3 at SSK

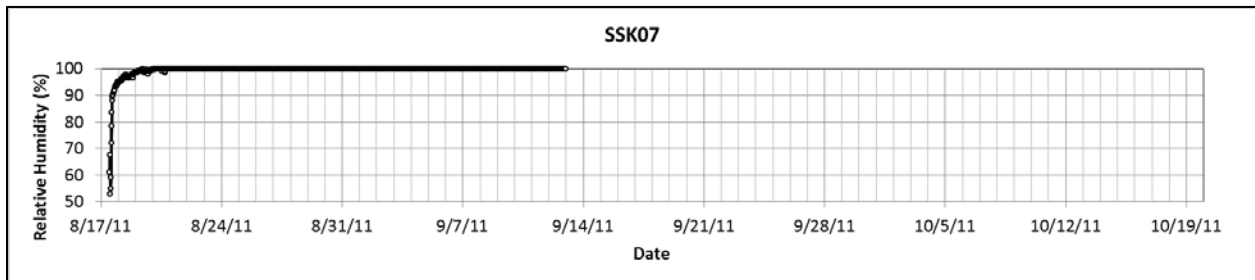
Figure 27 Relative Humidity of Duct 7 at SSK

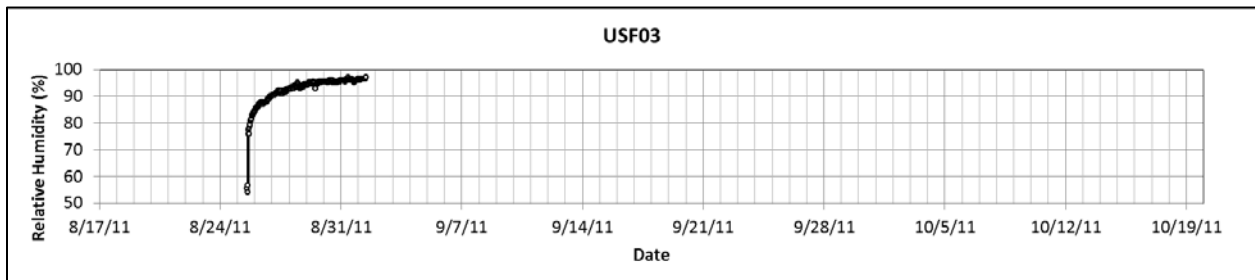
Figure 28 Relative Humidity of Duct 3 at USF

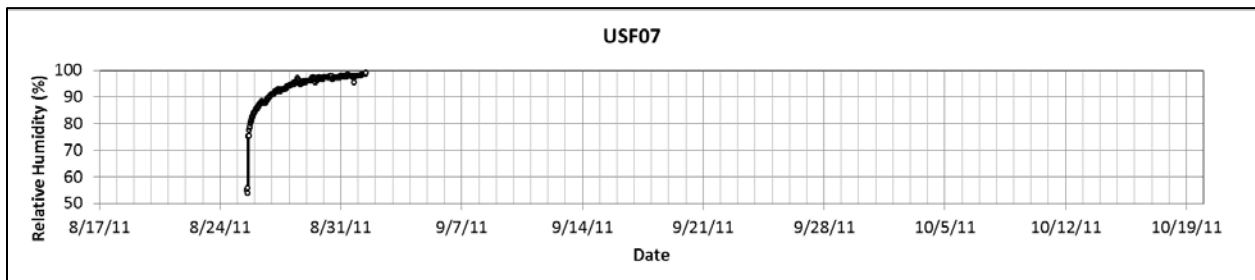
Figure 29 Relative Humidity of Duct 7 at USF

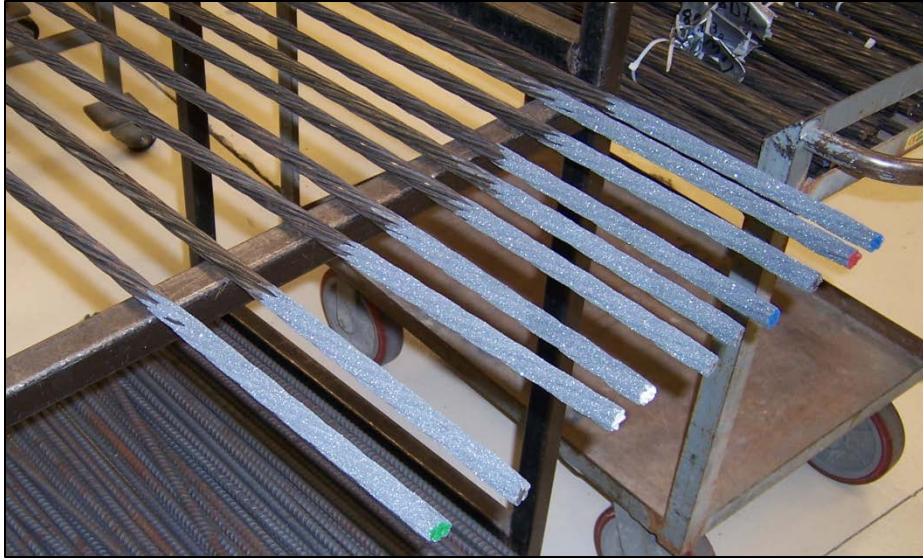
Figure 35 Sample Strands' Ends Coated in Grit Material Awaiting Tensile Testing

Three performance descriptors were evaluated from the results of the tensile pull test: total load at failure, total elongation, and load at 1% elongation. These values were then compared to the mechanical performance criteria as specified by ASTM A416 (ASTM International, 2006). The graphs in Figure 37 through Figure 48 show the cumulative fractions of each respective category. The vertical red lines indicate the ASTM specified requirement for satisfactory performance. Major slippage occurred when testing some strands. The cause was loss of gripping due to either improper application of the silicon carbide at the ends, or failure to suitably clean the jack grips before each sample was tested. Samples which displayed obvious grip slippage are not represented in the following data. Figure 35 shows the samples ready for testing with SiC coated ends. Figure 36 shows a sample break and the fully engaged grips used for testing.

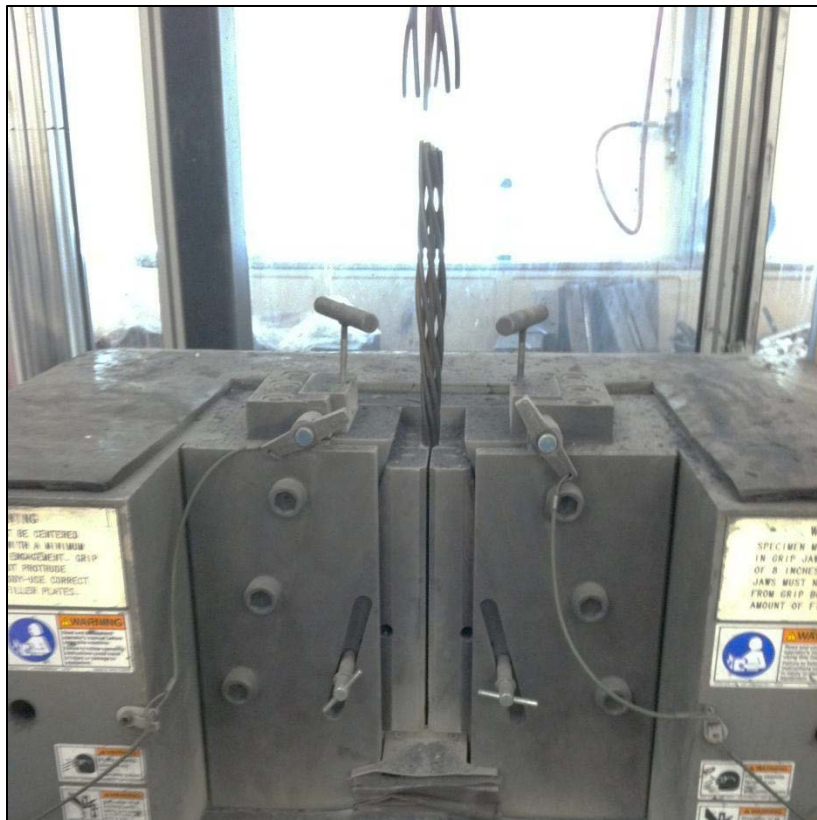
Figure 36 Sample Strand Break and Fully Engaged Grip

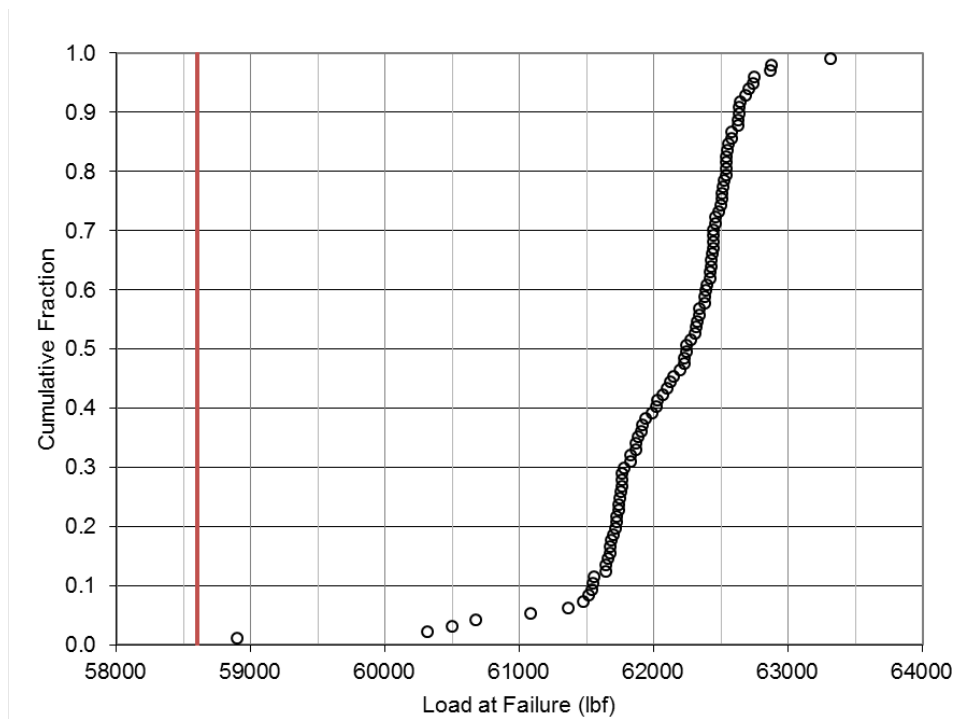
Figure 37 Total Cumulative Fraction of Load at Failure

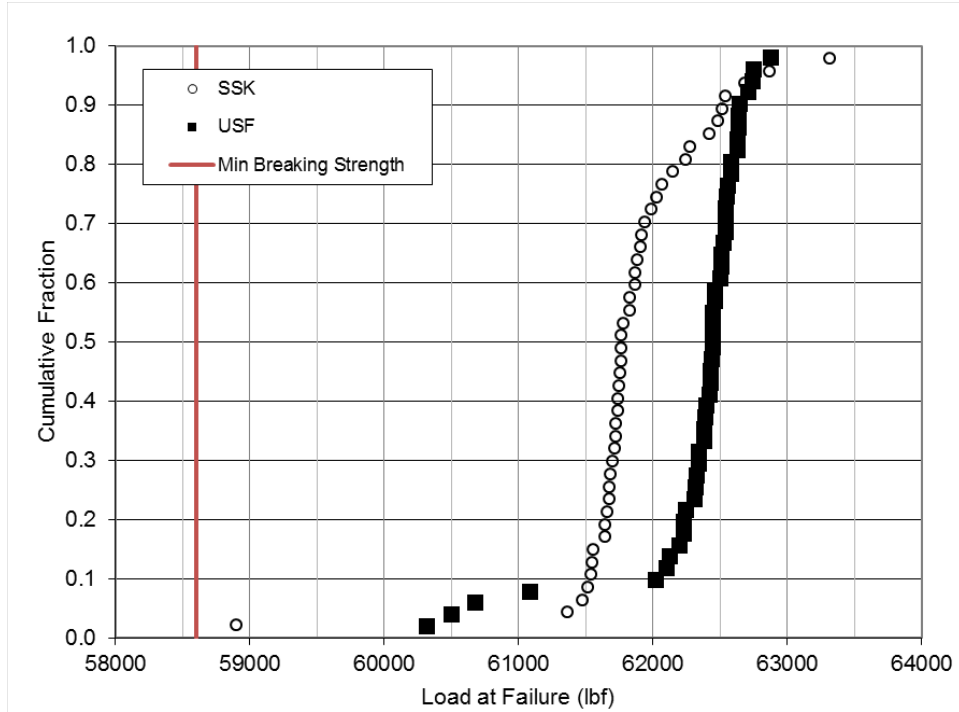
Figure 38 Cumulative Fraction of Load at Failure - Environment Comparison

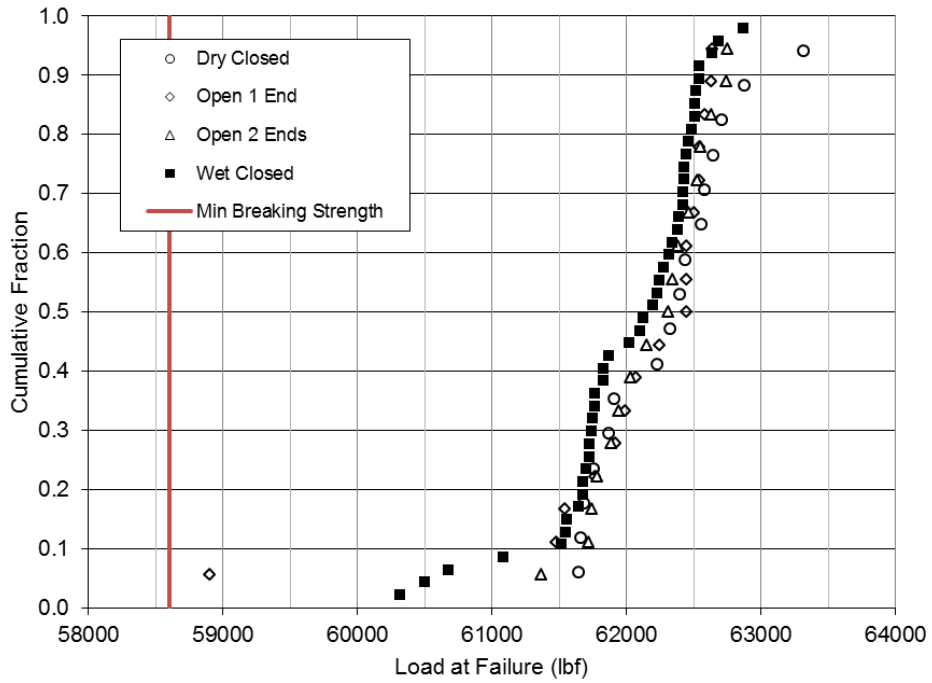
Figure 39 Cumulative Fraction of Load at Failure - Duct Condition Comparison

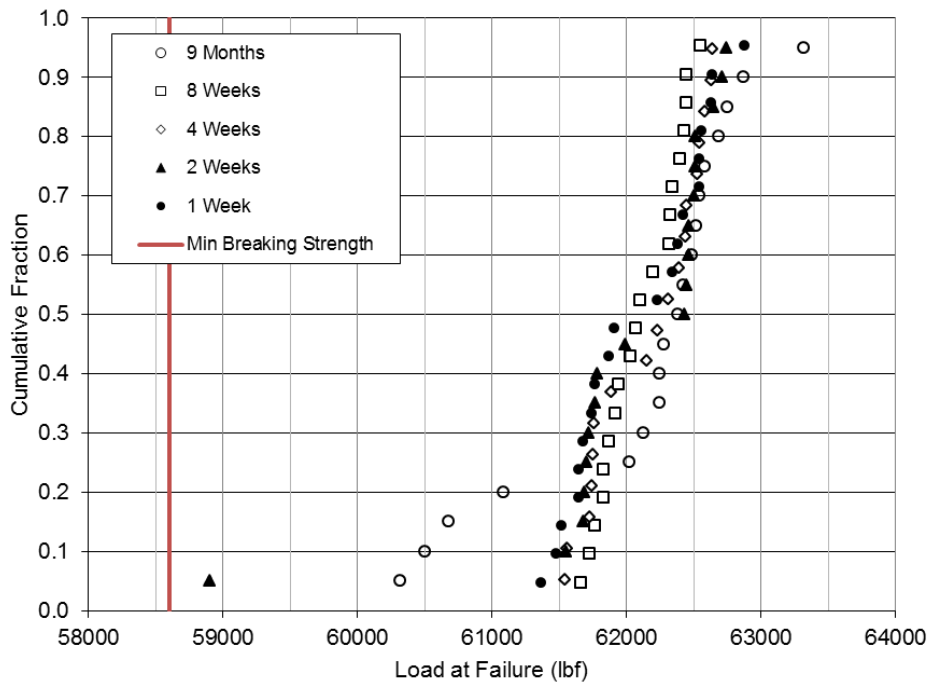
Figure 40 Cumulative Fraction of Load at Failure - Exposure Length Comparison

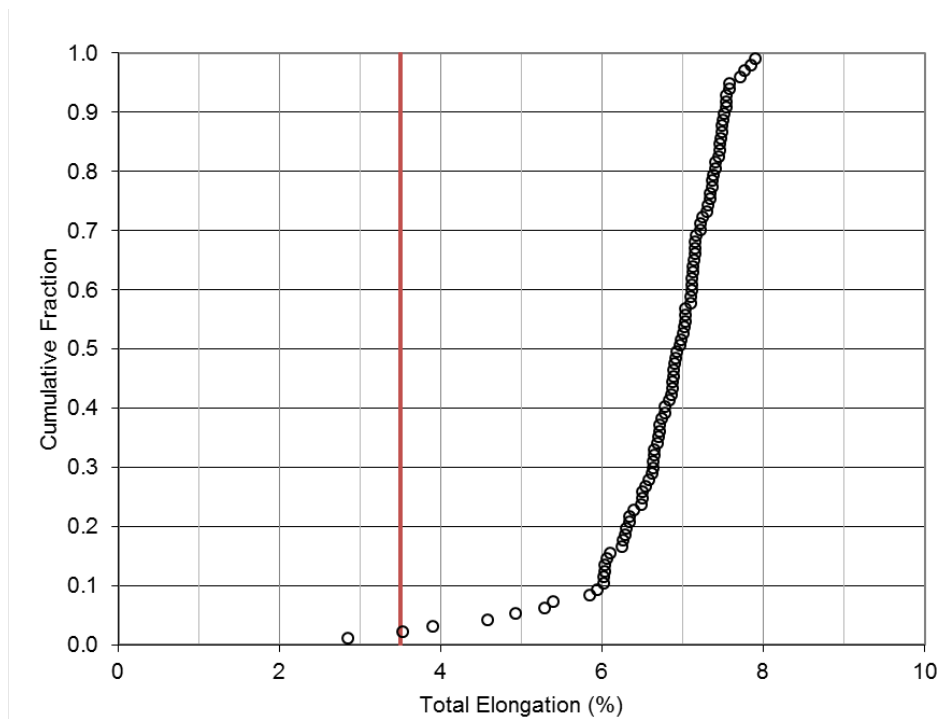
Figure 41 Total Cumulative Fraction of Total Elongation at Failure

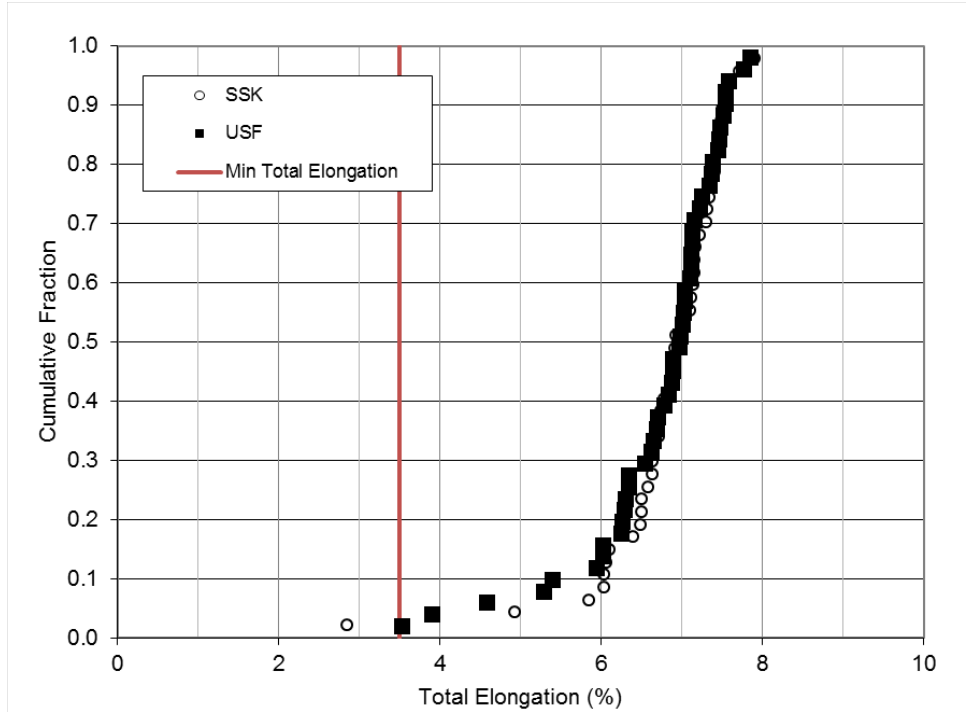
Figure 42 Cumulative Fraction of Total Elongation at Failure - Environment Comparison

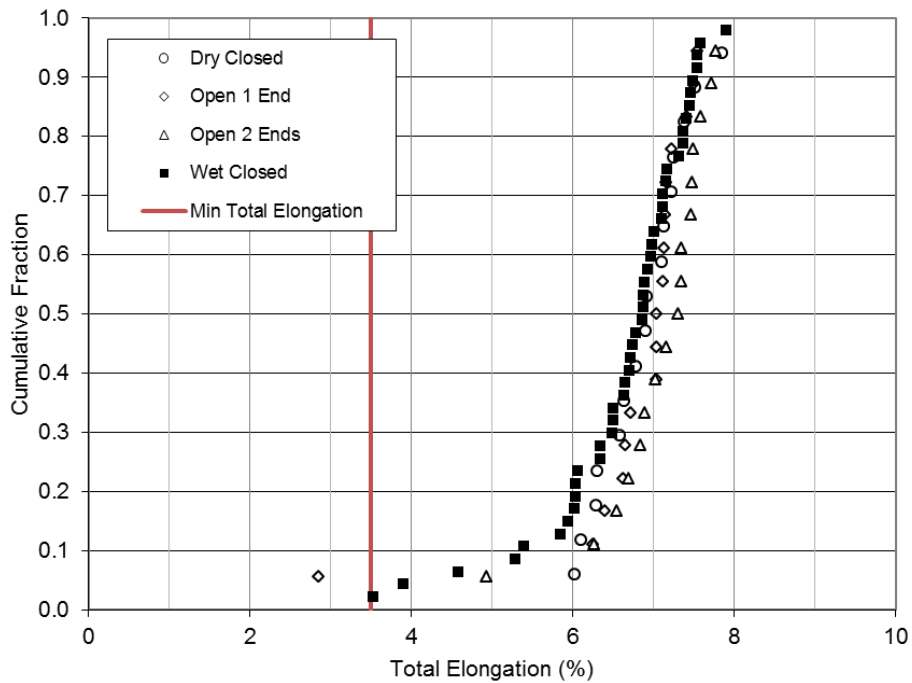
Figure 43 Cumulative Fraction of Total Elongation at Failure - Duct Condition Comparison

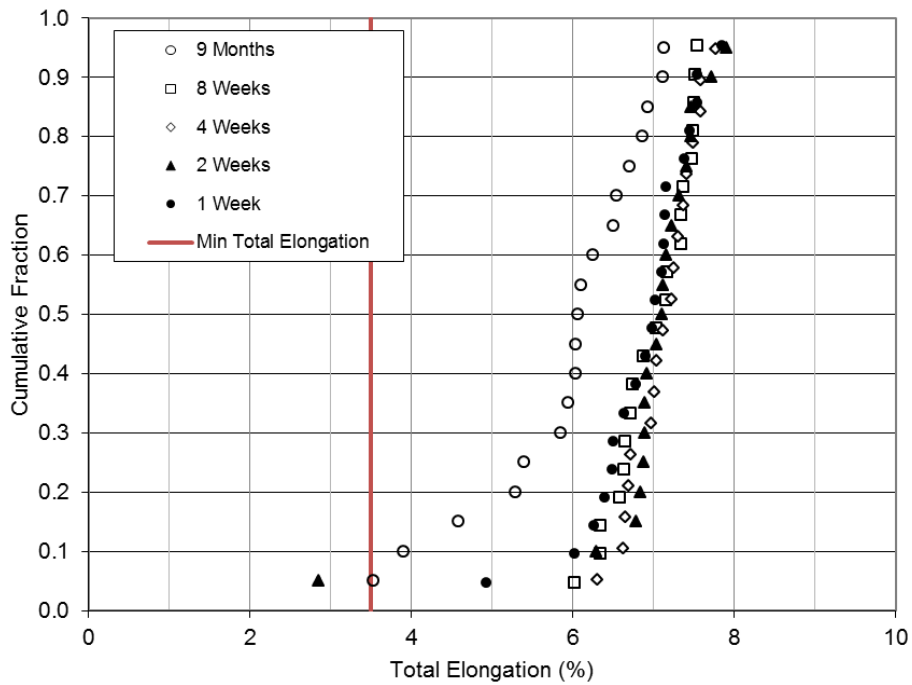
Figure 44 Cumulative Fraction of Total Elongation at Failure - Exposure Length Comparison

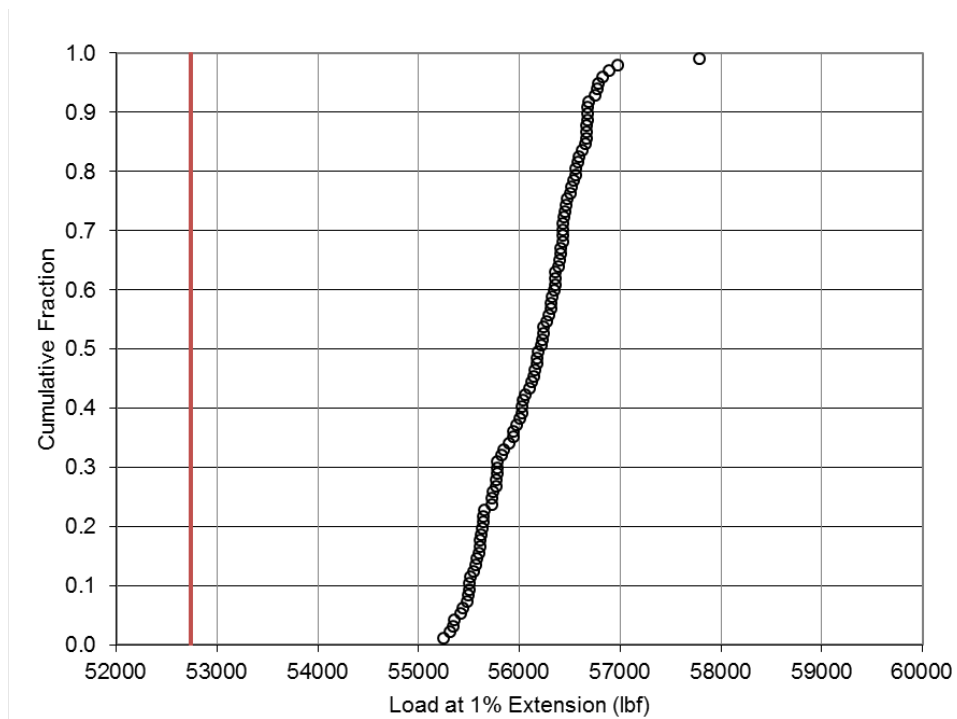
Figure 45 Total Cumulative Fraction of Load at 1% Extension

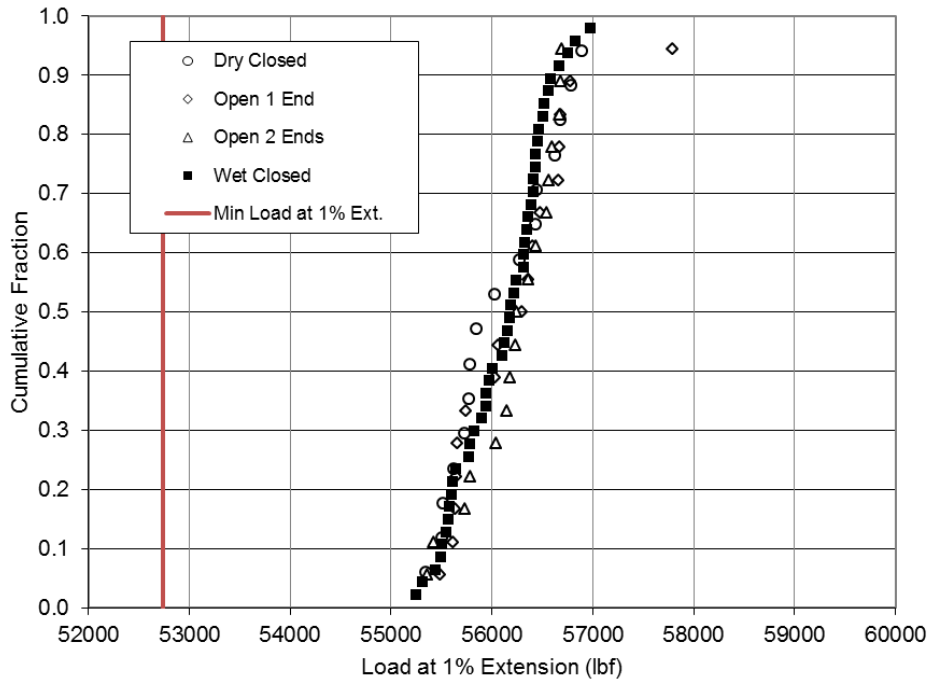
Figure 47 Cumulative Fraction of Load at 1% Extension - Duct Condition Comparison

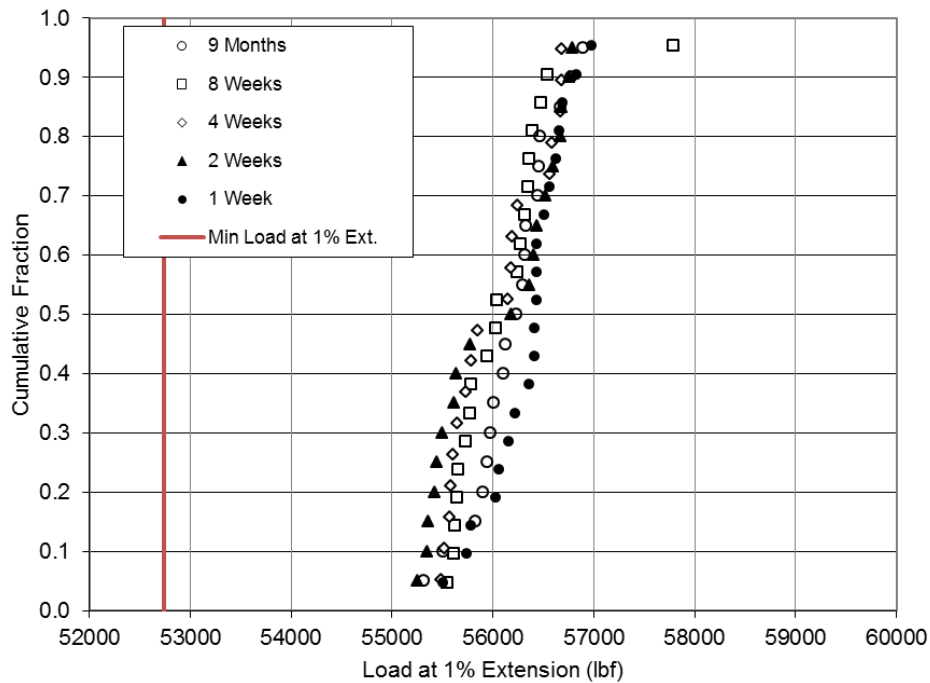
Figure 48 Cumulative Fraction of Load at 1% Extension - Exposure Length Comparison

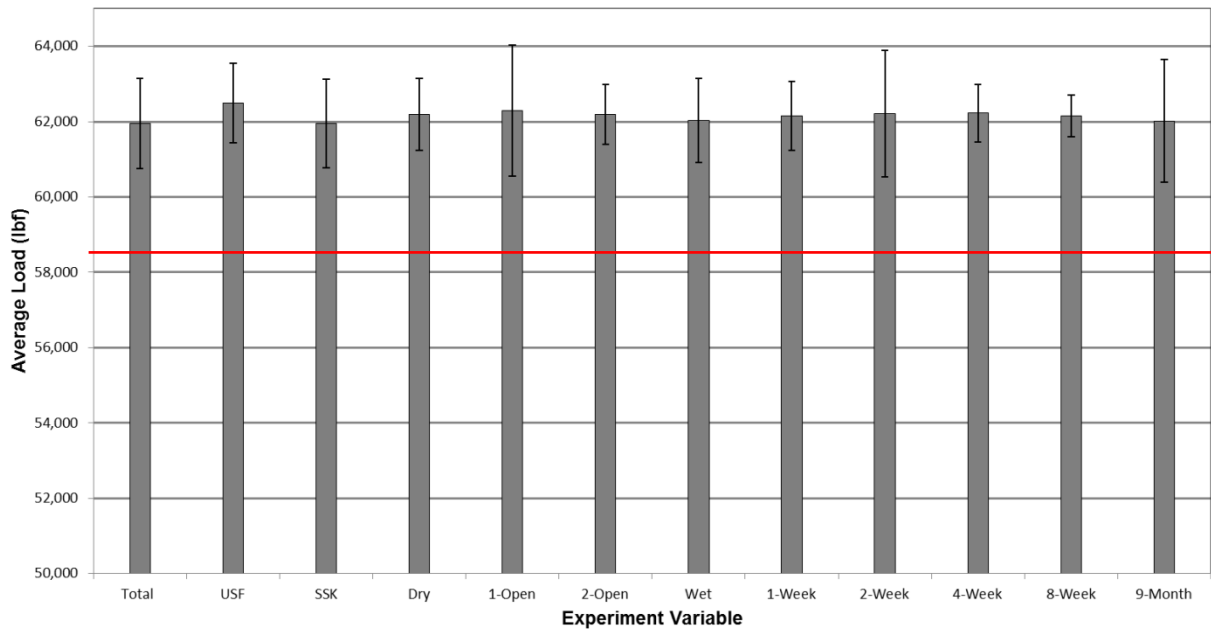
Figure 49 Average Load at Failure by Experiment Variable - Error Bars are 2 Standard Deviations Tall (Red Line Indicates ASTM A416 Minimum Requirement)

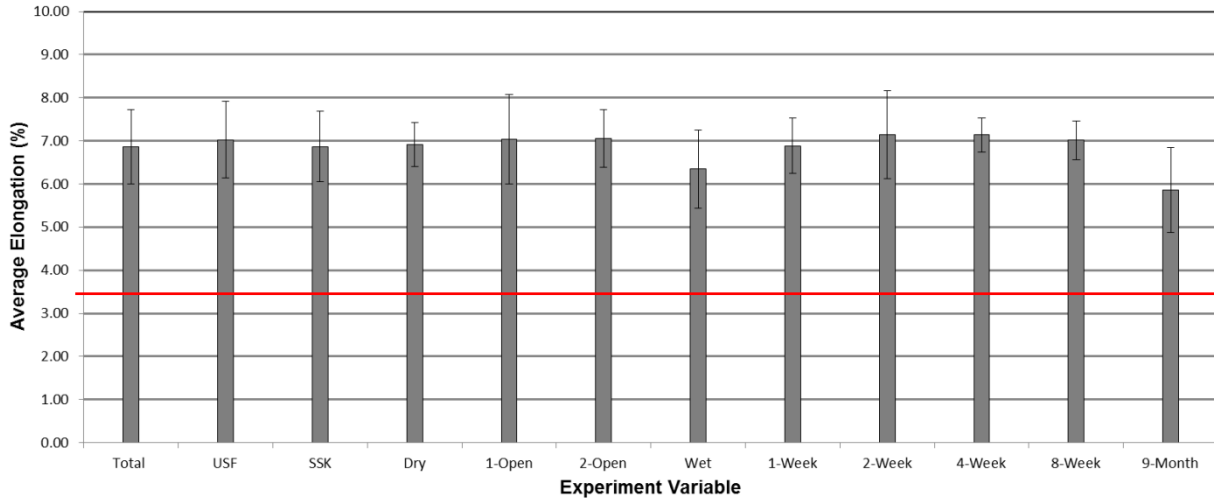
Figure 50 Average Elongation to Failure by Experiment Variable - Error Bars are 2 Standard Deviations Tail (Red Line Indicates ASTM A416 Minimum Requirement)

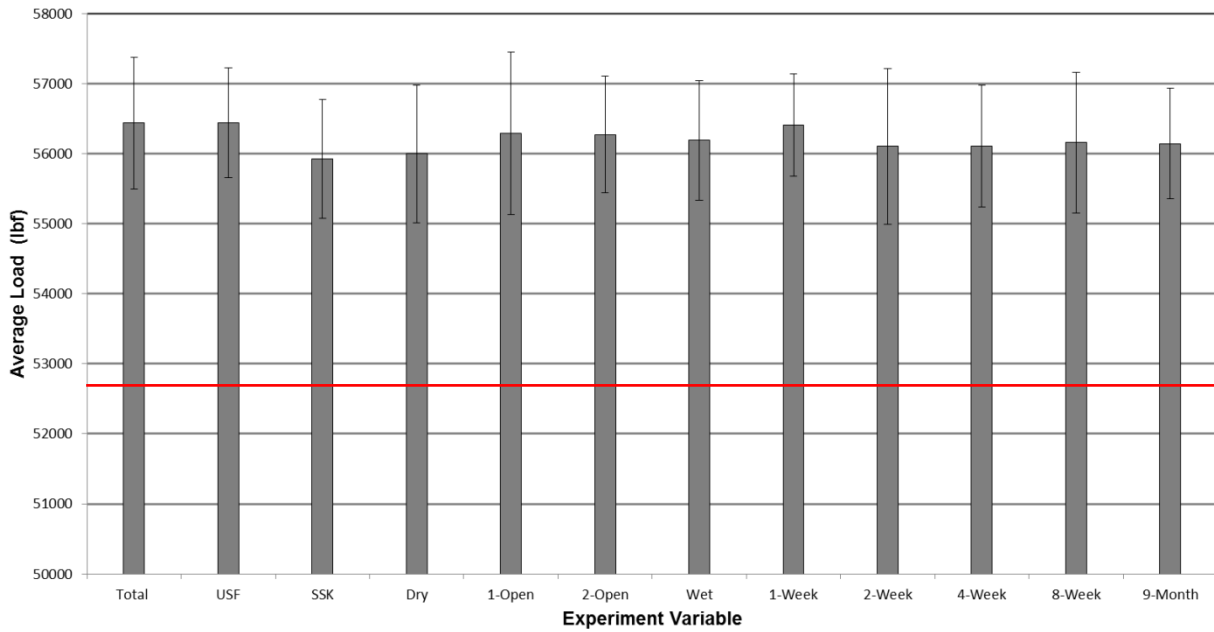
Figure 51 Average Load at 1% Extension by Experiment Variable - Error Bars are 2 Standard Deviations Tail (Red Line Indicates ASTM A416 Minimum Requirement)

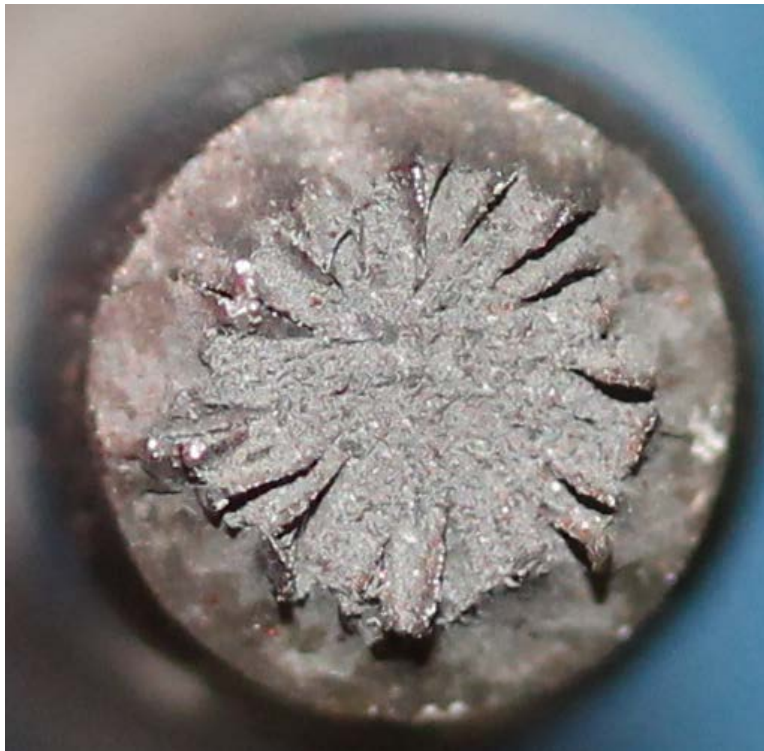
Figure 52 Typical Fracture Surface (1/4)

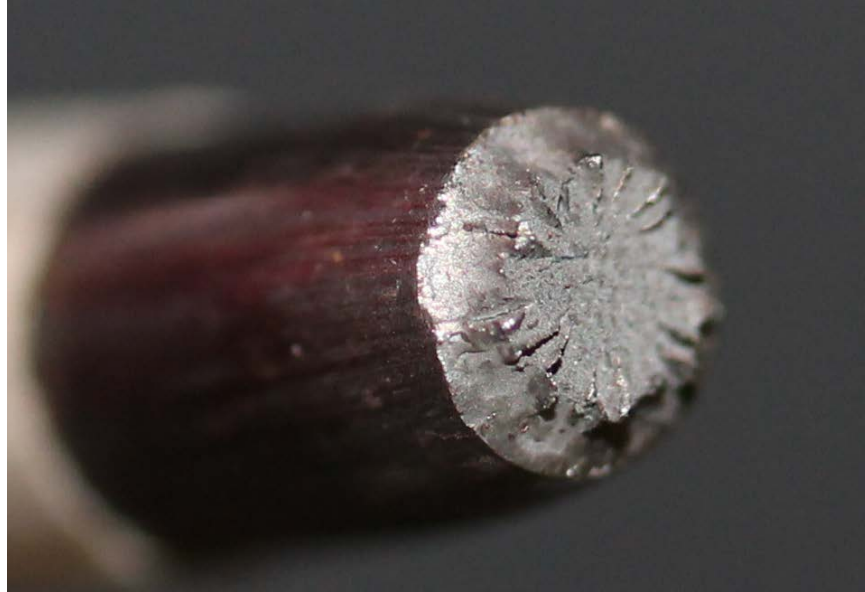
Figure 53 Typical Fracture Surface (2/4)
